20th July 2016

Ref.: 2-63649.00

Initial Seismic Assessment Report - 55 Coote Road, Napier

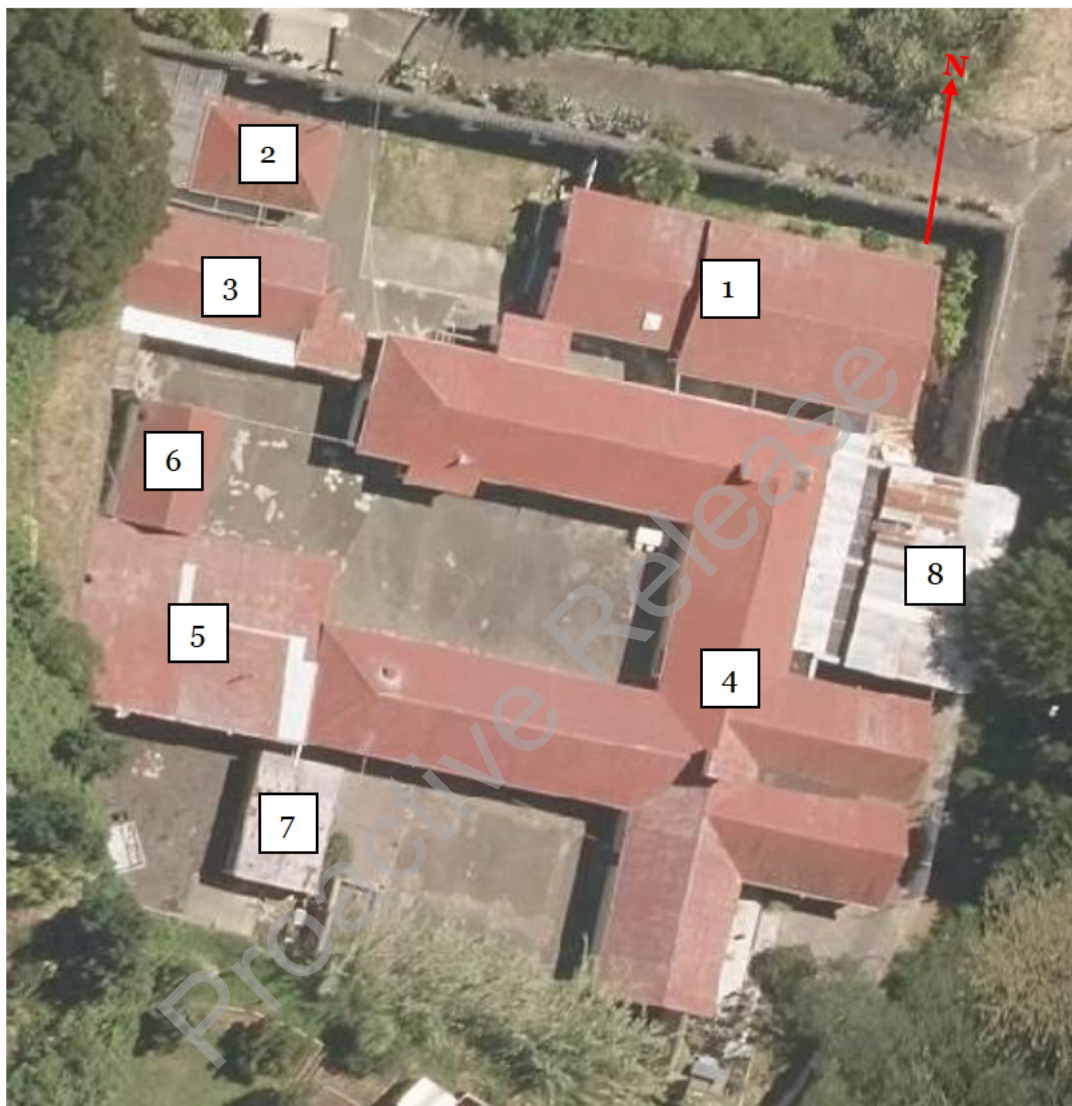
Figure 1: Overview of the prison complex with associated buildings numbered

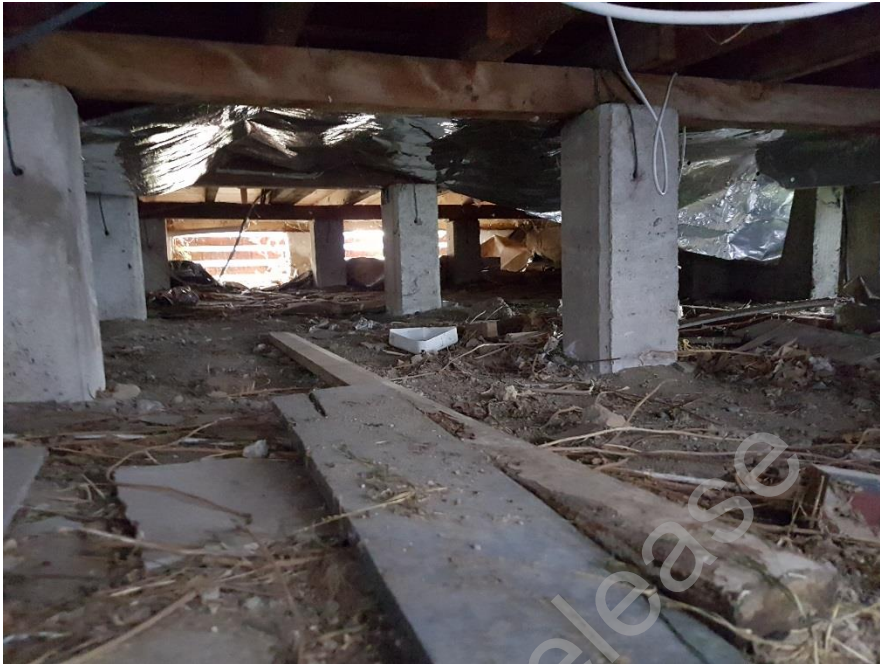
Figure 2: Underneath the timber framed buildings that consist of suspended timber floors on concrete piles.

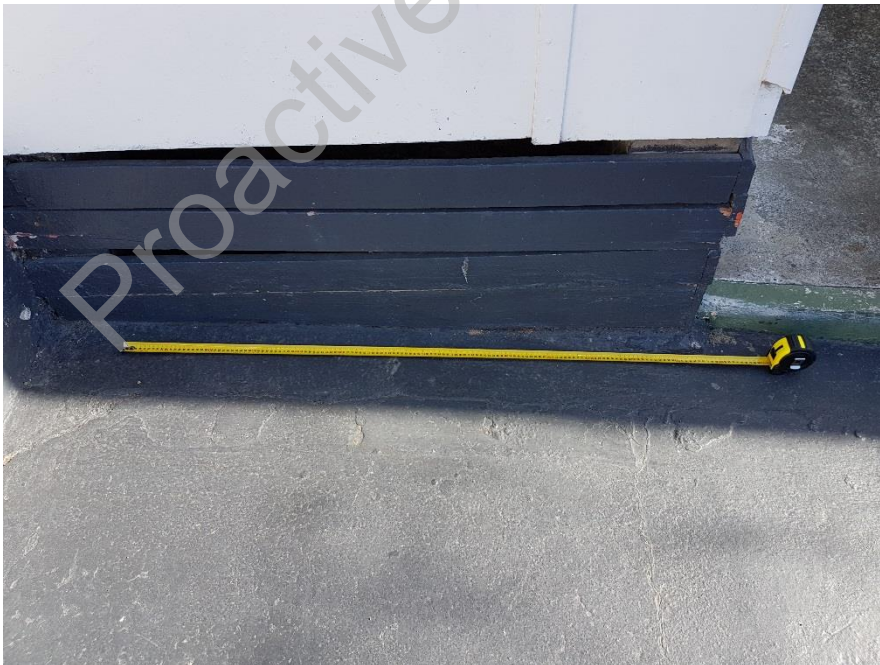
Figure 3: Timber board walls around the perimeter of the building.

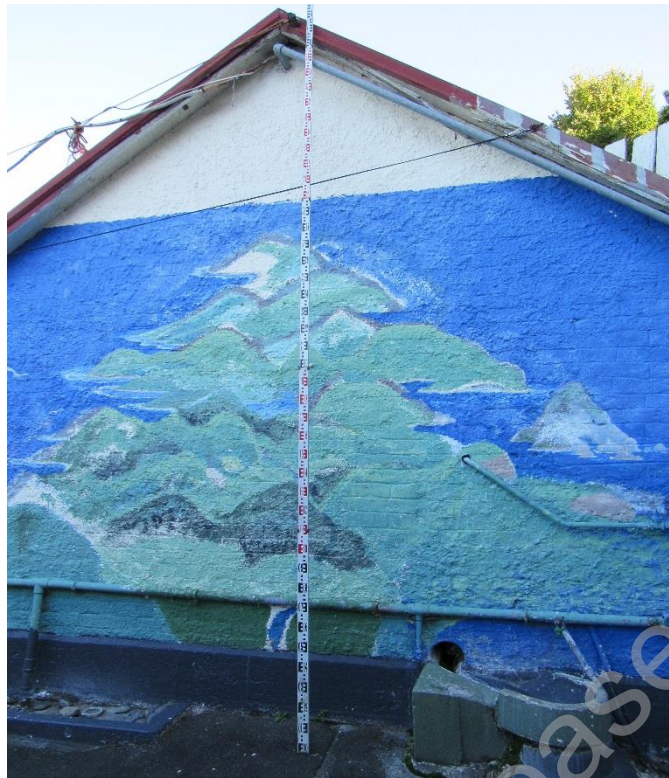
Figure 4: Concrete block wall at the base of the building - around the perimeter.

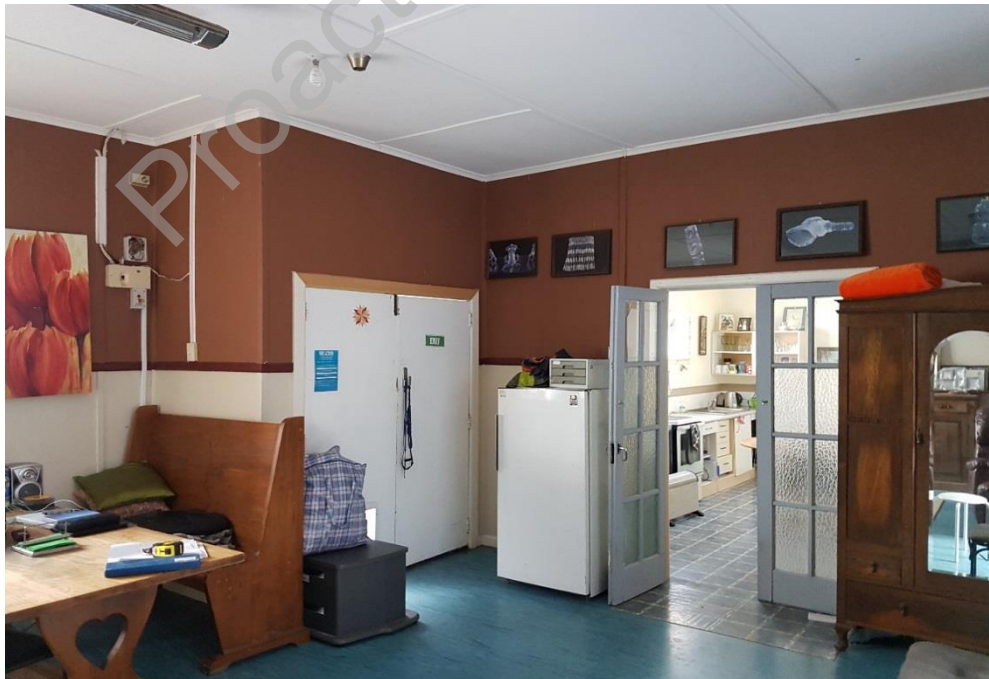
Figure 5: Internal view of dwelling area.

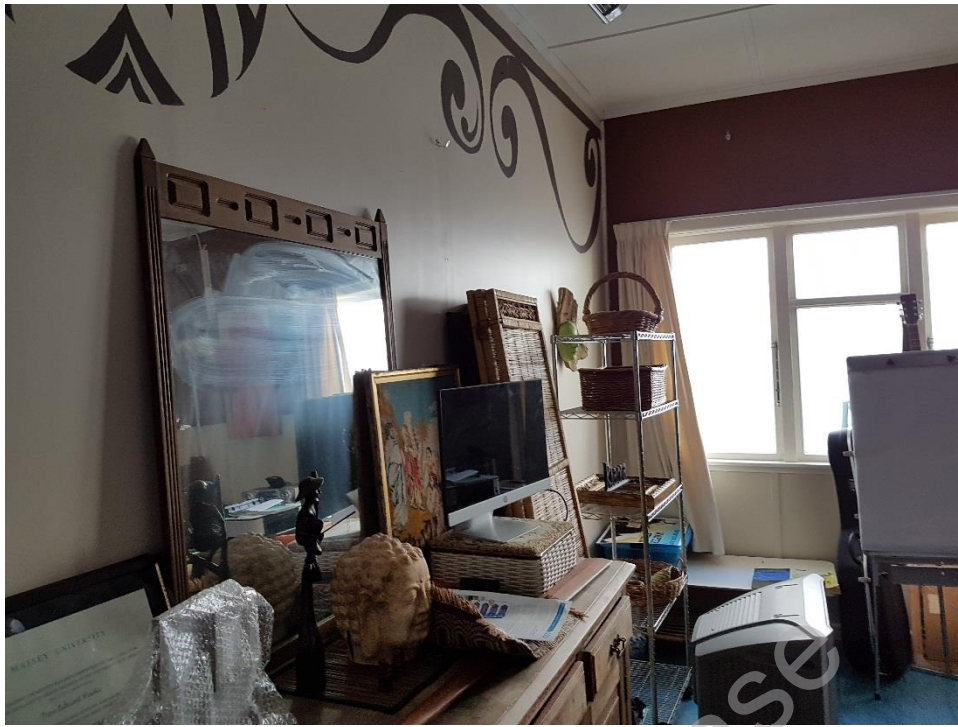
Figure 6: Internal partition wall (timber framed) up to ceiling joists installed in 2003. The wall is lined with Gib Board.

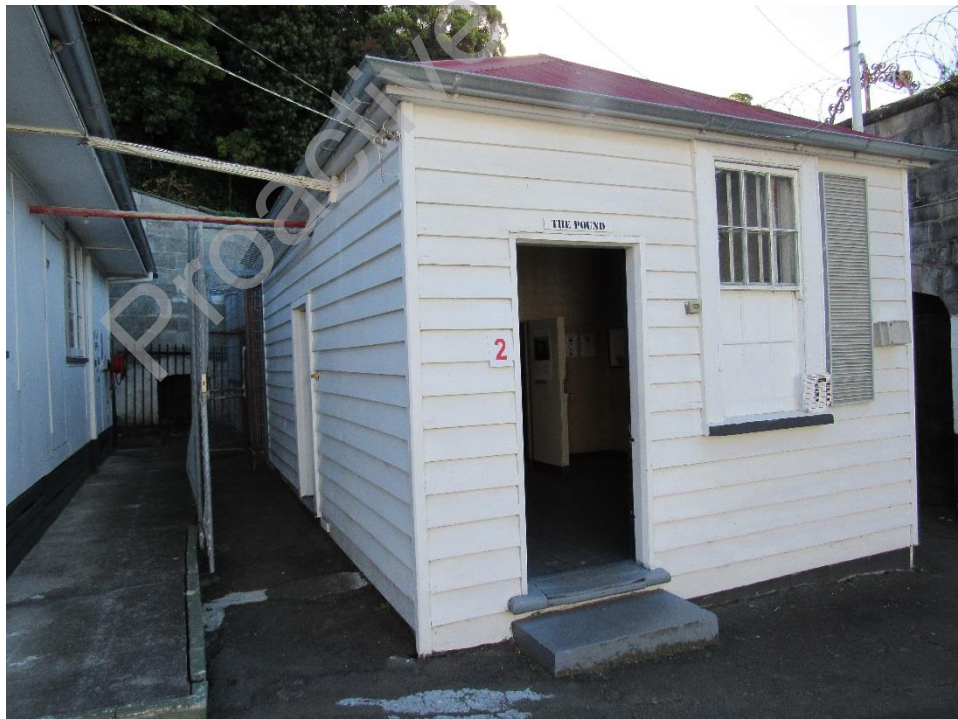
Figure 7: "The Pound"

The structure for "The Pound" as shown below features timber board cladding as the external wall lining while the internal walls are lined with 25mm timber sarking.

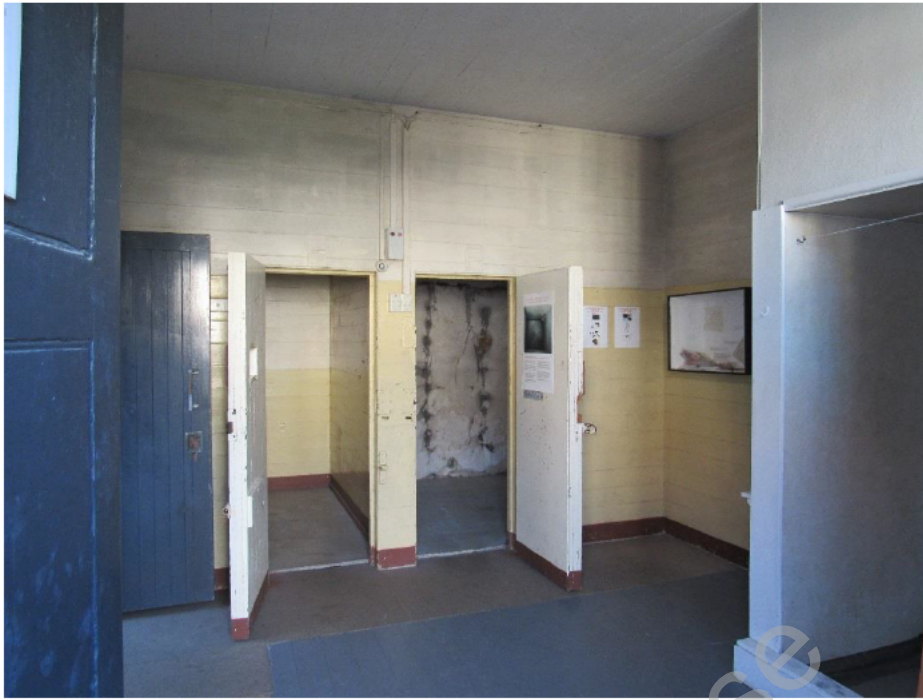
Figure 8: Timber sarking for internal walls.

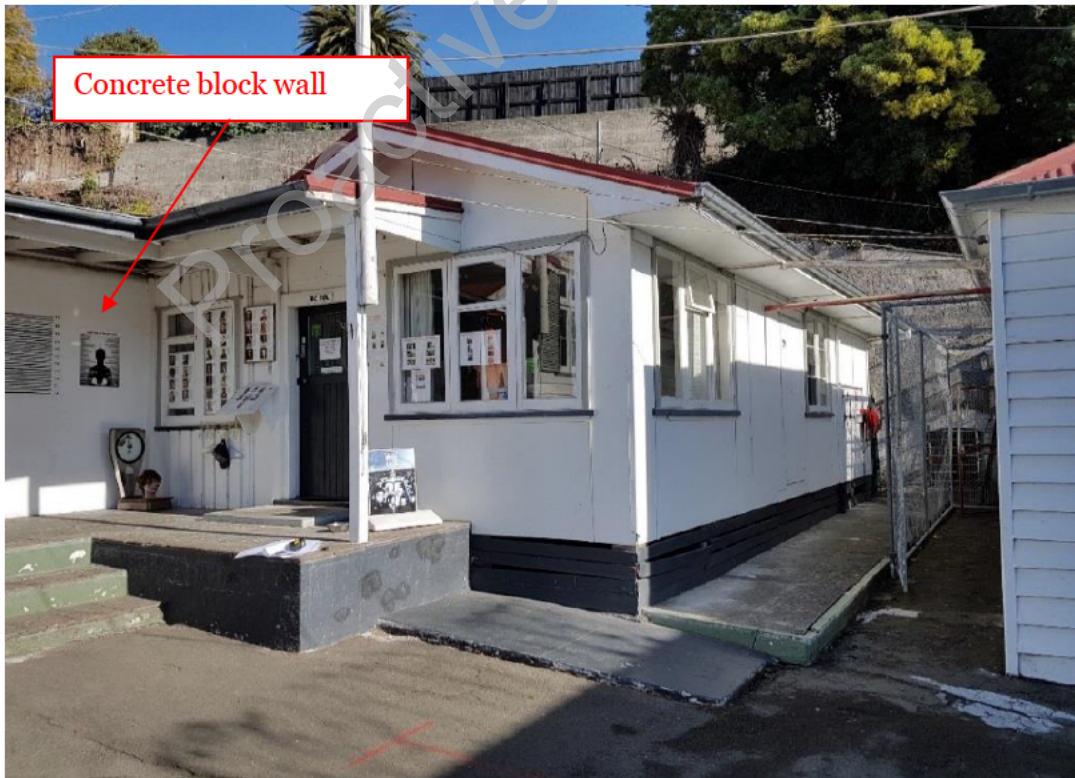
Figure 9: External view of the main office block.

The reasoning for the low scores for Buildings 3 and 5 is the unknown connection detailing between the buildings and the concrete wall due to the lack of structural drawings. The presence of the concrete wall may introduce heavy lateral loads in the out-of-plane direction and uneven distribution of load resistance in the in-plane direction. We also expect there may be damage between the interfaces between the timber and concrete wall.

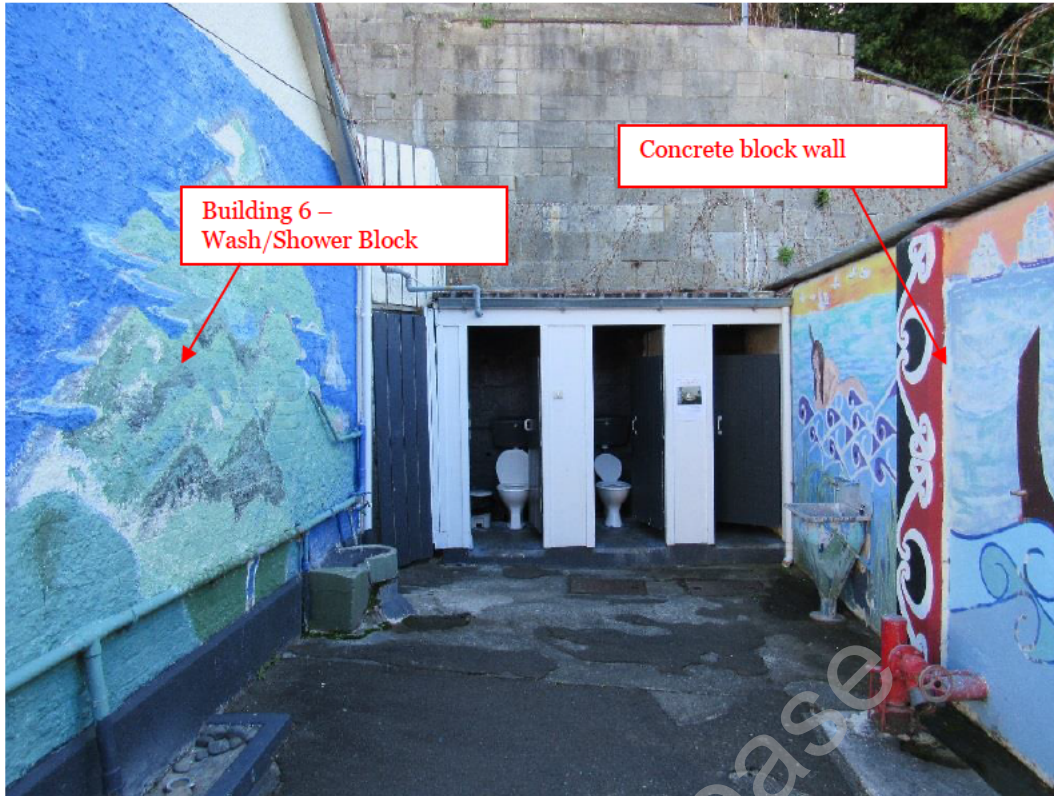
Figure 10: External view of the concrete block wall adjacent to the main office block and opposite to Building 6.

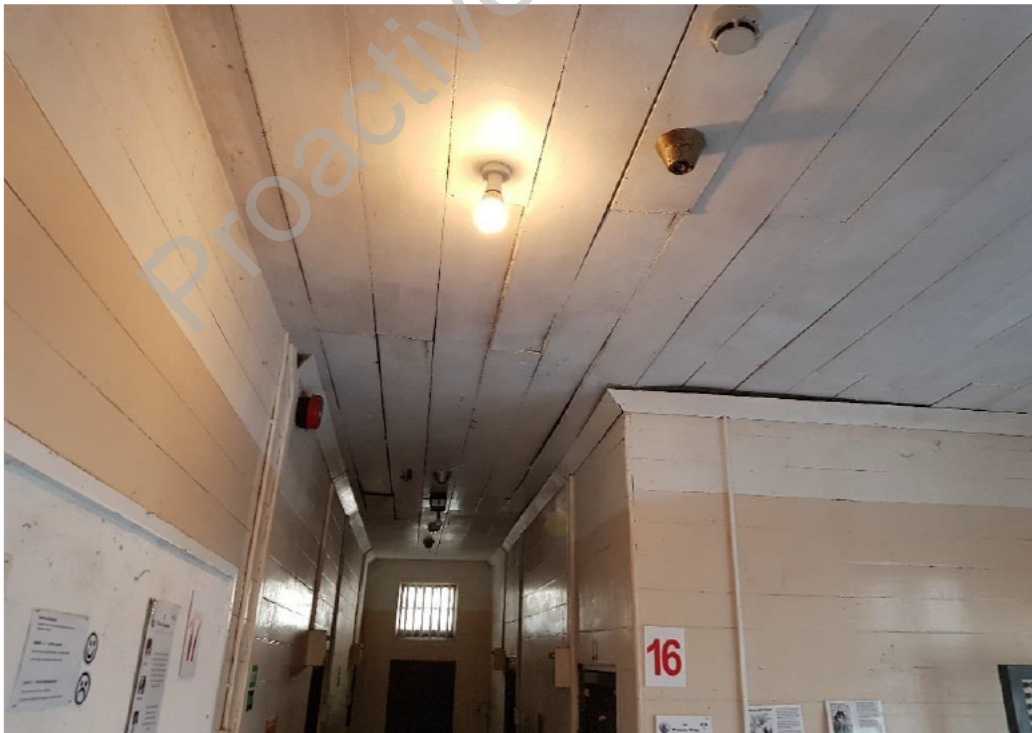
Figure 11: Timber staking boards for the internal wall and ceiling lining of the main prison block (Building 4).

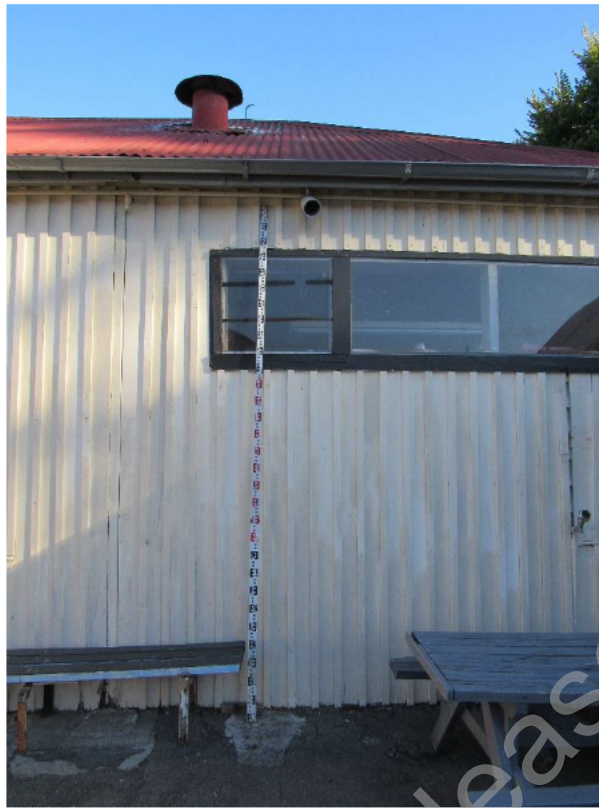
Figure 12: Timber board cladding for the external wall lining at the main prison block.

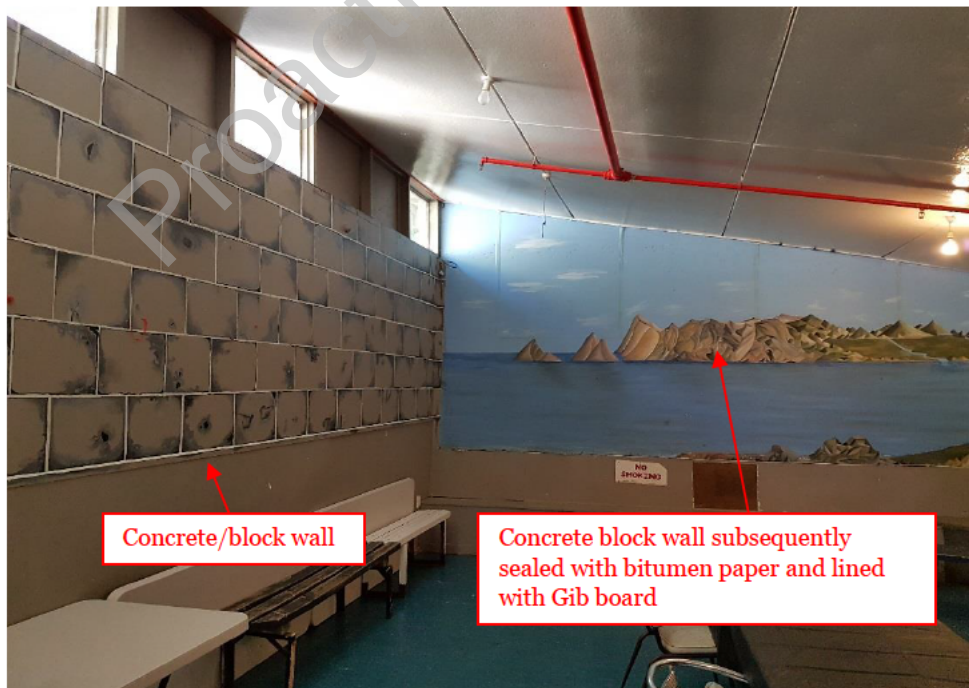
The Dining Hall and TV room are attached to the concrete block perimeter wall. Advice from the tenant on site is that the concrete block wall had leaked water into the building. The wall was subsequently sealed with bitumen tape and lined with Gib board as shown below.

Figure 13: Interior view of the Dining Hall.

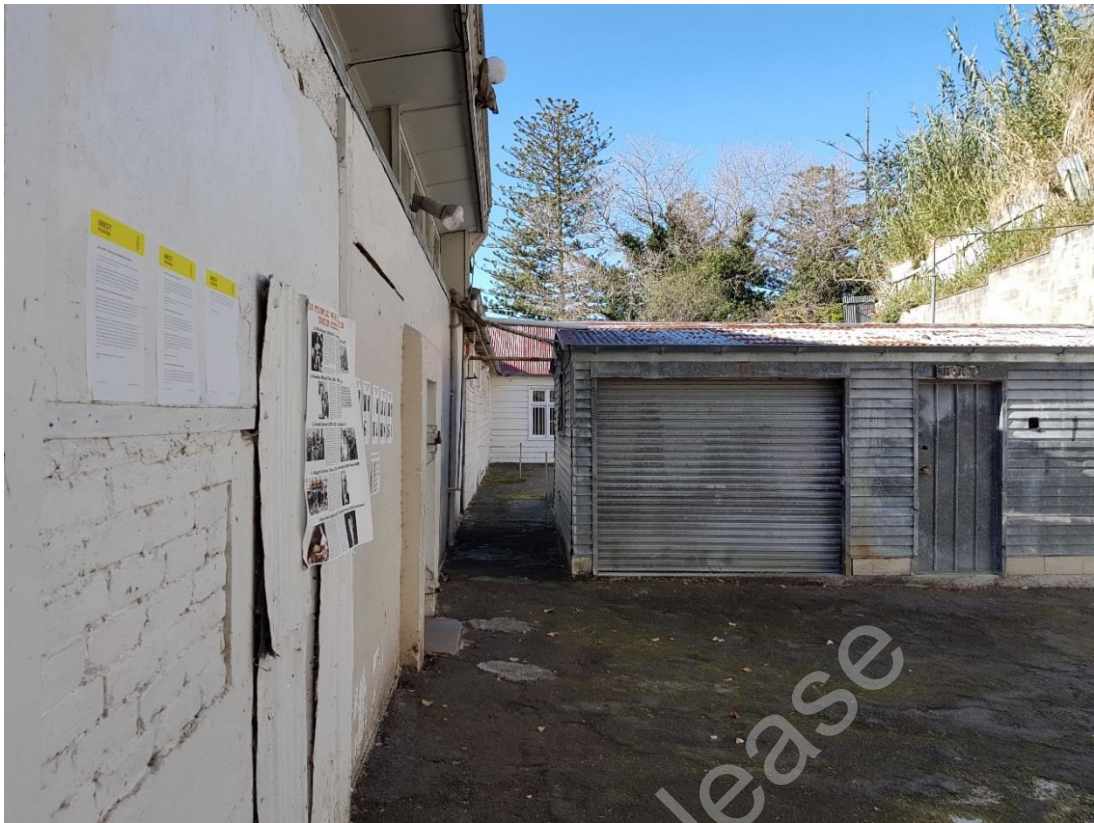
Figure 15: External view of the wall of the Dining Hall.

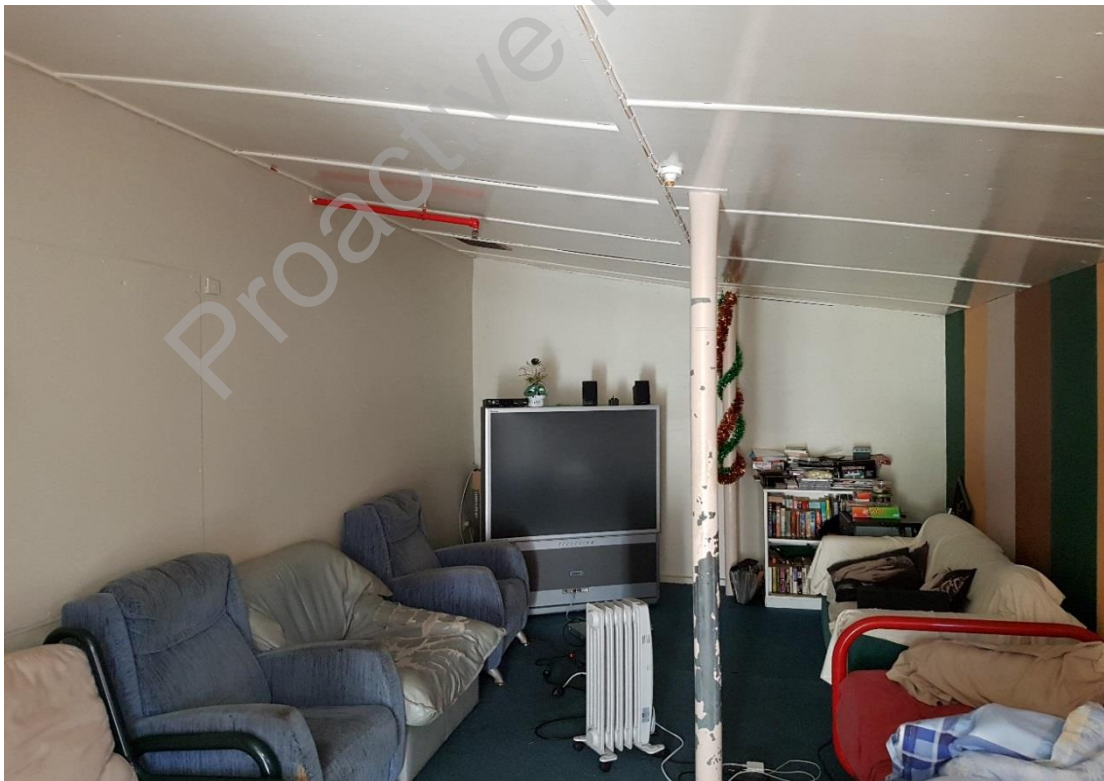
Figure 14: Internal view of the TV room adjacent to the Dining Hall.

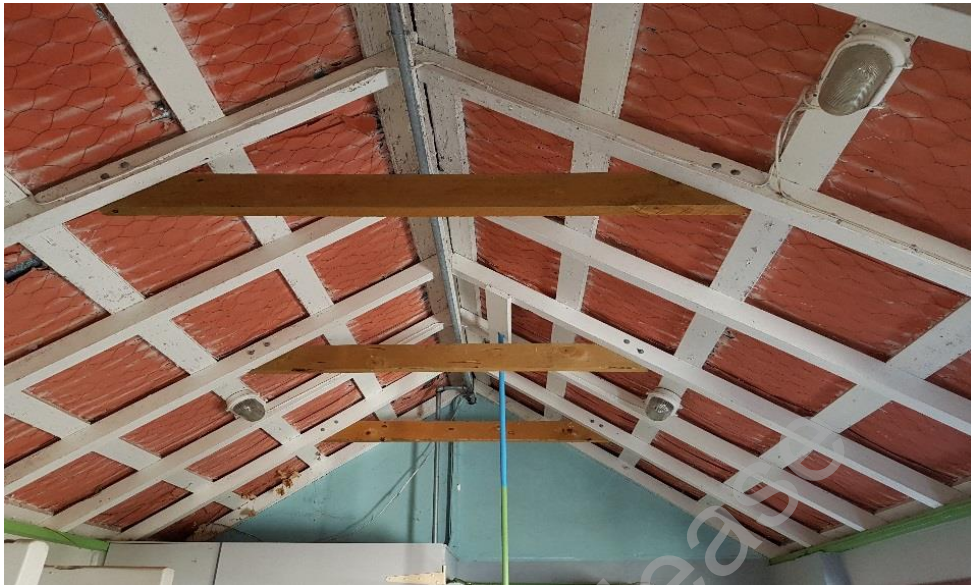
Figure 16: Timber framed structure in the wash/shower block (Building 6) with timber ties across the main rafters.

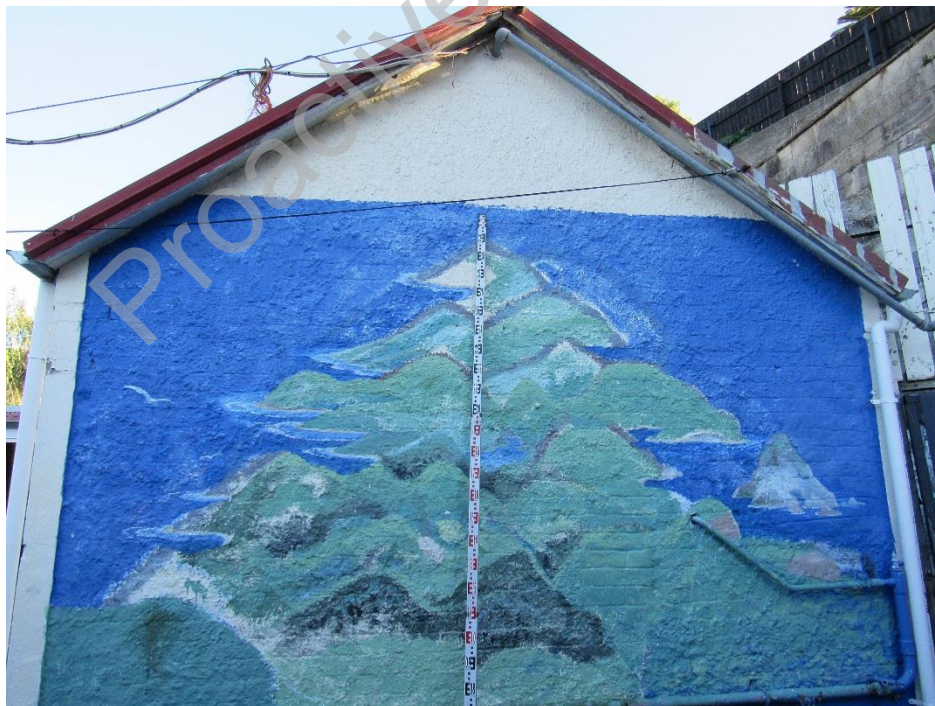
The wall lining for the shower block consists of horizontal timber laths with cement stabilised plaster that is applied between the timber gaps, forming a diaphragm wall.

Figure 17: External wall lining for the wash/shower block.

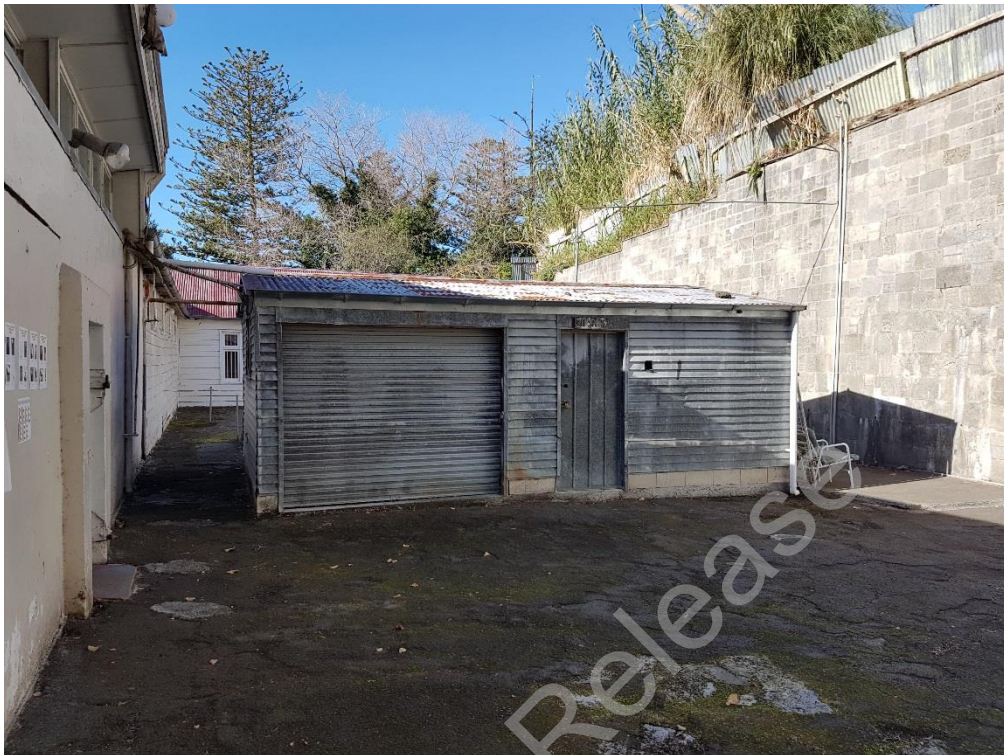
Figure 18: Overview of the Shed/Kit Store

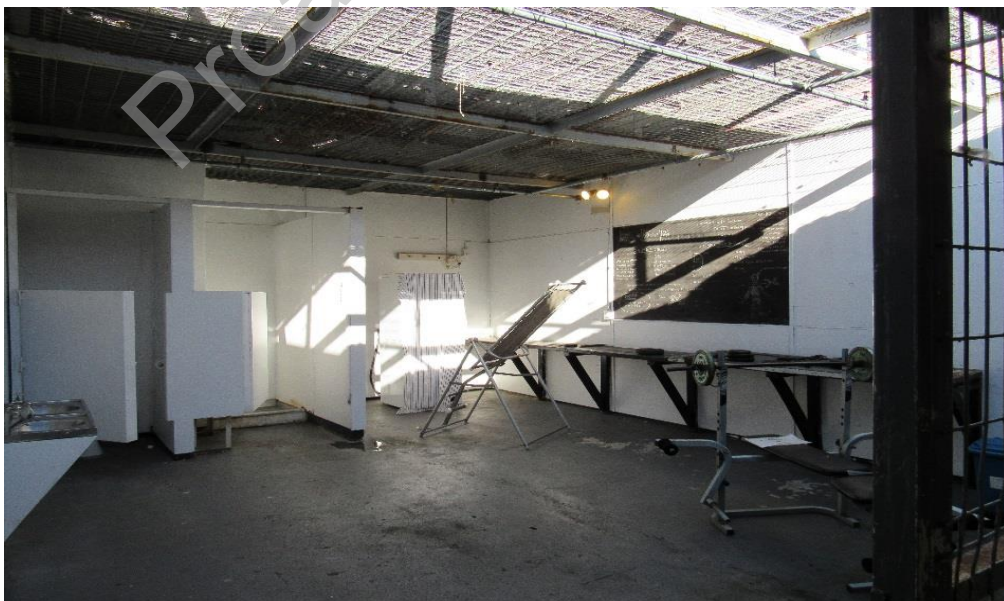
Figure 19: Internal view of the covered yard area.

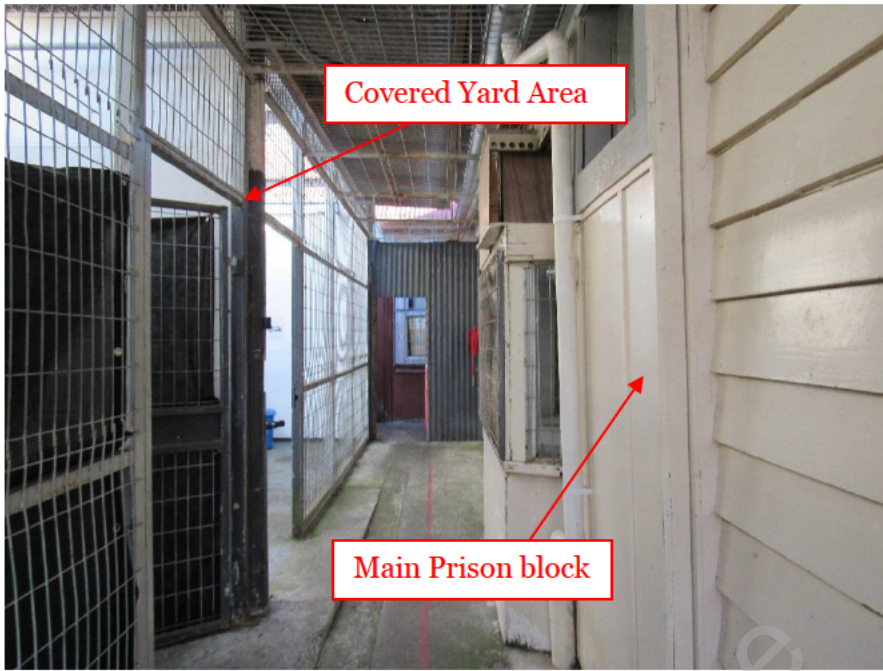
Figure 20: Corridor between the main prison block and the covered yard area
