# Memorandum

| To | <b>Hugh Donaldson</b> | From | [REDACTED] |

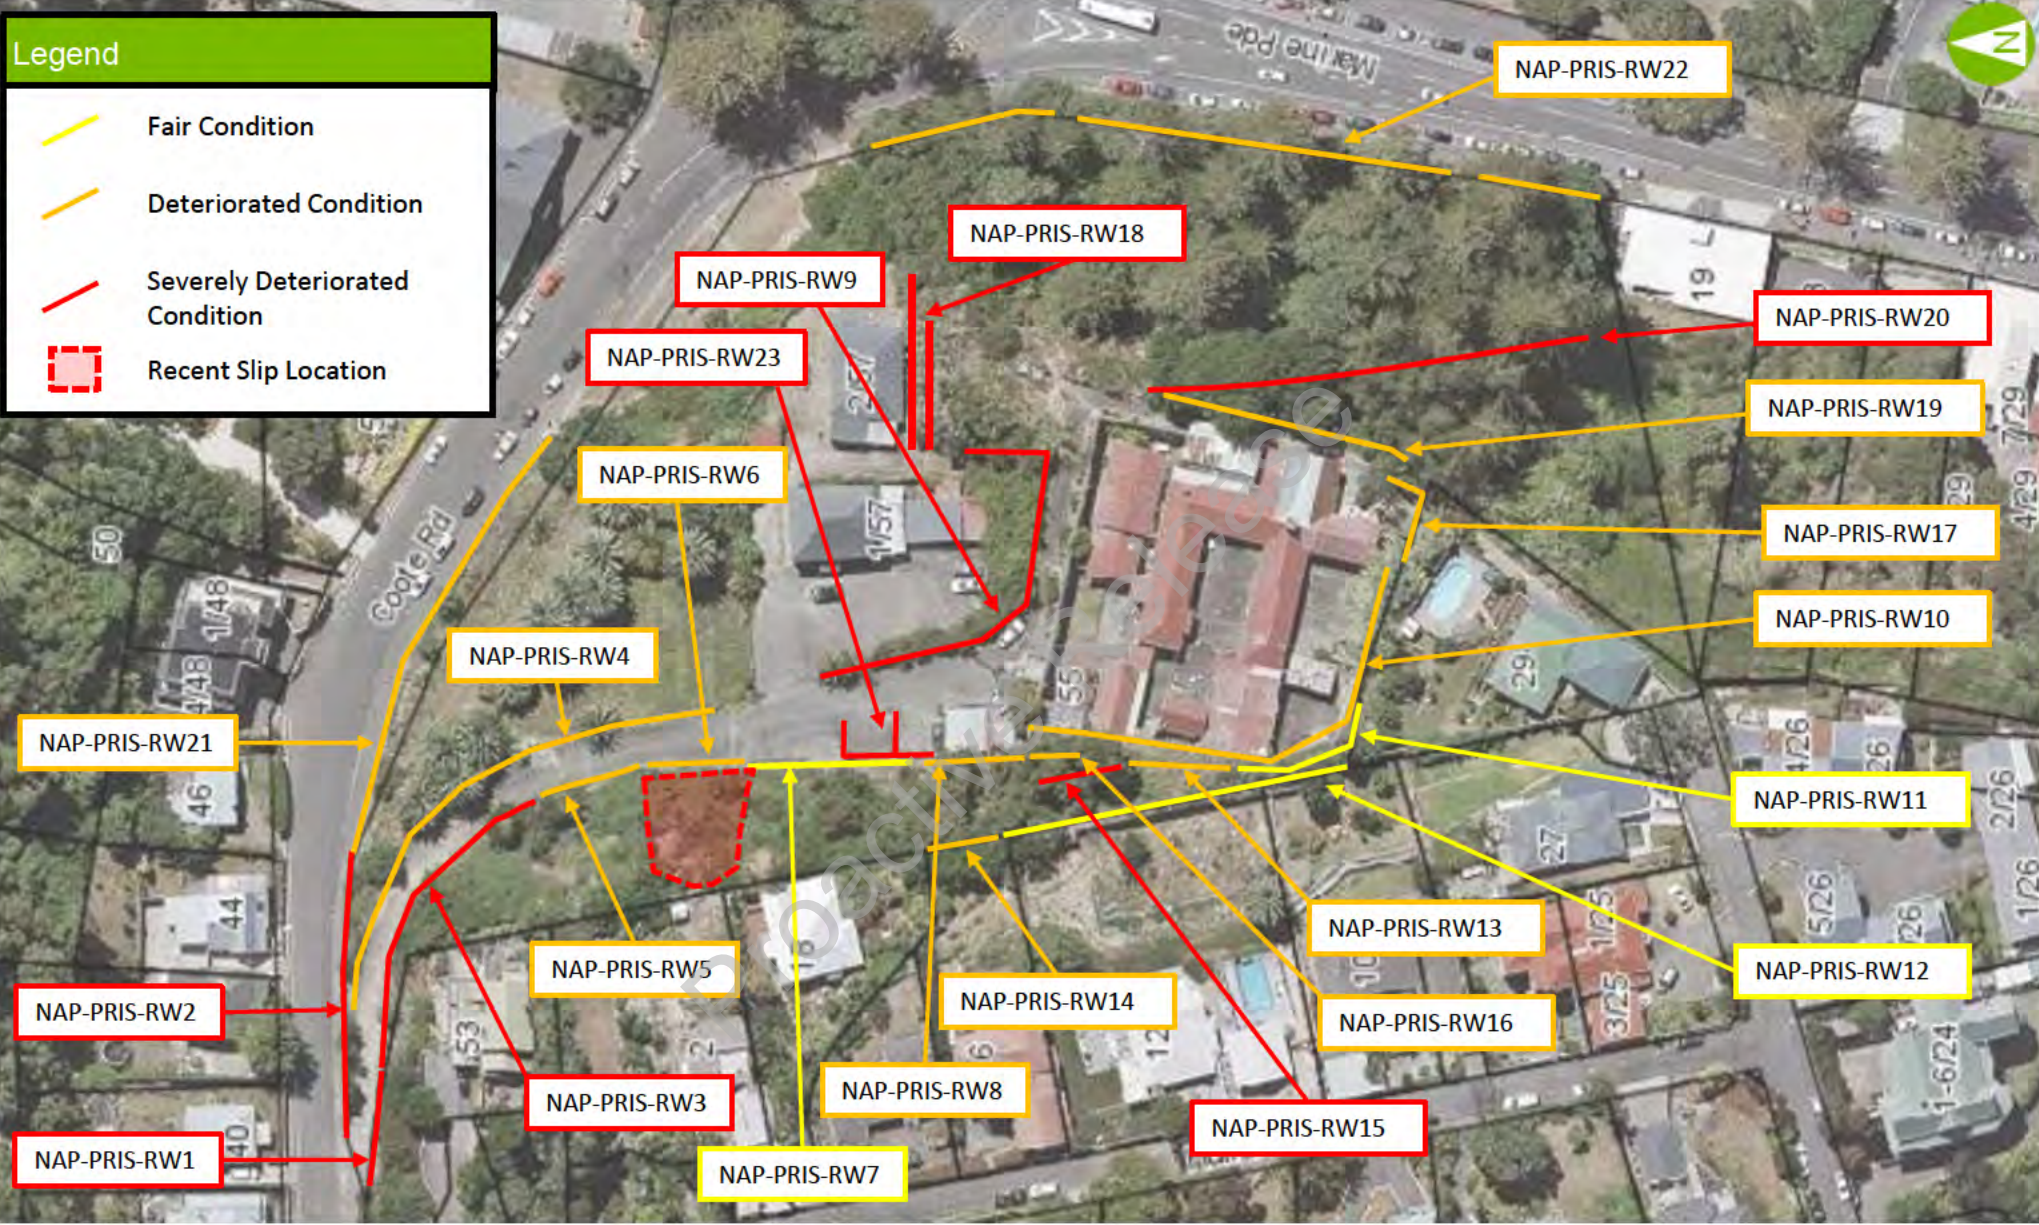
| CLIENT | | PRELIMINARY NOT FOR CONSTRUCTION | ALL DIMENSIONS APPROXIMATE ONLY | | SCALE | SIZE | TITLE | INDICATIVE RETAINING WALL LOCATIONS | | | | | |

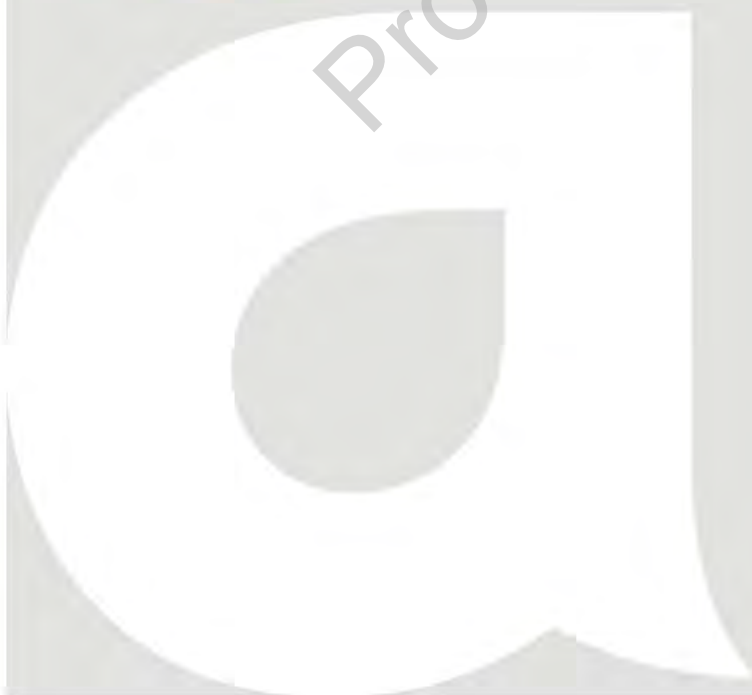
# Appendix B Assessment Table

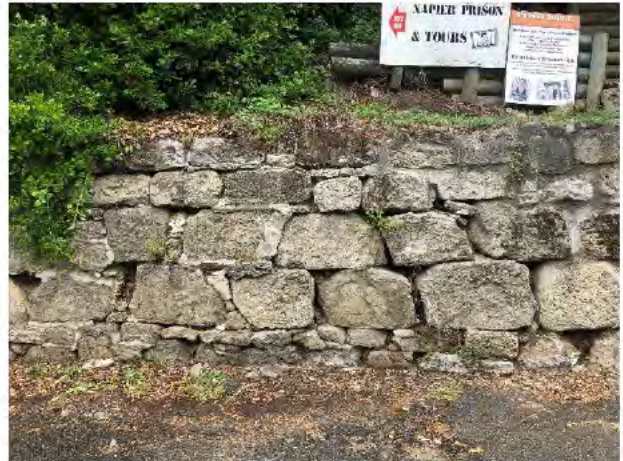
**Photo 2) Loose, dislodged blocks.**

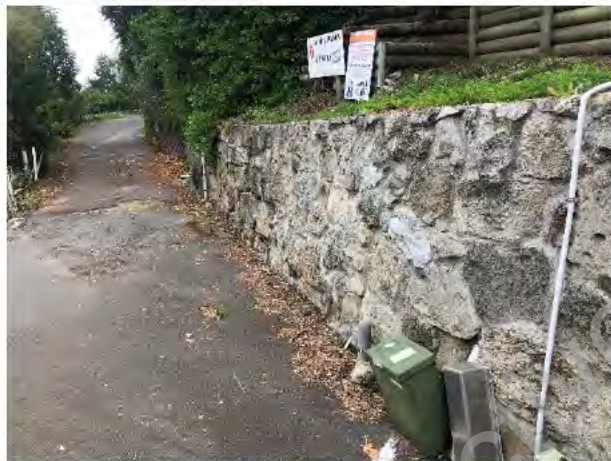
**Photo 3) Power box and services in front of wall.**

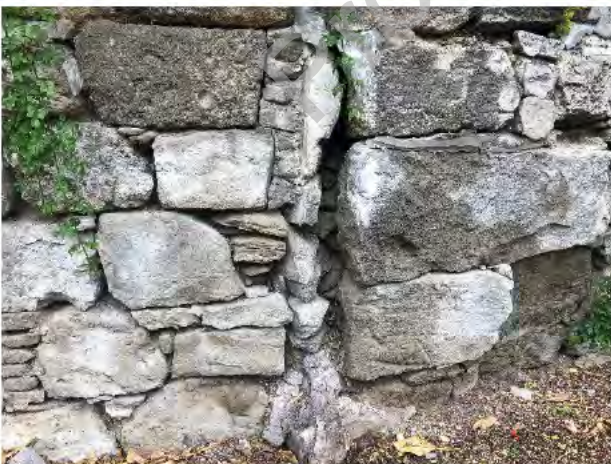
**Photo 5) Large displacement/gaps observed in wall. Note old tree root at toe of wall.**

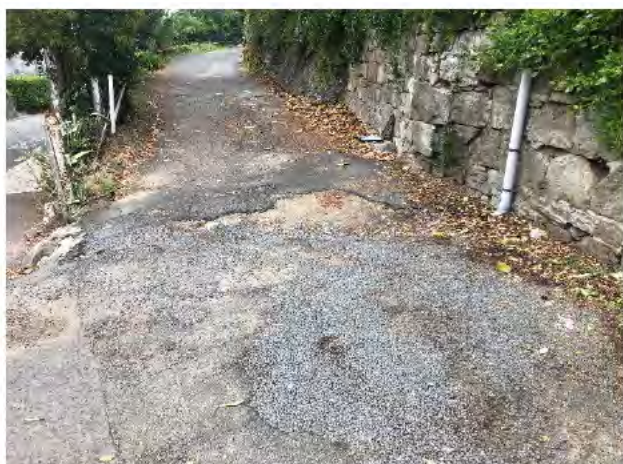
**Photo 6) Site driveway/entrance showing PVC pipe outlet and erosion of soil/asphalt.**

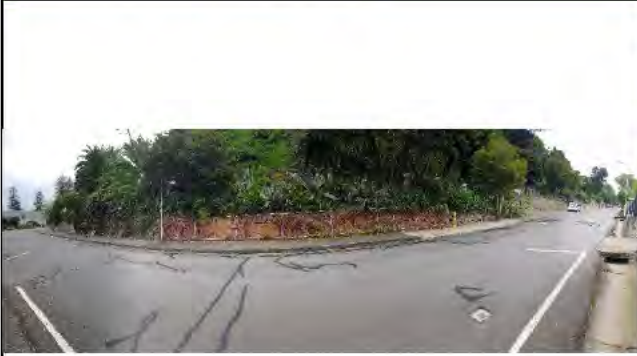
**Photo 1)** NAP-PRIS-02 View. Note possible ground cracking in road in front of wall.

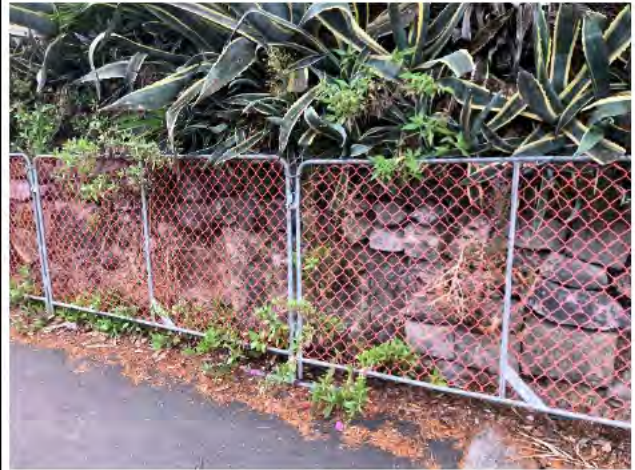
**Photo 2)** Loose, dislodged blocks and partial collapse.

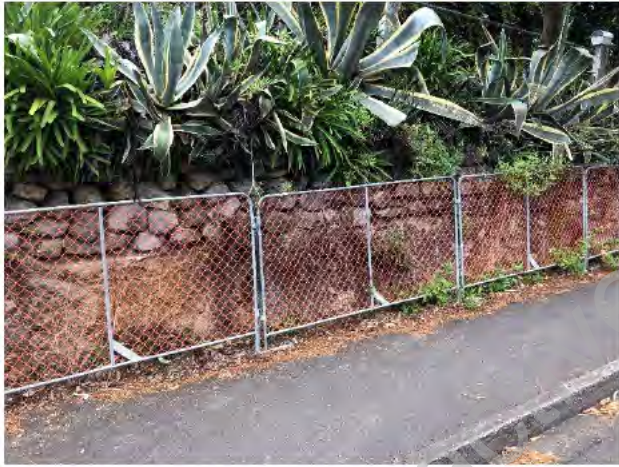
**Photo 3)** Loose blocks and partial collapse of wall.

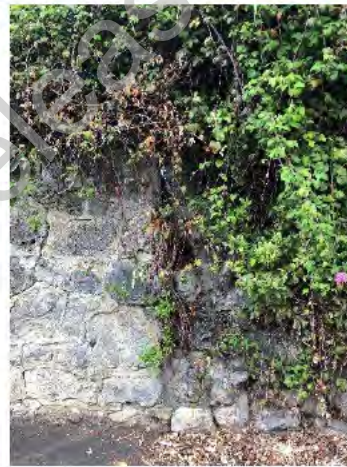
**Photo 4)** Transition between NAP-PRIS-02 (right) and NAP-PRIS-21 (left).

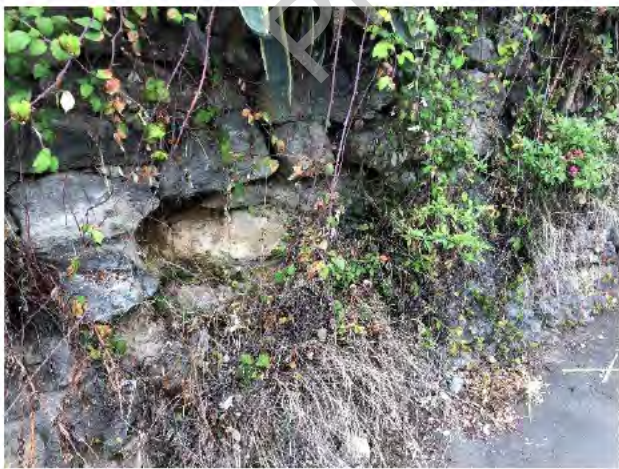
**Photo 5)** Loose blocks, erosion and vegetation observed in wall face.

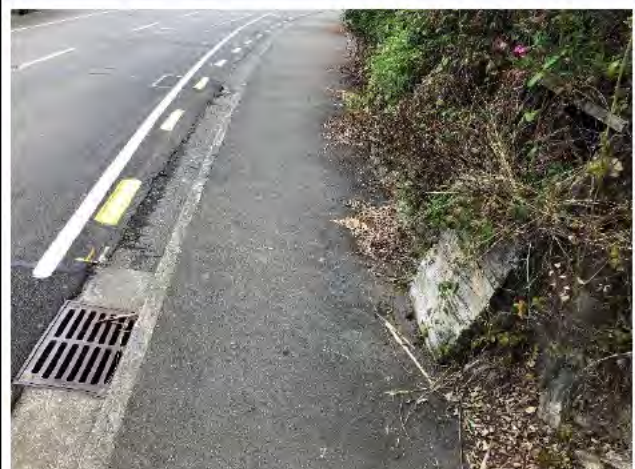
**Photo 6)** Inferred old stormwater channel observed in wall face.

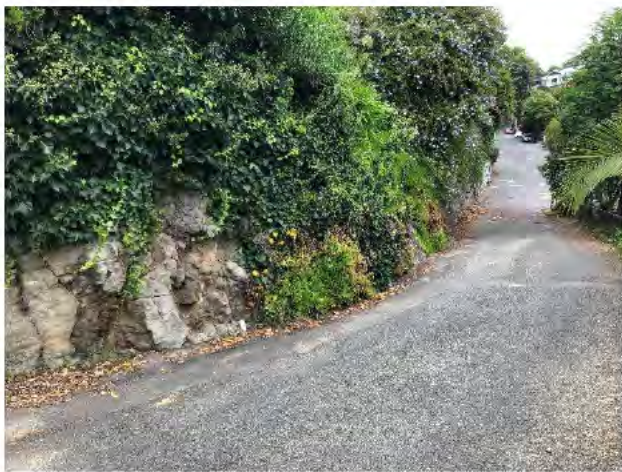
**Photo 1)** NAP-PRIS-03 view above site access/driveway.

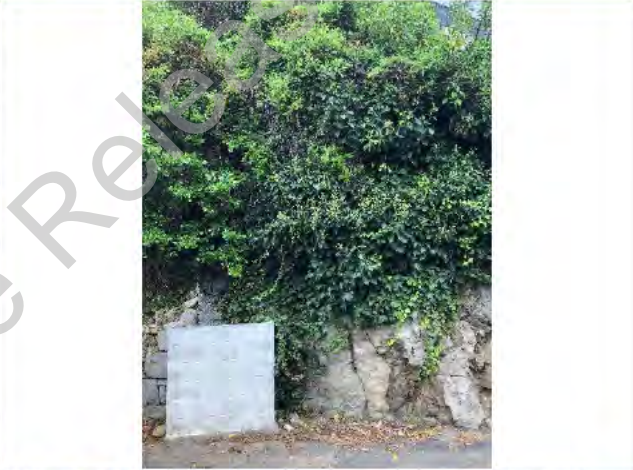
**Photo 4)** Historical concrete stormwater channel (inferred) observed in front of wall.

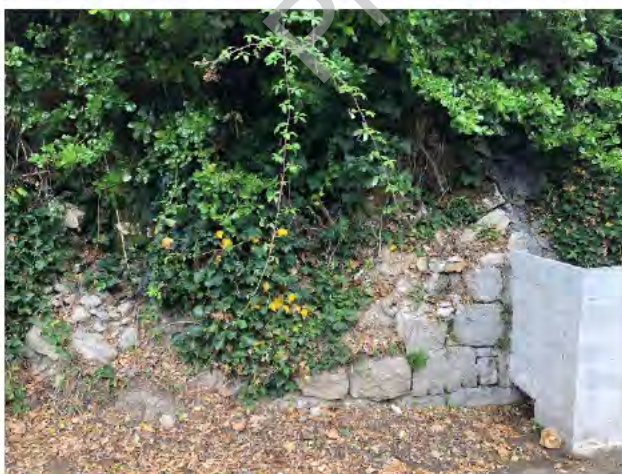
**Photo 5)** Evidence of old block wall, which has collapsed and eroded.

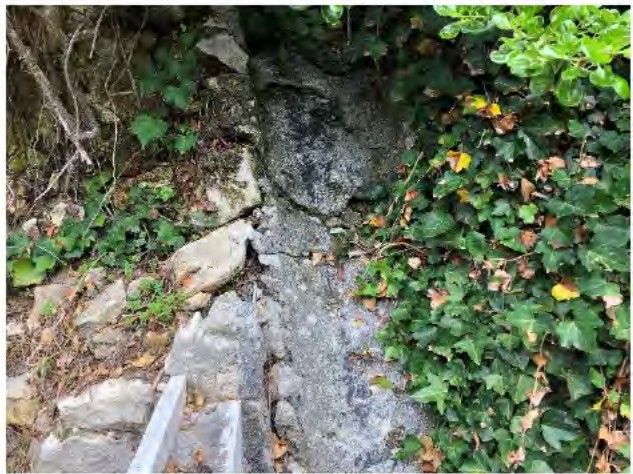
**Photo 6)** Significant cracking and degradation of upslope concrete channel.

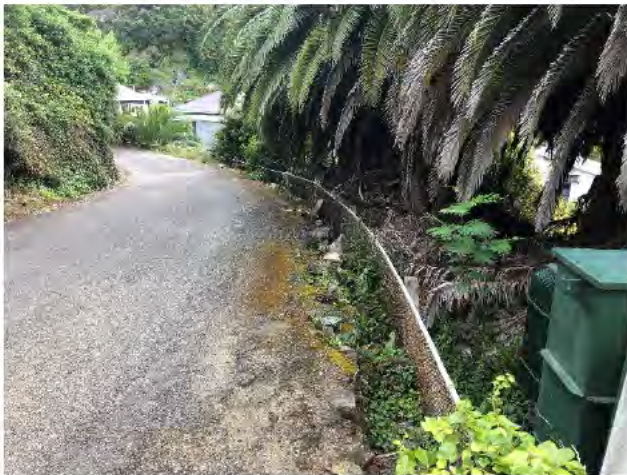
**Photo 1) NAP-PRIS-04 view.**

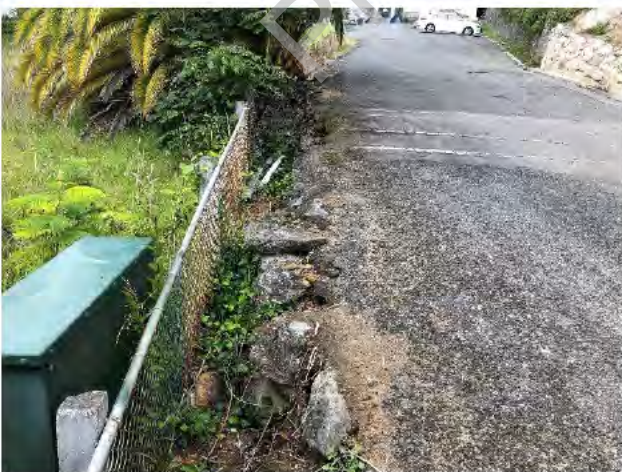
**Photo 5) Power box observed in front of wall.**

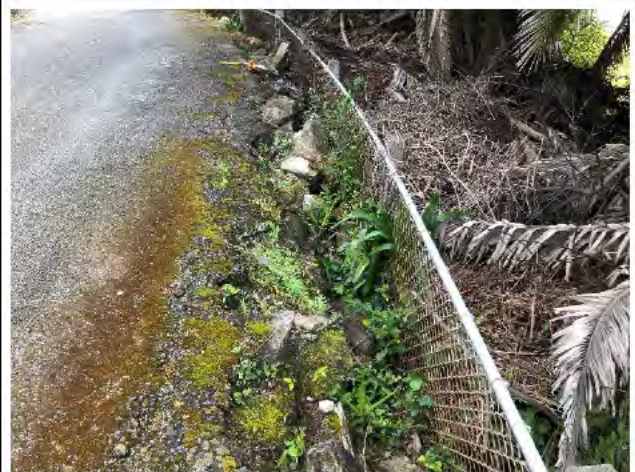
**Photo 6) Vegetation and partial collapse of wall.**

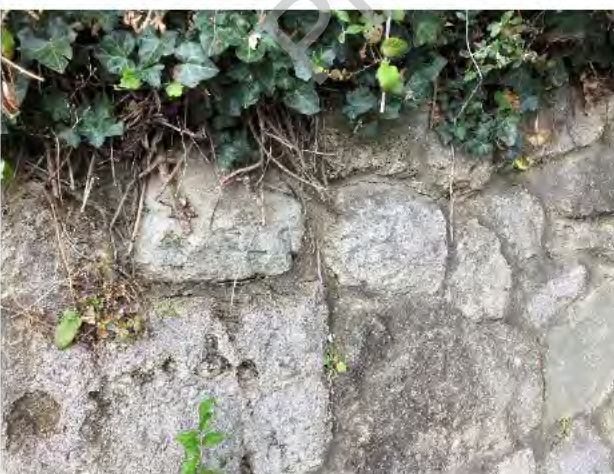
**Photo 5)** Cracking observed in mortar between blocks.

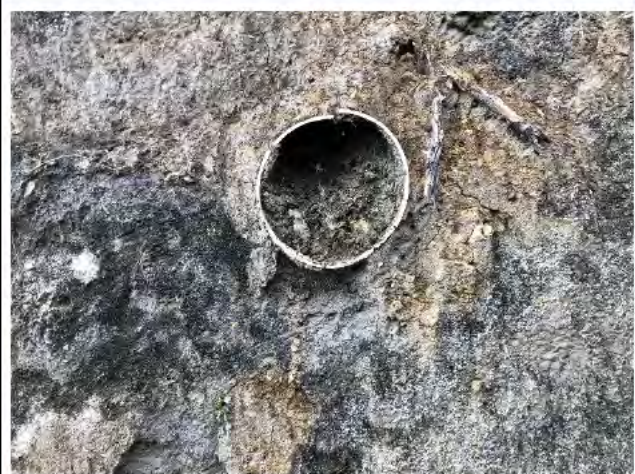
**Photo 6)** Weep hole, possibly recently installed, clogged with soil.

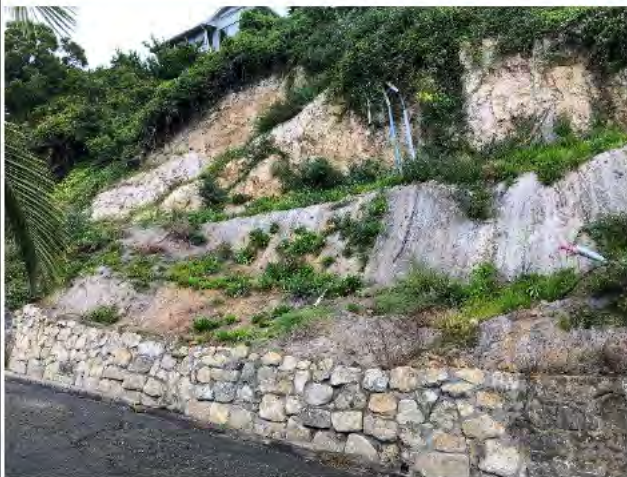
**Photo 1)** NAP-PRIS-06 view. Note recent slope failure and “new” construction of wall, also upslope residential property.

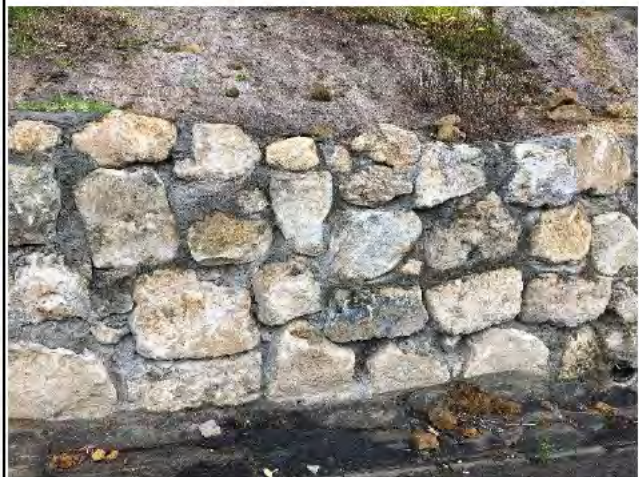
**Photo 2)** Cracked and missing mortar between blocks.

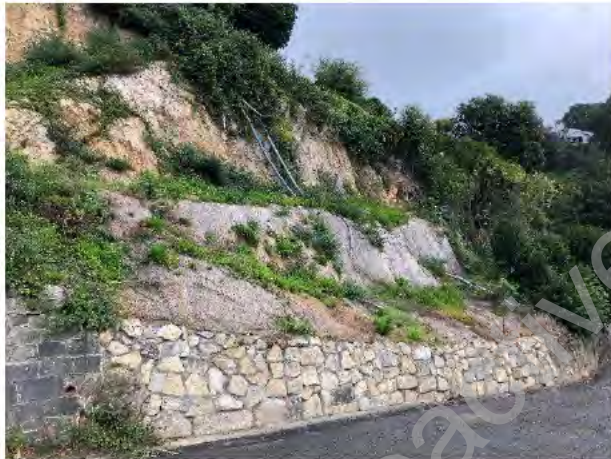
**Photo 3)** Benched slope covered with coconut matting following slip.

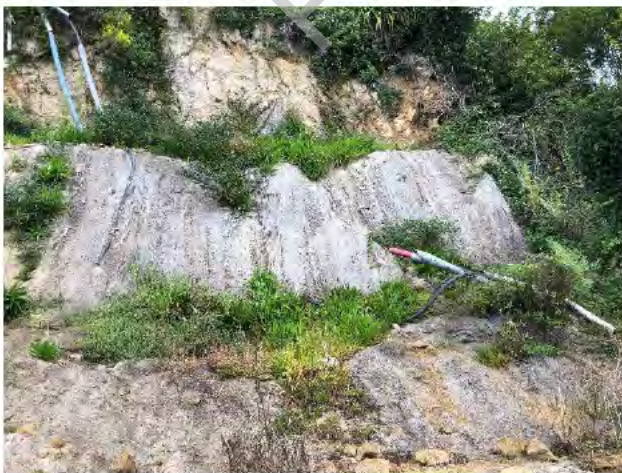
**Photo 5)** Coconut matting placed over slope following slip. Note protruding, broken services.

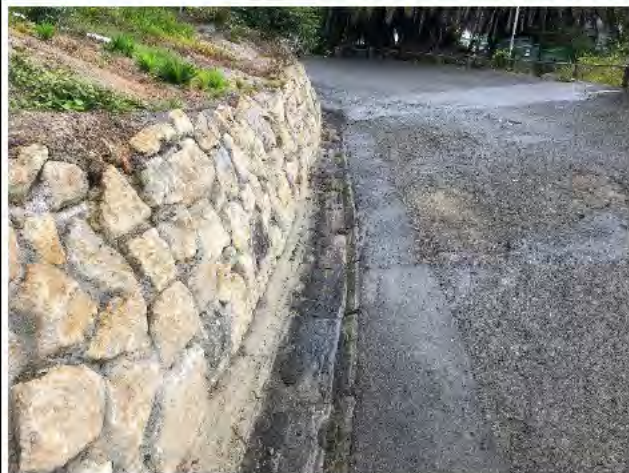
**Photo 6)** Wall face and drainage channel at toe of wall.

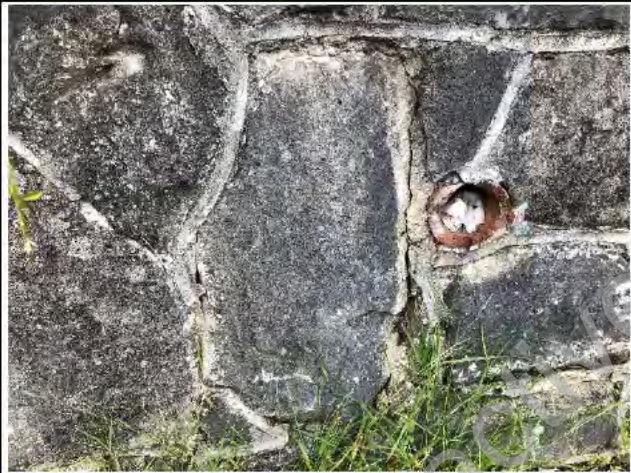
**Photo 3)** Cracking observed around blocks.

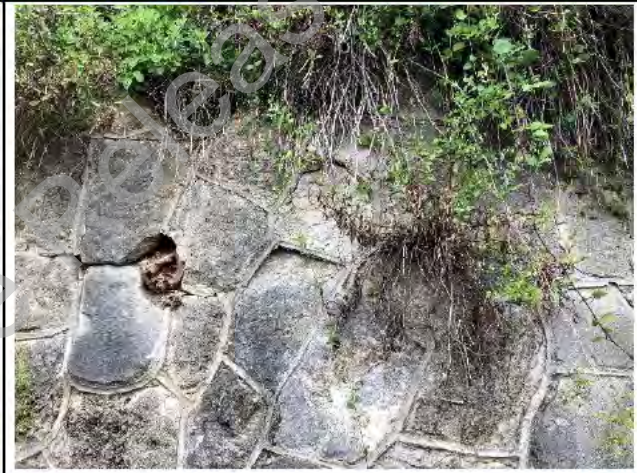
**Photo 4)** Cracking and broken drainage pipes observed.

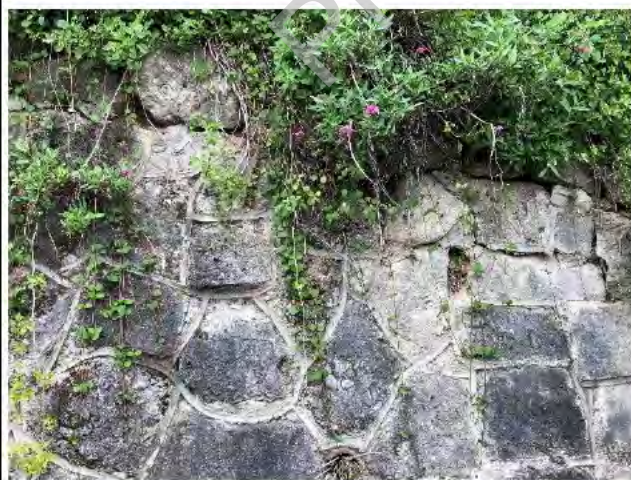
**Photo 5)** Cracking at top of wall where heavy vegetation present. Root growth through drains.

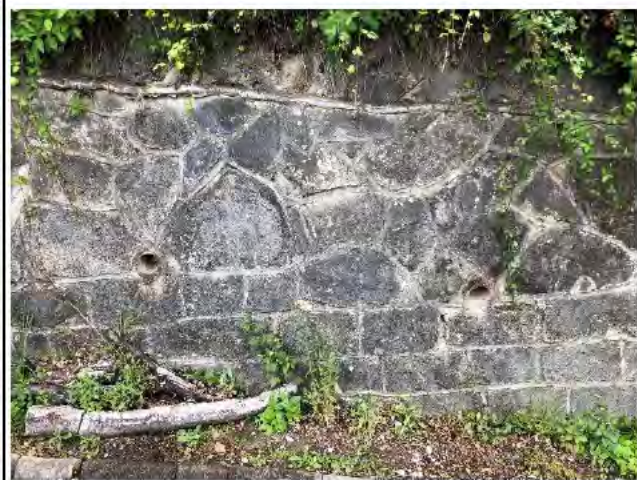
**Photo 6)** Wall face and drainage holes.

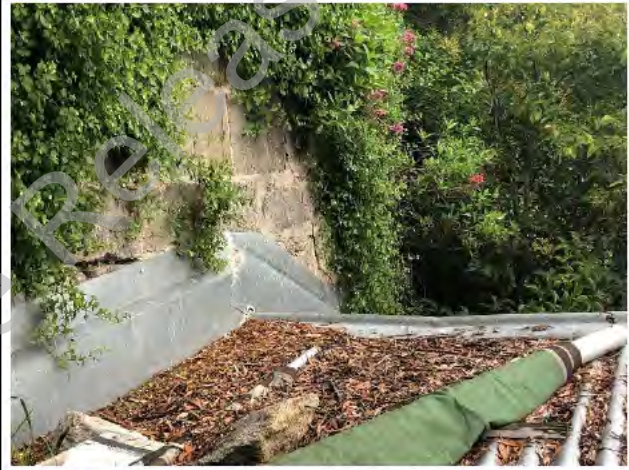
**Photo 4)** Cracking and observed in wall face.

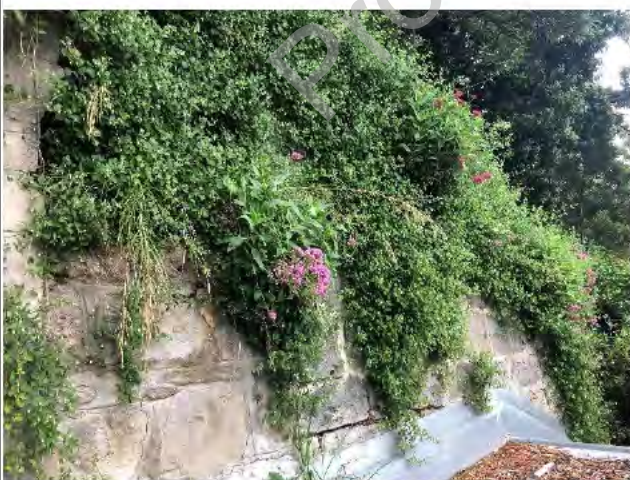
**Photo 5)** Cracking and vegetation growth through wall face.

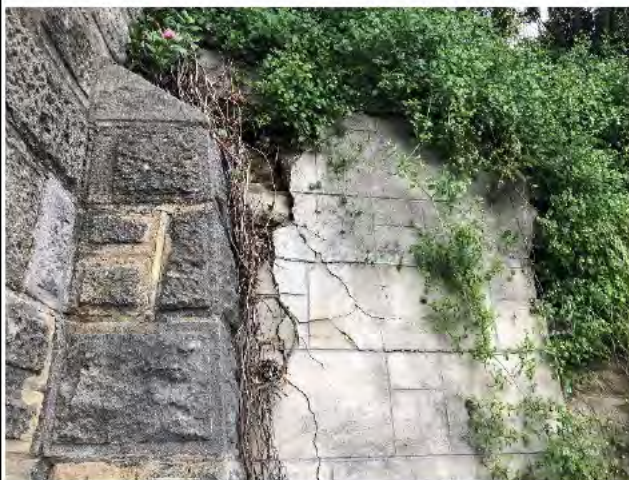
**Photo 6)** Cracked and partially collapsed façade. Note prison wall on left.

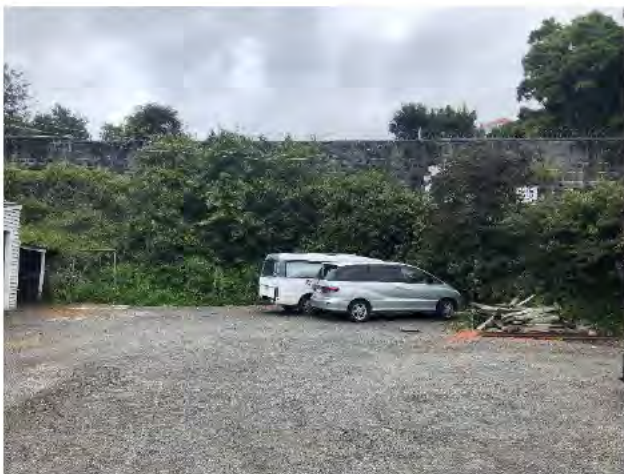
**Photo 1)** NAP-PRIS-09 view, note heavy vegetation and prison wall near top of wall.

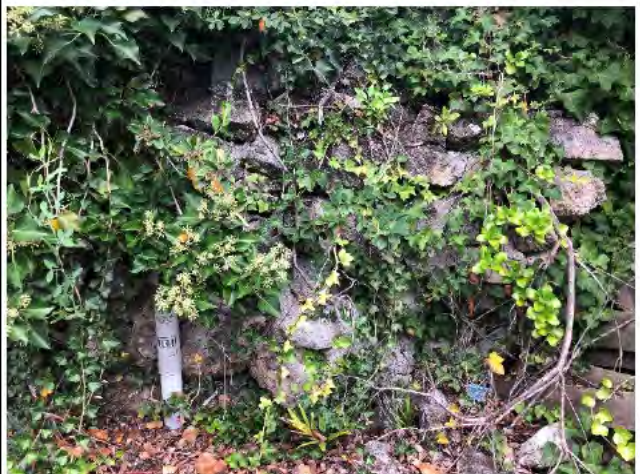
**Photo 2)** Heavily vegetated wall face with loosely stacked blocks.

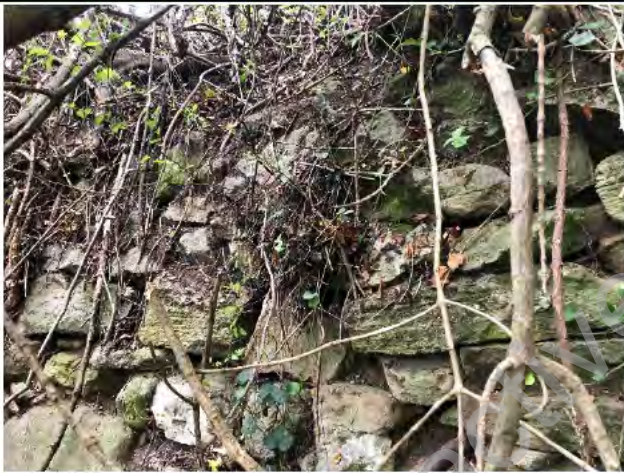
**Photo 3)** Loose blocks and partial wall collapse.

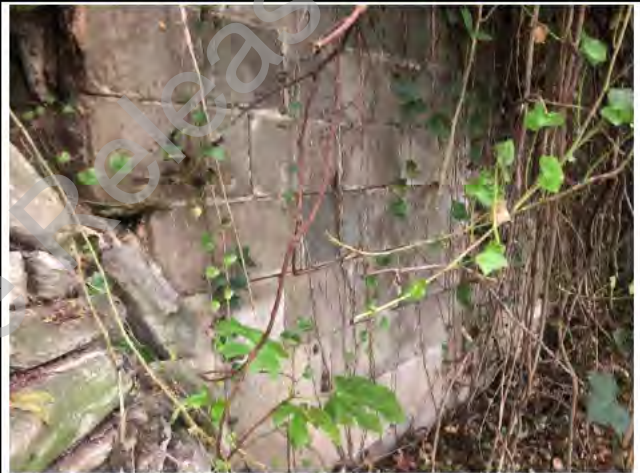
**Photo 4)** Concrete block section of NAP-PRIS-09.

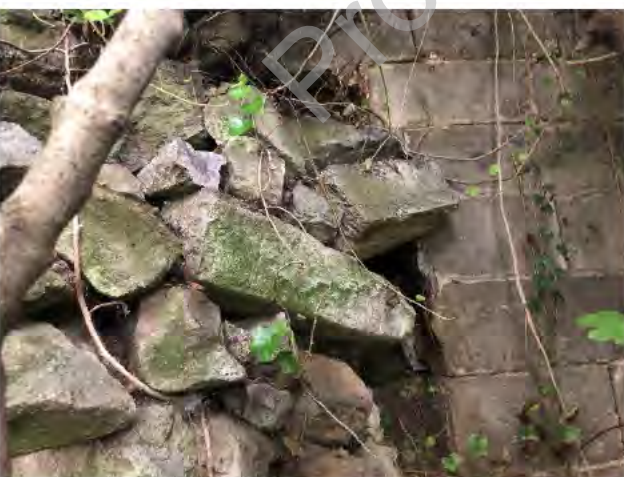
**Photo 5)** Interface between loose stone section and concrete block section. Note large void.

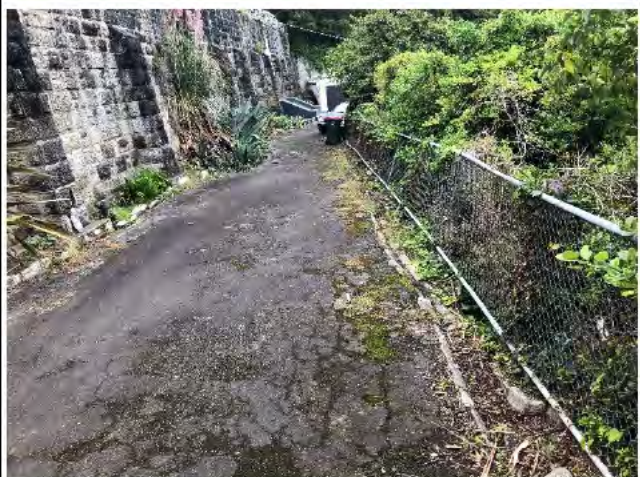
**Photo 6)** Cracking of access way and rotation of fence at top of wall.

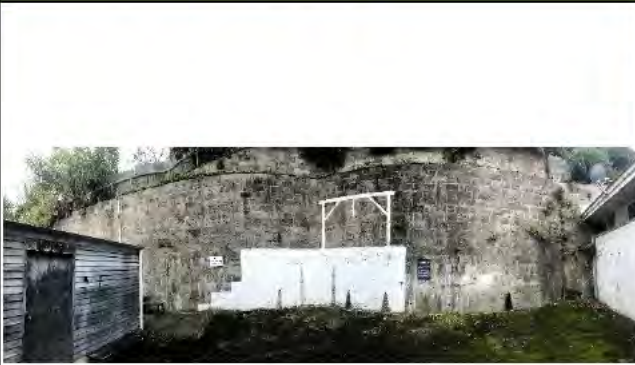
**Photo 1)** NAP-PRIS-10 view. Interior prison wall.

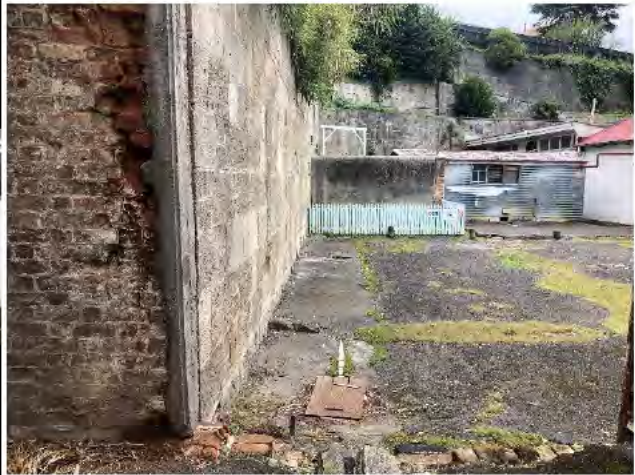
**Photo 2)** Brick masonry at cracking observed at end of wall.

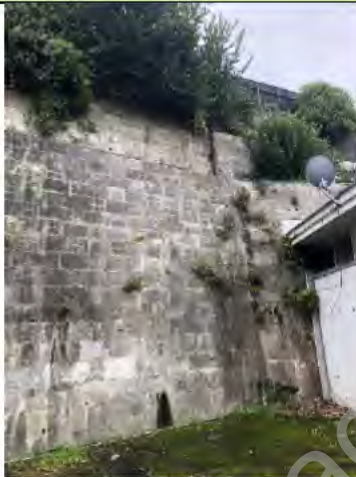
**Photo 3)** Vegetation and observed water seepage over wall face.

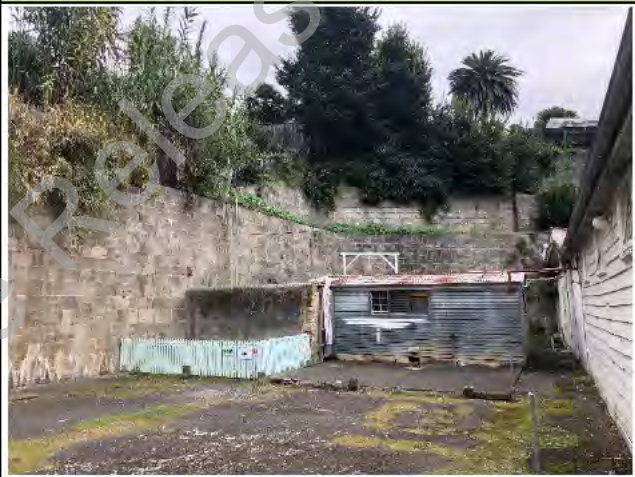
**Photo 4)** NAP-PRIS-10 view. Note picket fence area is the prison graveyard.

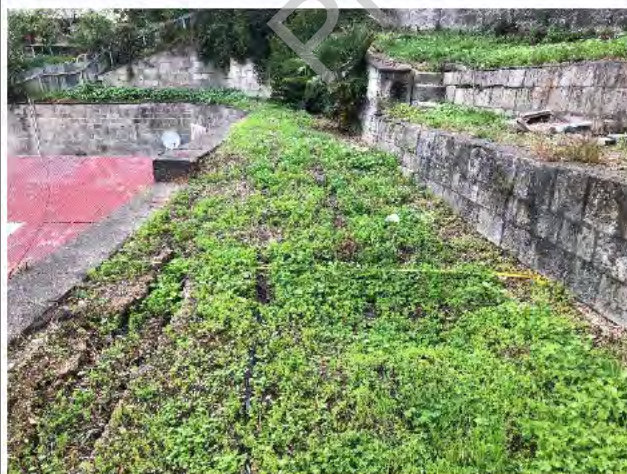
**Photo 5)** ~300mm wide ground cracks observed at the top of the wall.

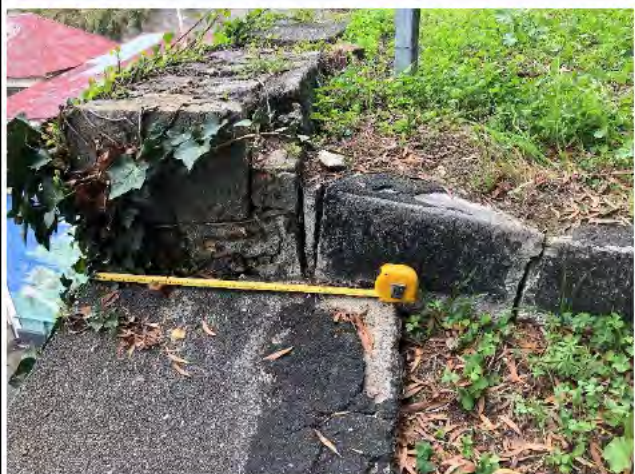
**Photo 6)** Cracking and possible rotation observed at top of wall.

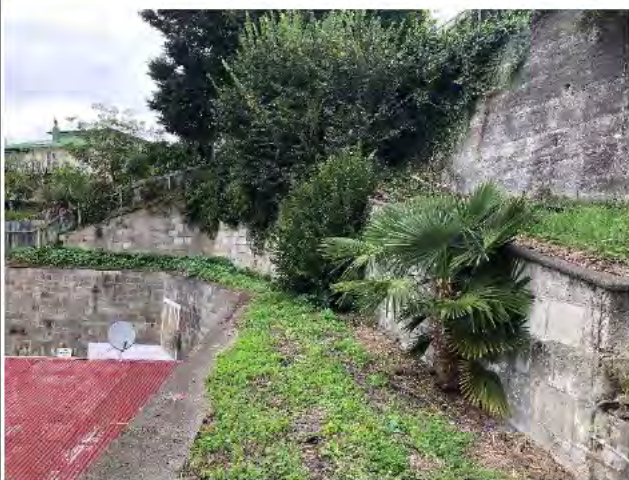
**Photo 1)** NAP-PRIS-11 view. Located above NAP-PRIS-10.

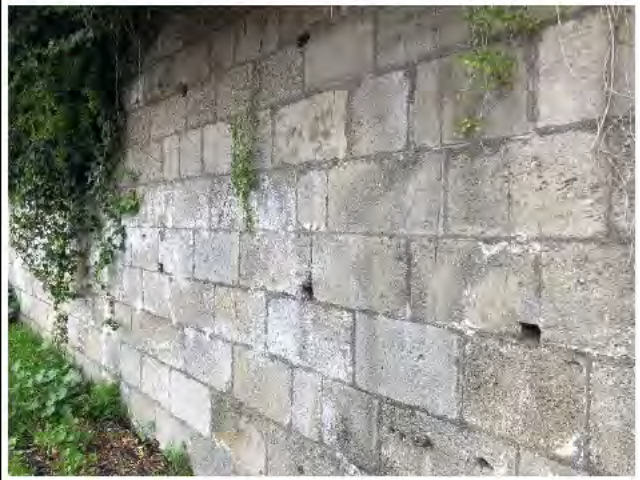
**Photo 2)** Typical wall face observed. Note "square" holes are weep holes/wall drainage.

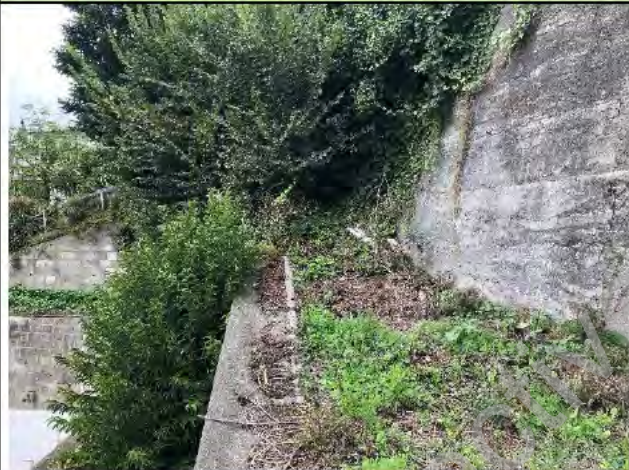
**Photo 3)** Heavy vegetation above top of wall.

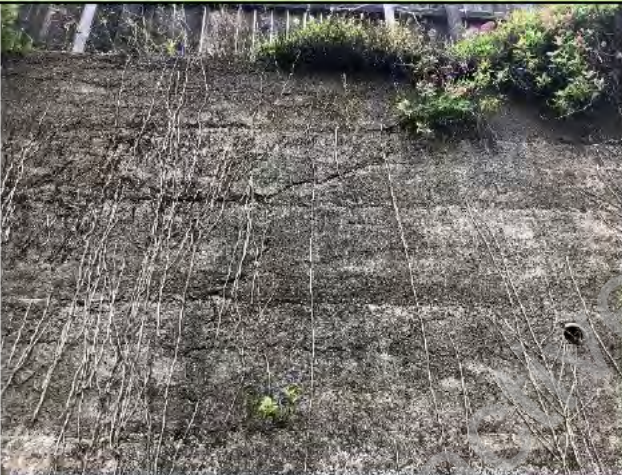
**Photo 3)** Some cracking observed in wall face.

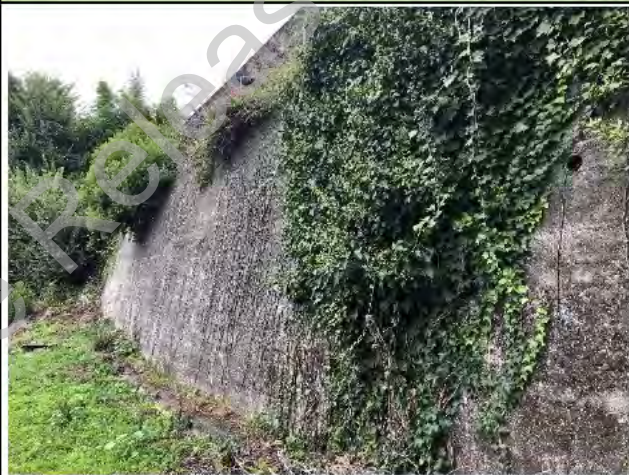
**Photo 4)** Vegetation growth over face.

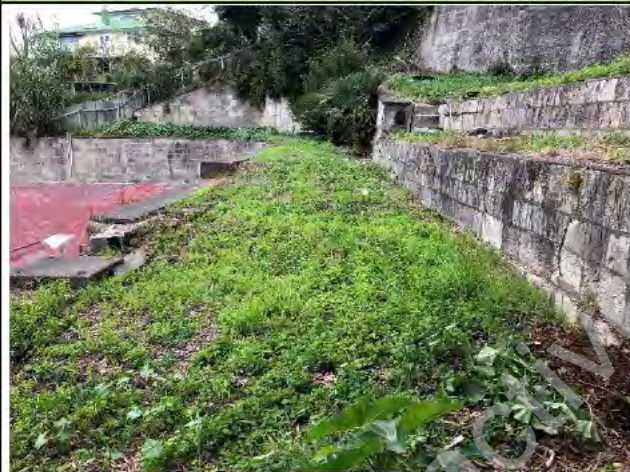
**Photo 3)** Ground cracking observed in front of wall (behind NAP-PRIS-RW10)

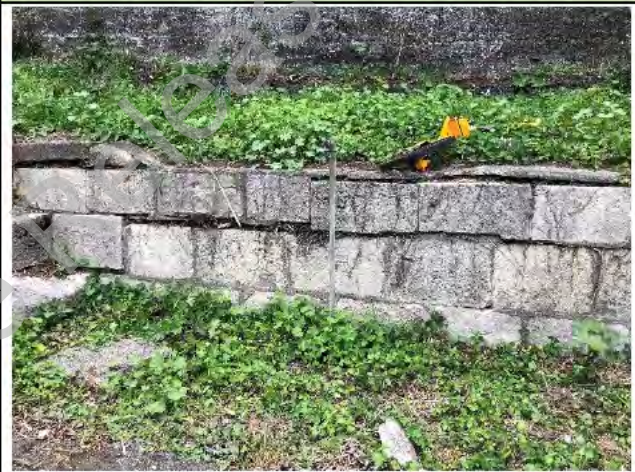
**Photo 4)** Loose/dislodged blocks observed.

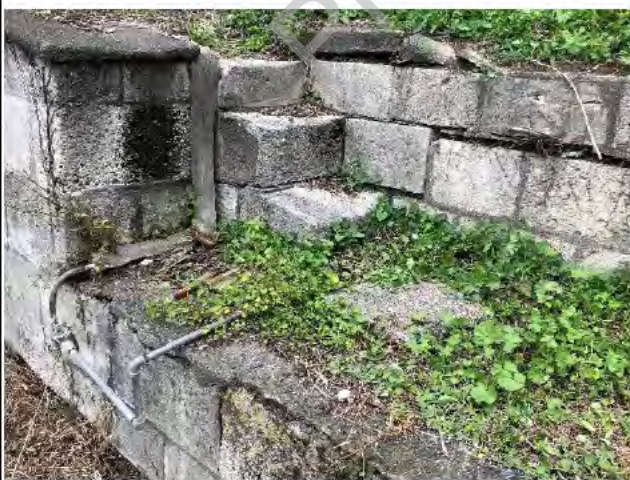
**Photo 5)** Loose/dislodged blocks observed. Possible wall settlement resulting in "gap".

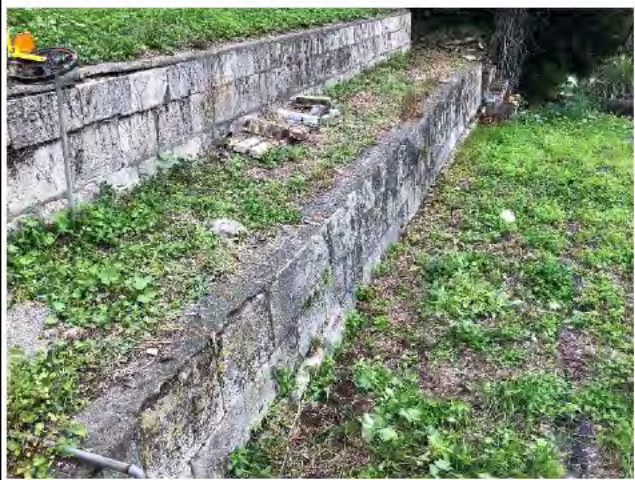
**Photo 6)** NAP-PRIS-RW13 view.

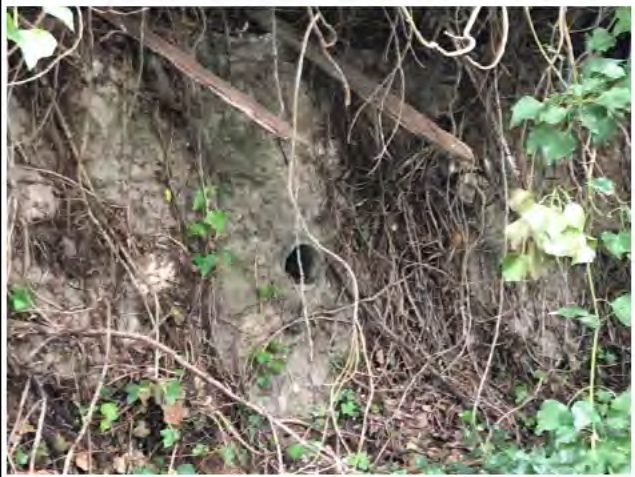
**Photo 2)** Drainage pipe observed.

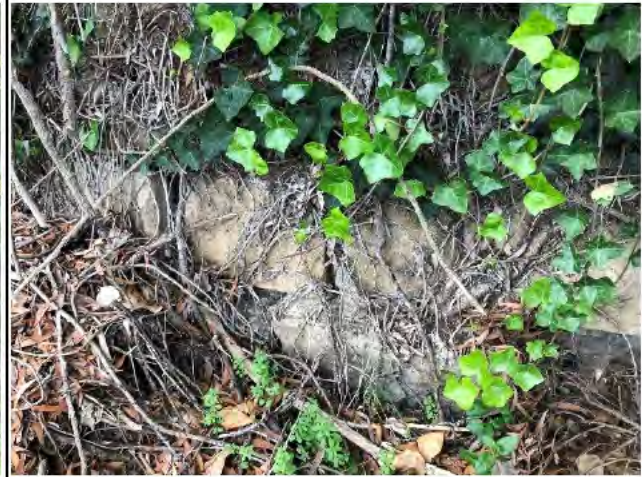
**Photo 2)** Loose blocks, heavy vegetation and partial collapse observed.

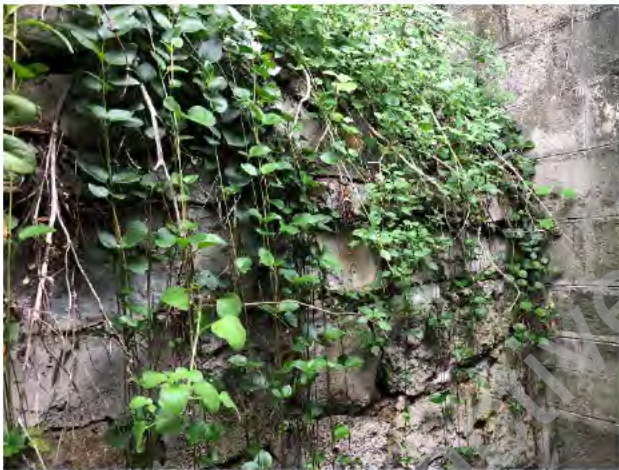
**Photo 3)** Vegetation observed at top of wall. Cracking and erosion of mortar and blocks.

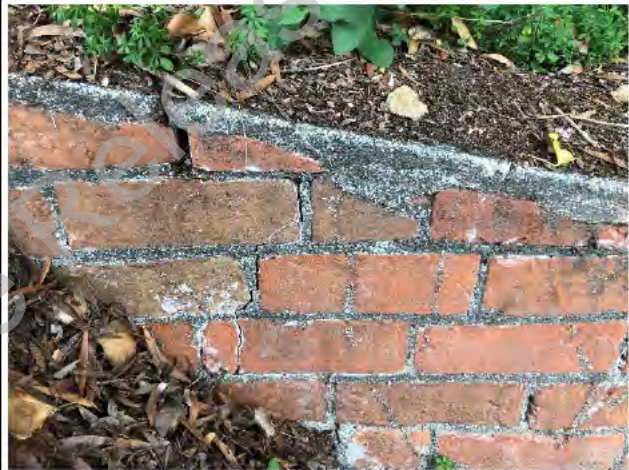
**Photo 4)** Cracking observed in brick masonry.

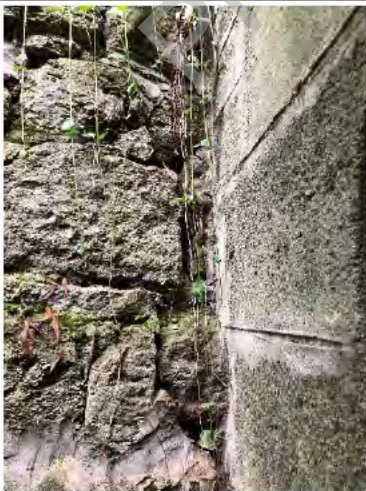
**Photo 5)** Cracking observed at end of wall.

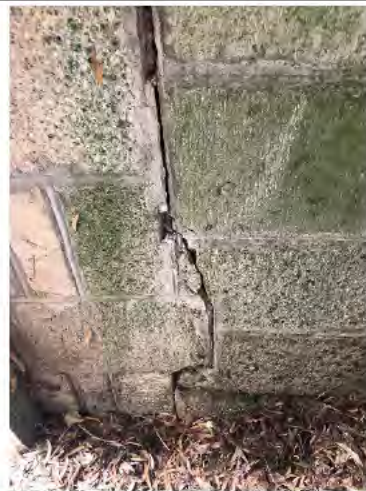
**Photo 6)** Cracking observed at base of wall.

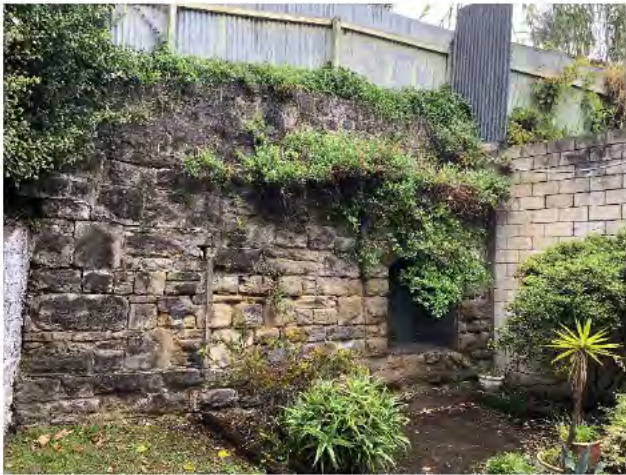
**Photo 1)** NAP-PRIS-RW17 view.

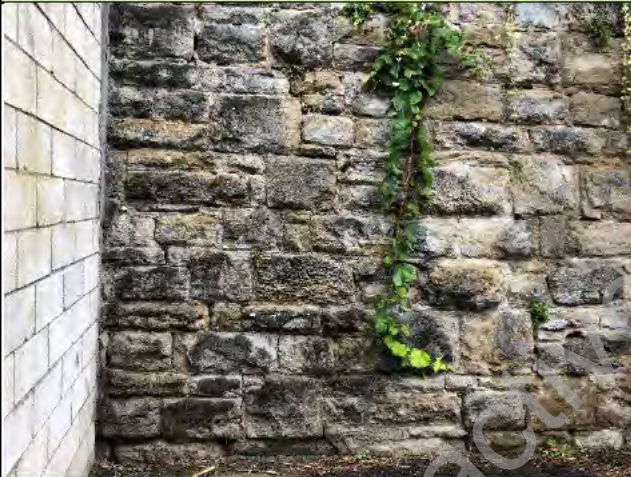
**Photo 3)** Cracking observed in wall face.

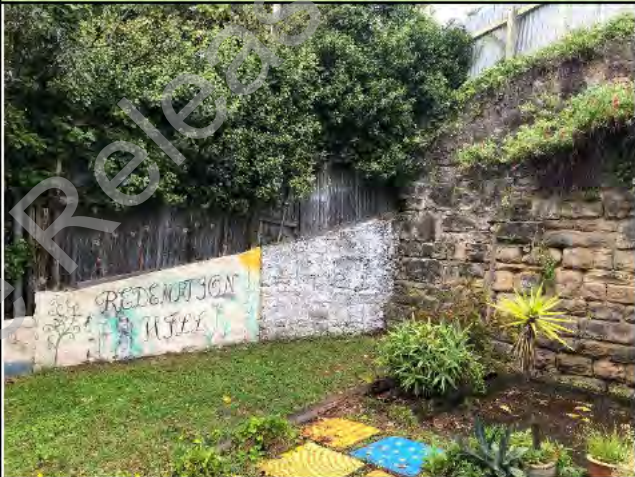
**Photo 4)** Mass concrete wall observed adjacent to NAP-PRIS-RW17.

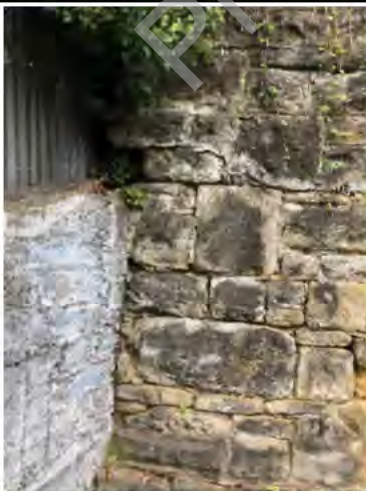
**Photo 5)** Erosion of stone blocks and mortar observed.

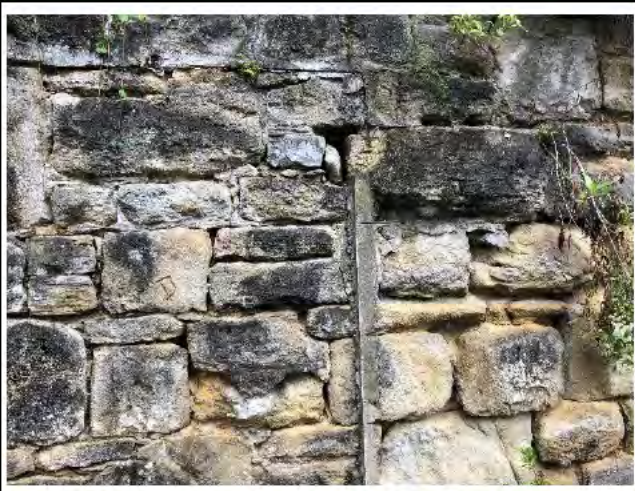
**Photo 6)** Erosion of stone blocks and mortar observed.

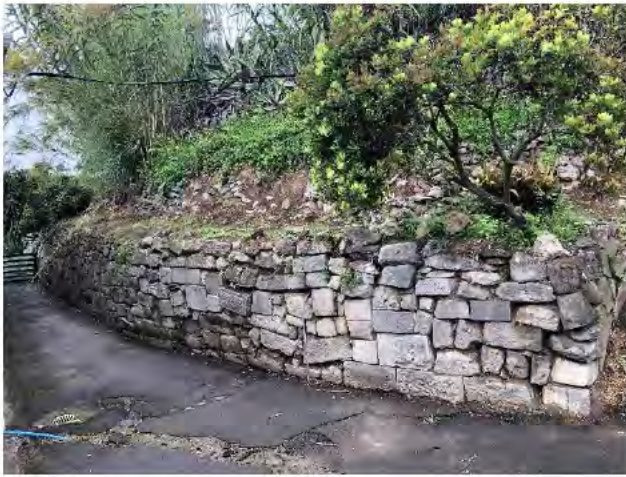
**Photo 1) NAP-PRIS-RW18 view.**

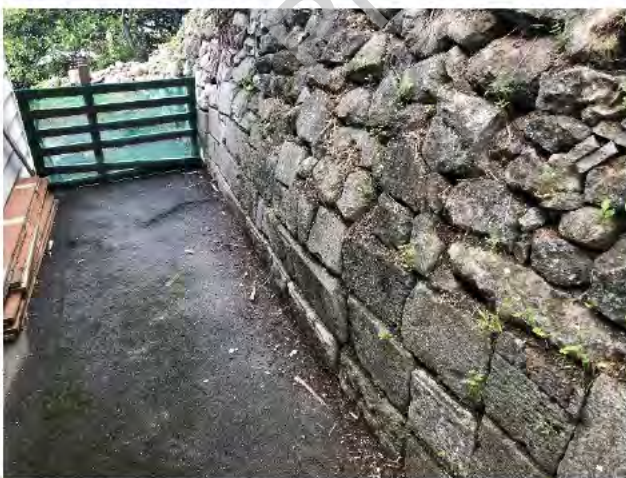
**Photo 5) Bulging of wall observed.**

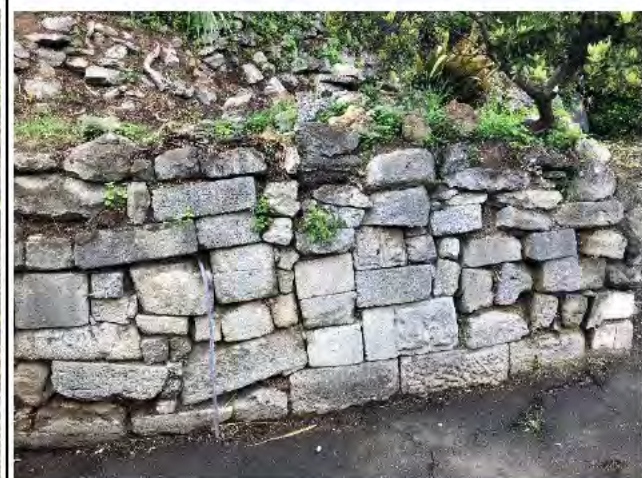
**Photo 6) Loosely stacked rocks of wall face.**
