# Memorandum

| To | <b>Hugh Donaldson</b> | From | [REDACTED] |

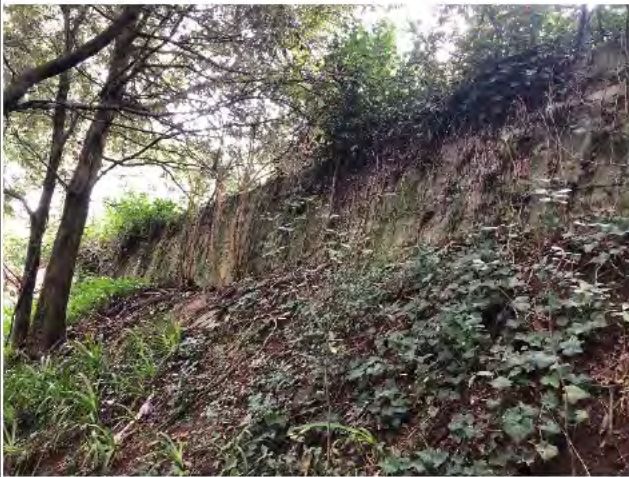
**Photo 1)** NAP-PRIS-RW19 view. Note steep toe slope.

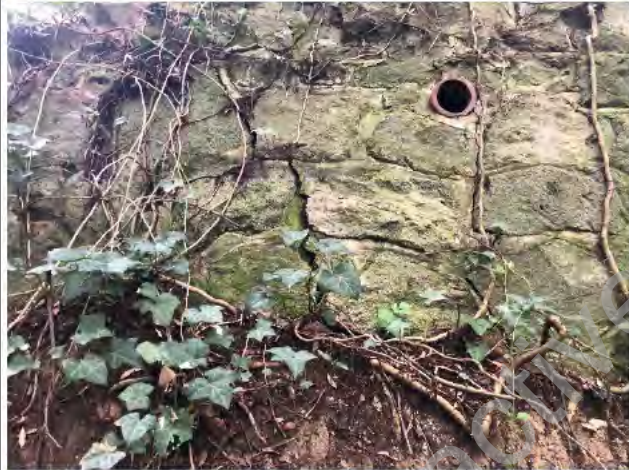
**Photo 3)** Cracking observed in wall face.

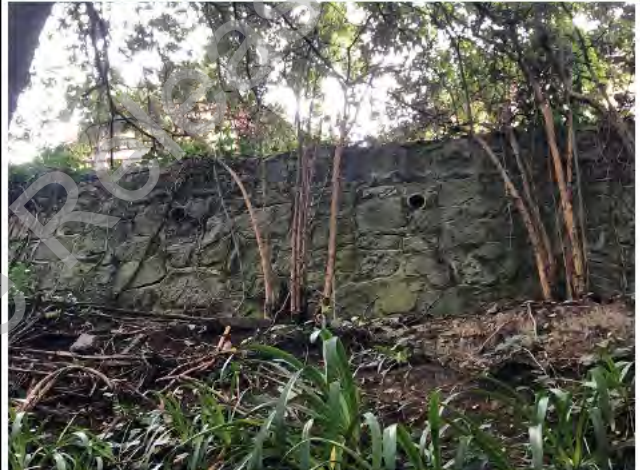
**Photo 4)** Typical wall face condition.

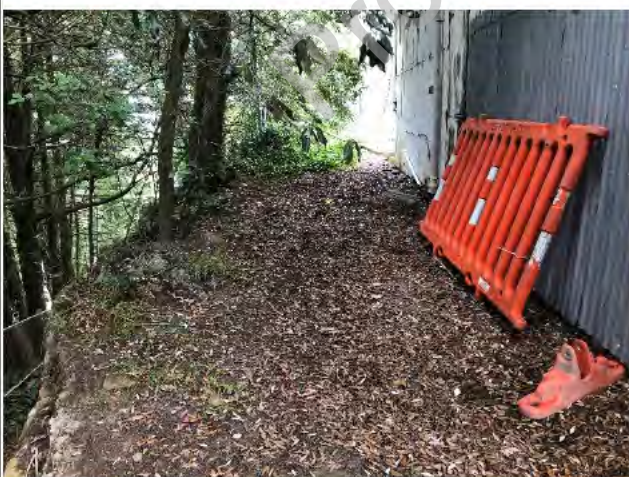
**Photo 5)** Top of wall. Note edge of prison building shown on right.

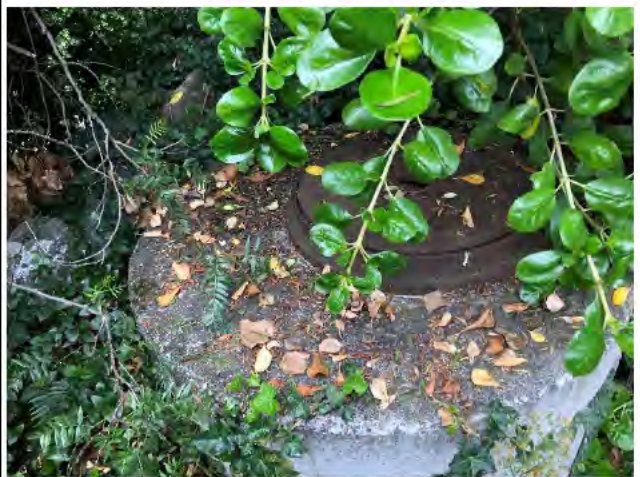
**Photo 6)** Manhole observed immediately behind top of wall.

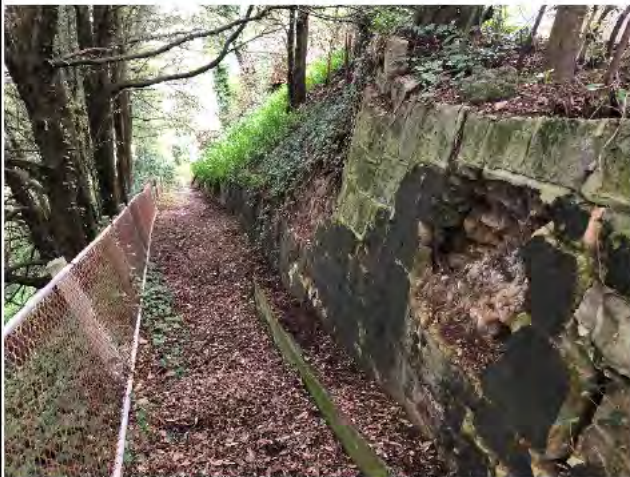
**Photo 1) NAP-PRIS-RW20 view.**

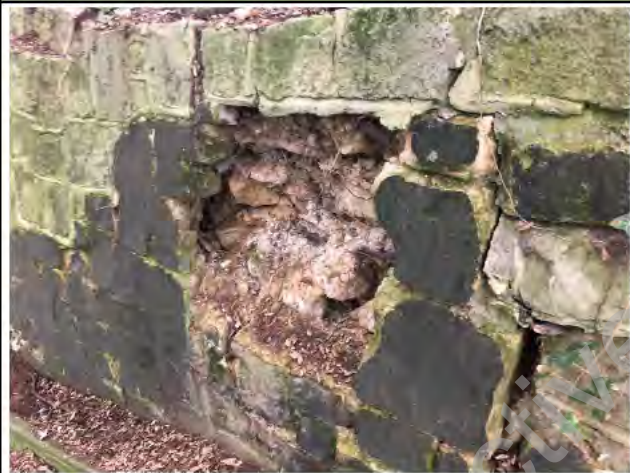
**Photo 3) Cracking and partial collapse of wall observed.**

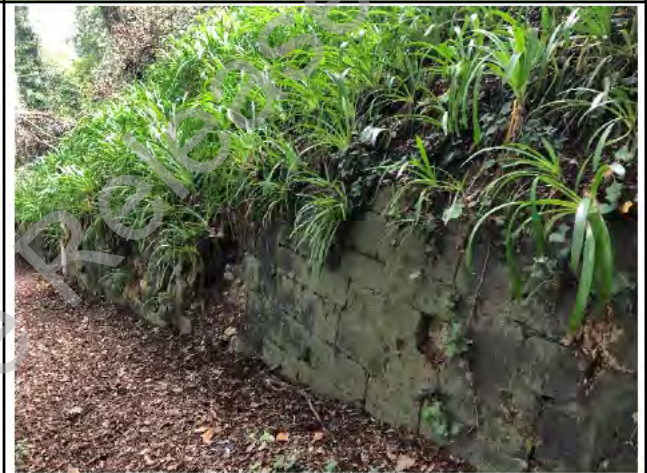
**Photo 4) Cracking and partial collapse of wall observed.**

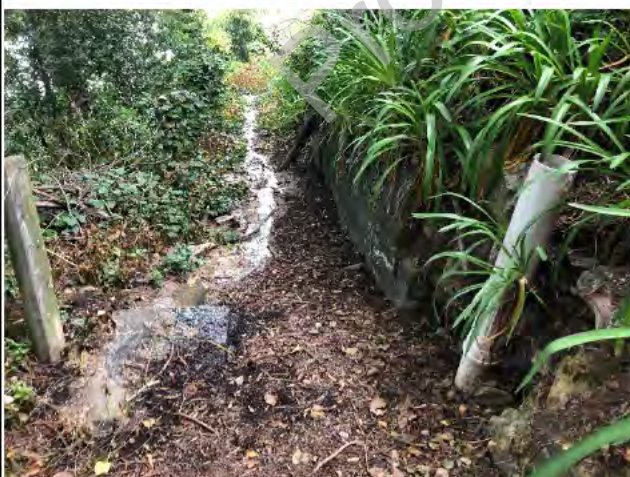
**Photo 5) Raw sewage leaking from sump in front of wall.**

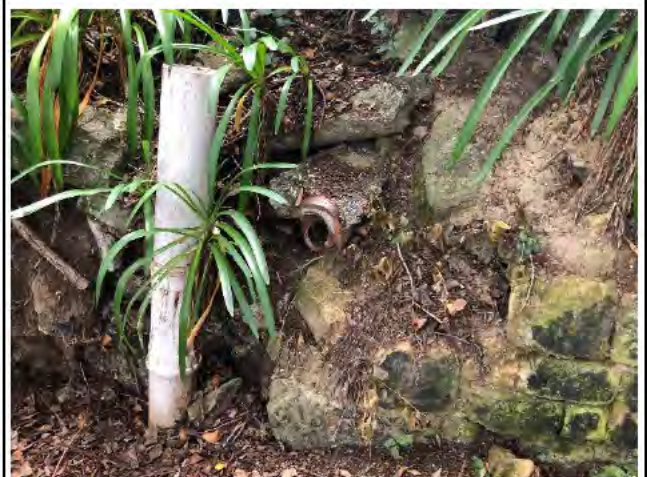
**Photo 6) Collapsed section of wall immediately upslope of sewage leak.**

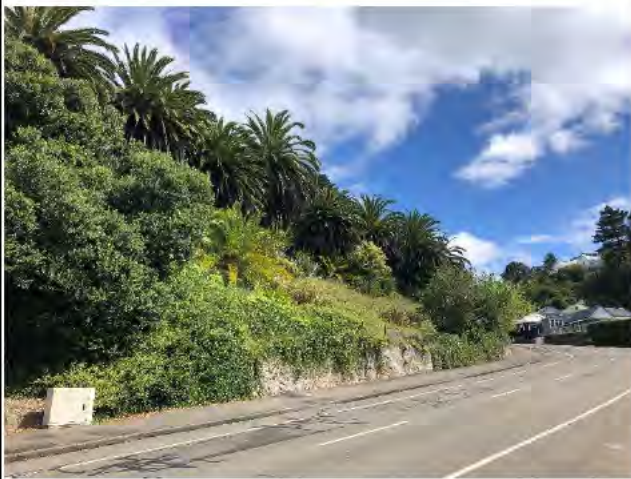
**Photo 1)** NAP-PRIS-RW21 view. Note Coote Road in foreground.

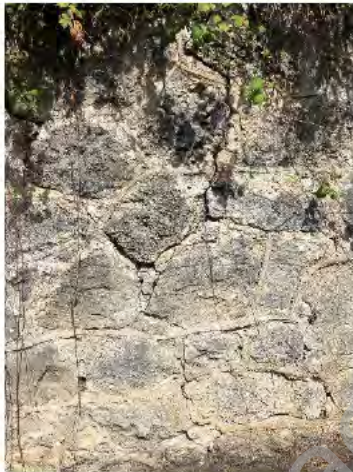
**Photo 3)** Cracking observed in wall face.

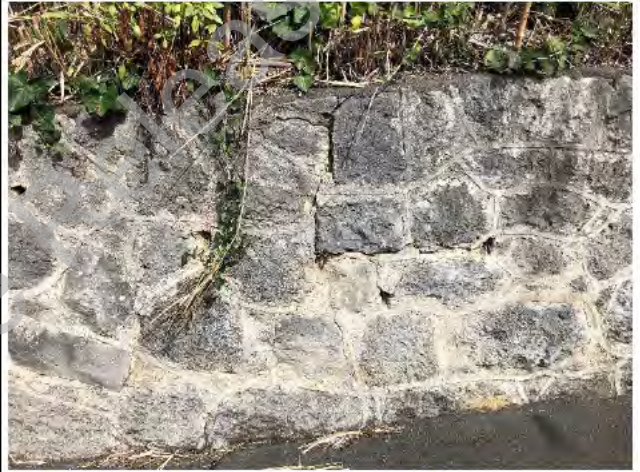
**Photo 4)** Cracking observed in wall face.

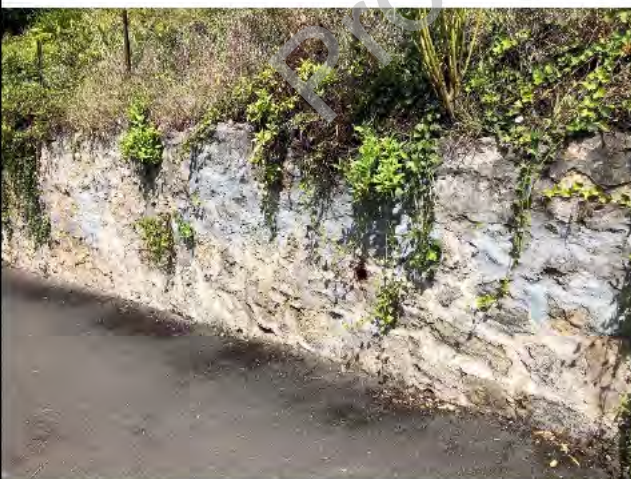
**Photo 5)** Section appears to have been re-mortared recently.

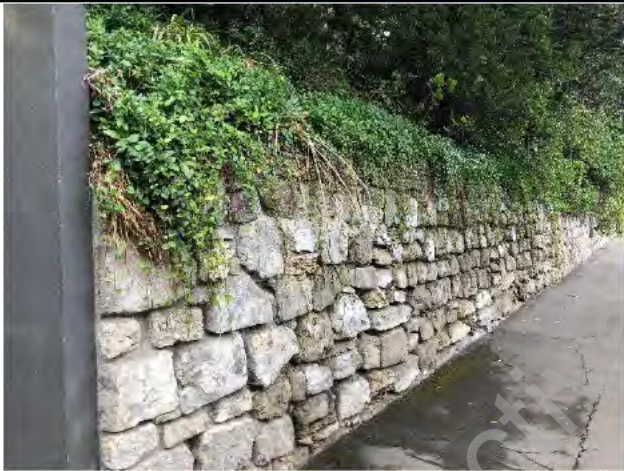
**Photo 3) Loose blocks/mortar eroded between blocks.**

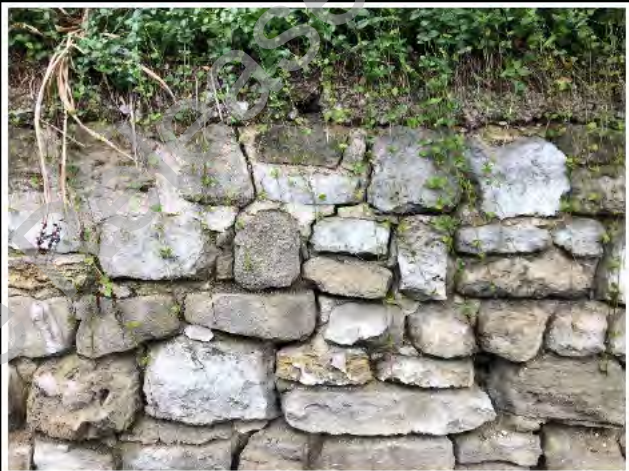
**Photo 4) Cracking observed between stone blocks.**

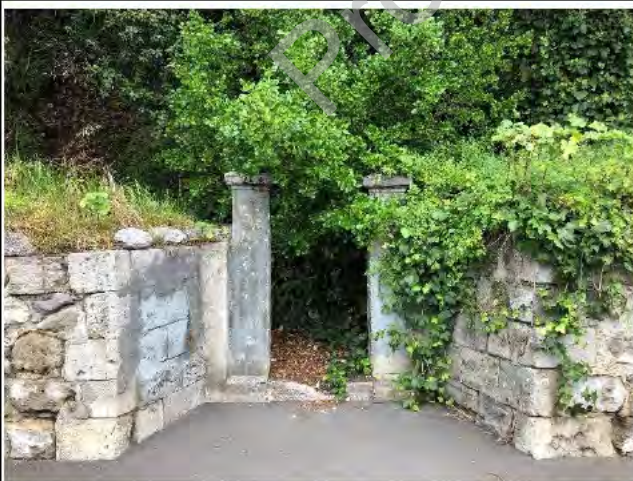
**Photo 5) Entrance way for old walkway upslope to prison site.**

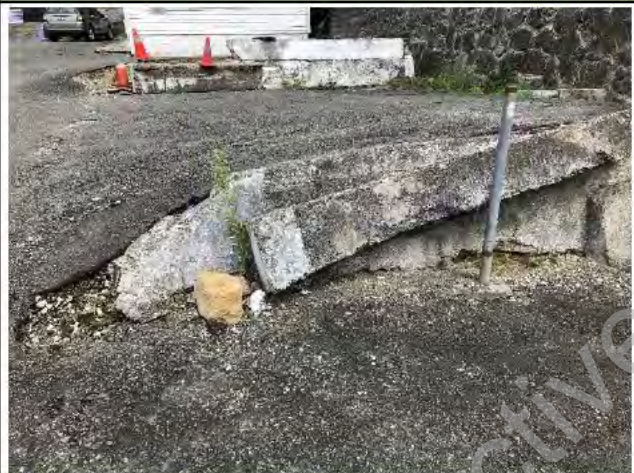
**Photo 3) Cracking and top barrier broken off top of wall.**

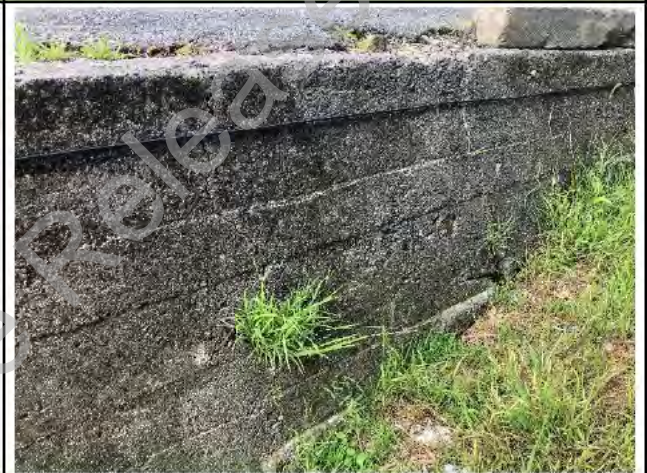
**Photo 4) Cracking observed in wall face.**

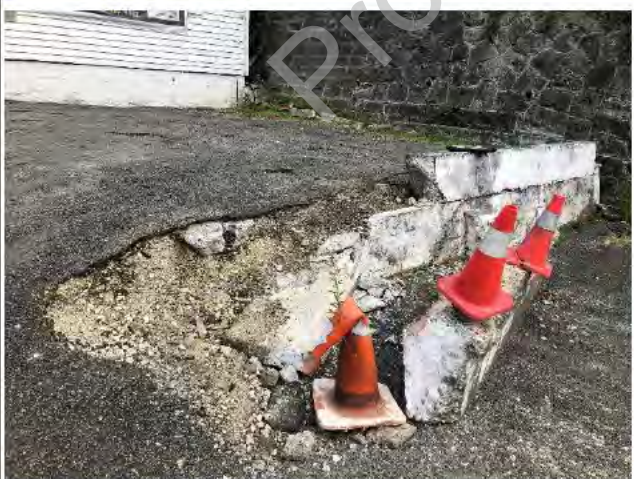
**Photo 5) Erosion, wall collapse and broken top barrier.**

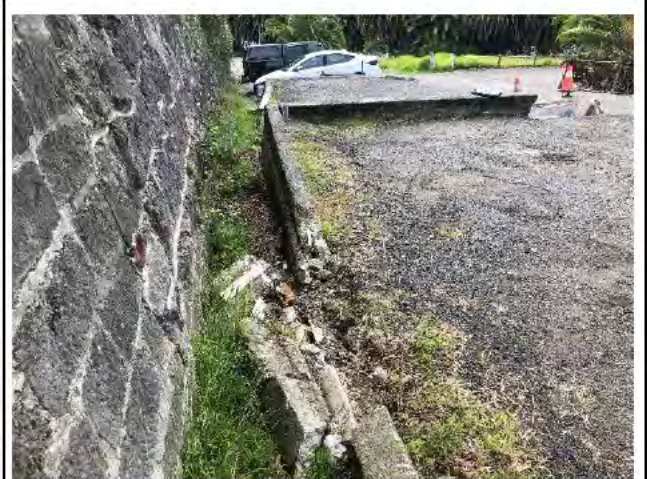
**Photo 6) Broken top barrier.**
