# Memorandum

| To | Hugh Donaldson | From | [REDACTED] |

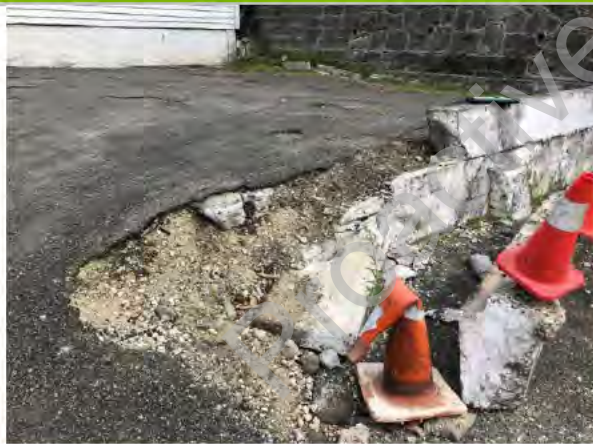
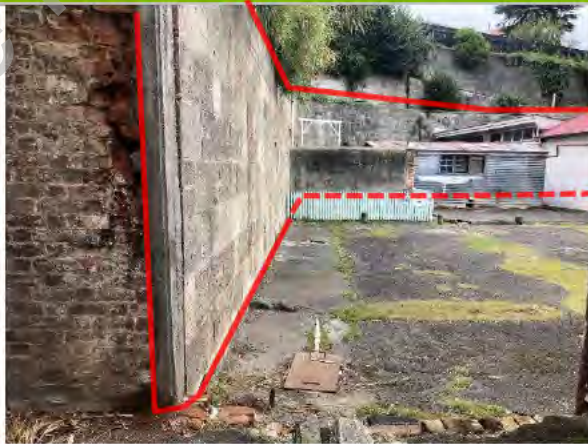
| '1 – Negligible' Consequence Rating Example | '5 – Severe' Consequence Rating Example |
|---|---|
| <p>An example of a wall at the site (NAP-PRIS-RW23) assigned a '1 – Negligible' consequence of failure rating, based on potential to cause limited disruption to carpark area only.</p> | <p>An example of a wall at the site (NAP-PRIS-RW10) assigned a '5 - Severe' consequence of failure rating, based on potential for serious injury / death, likelihood of undermining property (and tiered retaining system) above and damaging property (buildings) below in the event of wall failure. Failure mechanism would likely be overturning / toppling in a large earthquake or from build-up of water pressure behind face.</p> |

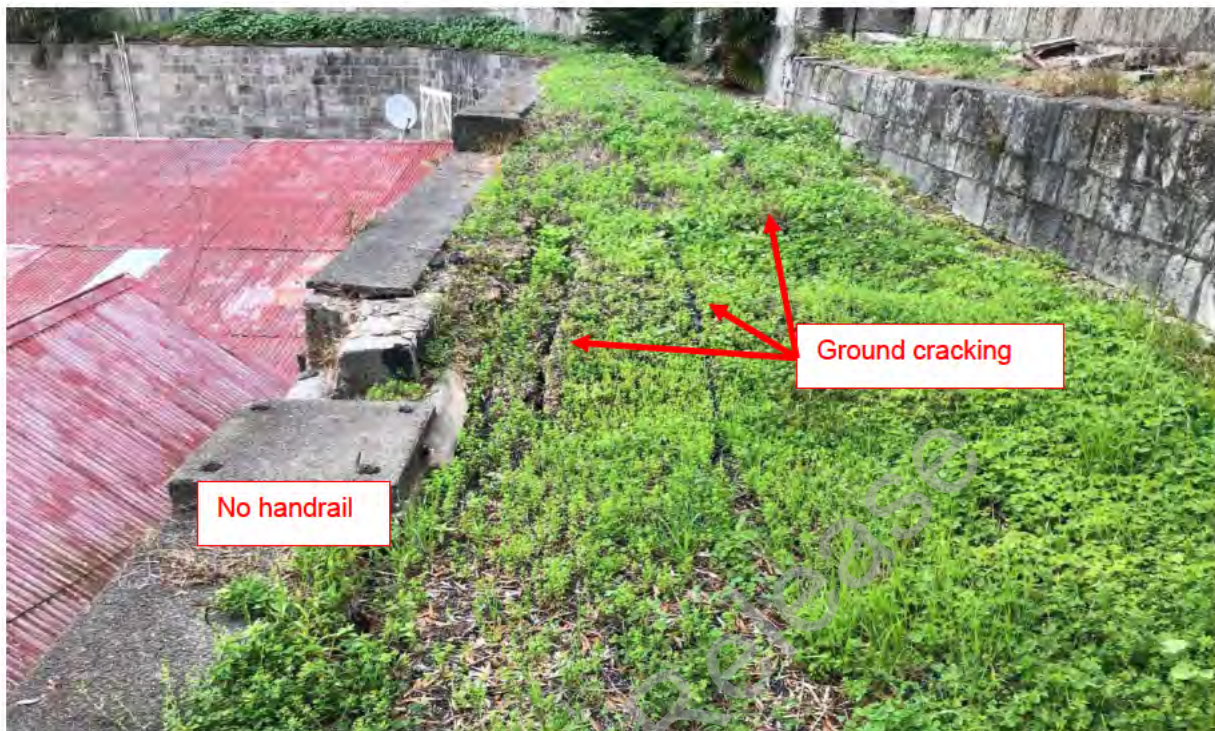
Figure 1. Ground cracking observed behind NAP-PRIS-RW10

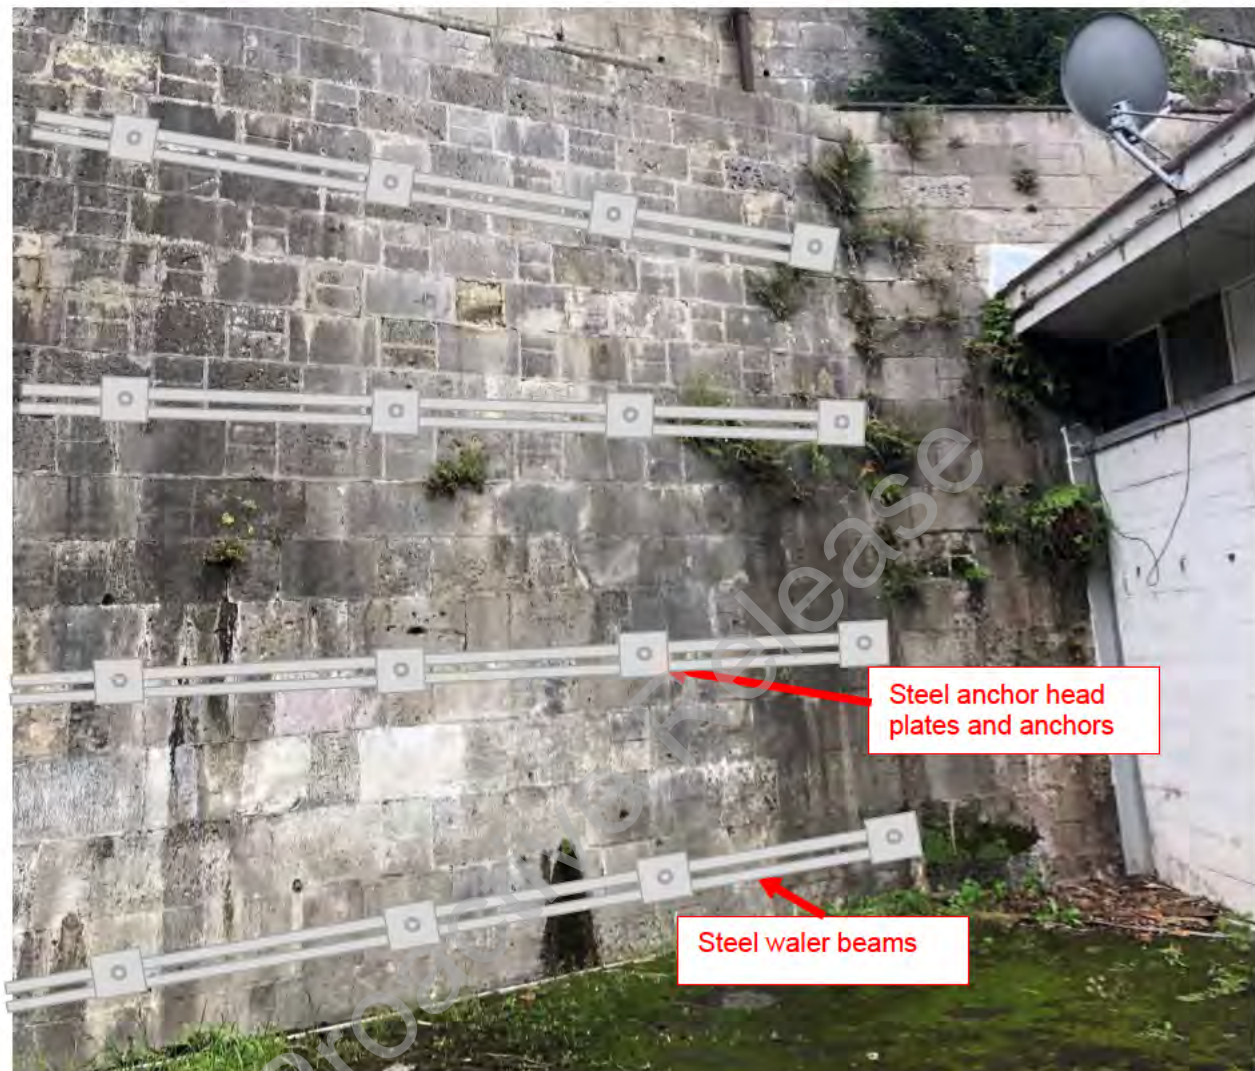
Figure 2. Indicative anchored wall system

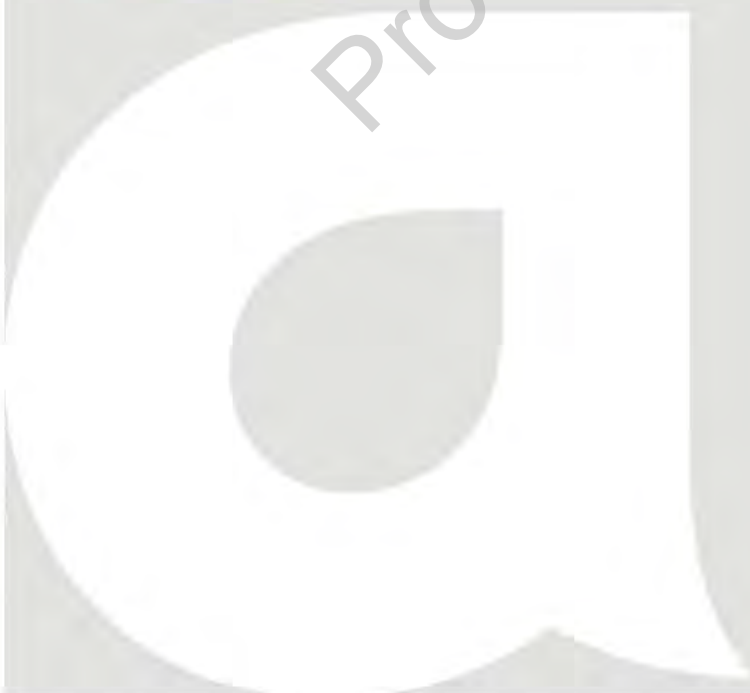
## Risk Assessment Table

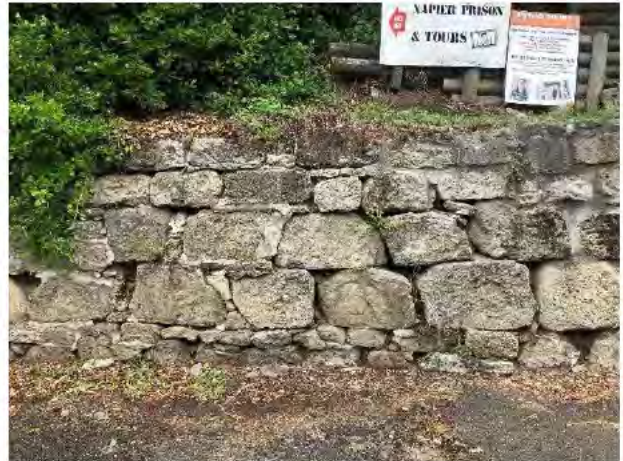
**Photo 2) Loose, dislodged blocks.**

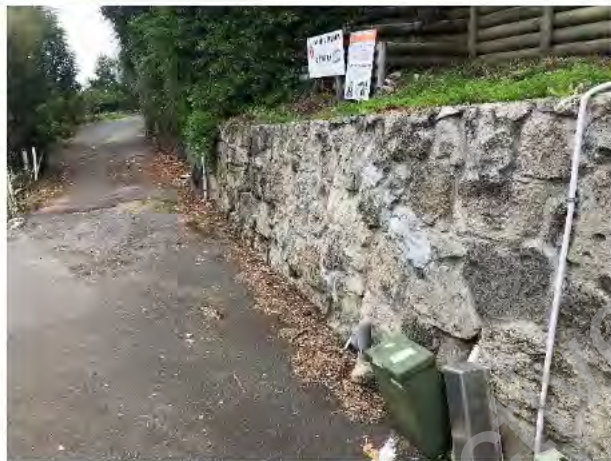
**Photo 3) Power box and services in front of wall.**

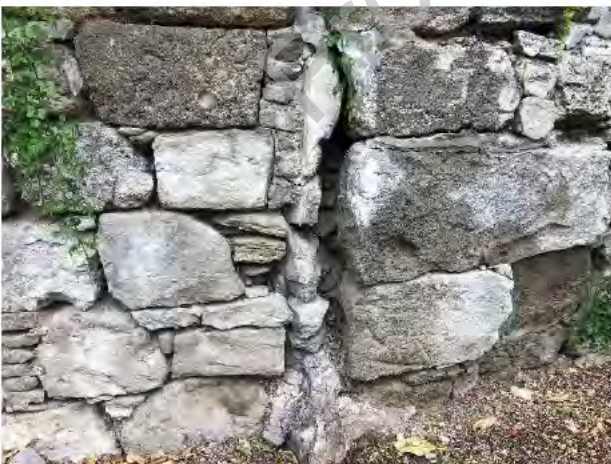
**Photo 5) Large displacement/gaps observed in wall. Note old tree root at toe of wall.**

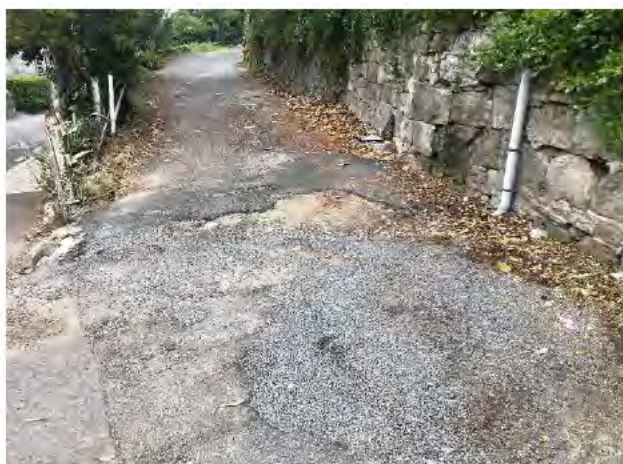
**Photo 6) Site driveway/entrance showing PVC pipe outlet and erosion of soil/asphalt.**

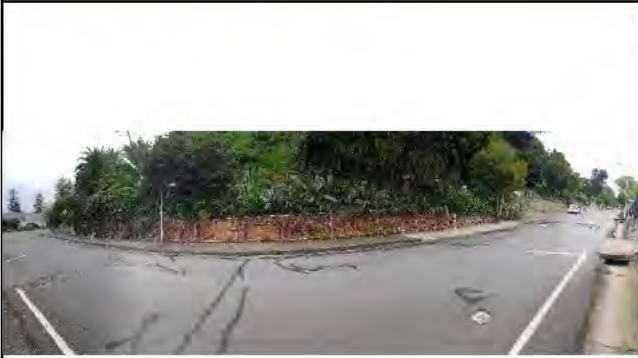
**Photo 1)** NAP-PRIS-02 View. Note possible ground cracking in road in front of wall.

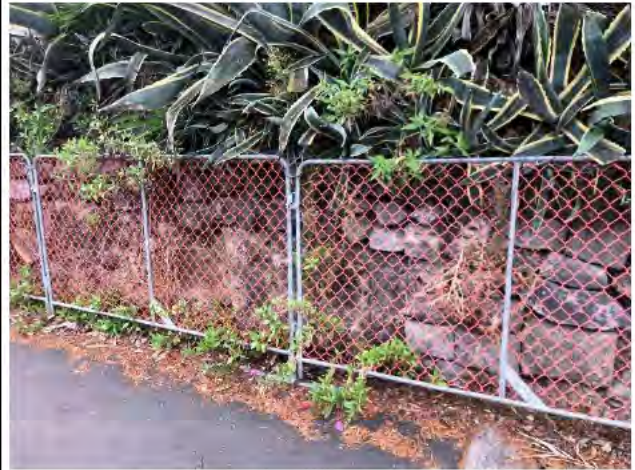
**Photo 2)** Loose, dislodged blocks and partial collapse.

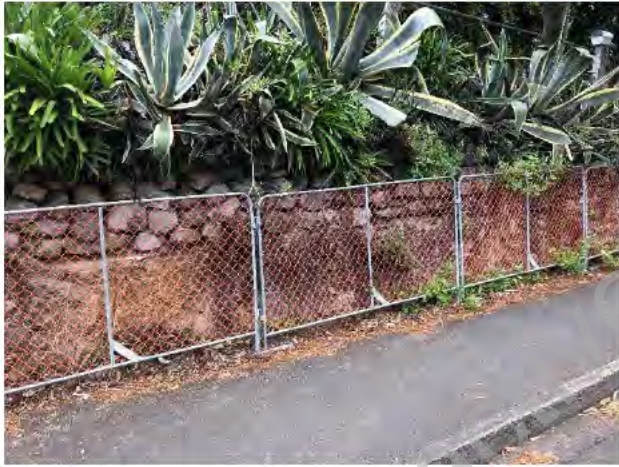
**Photo 3)** Loose blocks and partial collapse of wall.

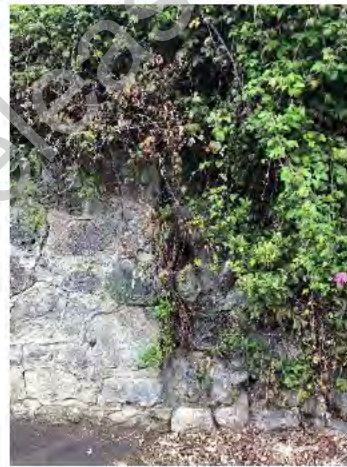
**Photo 4)** Transition between NAP-PRIS-02 (right) and NAP-PRIS-21 (left).

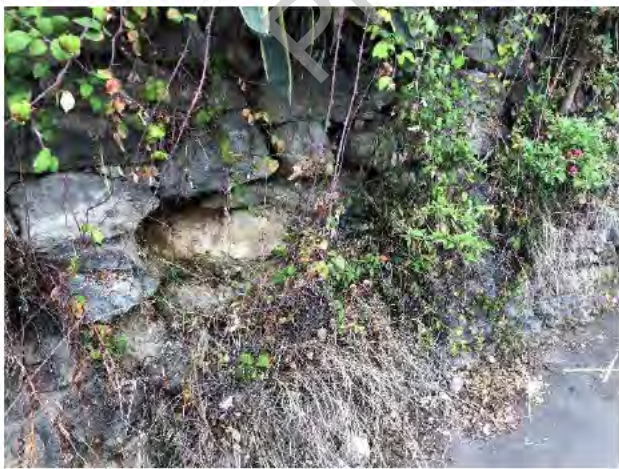
**Photo 5)** Loose blocks, erosion and vegetation observed in wall face.

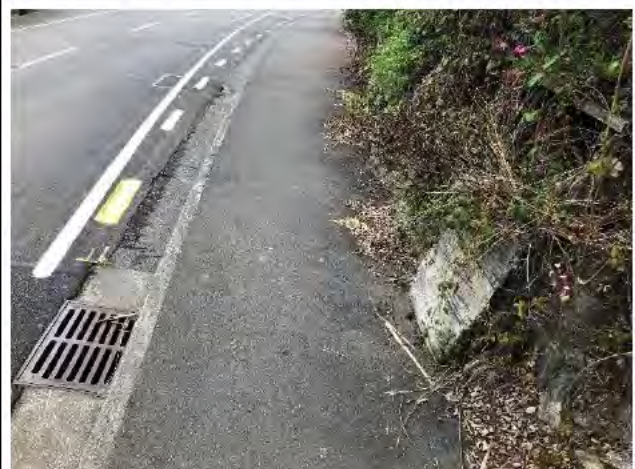
**Photo 6)** Inferred old stormwater channel observed in wall face.

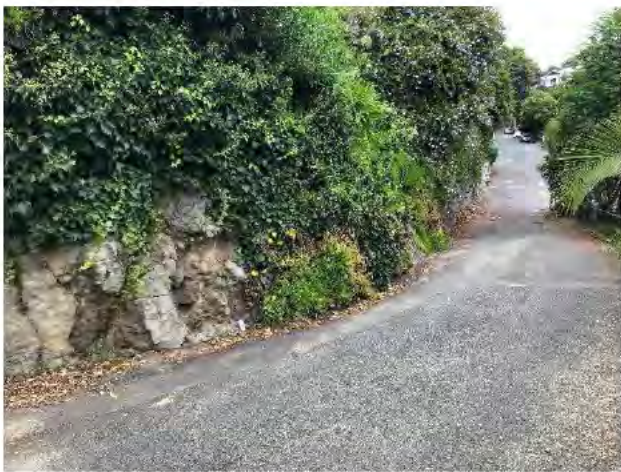
**Photo 1)** NAP-PRIS-03 view above site access/driveway.

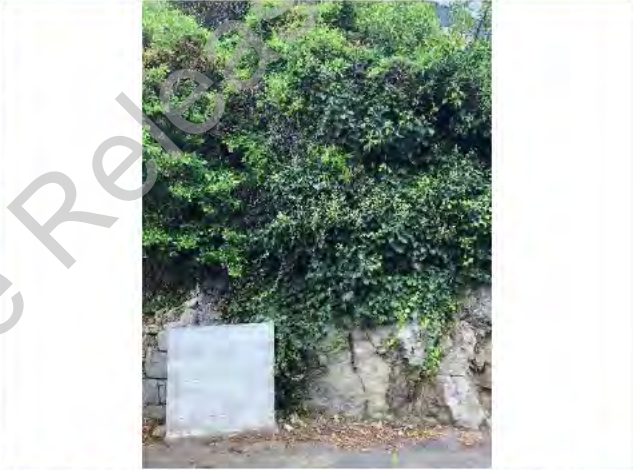
**Photo 4)** Historical concrete stormwater channel (inferred) observed in front of wall.

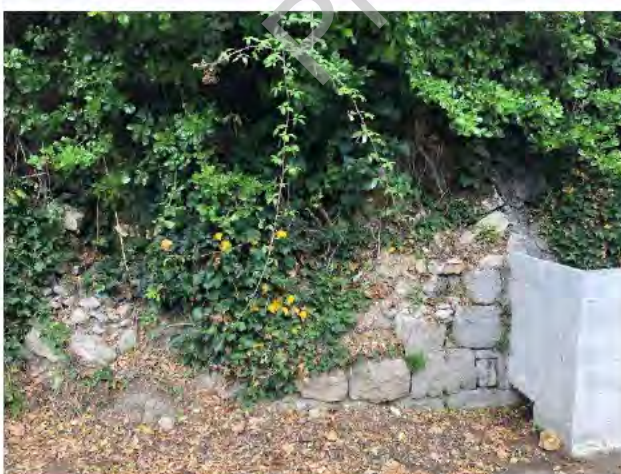
**Photo 5)** Evidence of old block wall, which has collapsed and eroded.

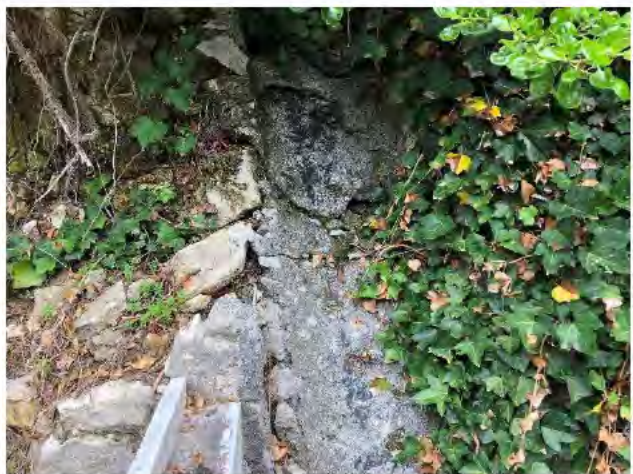
**Photo 6)** Significant cracking and degradation of upslope concrete channel.

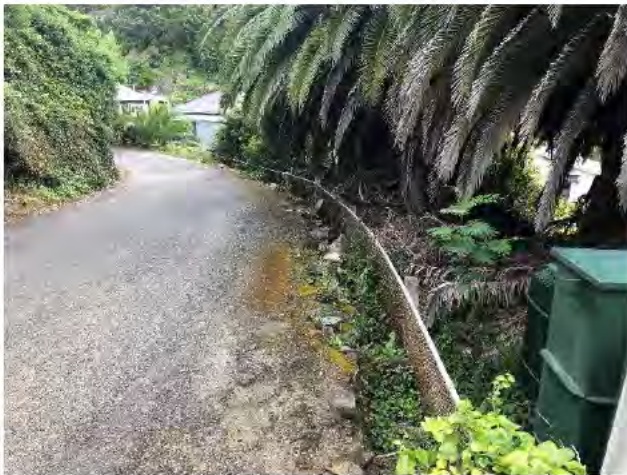
**Photo 1)** NAP-PRIS-04 view.

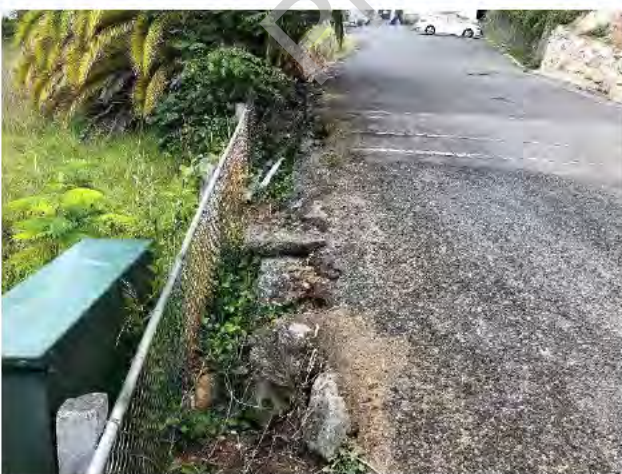
**Photo 5)** Power box observed in front of wall.

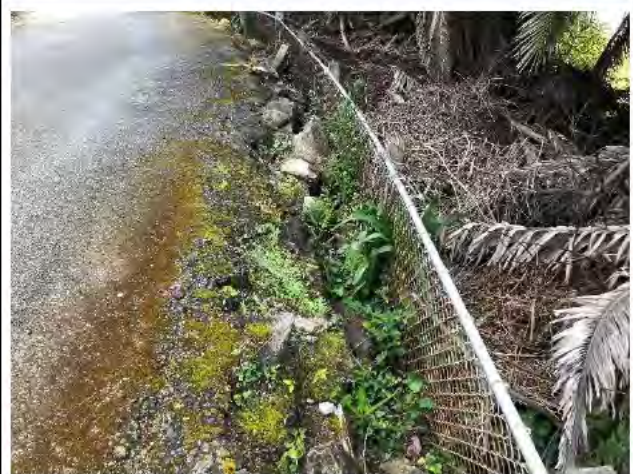
**Photo 6)** Vegetation and partial collapse of wall.

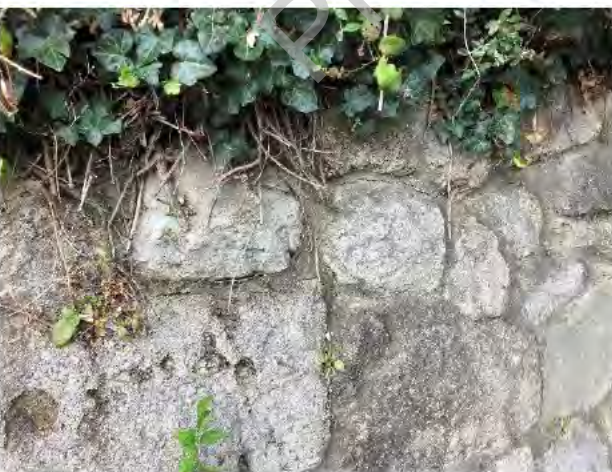
**Photo 5)** Cracking observed in mortar between blocks.

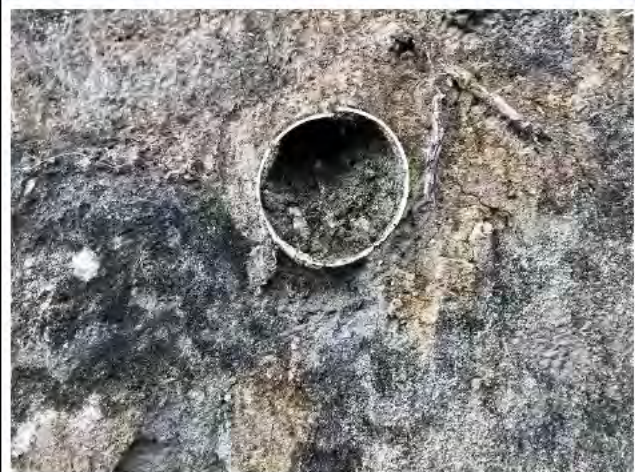
**Photo 6)** Weep hole, possibly recently installed, clogged with soil.

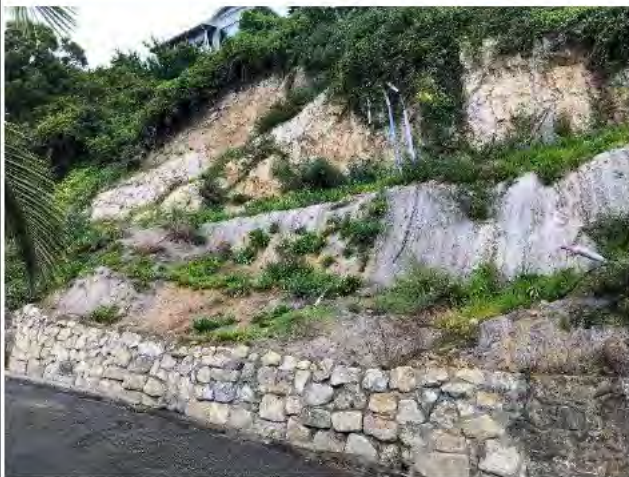
**Photo 1)** NAP-PRIS-06 view. Note recent slope failure and “new” construction of wall, also upslope residential property.

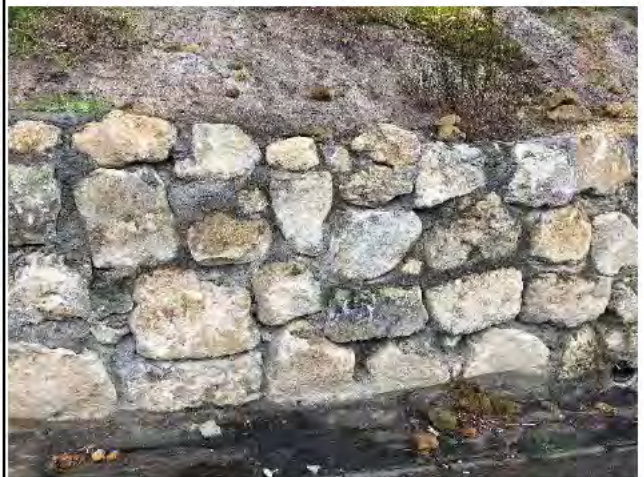
**Photo 2)** Cracked and missing mortar between blocks.

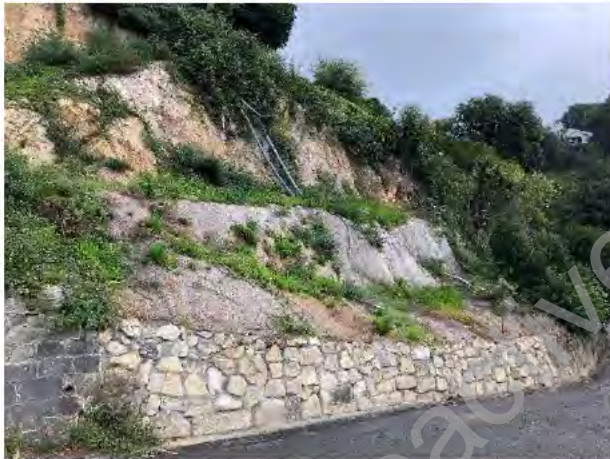
**Photo 3)** Benched slope covered with coconut matting following slip.

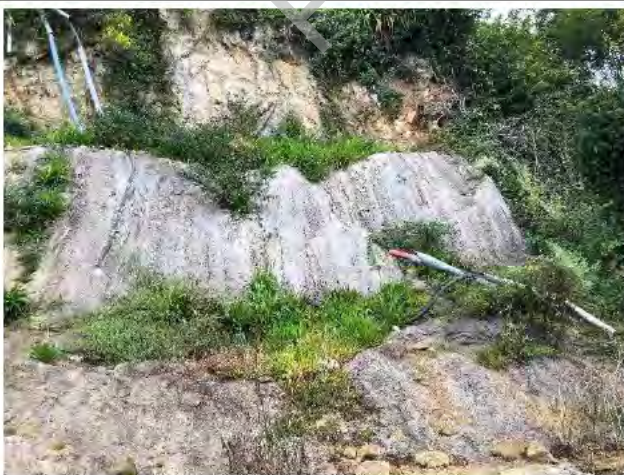
**Photo 5)** Coconut matting placed over slope following slip. Note protruding, broken services.

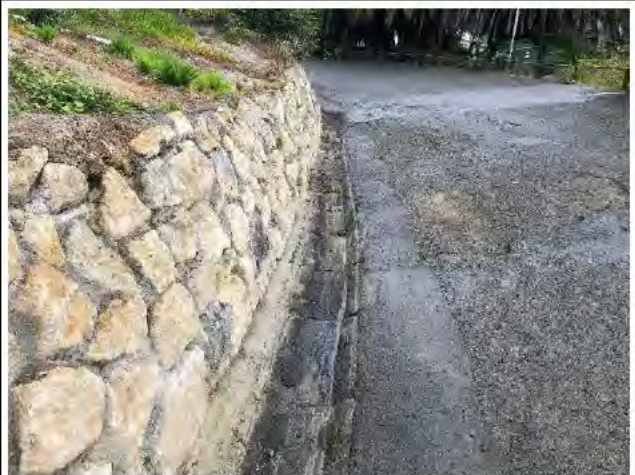
**Photo 6)** Wall face and drainage channel at toe of wall.

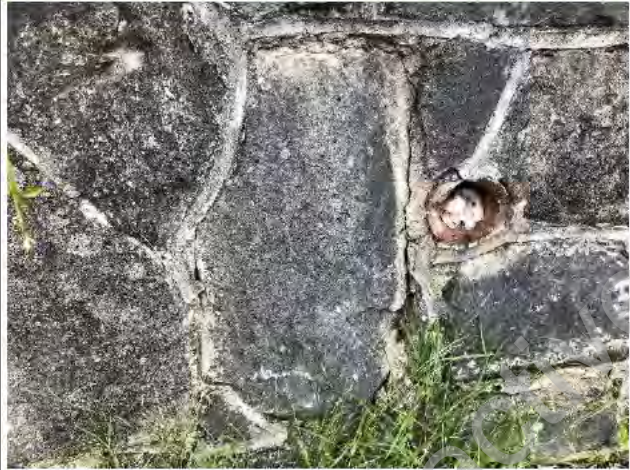
**Photo 3)** Cracking observed around blocks.

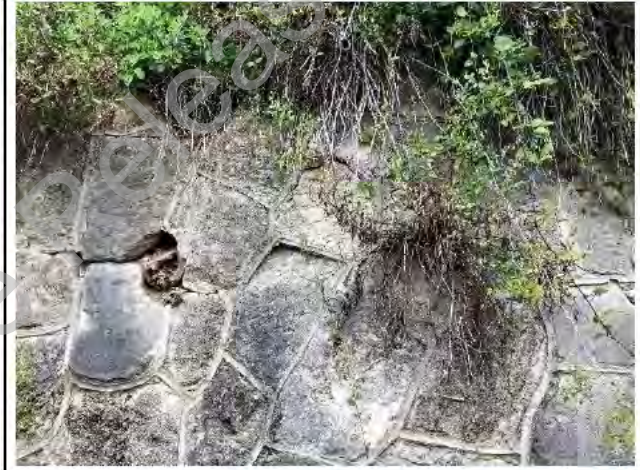
**Photo 4)** Cracking and broken drainage pipes observed.

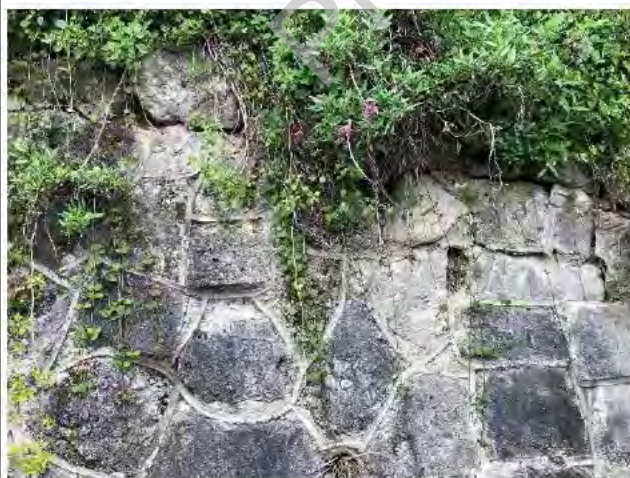
**Photo 5)** Cracking at top of wall where heavy vegetation present. Root growth through drains.

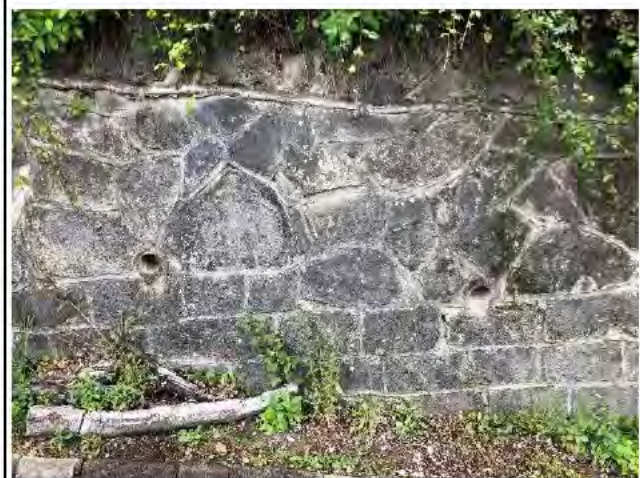
**Photo 6)** Wall face and drainage holes.

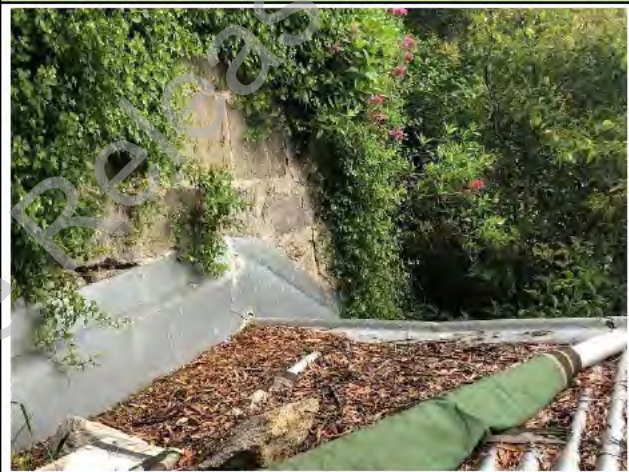
**Photo 4)** Cracking and observed in wall face.

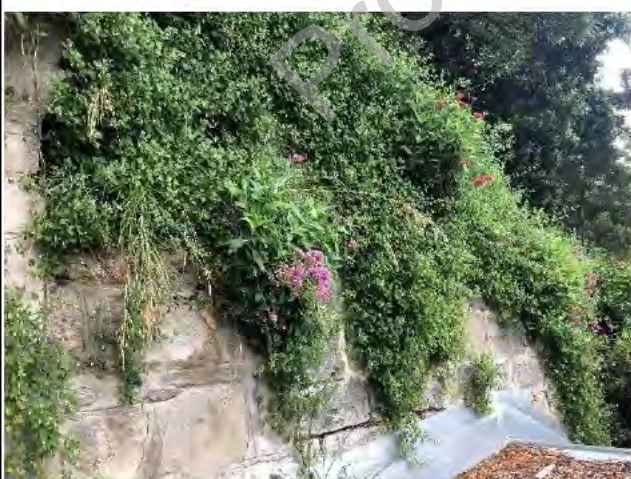
**Photo 5)** Cracking and vegetation growth through wall face.

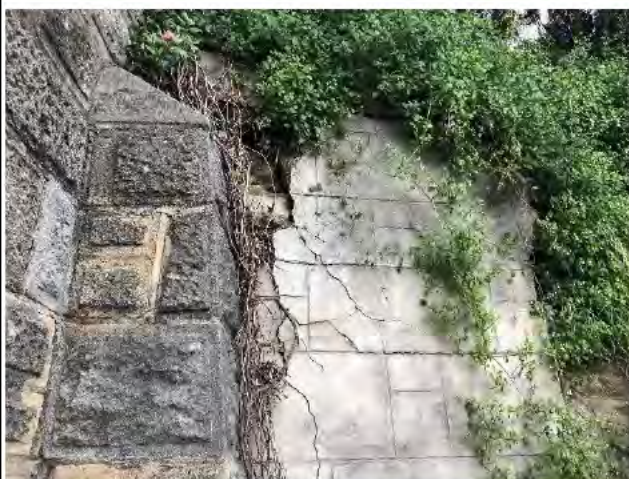
**Photo 6)** Cracked and partially collapsed façade. Note prison wall on left.

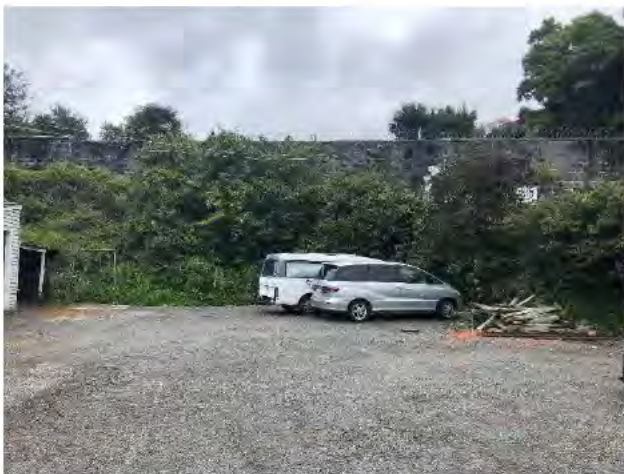
**Photo 1)** NAP-PRIS-09 view, note heavy vegetation and prison wall near top of wall.

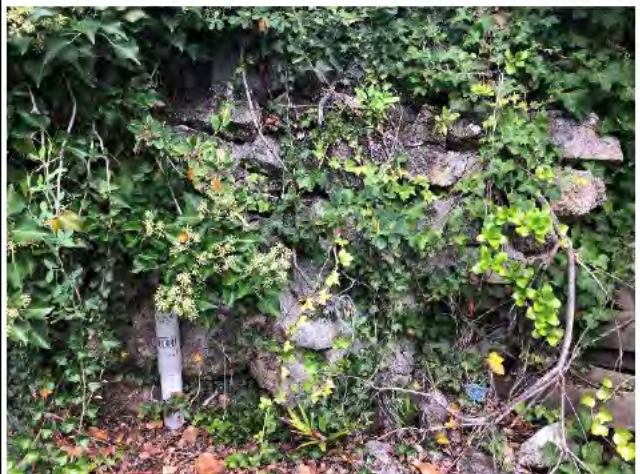
**Photo 2)** Heavily vegetated wall face with loosely stacked blocks.

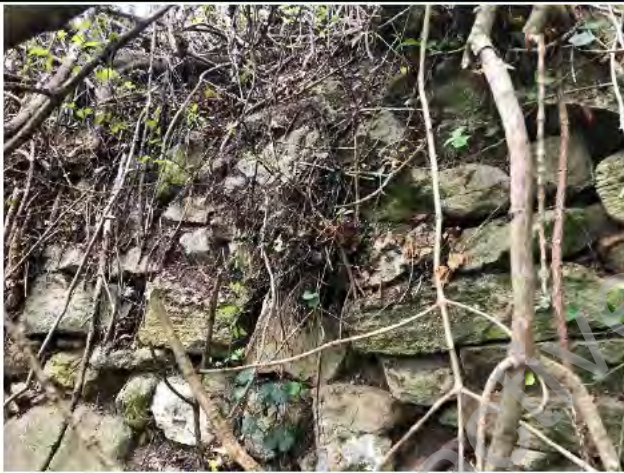
**Photo 3)** Loose blocks and partial wall collapse.

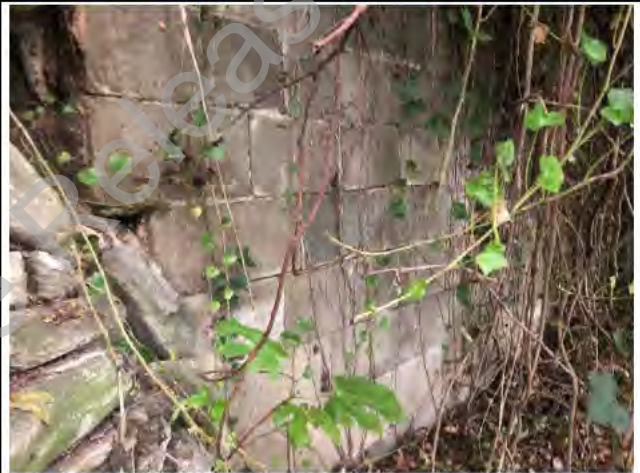
**Photo 4)** Concrete block section of NAP-PRIS-09.

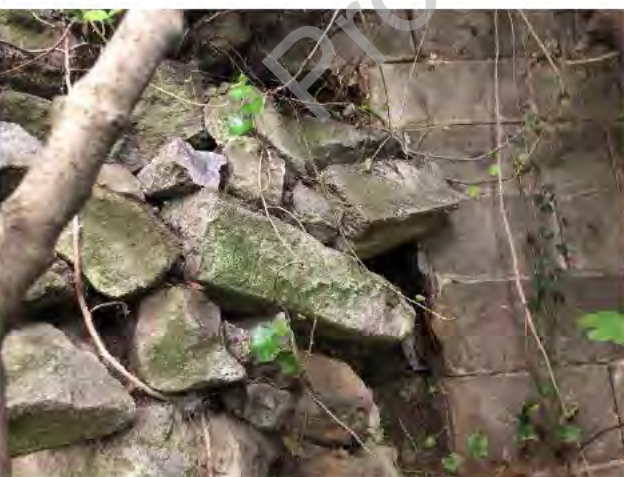
**Photo 5)** Interface between loose stone section and concrete block section. Note large void.

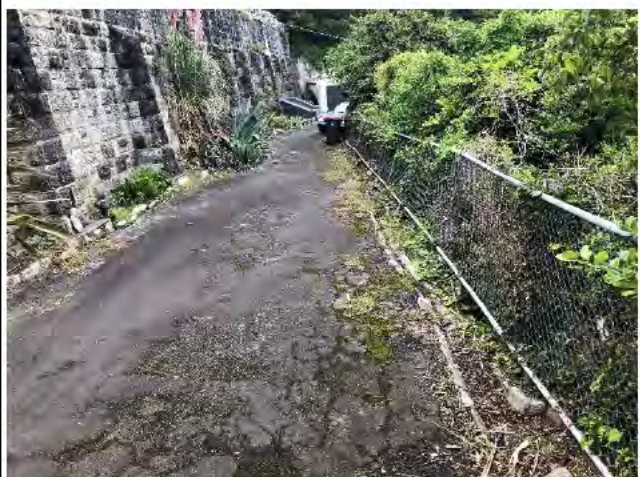
**Photo 6)** Cracking of access way and rotation of fence at top of wall.

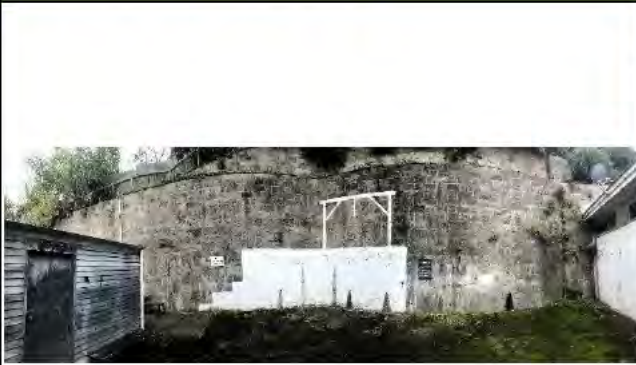
**Photo 1)** NAP-PRIS-10 view. Interior prison wall.

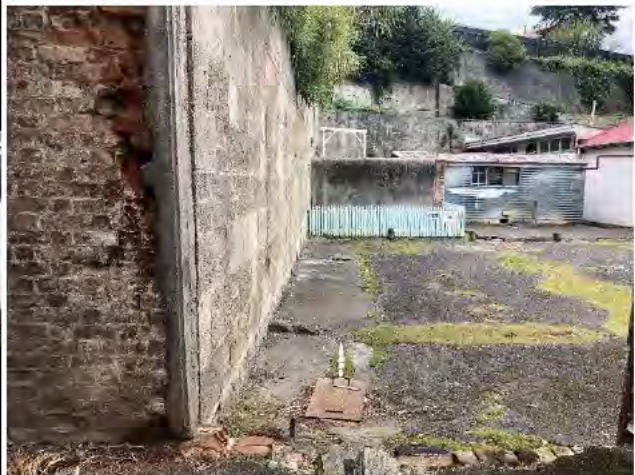
**Photo 2)** Brick masonry at cracking observed at end of wall.

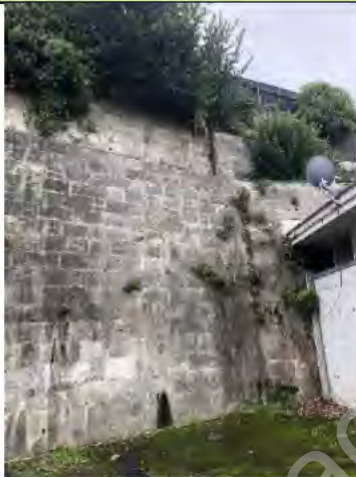
**Photo 3)** Vegetation and observed water seepage over wall face.

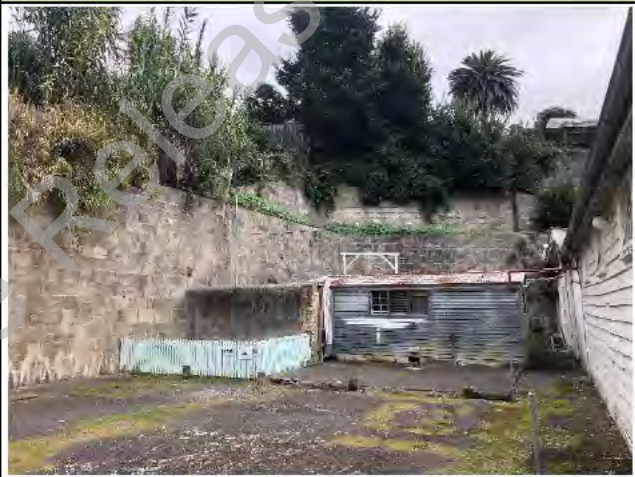
**Photo 4)** NAP-PRIS-10 view. Note picket fence area is the prison graveyard.

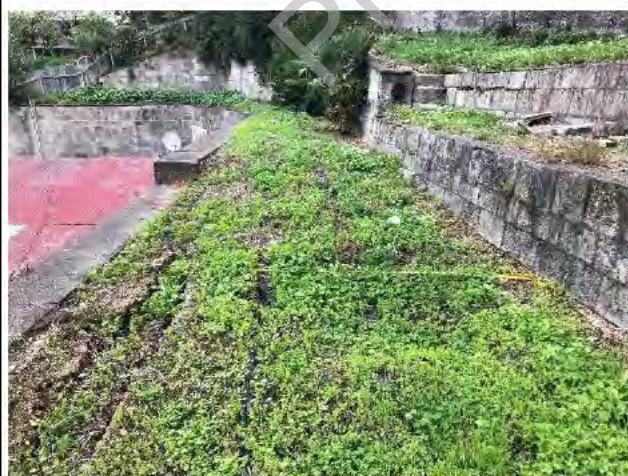
**Photo 5)** ~300mm wide ground cracks observed at the top of the wall.

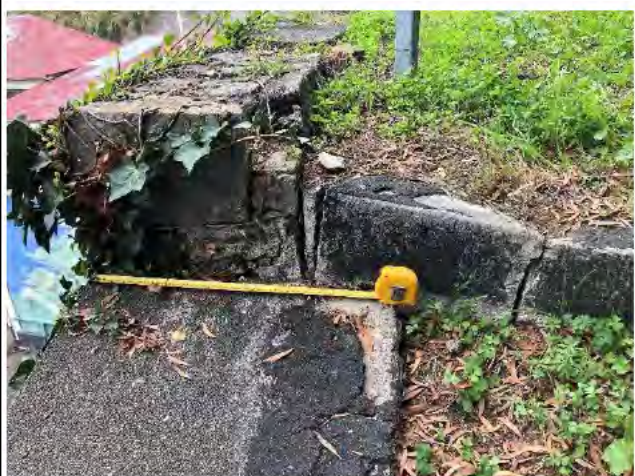
**Photo 6)** Cracking and possible rotation observed at top of wall.

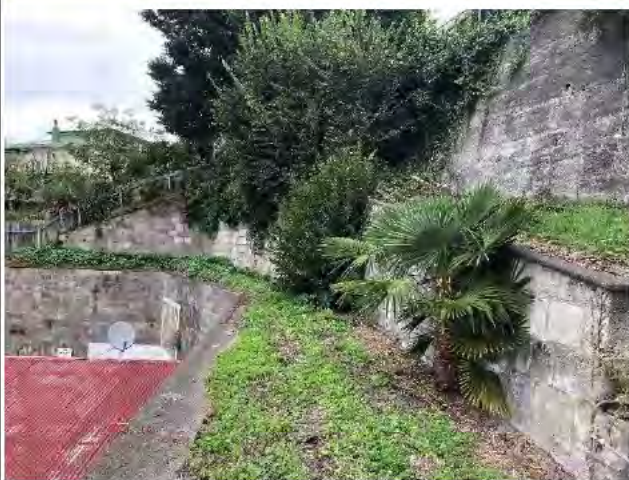
**Photo 1)** NAP-PRIS-11 view. Located above NAP-PRIS-10.

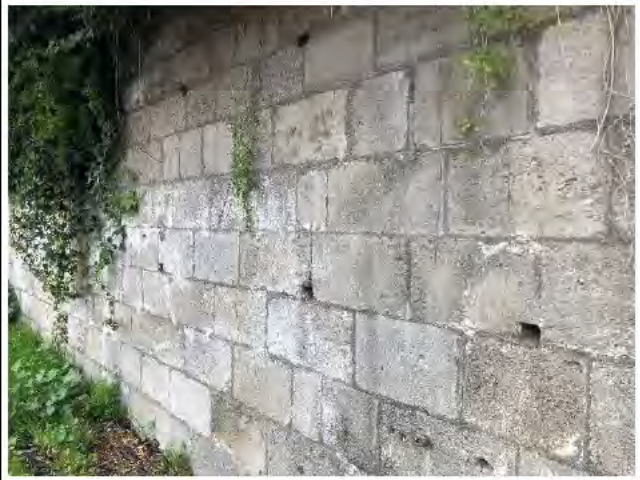
**Photo 2)** Typical wall face observed. Note "square" holes are weep holes/wall drainage.

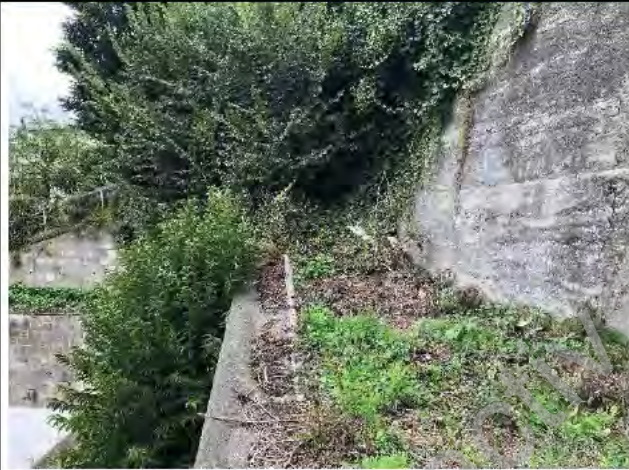
**Photo 3)** Heavy vegetation above top of wall.

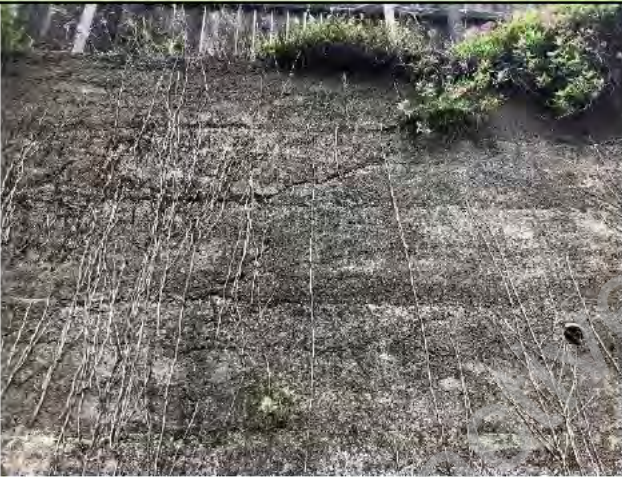
**Photo 3)** Some cracking observed in wall face.

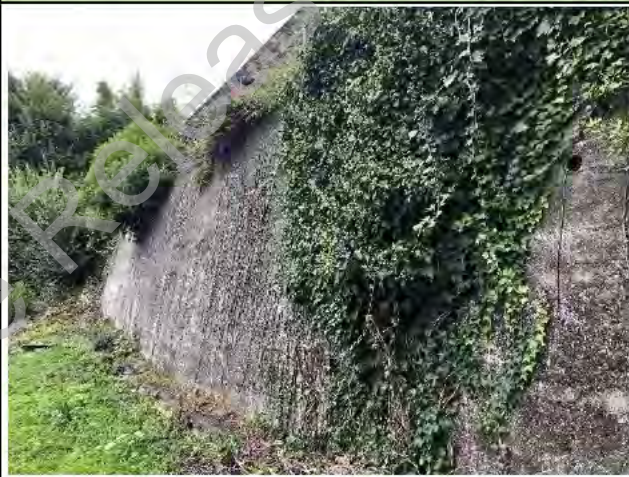
**Photo 4)** Vegetation growth over face.

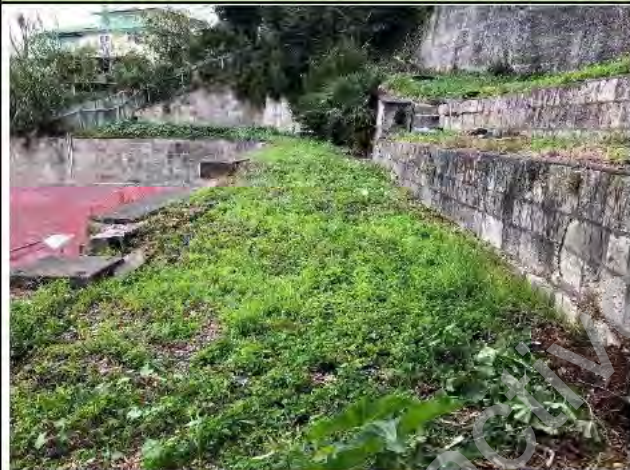
**Photo 3)** Ground cracking observed in front of wall (behind NAP-PRIS-RW10)

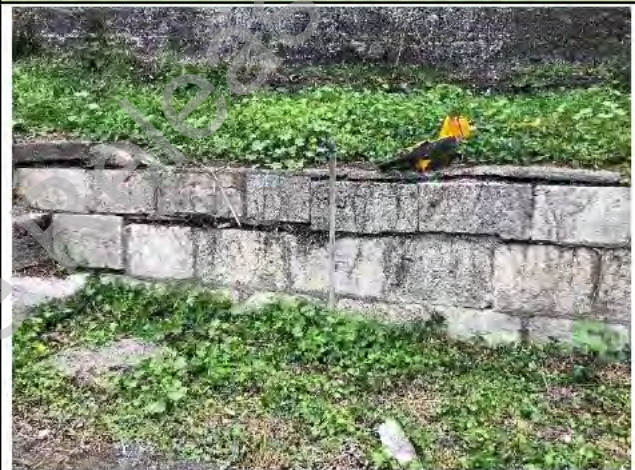
**Photo 4)** Loose/dislodged blocks observed.

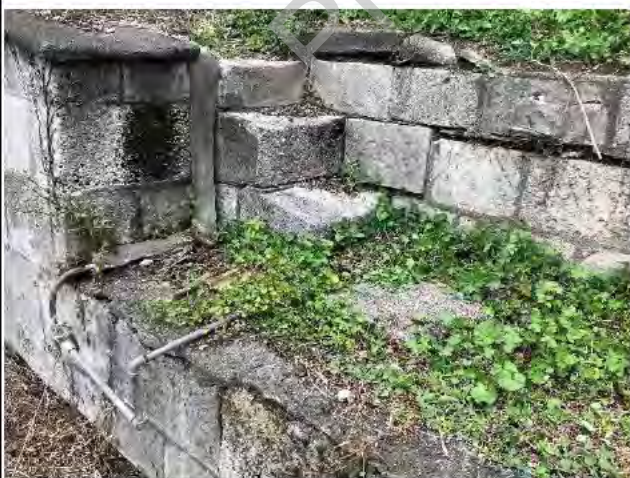
**Photo 5)** Loose/dislodged blocks observed. Possible wall settlement resulting in "gap".

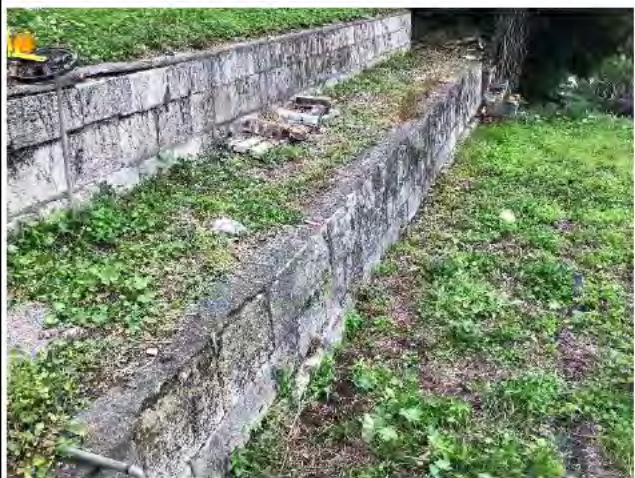
**Photo 6)** NAP-PRIS-RW13 view.

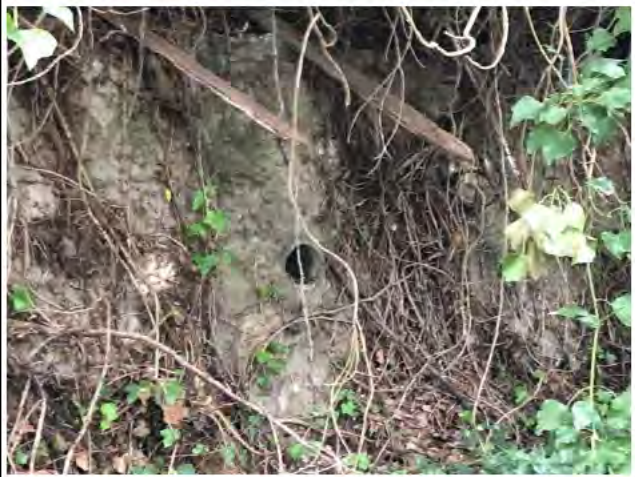
**Photo 2)** Drainage pipe observed.

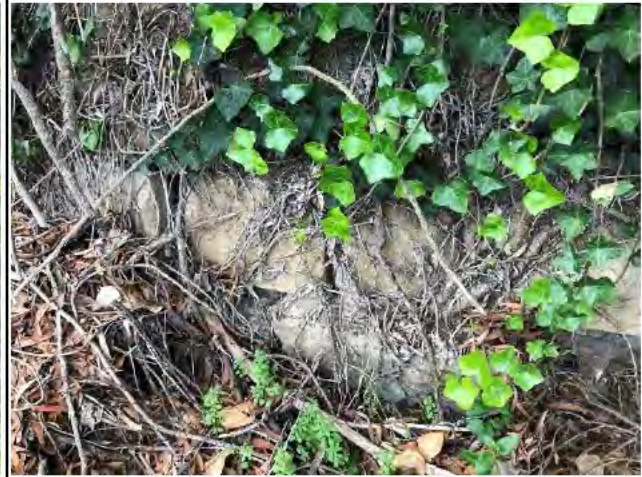
**Photo 2)** Loose blocks, heavy vegetation and partial collapse observed.

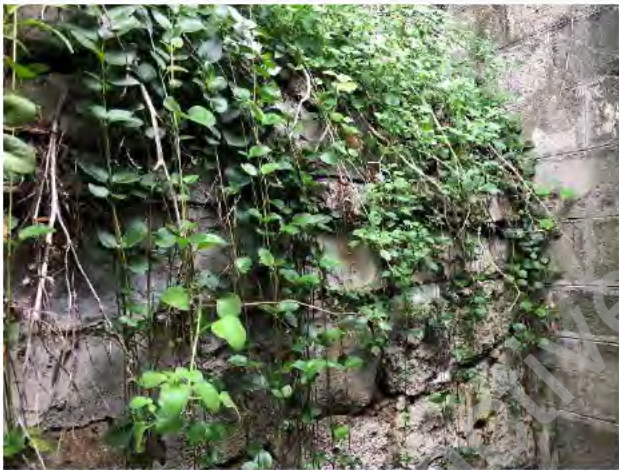
**Photo 3)** Vegetation observed at top of wall. Cracking and erosion of mortar and blocks.

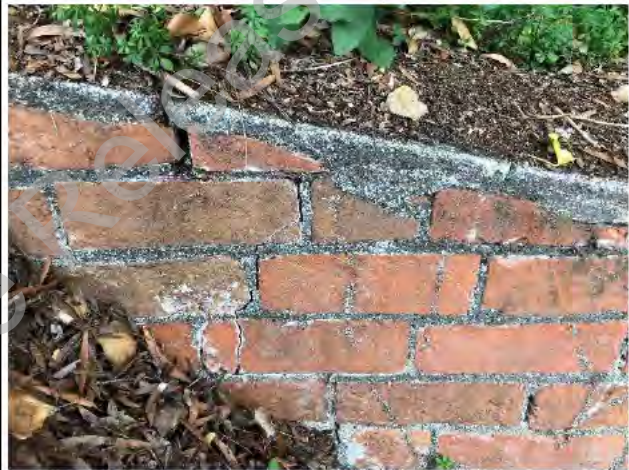
**Photo 4)** Cracking observed in brick masonry.

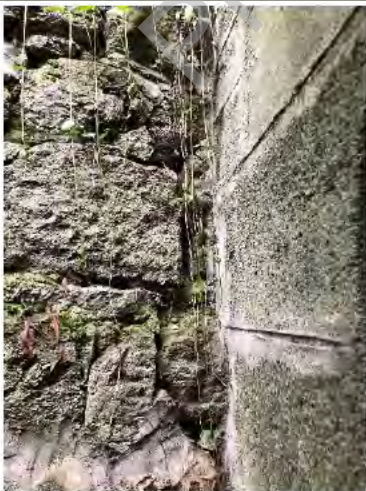
**Photo 5)** Cracking observed at end of wall.

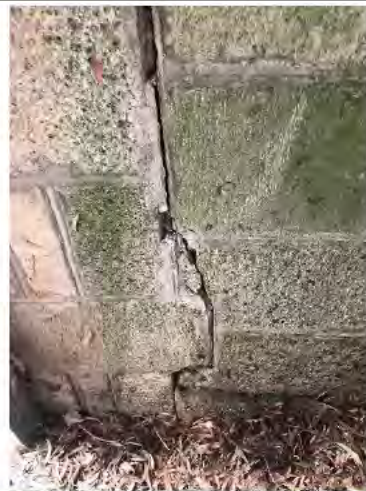
**Photo 6)** Cracking observed at base of wall.

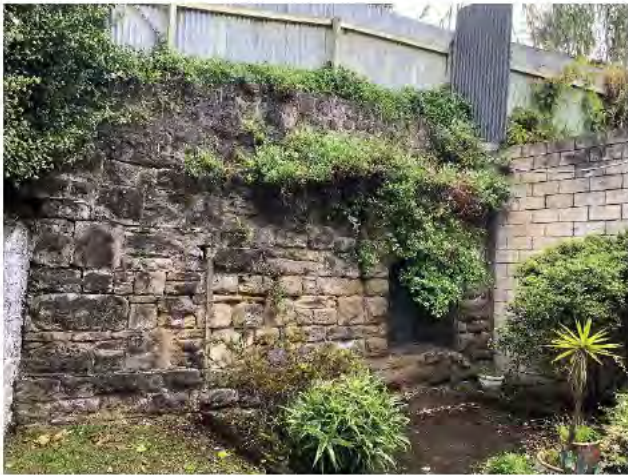
**Photo 1) NAP-PRIS-RW17 view.**

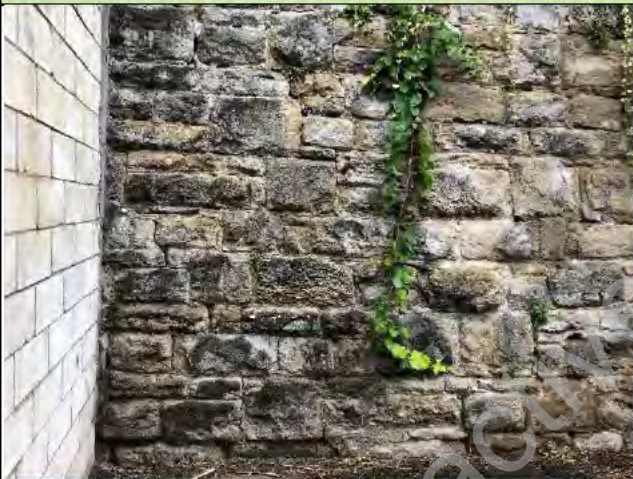
**Photo 3) Cracking observed in wall face.**

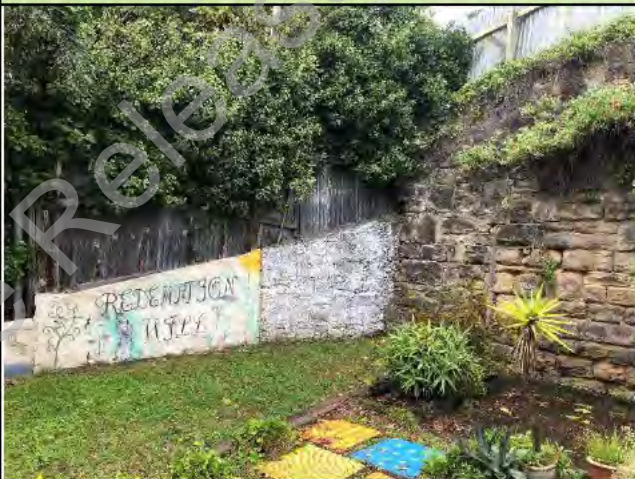
**Photo 4) Mass concrete wall observed adjacent to NAP-PRIS-RW17.**

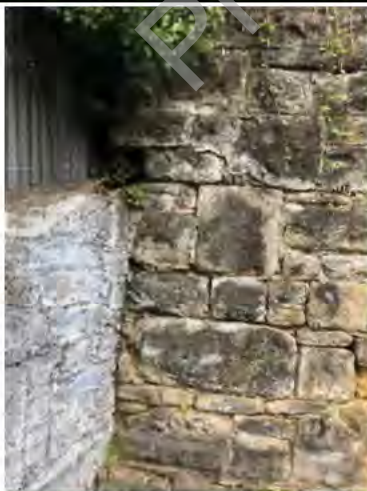
**Photo 5) Erosion of stone blocks and mortar observed.**

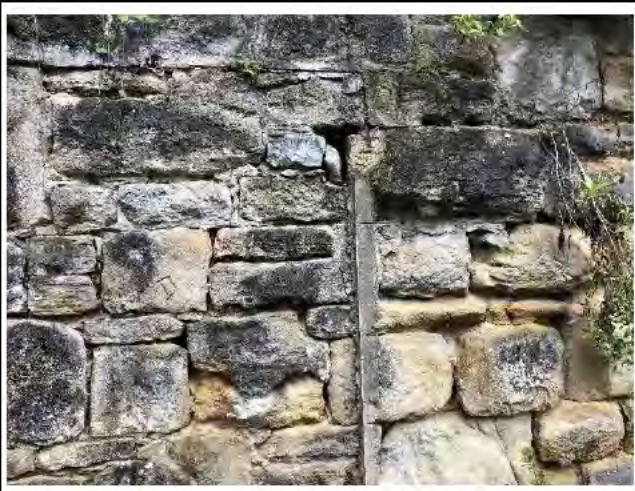
**Photo 6) Erosion of stone blocks and mortar observed.**

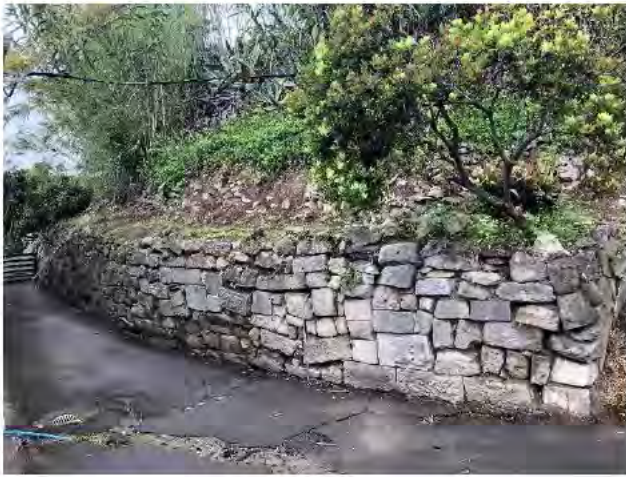
**Photo 1) NAP-PRIS-RW18 view.**

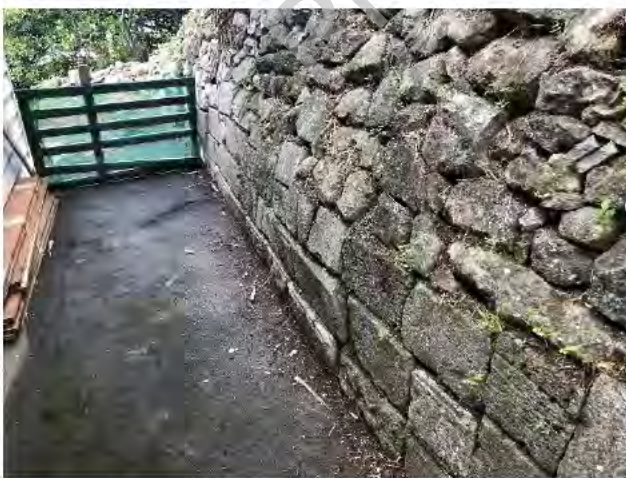
**Photo 5) Bulging of wall observed.**
