# Memorandum

| To | Hugh Donaldson | From | [REDACTED] |

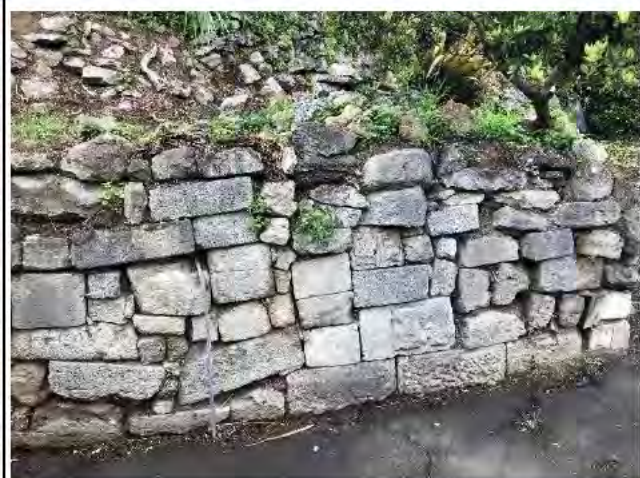
**Photo 6) Loosely stacked rocks of wall face.**

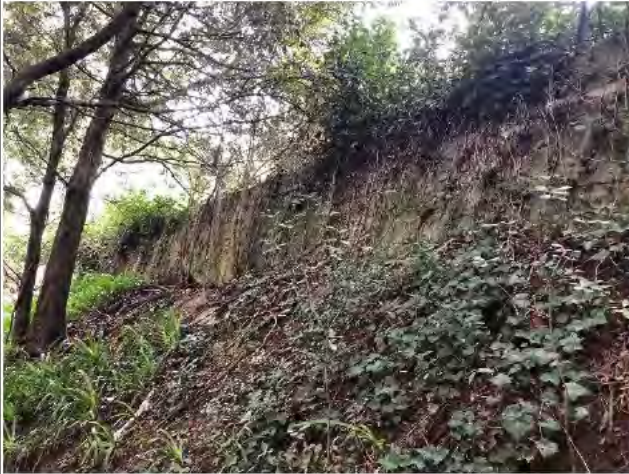
**Photo 1)** NAP-PRIS-RW19 view. Note steep toe slope.

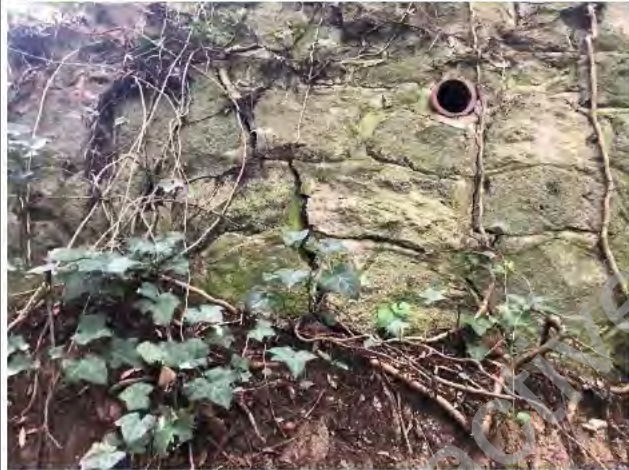
**Photo 3)** Cracking observed in wall face.

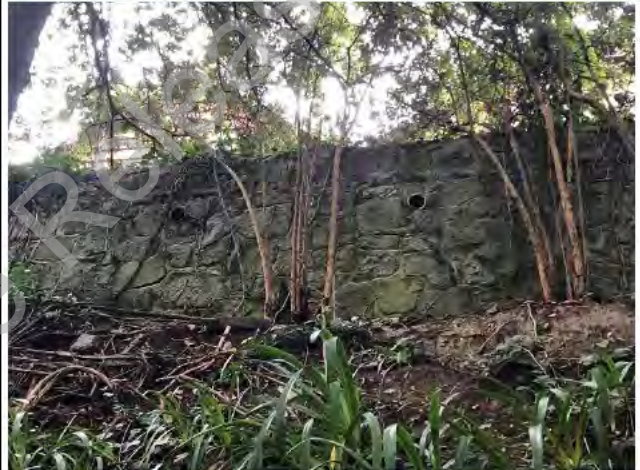
**Photo 4)** Typical wall face condition.

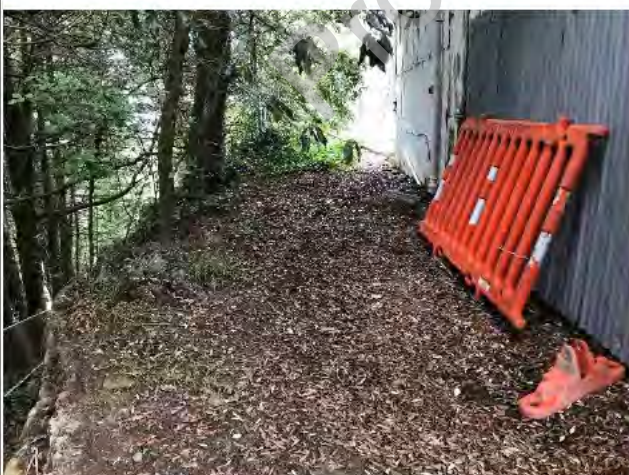
**Photo 5)** Top of wall. Note edge of prison building shown on right.

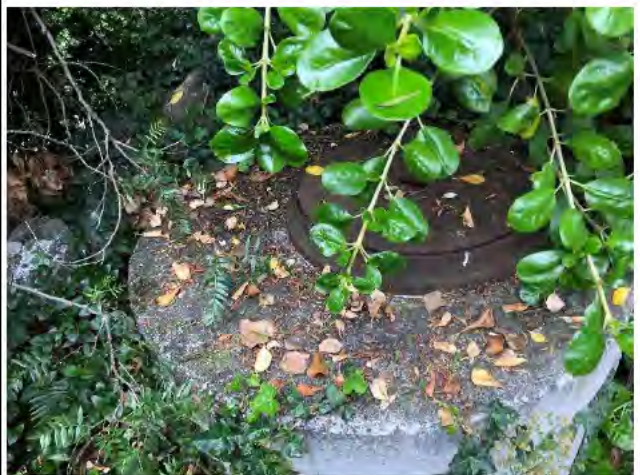
**Photo 6)** Manhole observed immediately behind top of wall.

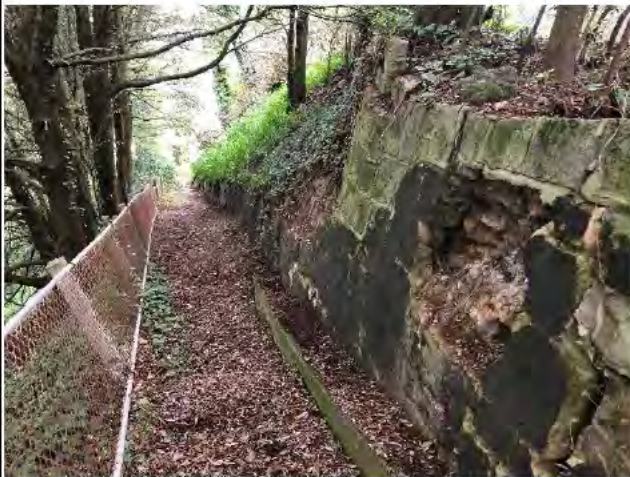
**Photo 1) NAP-PRIS-RW20 view.**

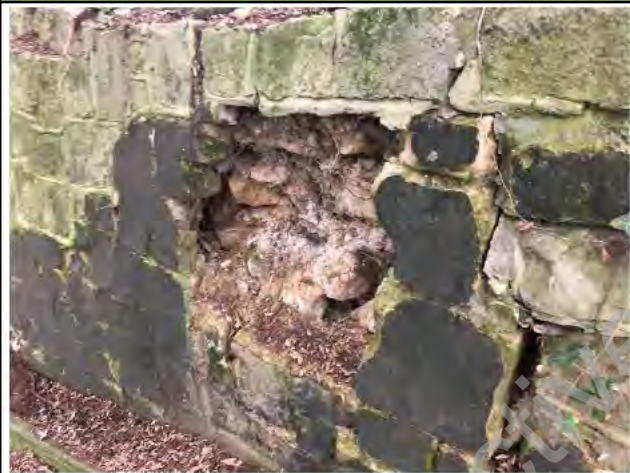
**Photo 3) Cracking and partial collapse of wall observed.**

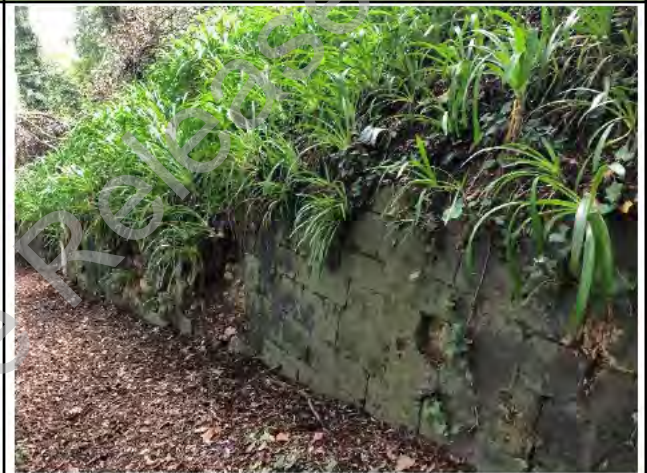
**Photo 4) Cracking and partial collapse of wall observed.**

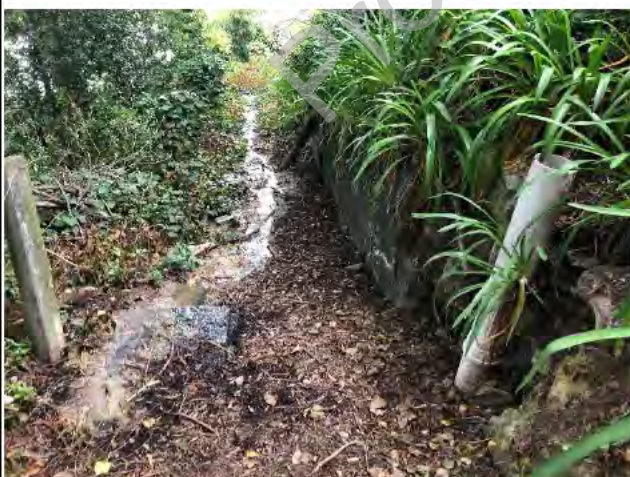
**Photo 5) Raw sewage leaking from sump in front of wall.**

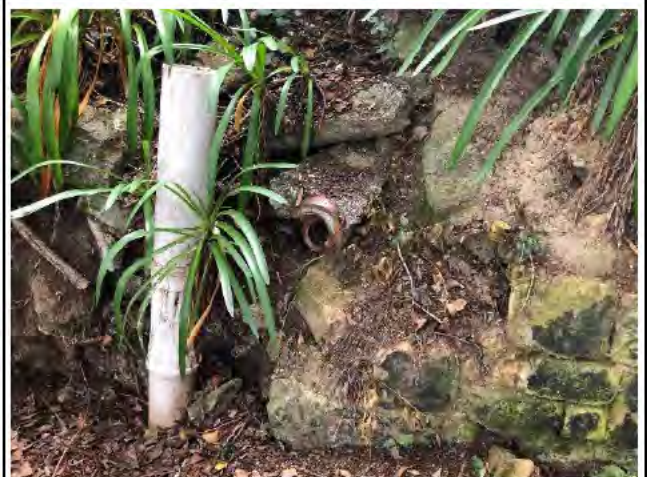
**Photo 6) Collapsed section of wall immediately upslope of sewage leak.**

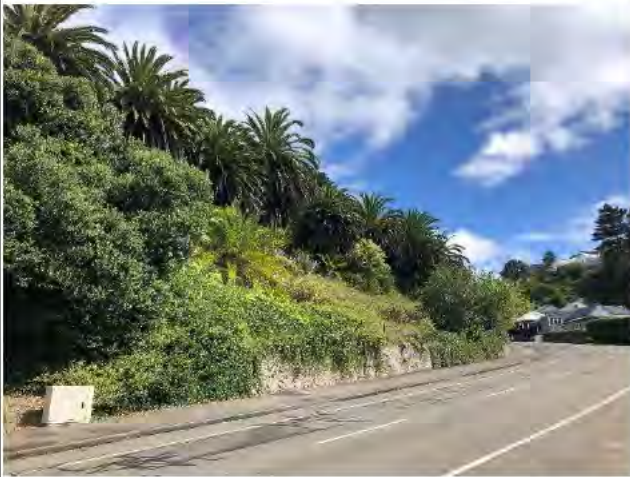
**Photo 1)** NAP-PRIS-RW21 view. Note Coote Road in foreground.

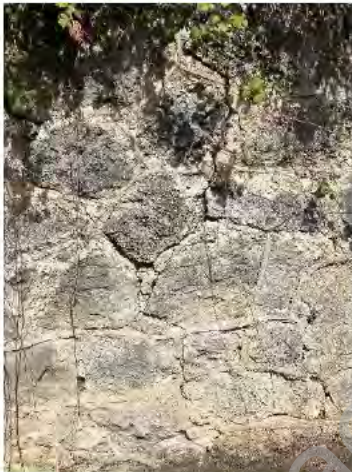
**Photo 3)** Cracking observed in wall face.

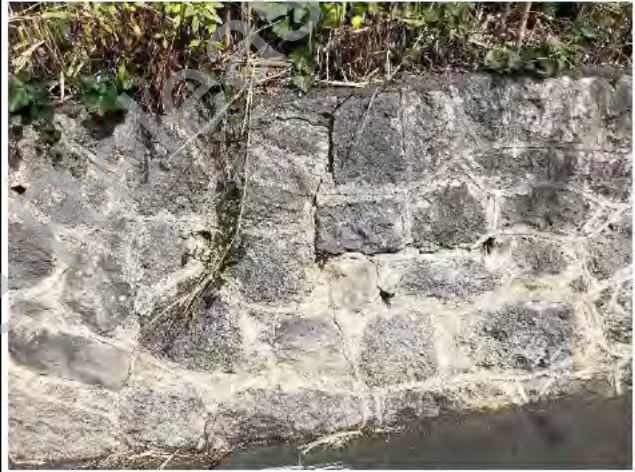
**Photo 4)** Cracking observed in wall face.

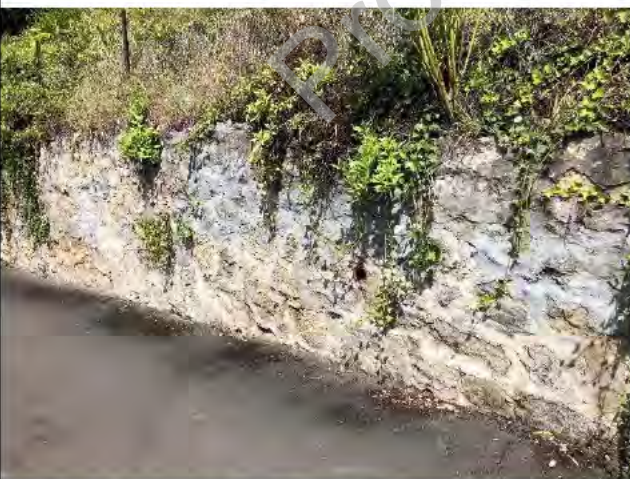
**Photo 5)** Section appears to have been re-mortared recently.

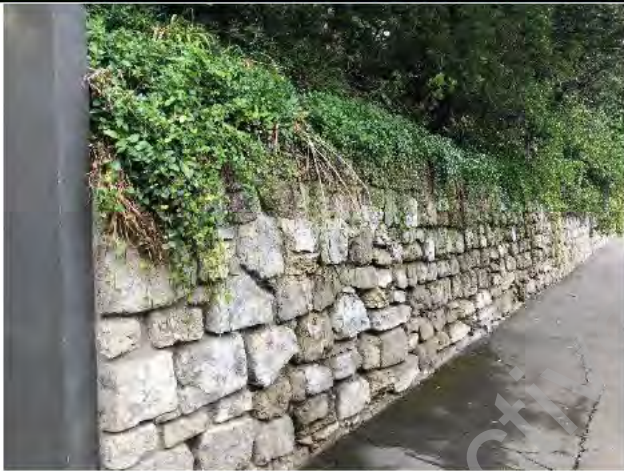
**Photo 3) Loose blocks/mortar eroded between blocks.**

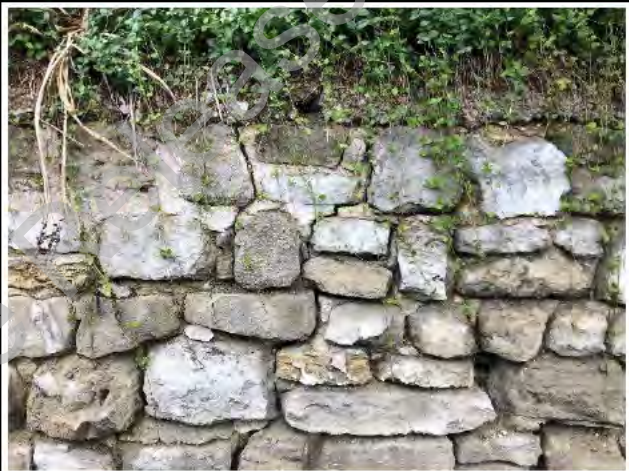
**Photo 4) Cracking observed between stone blocks.**

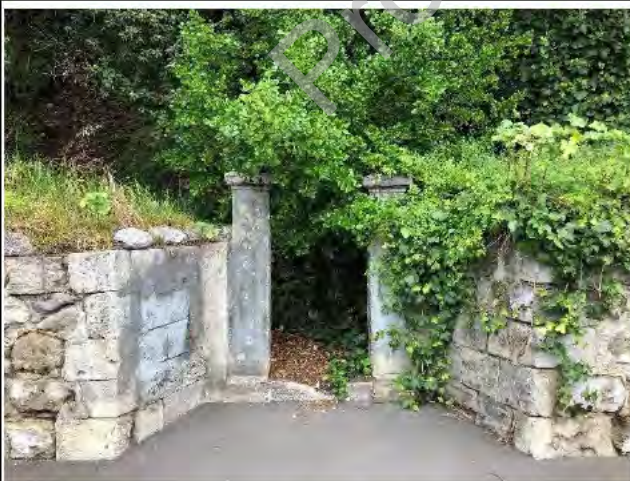
**Photo 5) Entrance way for old walkway upslope to prison site.**

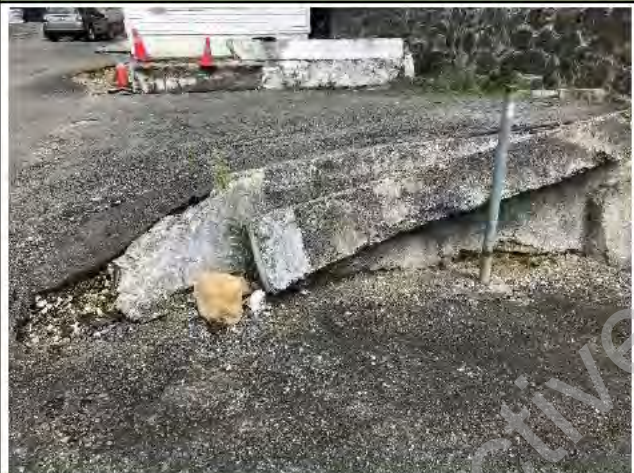
**Photo 3) Cracking and top barrier broken off top of wall.**

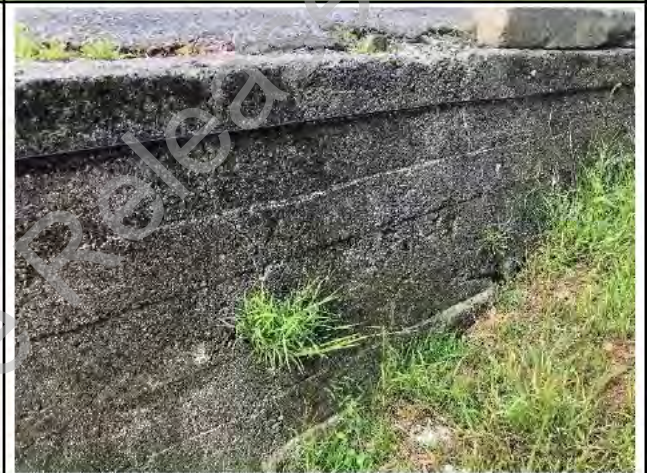
**Photo 4) Cracking observed in wall face.**

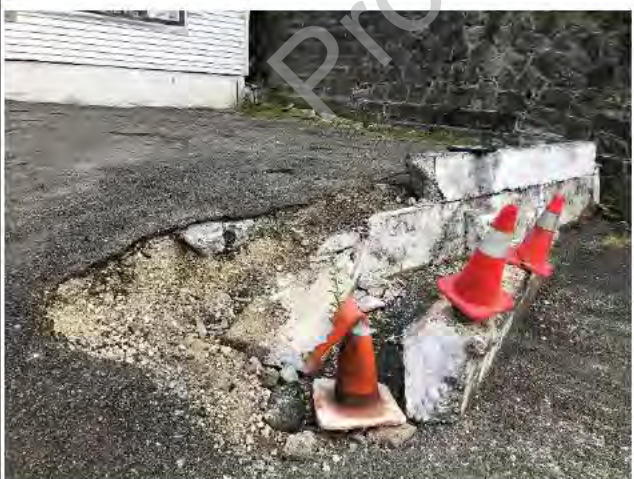
**Photo 5) Erosion, wall collapse and broken top barrier.**

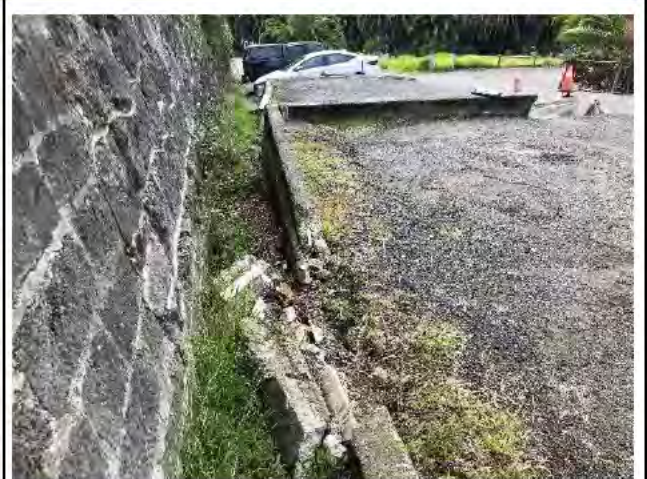
**Photo 6) Broken top barrier.**

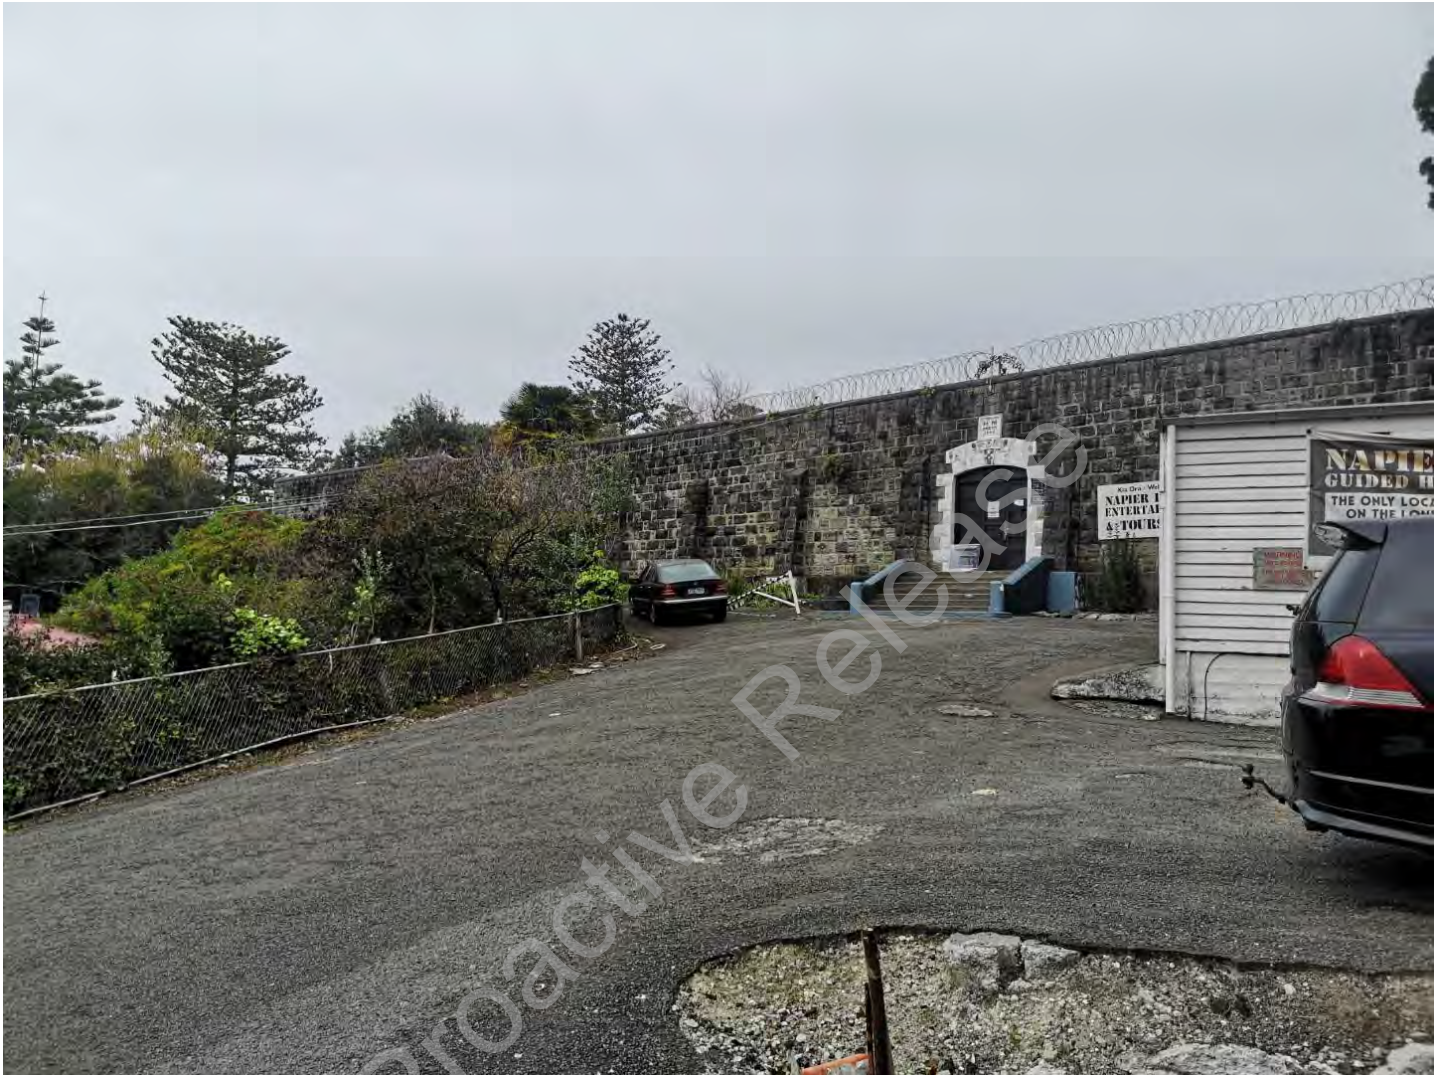
Site Identification Photograph – Northern Elevation of the Prison Wall (External)

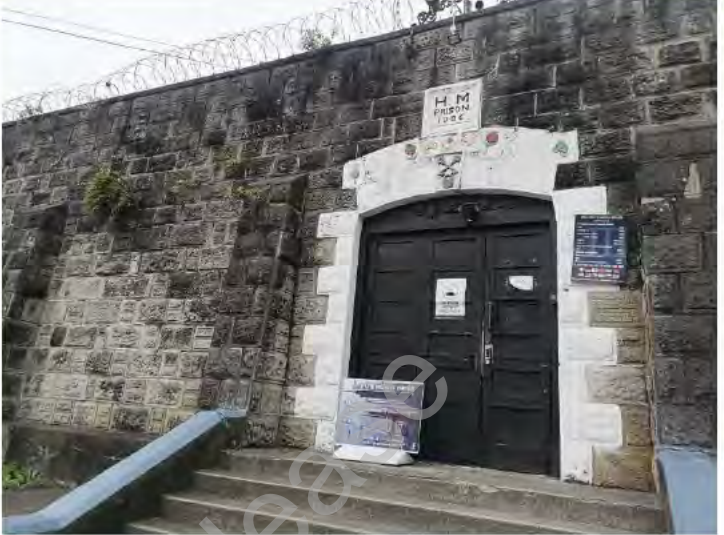
| Example Existing Condition Photographs | |
|---|---|
| <p>1</p> | <p>General view of the main entrance to the prison in the northern elevation of the wall.</p> |

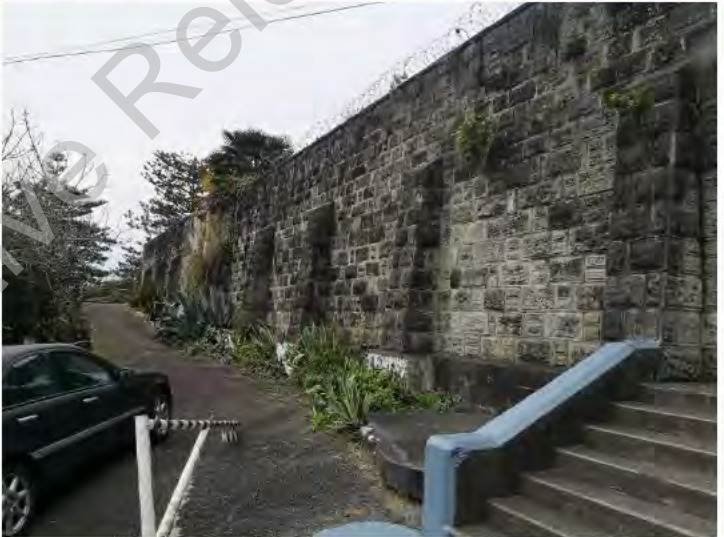
| Example Existing Condition Photographs | |
|---|---|
| <p>2</p> | <p>North elevation of the prison wall looking east.</p> |

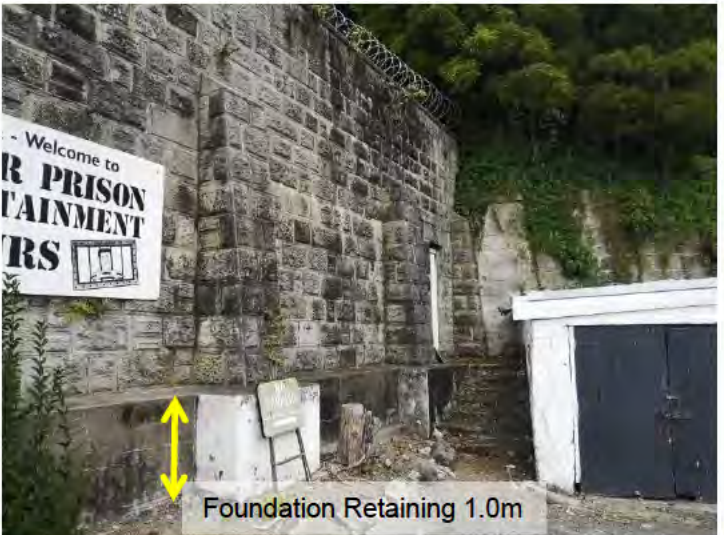
| Example Existing Condition Photographs | |
|---|---|
| <p>3</p> | <p>North elevation of the prison wall looking West. Note the foundations for the wall are retaining approximately 1m of ground on the prison side. This tapers down to zero at the eastern end of the wall.</p> <p>Foundation Retaining 1.0m</p> |

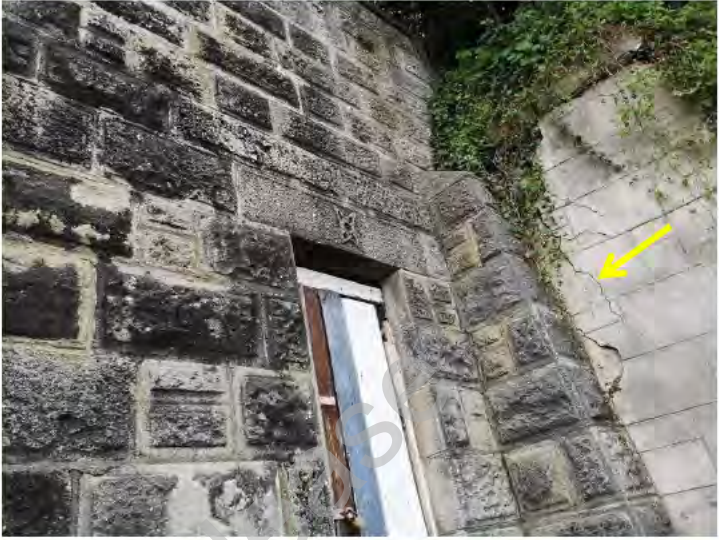
| Example Existing Condition Photographs | |
|---|---|
| 4 | <p>Localised cracking to retaining wall at interface with perimeter wall indicating likely differential movement.</p> |

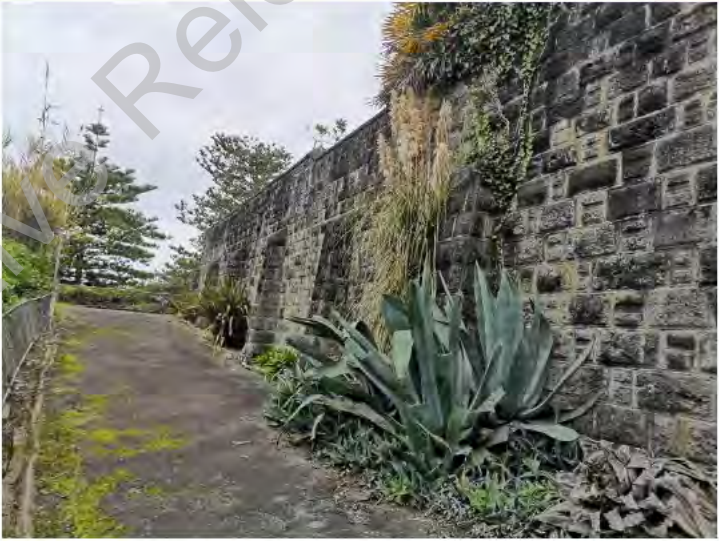
| Example Existing Condition Photographs | |
|---|---|
| 5 | <p>North elevation of the prison wall looking east.</p> |

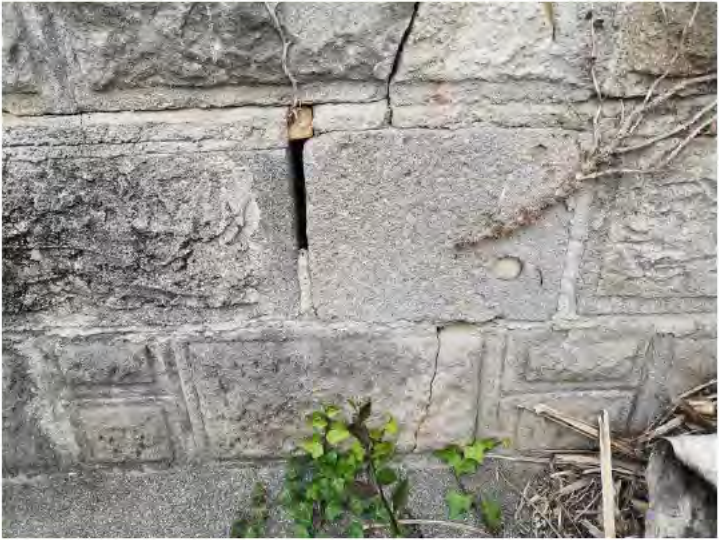
| Example Existing Condition Photographs | |
|---|---|
| 6 | <p>Missing mortar and minor cracking to stone blocks on the north elevation.</p> |

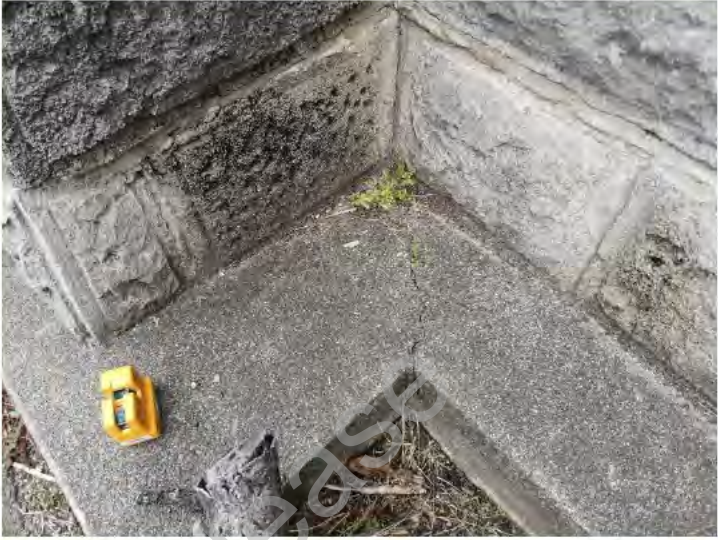
| Example Existing Condition Photographs | |
|---|---|
| 7 | <p>Typical minor cracking to foundation on north elevation.</p> |

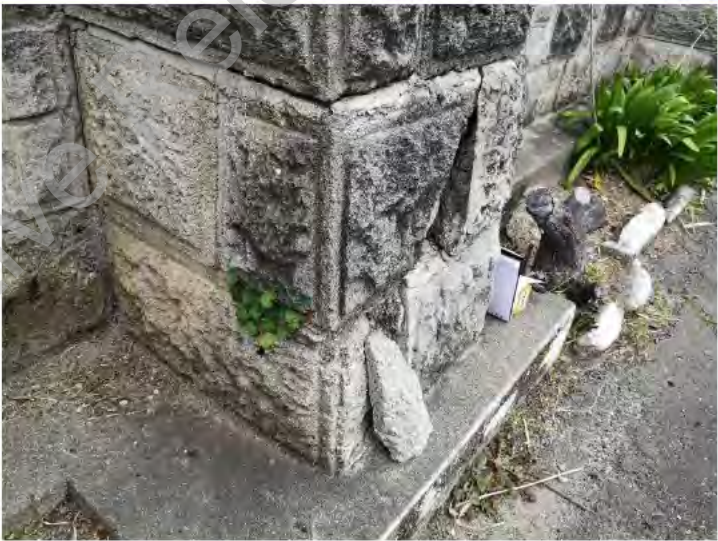
| Example Existing Condition Photographs | |
|---|---|
| 8 | <p>Damage to stone block and cracking to mortar to a pilaster on the northern elevation.</p> |

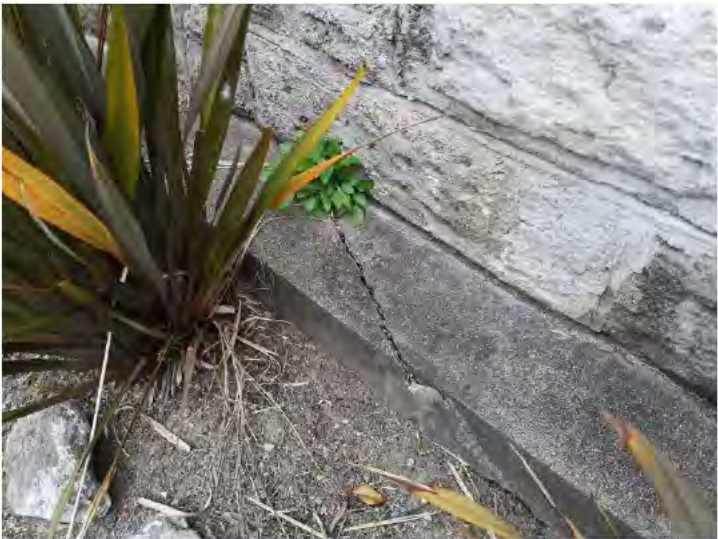
| Example Existing Condition Photographs | |
|---|---|
| 9 | <p>Cracking to foundation on north elevation. Approximately 5mm wide.</p> |

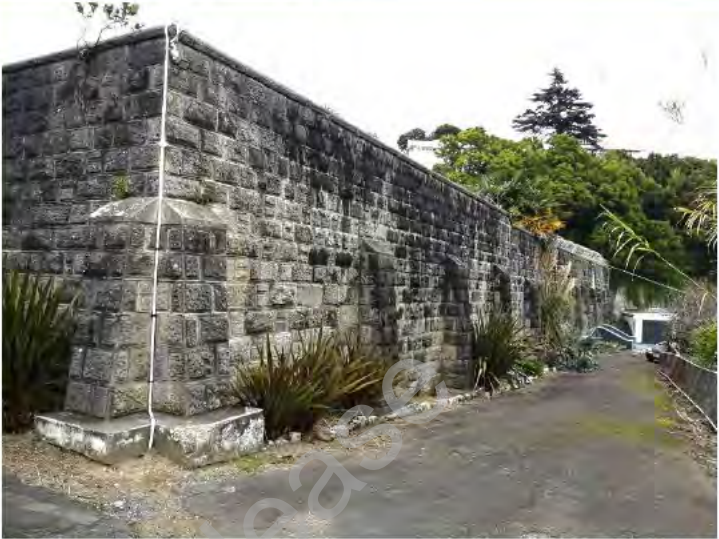
| Example Existing Condition Photographs | |
|---|---|
| 10 | <p>North side of the prison wall looking west.</p> |

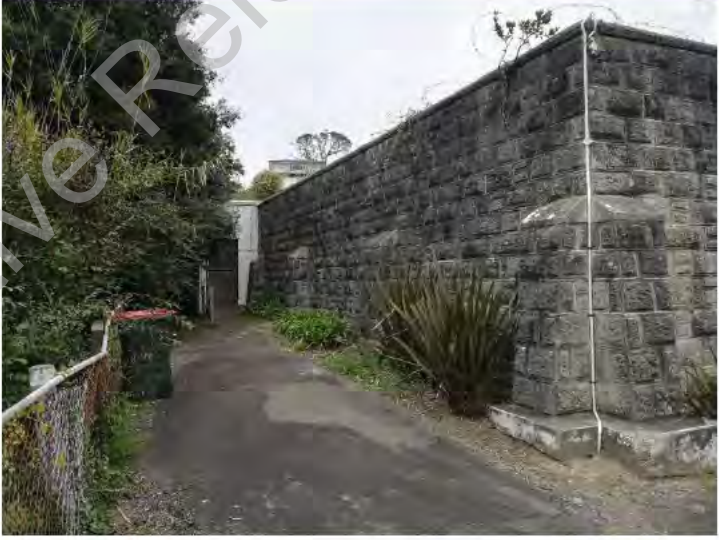
| Example Existing Condition Photographs | |
|---|---|
| 11 | <p>External elevation of the east end return of the prison wall looking south.</p> |

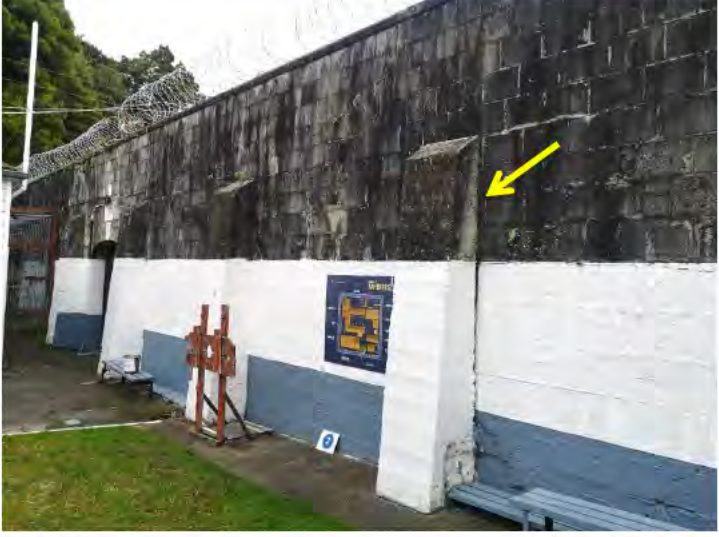
| Example Existing Condition Photographs | |
|---|---|
| 12 | <p>South elevation of the prison wall looking west. Note concrete pilaster leaning out and separating from the face of the wall.</p> |

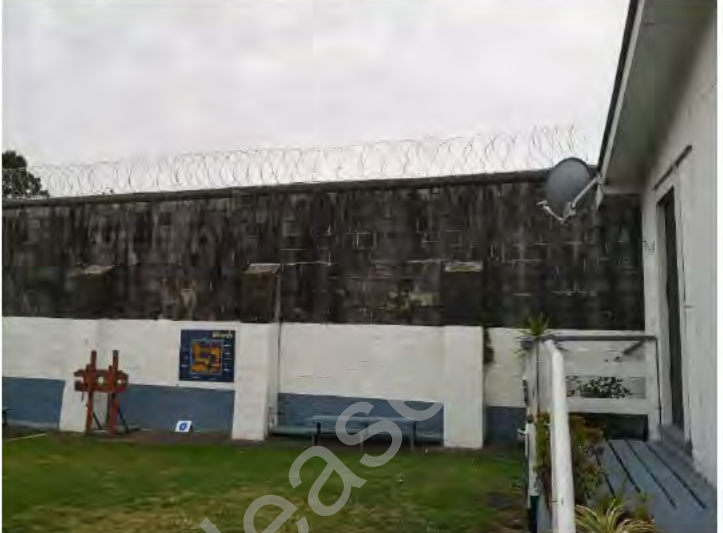
| Example Existing Condition Photographs | |
|---|---|
| <p>13</p> <p>South elevation of the prison wall.</p> | |

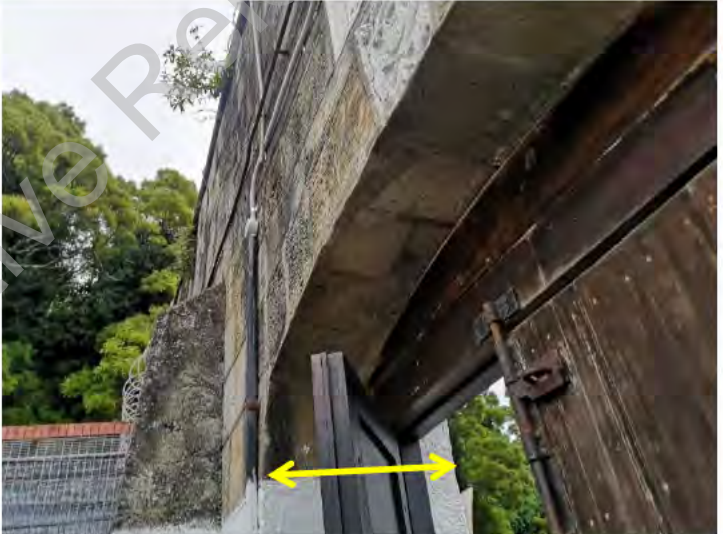
| Example Existing Condition Photographs | |
|---|---|
| <p>14</p> <p>View of the entrance showing overall thickness of wall.</p> | |

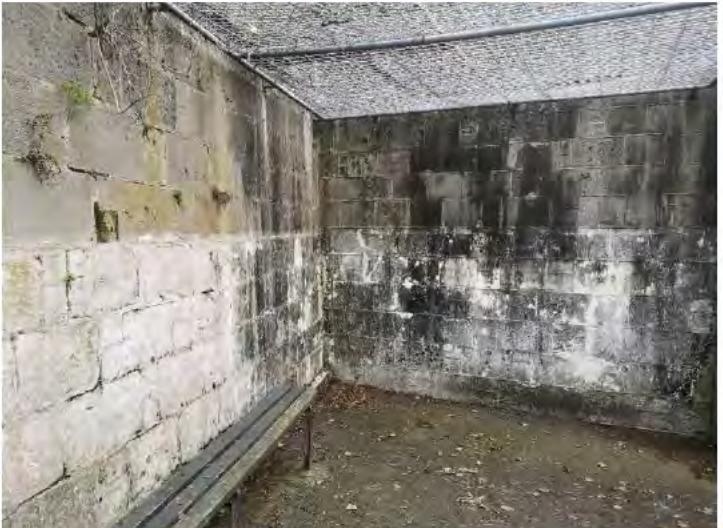
| Example Existing Condition Photographs | |
|---|---|
| <p>15</p> <p>Internal elevation of the western corner of the prison wall looking North.</p> | |

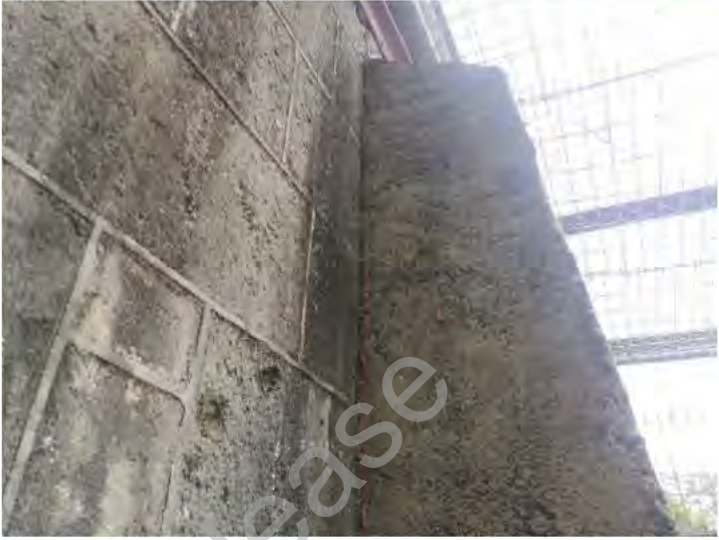
| Example Existing Condition Photographs | |
|---|---|
| 16 | <p>General view of the interface between the internal concrete pilasters and the stone wall. Note laser line indicates wall and pilaster are vertical.</p> |

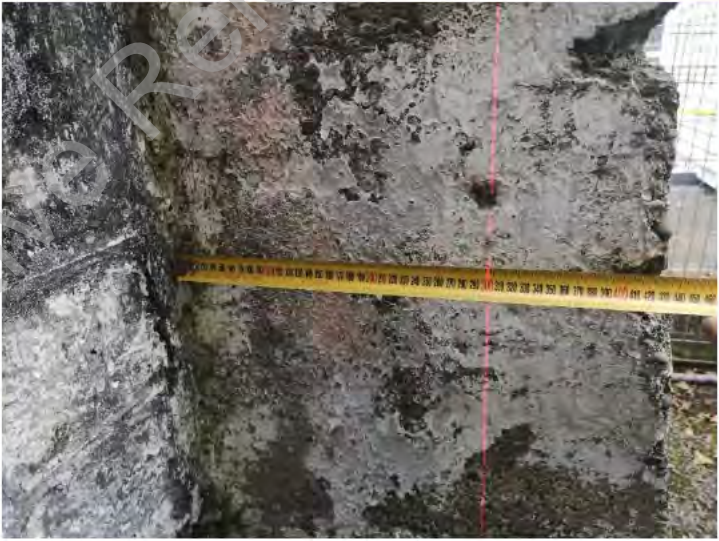
| Example Existing Condition Photographs | |
|---|---|
| 17 | <p>General view of the interface between the internal concrete pilasters and the stone wall. Note laser line indicates thickness of pilaster at top.</p> |

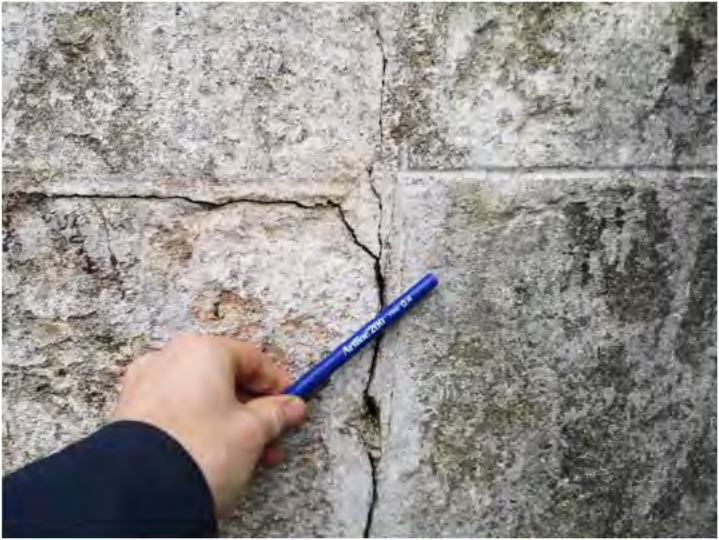
| Example Existing Condition Photographs | |
|---|---|
| 18 | <p>Cracking to mortar joints on the internal elevation of the western end return of the wall.</p> |

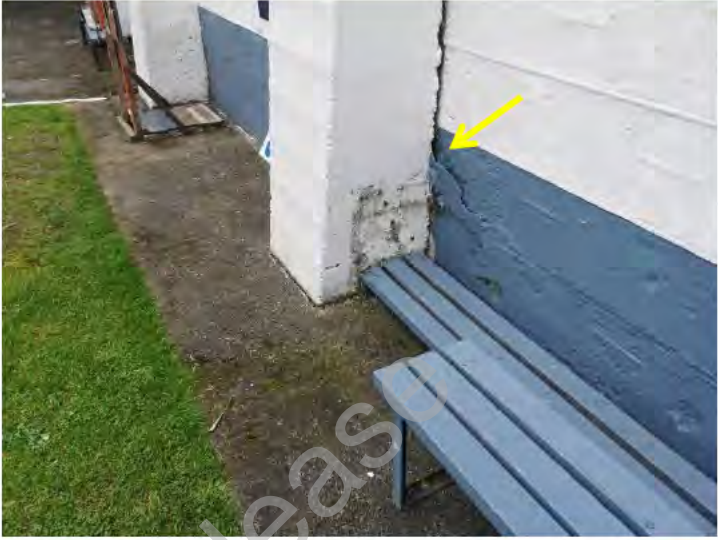
| Example Existing Condition Photographs | |
|---|---|
| 19 | <p>Damage to stone blocks due to rotation and separation of the concrete pilaster from the wall on the southern elevation.</p> |

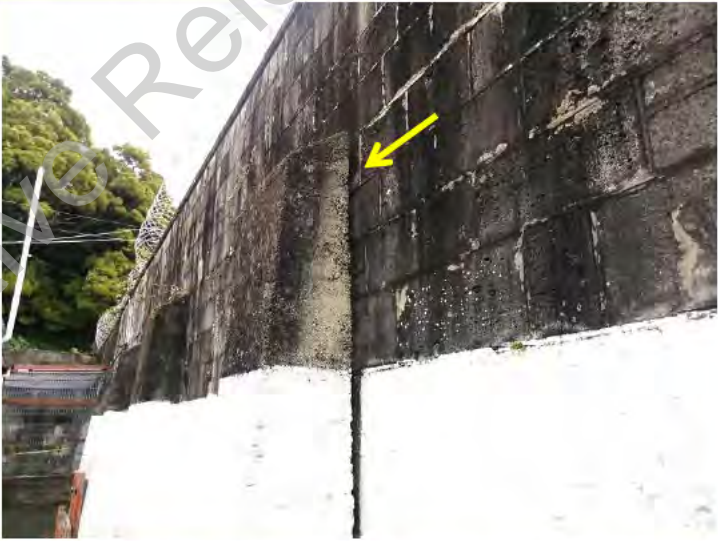
| Example Existing Condition Photographs | |
|---|---|
| 20 | <p>Top view of the concrete pilaster which has rotated and separated from the wall on the southern elevation.</p> |

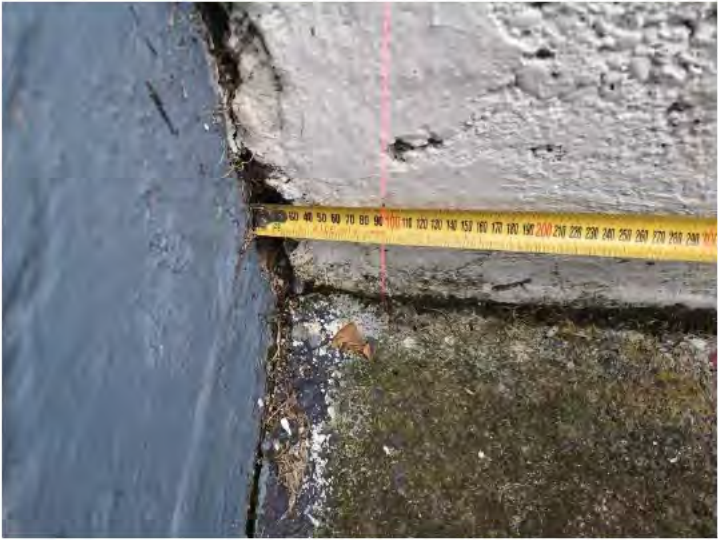
| Example Existing Condition Photographs | |
|---|---|
| 21 | <p>Bottom view of the concrete pilaster which has rotated and separated from the wall on the southern elevation. Laser line shows the width of the gap at the top of the pilaster.</p> |

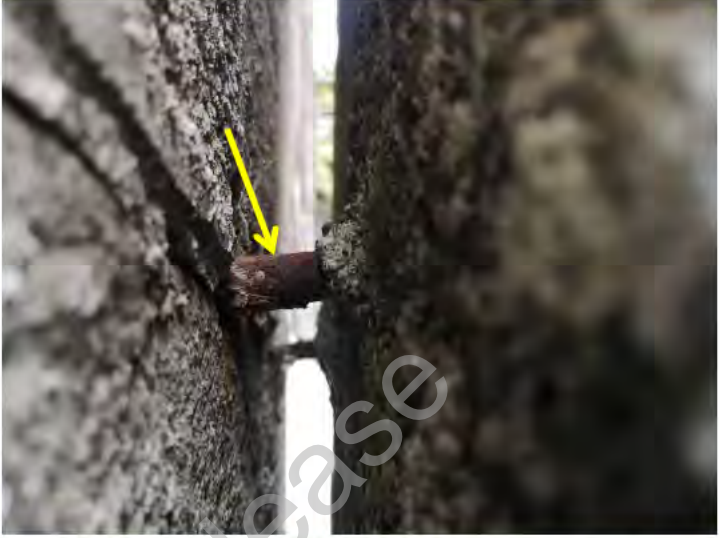
| Example Existing Condition Photographs | |
|---|---|
| 22 | <p>4x steel dowel bars observed tying the rotated concrete pilaster to the stone wall. The dowels were observed have undergone significant corrosion.</p> |

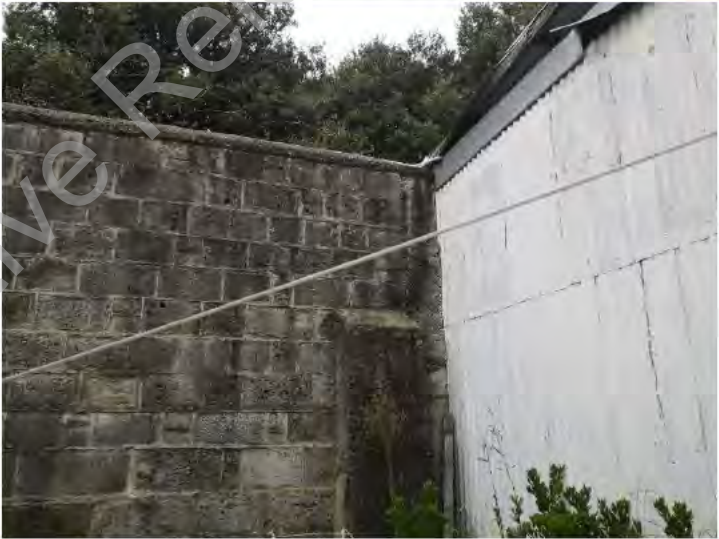
| Example Existing Condition Photographs | |
|---|---|
| 23 | <p>Internal elevation of the east end return of the prison wall where it abuts one of the prison buildings.</p> |

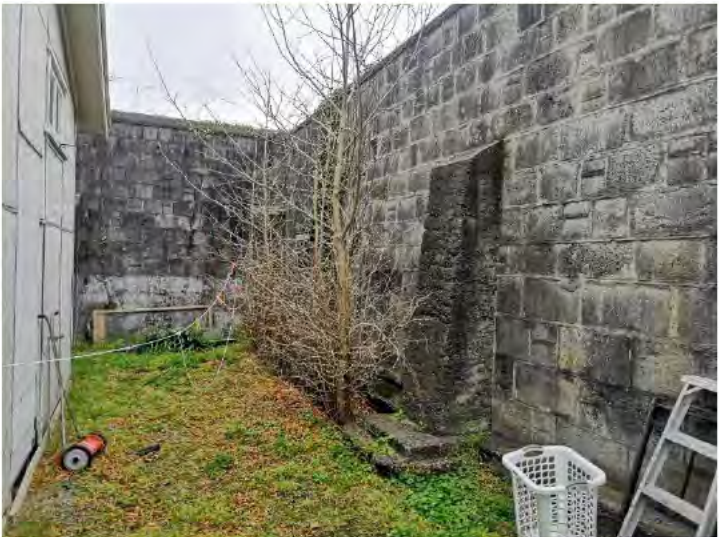
| Example Existing Condition Photographs | |
|---|---|
| 24 | <p>Internal elevation of the east end return of the prison wall looking north.</p> |

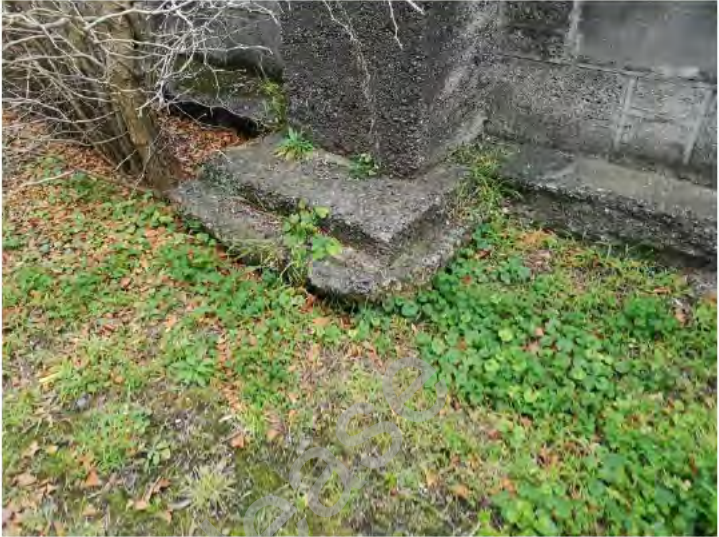
| Example Existing Condition Photographs | |
|---|---|
| | |

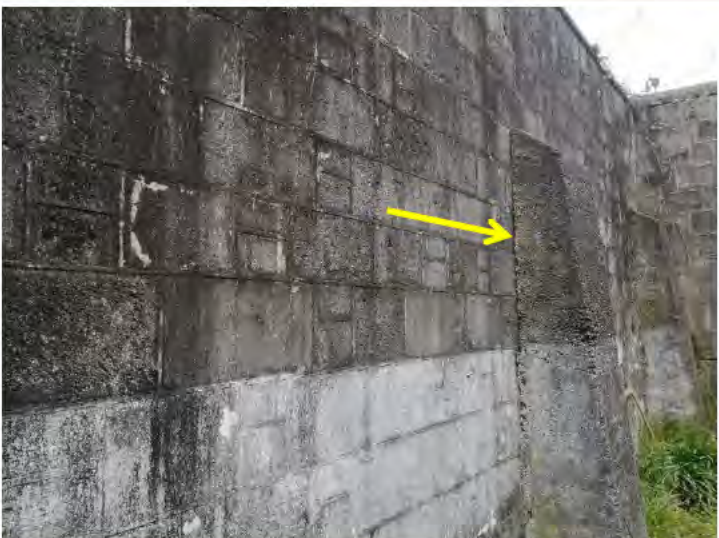
| Example Existing Condition Photographs | |
|---|---|
| | |

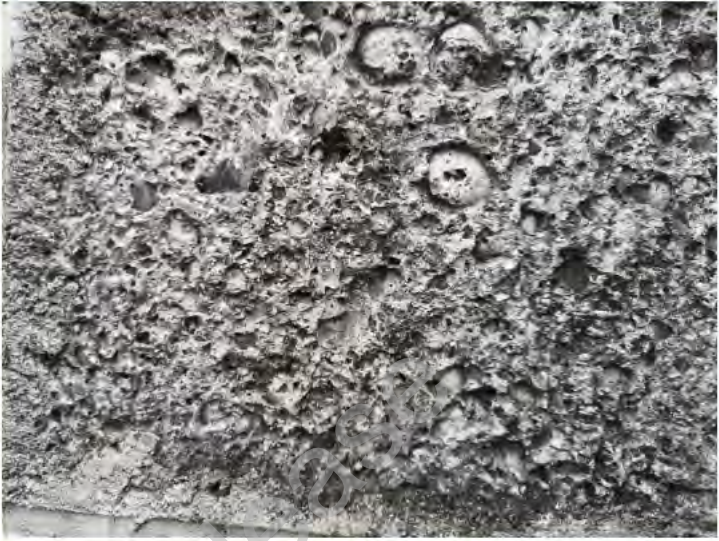
| Example Existing Condition Photographs | |
|---|---|
| 28 | <p>Closeup photo of a typical stone facing block.</p> |
