# Former Tokanui Hospital

## Preliminary Site Investigation

Toitū Te Whenua - Land Information New Zealand

12 May 2022

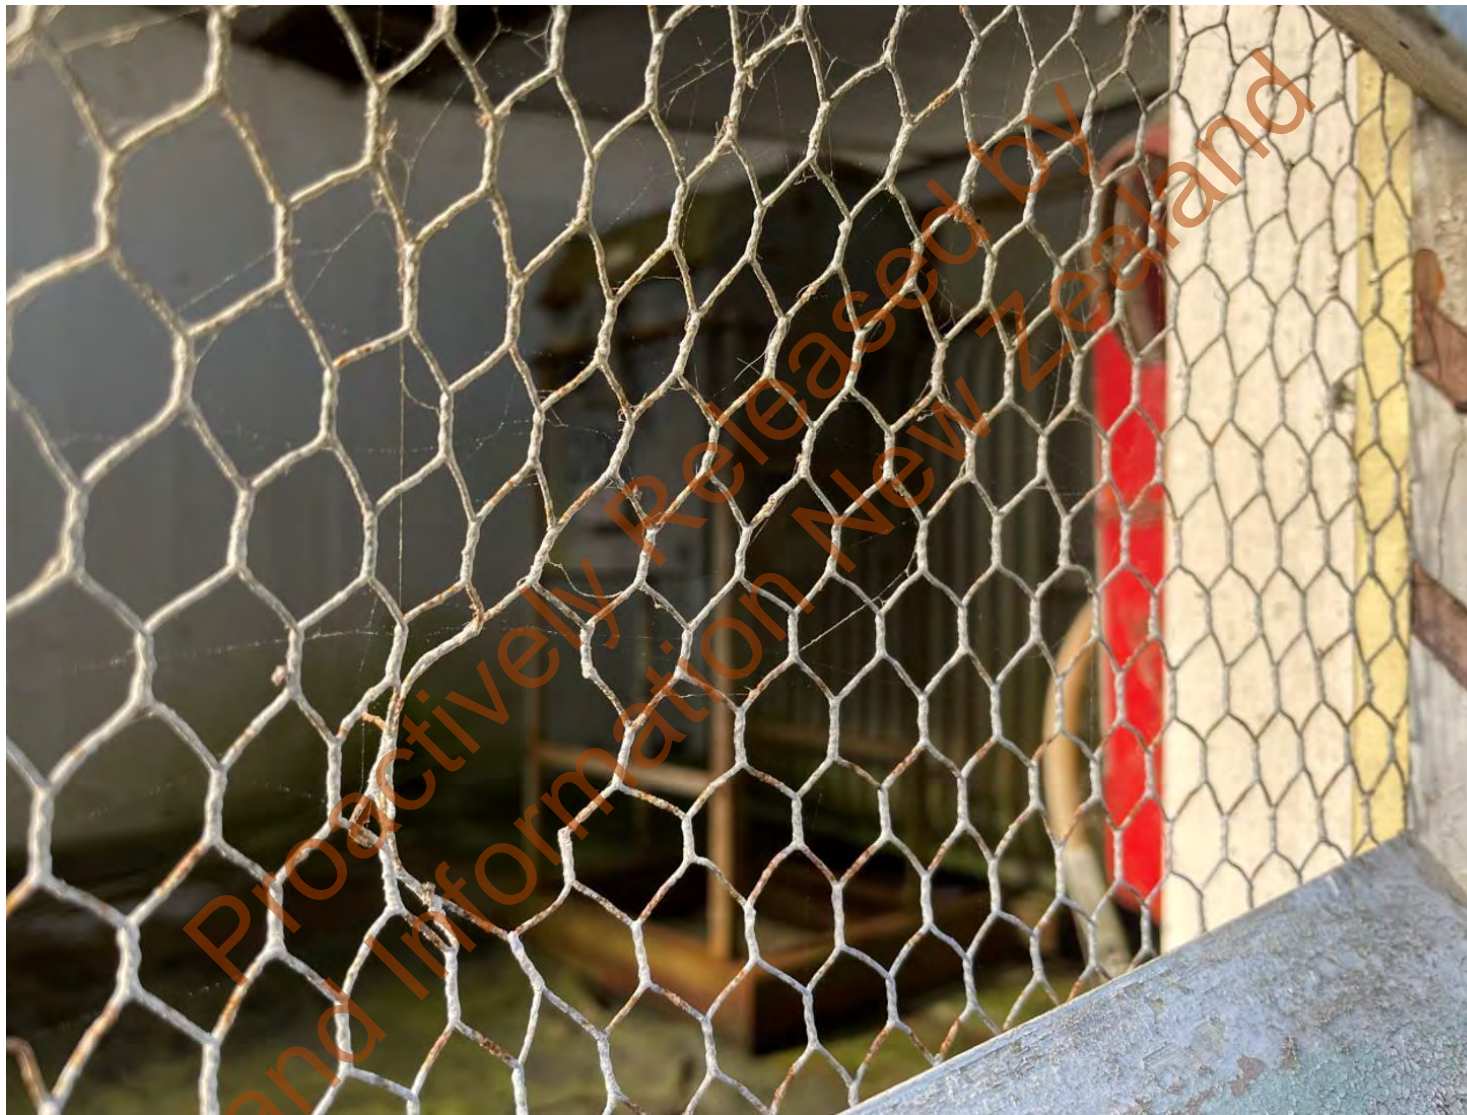
Photo 13:  
S2  
Substation 2  
11/08/2022

S2: Substation 2	Chicken wire is placed across the door. Equipment, including transformers can be observed inside.
Gully to the south of B8	The gully has a culvert which enters from the eastern side. Appears to be a surface water collection area. This location was sampled by AECOM as part of their site investigation.
B59: Gardeners Shed	Contains old, empty Intermediate Bulk Containers (IBCs) and drums. Currently used by the farmer for storage. An old concrete pad near the door with weed spray storage signage on it on the eastern side.
B61: Shed 11	A small square building in the commercial area of the Site. It has no windows and has vents on the outside. Initially not accessible at time of initial site inspection, but subsequent access has shown it contains a small above ground tank (potentially an air compressor) and associated pipework. Its exact use is unknown. The current utility service plans for the area do not show a piped connection to this building. Some minor oil staining on the internal floor was evident.

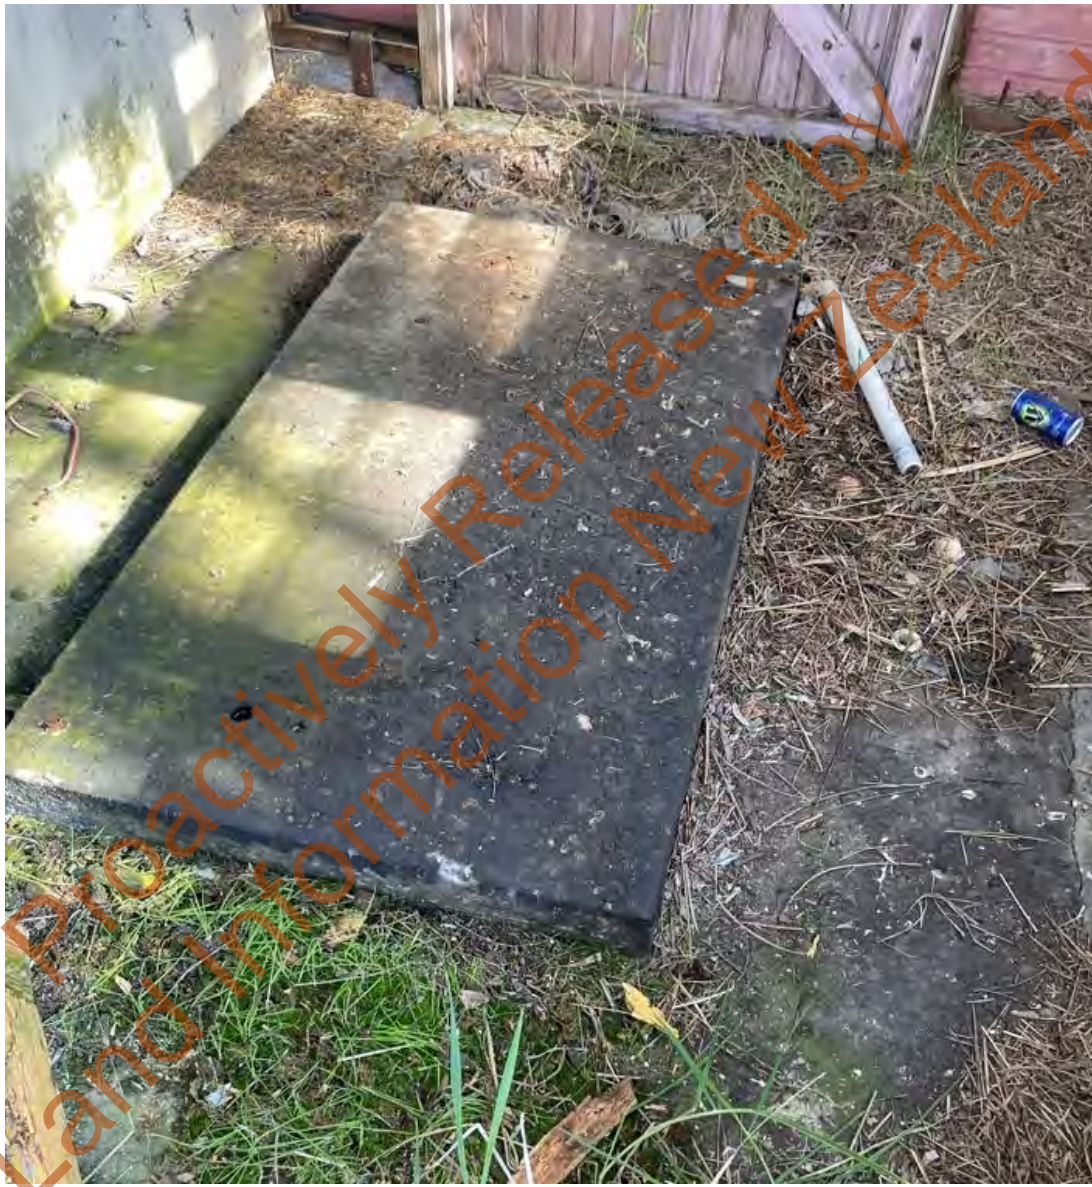
Photo 40:  
B73: Shed 7  
11/08/2022

B73: Shed 7	Appears to be a pump house associated with the laundry. The discharge point from the shed is unknown. There is a concrete plinth inside which has oil staining. A pipe tunnel with concrete paver covering in the paddock to the north appears to connect to the Laundry Building (B74). A scrub area in the paddock appears to have a discharge point within it, with stepped concrete surrounding it. This is heavily overgrown and may just be a stormwater drainage point.
B74: Laundry	A long building with a high glass roof. GHD was unable to access the building due to the risk of glass dropping inside. There are small concrete channels exiting the base of the building towards B73. On the western side of the laundry building is a blue stick up pipe, which looks like a monitoring well without a cap. There are piles of asphalt scrapings in the same area. On the south side near the pedestrian entrance there are downpipes to the ground which come from the inside of the building and may be a possible area of discharge to the ground.

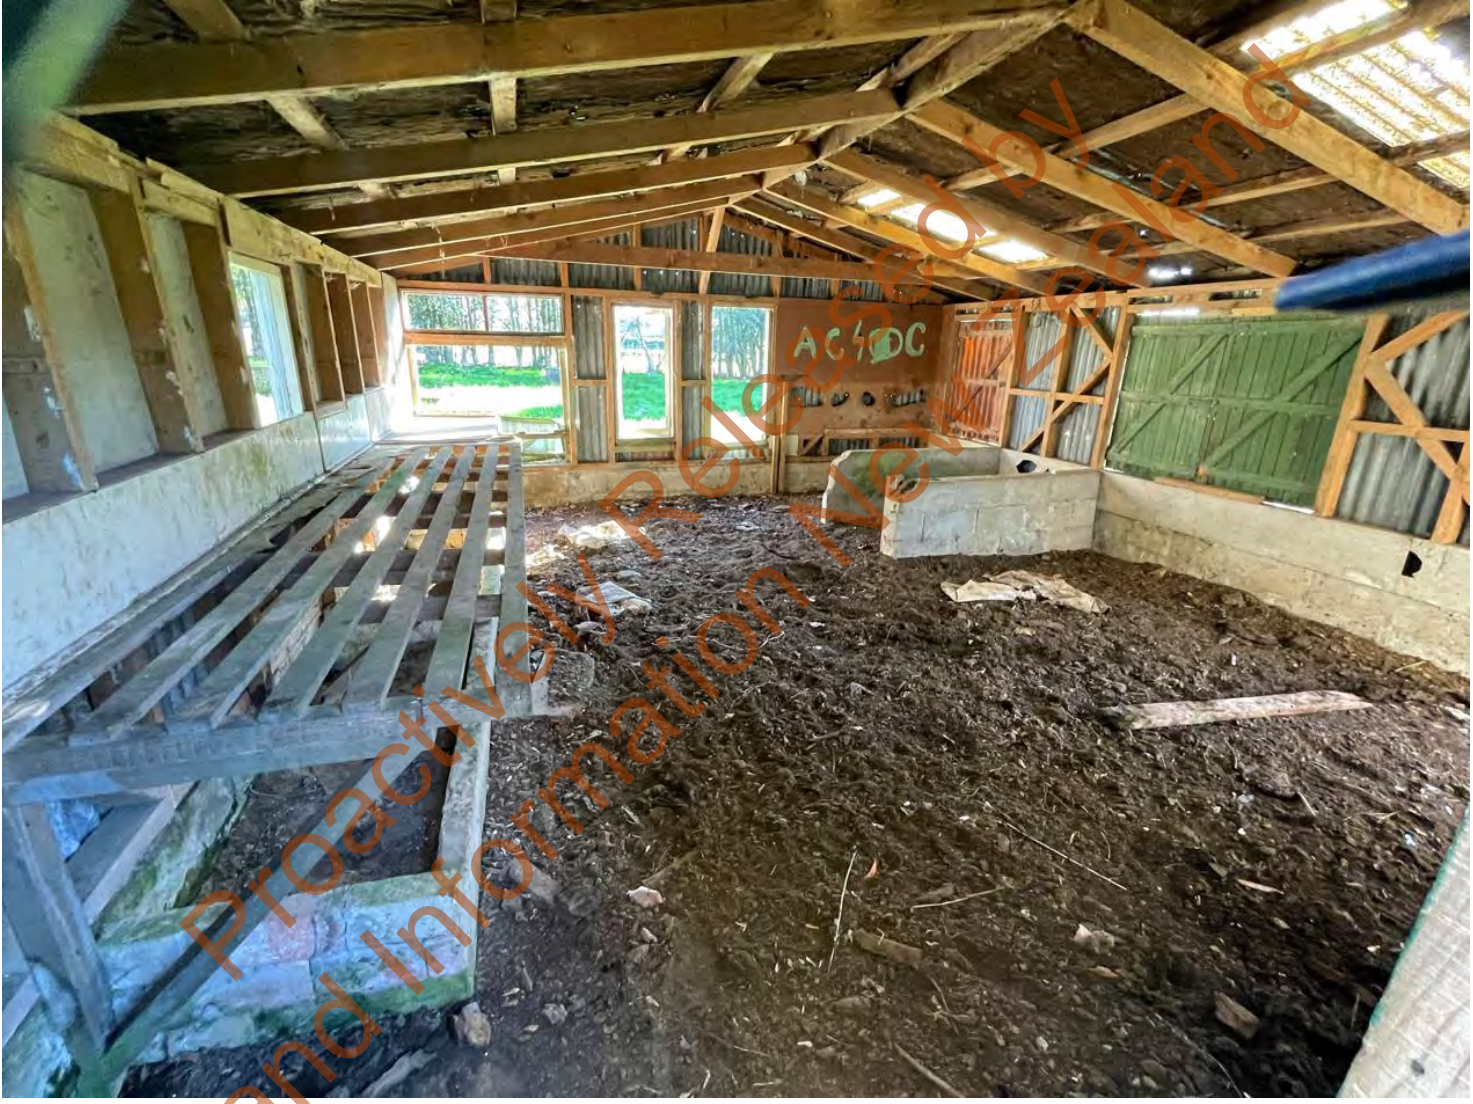
Photo	Photograph
<p data-bbox="193 235 359 349">Photo 51: B35 Shed 1 12/08/2022</p>

Building/area	Observations
B35: Shed 1	A corrugated iron shed with no internal floor. Inside is some internal wooden racking and concrete structures. Immediately to the west are the ruins of a larger building, which includes areas of concrete lined below ground pits.
Area between B34 and B35	A number of concrete foundations, believed to be from former glasshouses.
Eastern/ south-eastern edge of paddock	A linear concrete structure leading to the paddock fence in the direction of the stream. The use of this structure is unknown but may have been used as a livestock dip.
South-east of the paddock	An old chimney base and other depressions and hummocks are present in the ground.
WWTP Seepage	The WWTP pump station appears to discharge to the Wharekōrino stream just south of the main road. Seepage was observed near the main discharge pipe, flowing from an area showing some ground collapse.
WWTP Discharge	During the walkover it was noted that a concrete discharge pipe flows into the Wharekōrino Stream from the pump station. This was associated with visibly poor water quality and algal growth.
