FORMER TOKANUI HOSPITAL  
DEMOLITION AND REMEDIATION  
HORIZONTAL INFRASTRUCTURE ASSESSMENT REPORT

Project No.	33205	Approved for Issue	
Version No.	3	Name	Sean Finnigan
Status	Final	Signature	 
Authors	D Khoo / S Finnigan		
Reviewer	S Finnigan	Date	09/11/2023

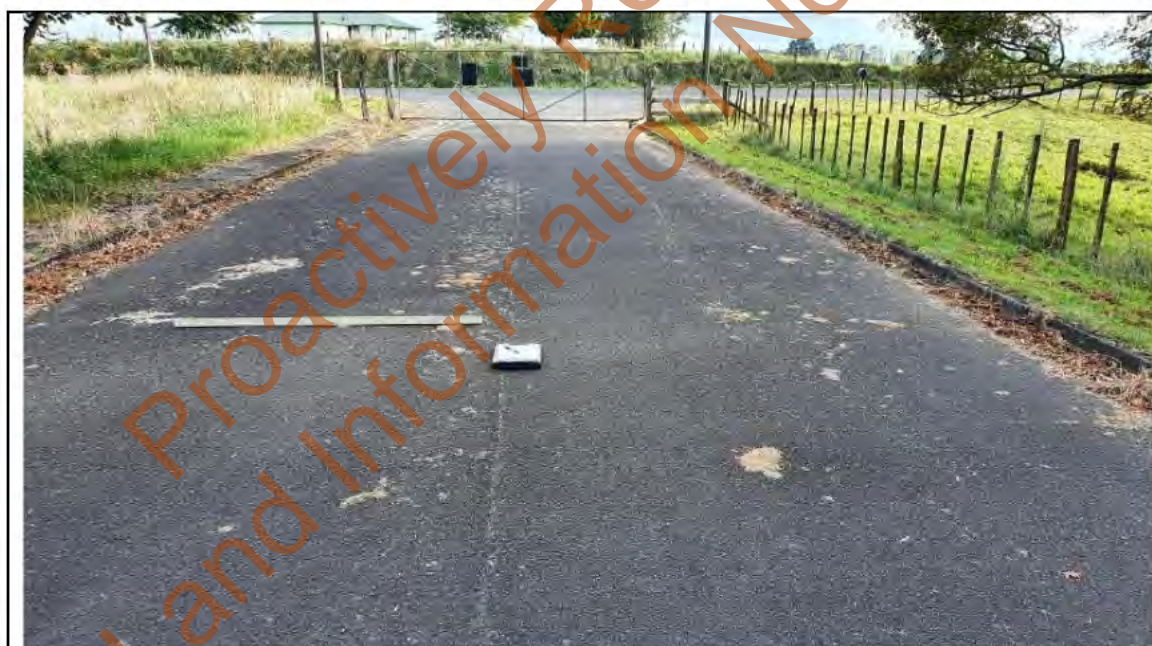
Figure 4: Typical good dual cross-fall, kerb and channel but overgrown

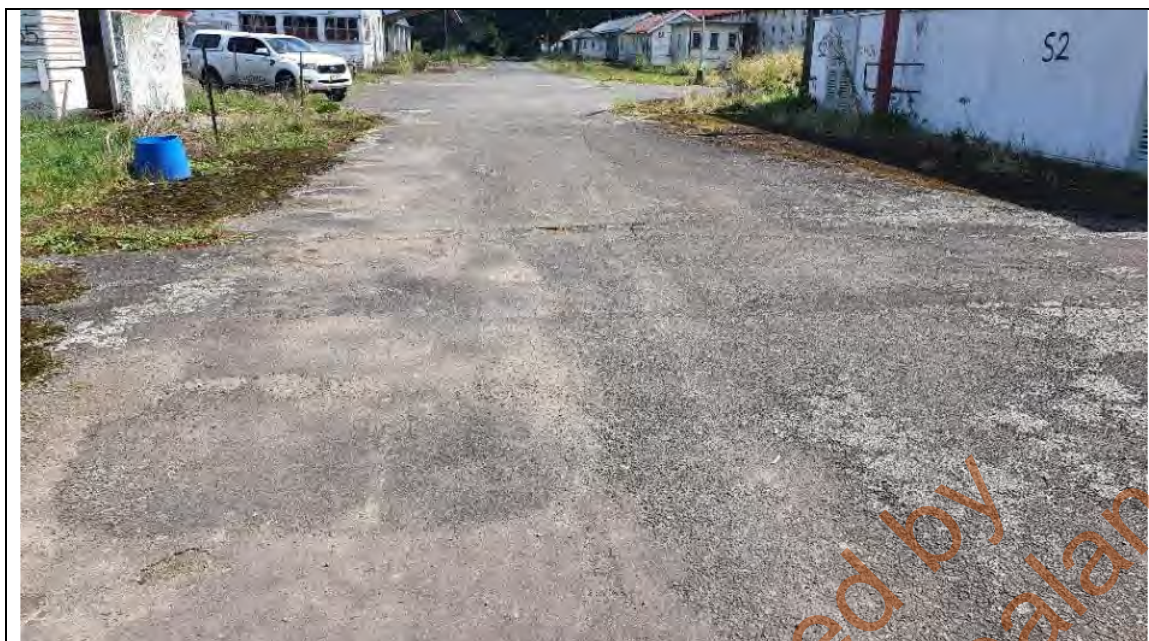
**Figure 5: Typical settlement at service trench road crossings**

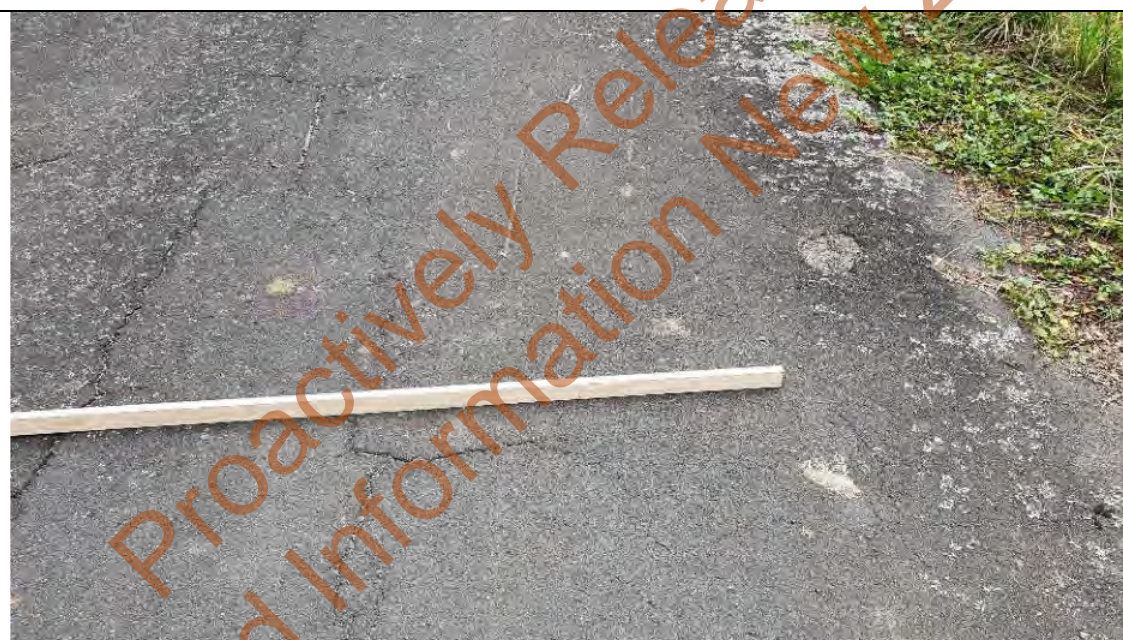
**Figure 6: Typical surface cracks**

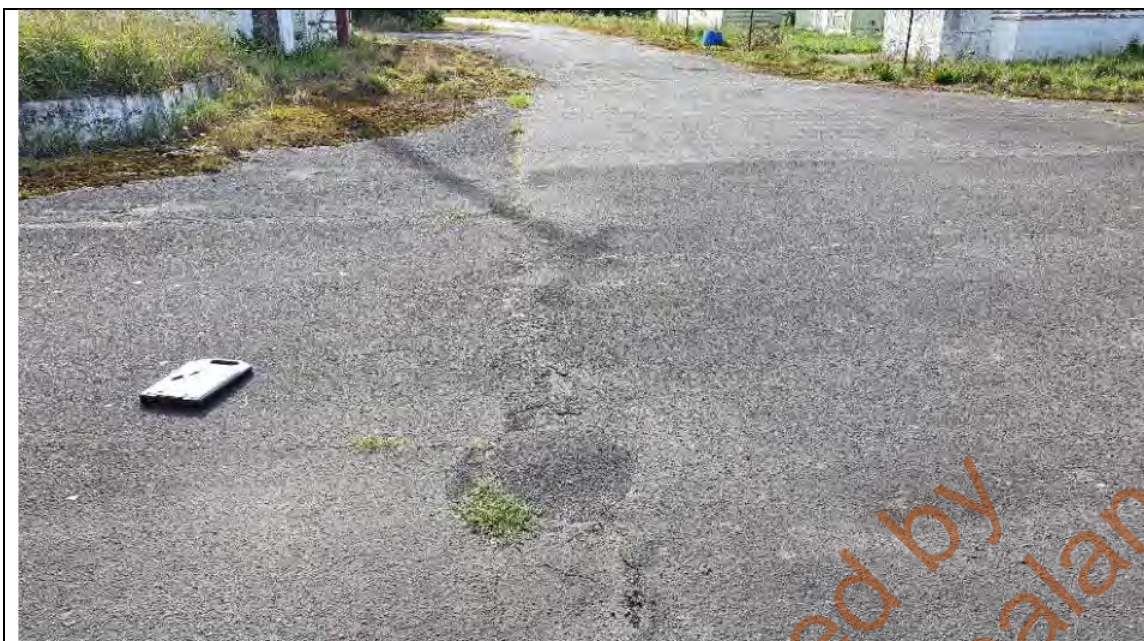
**Figure 7: Typical joint without seal**

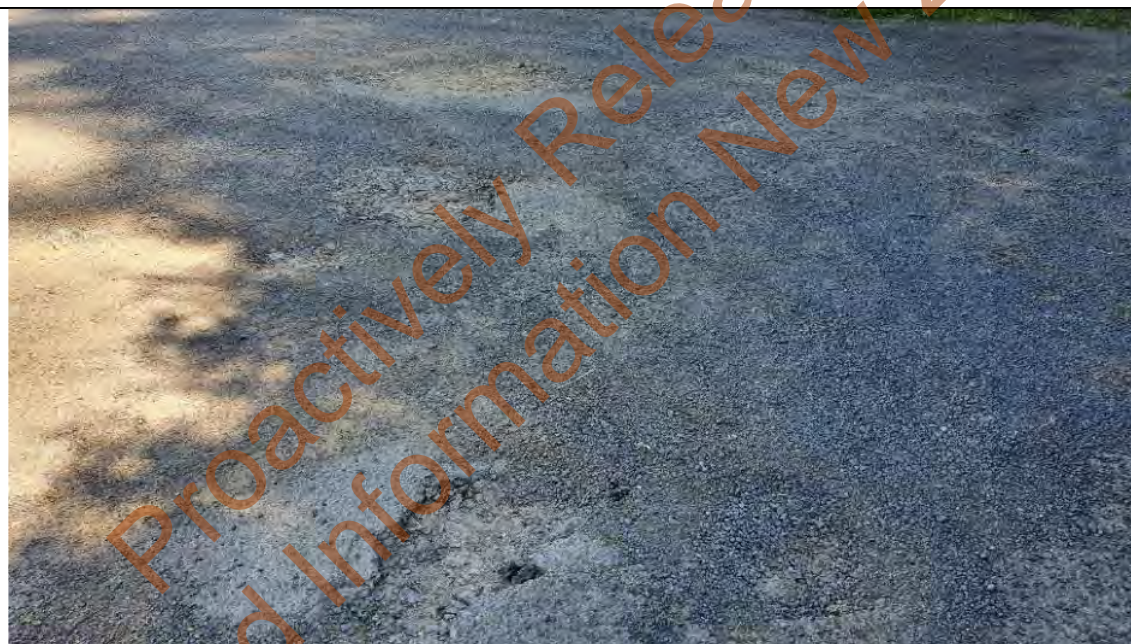
**Figure 8: Typical potholes**

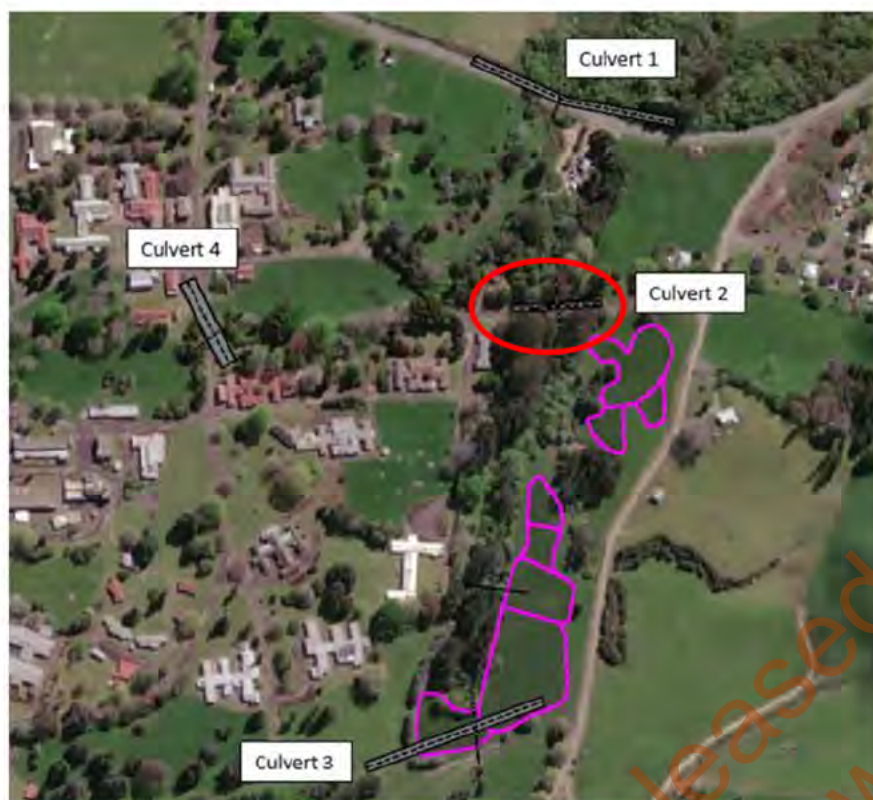
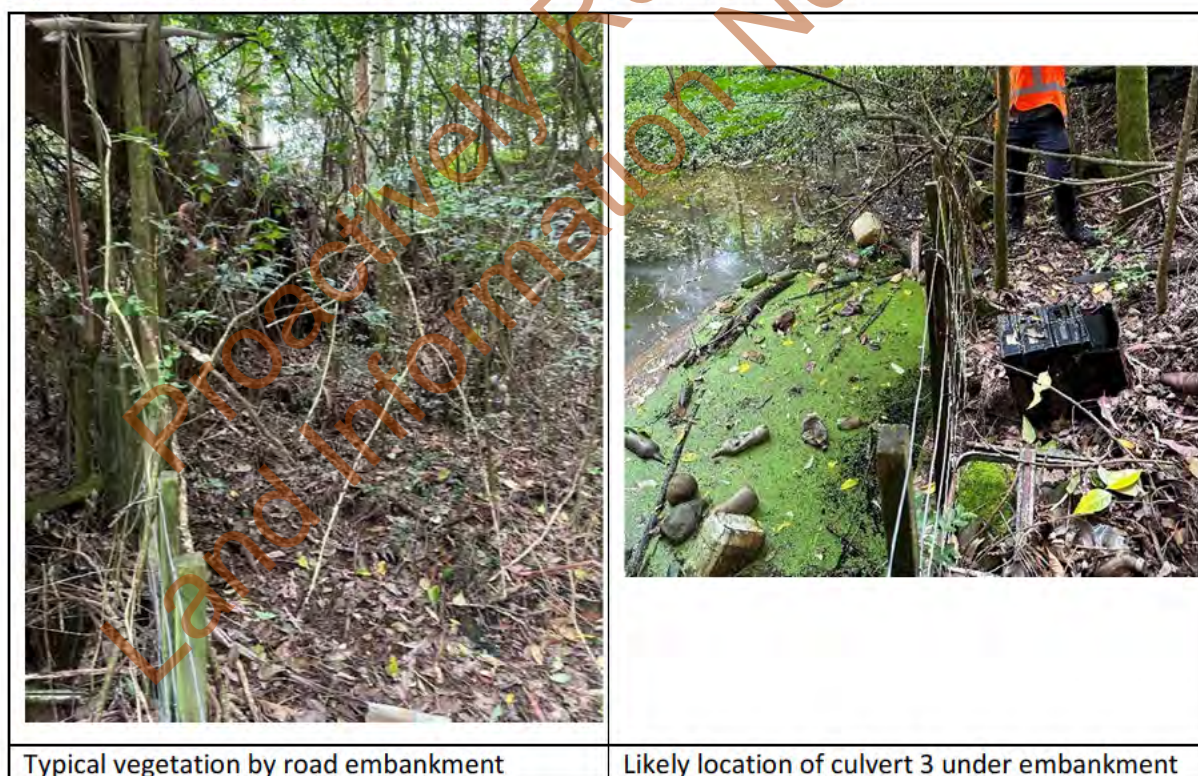
Figure 11: Redundant Road Embankment Crossing Wharekōrino Stream

The location of this road crossing is highlighted in red below. A site inspection of this crossing indicates there appears to be a culvert (identified as culvert 2 below) running under the embankment, but this has not been able to be confirmed yet, due to the culvert being completely submerged. This culvert is estimated to have a diameter of 1350mm to be consistent with the upstream culvert 3. The road embankment is relatively high, with an estimated height of 5.5m from the stream bed to the embankment crest. This culvert has a significant influence on flood levels affecting the existing disposal site (highlighted in pink below) while the road embankment acts as a dam, affecting stream flow patterns and ecology. The embankment itself is heavily overgrown and has been subject to flytipping. The ground surface across the embankment is very uneven and a safety hazard.

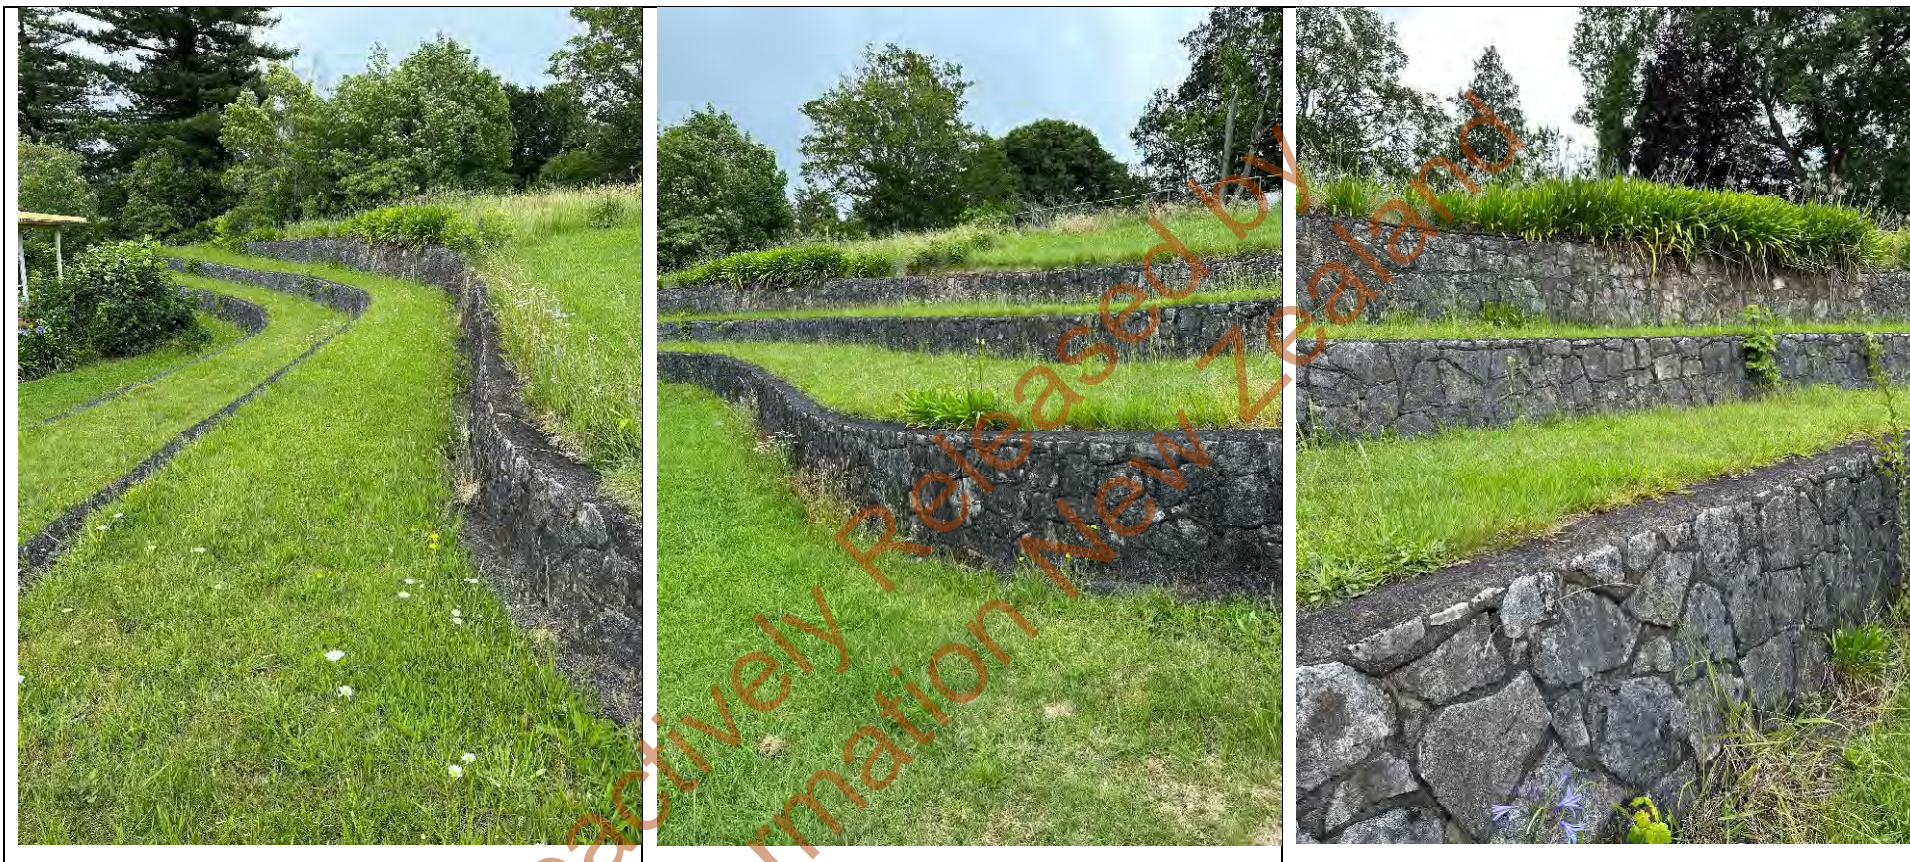
- Terrace 1: 36m long of variable height from 0.75-1.08m.
- Terrace 2: 43m long of variable height 0.79-1.03m.
- Terrace 3: 43m long of variable height 0.55-1.70m.

**Figure 14: Three views of retaining wall showing the terraces and its general condition**

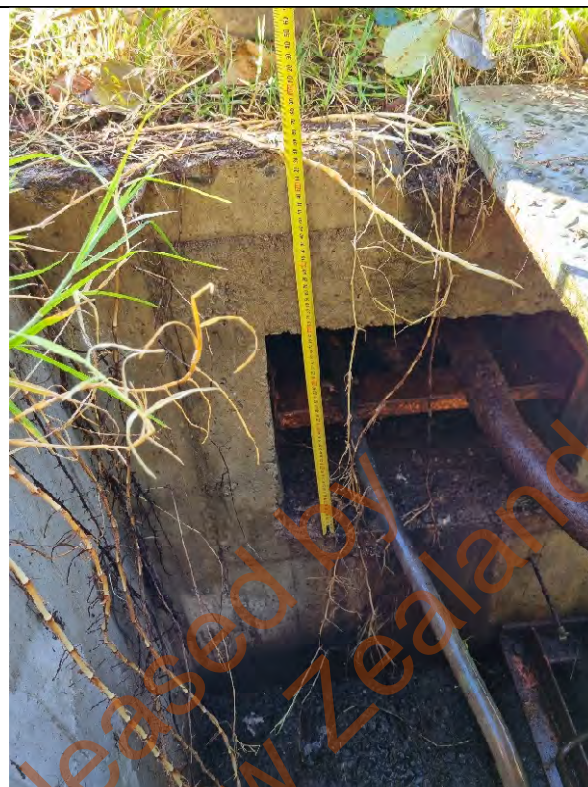
Chamber – LID K01 located at B55 Ward K showing the internal duct height as 500mm

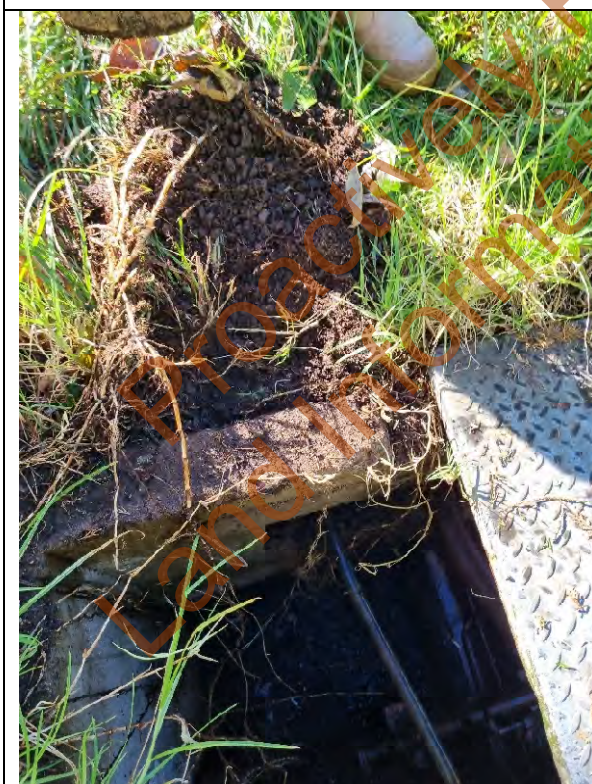
Chamber – LID K01 showing 50mm cover where the duct connects to the building

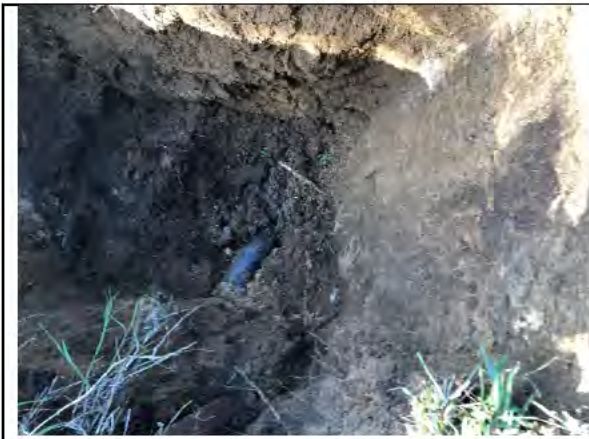
Pothole adjacent to fire hydrant. 150NB (200OD) Ductile Iron Pipe found at approx. 1m depth. Pipe wrapped in denso tape.

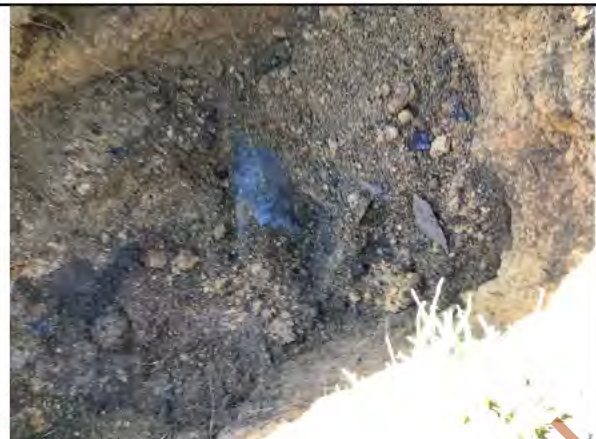
Pothole in southern area of site adjacent to fire hydrant: 100NB AC pipe at 1.2m depth.

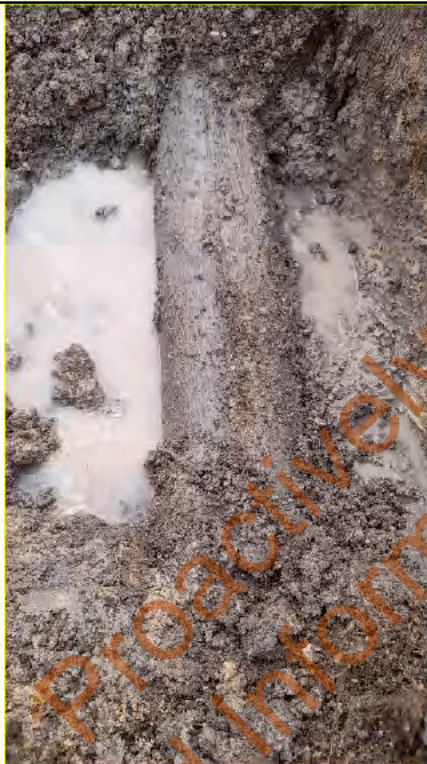
180mm diameter AC pipe exposed during hydroexcavation at location 17, refer to Civtec documents.

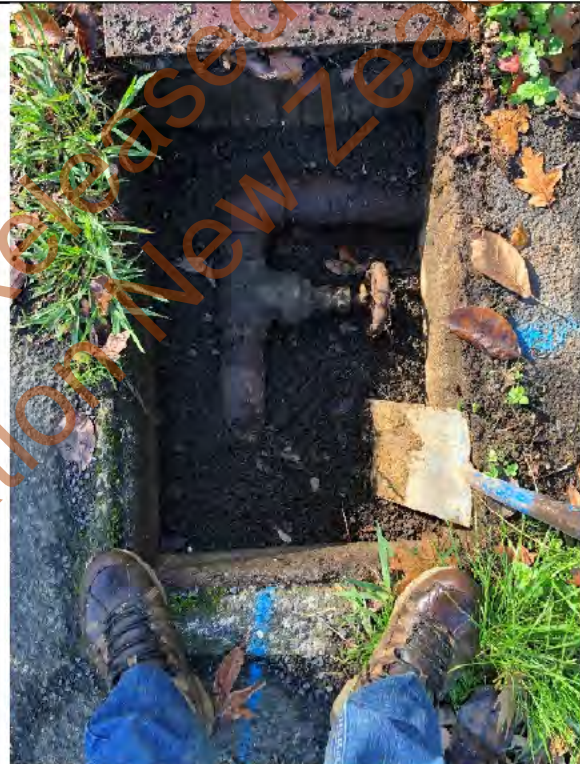
Inspection of a valve chamber at the northern area of the site showing heavily pitted and corroded pipes.

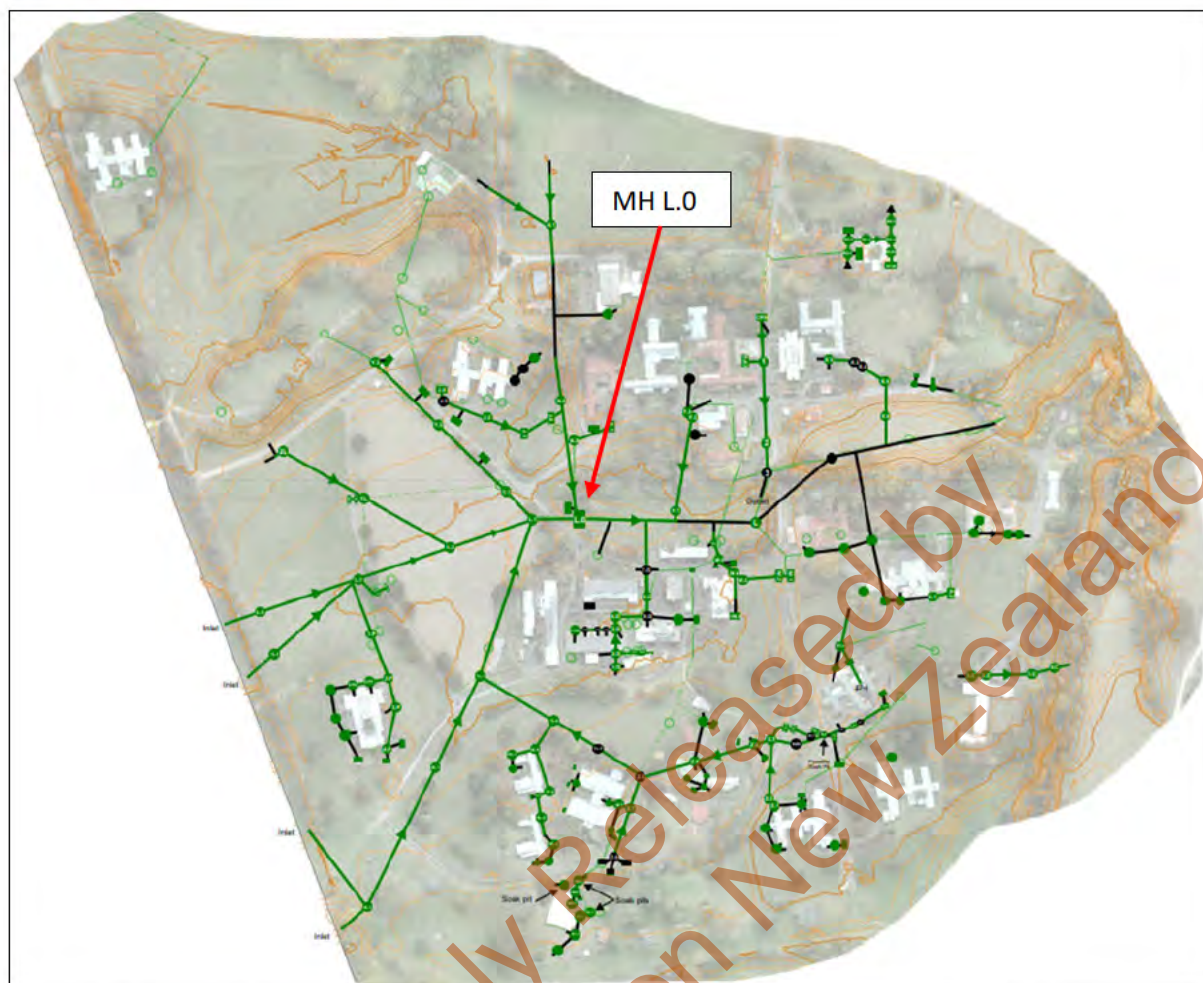
Figure 26: CCTV as-built map of the existing stormwater system on the site (black = flooded pipes during CCTV investigation)

During the site investigation and reviewing the CCTV results, it was found that the trunk stormwater pipes were in moderate condition with major cracking at certain locations causing groundwater infiltration into the pipes. It was found that the north-western wetland area had constant water draining into the 900mm diameter trunk main; however this could be because there were days of heavy rain before our site visit.

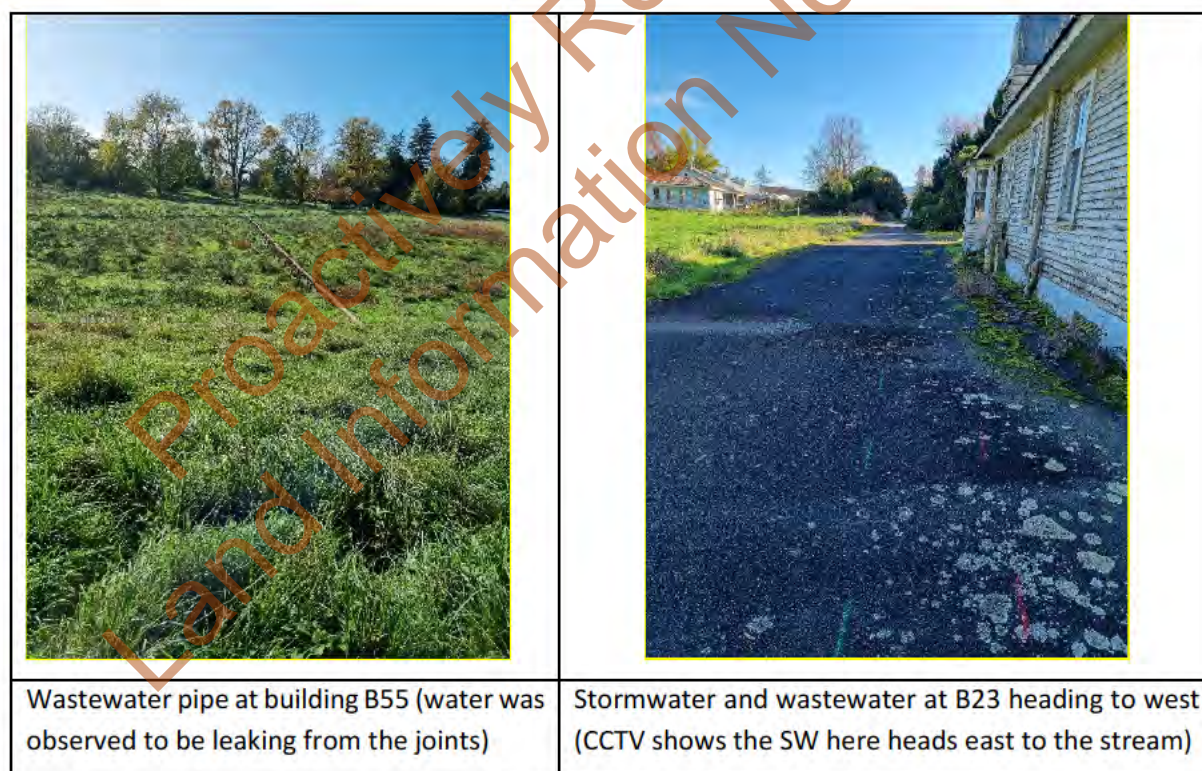
**Figure 28: Stormwater Non-Trunk System Photos**

- The stormwater connection at building B55 is likely to have a cross connection into the above ground steel wastewater pipe. This was inferred on site as the stormwater manholes were running with water (presuming from groundwater infiltration) and the wastewater pipe above ground had water leaking out from the joints.
- The stormwater laterals at building B23 were shown to outlet separately into the stream on the CCTV results; however our site investigation confirmed that this was not the case and that it connects into the trunk main.

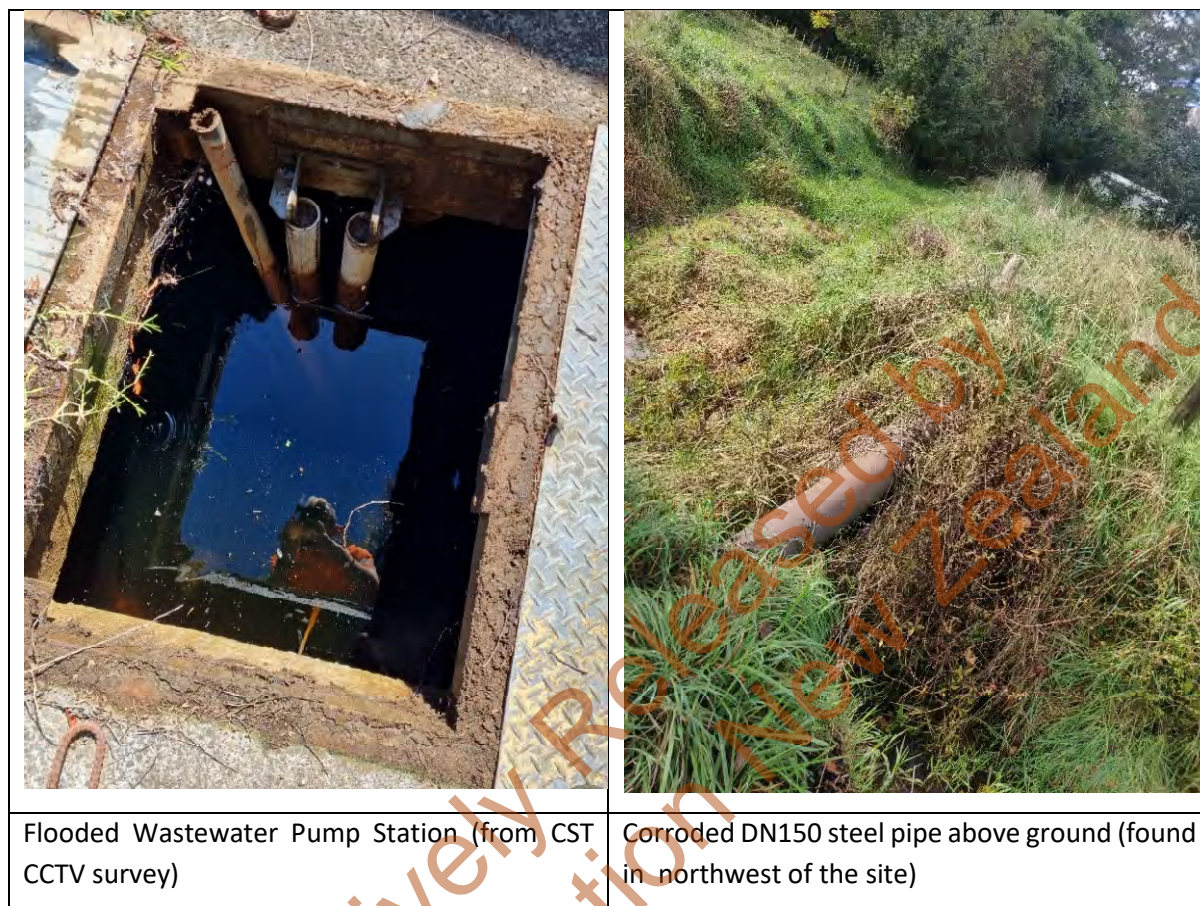
**Figure 34: Photos of other wastewater features found on the site**

the north west of the site, above ground DN150 steel wastewater pipes were found, with these pipes being heavily corroded. As mentioned in the stormwater section, it is possible that these pipes have cross connections to stormwater as it was seen on site that water was leaking from the pipe joints and there are no known stormwater connections into the wetland in the northwestern area.

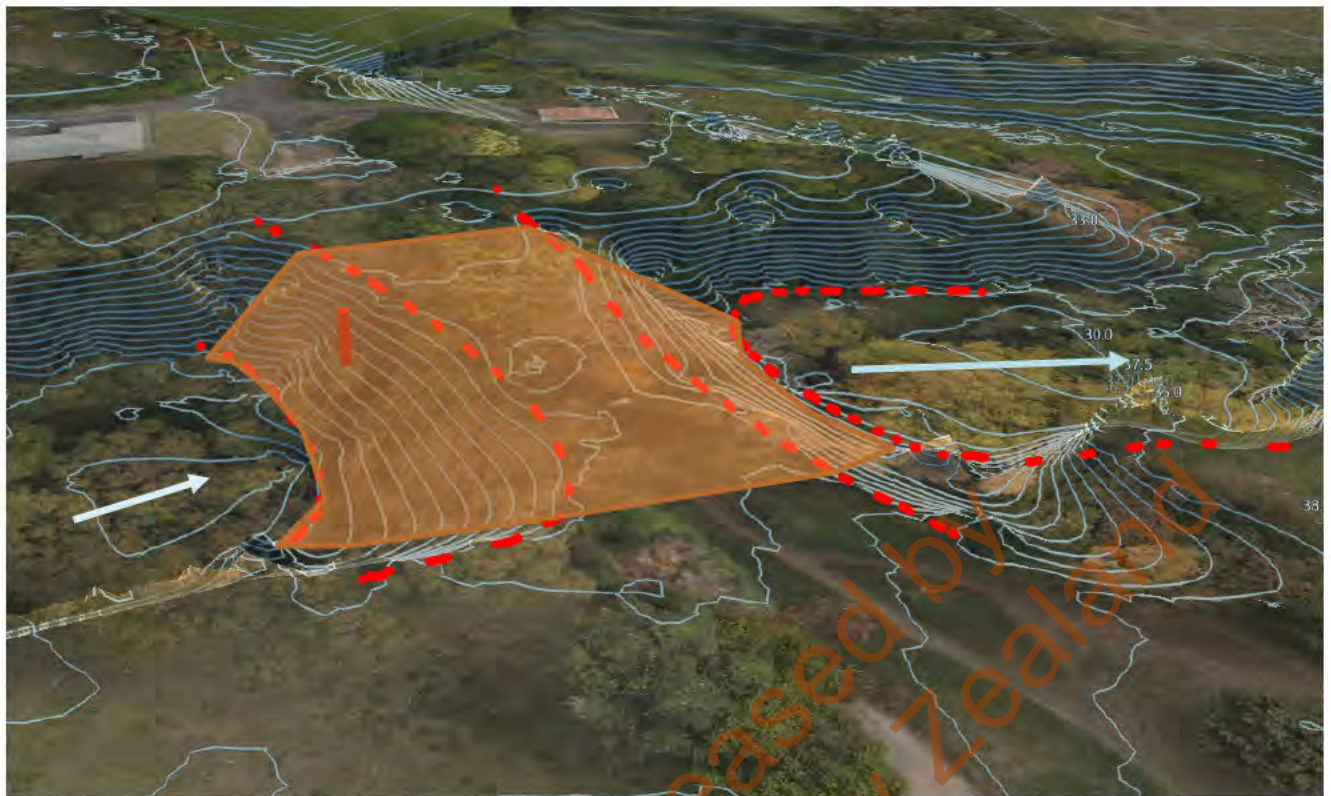
**Figure 44: Obsolete road embankment that could be removed in orange; arrows show stream flow direction**
