Former Tokanui Hospital

Preliminary Site Investigation

Toitū Te Whenua - Land Information New Zealand

12 May 2022

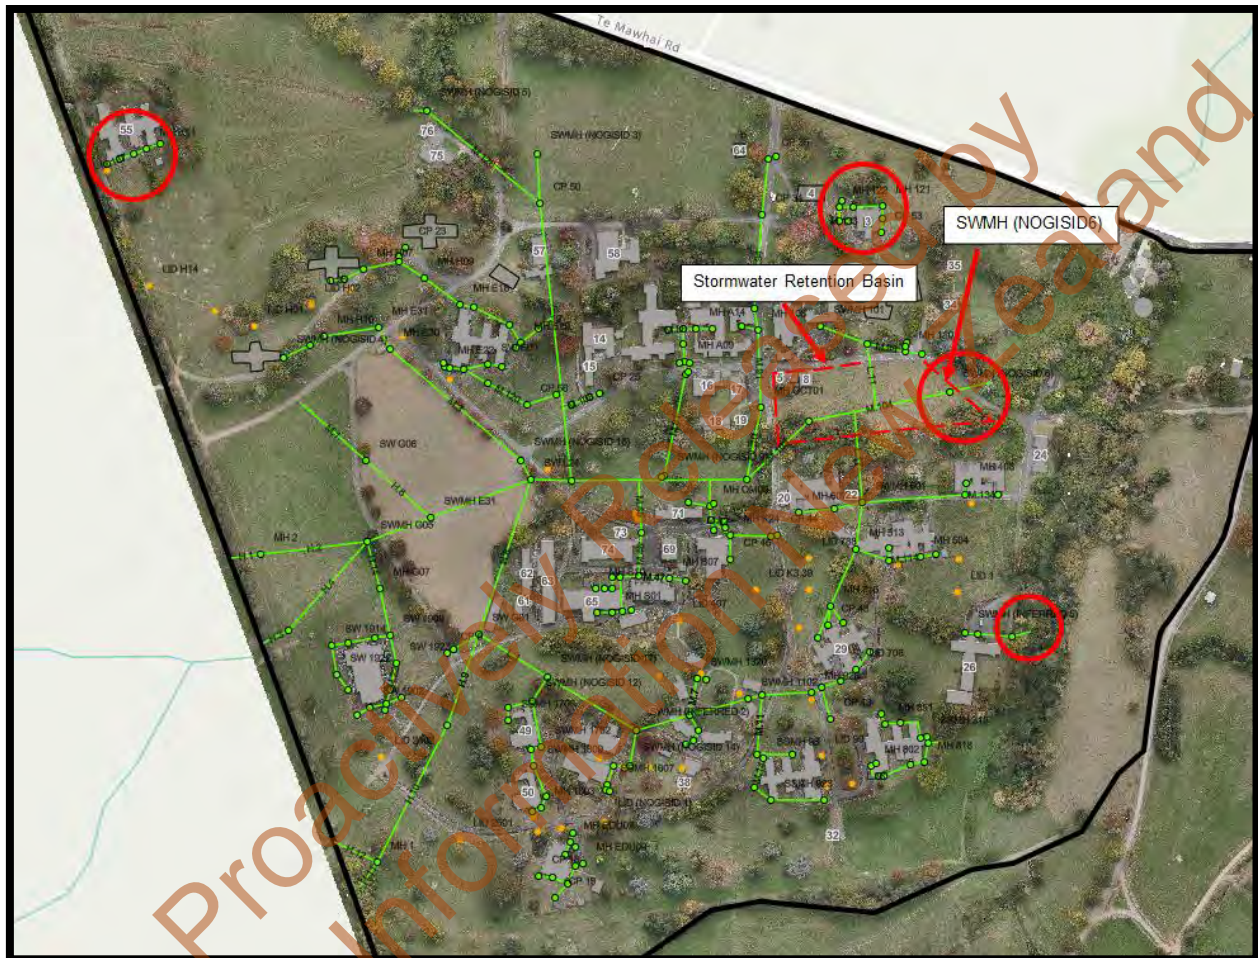
Figure 6 Stormwater discharge points

A survey of horizontal infrastructure undertaken by FTL (Fraser Thomas, 2023) included an assessment of the stormwater system at the Site. The majority of stormwater is routed to a retention basin in the centre-east of the Site and then to a tributary of the Wharekōrino Stream. This is known as the Trunk Stormwater System. Remaining stormwater was found to discharge via a separate discharge point or was cross connected to other services (e.g. discharged to the sewer). Key findings are as follows:

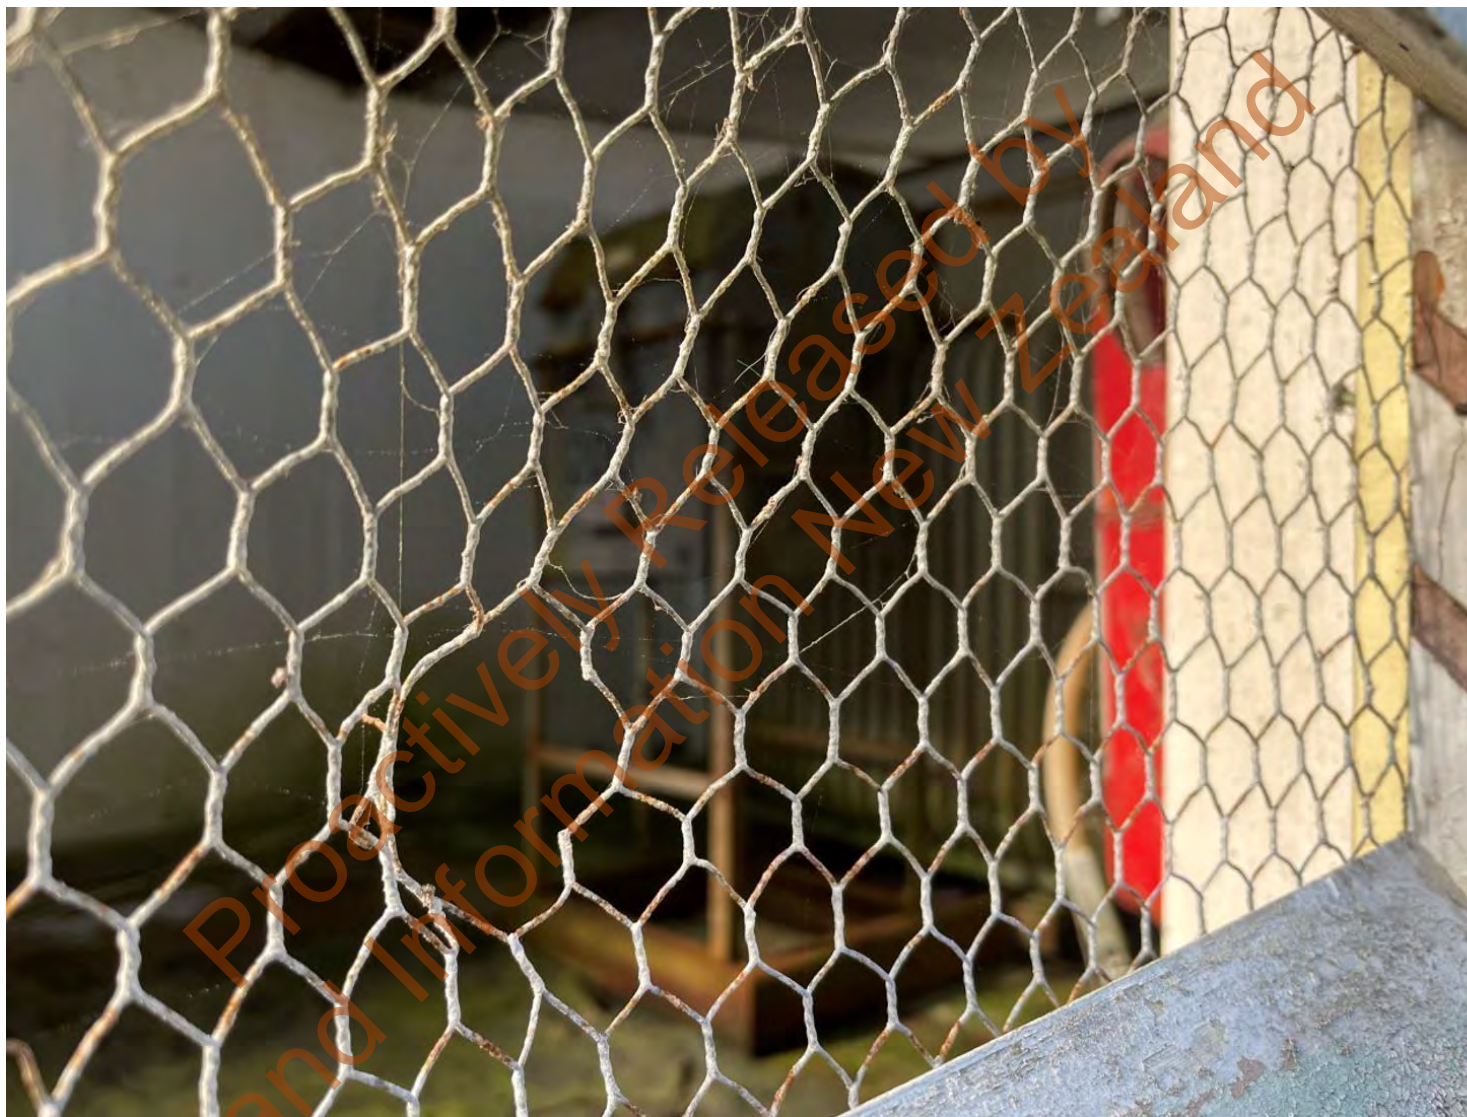
Photo 13:
S2
Substation 2
11/08/2022

S2: Substation 2	Chicken wire is placed across the door. Equipment, including transformers can be observed inside.
Gully to the south of B8	The gully has a culvert which enters from the eastern side. Appears to be a surface water collection area. This location was sampled by AECOM as part of their site investigation.
B59: Gardeners Shed	Contains old, empty Intermediate Bulk Containers (IBCs) and drums. Currently used by the farmer for storage. An old concrete pad near the door with weed spray storage signage on it on the eastern side.
B61: Shed 11	A small square building in the commercial area of the Site. It has no windows and has vents on the outside. Initially not accessible at time of initial site inspection, but subsequent access has shown it contains a small above ground tank (potentially an air compressor) and associated pipework. Its exact use is unknown. The current utility service plans for the area do not show a piped connection to this building. Some minor oil staining on the internal floor was evident.

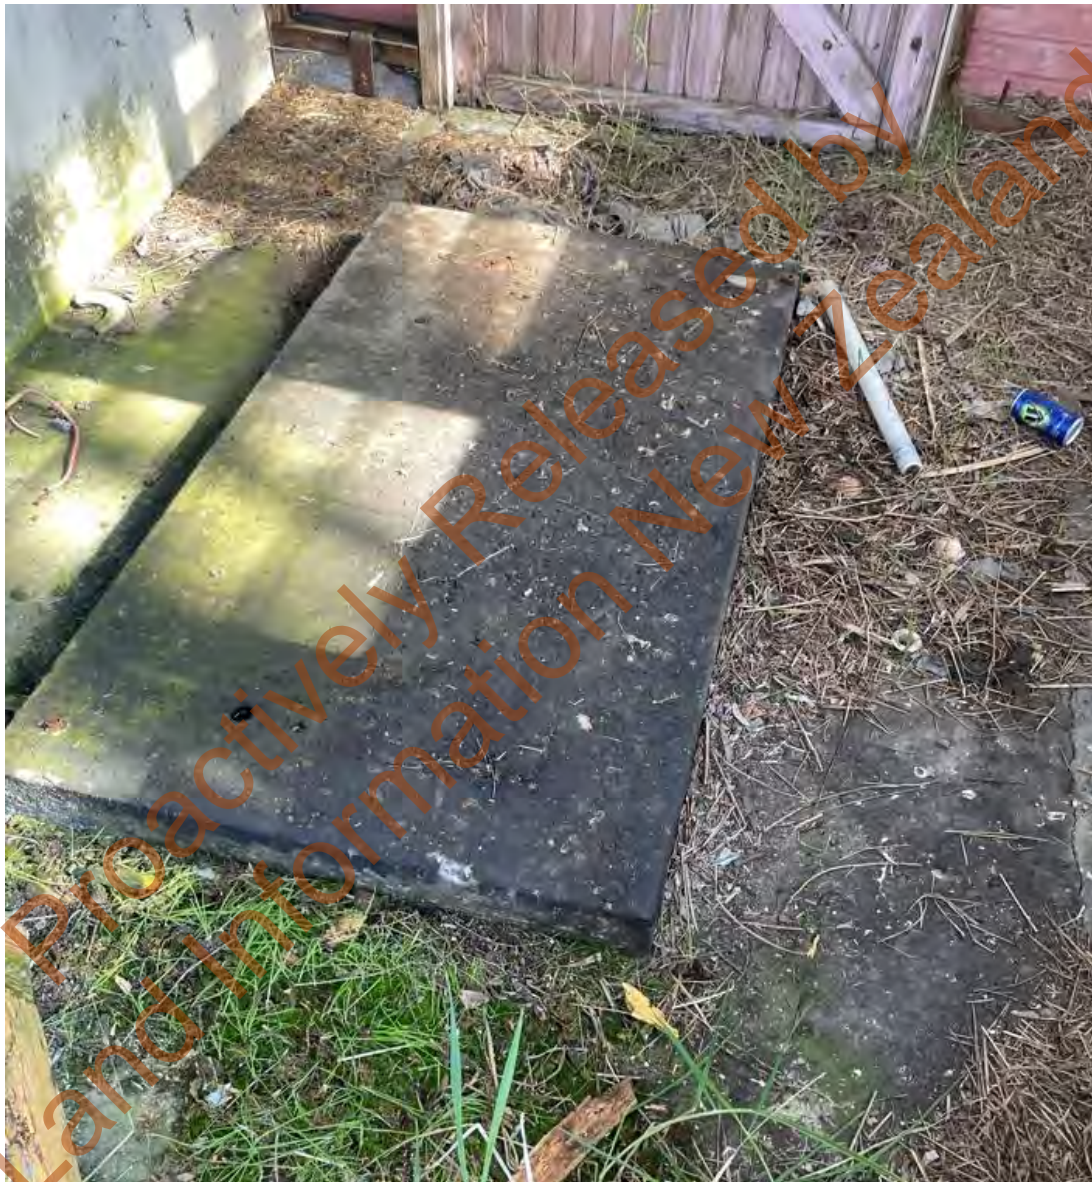
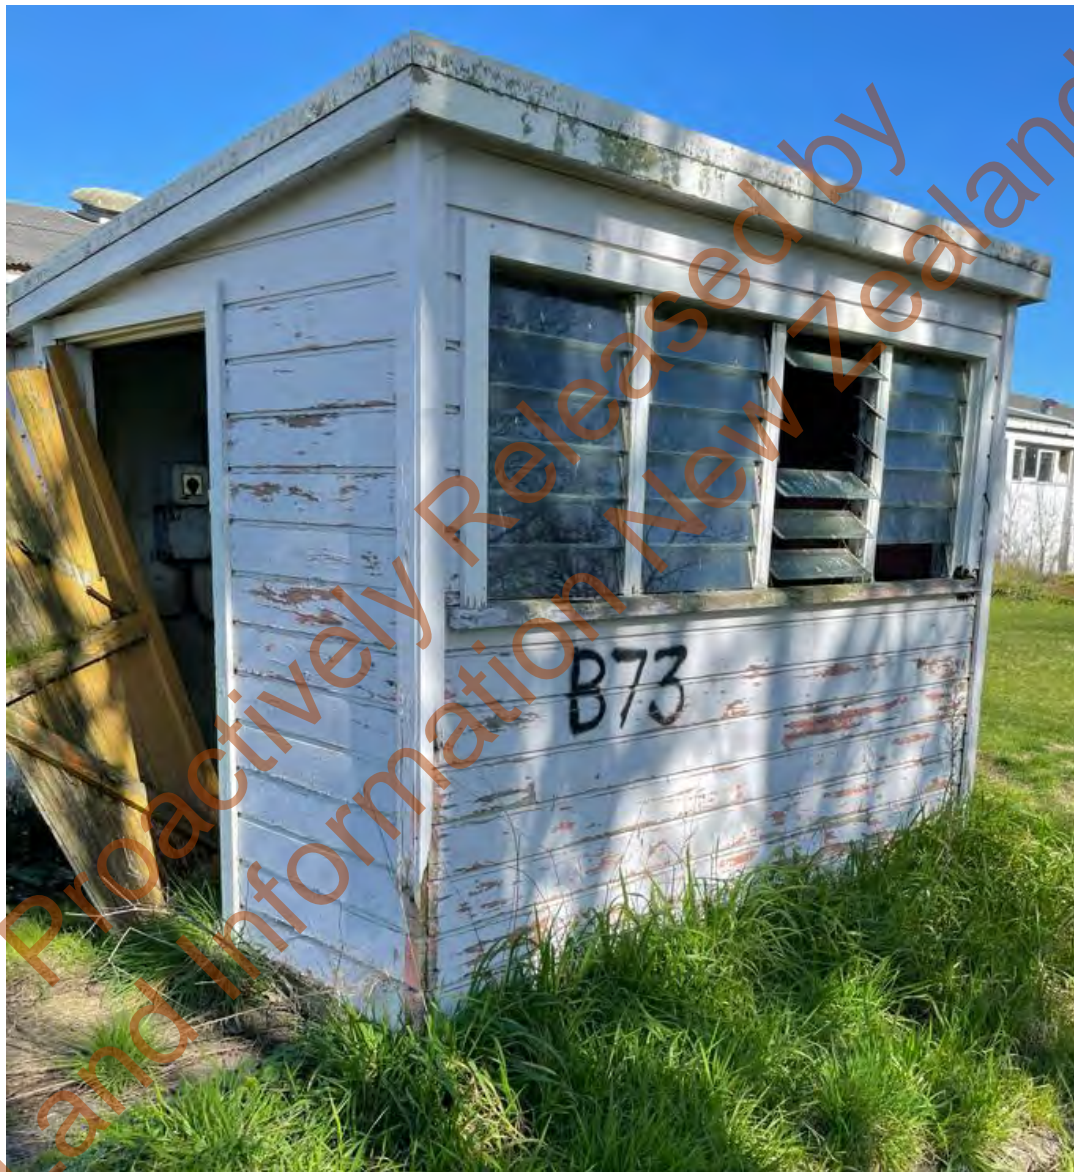
Photo 40:
B73: Shed 7
11/08/2022

B73: Shed 7	Appears to be a pump house associated with the laundry. The discharge point from the shed is unknown. There is a concrete plinth inside which has oil staining. A pipe tunnel with concrete paver covering in the paddock to the north appears to connect to the Laundry Building (B74). A scrub area in the paddock appears to have a discharge point within it, with stepped concrete surrounding it. This is heavily overgrown and may just be a stormwater drainage point.
B74: Laundry	A long building with a high glass roof. GHD was unable to access the building due to the risk of glass dropping inside. There are small concrete channels exiting the base of the building towards B73. On the western side of the laundry building is a blue stick up pipe, which looks like a monitoring well without a cap. There are piles of asphalt scrapings in the same area. On the south side near the pedestrian entrance there are downpipes to the ground which come from the inside of the building and may be a possible area of discharge to the ground.

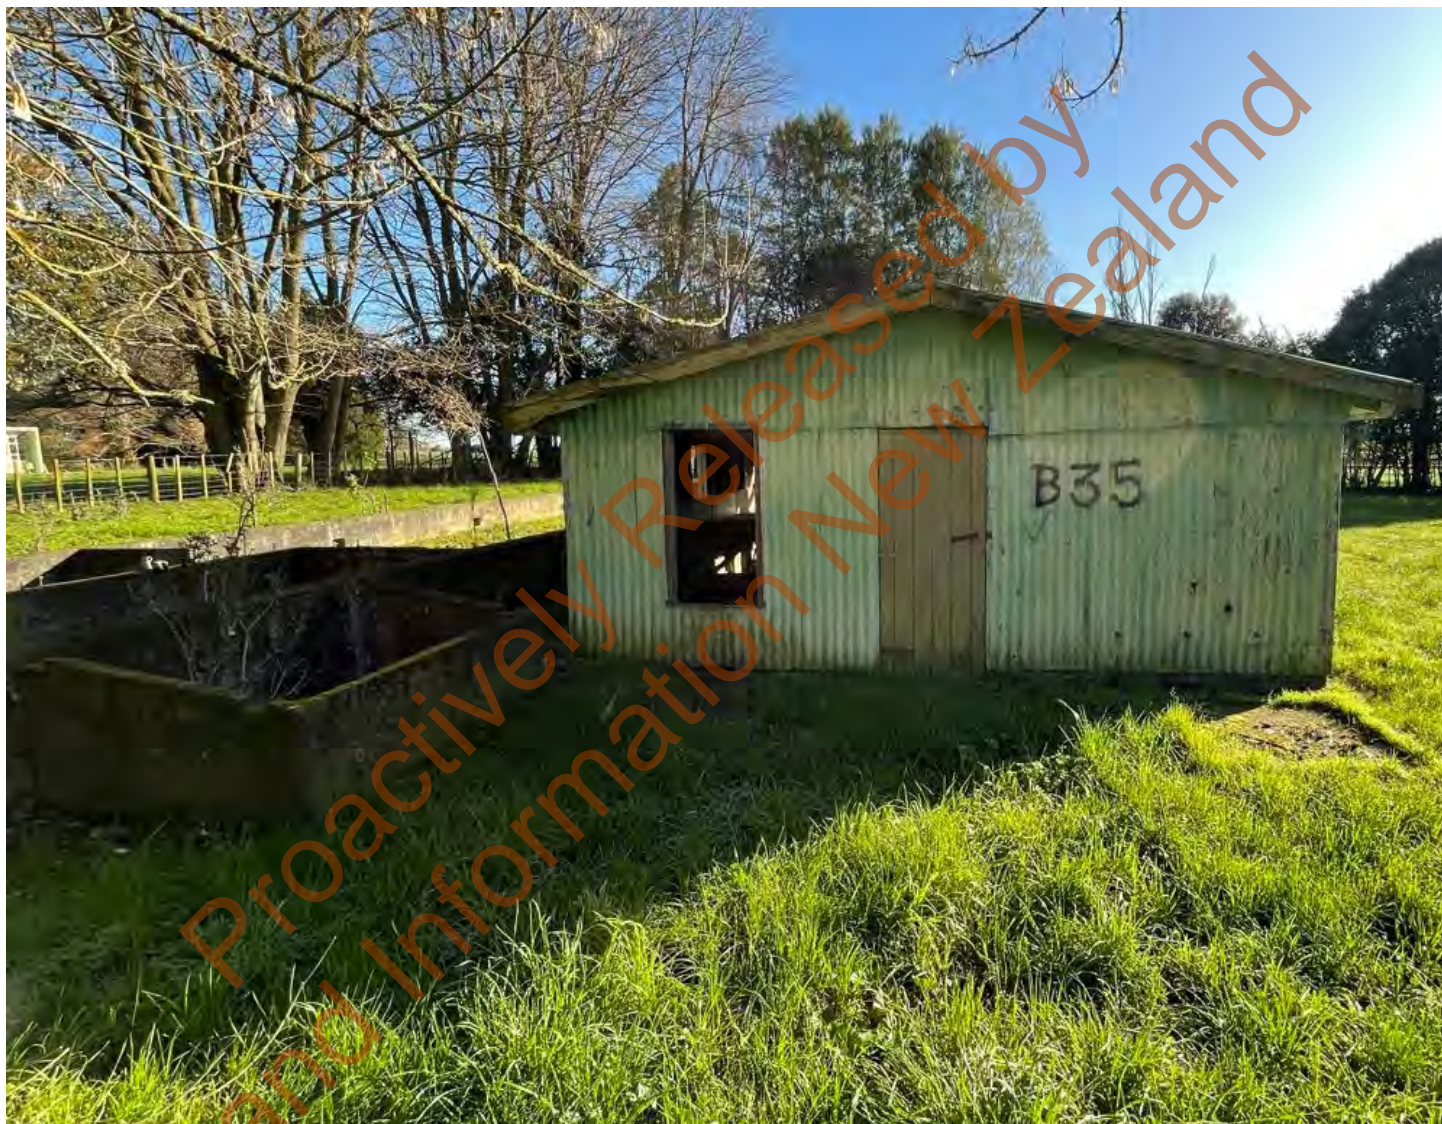
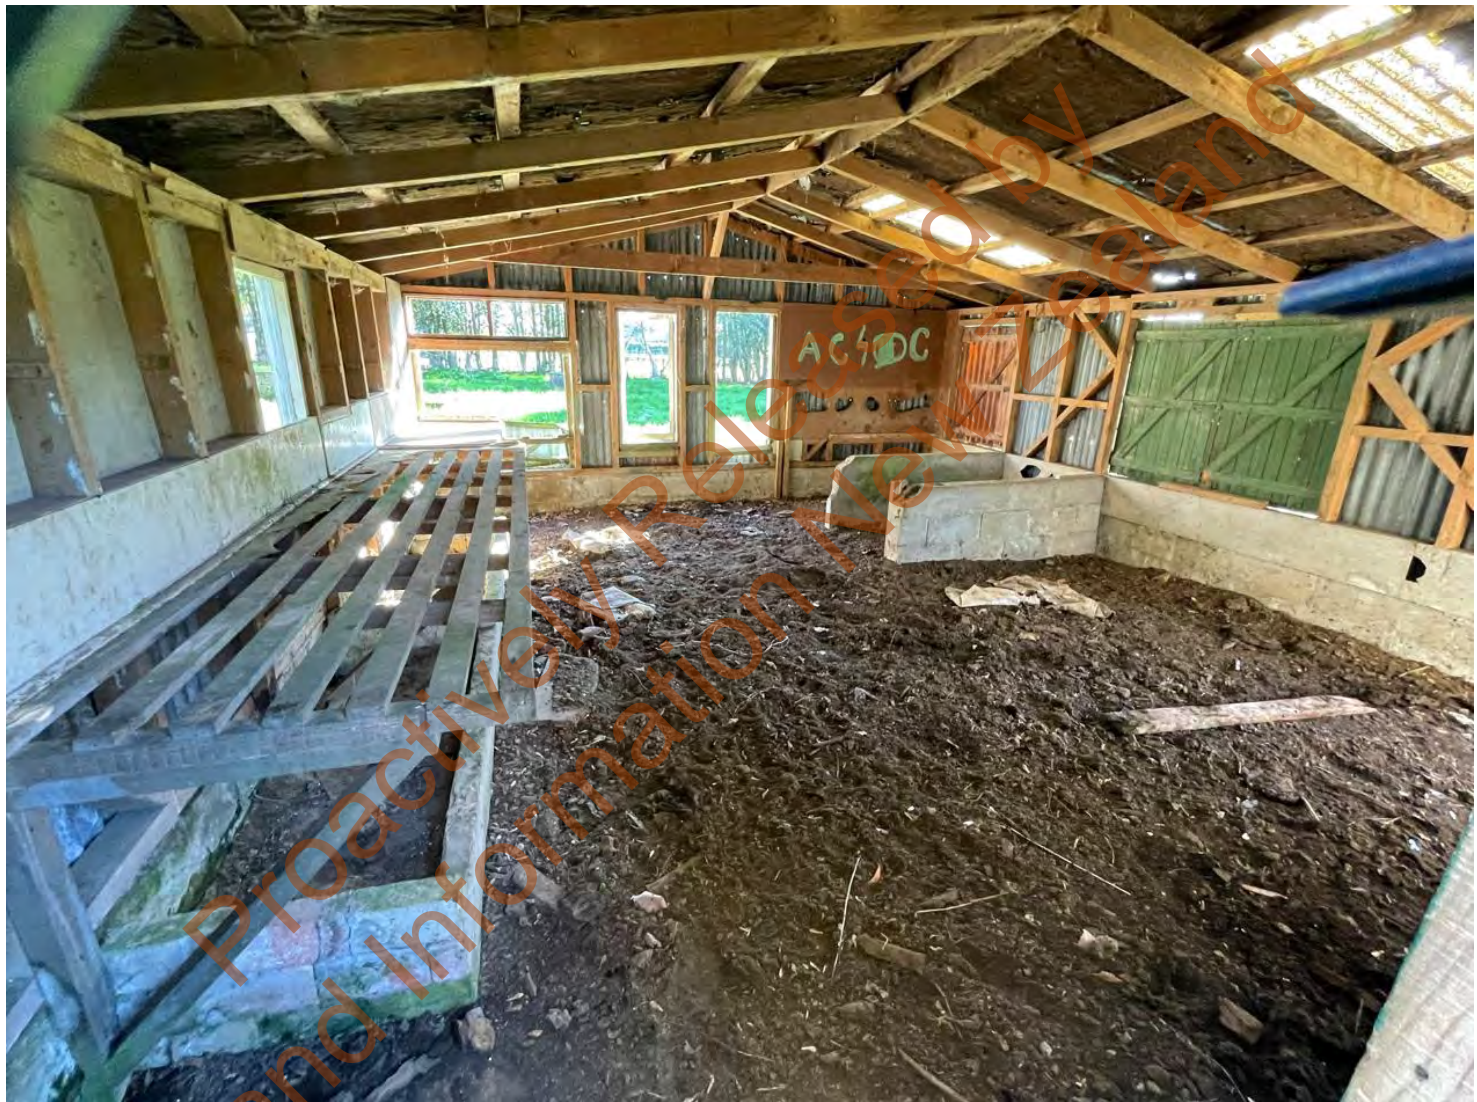
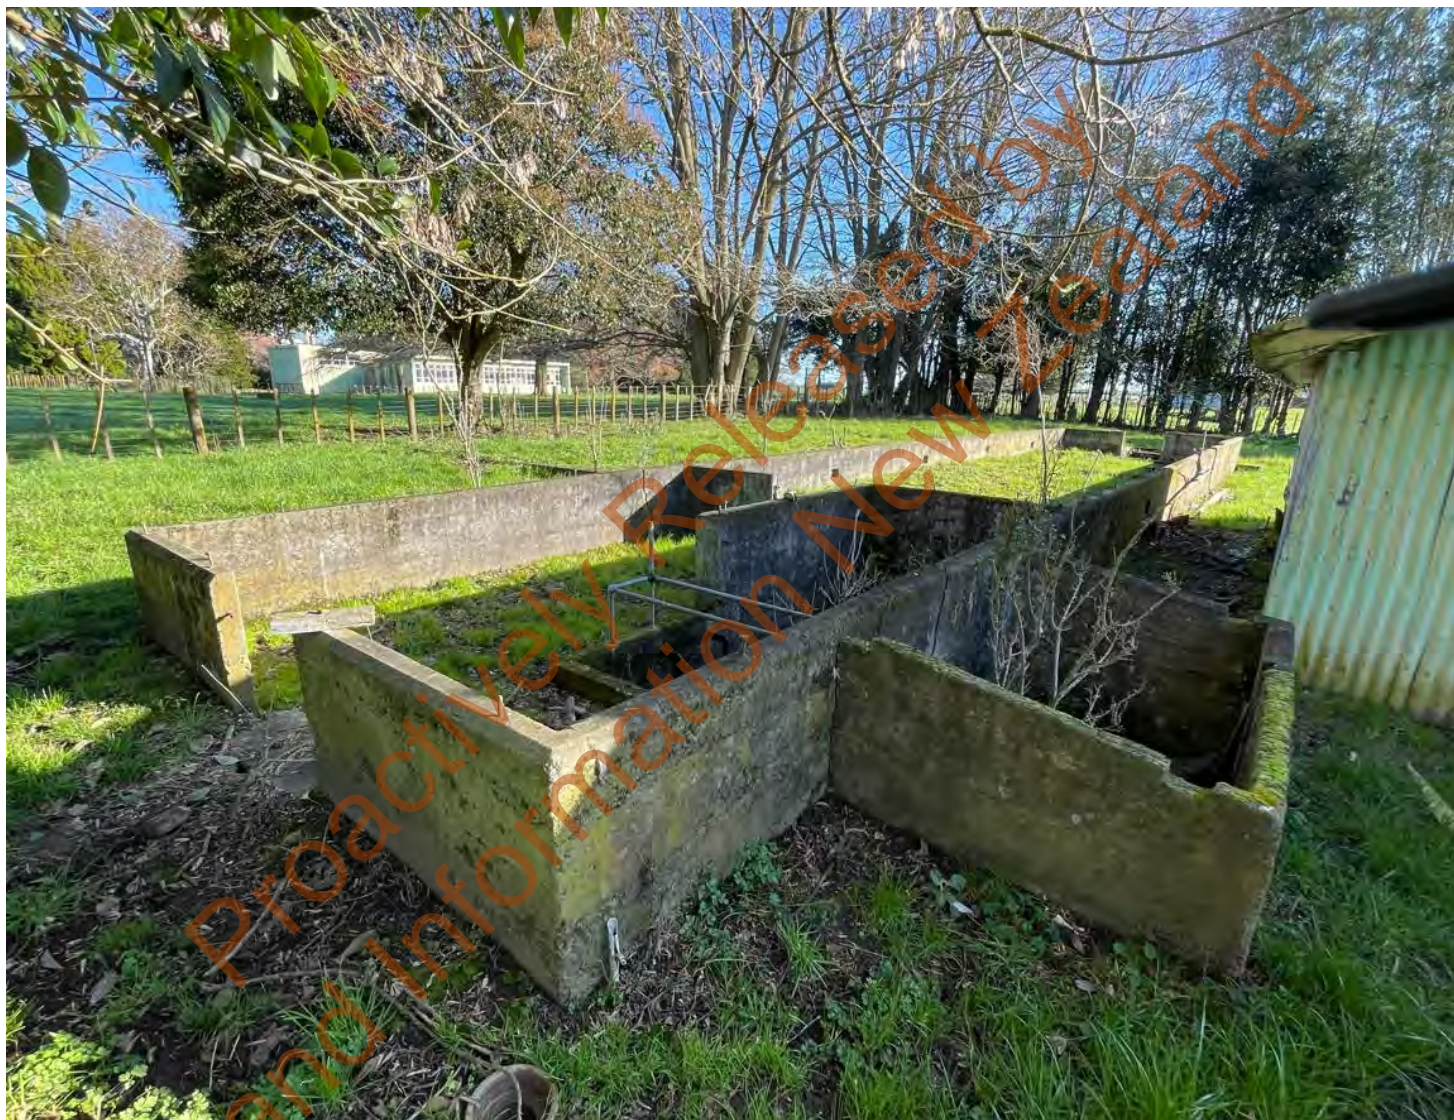
Photo 50:
B35 Shed 1
12/08/2022

Building/area	Observations
B35: Shed 1	A corrugated iron shed with no internal floor. Inside is some internal wooden racking and concrete structures. Immediately to the west are the ruins of a larger building, which includes areas of concrete lined below ground pits.
Area between B34 and B35	A number of concrete foundations, believed to be from former glasshouses.
Eastern/ south-eastern edge of paddock	A linear concrete structure leading to the paddock fence in the direction of the stream. The use of this structure is unknown but may have been used as a livestock dip.
South-east of the paddock	An old chimney base and other depressions and hummocks are present in the ground.
WWTP Seepage	The WWTP pump station appears to discharge to the Wharekōrino stream just south of the main road. Seepage was observed near the main discharge pipe, flowing from an area showing some ground collapse.
WWTP Discharge	During the walkover it was noted that a concrete discharge pipe flows into the Wharekōrino Stream from the pump station. This was associated with visibly poor water quality and algal growth.
