Arboricultural Safety Audit Te Motu Kairangi

Arboricultural Safety Audit

Date: 24/07/2020

Job Ref:33269

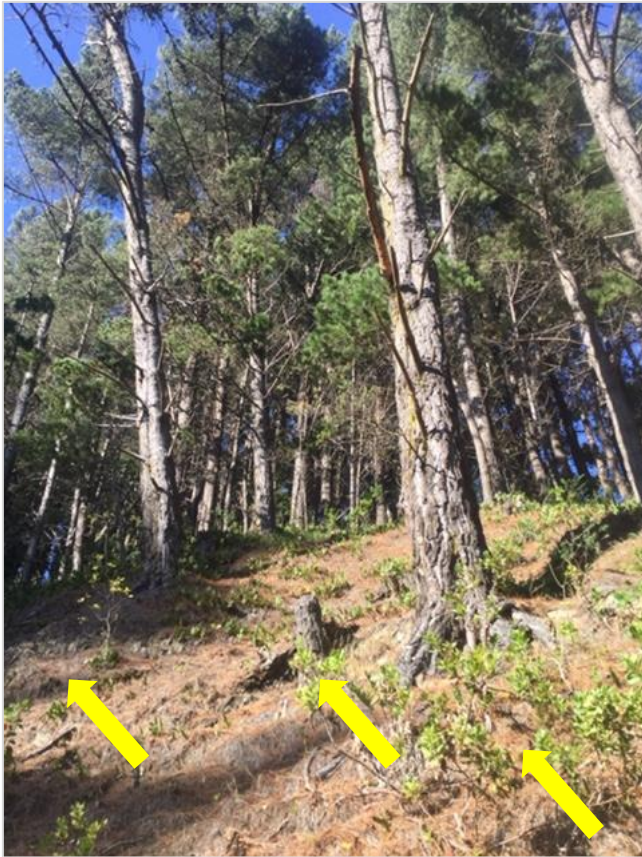
Photo 1: Group S2

ID	Description of Assessed Risk	Annual Risk Of Harm	ALARP* Cost Benefit	Management Recommendation
S2	Assessment of pines growing on eroding bank over 1885 Military Road. Whole tree failure onto track due to bank failure. Multiple trees	1/1,000,000	\$4.34	Recommended removal of under-cut <i>Pinus radiata</i> on bank over 1885 Military Road.
S3	Whole tree failure onto 1885 Military Road	<1/1,000,000	< \$4.34	No work recommended based on risk
	Limb failure onto road	<1/1,000,000	< \$4.34	No work recommended based on risk
	Whole tree failure onto power lines	<1/1,000,000	< \$4.34	No work recommended based on risk
S6	Whole failure on to track	<1/1,000,000	< \$4.34	No work recommended based on risk
	Branch failure onto track	<1/1,000,000	< \$4.34	No work recommended based on risk
	Deadwood failure onto track	1/500,000	\$8.68	Tolerable; dead wood tree.
	Whole tree failure onto power lines	<1/1,000,000	< \$4.34	No work recommended based on risk

- 7.1.1 **Group: Stand Area S2** – The group of *Pinus radiata* has an ARoH of 1/1,000,000. The Pines are growing on an eroding bank over 1885 Military Road. Whole tree failure onto the track due to embankment erosion is foreseeable. Due to the groups low retention value it is recommended that they be removed. This level of risk is generally considered tolerable.

- 10.4 Proactive removal of the following trees should be considered: T6.2, T15.1, T2.1, T21.4, T21.5, T24.1, T8.2 and S2.
- 10.5 Remedial Pruning and Deadwood Removal is recommended for: T.14.1, T21.3, T23.1, T23.2, T26.2 and S6.

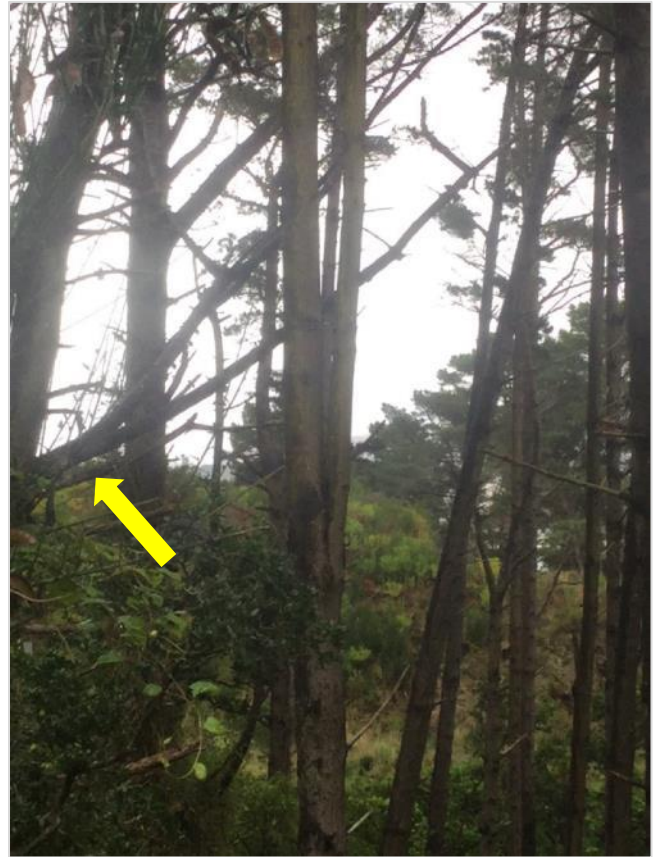
Photo 2: Single Tree T8.2

- 7.2.4 **Single Tree T8.2** - *Pinus radiata* has an ARoH of 1/300,000. The tree has poor structure and branch unions and if the tree is to fail it could foreseeably cause damage to the nearby powerlines. Therefore it is recommended that the tree be removed as the trees retention value is low. Alternatively, as this level of risk is generally considered tolerable regular inspections of trees vitality is an option.

- 8.1 The highest Annual Risk of Harm (ARoH) posed by any tree(s) on site are Trees T6.2, T.8.1, and Tree T8.2 which are all mature *Pinus radiata*. These three (3) trees have poor structure and are all in the vicinity of overhead powerlines which elevates the ARoH to 1/30,000. This level of risk can be considered tolerable. However; as the subject trees have a low retention levels (Barrell, J.D., 2009). It is recommended that they be removed. The ALARP cost benefit analysis does not justify the removal of these trees. However, proactive removal, or alternative risk reduction methods should be considered dependent upon the tree owner's priorities. An alternative management option to tree removal could be a crown reduction, or "monolithing". Monolithing is the practice of reducing a tree back to a standing stem so it can be retained for its habitat value. Both options reduce the Probability of Failure and consequently the Annual Risk of Harm by reducing the trees wind loading.

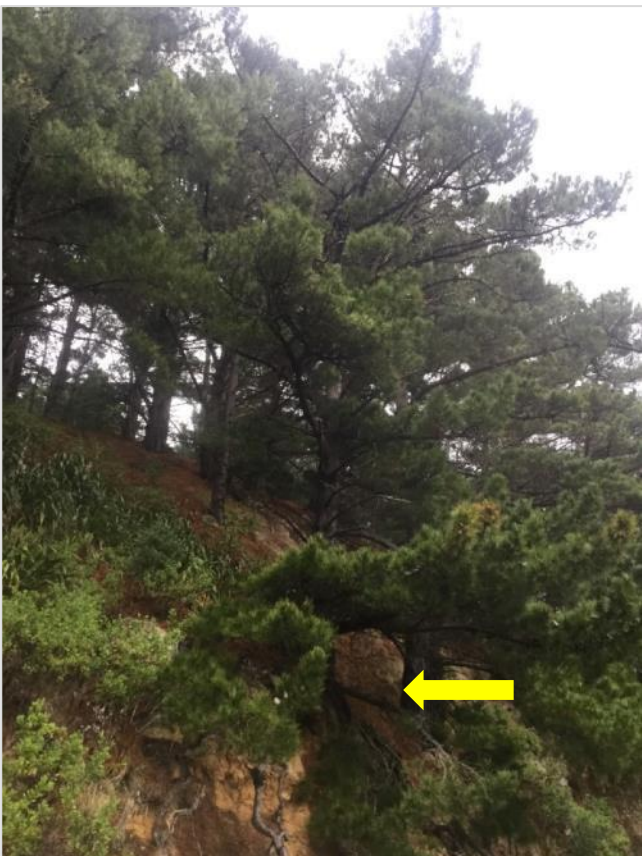
Photo 3: Single Tree T2.1

ID	Description Of Assessed Risk	Annual Risk Of Harm	ALARP* Cost Benefit	Management Recommendation
T2.1	Whole tree failure due to bank erosion onto track	1/1,000,000	\$4.34	Proactive removal as part of the stand management & erosion concerns.
T6.1	Whole tree failure due to bank erosion onto track	<1/1,000,000	< \$4.34	No work recommended based on risk
	Whole tree failure due to bank erosion onto power lines	<1/1,000,000	< \$4.34	No work recommended based on risk
T6.2	Whole tree failure due to bank erosion onto track	<1/1,000,000	< \$4.34	No work recommended based on risk
	Whole tree failure due to bank erosion onto power lines	1/300,000	\$14.47	Tolerable; Remove or Monitor group for decline in tree health & erosion.
T6.4	Stem failure at union on to track	<1/1,000,000	< \$4.34	No work recommended based on risk
T6.5	Standing dead stem failure on to track	<1/1,000,000	< \$4.34	No work recommended based on risk

- 7.2.1 **Single Tree T2.1** - *Pinus radiata* has an ARoH of 1/1,000,000. There is visible embankment erosion. As the tree has a low retention value it is recommended that the tree is removed as part of the stand management. This is a proactive option. Alternatively, as this level of risk is generally considered tolerable regular inspections of both the embankment and the trees vitality is an option.
- 7.2.2 **Single Tree T6.2** – *Pinus radiata* has an ARoH of 1/300,000. There is visible embankment

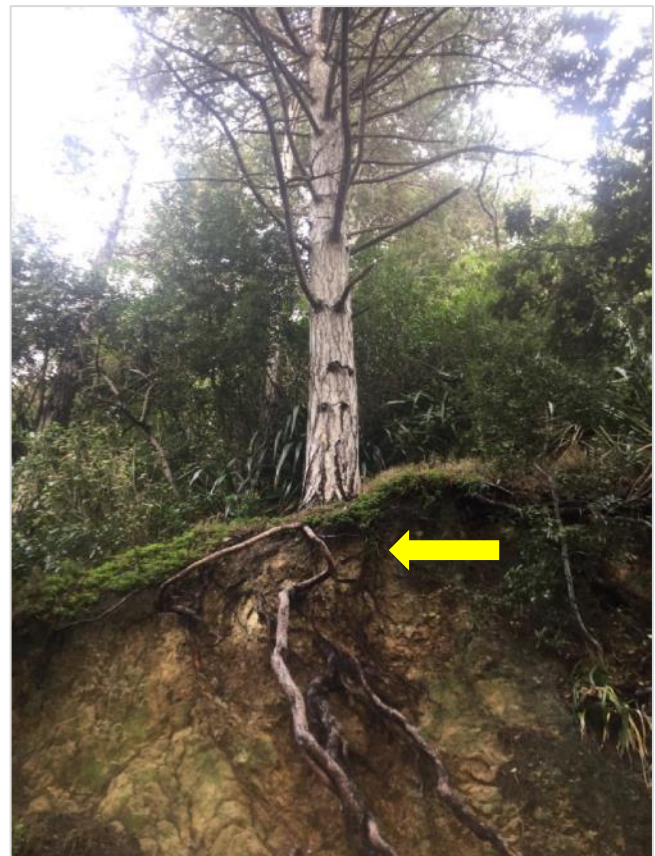
Photo 4: Single Tree T15.1

- 7.2.6 **Single Tree T15.1** - *Pinus radiata* has an ARoH of 1/1,000,000. There is visible embankment erosion. As the tree has a low retention value it is recommended that the tree is removed as part of the stand management. This is a proactive option. Alternatively, as this level of risk is generally considered tolerable regular inspections of both the embankment and the trees vitality is an option.

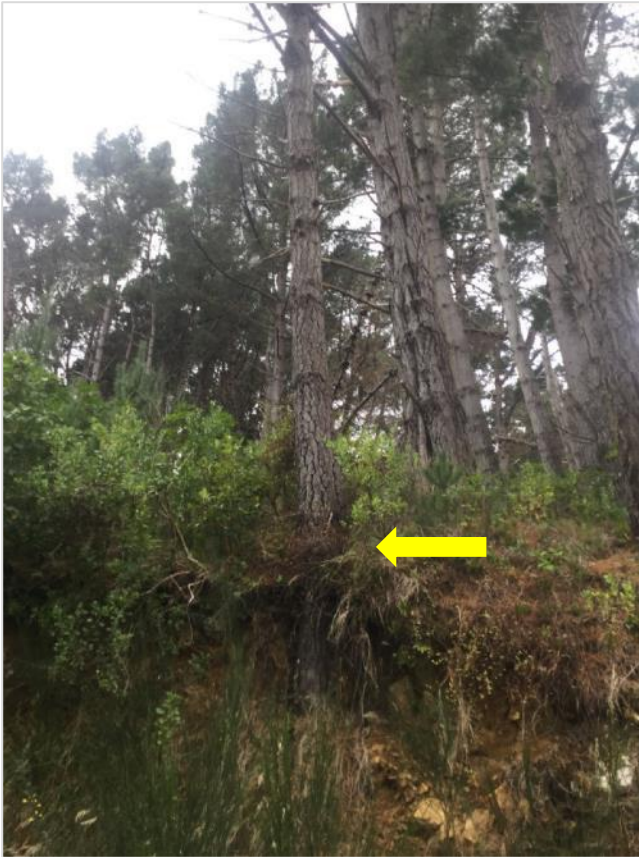
Photo 5: Single Tree T6.2

erosion. Therefore it is recommended that both the tree vitality and the embankment be regularly inspected. This level of risk is generally considered tolerable.

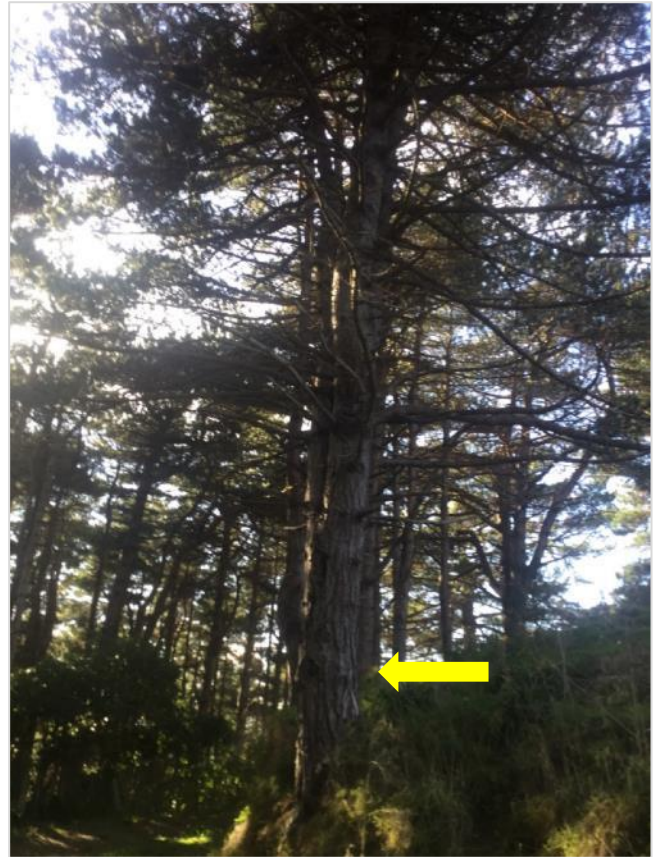
Photo 6: Single Tree T21.5

with flawed branch unions. As the tree has a low retention value it is recommended that the tree is removed as part of the stand management. This is a proactive option. Alternatively, as this level of risk is generally considered tolerable regular inspections of trees vitality is an option.

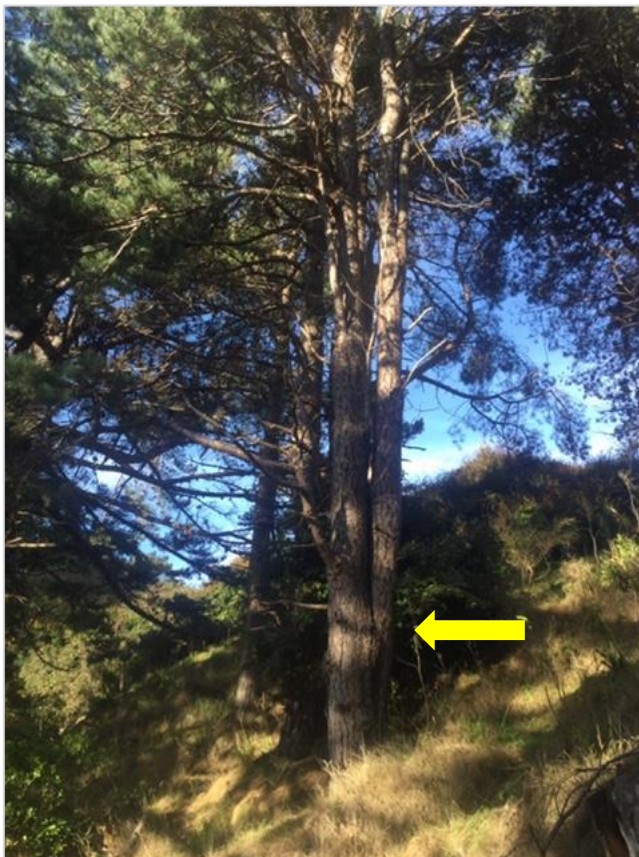
Photo 7: Single Tree T21.4

ID	Description Of Assessed Risk	Annual Risk Of Harm	ALARP* Cost Benefit	Management Recommendation
T21.4	Stem failure at poor union onto track	1/1,000,000	\$4.34	Proactive tree removal as part of the stand management.
T21.5	Stem failure at poor union onto track	1/1,000,000	\$4.34	Proactive tree removal as part of the stand management.
T23.1	Hung up deadwood failure onto track	1/500,000	\$8.68	Remove hanger & dead wood.
T23.2	Hung up deadwood failure onto track	1/500,000	\$8.68	Remove hanger & dead wood.
T24.1	Whole tree failure onto track. Fire damaged stems with decay evident	1/400,000	\$10.85	Low retention value. Proactive removal.
T26.1	Hung up tree over track	<1/1,000,000	< \$4.34	Remove hanger
T26.2	Hanging broken branch failure onto track	1/500,000	\$8.68	Remove hanger & dead wood.

- 7.2.8 **Single Tree T21.4** - *Pinus radiata* has an ARoH of 1/1,000,000. The tree has poor structure with flawed branch unions. As the tree has a low retention value it is recommended that the tree is removed as part of the stand management. This is a proactive option. Alternatively, as this level of risk is generally considered tolerable regular inspections of trees vitality is an option.

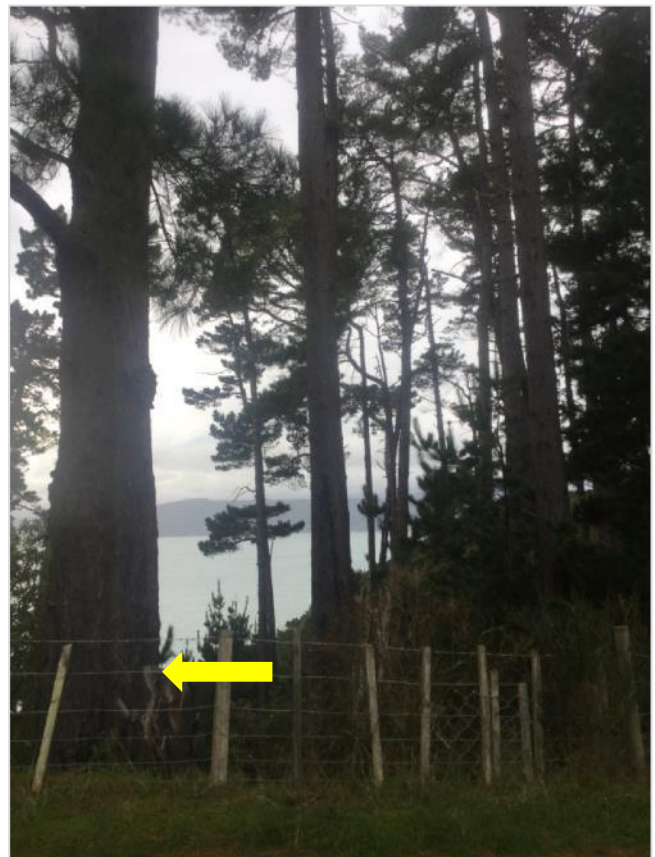
Photo 8: Single Tree T24.1

7.2.12 **Single Tree T24.1** - *Pinus radiata* has an ARoH of 1/400,000. The trees main stem has been damaged due to fire and decay is visible. As the tree has a low retention value it is recommended that the tree is removed as part of the stand management. This is a proactive option. Alternatively, as this level of risk is generally considered tolerable regular inspections of trees vitality is an option.

- 8.2 The second highest Annual Risk of Harm (ARoH) posed by any tree on site has been identified as Tree T24.1 – a *Pinus radiata* with a fire damaged main stem and visible decay. Its ARoH was assessed as being tolerable (1/400,000). The ALARP cost benefit analysis does not justify the removal of the subject tree. However, proactive removal should be considered dependent upon the tree owner's priorities.

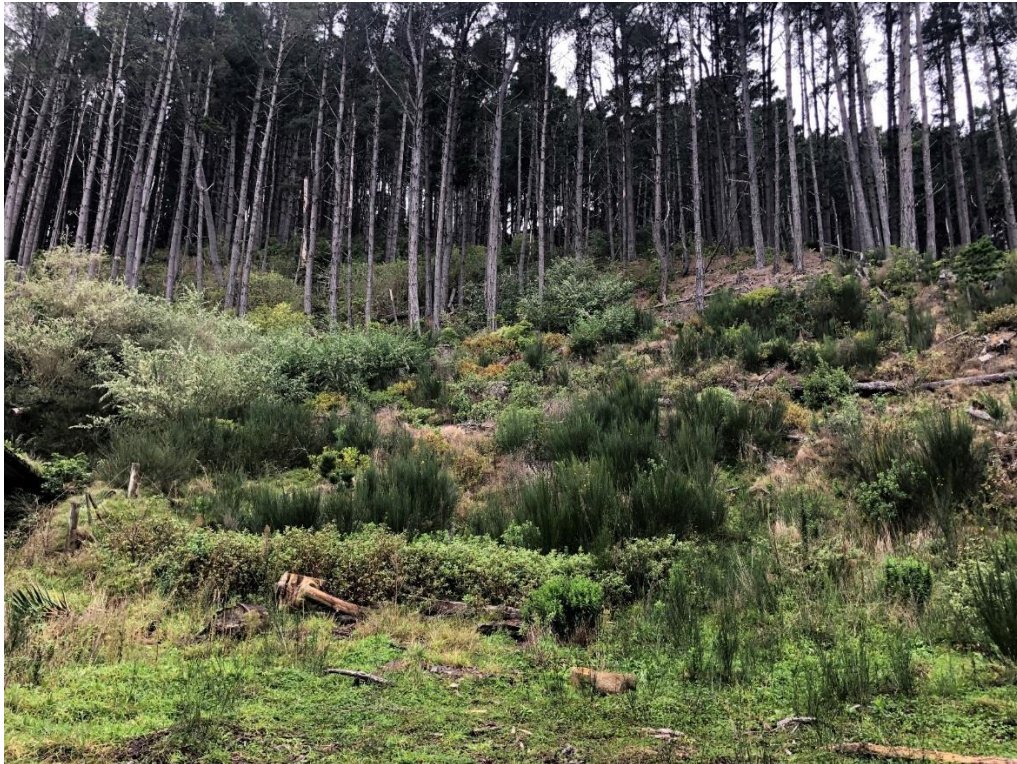
Photo 9: Abundant pest plants within the previously felled area along the western edge of the Western Pine Forest.

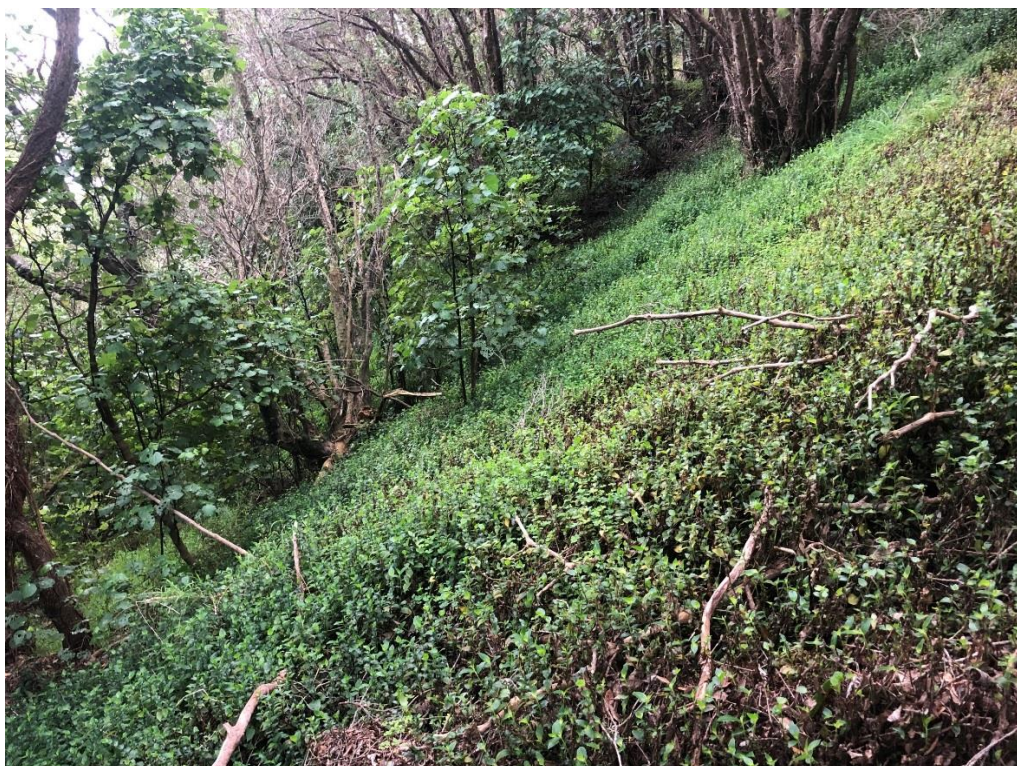
7.3.2 Northern Point – pest plants within the northern point area are most abundant along the coastal edges and walking tracks. Pohutukawa forms the majority of the canopy along the northern and western areas of the vegetation unit. Karo are commonly found growing underneath the Pohutukawa canopy and within light gaps.

Photo 10: Large Tradescantia infestation beneath Pohutukawa canopy in the Northern Point.

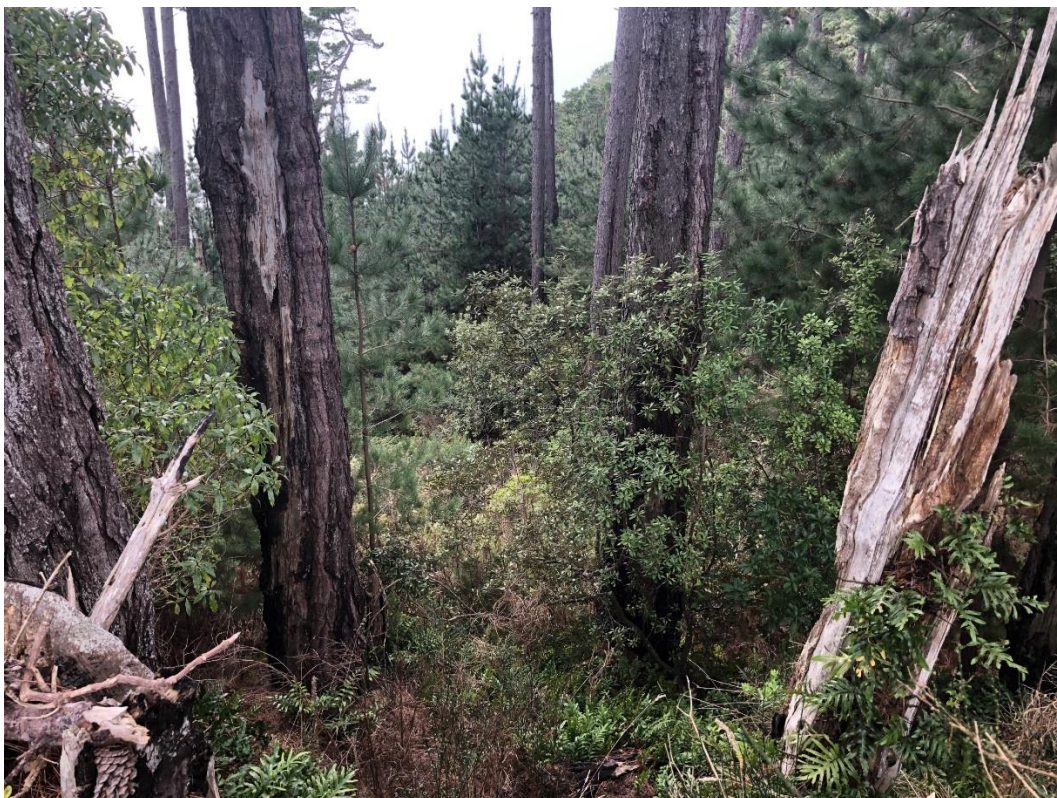
7.3.4 Eastern Pine Forest – pest plants within the eastern pine forest are predominantly found around the forest edges. The canopy of the eastern pine forest is less dense than that of the western pine forest, allowing more sunlight to reach the forest floor. As a result, pest plants are present throughout the understory of the vegetation unit. Pine saplings and karo are frequently found growing in the understory and sub-canopy.

Photo 12: Pine sapling and karo establishing beneath pine canopy in Eastern Pine Forest.

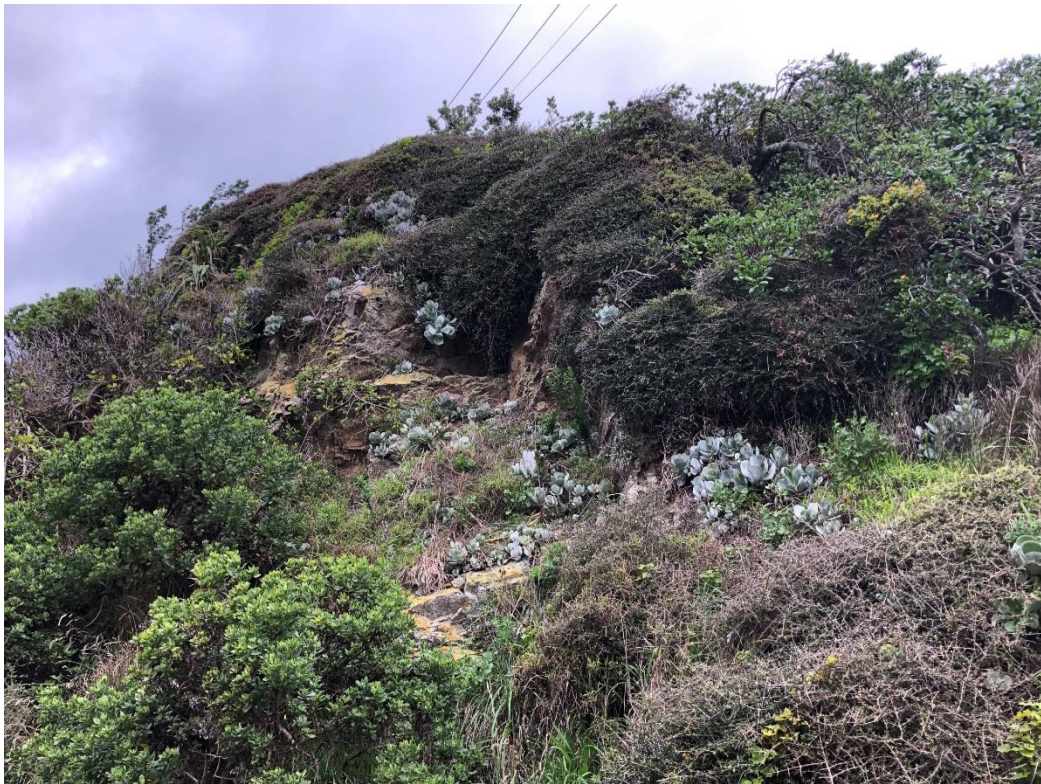
Photo 13: Mixture of native and exotic species within Eastern Coastal Scrub.
