Watts Peninsula, Wellington

Heritage and condition assessment

Report Prepared for Toitū Te Whenua Land Information New Zealand

Submitted: December 2022

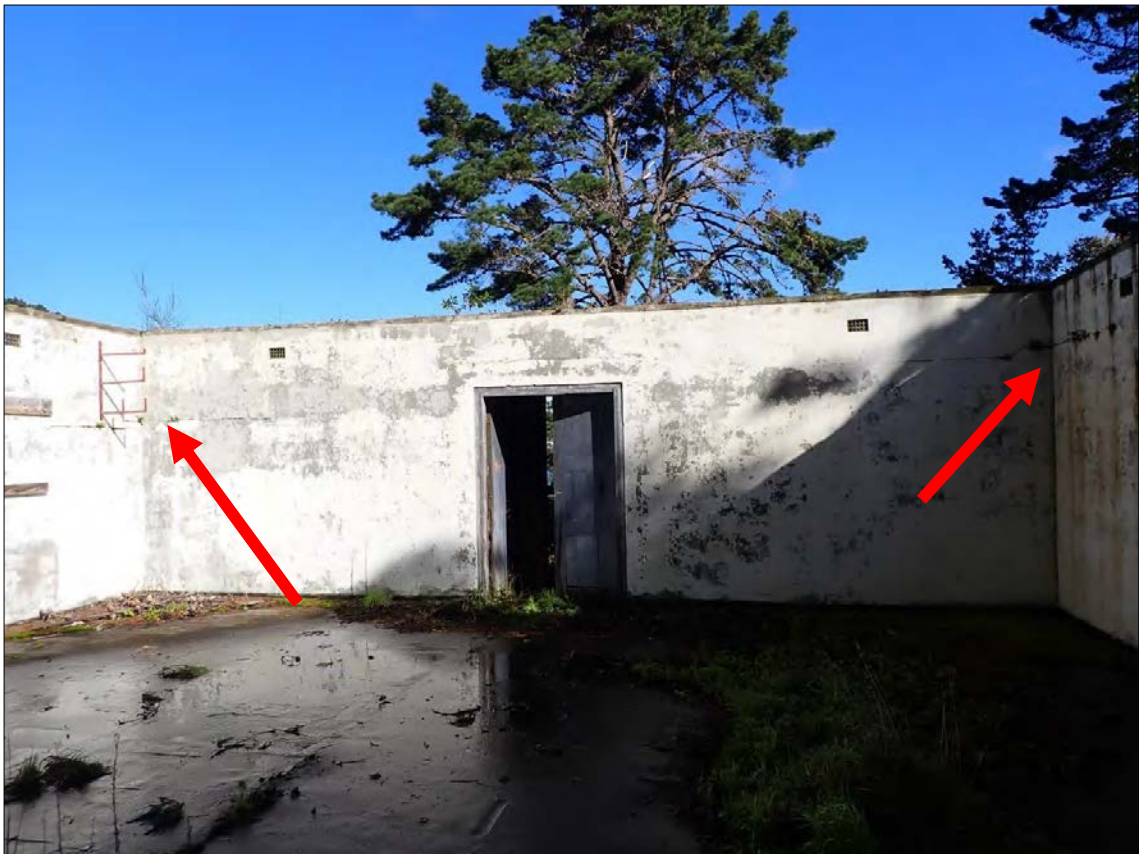
Figure 85. Feature 1: Magazine 1. Interior - Looking towards the entrance. Horizontal cracking is indicated at the corners.

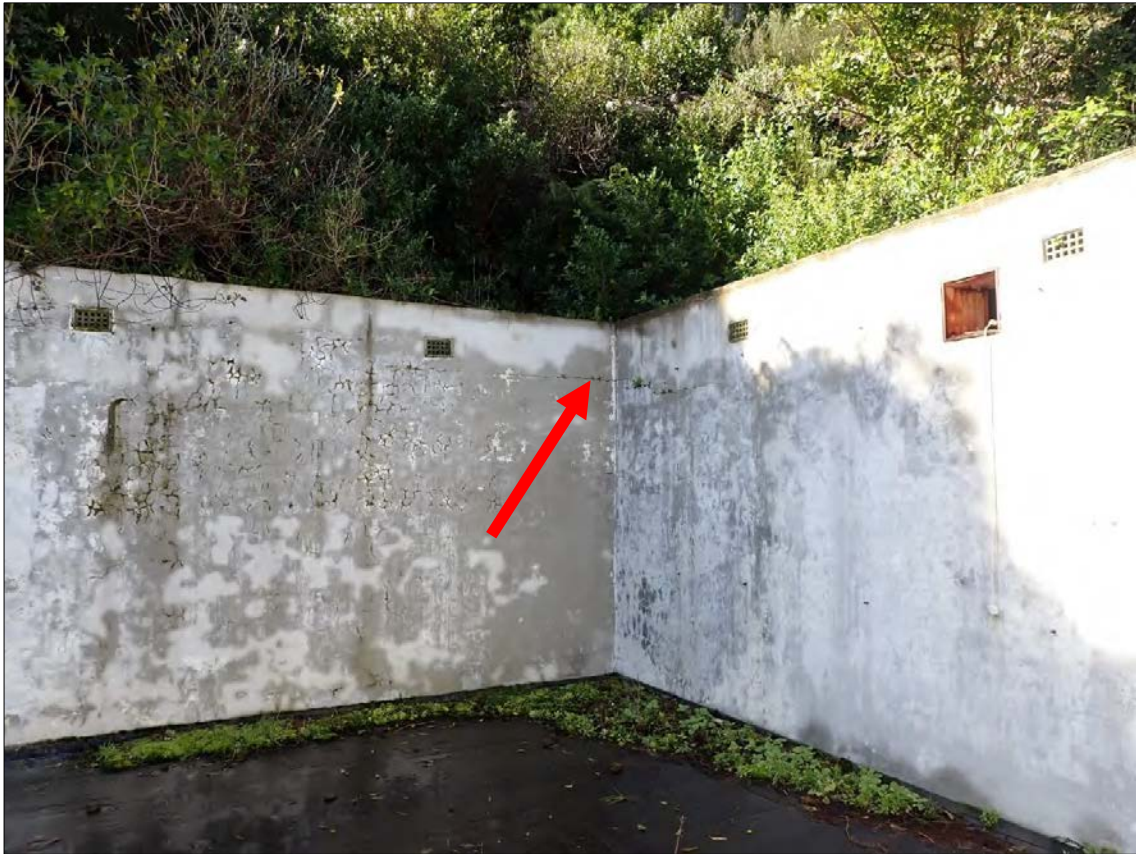
Figure 86. Feature 1: Magazine 1. Interior - Horizontal cracking is indicated at the rear northeastern corner.

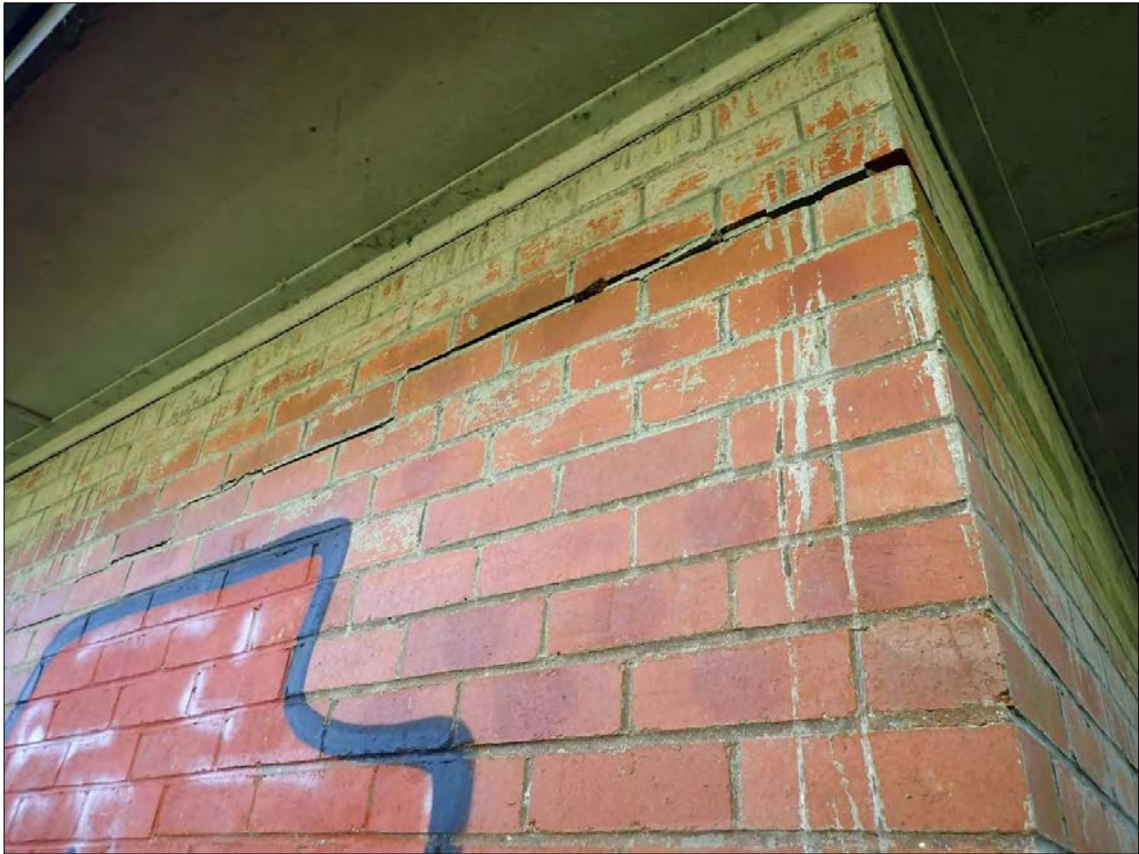
Figure 98. Feature 3: Magazine 3. Typical horizontal crack is evident at the corner of the southern (side) elevation.

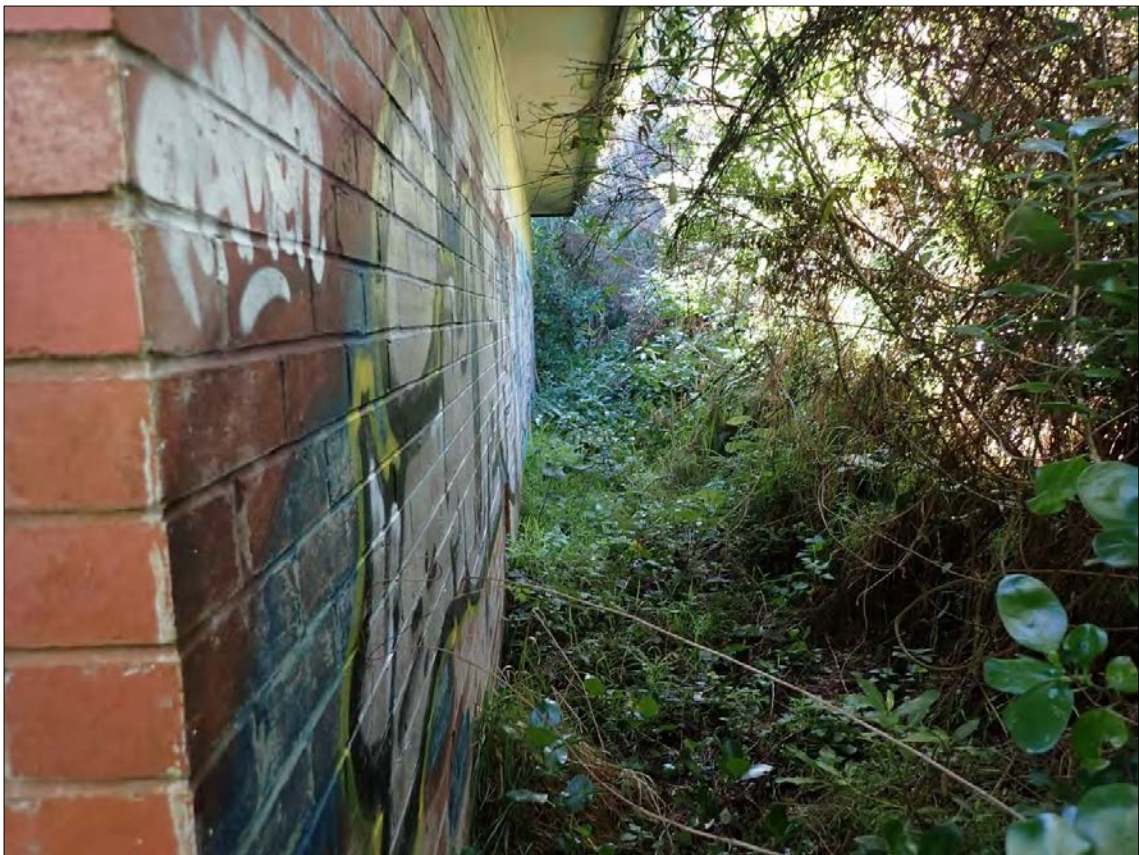
Figure 99. Feature 3: Magazine 3. Looking along the eastern (rear) elevation. Debris and vegetation have accumulated against the structure. Graffiti is present.

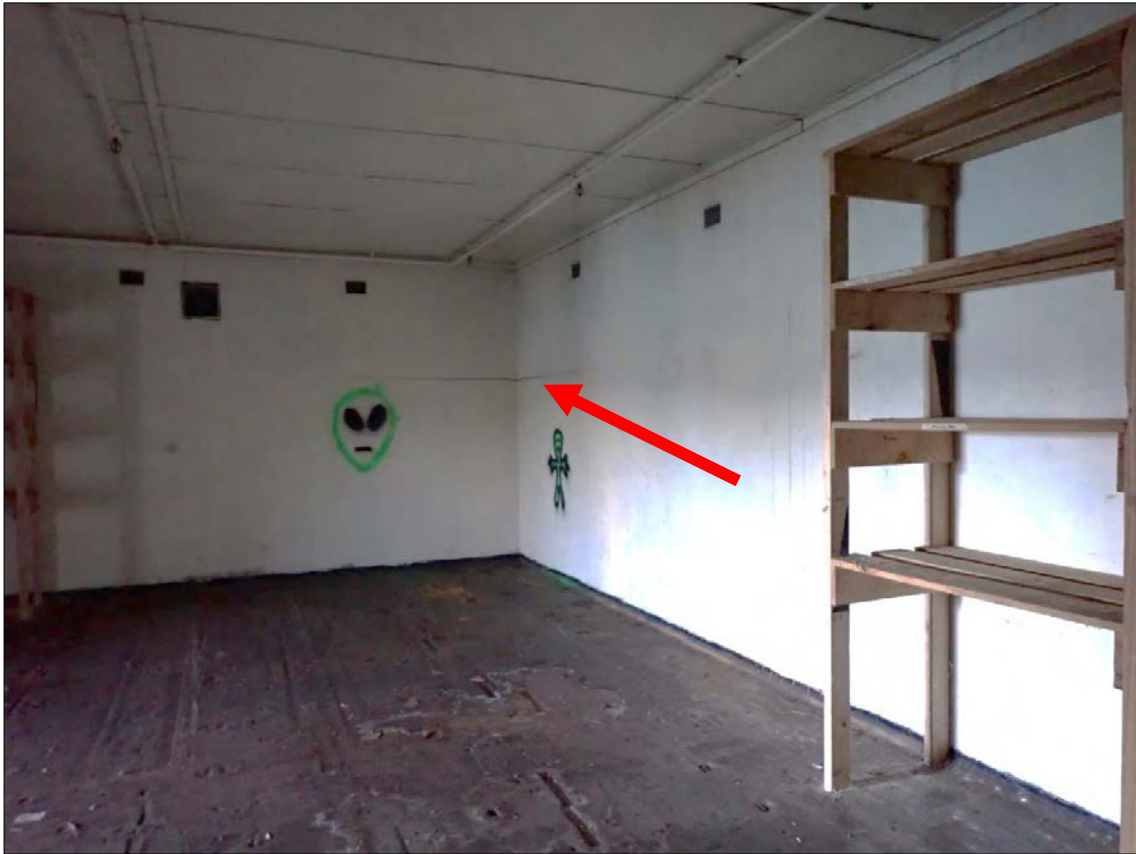
Figure 100. Feature 3: Magazine 3. Interior – Ceiling is present and fire sprinklers are evident. Graffiti is present. Typical horizontal crack at corner is indicated.

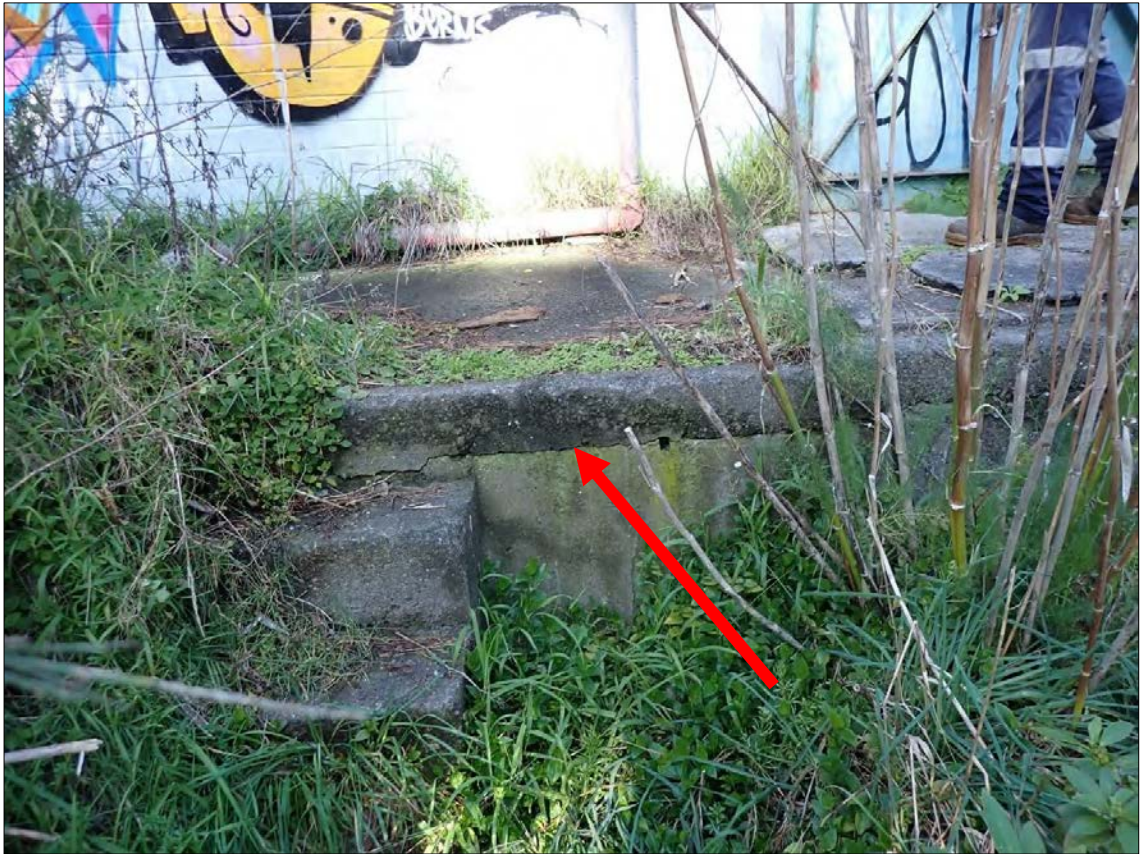
Figure 104. Feature 4: Magazine 4. Looking towards the northern (front) elevation. Horizontal cracking beneath the loading deck concrete slab is indicated.

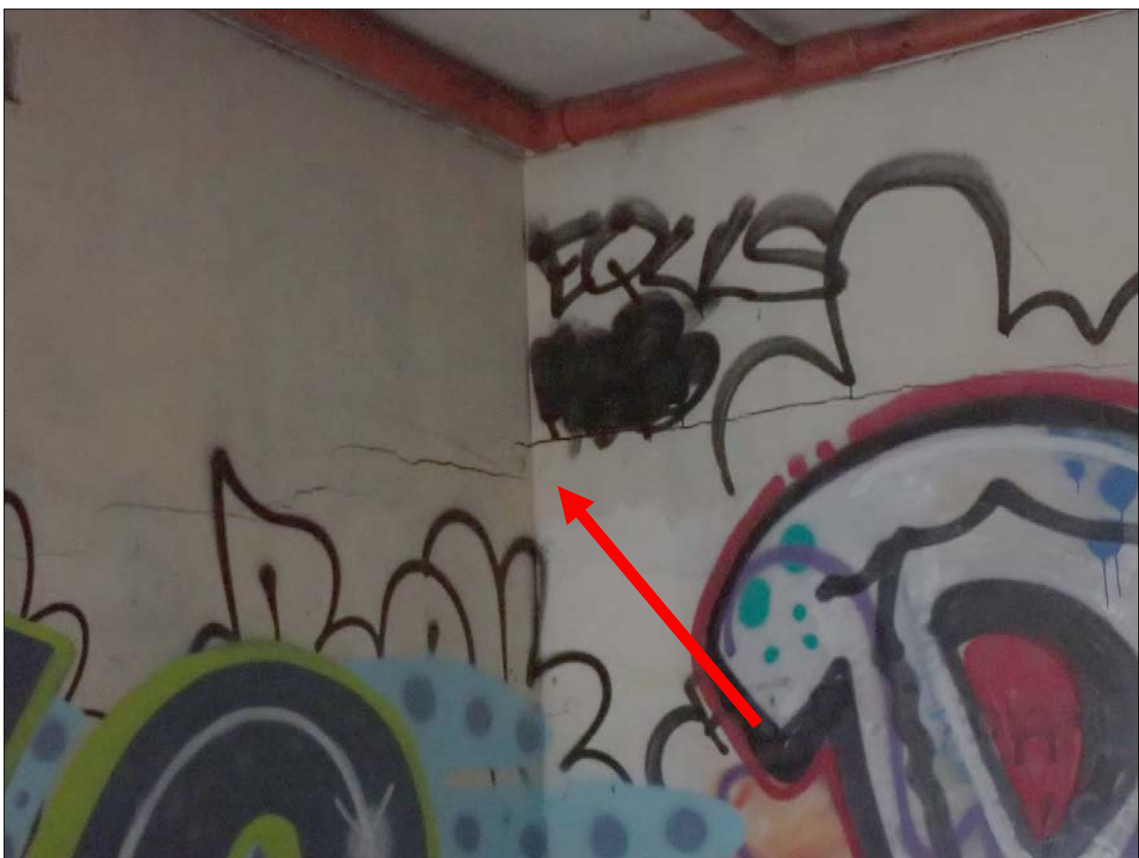
Figure 109. Feature 4: Magazine 4. Interior – Typical horizontal corner crack indicated.

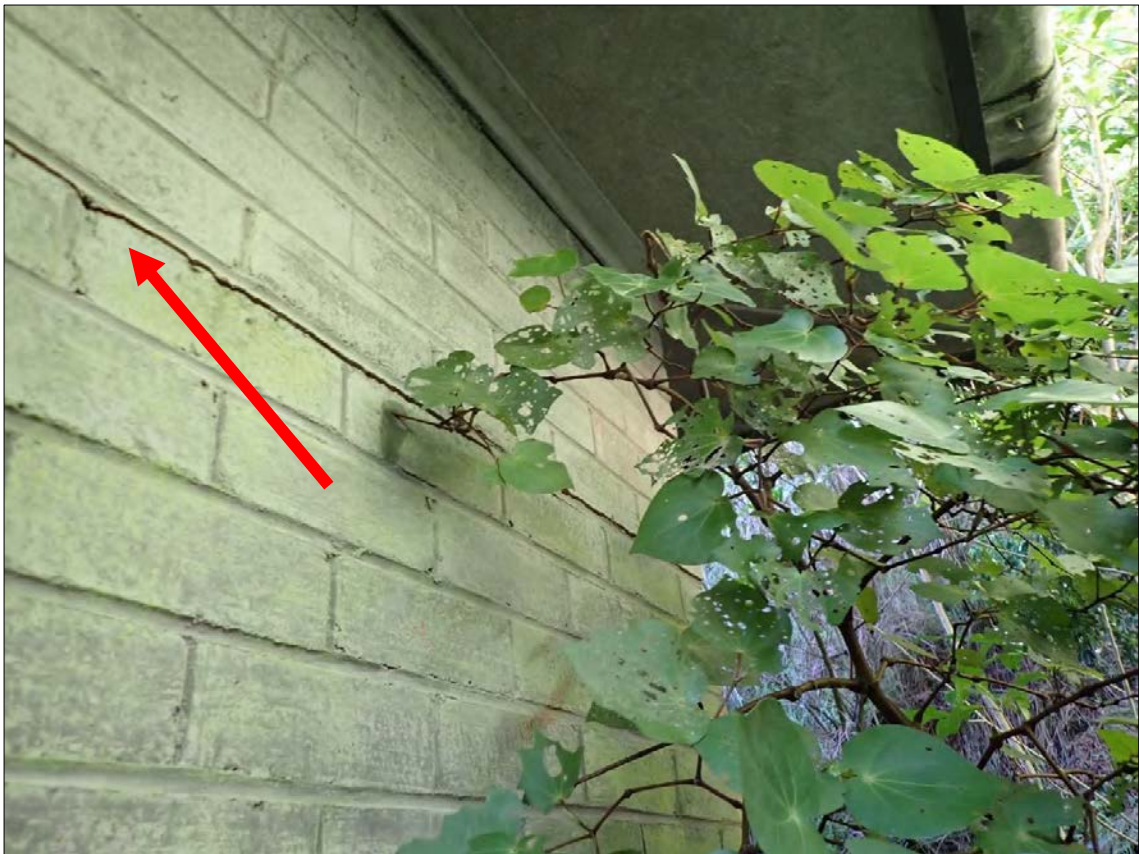
Figure 113. Feature 5: Magazine 5. Eastern (rear) elevation. Typical horizontal corner crack is indicated. Possible anti-graffiti coating.

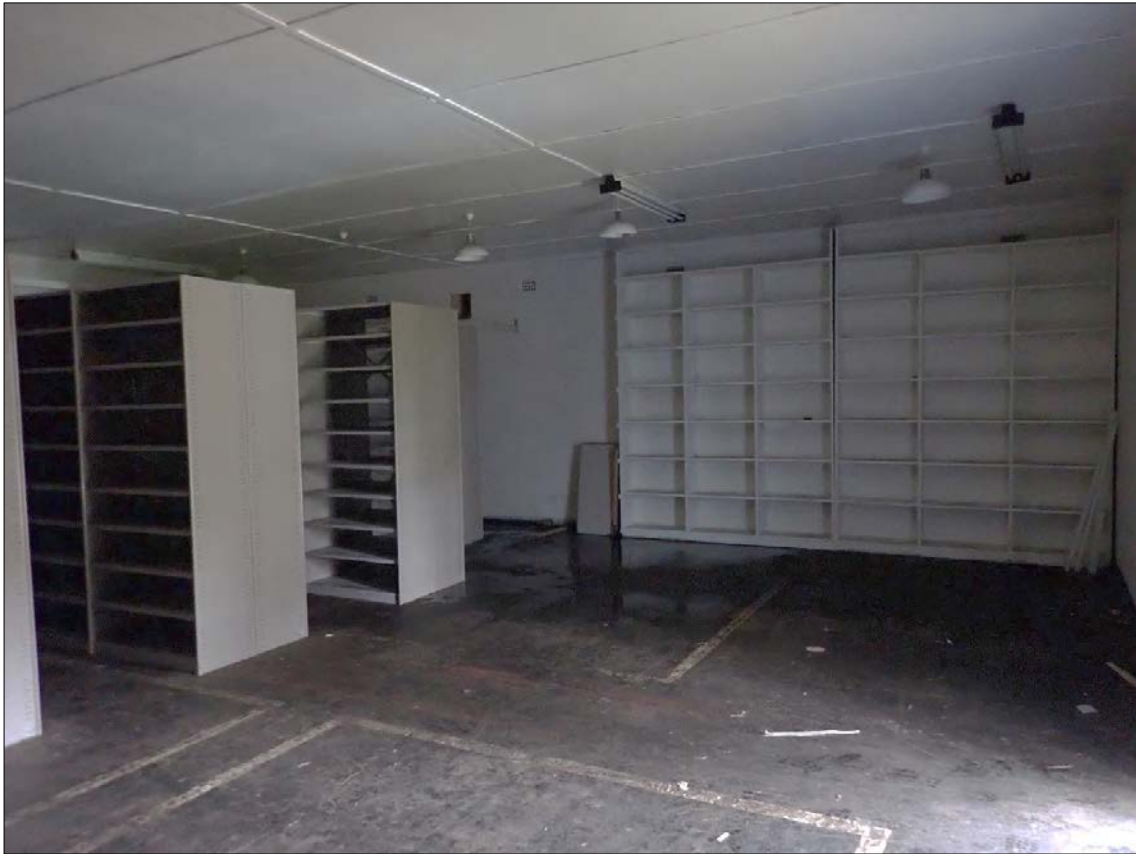
Figure 114. Feature 5: Magazine 5. Interior – Water is entering the structure and some material goods associated with the most recent occupation remain within the structure.

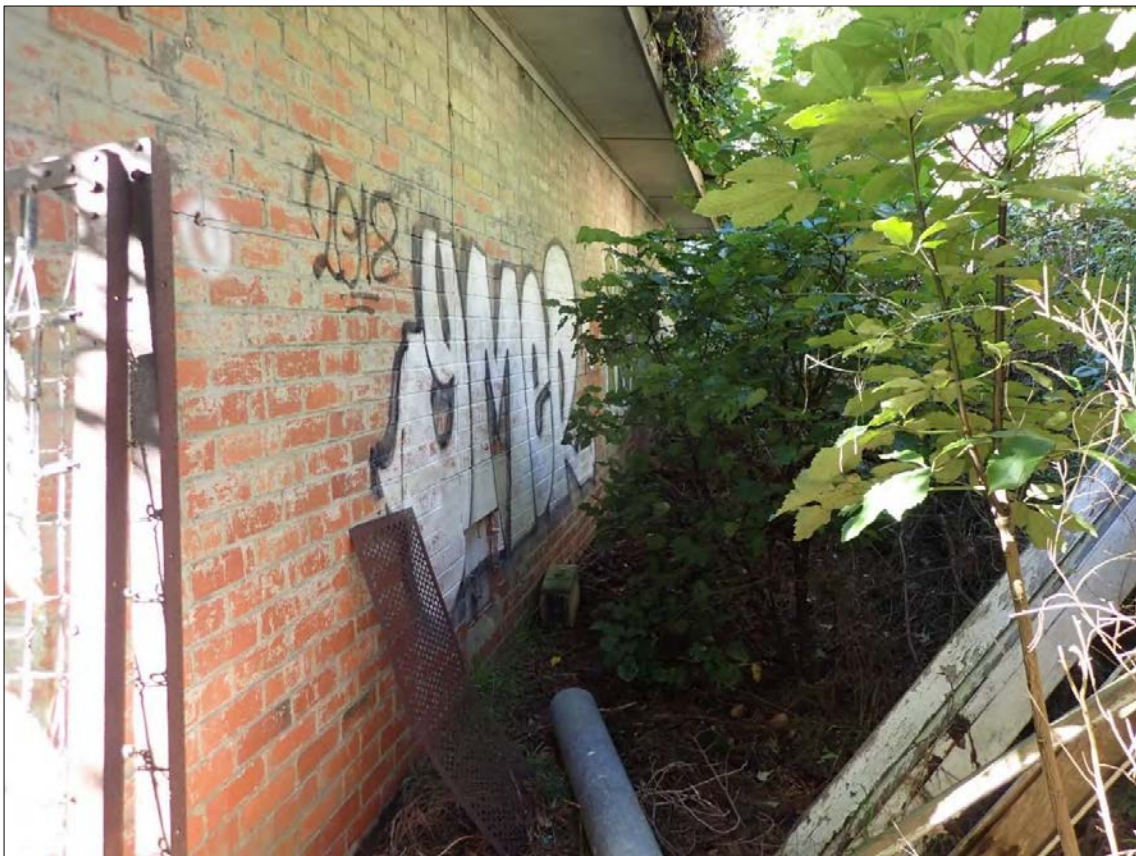
Figure 118. Feature 6: Magazine 6. Looking along the southwestern (side) elevation. Debris has accumulated against the structure. Graffiti is present.

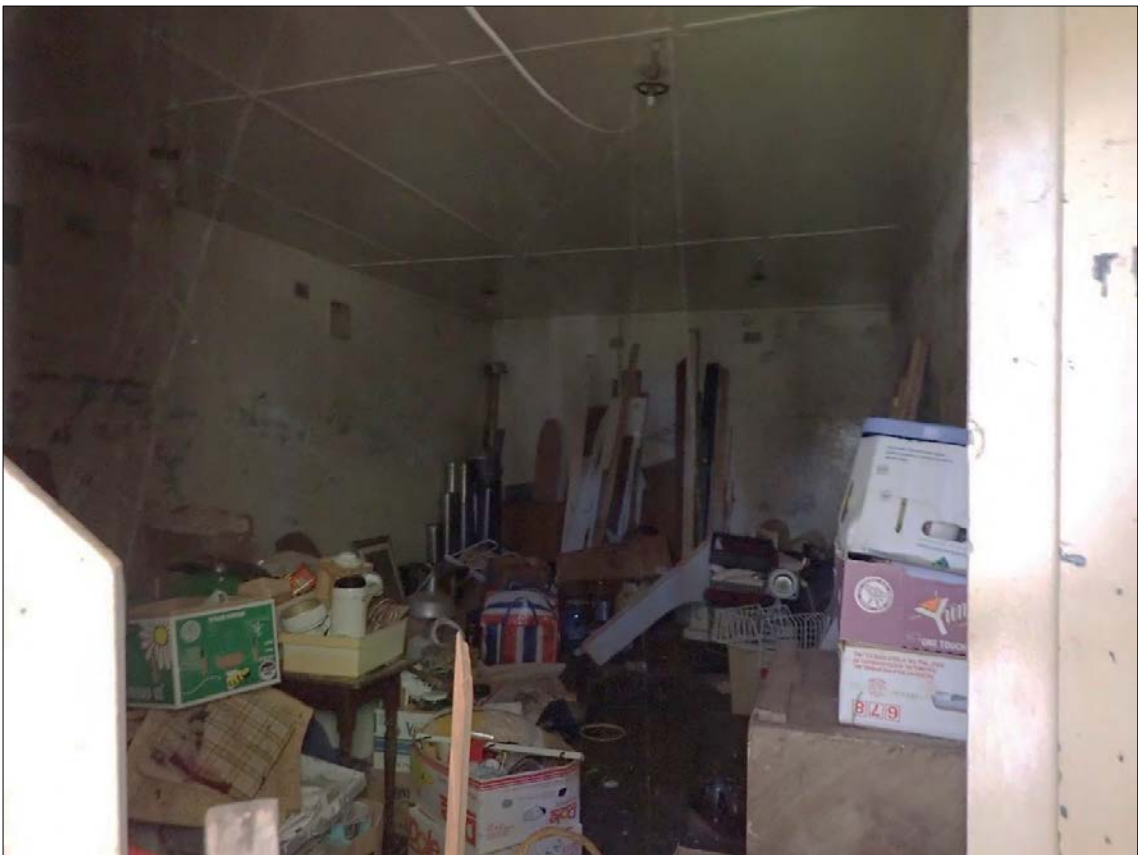
Figure 122. Feature 6: Magazine 6. Interior – Water penetration is evident. Some material goods remain within the structure.

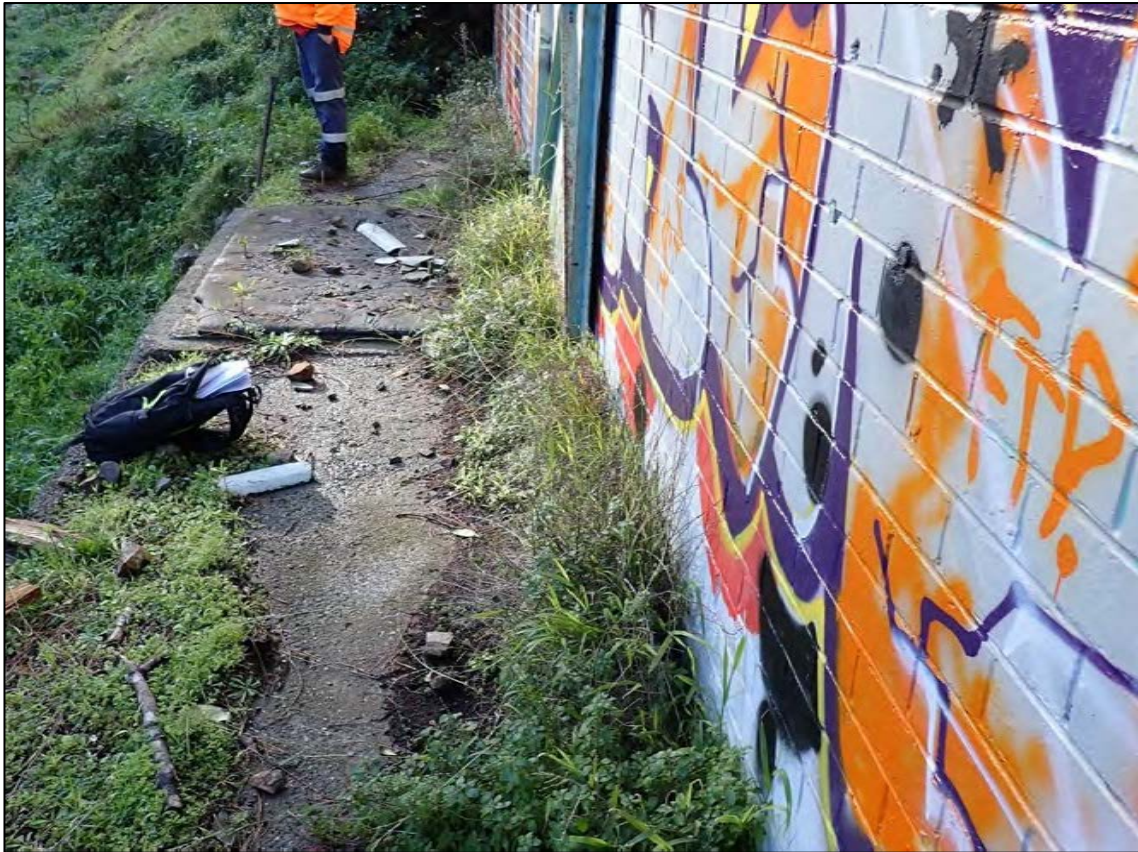
Figure 125. Feature 7: Magazine 7. Looking along the northern (front) elevation – cropped image. Vegetation is starting to ‘colonise’ the cracked loading deck.

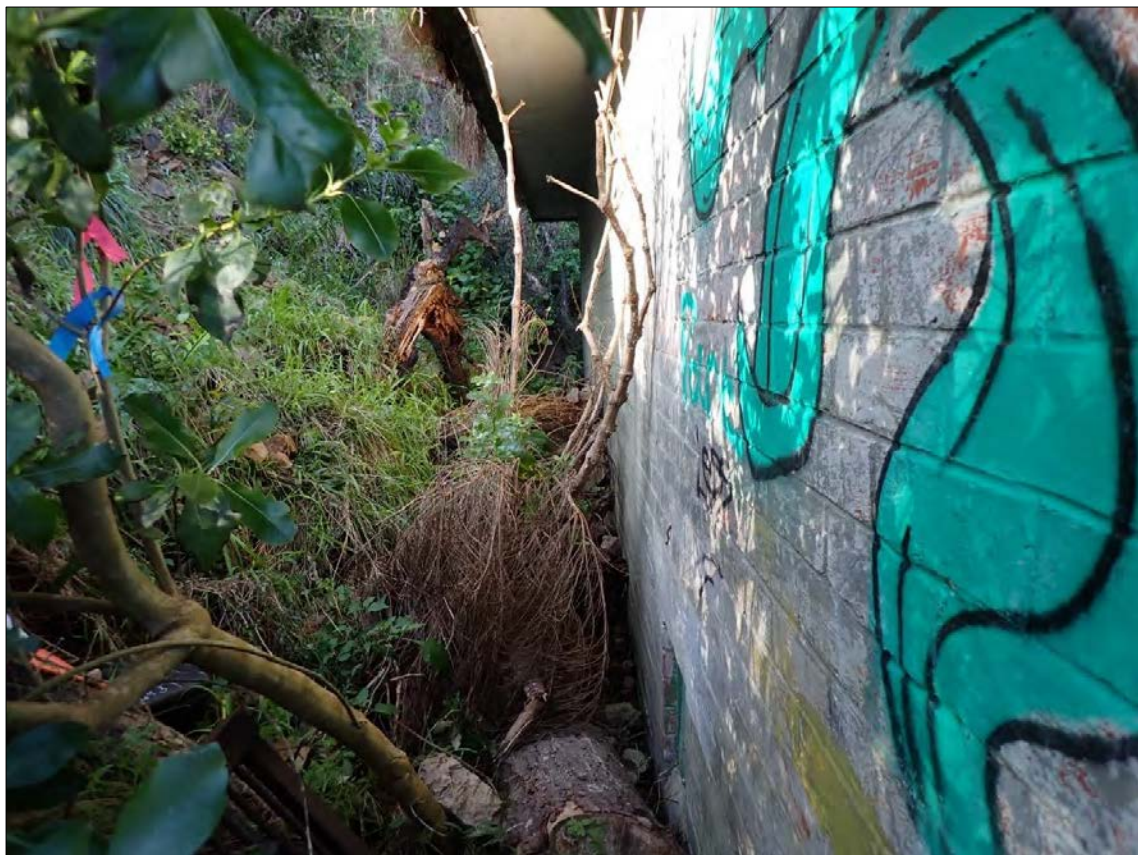
Figure 126. Feature 7: Magazine 7. Looking along the eastern (side) elevation. Vegetation and debris are accumulating against the side of the structure.

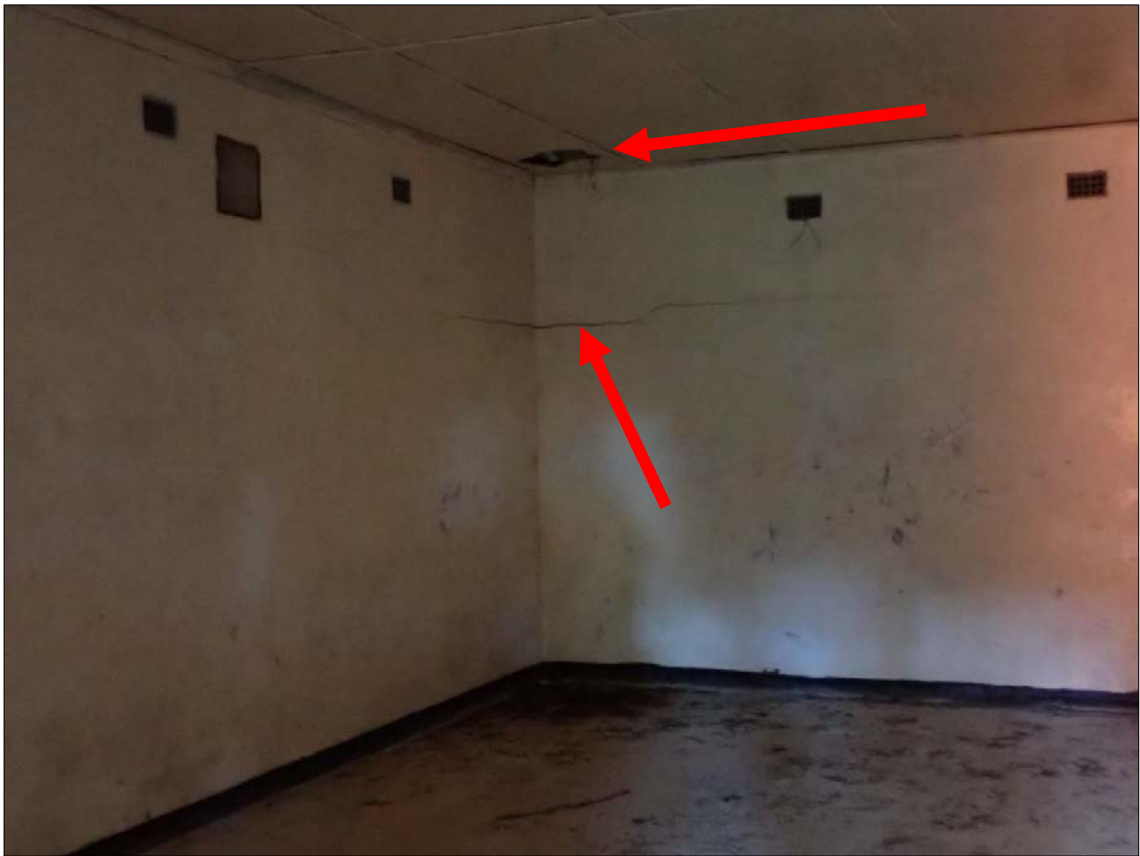
Figure 127. Feature 7: Magazine 7. Interior – typical horizontal corner crack indicated. Ceiling is failing in places.

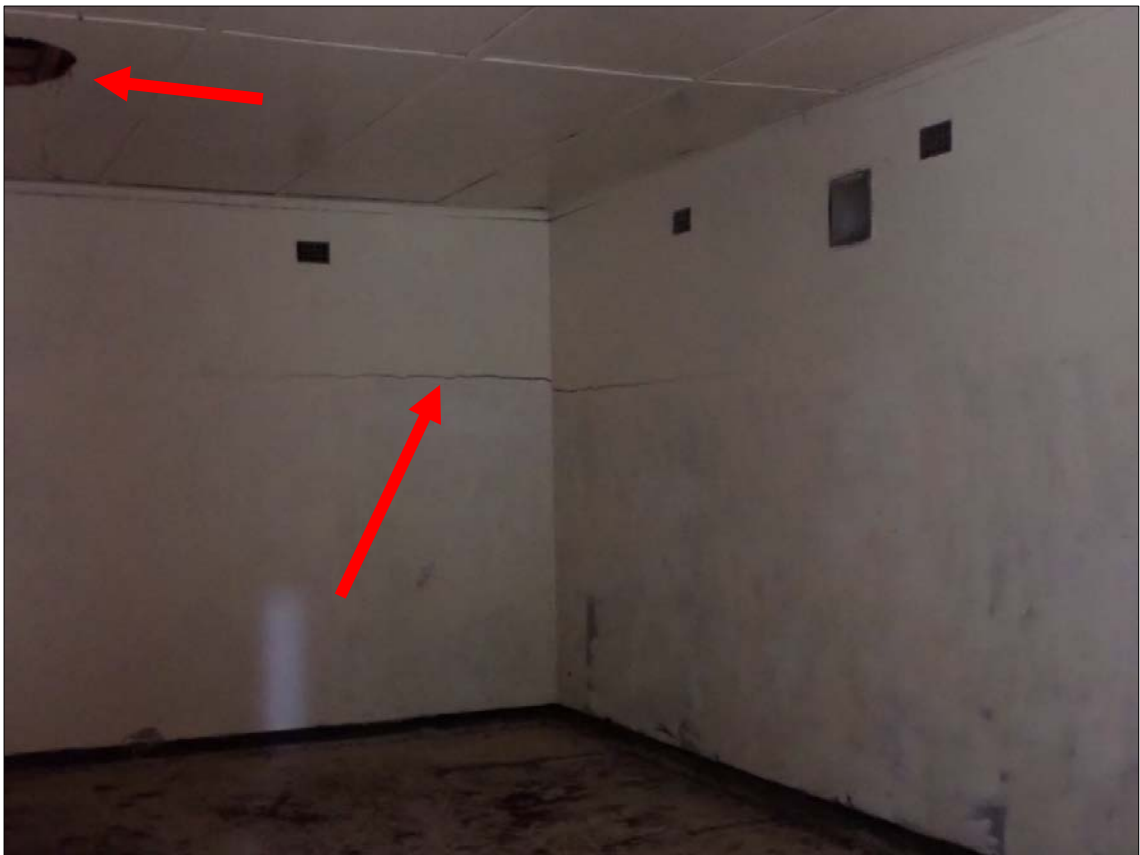
Figure 128. Feature 7: Magazine 7. Interior – typical horizontal corner crack indicated. Ceiling is failing in places.

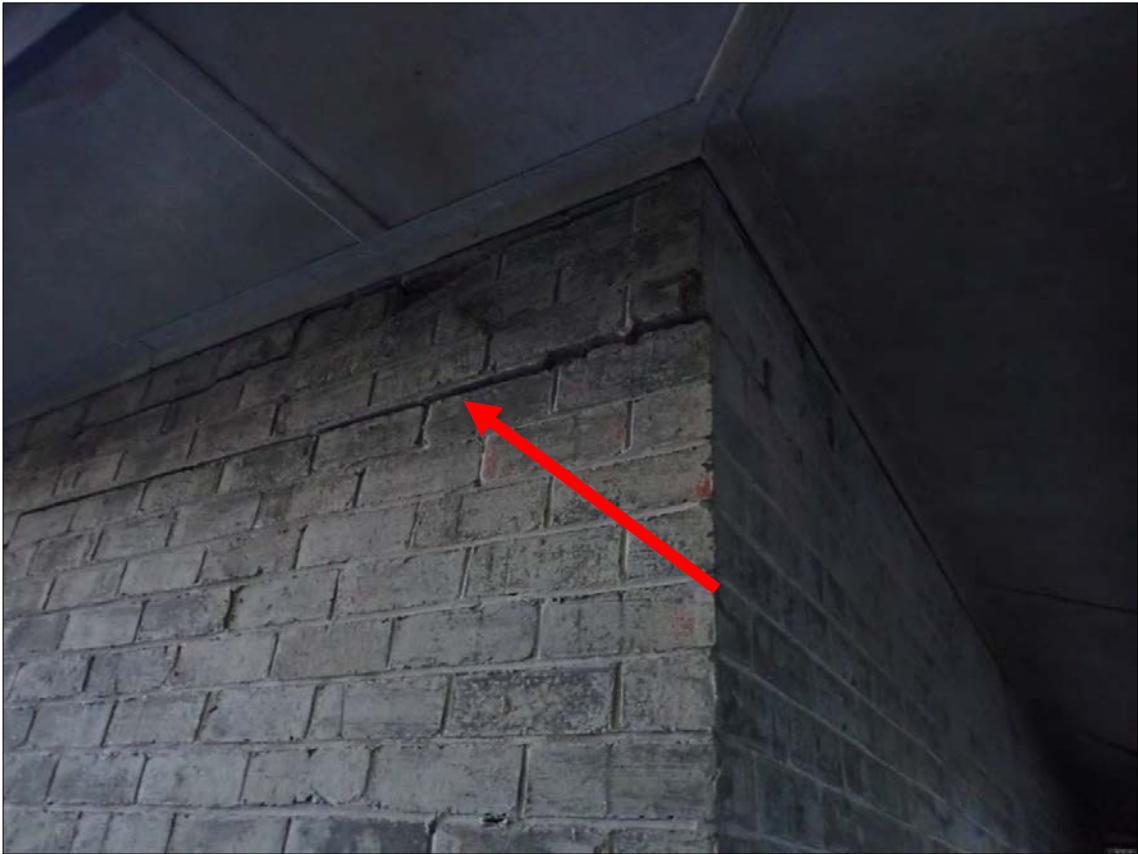
Figure 133. Feature 8: Magazine 8. Looking at the southeastern (rear) corner. A typical horizontal crack is indicated.

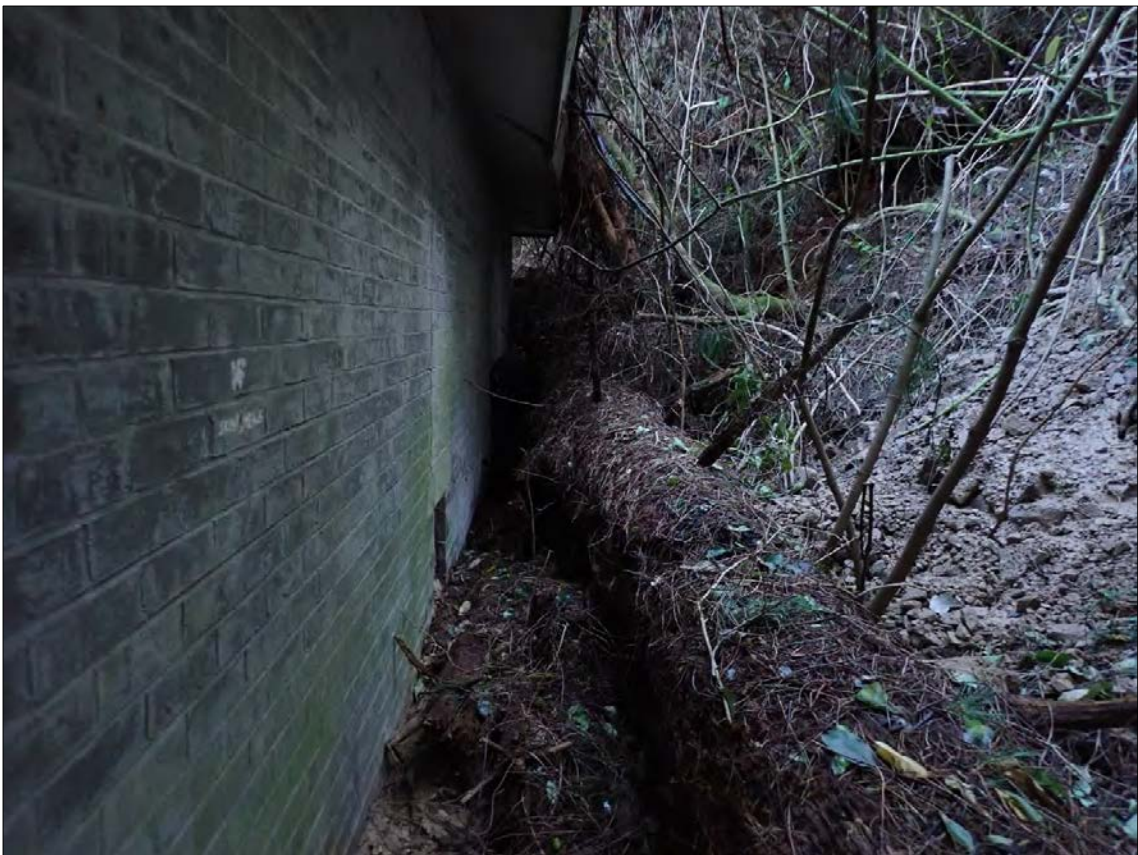
Figure 134. Feature 8: Magazine 8. Looking along the eastern (rear) elevation. A slip has occurred, and vegetation and debris are accumulating against the side of the structure.

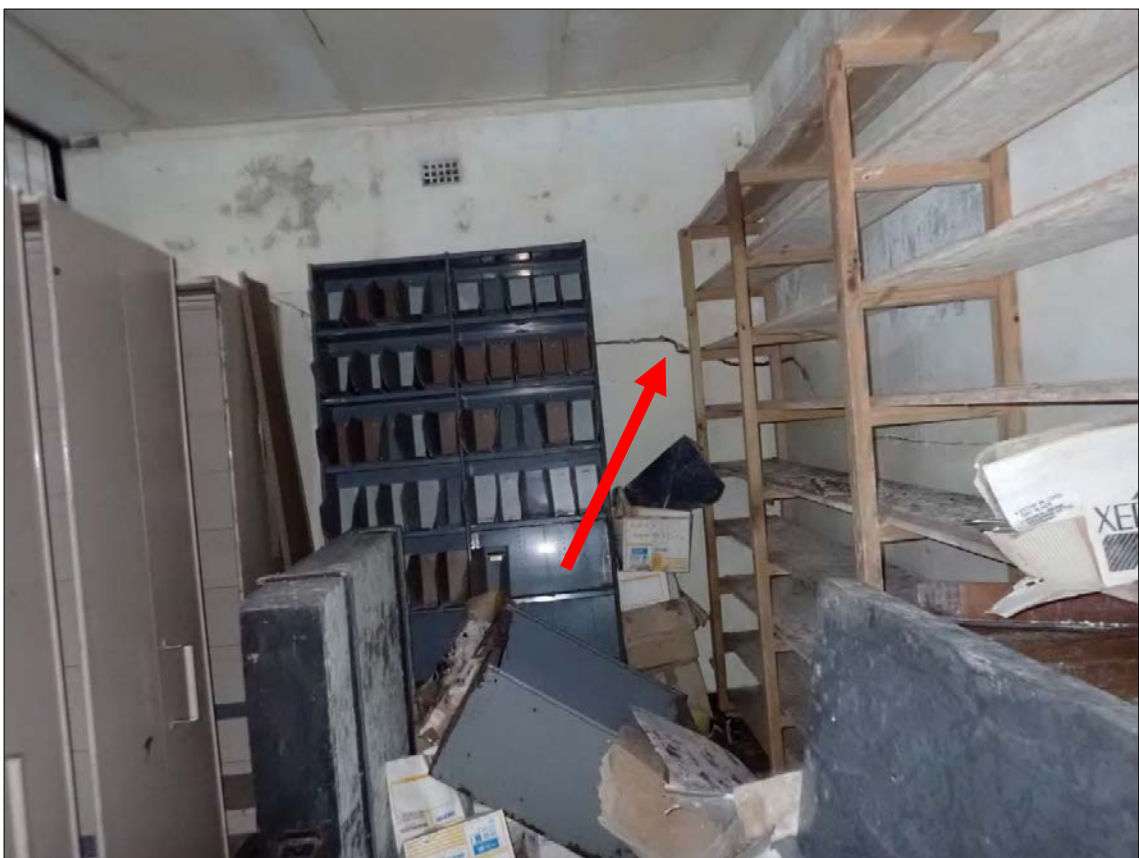
Figure 136. Feature 8: Magazine 8 Interior – Substantial horizontal corner crack indicated. Some material goods associated with the most recent use remain within the structure.

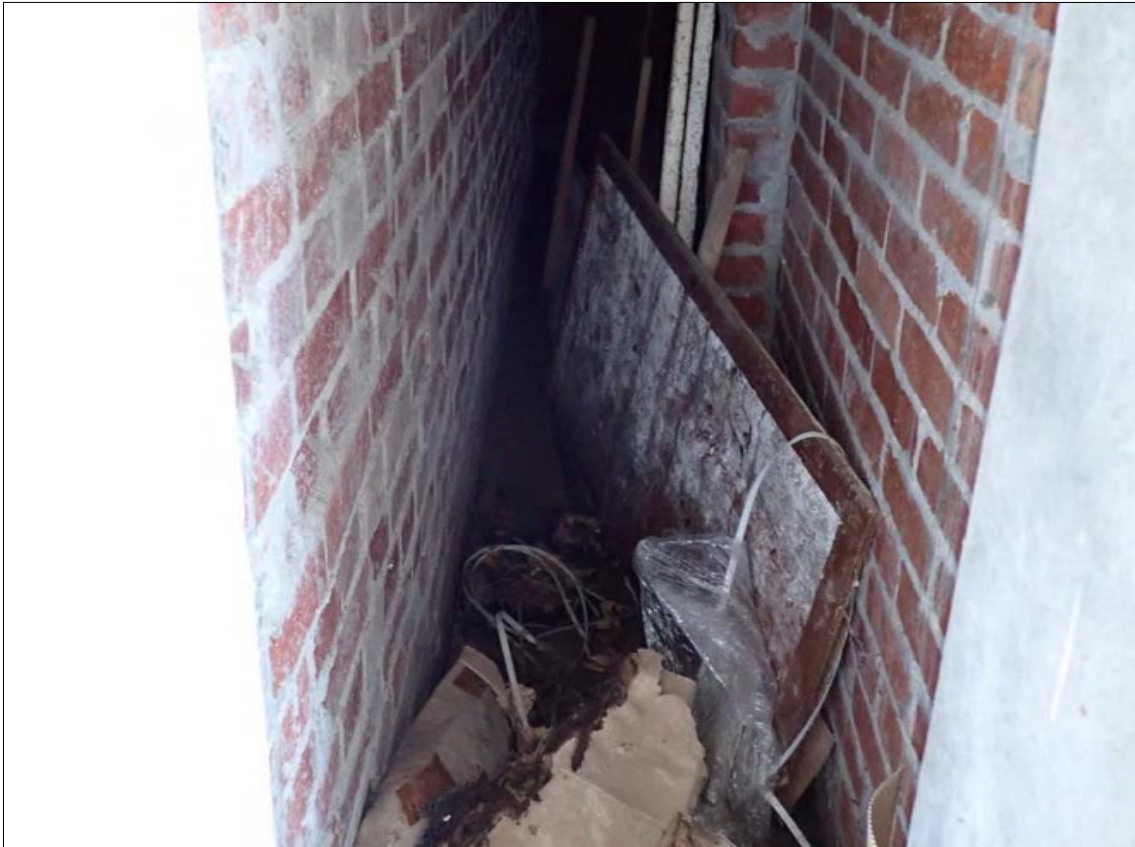
Figure 139. Feature 8: Magazine 8 Interior – Typical debris accumulation in the narrow passageway between the outer wall and the inner room – image cropped.

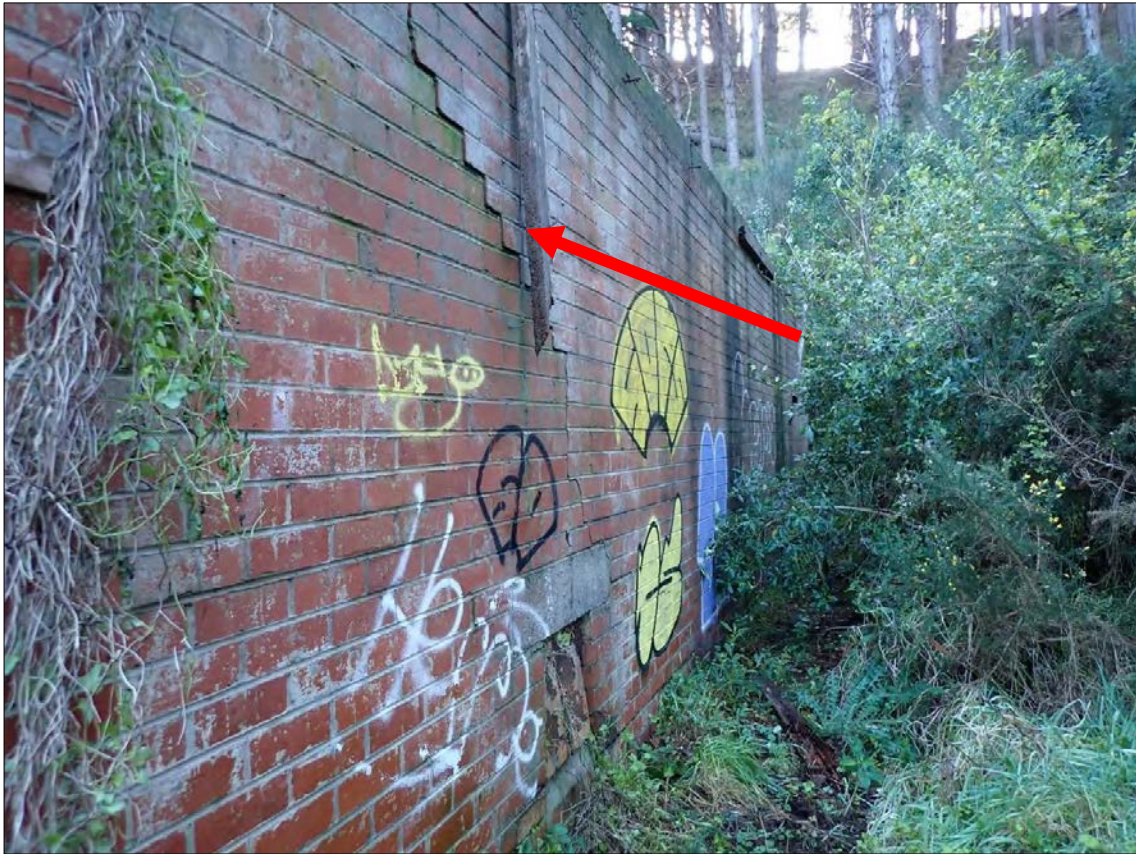
Figure 144. Feature 9: Magazine 9. Looking along the southern (side) elevation. Graffiti is present. Diagonal crack associated with horizontal cracking is indicated. Vegetation and debris have accumulated against the side of the structure.

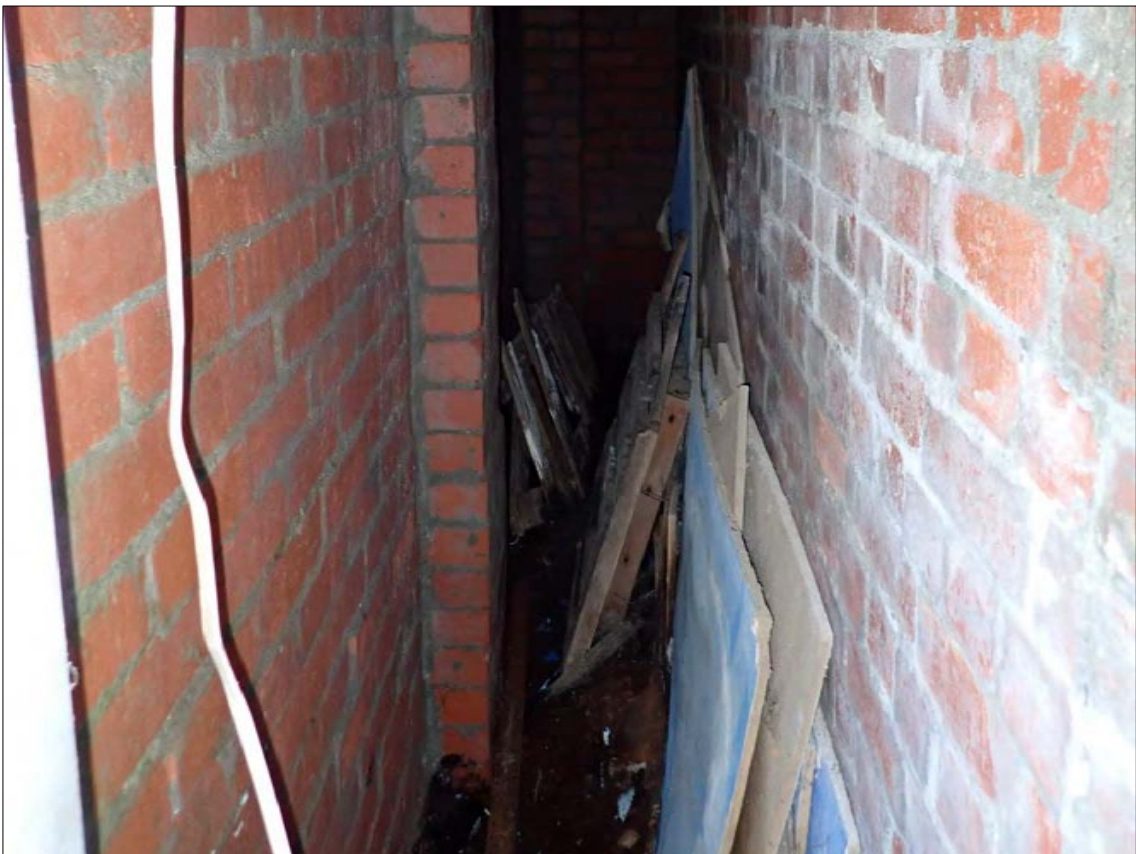
Figure 145: Feature 9: Magazine 9. Interior – Typical debris accumulation in the narrow passageway between the outer wall and the inner room – image cropped.

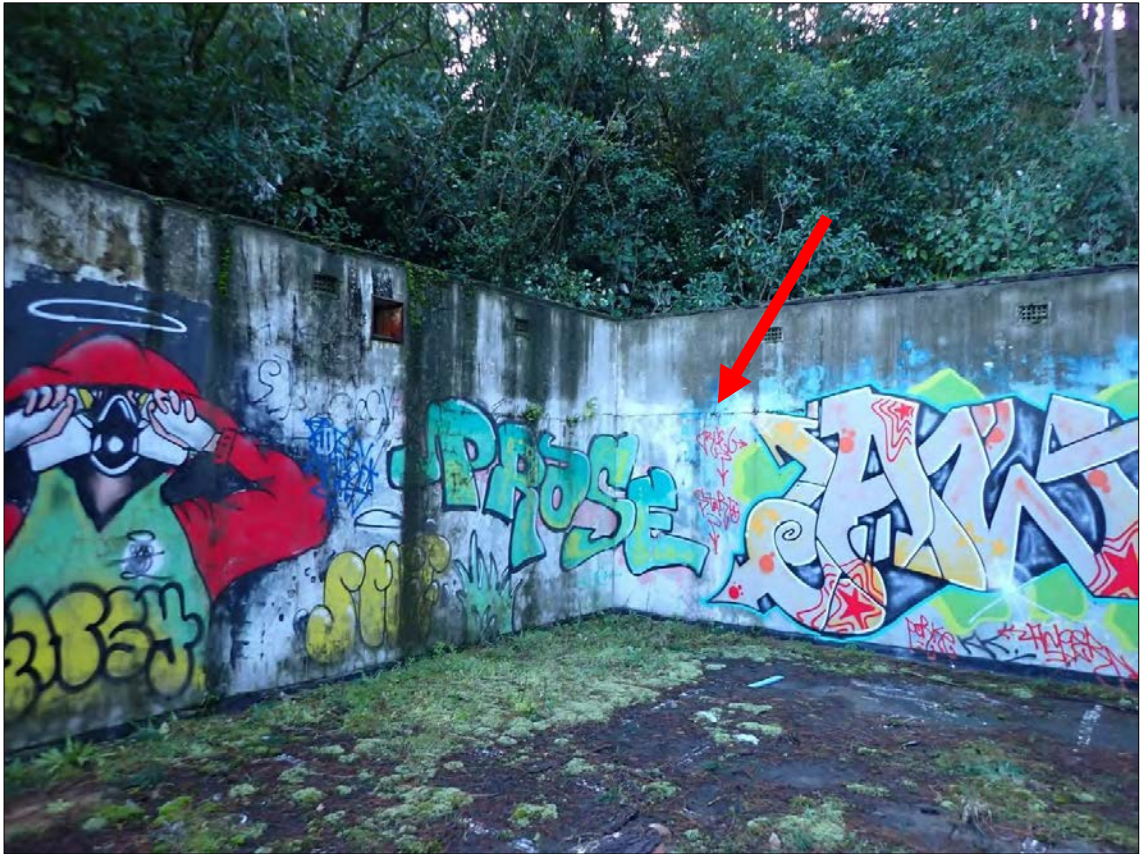
Figure 146. Feature 9: Magazine 9. Interior – Typical horizontal cracking to corners is indicated. Graffiti is present.

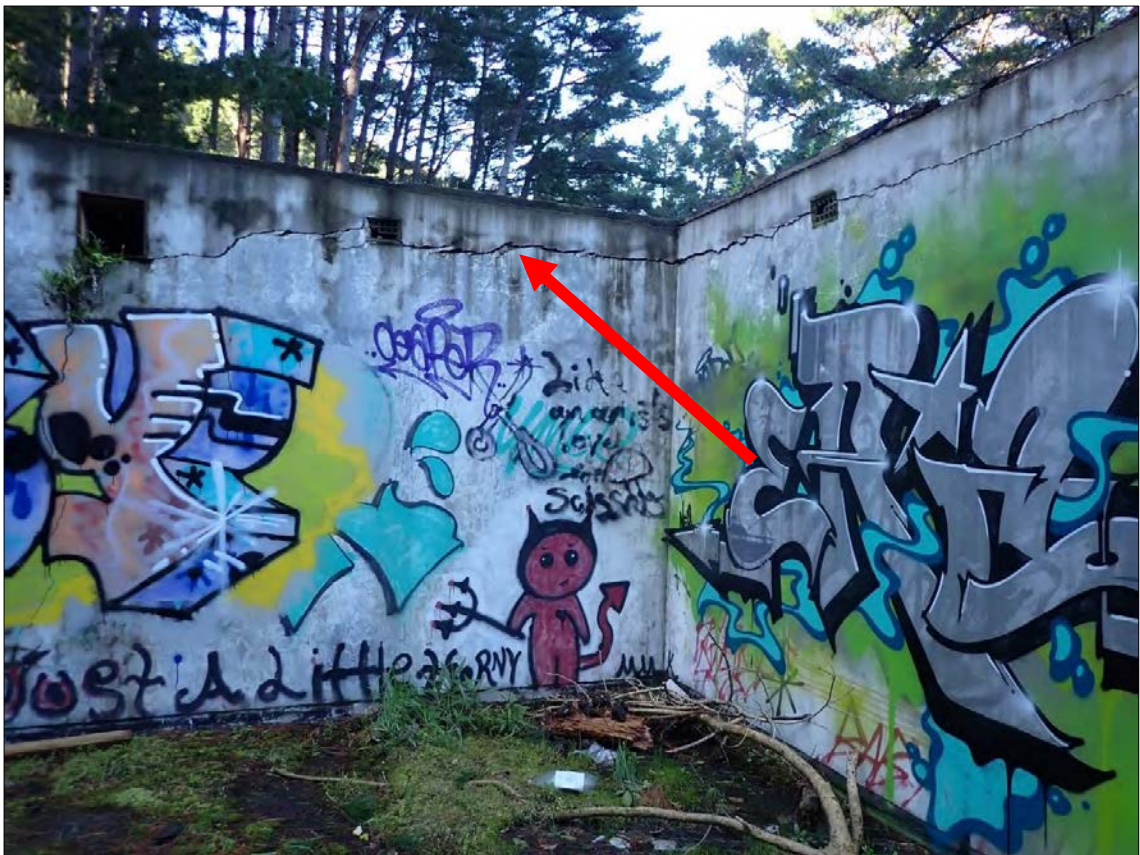
Figure 147. Feature 9: Magazine 9. Interior – Typical horizontal cracking to corners is indicated. Graffiti is present.
