Watts Peninsula, Wellington

Heritage and condition assessment

Report Prepared for Toitū Te Whenua Land Information New Zealand

Submitted: December 2022

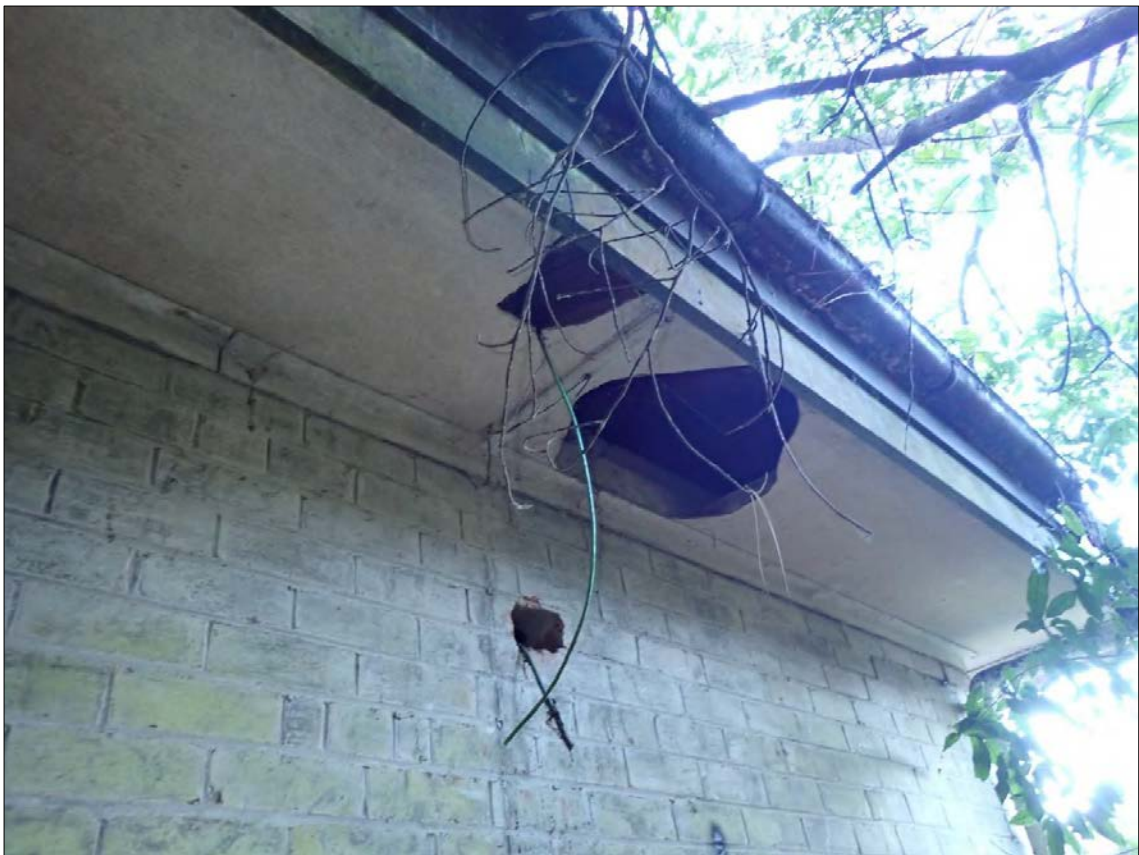
Figure 151. Feature 10: Magazine 10. Northern (side) elevation. Underside eaves is damaged.

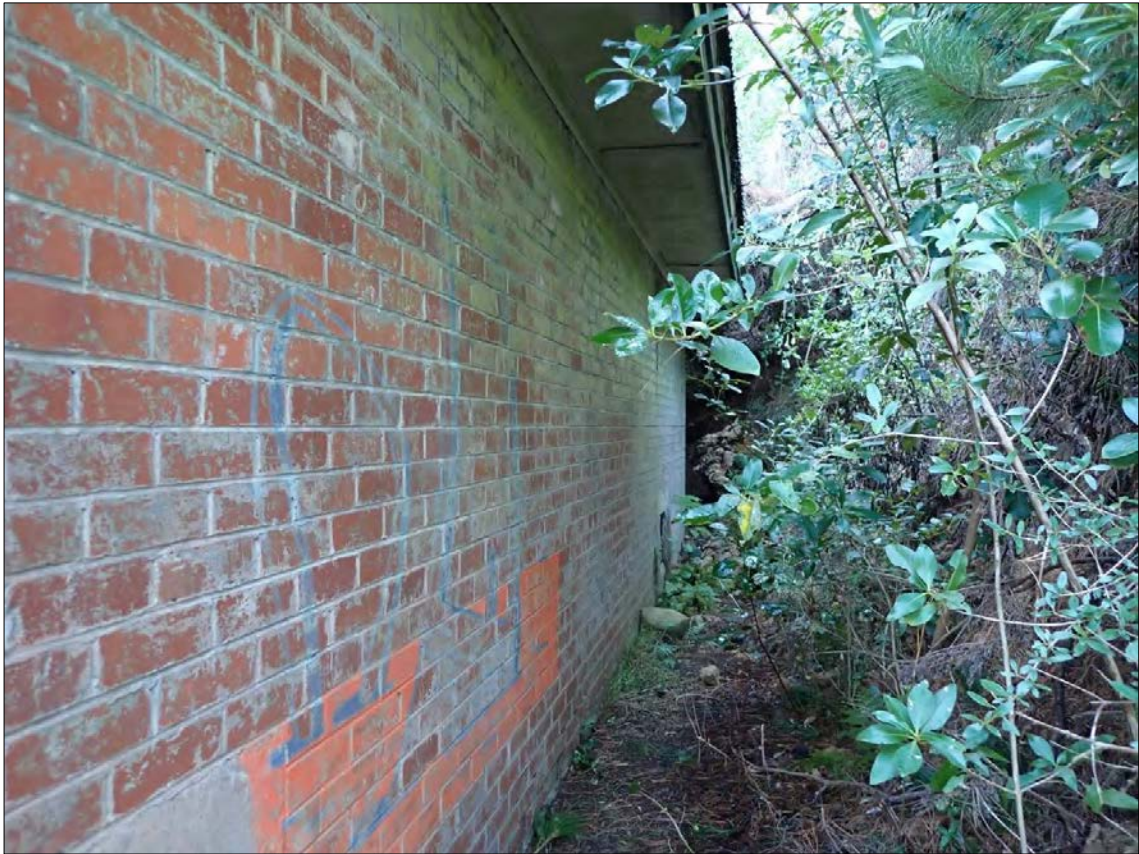
Figure 152. Feature 10: Magazine 10. Looking along the southern (side) elevation. Graffiti is present and a slip has occurred to the rear.

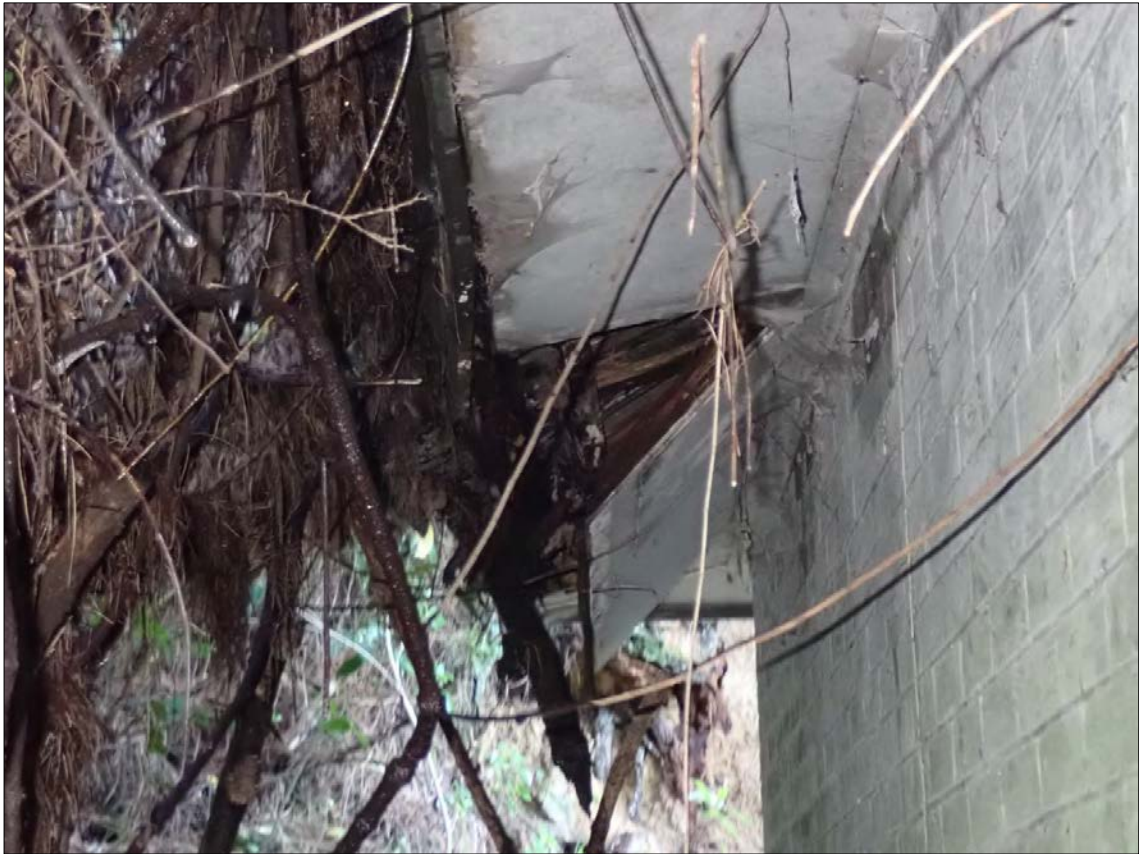
Figure 154. Feature 10: Magazine 10. Looking along the eastern (rear) elevation. The underside eaves is damaged.

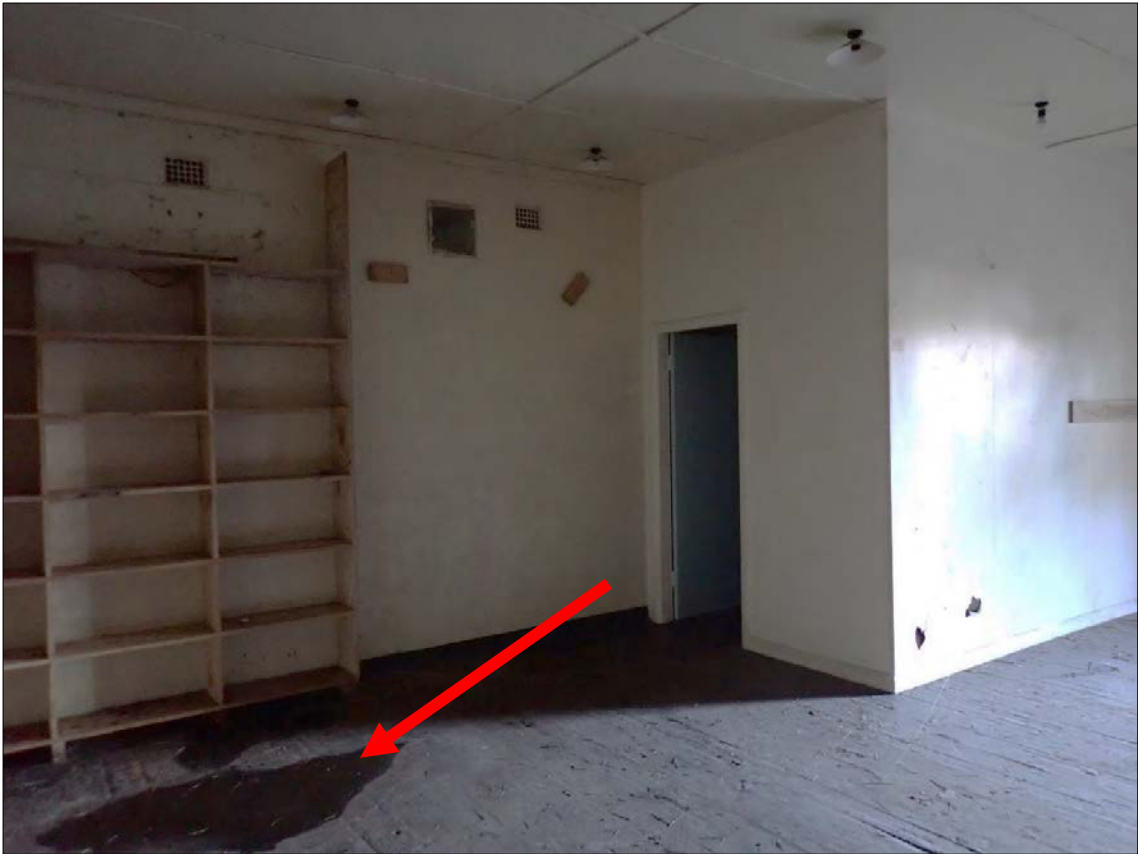
Figure 157. Feature 10: Magazine 10. Interior – Water is entering the structure.

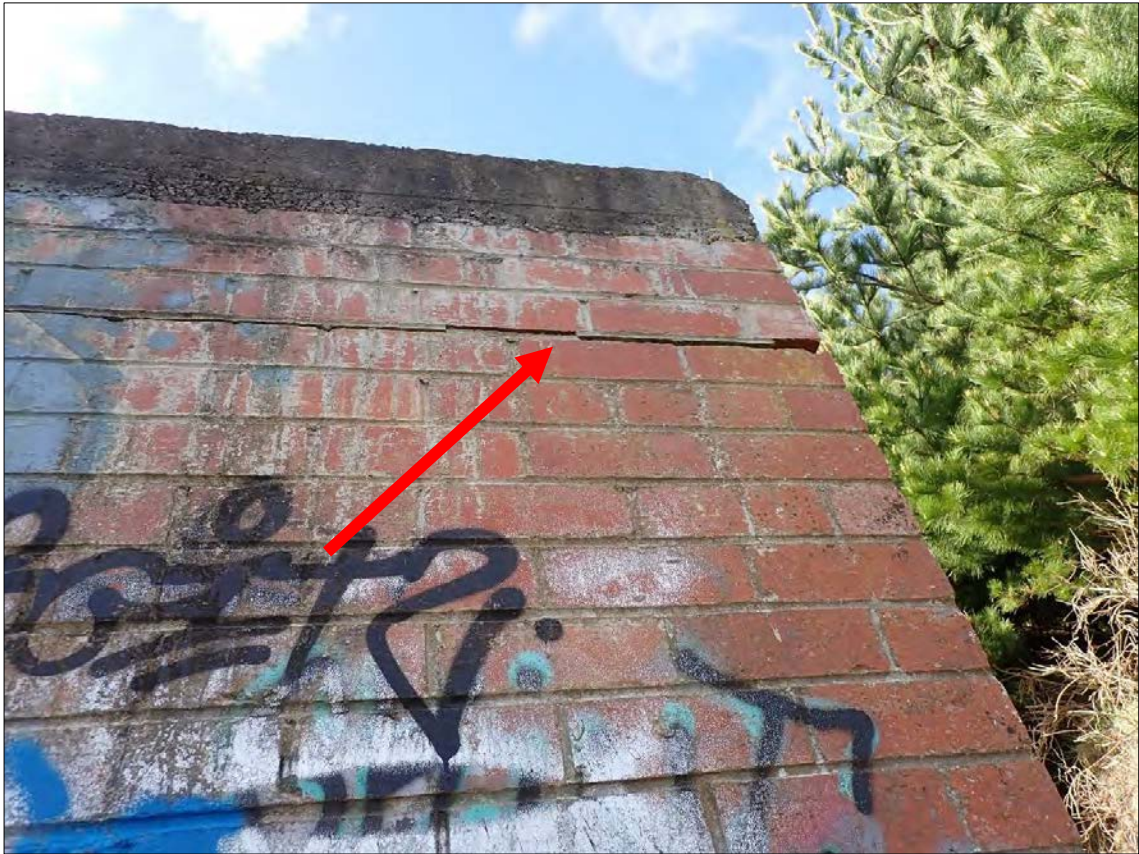
Figure 173. Feature 14: Magazine 11. Typical horizontal crack is evident at the corner of the western (front) elevation.

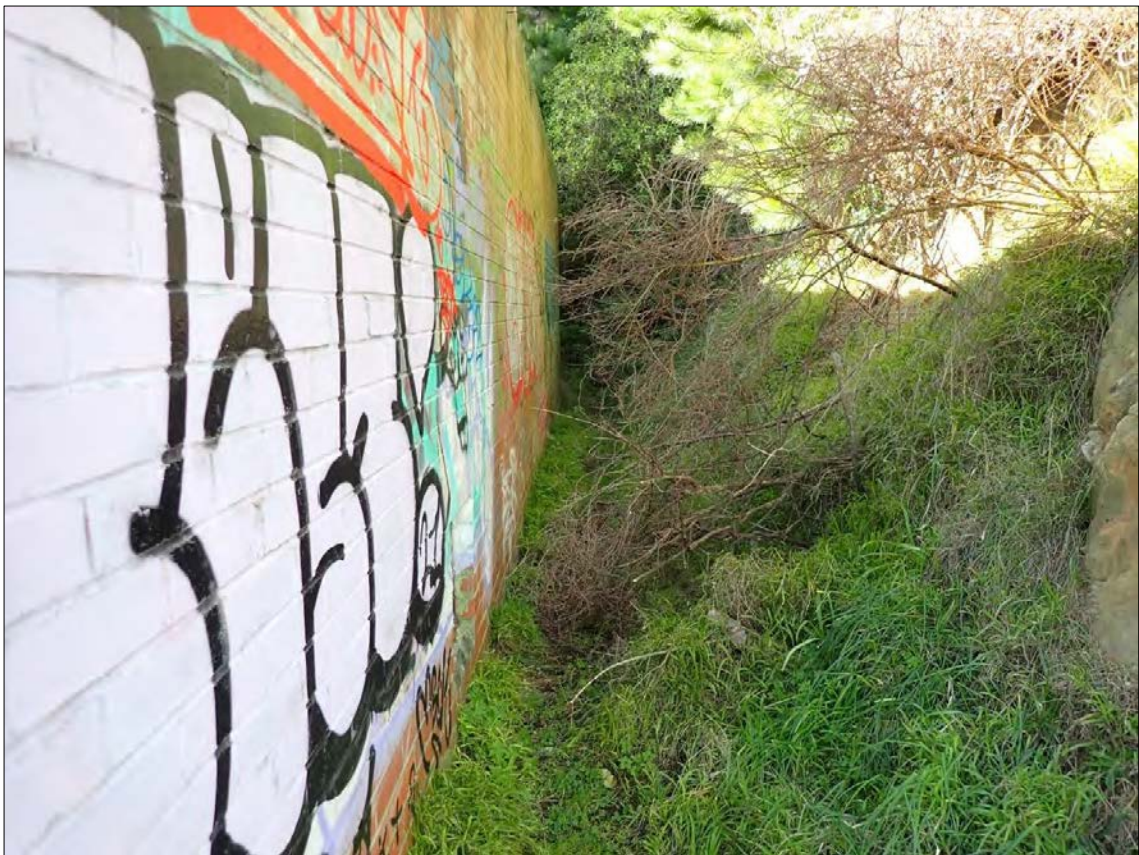
Figure 174. Feature 14: Magazine 11. Looking along the southern (side) elevation. Vegetation is accumulating against the side of the structure.

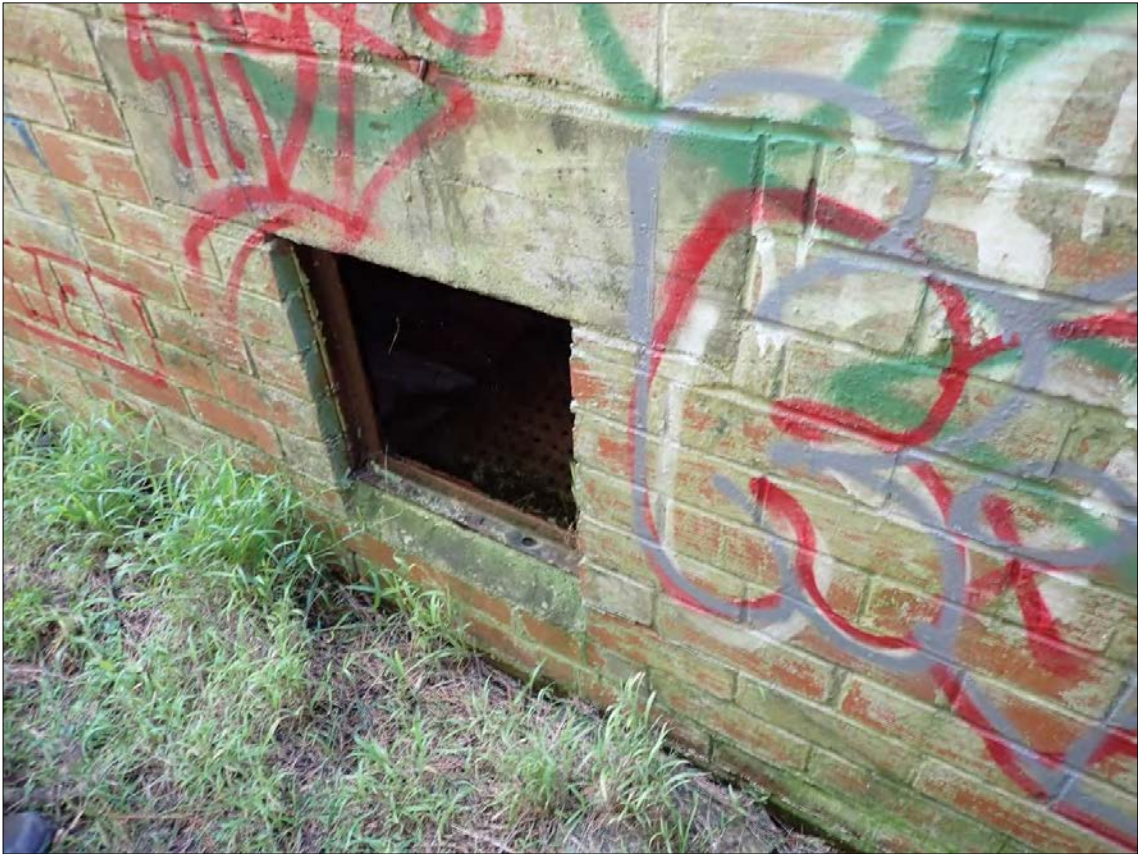
Figure 175. Feature 14: Magazine 11. Looking along the southern (side) elevation. Vent cover to passage between inner and outer wall of structure is missing.

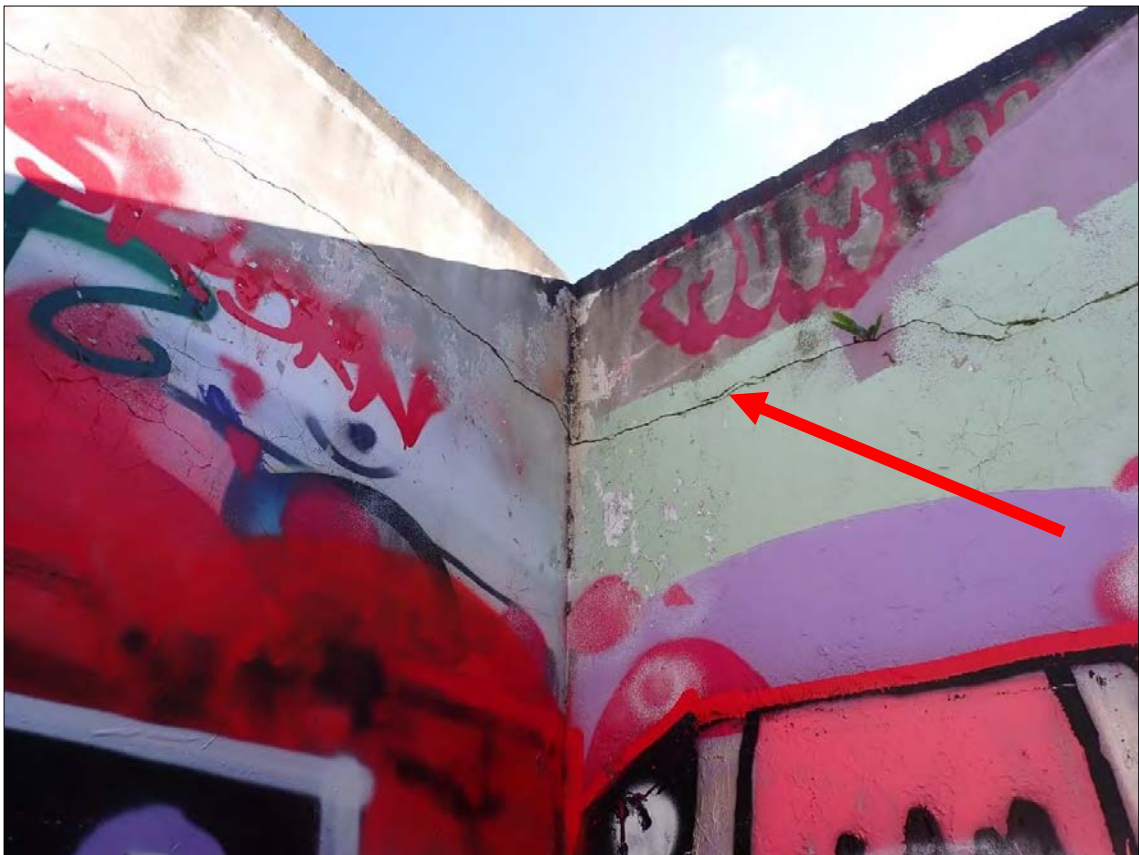
Figure 182. Feature 14: Magazine 11. Interior – Typical horizontal cracking to corners is indicated.

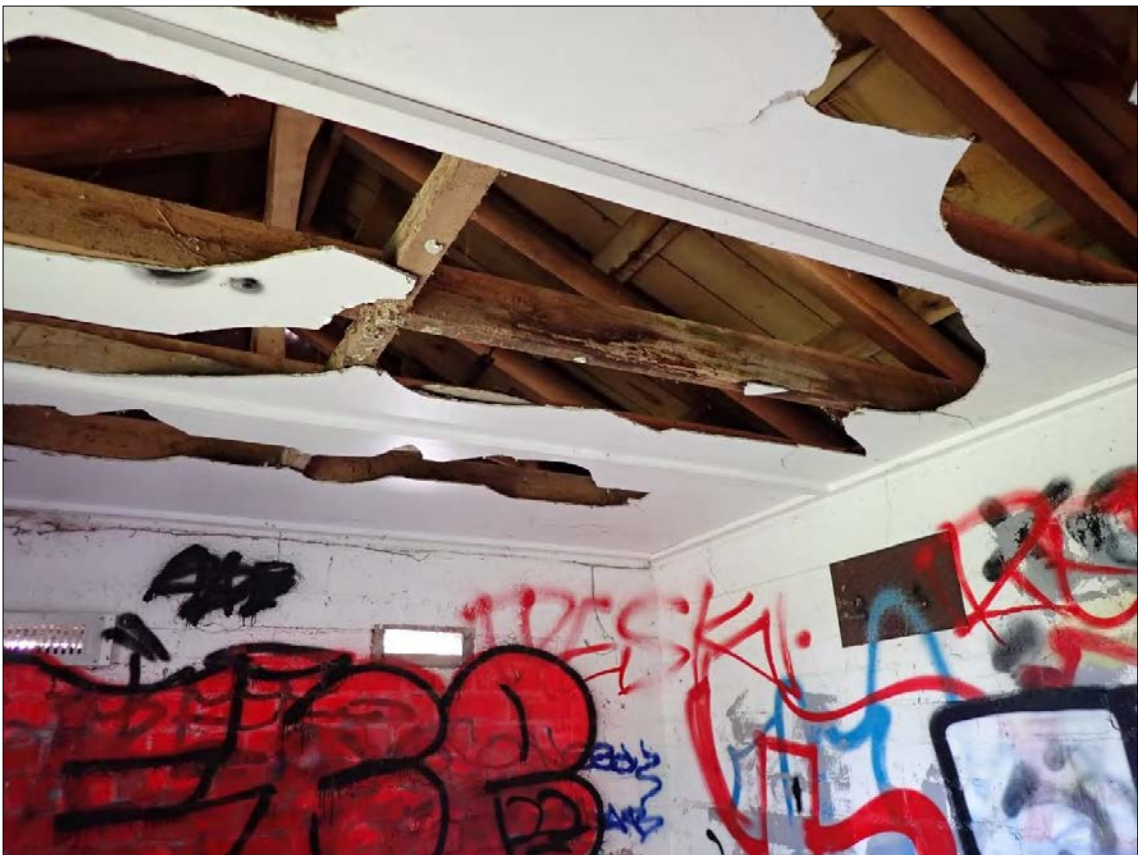
Figure 190. Feature 16: Arms store. Interior – Ceiling has been damaged. Graffiti is present.

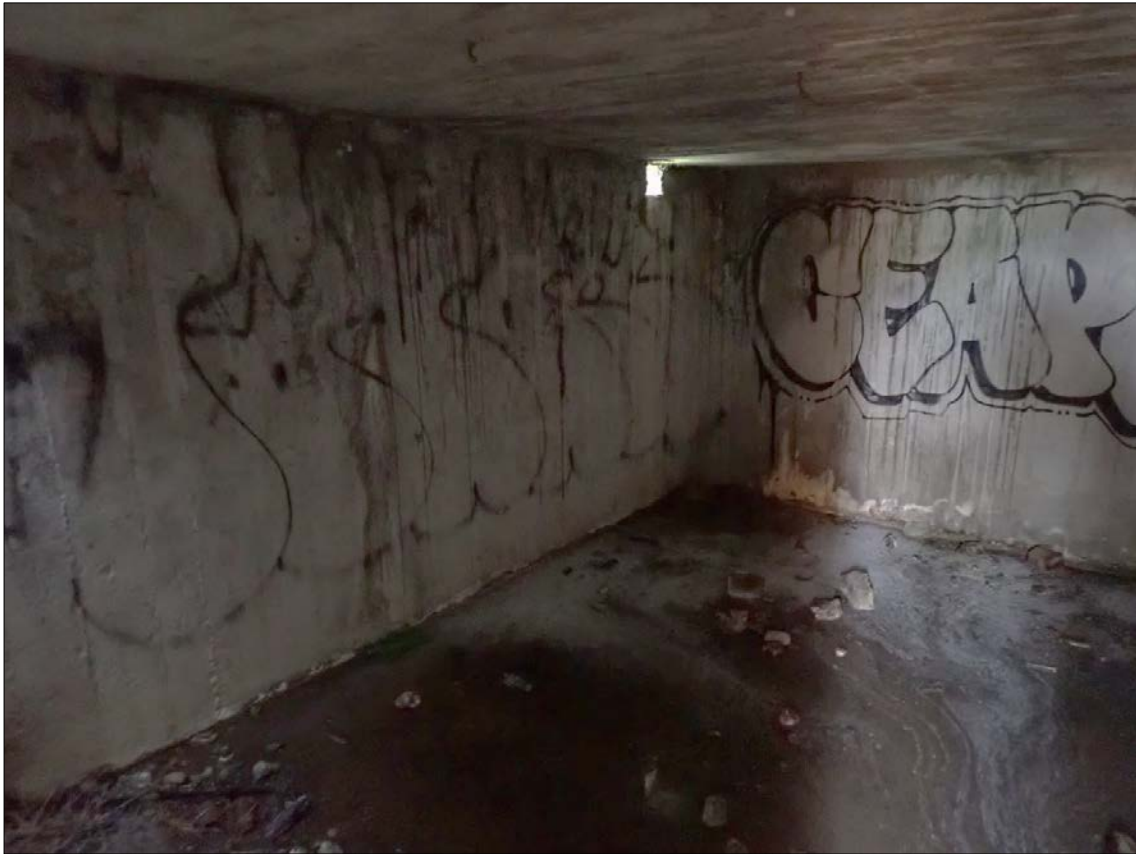
Figure 223. Feature 22: Mount Crawford Anti-Aircraft Battery gun emplacement. typical example of a chamber interior. Water is visible in a number of chambers. Graffiti is present.

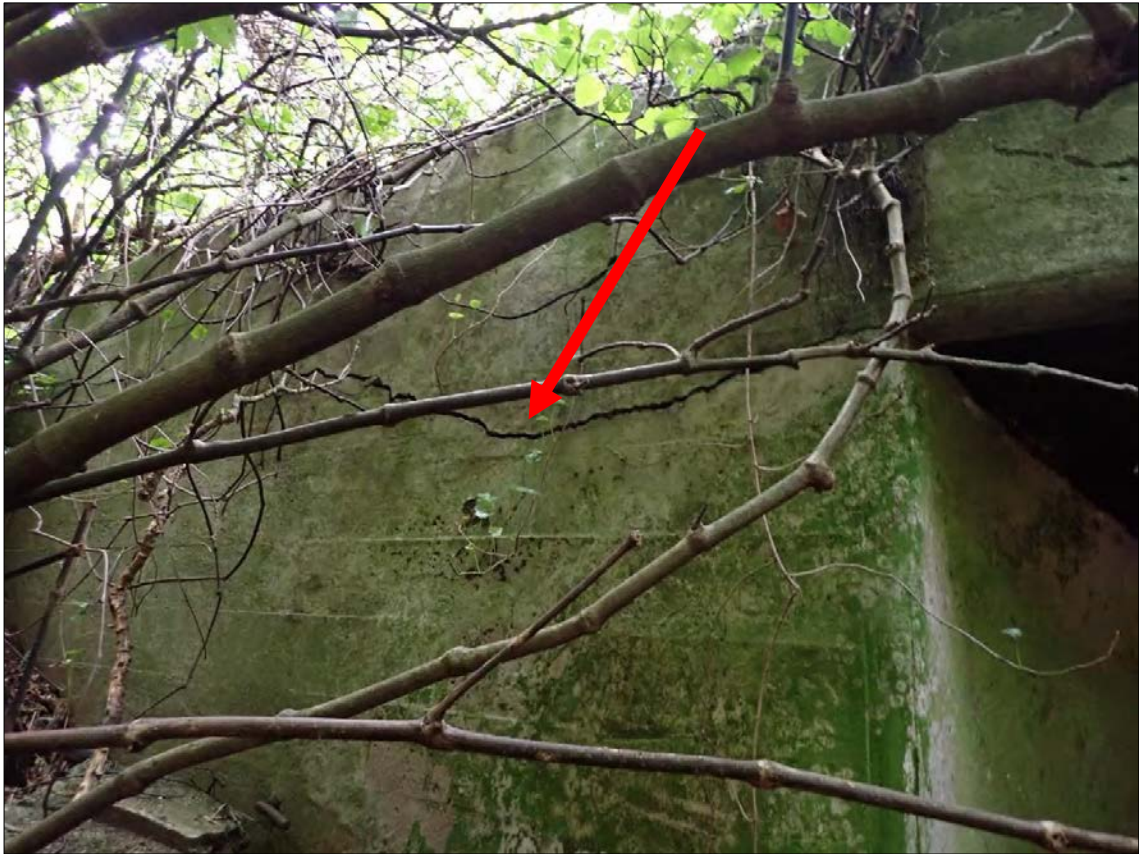
Figure 232, Feature 25: Fort Ballance. Cracking adjacent to opening at see-saw searchlight structure.

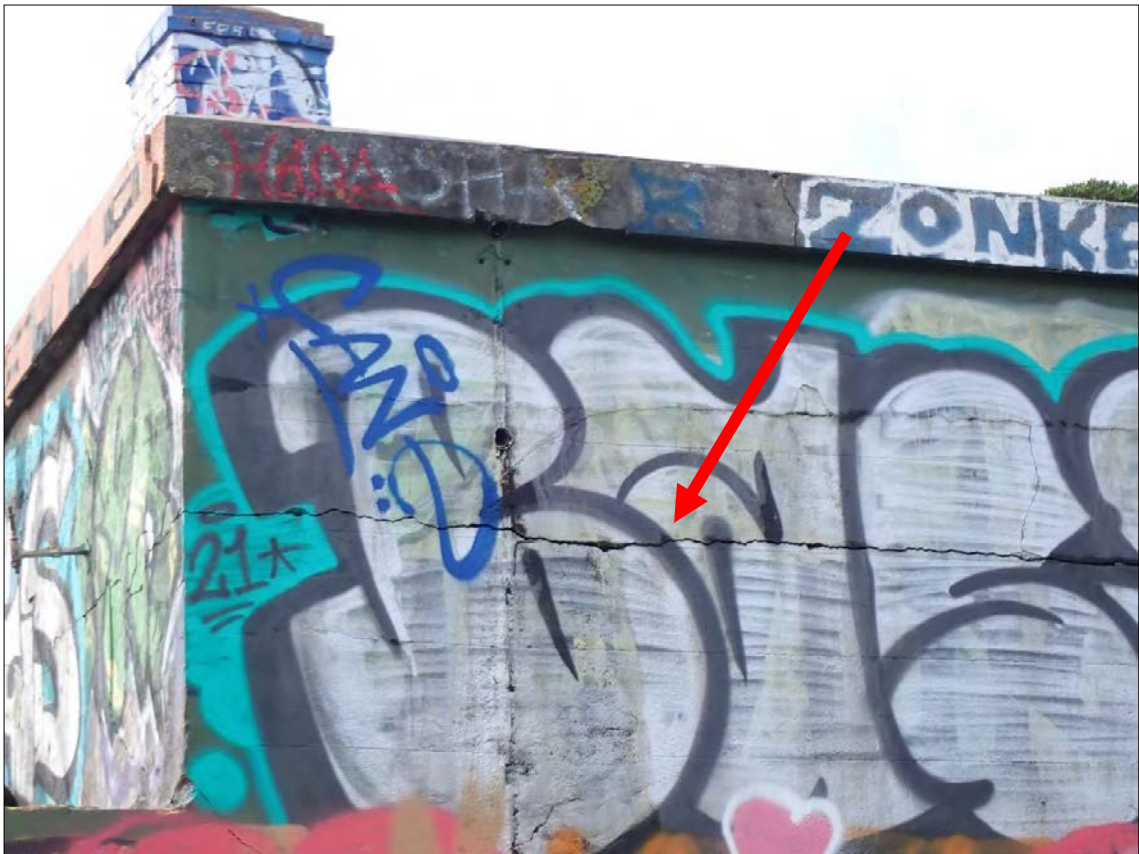
Figure 239: Feature 27: Fort Ballance. Artillery barracks. Typical example of horizontal cracking.

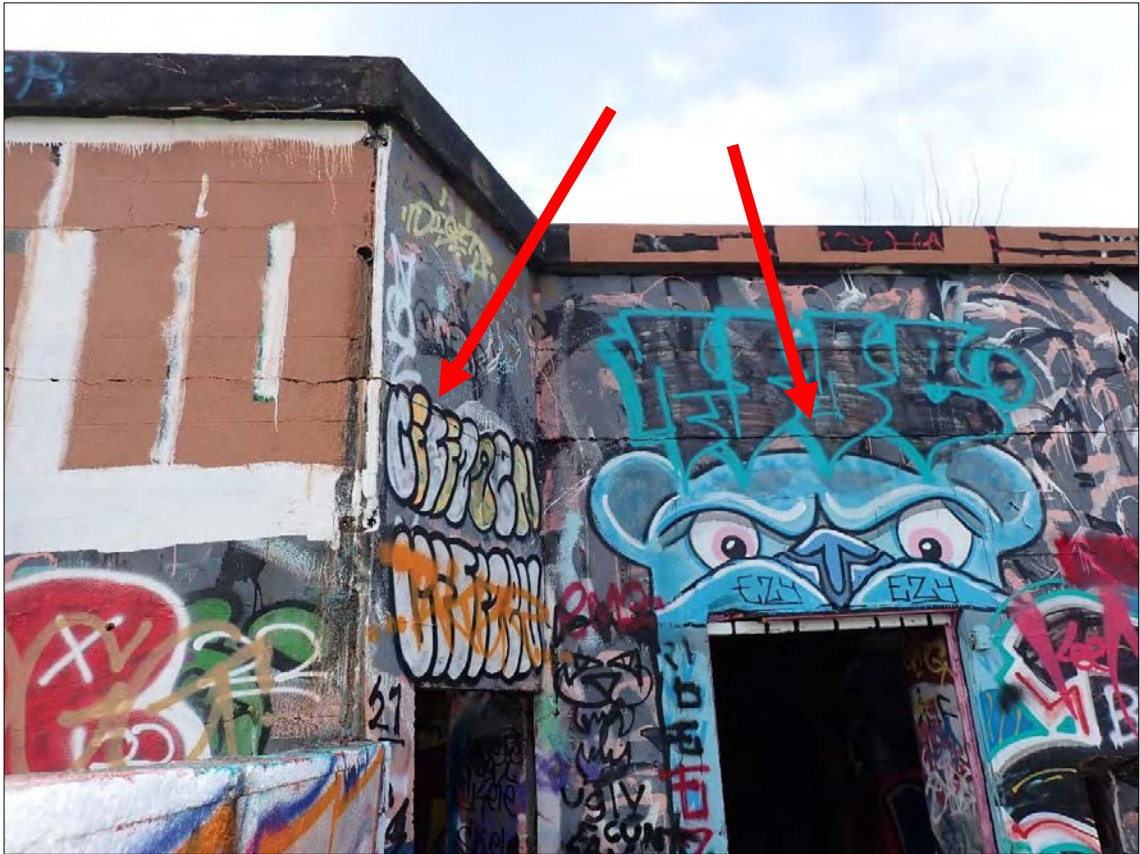
Figure 240. Feature 27: Fort Ballance. Artillery barracks. Typical example of horizontal cracking.

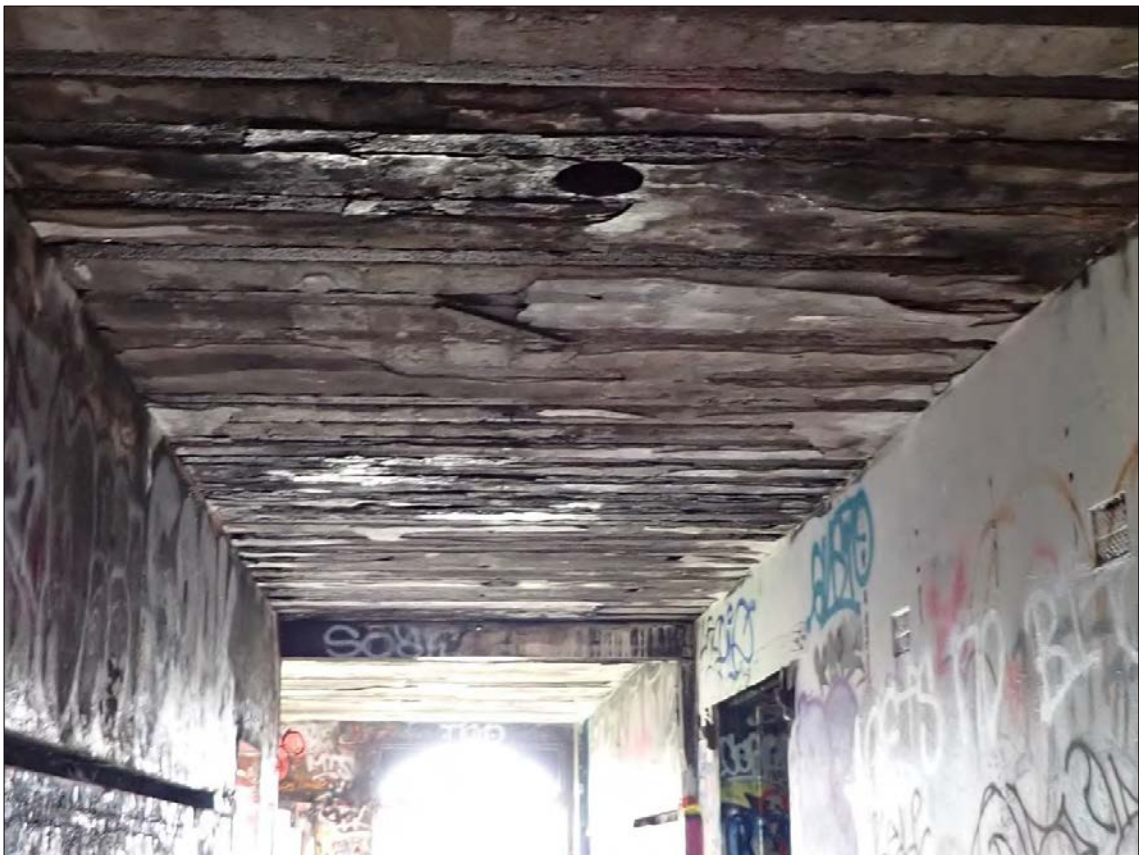
Figure 245. Feature 27: Fort Ballance. Artillery barracks. Underside roof steel reinforcement is rusting.

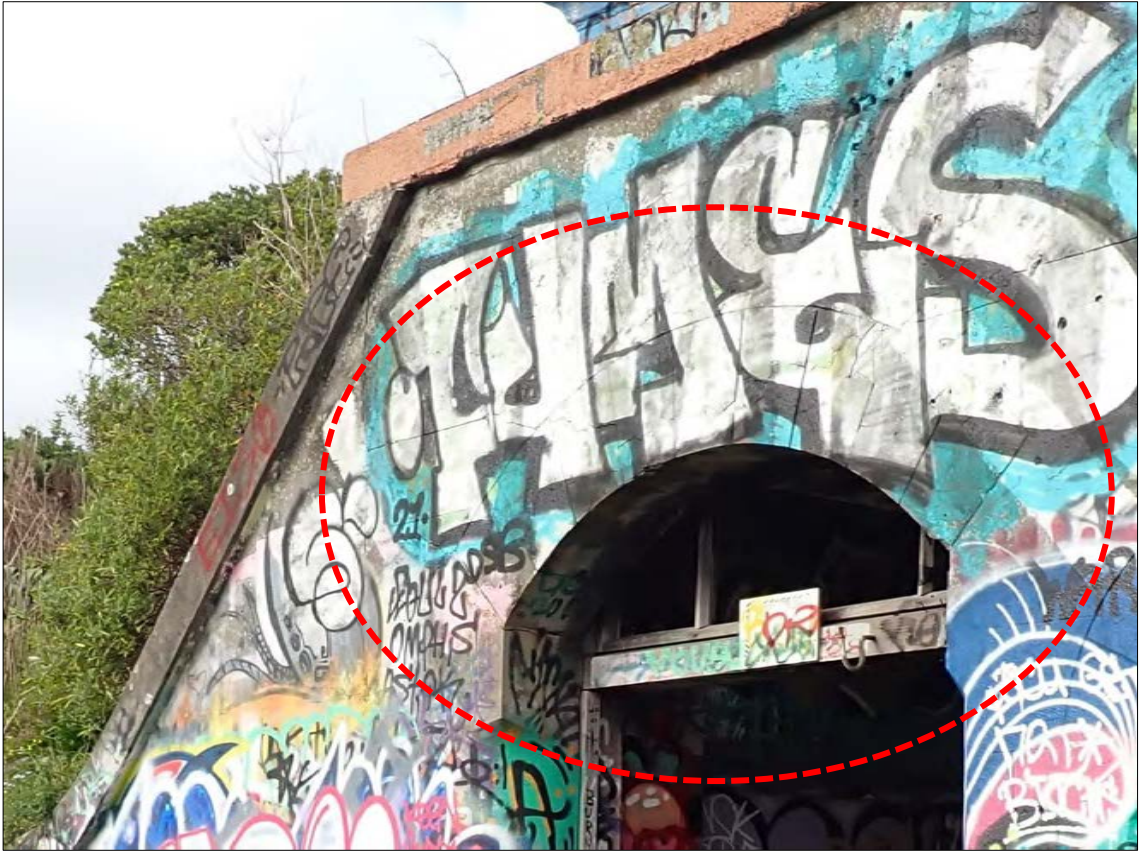
Figure 246. Feature 27: Fort Ballance. Artillery barracks. Graffiti obscures original scored concrete detailing to engine room. Image cropped.

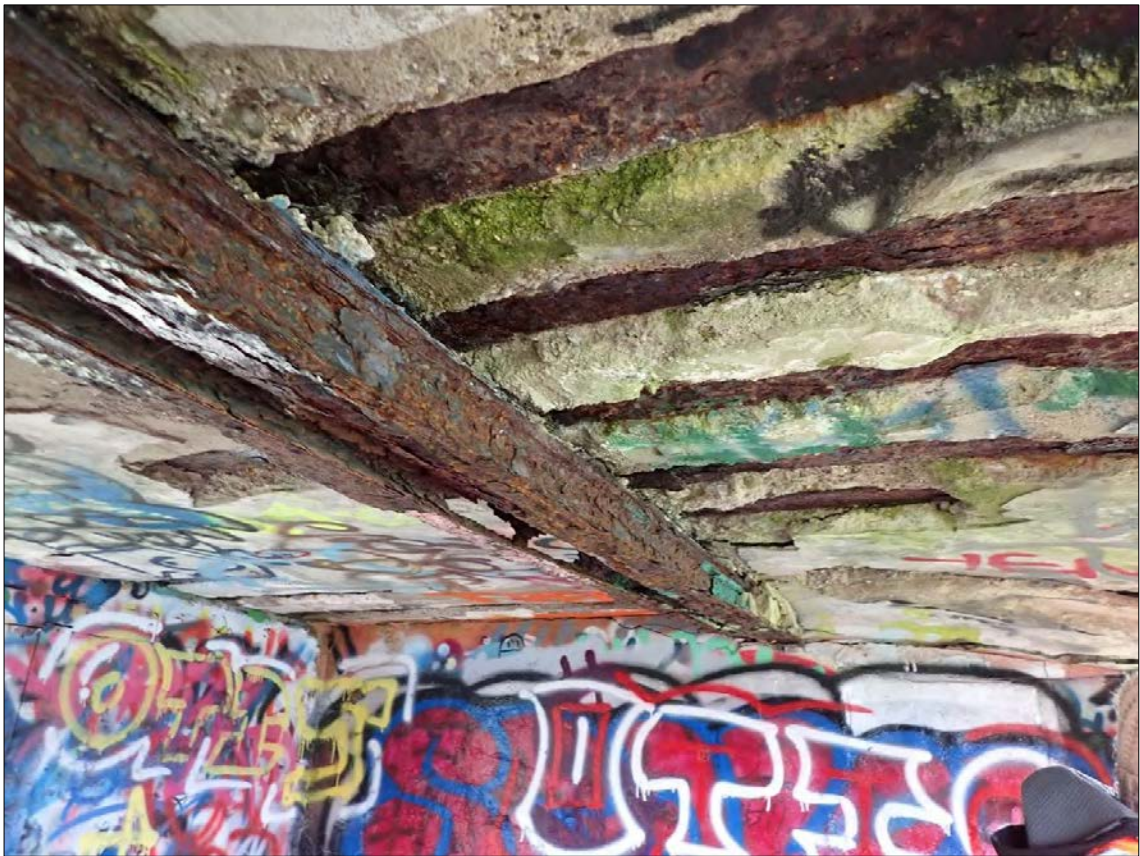
Figure 254. Feature 27: Fort Ballance. Pit B lookout. Underside slab reinforcement corroding and spalling of concrete.

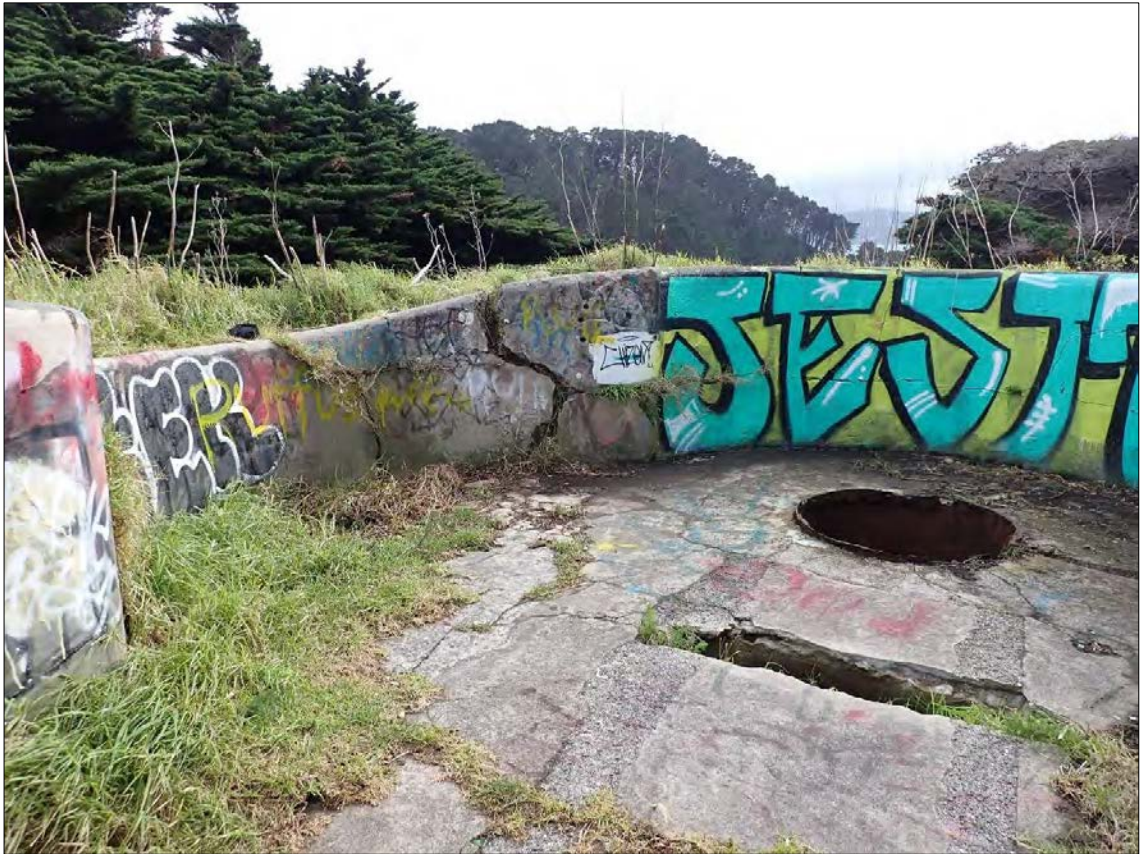
Figure 258. Feature 27: Fort Ballance. Extensive cracking at the 6QR PF.

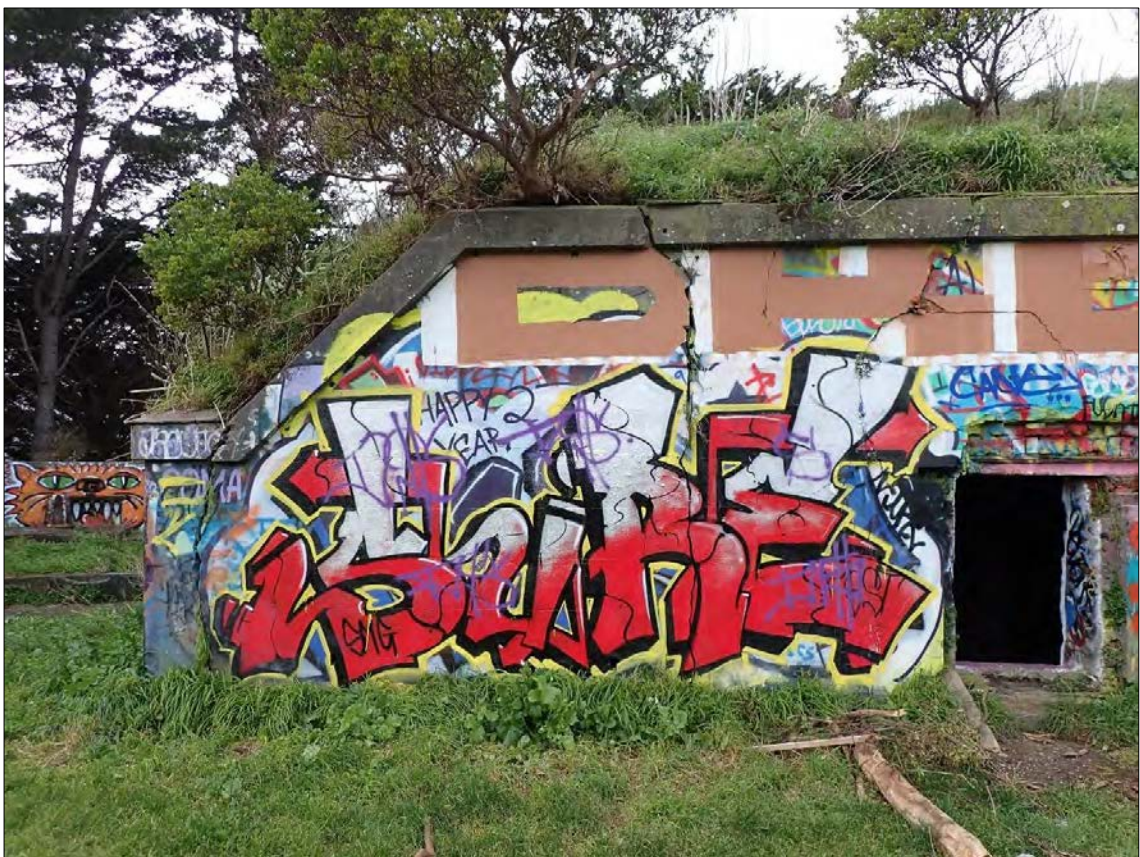
Figure 259. Feature 27: Fort Ballance. Example of cracking to walls.

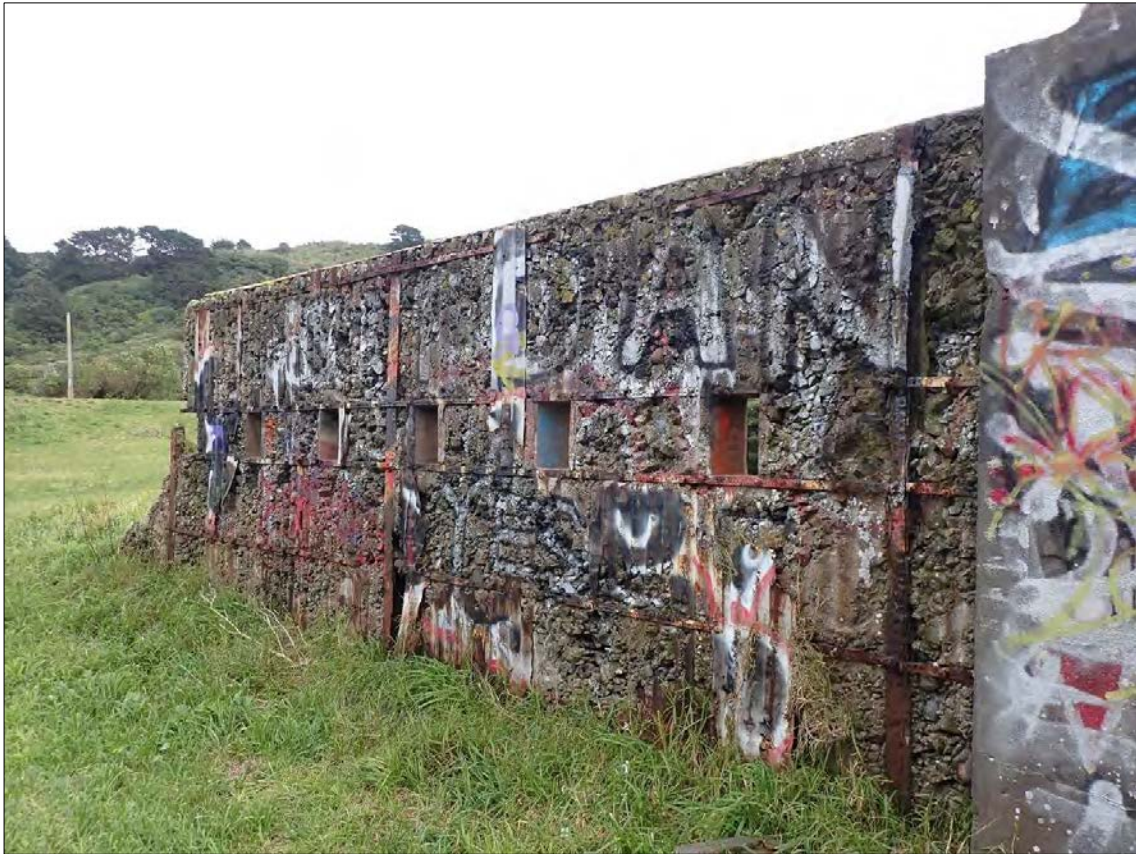
Figure 262. Feature 27: Fort Ballance. Example of graffitied loopholed wall.

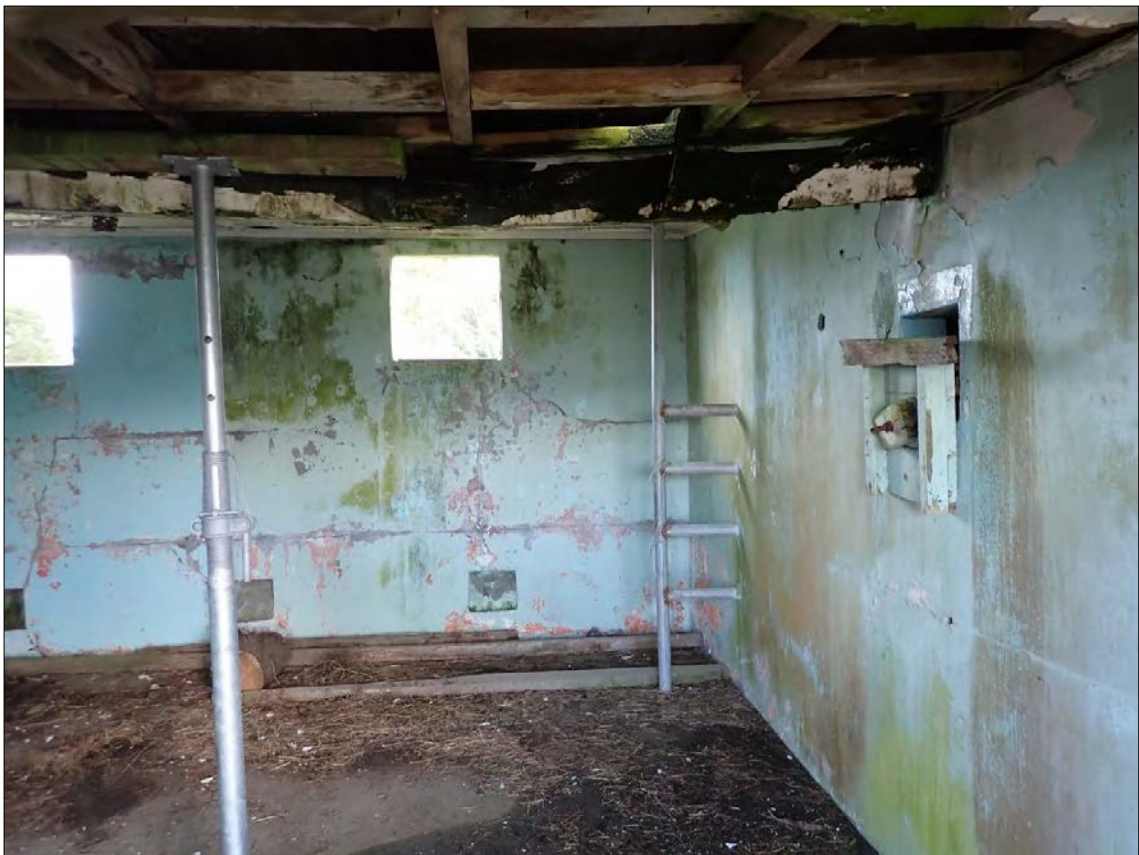
Figure 266. Feature 28: Farmstead. Milking shed interior. Roof being supported with an Acropop. Horizontal cracking is also evident.

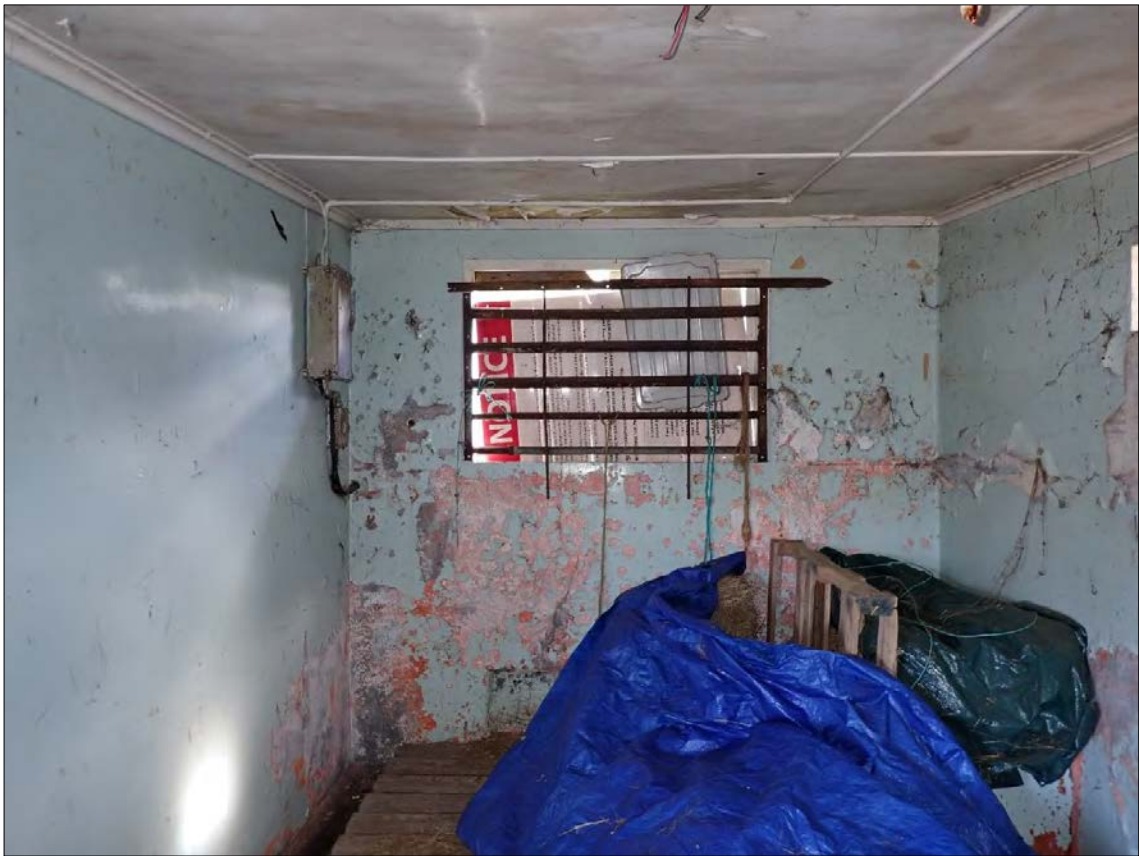
Figure 267. Feature 28: Farmstead. Milking shed interior displaying rising and falling damp, and horizontal cracking.
