Watts Peninsula

Geo-Hazard Assessment Report **LINZ**

Reference: 500946

Revision: 0 2020-07-31

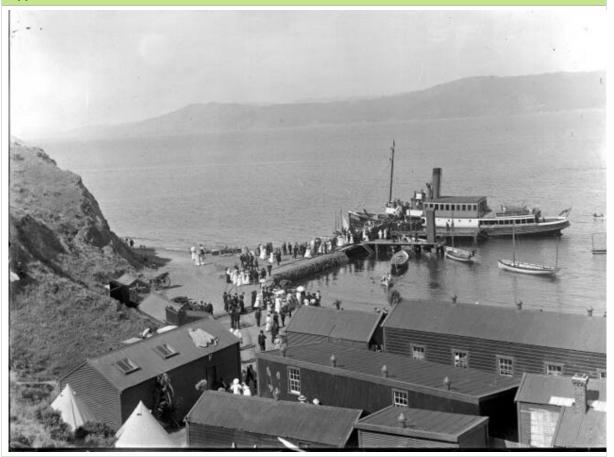
Photo 2: Image from circa 1910 at Mahanga Bay located on the eastern side of Watts Peninsula, possibly during a military camp open day. The steep slopes of the hillsides are visible. Photo obtained from the Alexander Turnbull Library Gallery.

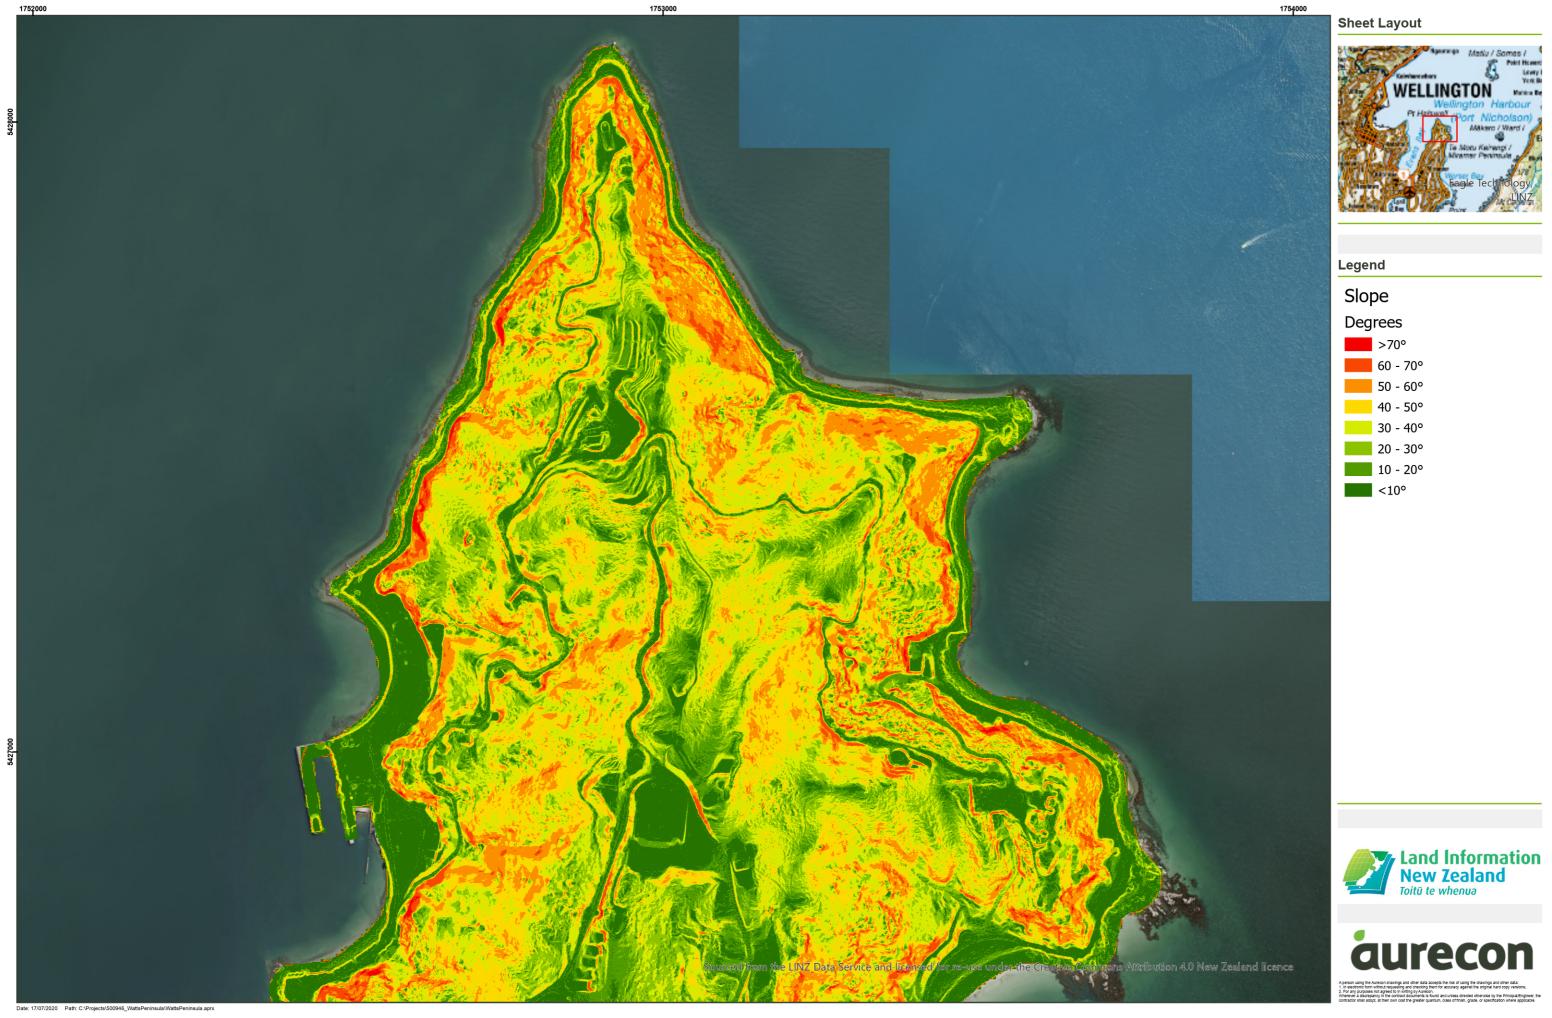
Appendix B LiDAR Slope Map

This was used to identify steeper areas and hence most likely to present greatest risk so to be targeted for closer study during the field assessment. This has also allowed for slope categorisation at a greater resolution as compared to the Greater Wellington Regional Council published regional hazard mapping.

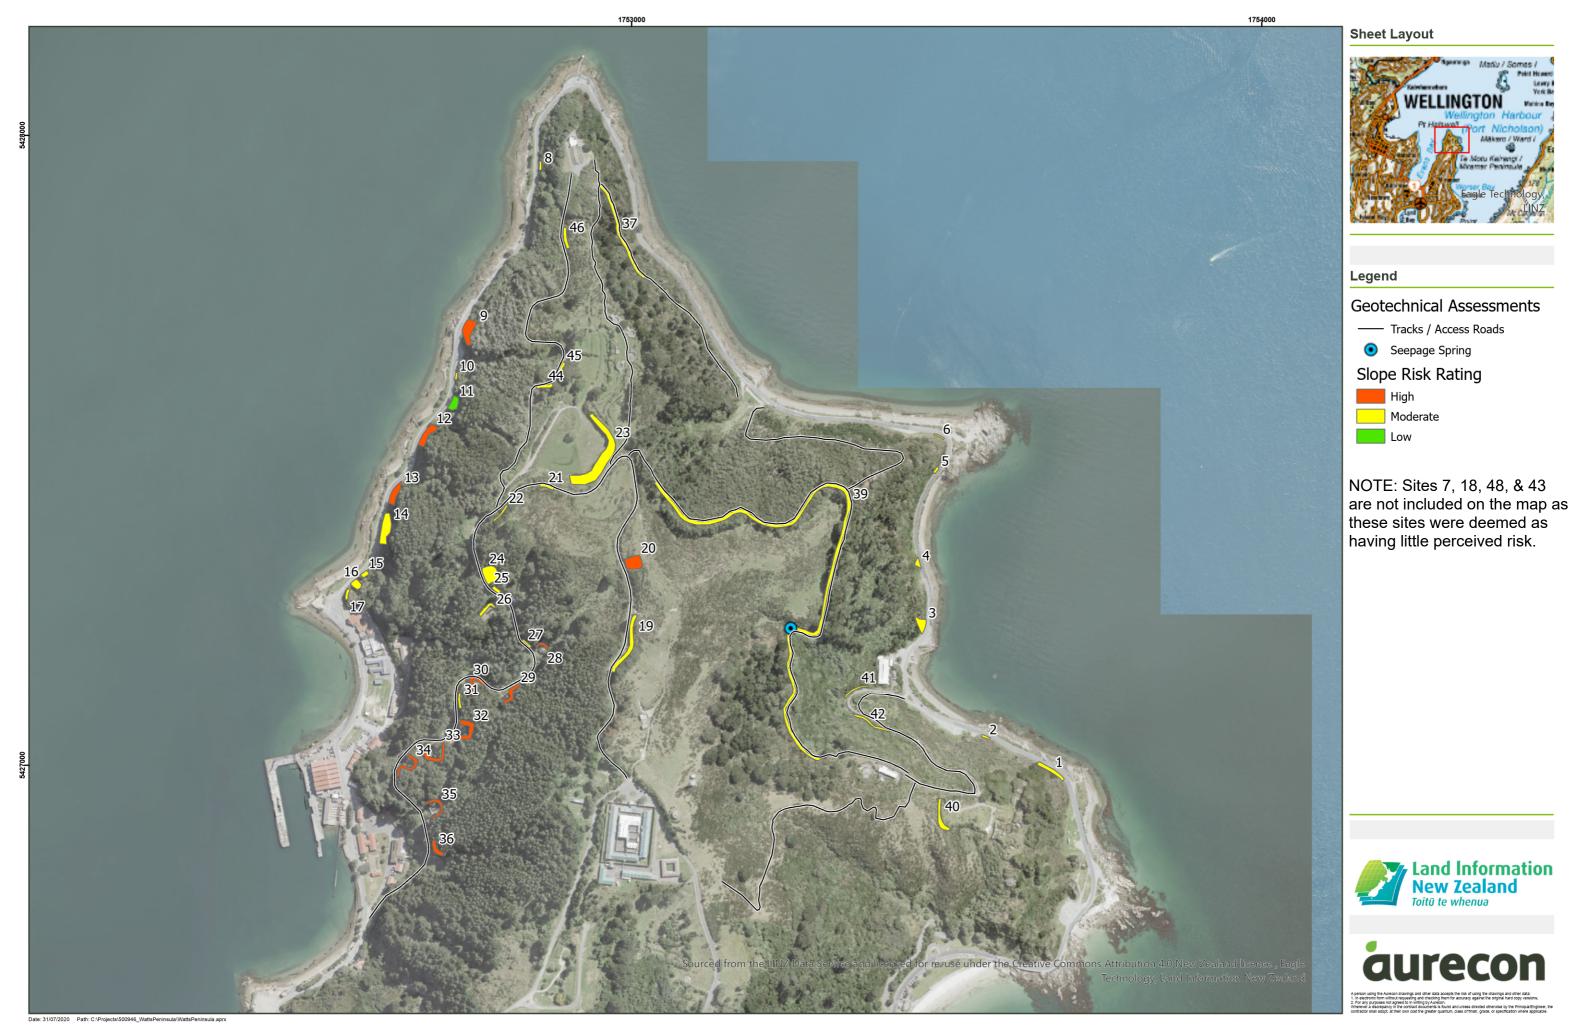
Slope Risk Map and Risk Assessment Summary

Forty-six slopes were identified as a hazard and may pose a risk to either road users, or users of the reserve above. The slope risk map is presented in Appendix E.

Geo-hazards were observed within and around the periphery of the reserve (see Appendix E for slope risk map). The general aspects of the slope hazard are as discussed below:

4.3.1 Remedial recommendations

As discussed, the Massey Road slopes are partially located within WCC Road Reserve. Remediation (if required) of these sites will likely fall under WCC's roading slope remediation budget as the road (and road users) is the sole asset at risk from any slope hazards.

Areas with steep slopes located around the outer edge of the reserve are heavily vegetated. This vegetation inhibits the public from accessing these areas and hence mitigates potential fall hazards. For the moderate risk Reserve sites, it is recommended that a site hazard information board is erected at main Reserve entrances summarising slope hazards and associated risks.
