# Hazardous Building Materials Survey

Survey Date - 18 March 2020

Watts Peninsula - Farm Buildings

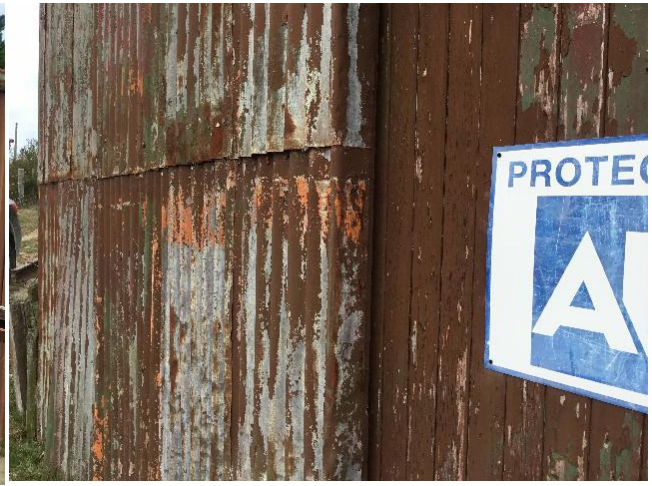
Sample/Observation Reference: **B03**

Exterior paint Small Barn  
External paint – 17.6 % lead (laboratory result)

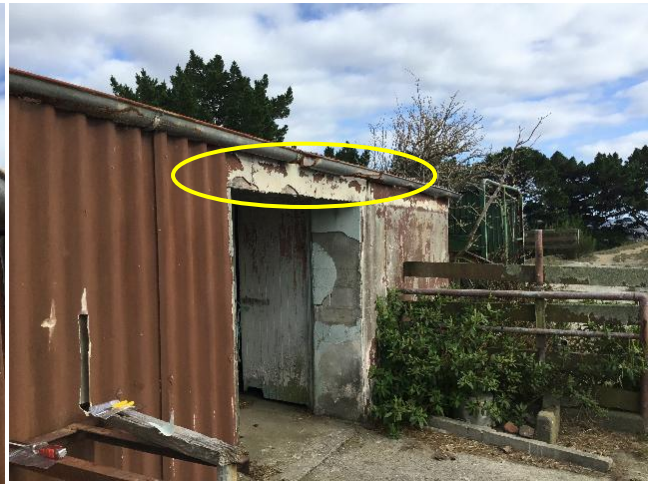
Assumed ACM  
Flashing Small Barn

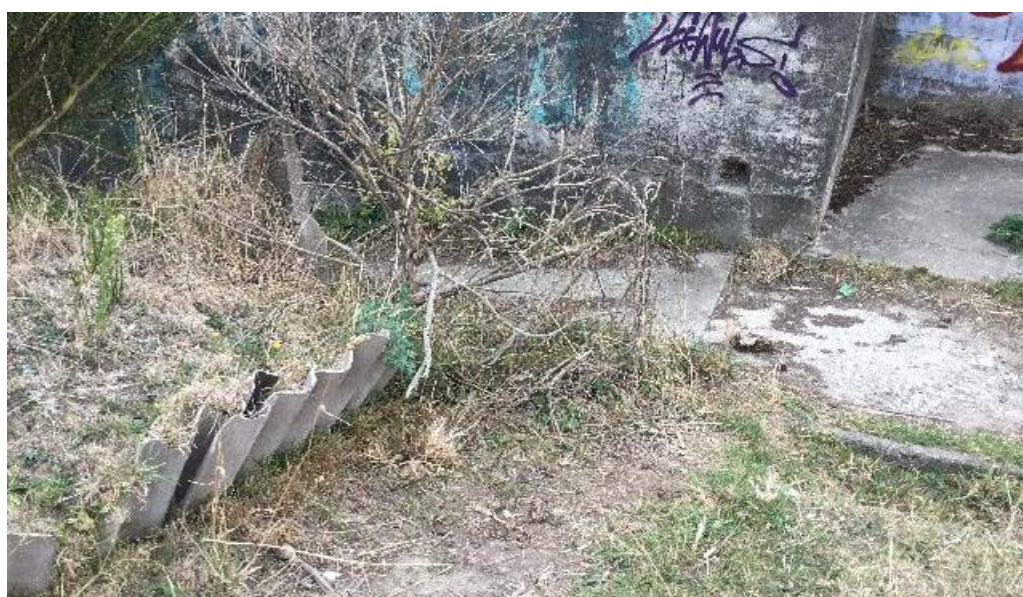
It was noted that there were a number of ACM cement sheets used to make a small retaining wall at the entrance to the intelligence centre (blue star, see Figure 1) and following photograph.

*ACM sheet retaining feature in front of the Intelligence Centre.*

Disturbing these non-friable asbestos containing materials should be appropriately planned by the contractor; if the quantity of these materials is  $\geq 10 \text{ m}^2$  this work must be undertaken by a Class B or Class A licensed asbestos removalist. The removalist must prepare an asbestos removal control plan before starting the works and notify WorkSafe New Zealand. Clearance works after the removal of the materials (when undertaken as licensed removal works) must be completed by a competent person (as defined in regulation 3 (1) – Health and Safety at Work (Asbestos) Regulations 2016).

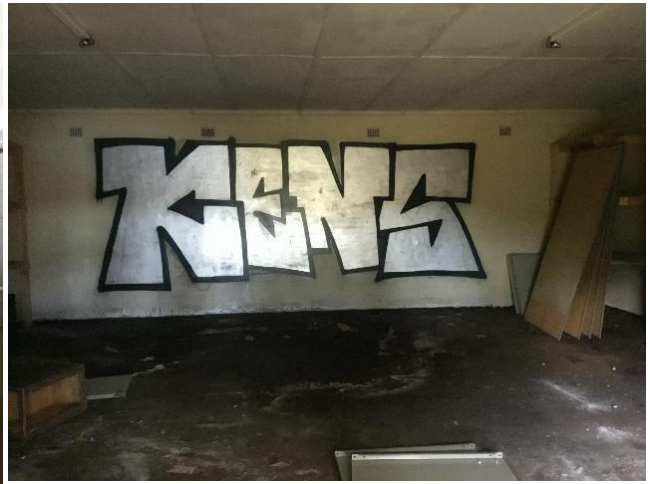
Sample/Observation Reference: **B02**

Debris on floor below broken light tubes

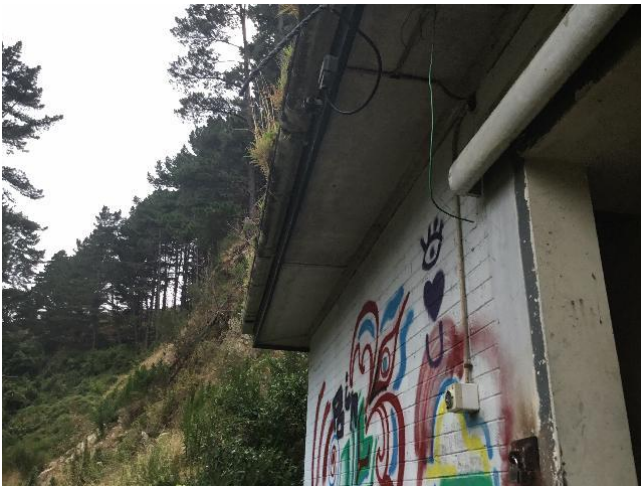
Sample/Observation Reference: **A05**  
Assumed ACM  
Replacement roof (steel) and gable end materials  
(assumed asbestos dust on roof structure below)

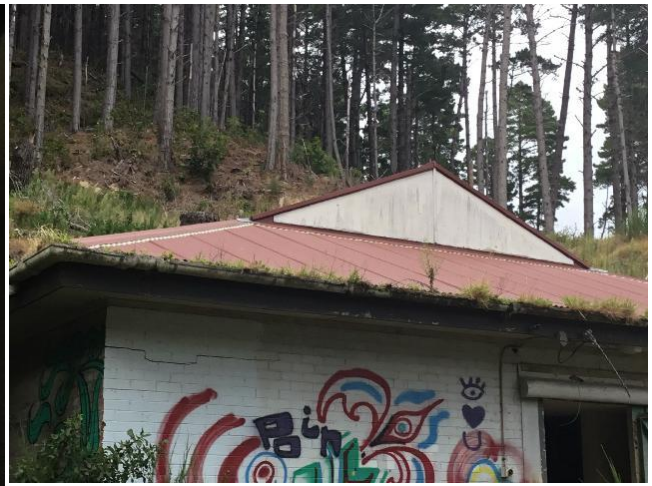
Sample/Observation Reference: **B03**  
Exterior paints  
3.62% lead (laboratory result)

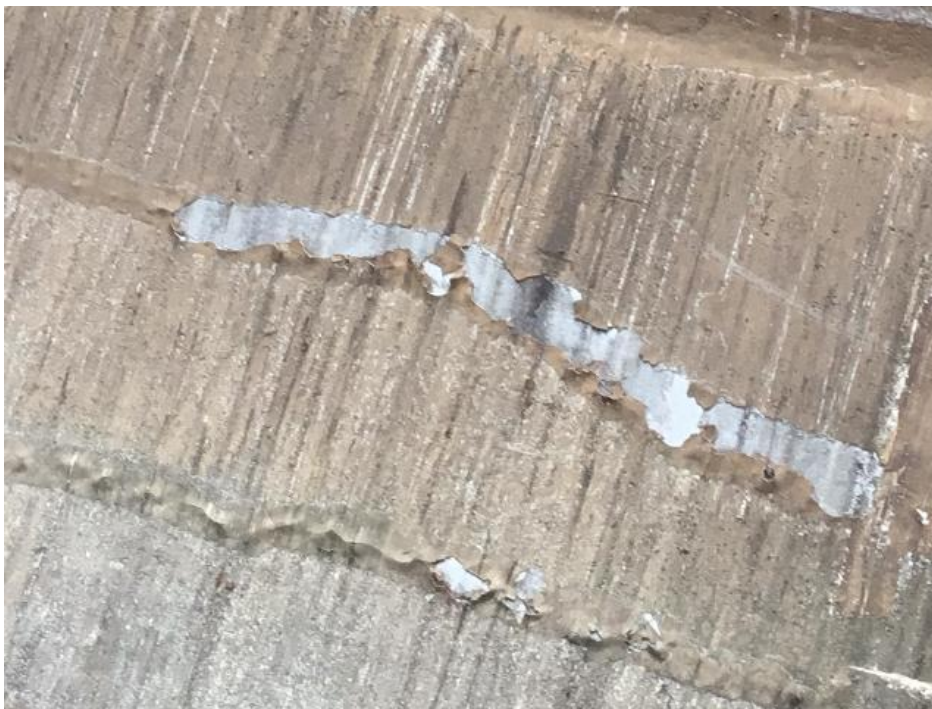
Access to the reservoir was prohibited by secure/high fencing. It comprises a concrete structure with a (beige) coating, possibly bitumen based material.

*Reservoir coating materials.*

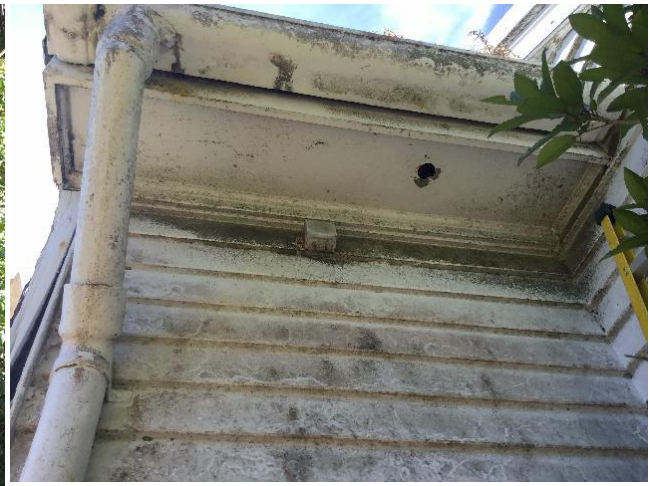
Sample/Observation Reference: **B02**

Down pipe - **Chrysotile asbestos** (laboratory result)

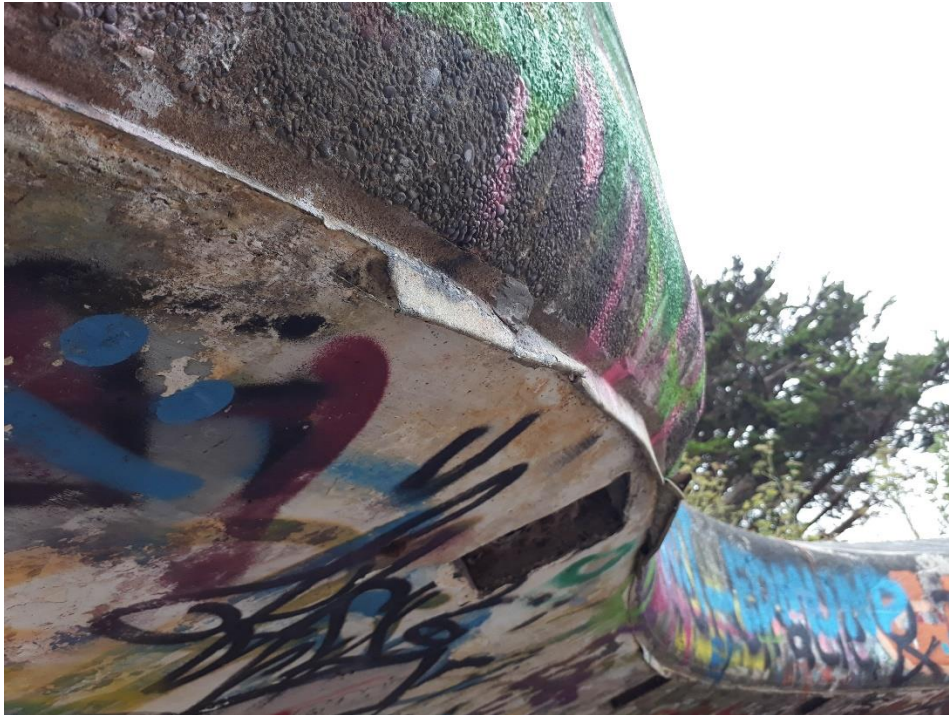
Lengths of lead flashing were noted in the side walls of the gun emplacements/batteries, this is illustrated below.

*Lead flashing in sidewall to gun emplacement/battery.*
