Subject: Land instability at 58 Akoranga Drive

As we discussed, there are a couple of issues pertaining to the Awataha Marae site at 58 Akoranga Drive, Northcote that need progressing.

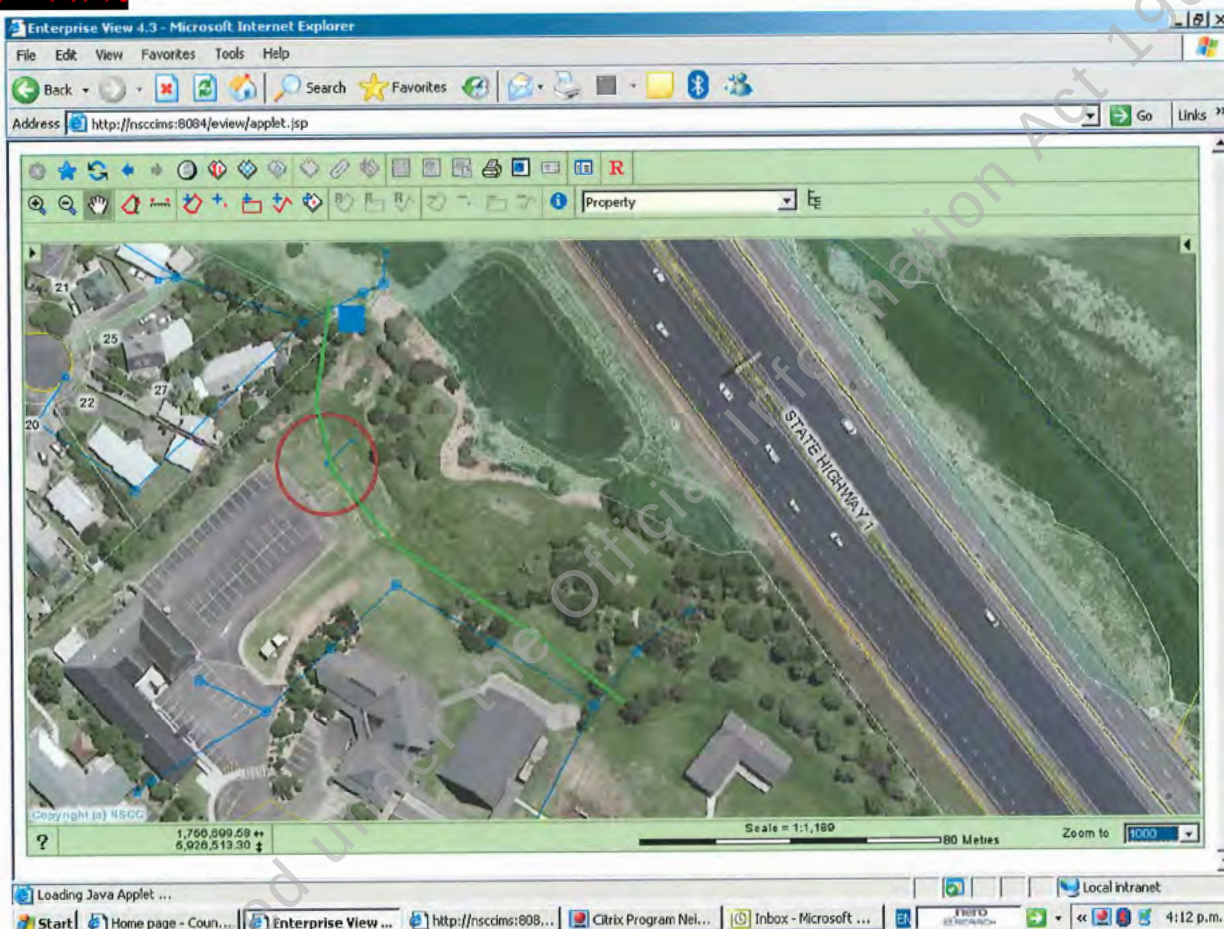
Here is a screen print from our GIS of the area I referred to in my previous email. The blue square indicates the approximate location of the wastewater pump station. The green line provides a rough indication of the scarp created by the ground instability. All stormwater and wastewater pipes intersecting this zone were found to be displaced. The public pipe network has been fixed. The stormwater pipe servicing the carpark on your site is identified by the red circle and is coloured light blue. This pipe is on our system because it has been surveyed by our CCTV contractor. The pipe appears to terminate a few metres away from the edge of the carpark. I believe that this was the section of pipe that the CCTV contractor was able to survey - the remaining section leading up to the catchpit located at the bottom of the carpark was not surveyed and is therefore not on this plan.

The proposed geotechnical investigation will assess the area along the green line and may extend further towards the southeast in order to establish the extent of the instability. The results of this investigation will become available to you once complete.
