**LAND INSTABILITY & STORMWATER MANAGEMENT  
58 AKORANGA DRIVE, NORTHCOTE, AUCKLAND**

**LAND INSTABILITY & STORMWATER MANAGEMENT – 58 Akoranga  
Drive, Northcote, Auckland**

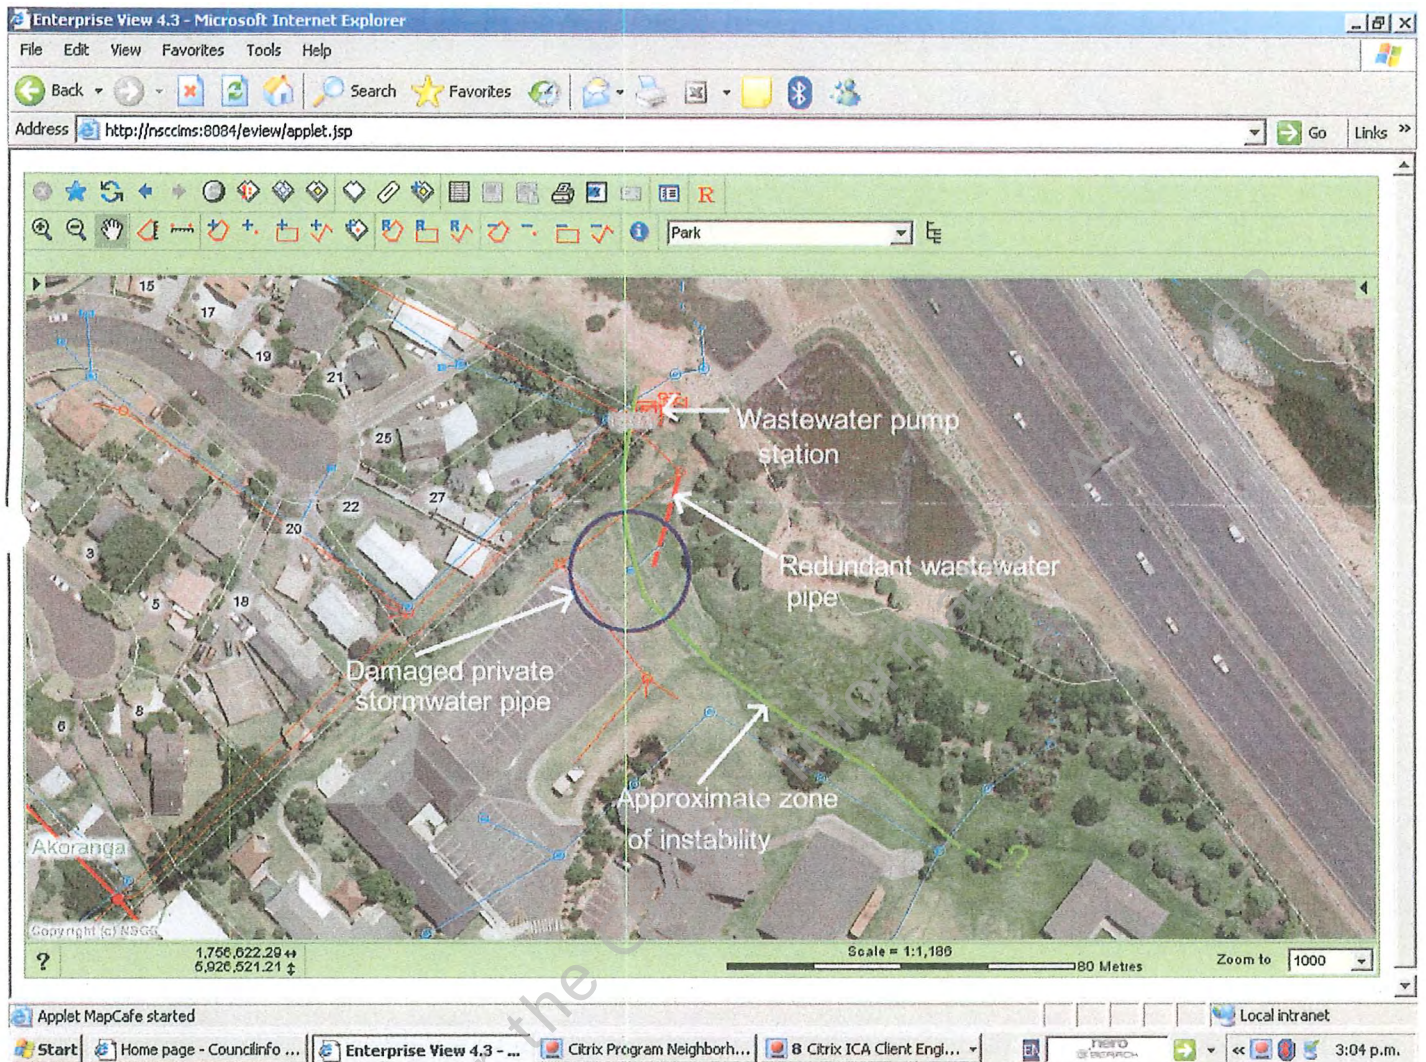
## 58 Akoranga Drive, Northcote - Screen print from Council GIS

Attached – Marked up map of area referred to in letter
