Memorandum

To	[s 9(2)(a)] (LINZ), [s 9(2)(a)] (LINZ), [s 9(2)(a)] (LINZ)	From	[s 9(2)(a)]
Copy	[s 9(2)(a)] (Aurecon)	Reference	500946
Date	2020-07-30	Pages (including this page)	11
Subject	Watts Peninsula – Initial Structural Observations

This memorandum has been written to provide an overview of the structural inspections of existing historical defence structures on the Watts Peninsula conducted by Aurecon ([s 9(2)(a)]) on 16/03/20 and 17/03/20. These inspections were carried out for Land Information New Zealand in order to identify structural risks on the Crown-Owned land. Where applicable this memorandum also comments on non-structural health and safety issues present also.

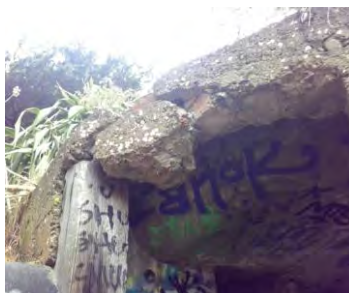
Figure 4 – 7 Inch RML pit door concrete fragment

One concrete fragment (~30mm long) was observed to be loose over one of the adjoining room entrances. It is recommended that this is removed to avoid the risk of falling.

- Fort Ballance General – Conduct intrusive investigation of roof reinforcement. Conduct desktop assessment of roof and brick structural elements.
- Fort Ballance 7-inch RML Gun Pit – Remove concrete fragment from entrance to adjoining room (see 3.7.4).

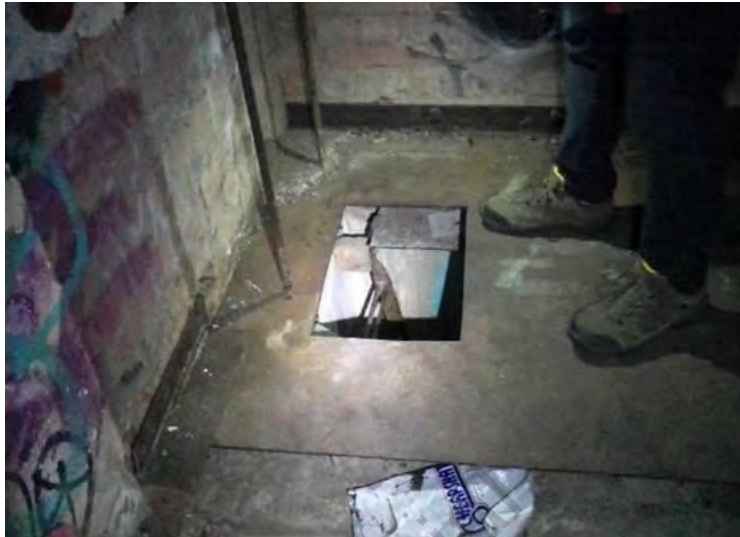
Figure 5 – Entry to lower level of 6" artillery store

Artillery store rooms adjoining the north 6" gun. The store has two levels. The lower level is beneath ground level and has not been accessed due to H&S concerns relating to confined space entry. The lower rooms had previously been closed off by the installation of a steel plate over the ladder, however it seems taggers have cut an opening with a grinder - see figure 5.

This opening will need to be closed over for safety relating to public access.

- Fort Ballance North 6-inch Gun Underground Artillery Store & OP – Close off access to lower level for safety. Break out and reinstate concrete roof soffit below crack (see 3.7.6)

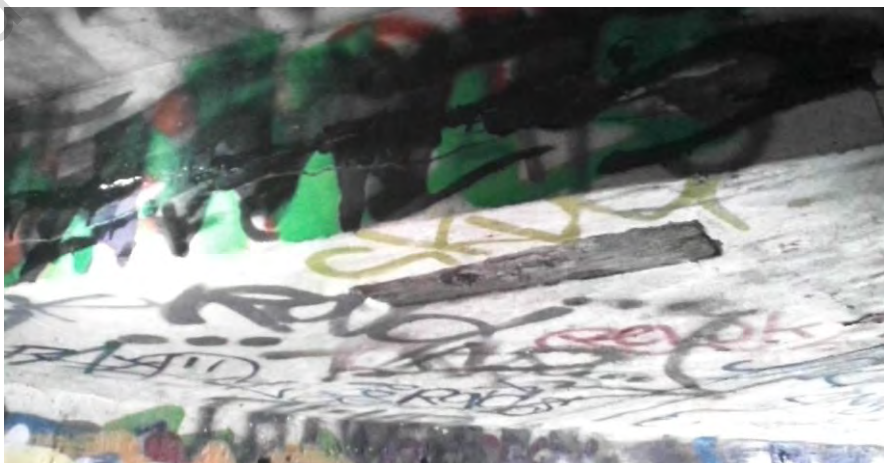
Figure 6 – Crack in 6" artillery store roof soffit

A horizontal crack was observed at the edge of the roof of the tunnel leading from the main room to the 6-inch gun pit. This crack is likely to have been caused by corrosion of reinforcement within the roof. Remedial work is required to prevent spalling from causing the concrete soffit of the roof falling in this localised area.

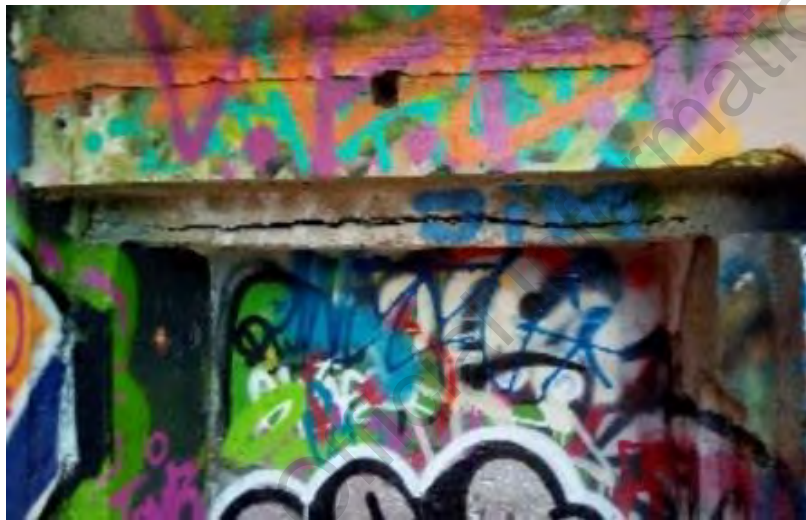
Figure 7 – Crack in 6" gun pit horizontal door crack

The gun pit is in relatively good condition. One horizontal crack was observed on the lintel of a disused door in the pit. This crack is likely to drop some fragments of concrete in the future.

- Fort Ballance South 6-inch Gun Pit and Underground Magazine – Remove loose spalling concrete from roof soffit, repair as appropriate
- Fort Ballance Observation Post and Room above Barracks – Cordon off observation post room and strengthen roof.

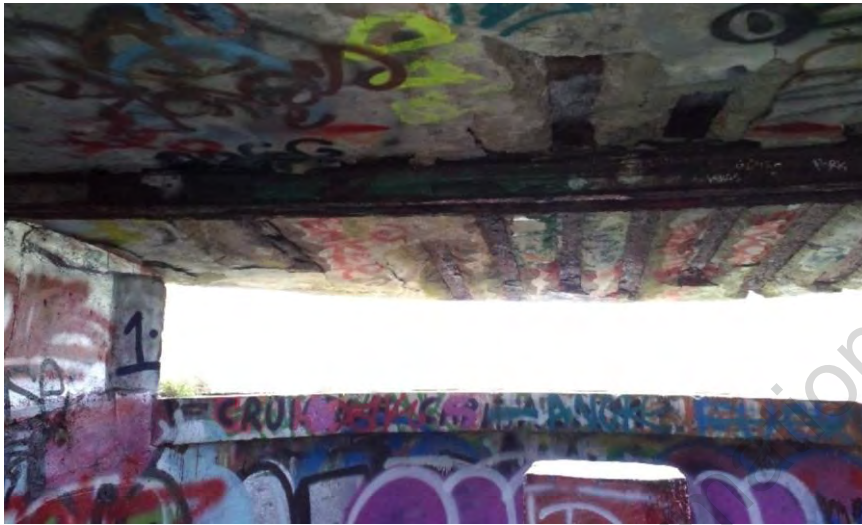
Figure 8 – OP Roof Corrosion

The observation post roof has been constructed with rail irons serving as both a central beam and cantilever observation pit ceiling. These rail irons are severely corroded. It is recommended that the observation post is cordoned off for safety and repair.
