Crown Pastoral Land Tenure Review

Lease name : CASTLE DENT

Lease number : PO 196

Conservation Resources Report - Part 3

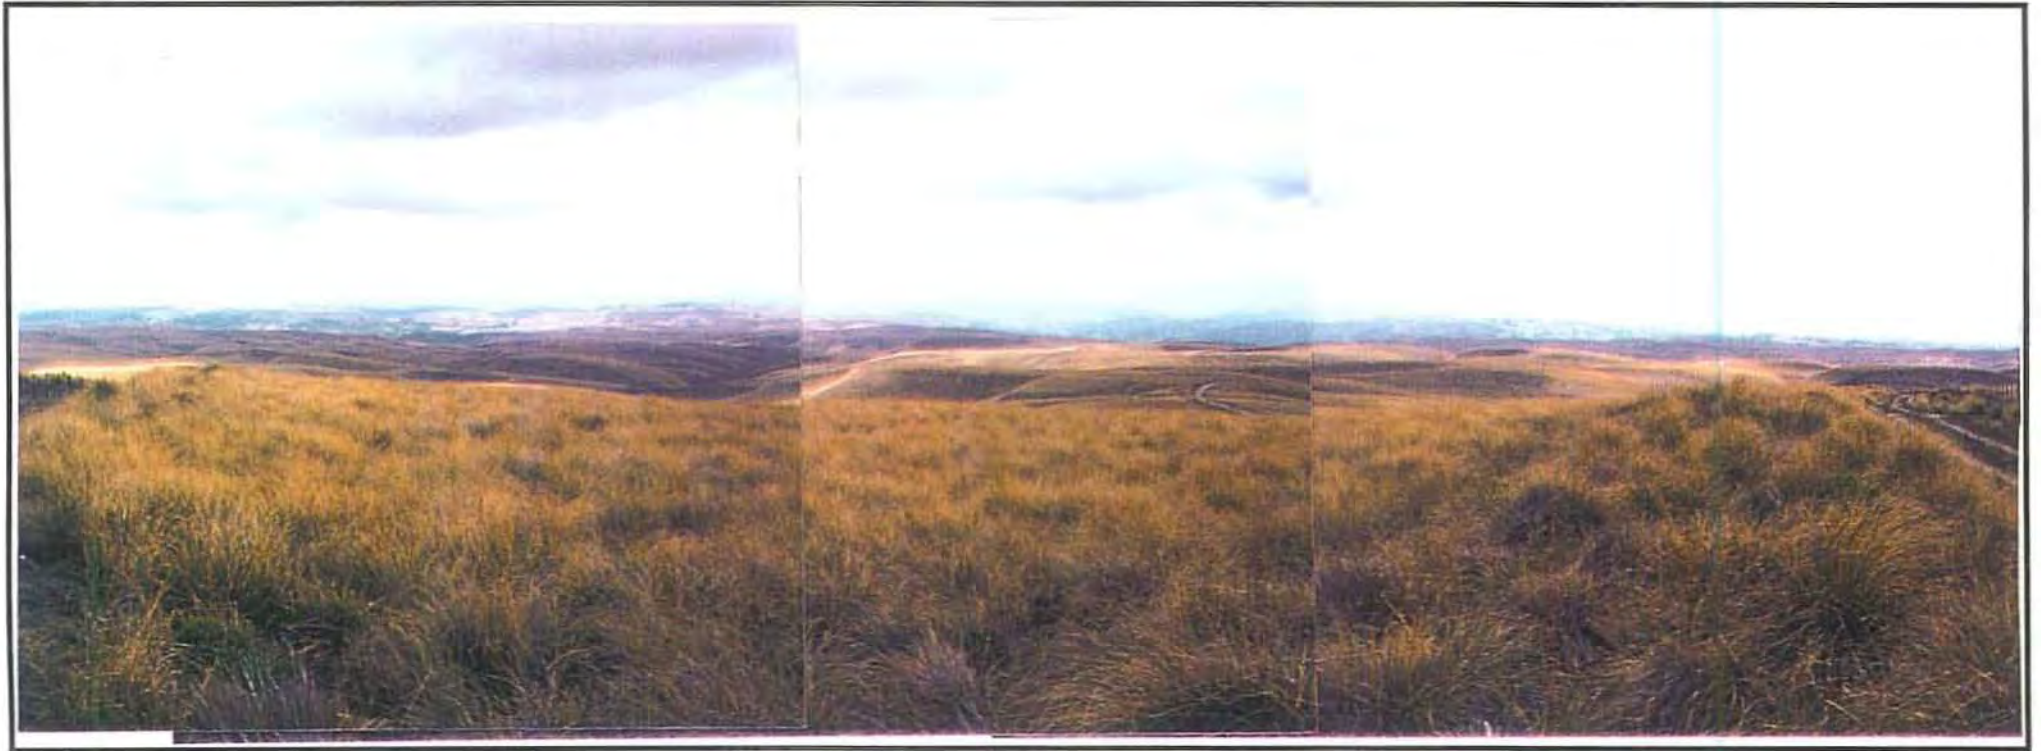
Photo I: Looking south from the north eastern corner of Run Block across the expansive plateau rise. These tall grasslands are continuous and unvarying with those in the adjoining Te Papanui Conservation Area.

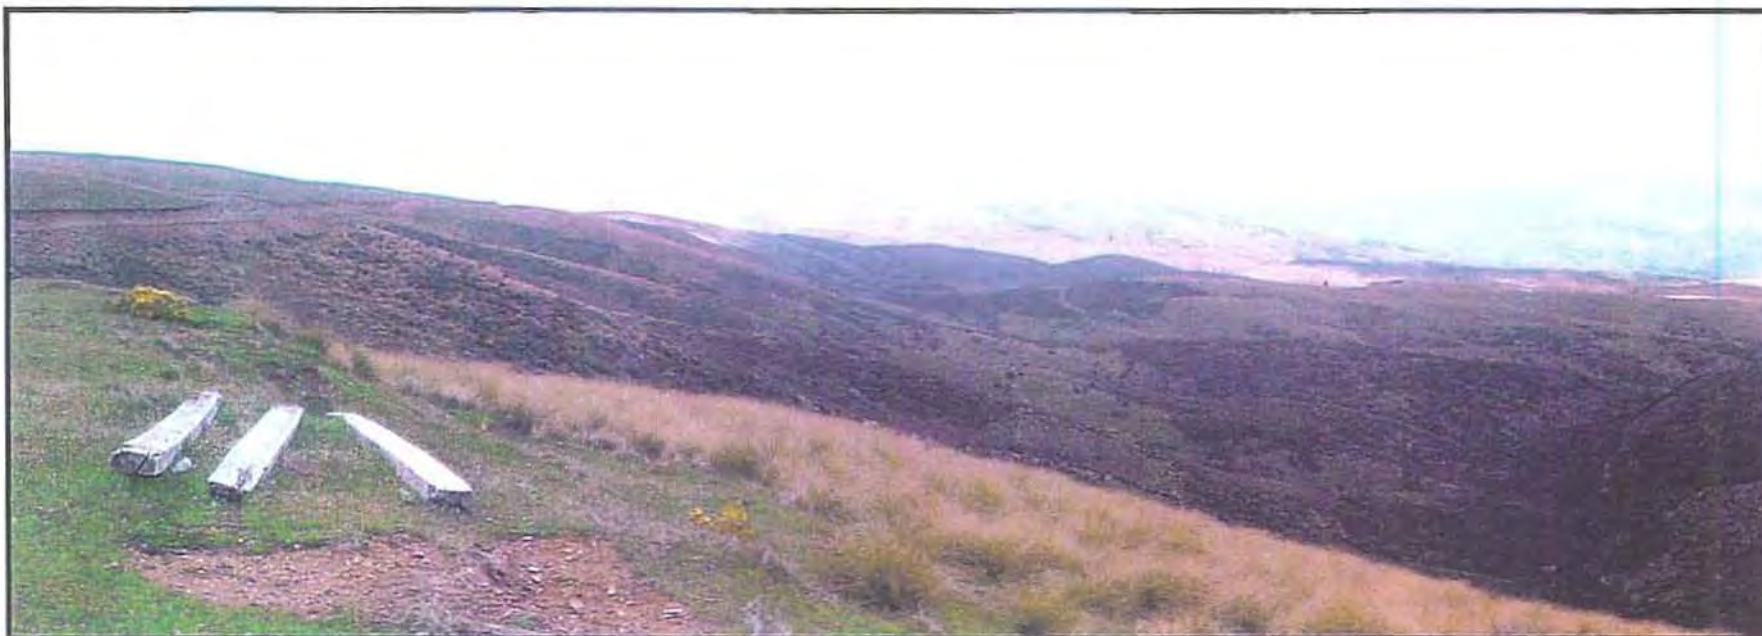
Photo 2: Looking down the Beaumont River. Notable features are the power company water race to the left and the area of regenerating shrublands between it and the Beaumont River.

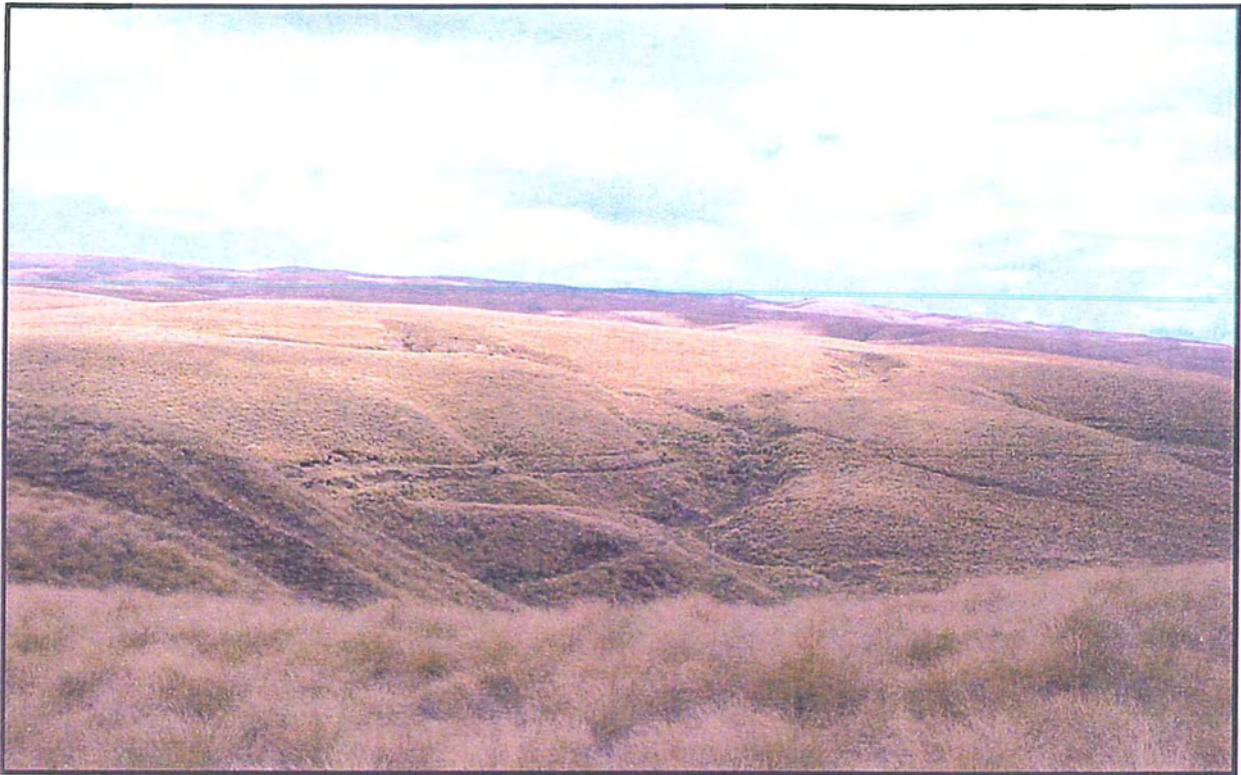
Photo 3: Looking north from the southern end of the Run Block. Water races are a common feature of this area.

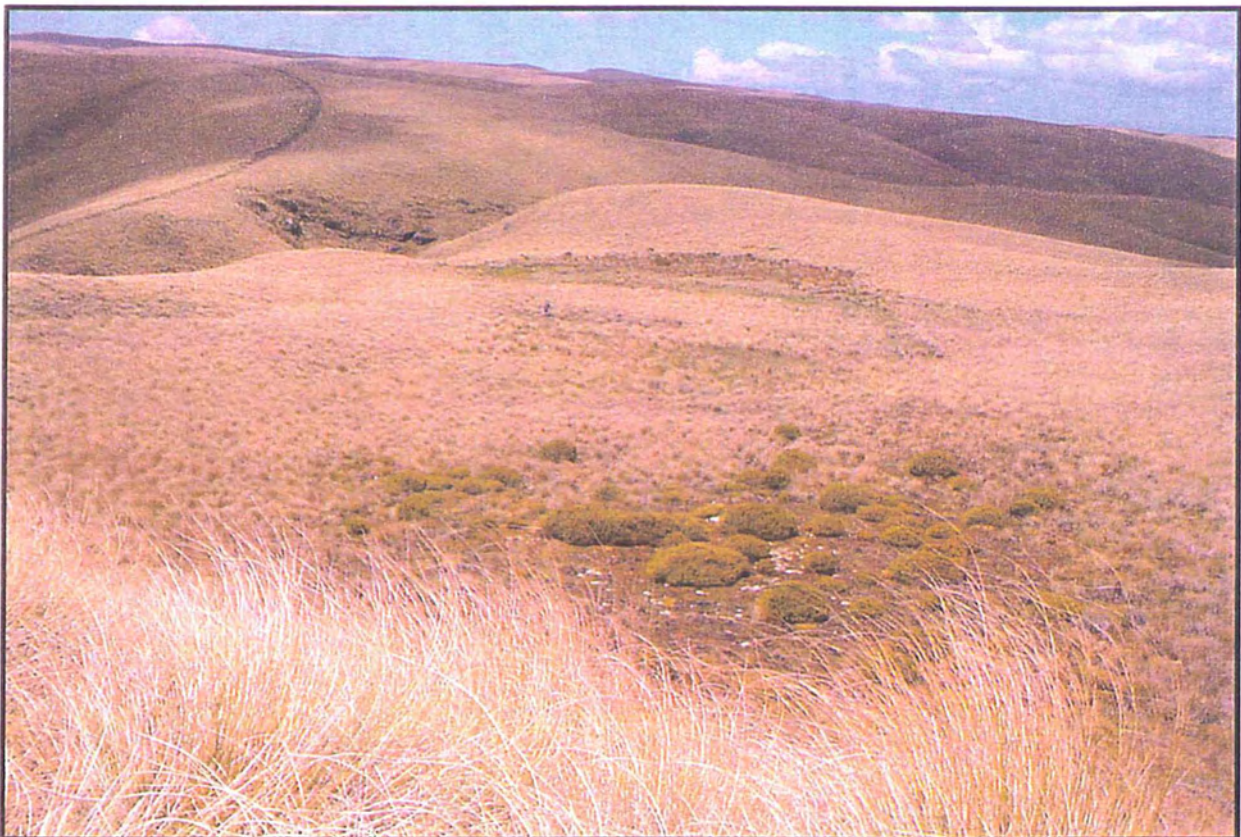
Photo 4: Stand of bog pine in the headwaters of a tributary of the Waipori River

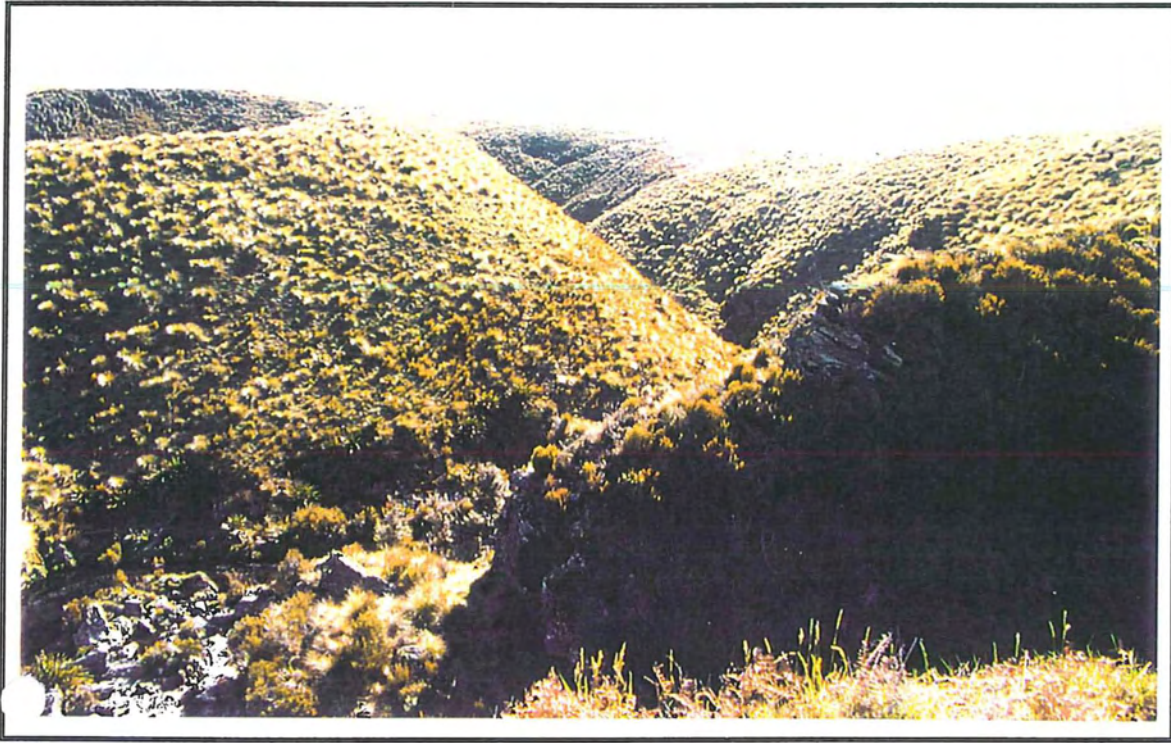
Photo 5: South eastern corner of the Run Block. Remnant silver beech and shrublands (at the left) are notable features in this section of the Waipori River riparian margin.

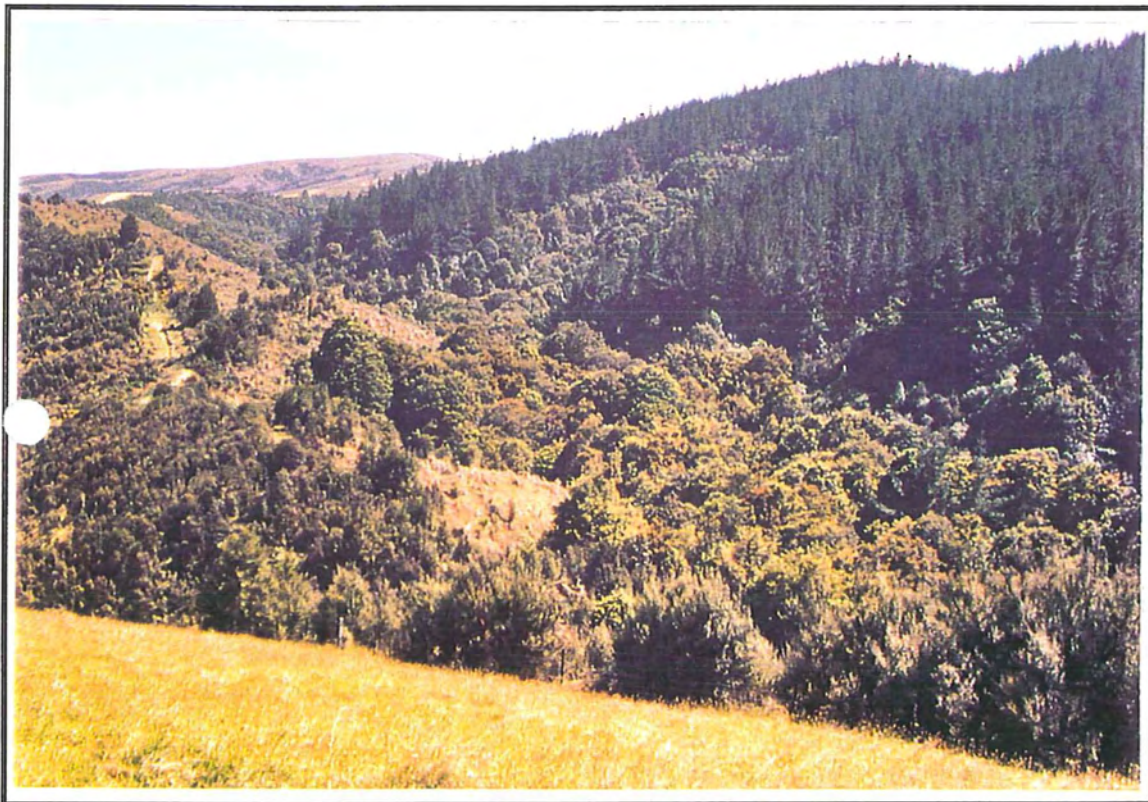
Photo 6: Silver beech and manukakanuka dominated shrublands in the north east of the I-lome Block form a riparian margin along the Tuapeka River.

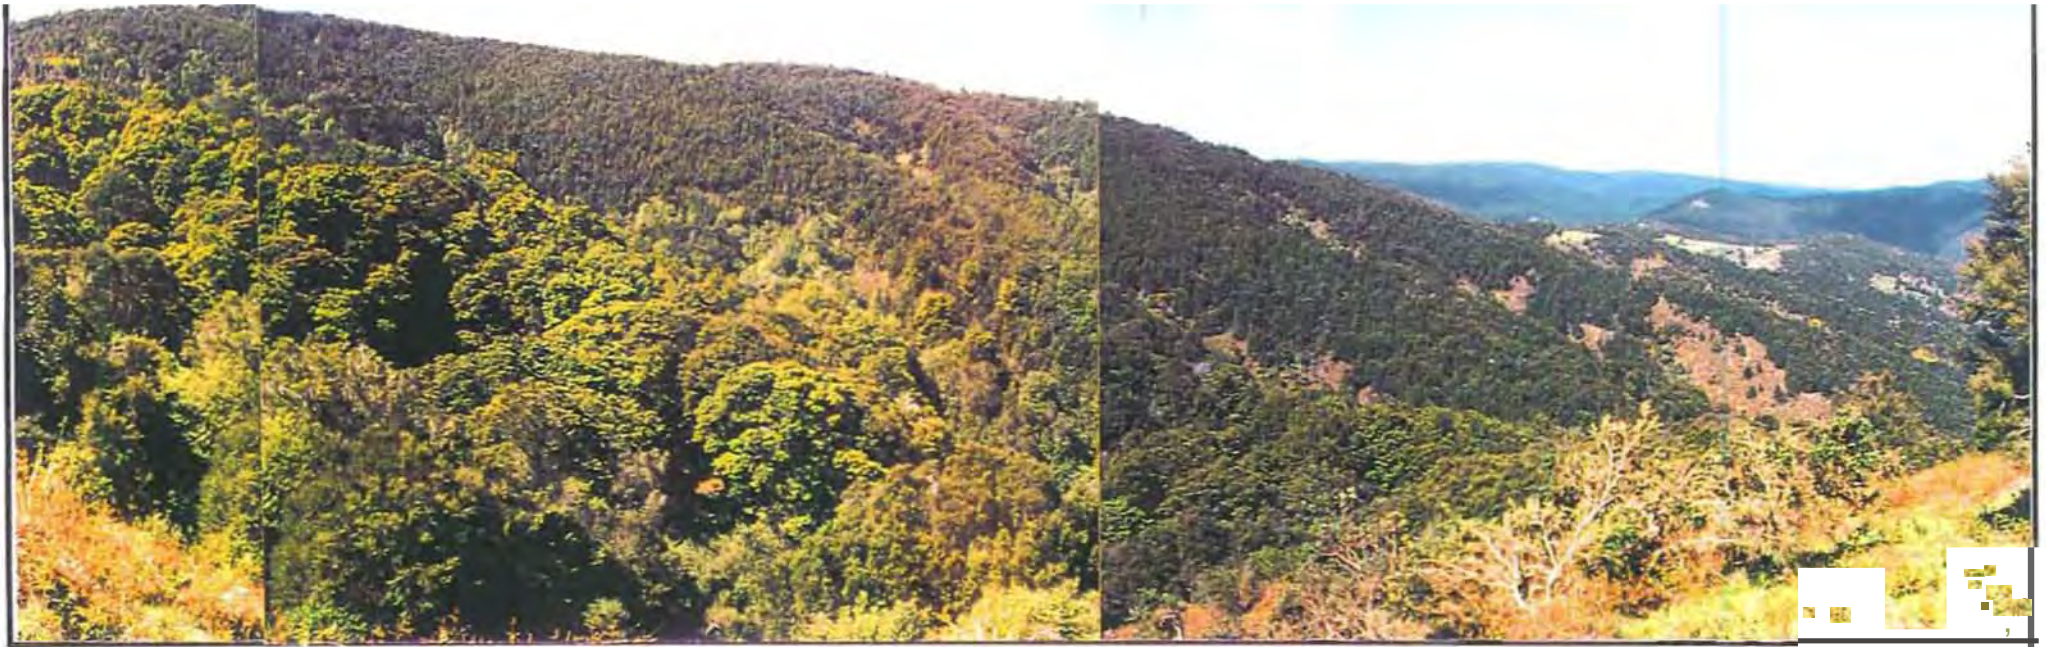
Photo 7: Contiguous manukalkanuka forest, remnant silver beech and shniblands extend from Youngs Road to the Tuapeka River. The vegetation on this face is typical of the majority of gullies in the northern half of the Home Block.

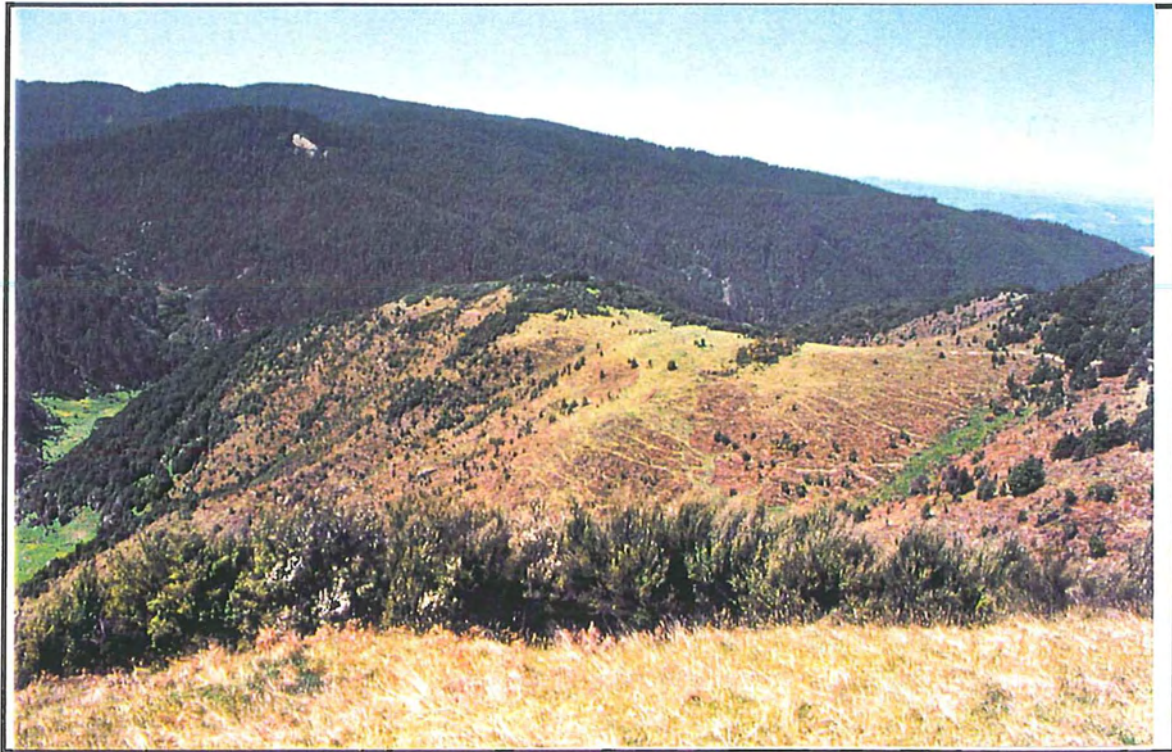
Photo 8: Steep, regenerating face above the Tuapeka This vegetation pattern is repeated on the faces between spot heights 363m asl. and 287m asl.

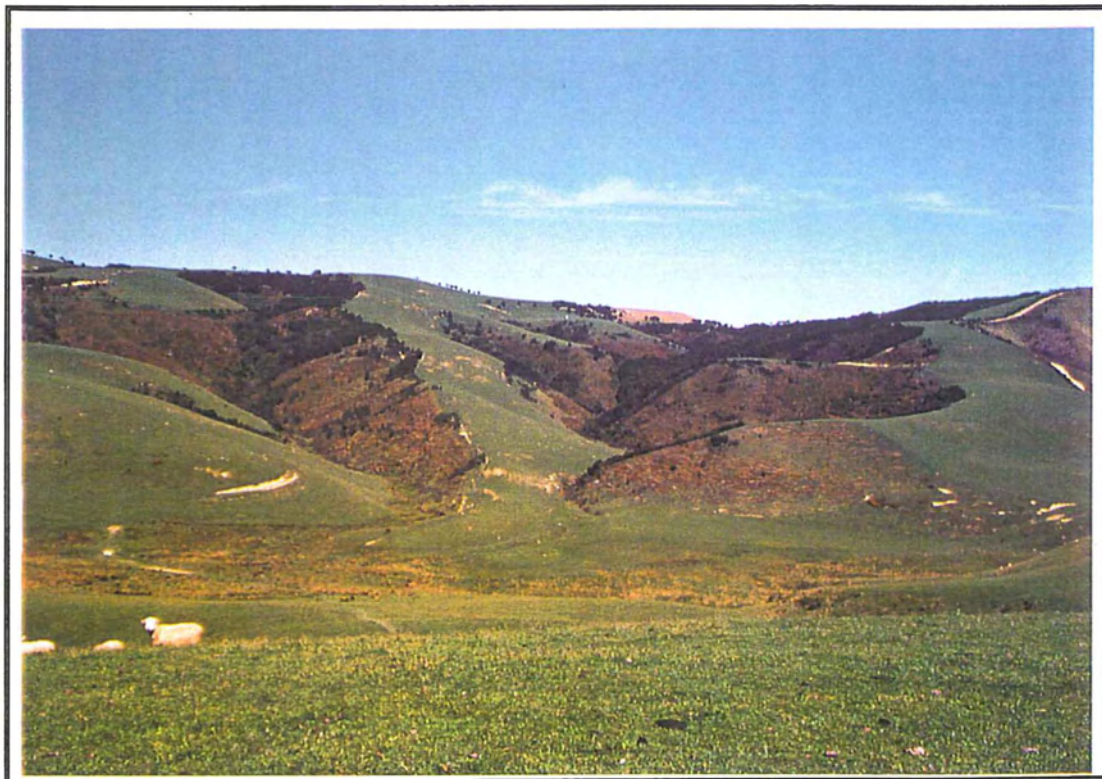
Photo 9: Top section of the Youngs Valley wetland and two regenerating gullies. The bladed fenceline at the right marks northern boundary of the Home Block.

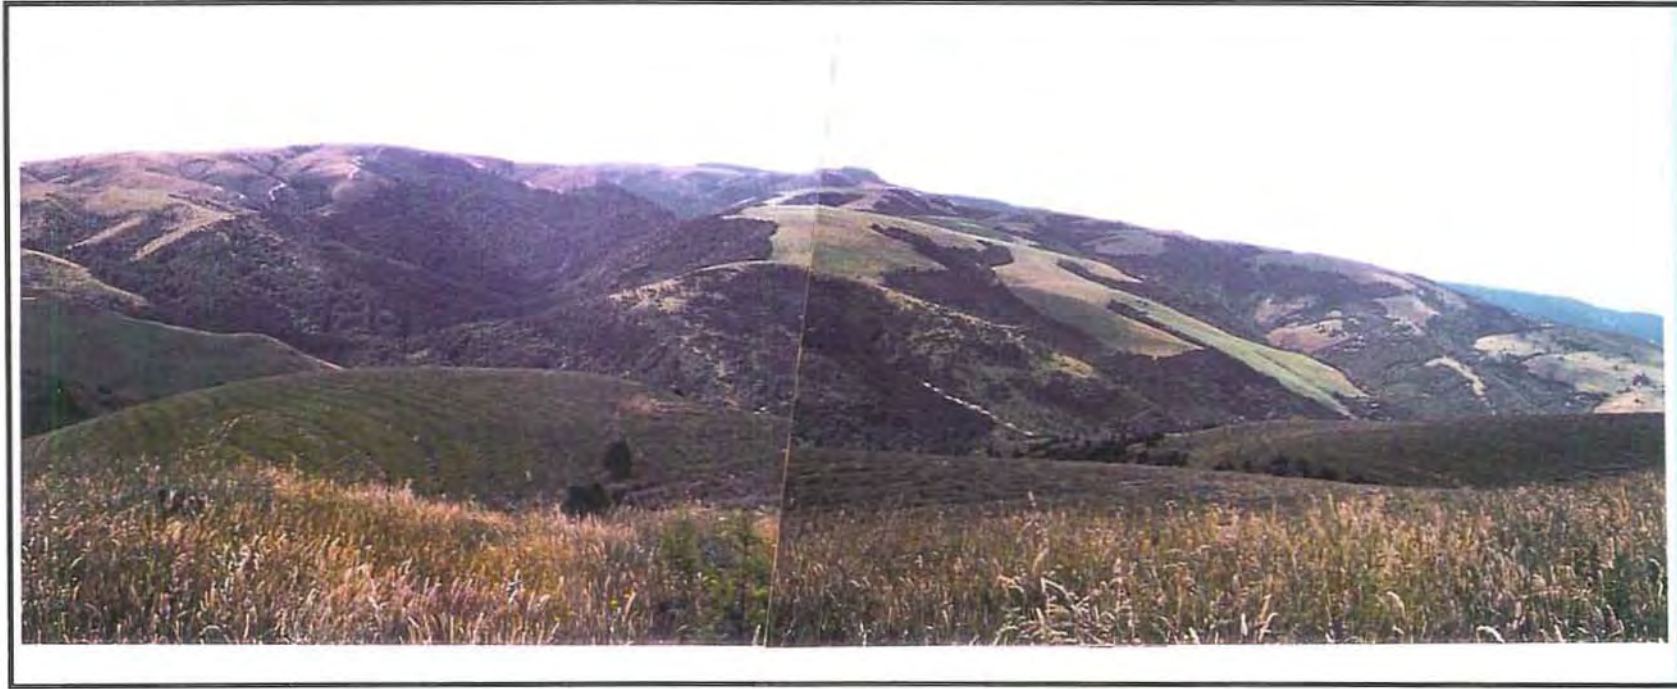
Photo 10: Looking east over the Bowlers Creek catchment from the neighbouring Halwyn property.
