**From:** [ s 9(2)(a) ]  
**Sent:** Thursday, 26 March 2009 2:34 p.m.  
**To:** [ s 9(2)(a) ]  
**Cc:** [ s 9(2)(a) ]  
**Subject:** 58 Akoranga Drive, Northcote - Stability and Drainage Issues  
**Attachments:** 10598 Response NCSS drain 260309.pdf

**LAND INSTABILITY & STORMWATER MANAGEMENT  
58 AKORANGA DRIVE, NORTHCOTE, AUCKLAND**

**LAND INSTABILITY & STORMWATER MANAGEMENT – 58 Akoranga  
Drive, Northcote, Auckland**

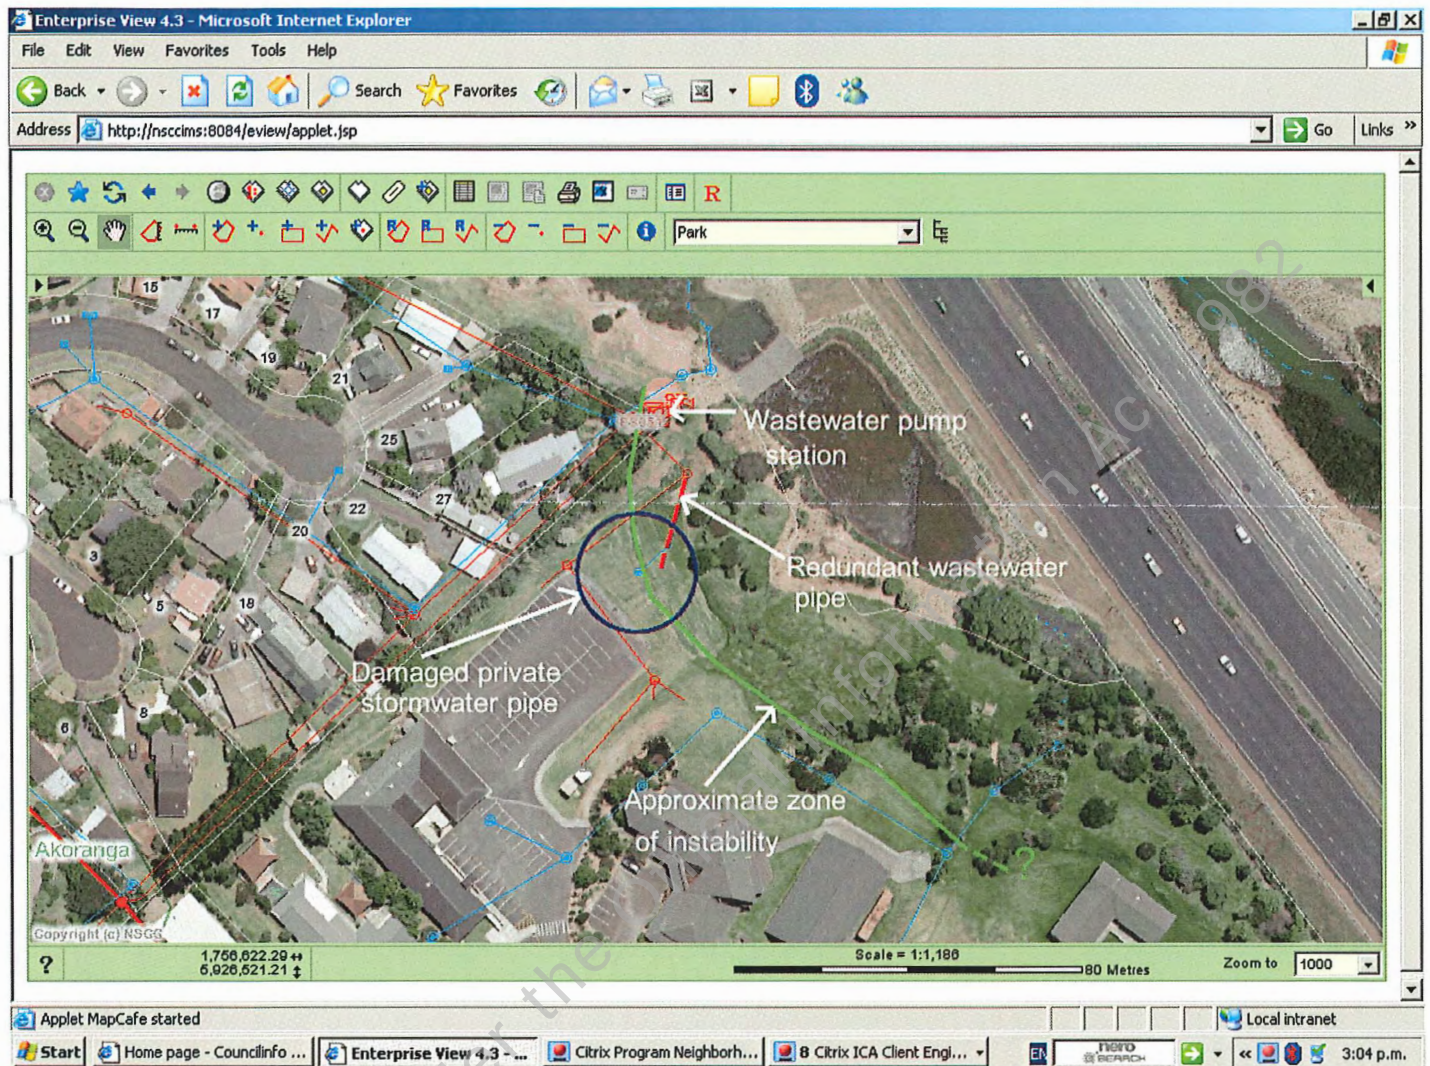
## 58 Akoranga Drive, Northcote - Screen print from Council GIS

For some time now council has been experiencing land instability issues around a public wastewater pump station, located adjacent to 27 Kitewao St, to the northwest of your site. In recent times this land deformation appears to have worsened and has compromised the integrity of the pump station and pipe network, putting the local wastewater network and surrounding environment at risk.

Several public pipes had experienced displacement or collapse. These public pipes have since been repaired. One privately owned pipe (draining the stormwater from the large car park beneath the health centre on 58 Akoranga Drive) was surveyed and was recorded as being damaged. This pipe appears to have been designed to collect rainwater runoff from the car park and discharge it onto the ground surface some distance down slope. A breakage in the pipe in the area of ground instability means that stormwater entering this pipe is being discharged directly into the ground. Stormwater entering the ground in this area may be contributing to the ground movement by acting as a lubricant between soil layers.

The stormwater pipe draining the car park needs to be repaired or redirected away from the area of instability. Your prompt action regarding remediation of the damaged stormwater drainage will be appreciated. Council will assist with advice on appropriate stormwater design (in reference to the issue at hand) if required.
