# Release notes for surveyors

Changes for surveyors as part of Landonline release 3.23

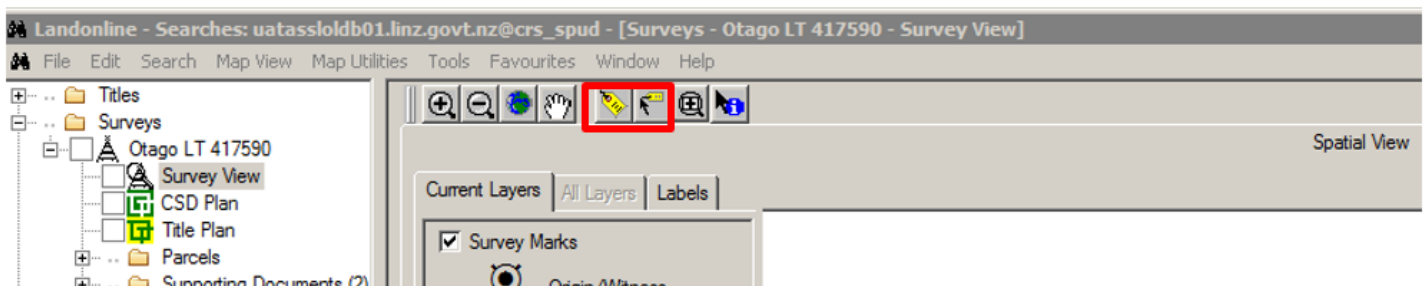
When trying to view labels in the 'Spatial View' of a plan, some labels were not displaying when they were selected using the label icons

When the 'Survey View' is opened from the Searches Tree, the Spatial View window opens up.

Selecting either of the two Label icons will now turn on the relevant label for each feature.

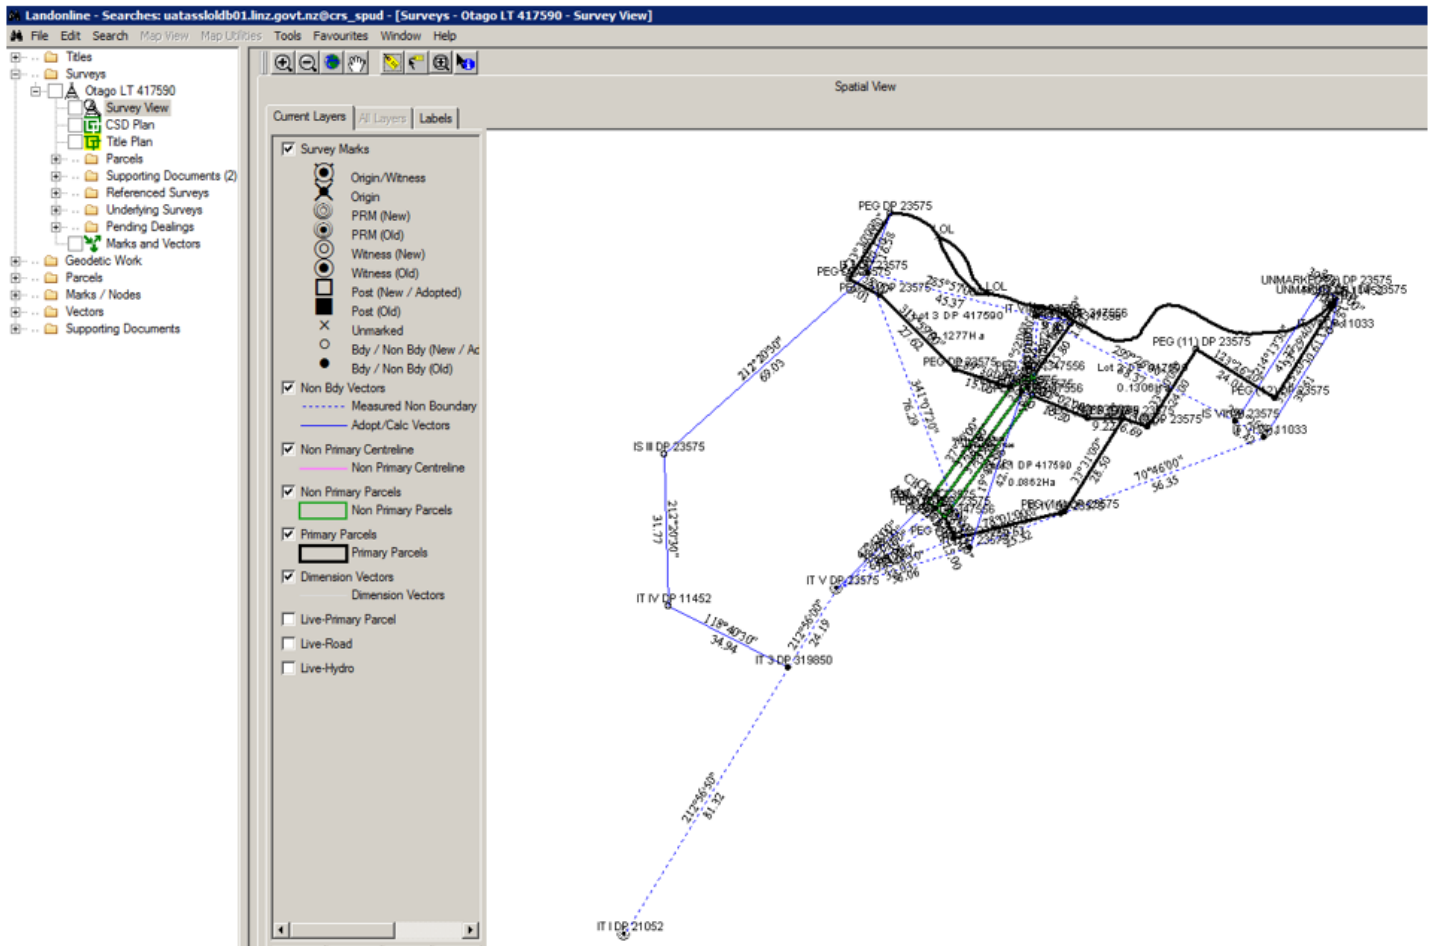
After clicking the large Label (selects all labels for features in an object) the vector and mark labels turn on

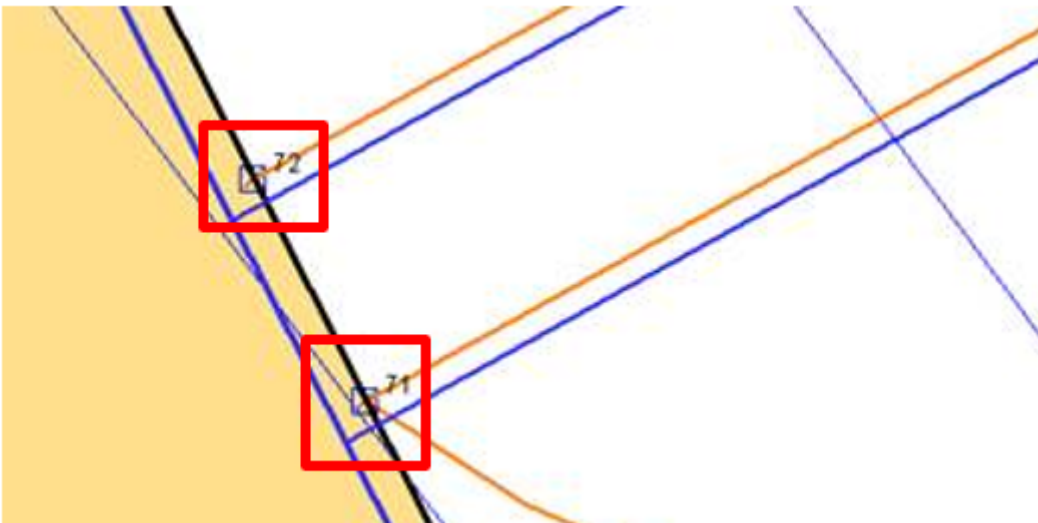
Defect in production, whereby we are seeing numerous plans that have parcels detached from their nodes after they have been linked. Unfortunately for the surveyor, it was not obvious that this has occurred.

Adjustment flag used in Plan Generation will reset every time the Layout Sheets are opened, to identify which routine to use in generating the parcel boundary lines to avoid the topology from becoming detached.
