# Maintaining and Enhancing Spatial Accuracy in the Digital Cadastre

NIC DONNELLY

21 October 2008

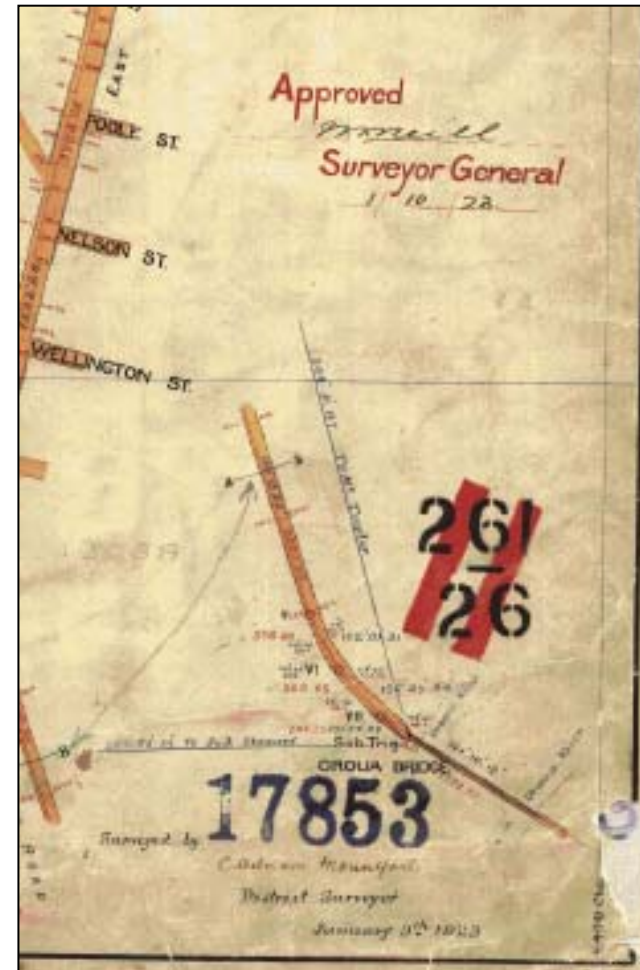
# Feilding Case Study

- Most observations from SO 13109 (1899 plan), some from SO 17853 (1923 plan)
- “Measurements are 1.7 links per mile too short” or 0.21m per kilometre (SO 13109)
- Variable OCD to geodetic bearing swings (-23 to -40 seconds)
- Difficulties for surveyors obtaining geodetic origins
- Difficulties for LINZ integrating data

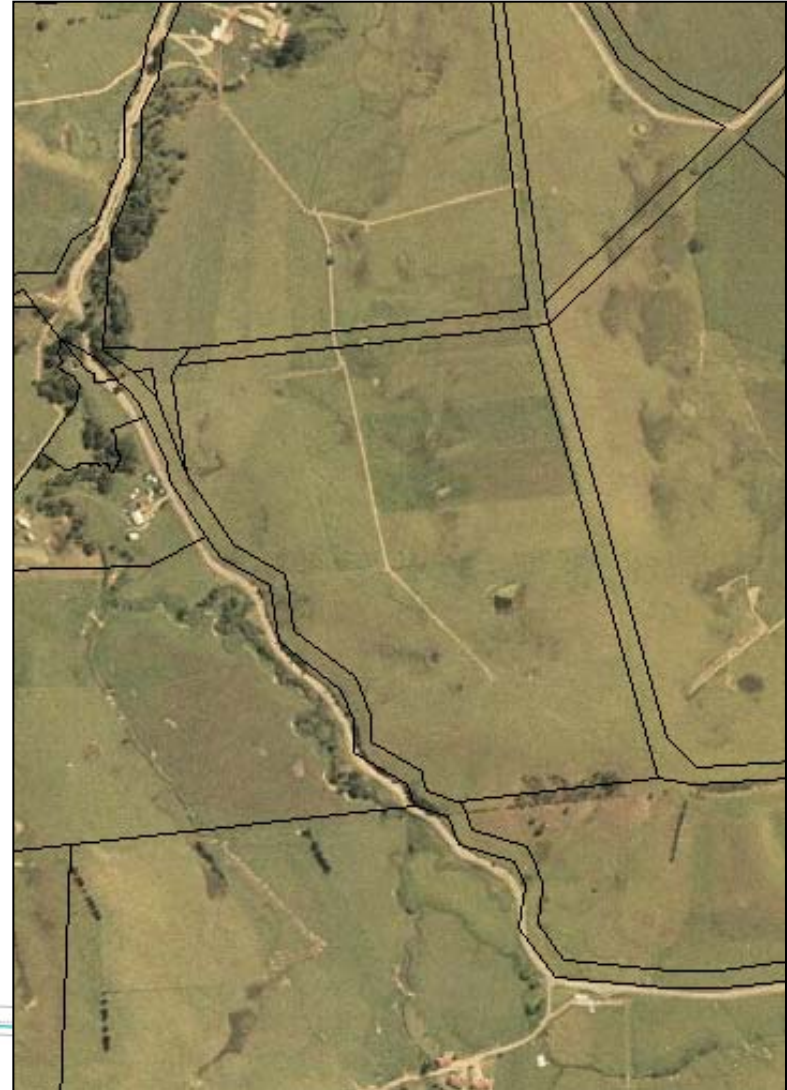
- Landonline data in non-SDC areas derived from digitised cadastral record maps
- Cadastre up to 50m out in rural areas
- Strong interest from local authorities and surveyors in having accurate parcel data
- Relative accuracy is often OK, but absolute accuracy may be poor

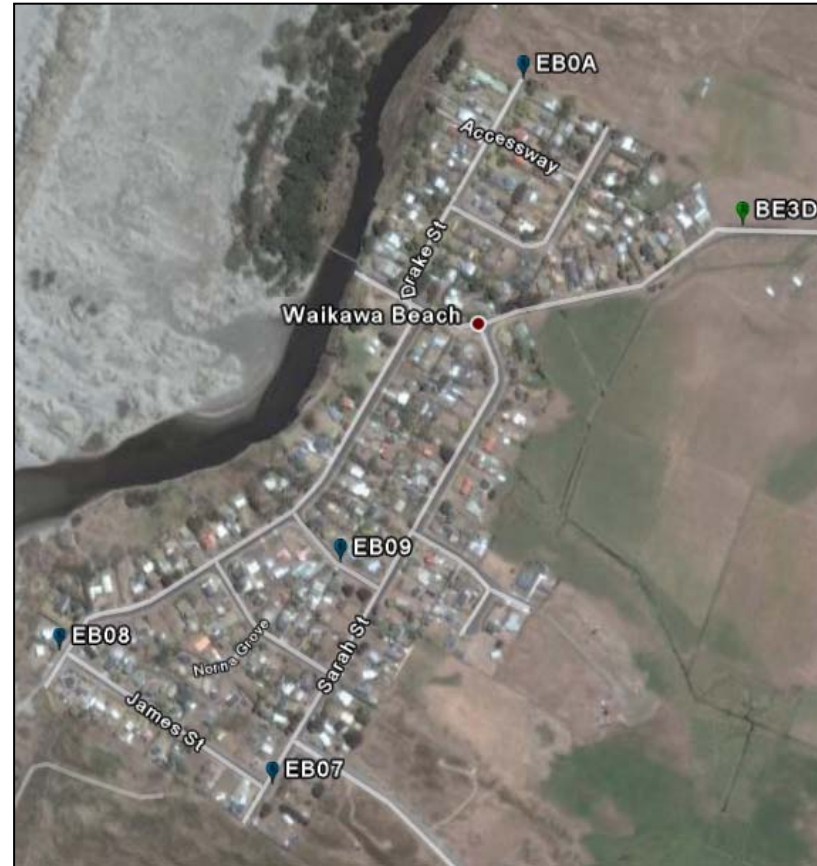
# Waikawa Beach Case Study

- New 5<sup>th</sup> Order control established at urban density
- Captured ties from control into boundaries
- Adjustment run holding these control marks fixed
- Error ellipses less than 2m at 95% CI – for many GIS users, this level of “visual” accuracy is sufficient
