**RE: REVIEW OF STONE RETAINING WALL STRENGTHENING AT NAPIER PRISON, 55
COOTE ROAD, NAPIER**

INTRODUCTION

APPENDIX A – Wall Strengthening Option

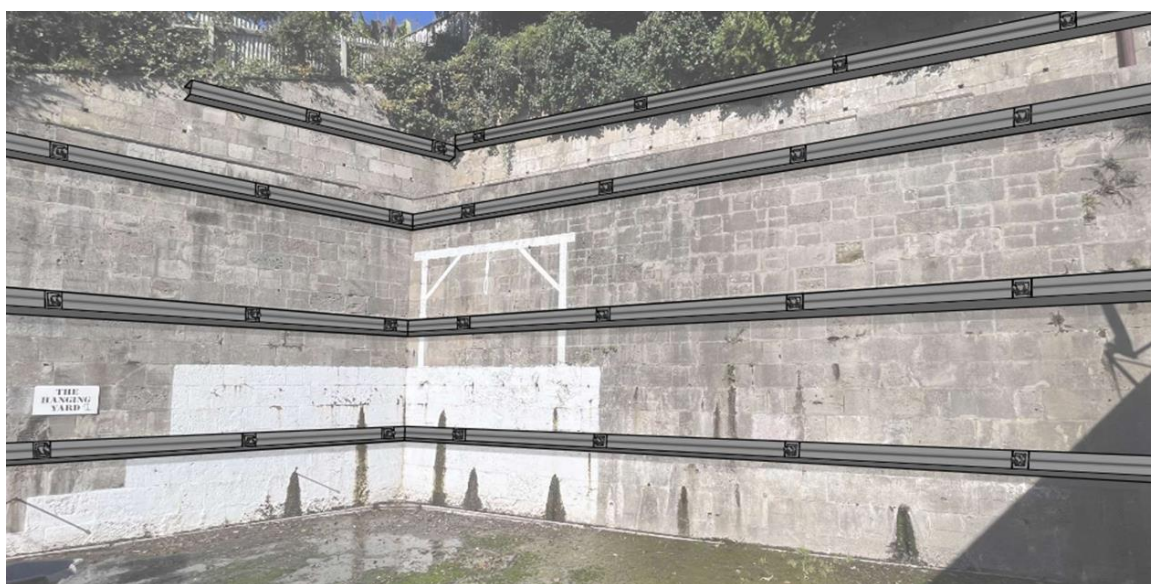
- Soil Nail Waler Beam Wall

Soil Nail Waler Beam Wall

- a) The visual impact of the walers is significantly impacting heritage values.
- b) The walers will collect debris and grow weeds, leading to potential corrosion issues.
- c) The wall is in the sea spray zone and will be difficult to prevent from corroding and hard to maintain.

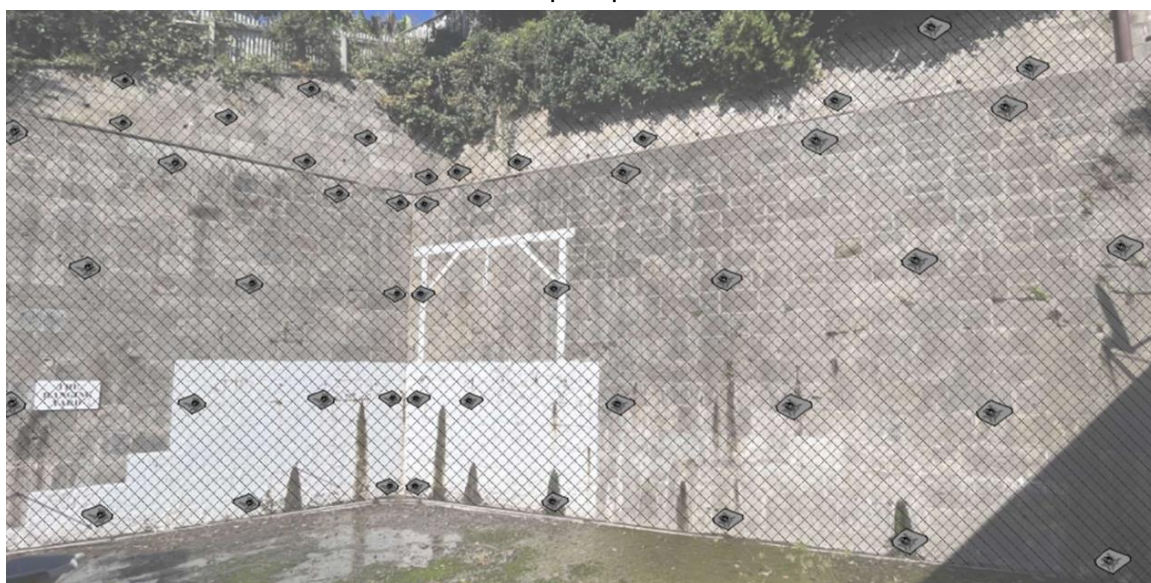
- TECCO G65/4 mesh wall with P33/50 N spike plates

TECCO G65/4 mesh wall with P33/50 N spike plates

- a) The visual impact of the mesh will significantly impact the heritage values.
- b) The mesh will collect debris and promote weed growth, which is likely to affect the face of the stonework and corrode the mesh.
- c) The wall is in the sea spray zone and will be difficult to prevent from corroding and hard to maintain.

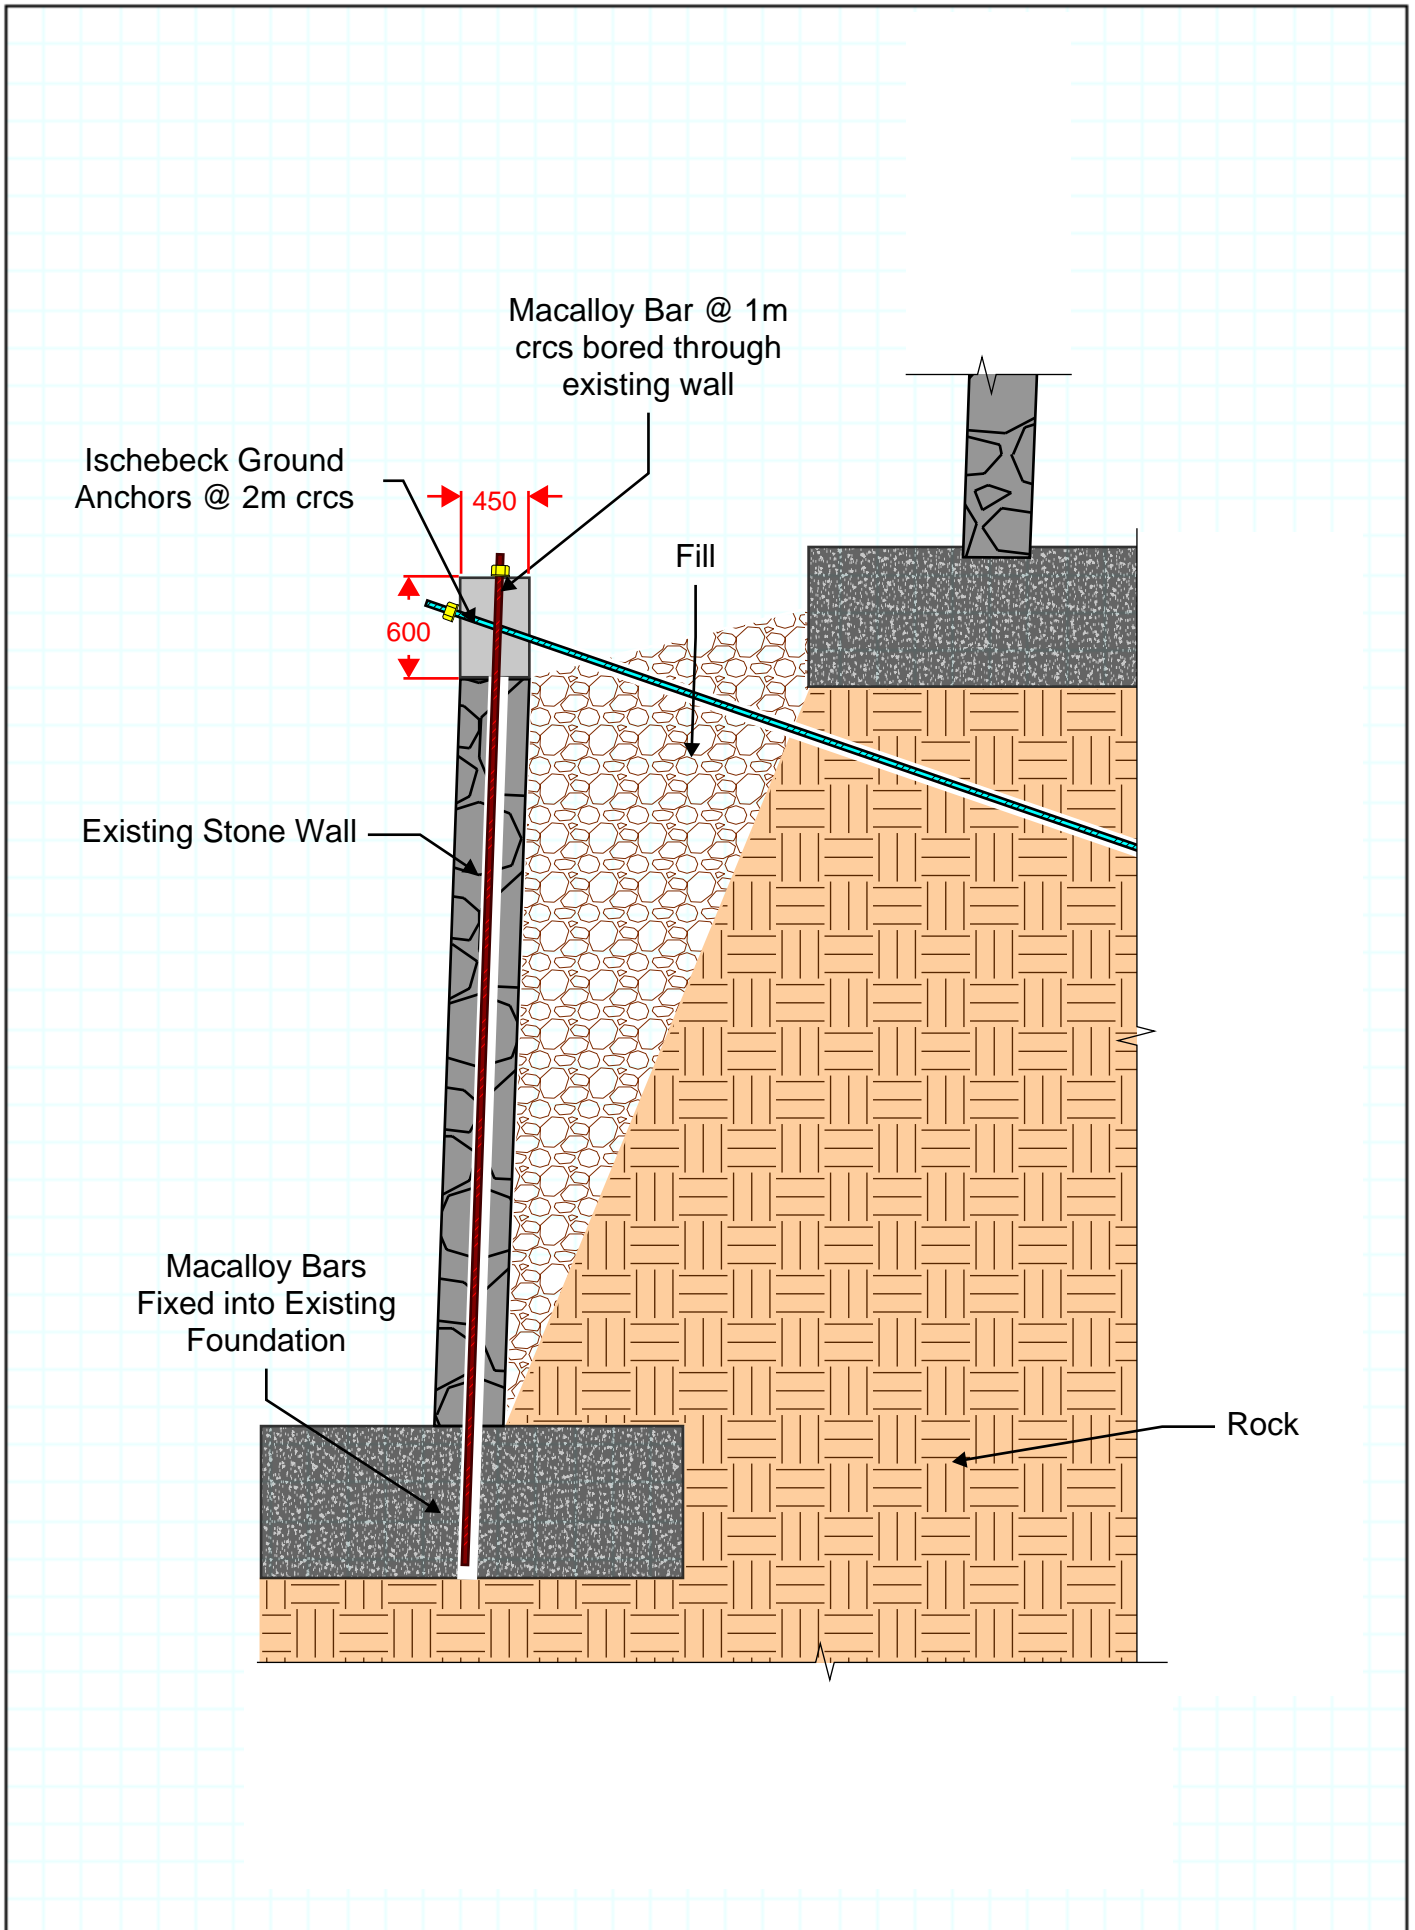
BMC note there are a number of options for providing strength to the walls, which will protect them from collapse in a moderate earthquake whilst retaining the heritage value of the walls. Many of these options involve installing structure either through or behind the wall to provide additional strength to the wall. Attached in Appendix A is one such solution that, once engineered and sized, will provide a more robust wall than is the current case. This solution may not provide the full seismic restraint as either of the Aurecon schemes, however, it is, in our opinion, more in keeping with conservation practices.
