# Napier Ex Prison Retaining Wall Assessment

Concept Design Report

Land Information New Zealand

Reference: 520969

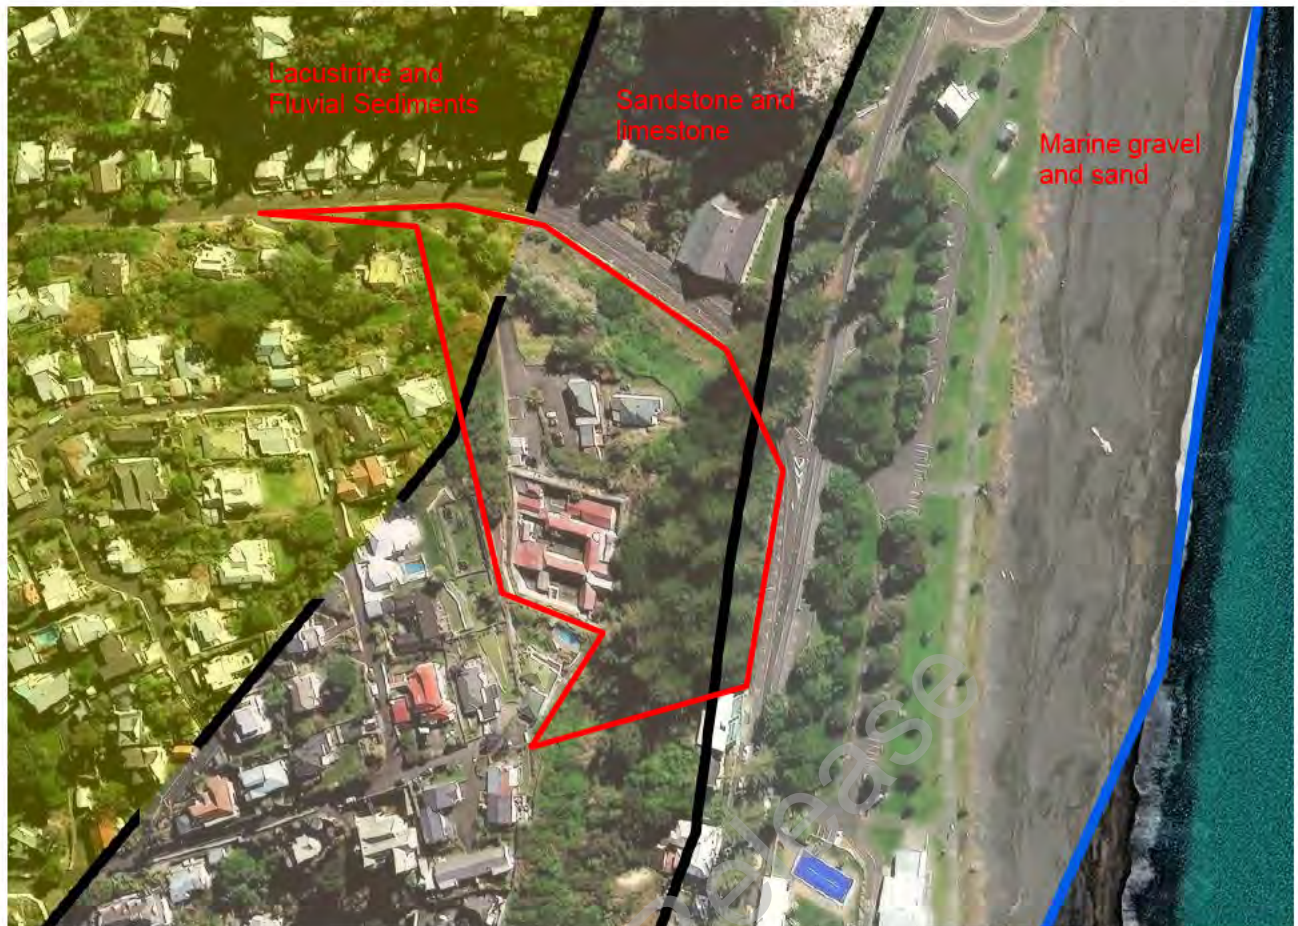
Figure 1: GNS Science (2013) mapped geology of the Napier Ex Prison site, 1:250k scale.

The geology of the centre of the site and the prison location is mapped as 'Late Pliocene Scinde Island Formation' and described as 'calcareous, cross-bedded sandstone and limestone' by Geological and Nuclear Science (GNS Science, 2013). The geology to the east of the prison, is mapped as 'Holocene ocean beach deposits' and described as 'unconsolidated marine gravel, sand and mud on modern beaches'. The geology of the northwest corner of the site, Bluff Hill and Hospital Hill has been mapped as 'early Pleistocene river, lake and intertidal deposits' and described as 'lacustrine and fluvial sediments'. The mapped geology is present in Figure 1.

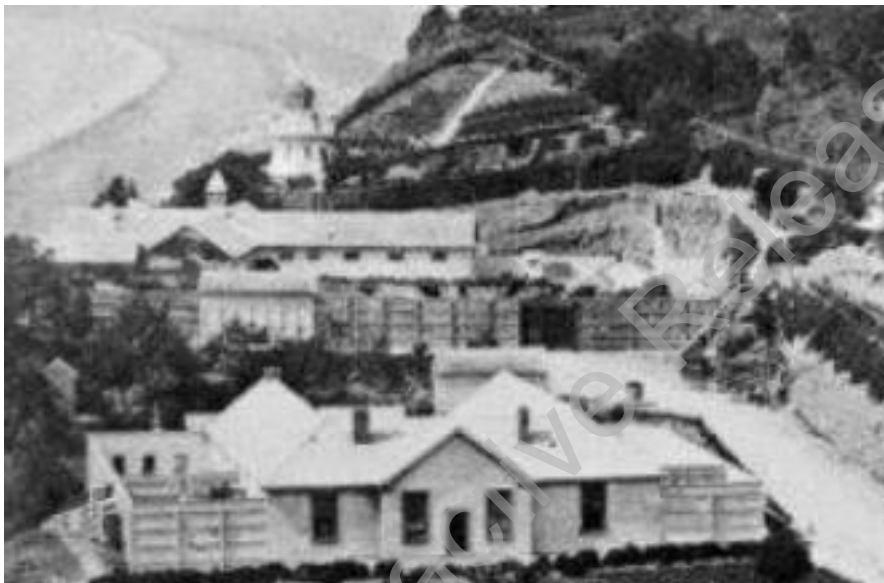
Figure 2: Napier Prison in the 19<sup>th</sup> Century (Napier Prison Tours, 2023).

An early photo of the prison appears to show a cut slope with exposed rock in the retaining wall locations to the west and south of the prison as shown in Figure 2 (Napier Prison Tours, 2023). Another photo shows a cut slope with exposed rock at the Centennial Gardens approximately 200m north of the site as shown in Figure 3 (Napier Prison Tours, 2023). The Centennial Gardens have the same mapped geology as the site and the area was used as a rock quarry.

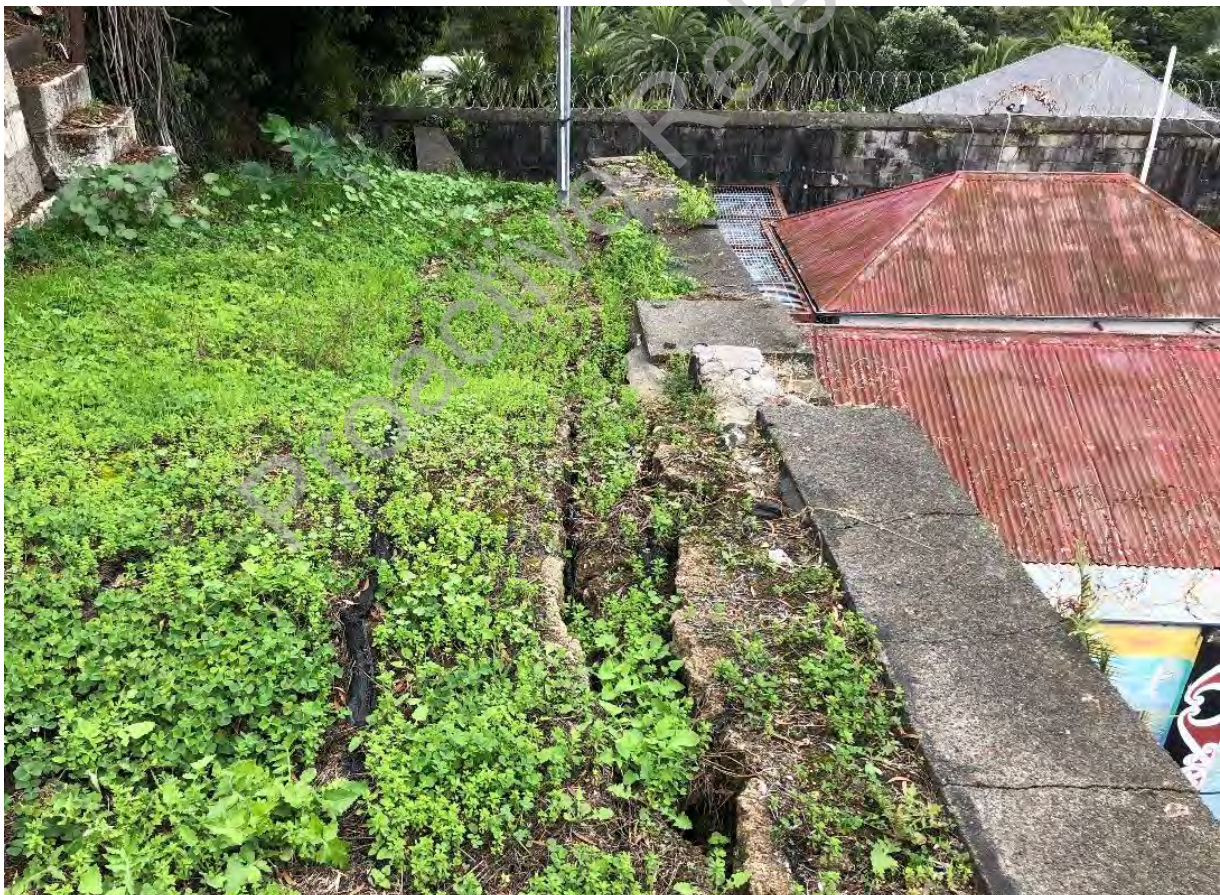
During the first and second site inspections, tension cracks were observed in the silt above Retaining Wall RW10. Single tension cracks were measured to be up to approximately 0.2m wide and 0.4m deep. These cracks have likely formed within a silt backfill between the gravity Retaining Wall RW10 and a cut rock face after movement of the retaining wall. Photos of these tension cracks are presented in Figures 4 and 5.

Figure 4: Tension cracks in the inferred silt backfill behind Retaining Wall RW10 during the site inspection between 14 and 17 March 2022.

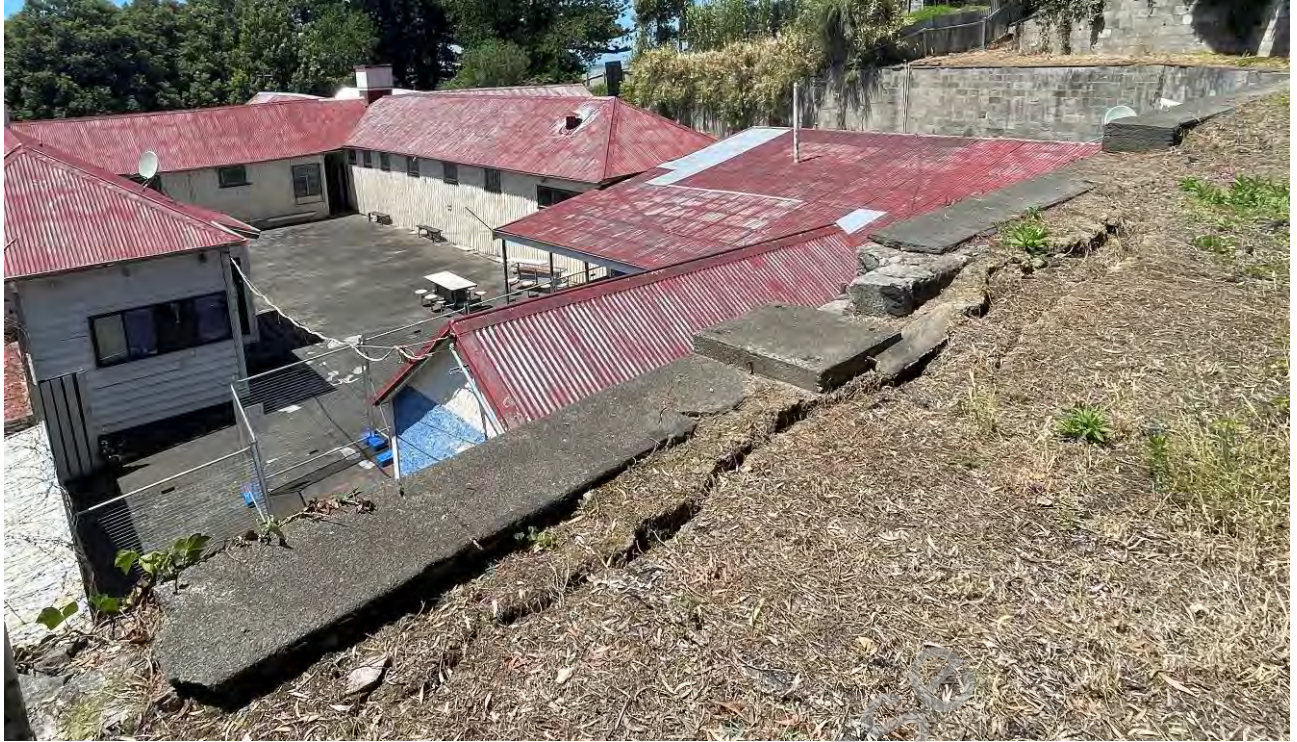
Figure 5: Tension cracks in the inferred silt backfill behind Retaining Wall RW10 during the site inspection on 24 November 2022.

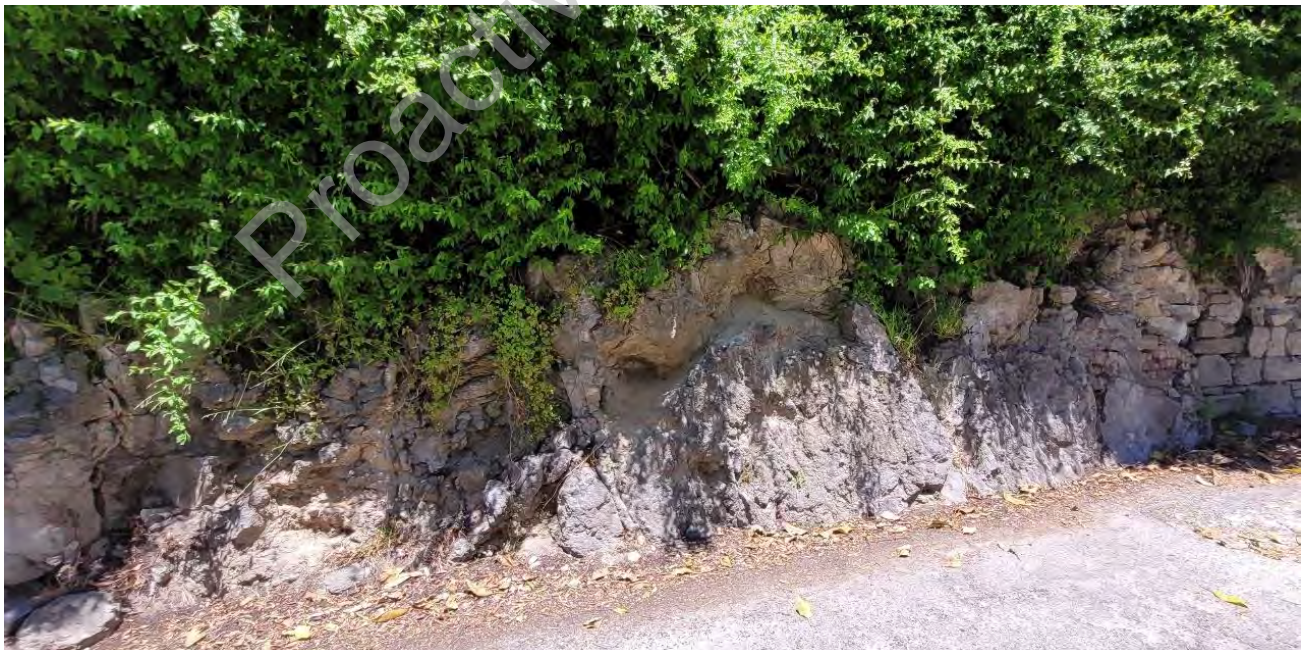
During the site inspections, approximately vertical rock faces were observed above the site access driveway, likely exposed during the construction of the driveway. These limestone rock faces are likely similar to other cut slopes at the site including those covered by the retaining walls around the prison. Photos of these rock faces are presented in Figures 6 and 7.

Figure 6: Exposed cut limestone rock face along site access driveway on 22 November 2022.

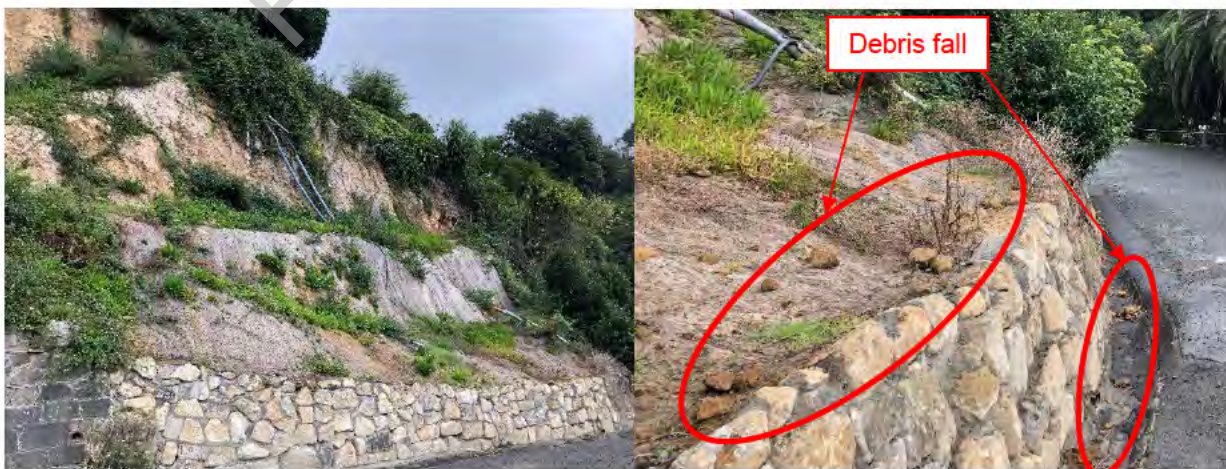
During the site inspection between 14 and 17 March 2022, small pieces of debris were observed on top of and below Retaining Wall RW6 indicating ongoing erosion as shown in Figure 8. During the inspection on 22 November 2022, the vegetation on the slip had increased from the previous inspection and more debris was observed at the base of the slip and the retaining wall as shown in Figure 9. During the inspection on 17 February 2023, larger pieces of debris were observed below the existing slip as shown in Figure 10. This larger debris fall was likely caused by rainfall events between 22 November 2022 and 17 February 2023, including Typical Cyclone Gabrielle.

Figure 8: Retaining Wall RW6, the existing slip and loose debris during the site inspection between 14 and 17 March 2022.

Retaining Wall RW6 is a stone block gravity retaining wall situated on the uphill side of the site access driveway (western side). In Aurecon's Memorandum '520969 – Napier Ex-Prison – Retaining Wall Assessment – Stage 2 Risk Assessment', the wall was assessed to be in a fair condition and likely recently constructed after the slip above. Photos of the wall are presented in Figures 8, 9 and 10.

During the site inspections, an existing slip was observed above Retaining Wall RW6. The slope where this slip had occurred was benched and matting and broken service pipes were observed on the slope. Observations of this slip over time are detailed in Section 3.4.3. In summary, debris has continued to fall from this slope onto the top of Retaining Wall RW6 and the site access driveway. Photos of the slip are presented in Figures 8, 9 and 10.

As the condition of Retaining Wall RW6 has been assessed as fair, replacement or remediation of this wall is not recommended. Aurecon recommends the existing slip is remediated by installing MacMat R, a reinforced geomat, over the slope. MacMat R is a product by Maccaferri, which is designed to control slope erosion. This geomat needs to be pinned down with shallow soil nails, ideally while works occur elsewhere on the site. The MacMat R brochure by Maccaferri is included in Appendix G.

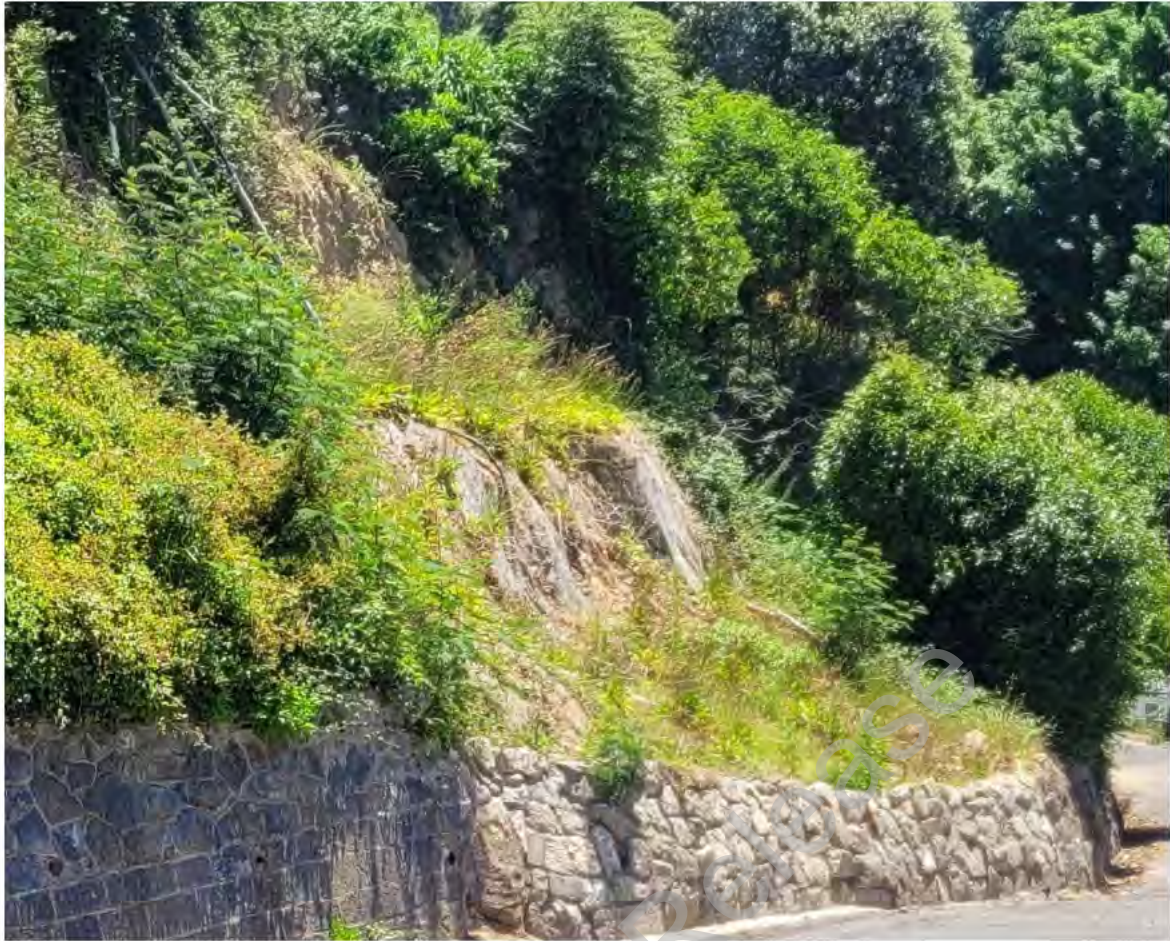
Figure 9: Retaining Wall RW6 and the existing slip with increased vegetation cover on 22 November 2022.

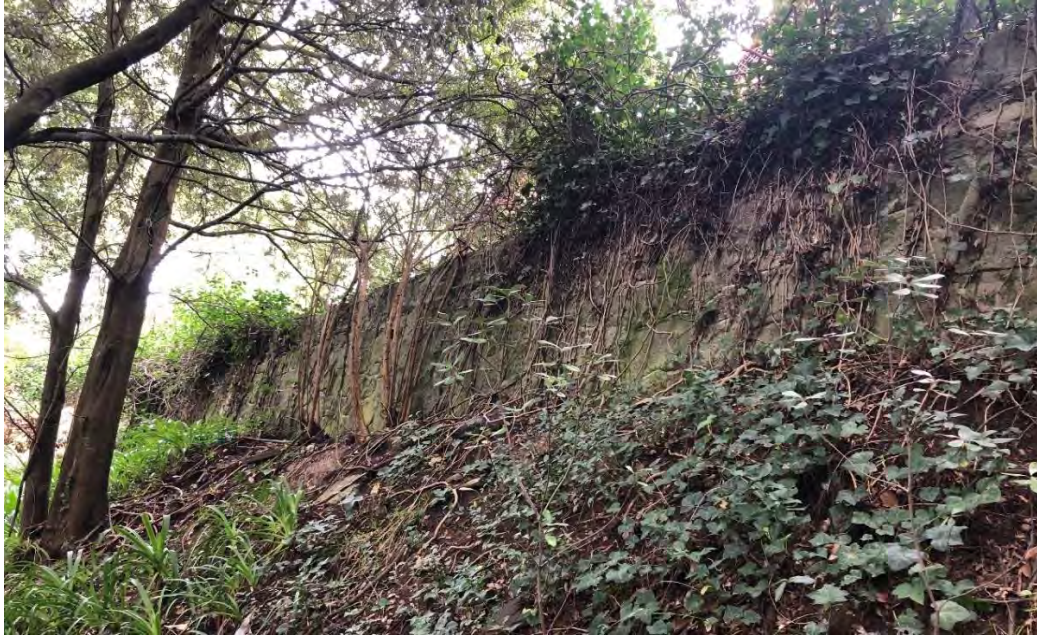
Retaining Wall RW19 is a stone block gravity retaining wall situated below the prison along the eastern edge. The failure of this wall poses a low risk to life but a high risk to the prison building foundations and services. This wall is noted to be in a deteriorated condition. A photo of this wall taken during the initial site works is presented in Figure 11.

In Aurecon's Memorandum '520969 – Napier Ex-Prison – Retaining Wall Assessment – Stage 2 Risk Assessment', it was noted that the failure of Retaining Wall RW20 at the northernmost end may cause Retaining Wall RW19 to be undermined.

Figure 11: Retaining Wall RW19 during the initial site works between 14 and 17 March 2022.

Due to the deteriorated condition of Retaining Wall RW19, Aurecon recommends that maintenance is undertaken on the wall by removing vegetation. We note that there is the potential to adversely affect the wall by vegetation clearance. In addition to maintenance, if the wall is to be preserved, the installation of soil nails with active mesh is recommended. The soil nail design for this wall could be based on the detailed soil nail design for the Group 1 retaining walls once completed. Active mesh is recommended to prevent individual blocks falling out of the wall. Visual effects of the active mesh have been assessed as low due to the wall being below the prison and covered by vegetation from most viewpoints. Alternatively, Retaining Wall RW19 could be demolished and replaced with a timber pole retaining wall, but the feasibility of this option will need to be confirmed once intrusive ground investigations are completed.

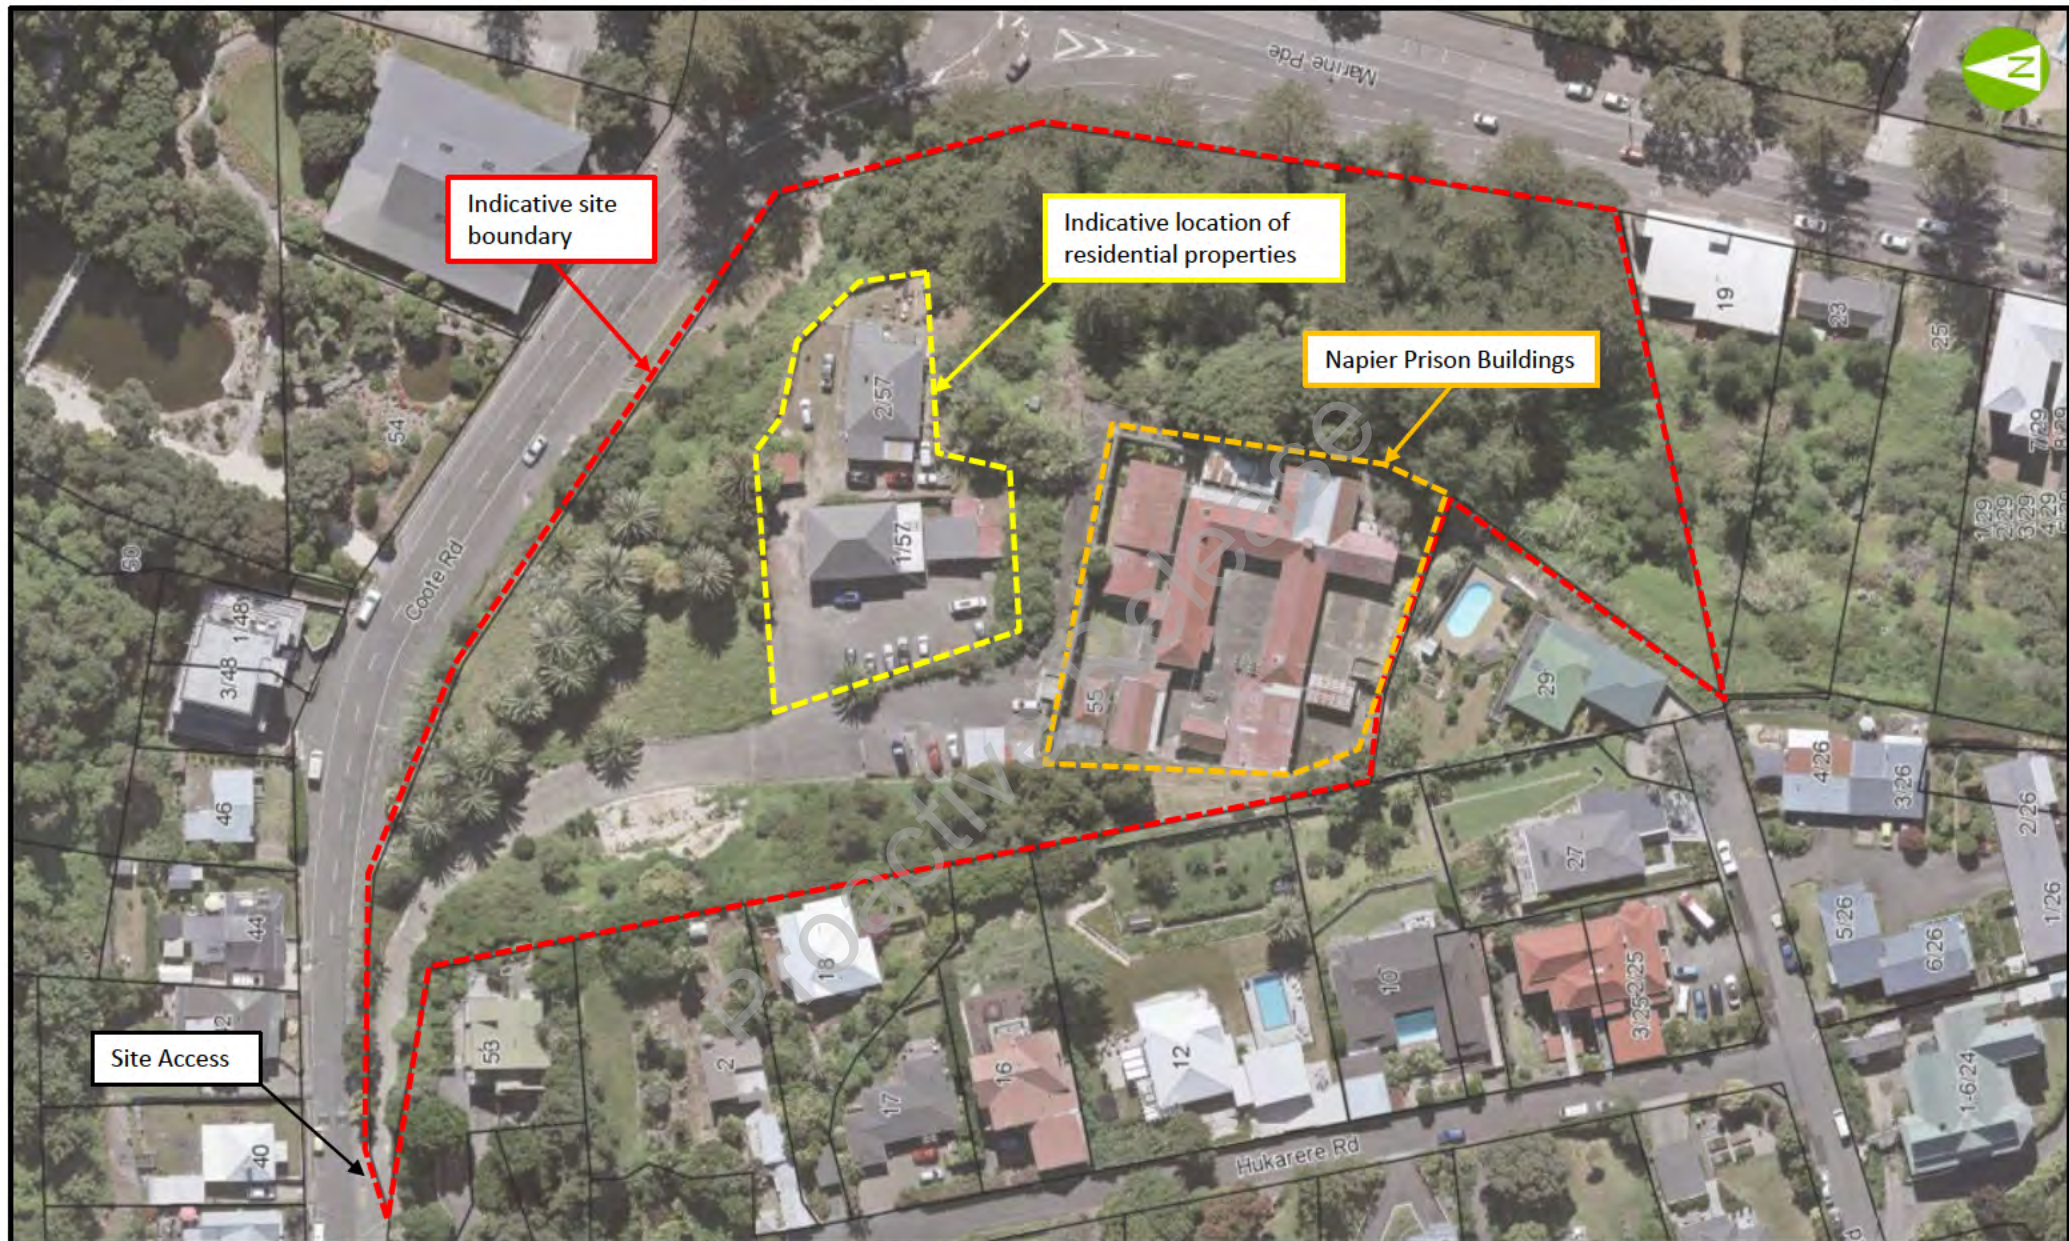
CLIENT	PRELIMINARY NOT FOR CONSTRUCTION	ALL DIMENSIONS APPROXIMATE ONLY	SCALE	SIZE	TITLE
			NTS	-	SITE LOCATION PLAN
FIGURE	FIGURE 1		BY		
			A. HILLS		
PROJECT	NAPIER PRISON – RETAINING WALL ASSESSMENT		REVIEWED		REFERENCE
			J. MUIRSON		BACKGROUND IMAGE RETRIEVED FROM: HTTP://WWW.GIS.NAPIER.GOV.NZ/INTRAMAPS80/DEFAULT.HTM?PROJECT=NCC&MODULE=PROPERTY
			DATE	FIGURE No.	
			5 SEPTEMBER 2022		
				PROJECT	WBS
				520969	000
				TYPE	DISC
				FIG	GE
				NUMBER	REV
				01

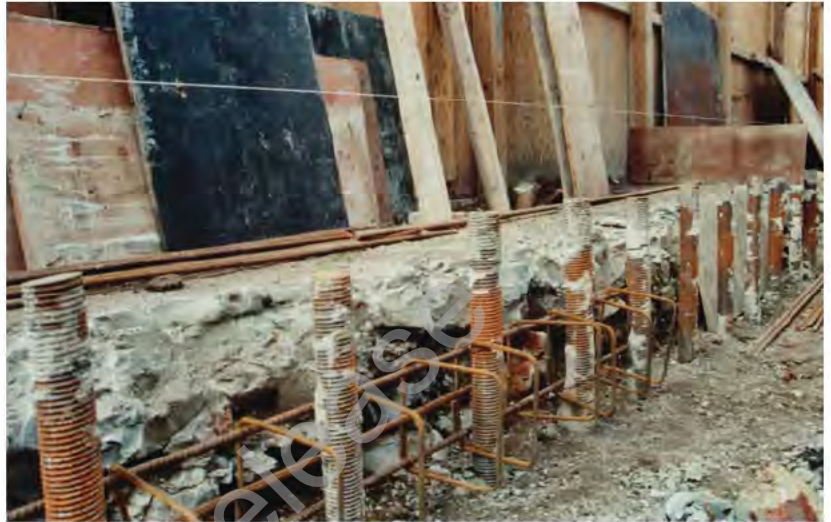
The construction of a 3.5m deep basement at a private residence in London made full use of Ischebeck Titan micropiles. Some 150No. 6m long 73/45 micropiles were installed using a cross-cut drill bit. The micropiles formed an integral part of the substructure with the base and ground floors.

- 150No. 6.5m 73/45 micropiles
- 175mm cross-cut drill bit
- Gravels over sand overlying stiff clay

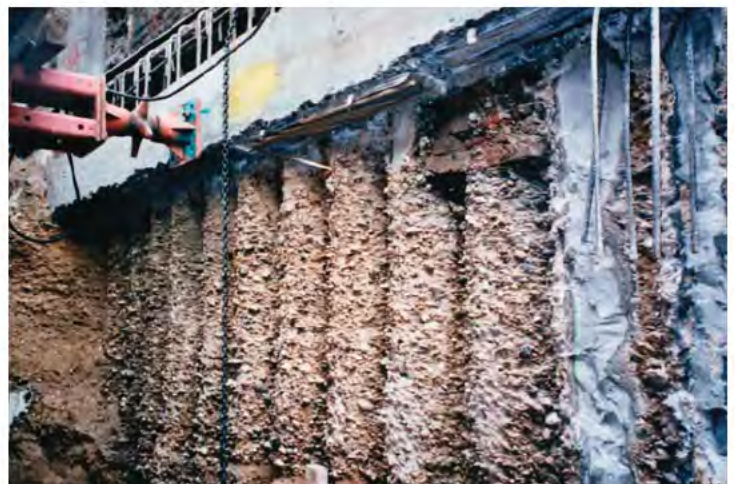
Construction of a double basement to the front and rear of the garden and under the existing house. Ischebeck Titan micropiles were used as temporary works in two forms; Firstly for soil retention and then for support to stabilise the sway frames to allow for plant access. Approximately 50No. 8m 127/111 piles were installed using a 220mm drill bit for the soil retention and 30No. 9m 40/20 piles were installed for the sway frames.

- 40/20 and 127/111 micropiles installed into dense gravels
- Confined access
- 127/111 tendon exposed and used as part of permanent works

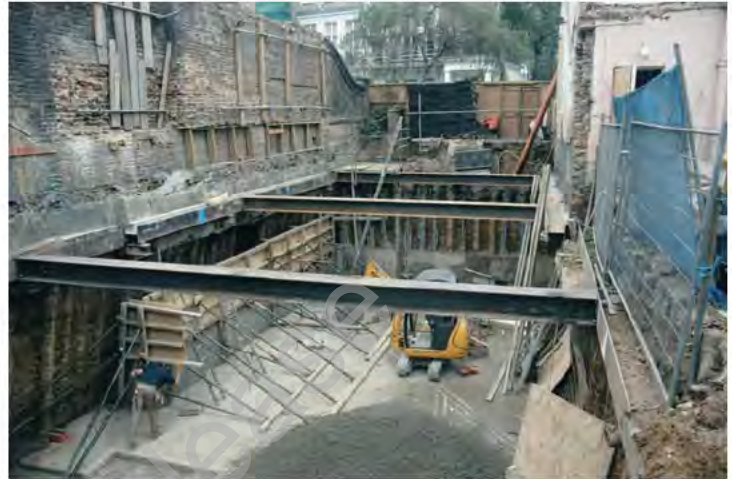
Redevelopment and conversion of two adjoining properties into a single prestigious residence. To accommodate a new basement the end property had to be demolished and rebuilt, but this left the problem of excavating the 4.5m deep basement adjacent to the neighbouring property and garden/boundary wall on the other side. Traditional underpinning would have proved a costly and risky operation and bored piling was ruled out as the client wanted to maximise the basement's footprint.

- 7.5m 127/111 micropiles installed
- Piles installed both vertically and raked
- Grout broken off front of piles to maximise footprint

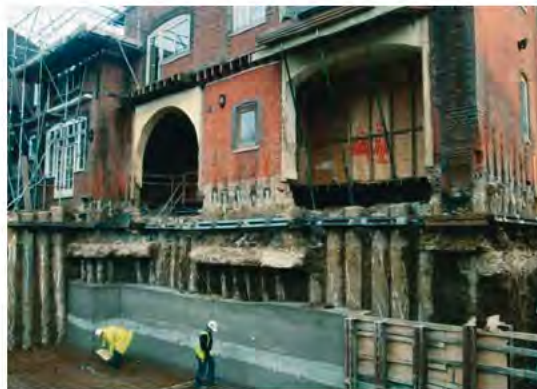
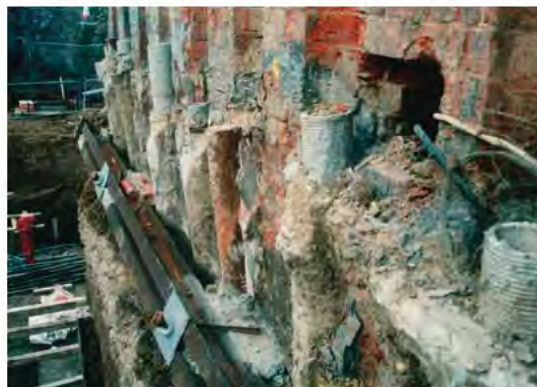
Construction of basement to the rear of garden to accommodate a swimming pool. Ischebeck Titan micropiles were used as temporary works for soil retention as an alternative to traditional underpinning. 127/111 piles used in conjunction with temporary 30/14 ground anchors installed under the existing house. This eliminated the need to prop internally, thus freeing up workspace, allowing improvement on the programme. Approximately 40No. 9m 127/111 piles were installed using a 220mm drill bit for the soil retention and 20No. 9m 30/14 ground anchors.

- 127/111 micropiles plus 30/14 ground anchors
- Quicker and safer than traditional methods of soil retention
- Micropiles raked under the house to maximise basement footprint

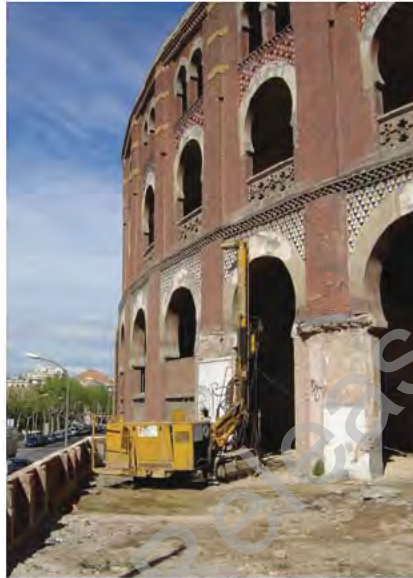
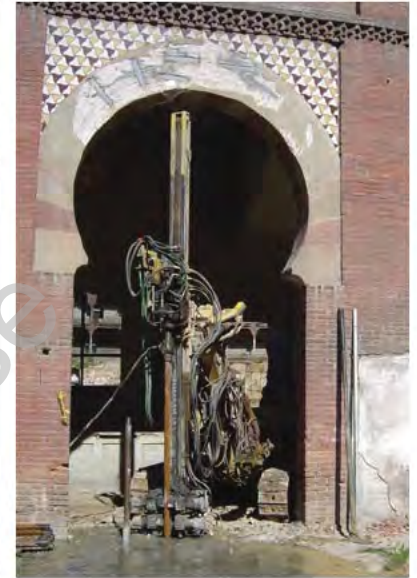
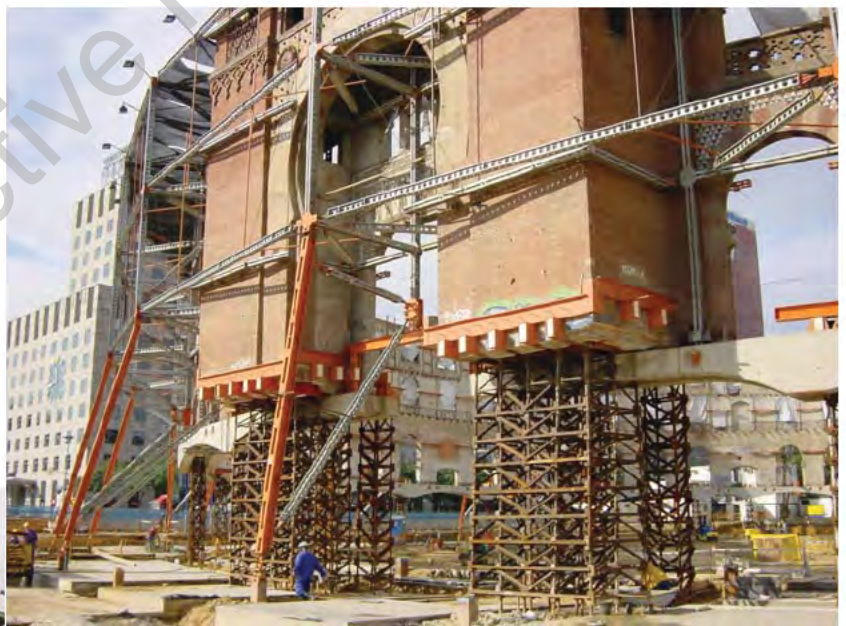
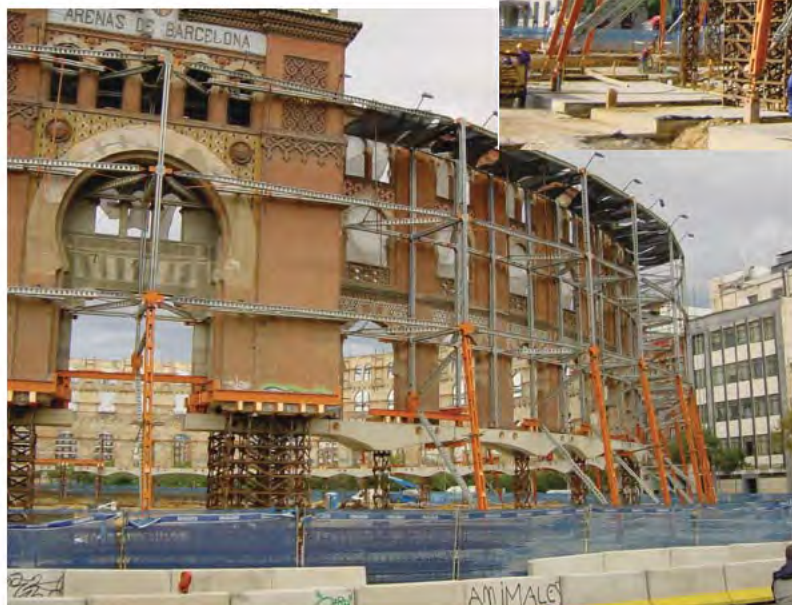
This impressive project to create a new commercial centre with underground parking within the historic façade of Barcelona's main bullring admirably demonstrates the potential of Ischebeck Titan micropiles. Consultation at the early stages of project design was the key to its success..

In order to retain the original structure's imposing and symbolic façade, it was supported by micropile columns installed at intervals around the structure. Parallel in-situ concrete beams were used inside and outside to distribute the weight of the freestanding façade. The interior of the structure was removed and excavation commenced to create the five levels of underground parking.

- 21m 73/53 Micropiles
- Underpinning Roman bullring
- Historic façade retained

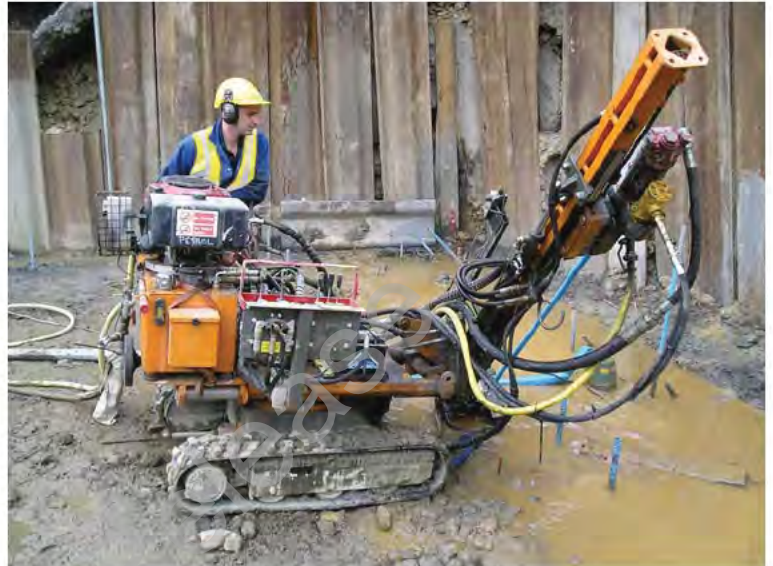
Private housing development to build eco-friendly home. Micropiles used to anchor house's split-level base slab. Total of 36No. vertical and raked 30/11 combi-coated micropiles installed through boulder clay and sandstone to 9m depth. Restricted access required mini Marini Voyager drilling rig with MA100 rotary percussive head.

- Restricted access
- Anchor split-level base slab
- 30/11 combi-coated micropiles

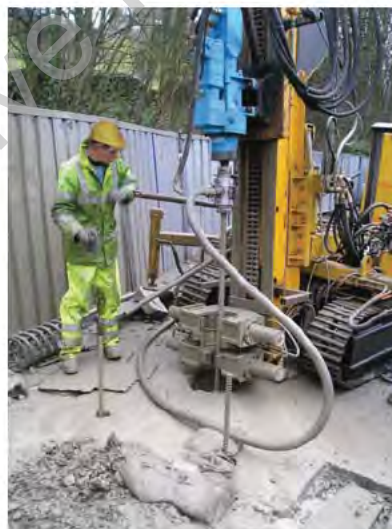
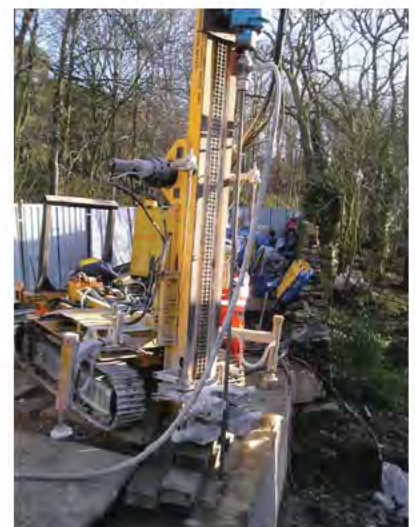
Collapsed retaining wall very close to the wing wall of a house required stabilisation. A concrete block initially poured to prevent further collapse of the road edge. Scheme combined 40/16 micro piles and 30/11 soil nails to stabilise road whilst spoil material excavated. Piles installed at 0.5m intervals through concrete block to about 12m in the underlying soft material and then into sandstone, creating contiguous piled wall. As spoil material excavated in front of vertical wall rows of soil nails were installed to prevent any lateral movement. Soil nails installed to 9m into sandstone.

- Combined micropile/soil nail solution
- 40/16 micropiles to 12m. 30/11 soil nails to 9m
- Contiguous piled wall

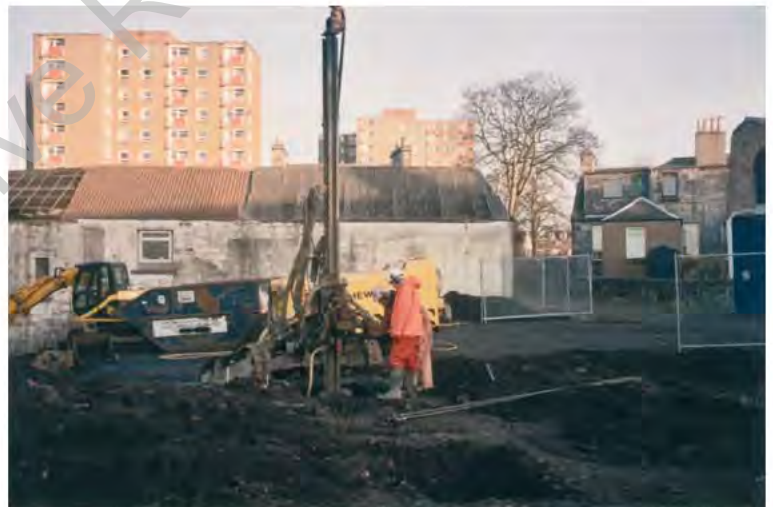
Private housing development comprising two-storey flats of timber frame construction. Ground conditions of made ground and clay over sandstone dictated that foundations be stabilised. A total of 29No. 30/16 black micropiles installed to depth of 9m using 95mm hardened clay drill bit. Piles used in compression to vertical load of 75kN.

- 30/16 black micropiles
- Vertical pile load 75kN in compression
- Made ground and clay over sandstone

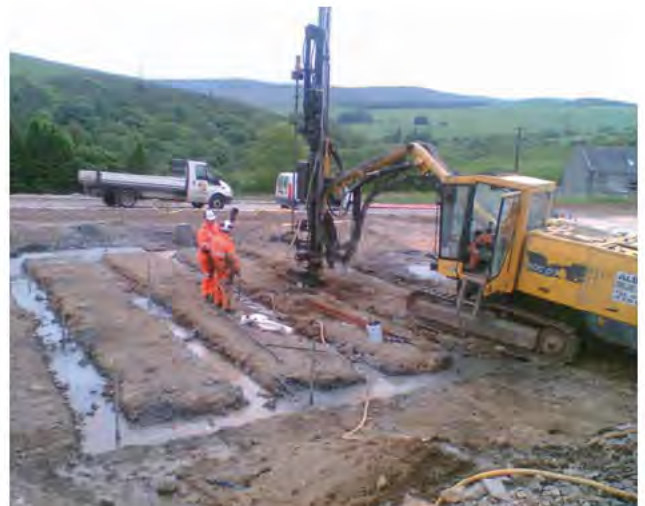
Private housing development of fourteen new timber framed homes constructed on former quarry site. Ground conditions of up to 15.5m of made ground on very strong limestone demanded that foundations be stabilised. A total of 52No. 40/20 black micropiles installed to depths of 17m and 10.5m using 70mm button drill bit. Piles used in compression to vertical load of 170kN.

- 40/20 black micropiles
- Vertical pile load 170kN in compression
- Made ground on very strong limestone

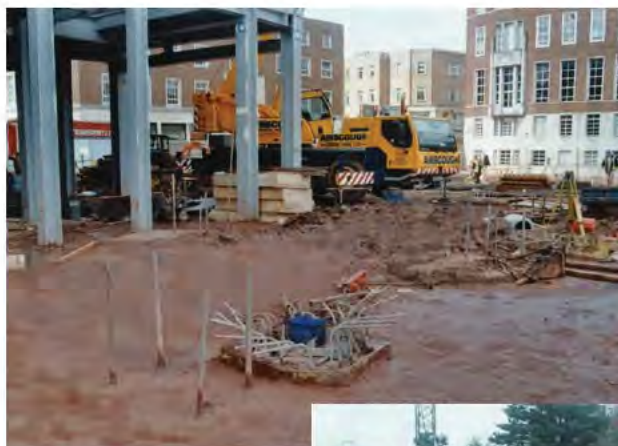
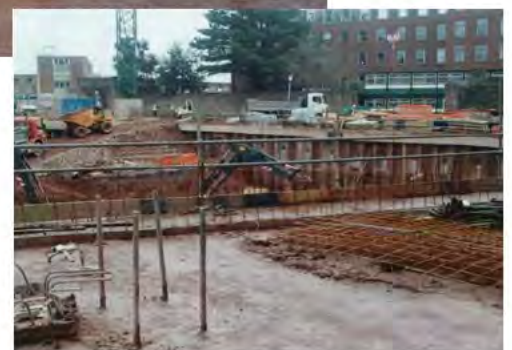
Demonstrating the versatility of the Ischebeck Titan solution, this retail construction project utilised 40/16 micropiles to anchor the base of a tower crane on ground consisting of clay overlying gravelly clay. The micropiles were installed as groups of four in several locations throughout the development site.

- 40/16 micropiles
- 150mm hardened clay drill bit
- Clay overlying gravelly clay

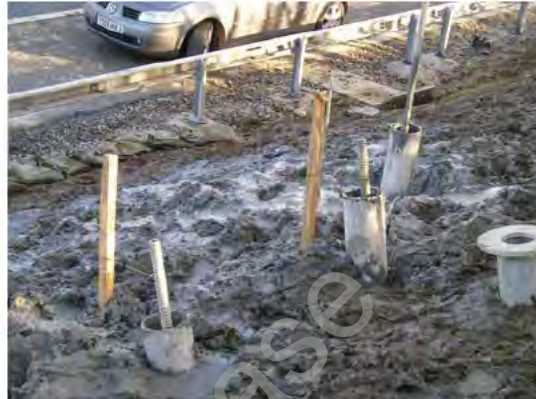
MS4 signal gantry bases and foundations for signal upgrade on M40 between junctions 9 and 11. Ischebeck Titan provided micropile foundations where bases were situated over harder/rocky material which would prevent installation of contractor's auger piles. Eleven bases installed, each with 8No. 10m long 40/16 micropiles with ultimate load carrying capacity of 660kN. Drill mounted on excavator arm and drilled mostly from hard shoulder which enabled crash barriers to remain in place. The work was successfully carried out under a single lane closure and has led to further contracts.

- Motorway signal upgrade
- 40/16 micropiles
- Single lane closure

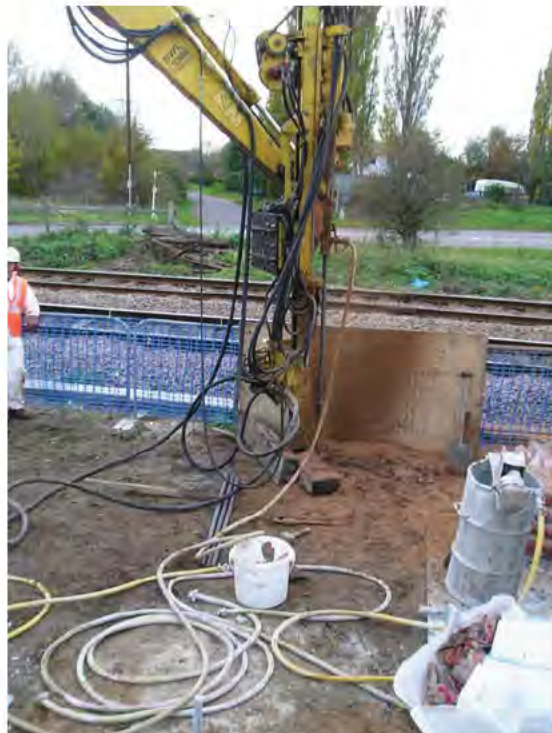
Approximately twenty GSRM bases have been constructed for Network Rail as part of the emergency communications network which allows the driver to talk to the control station. The bases have been constructed using 40/20 micropiles to an average of 12m depending on underlying ground conditions. Each base has between 4No. and 8No. micro piles depending on size of the antenna required.

- 40/20 micropiles
- Network Rail communications antennae
- Average 12m depth

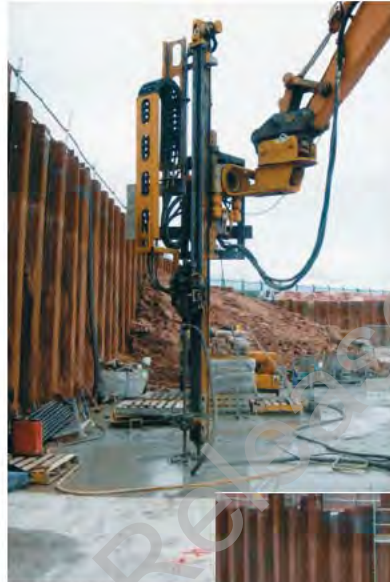
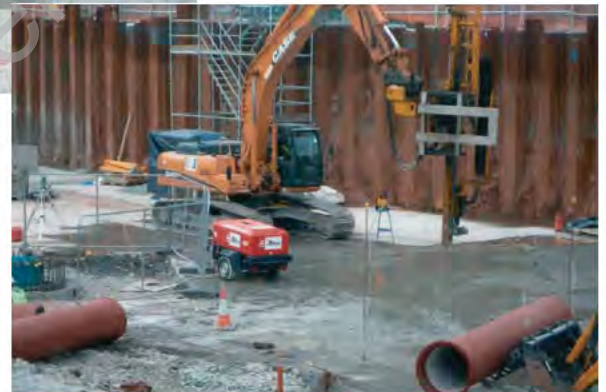
This scheme was part of a waste water treatment works upgrade, which involved installing tension micropiles through the concrete slab of a new filter tank. They were designed as anti-flotation piles due to the proximity of the sea, with an ultimate load of 900kN. A washer plate with a spherical collar nut above and below the plate was cast into the slab. The 13m long 52/26 Ischebeck Titan micropiles were installed through the overlying clay into weathered sandstone.

- 115mm button type drill bit
- 13m 52/26 black tension micropiles
- 56No. permanent micropiles

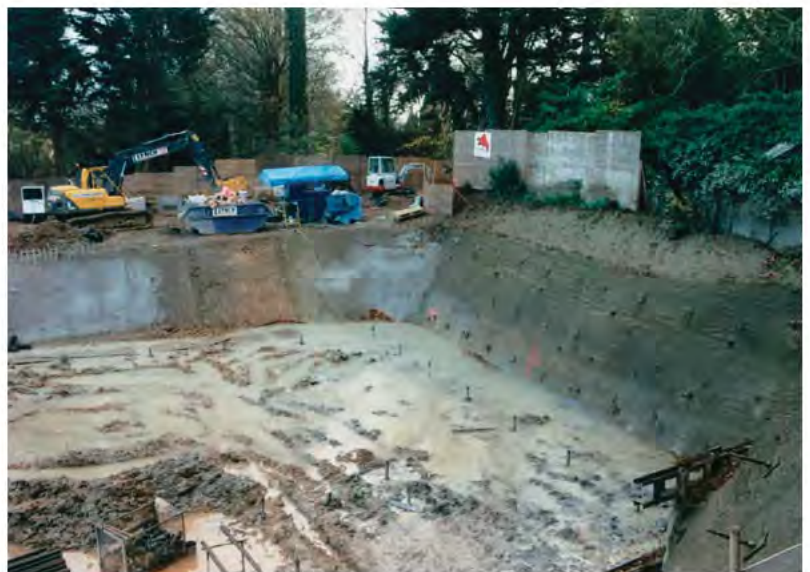
Project involved demolition of an existing bungalow and subsequent construction of a much larger bungalow on same site. Part of the scheme involved the construction of a large basement beneath the dwelling to accommodate a gym and cinema. Some 77No. micropiles were installed, working in tension and compression to secure the reinforced basement floor slab. Working loads of up to 450kN were required, using drill bit diameters of up to 280mm in the London Clay.

- Permanent works using black tendons
- 40/16, 52/26 and 73/53 micropiles installed
- Bearing plate with dual spherical collar nuts cast into slab

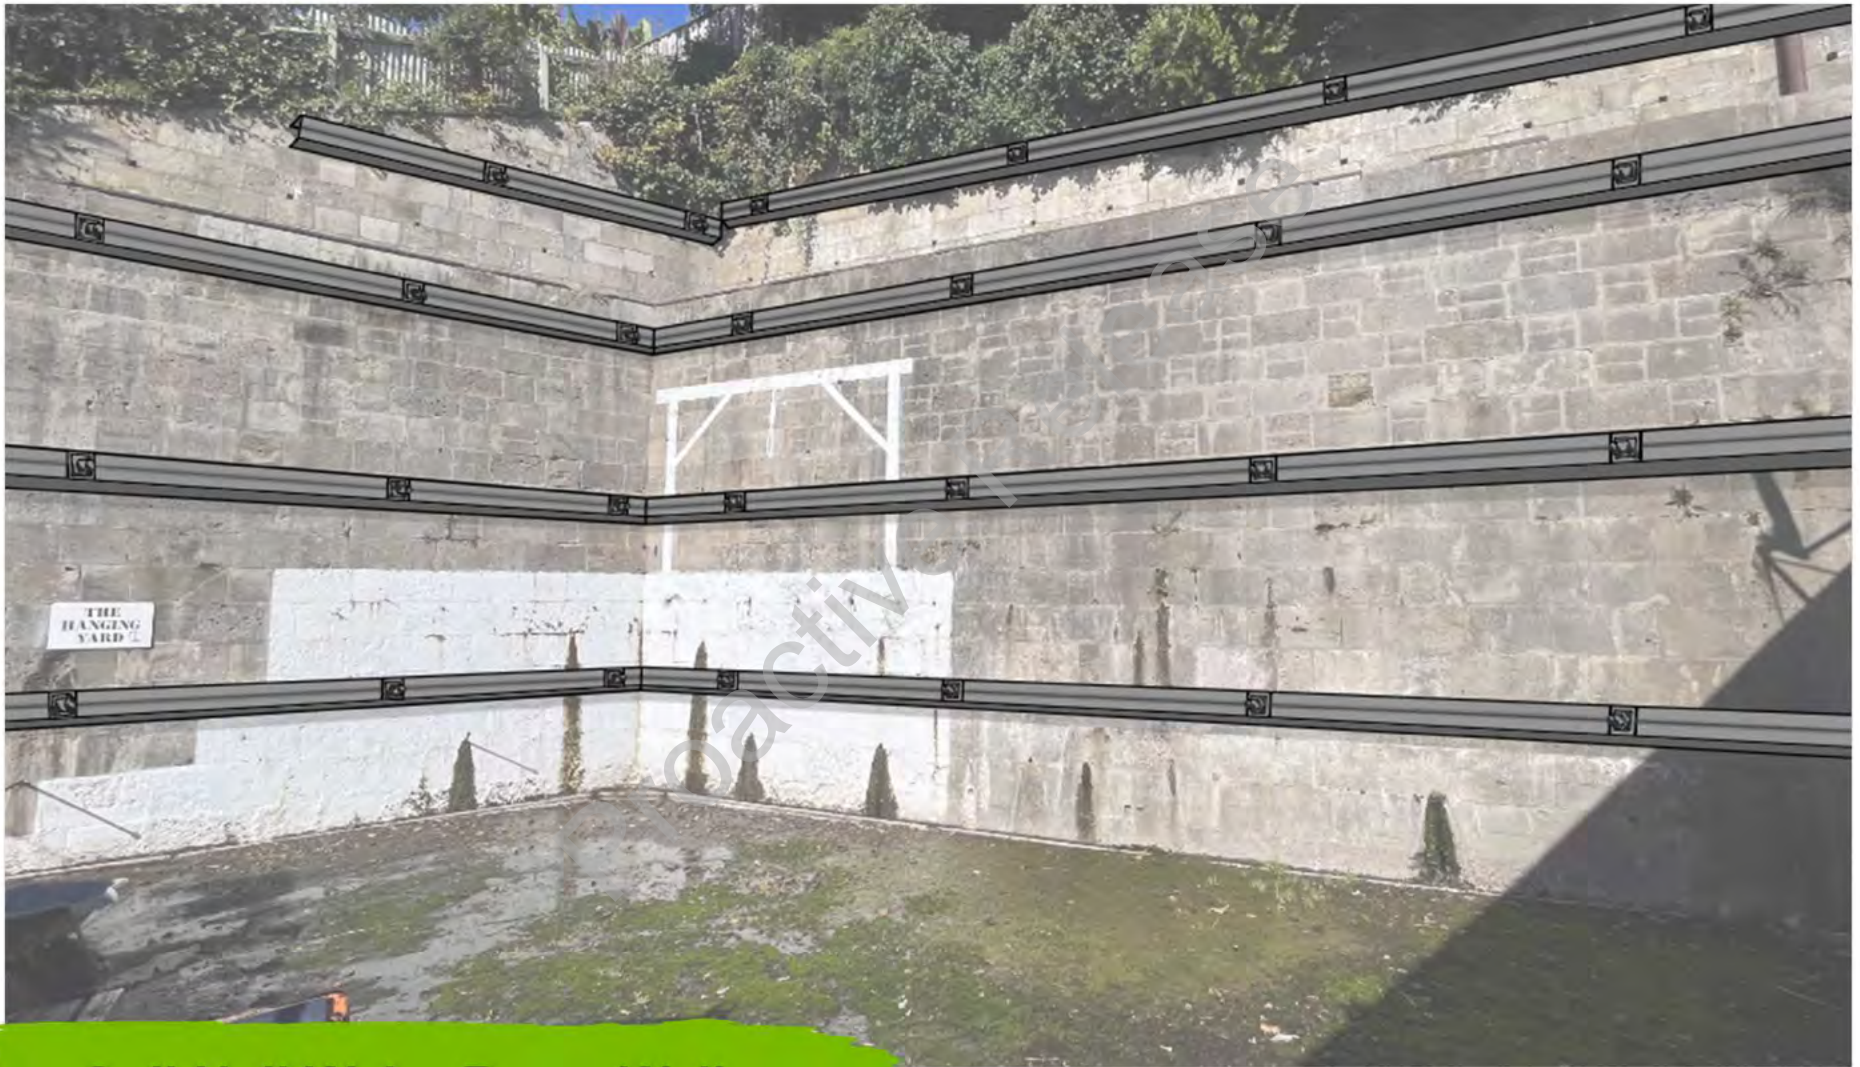
**Soil Nail Waler Beam Wall**
