# Napier Ex Prison Retaining Wall Assessment

Concept Design Report

Land Information New Zealand

Reference: 520969

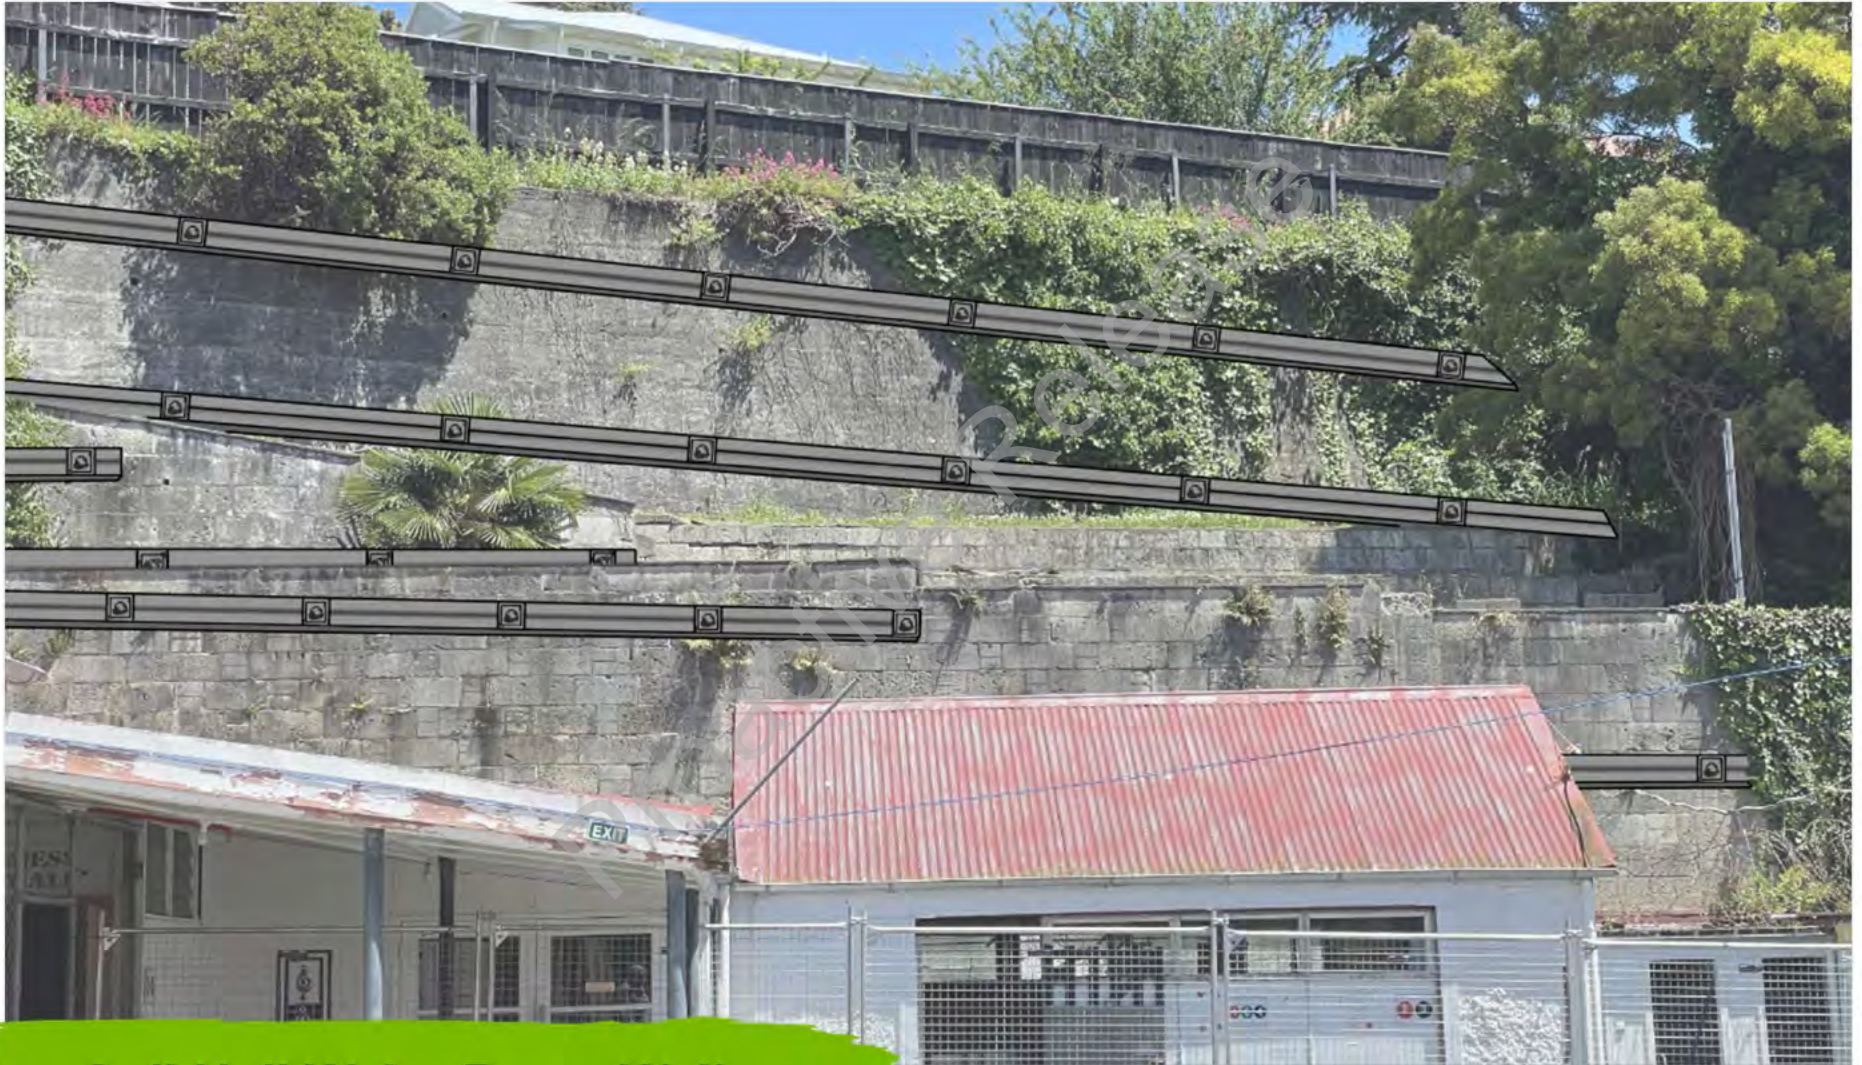
**Soil Nail Waler Beam Wall**

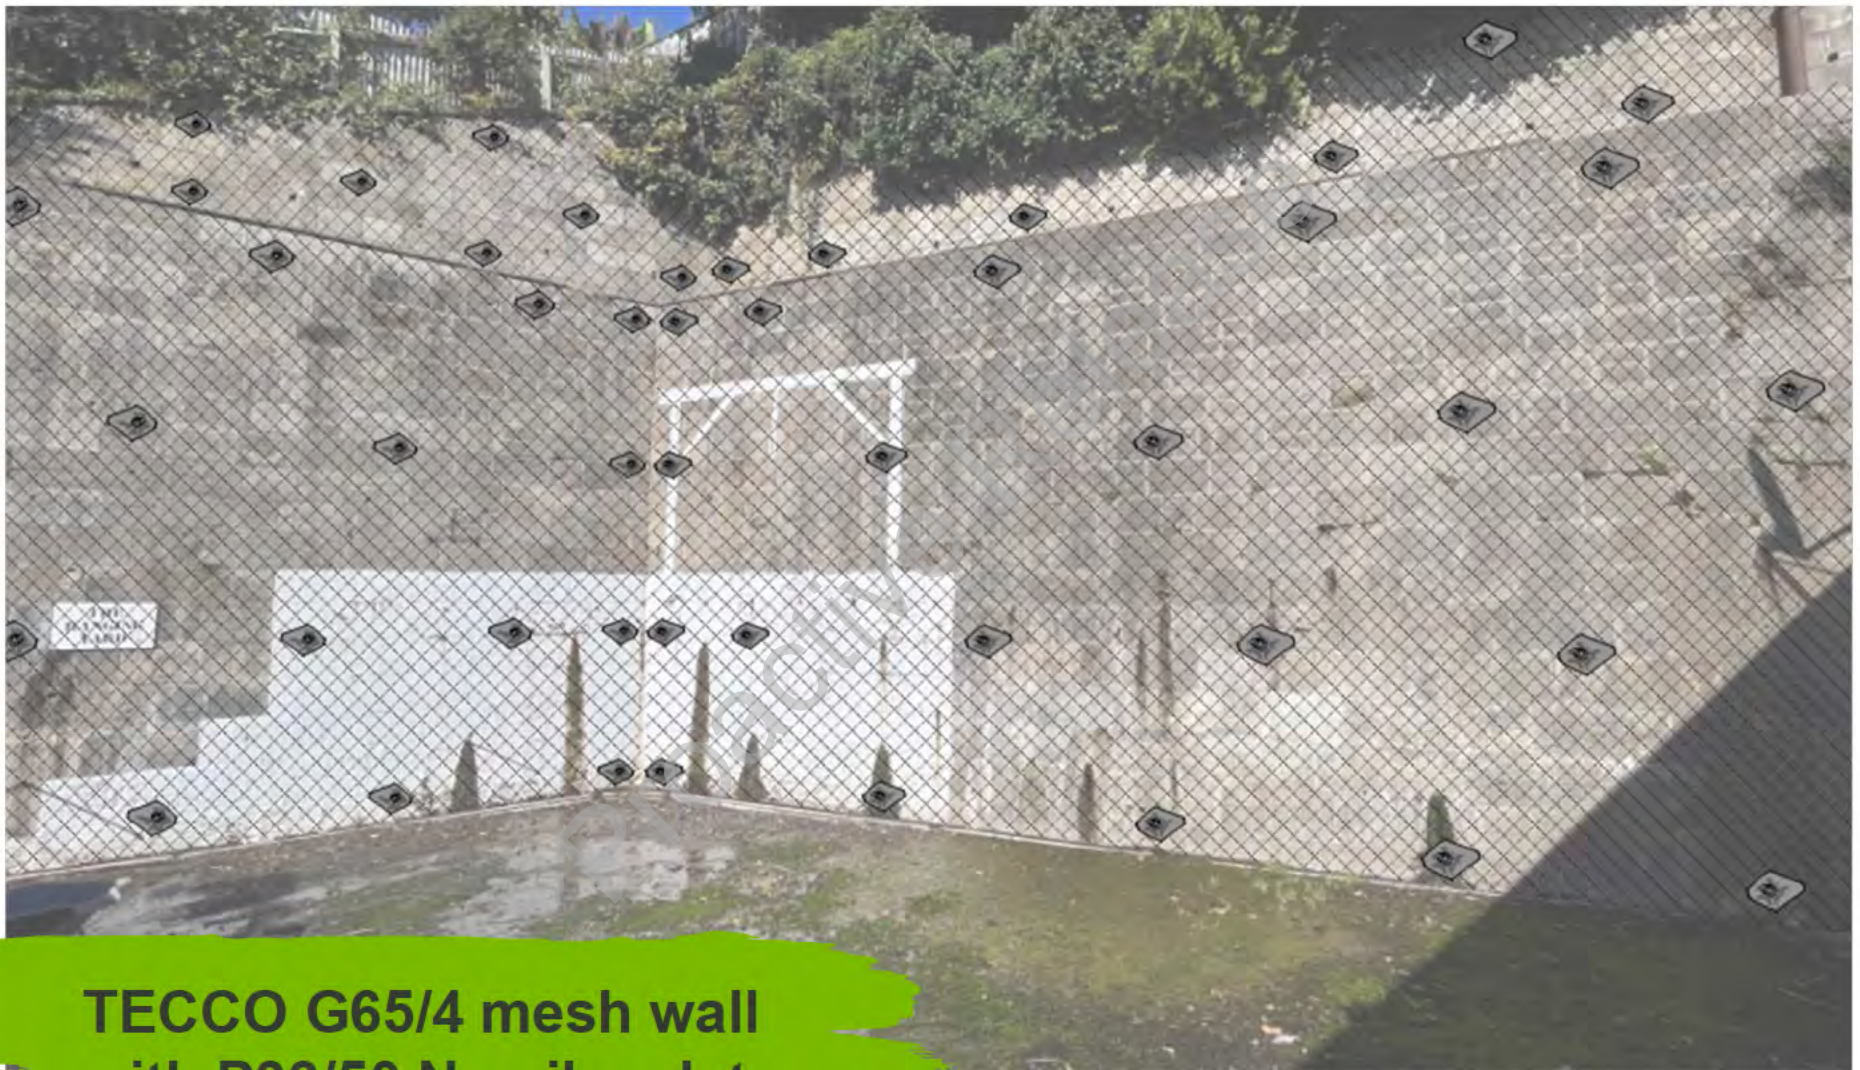
**TECCO G65/4 mesh wall  
with P33/50 N spike plates**

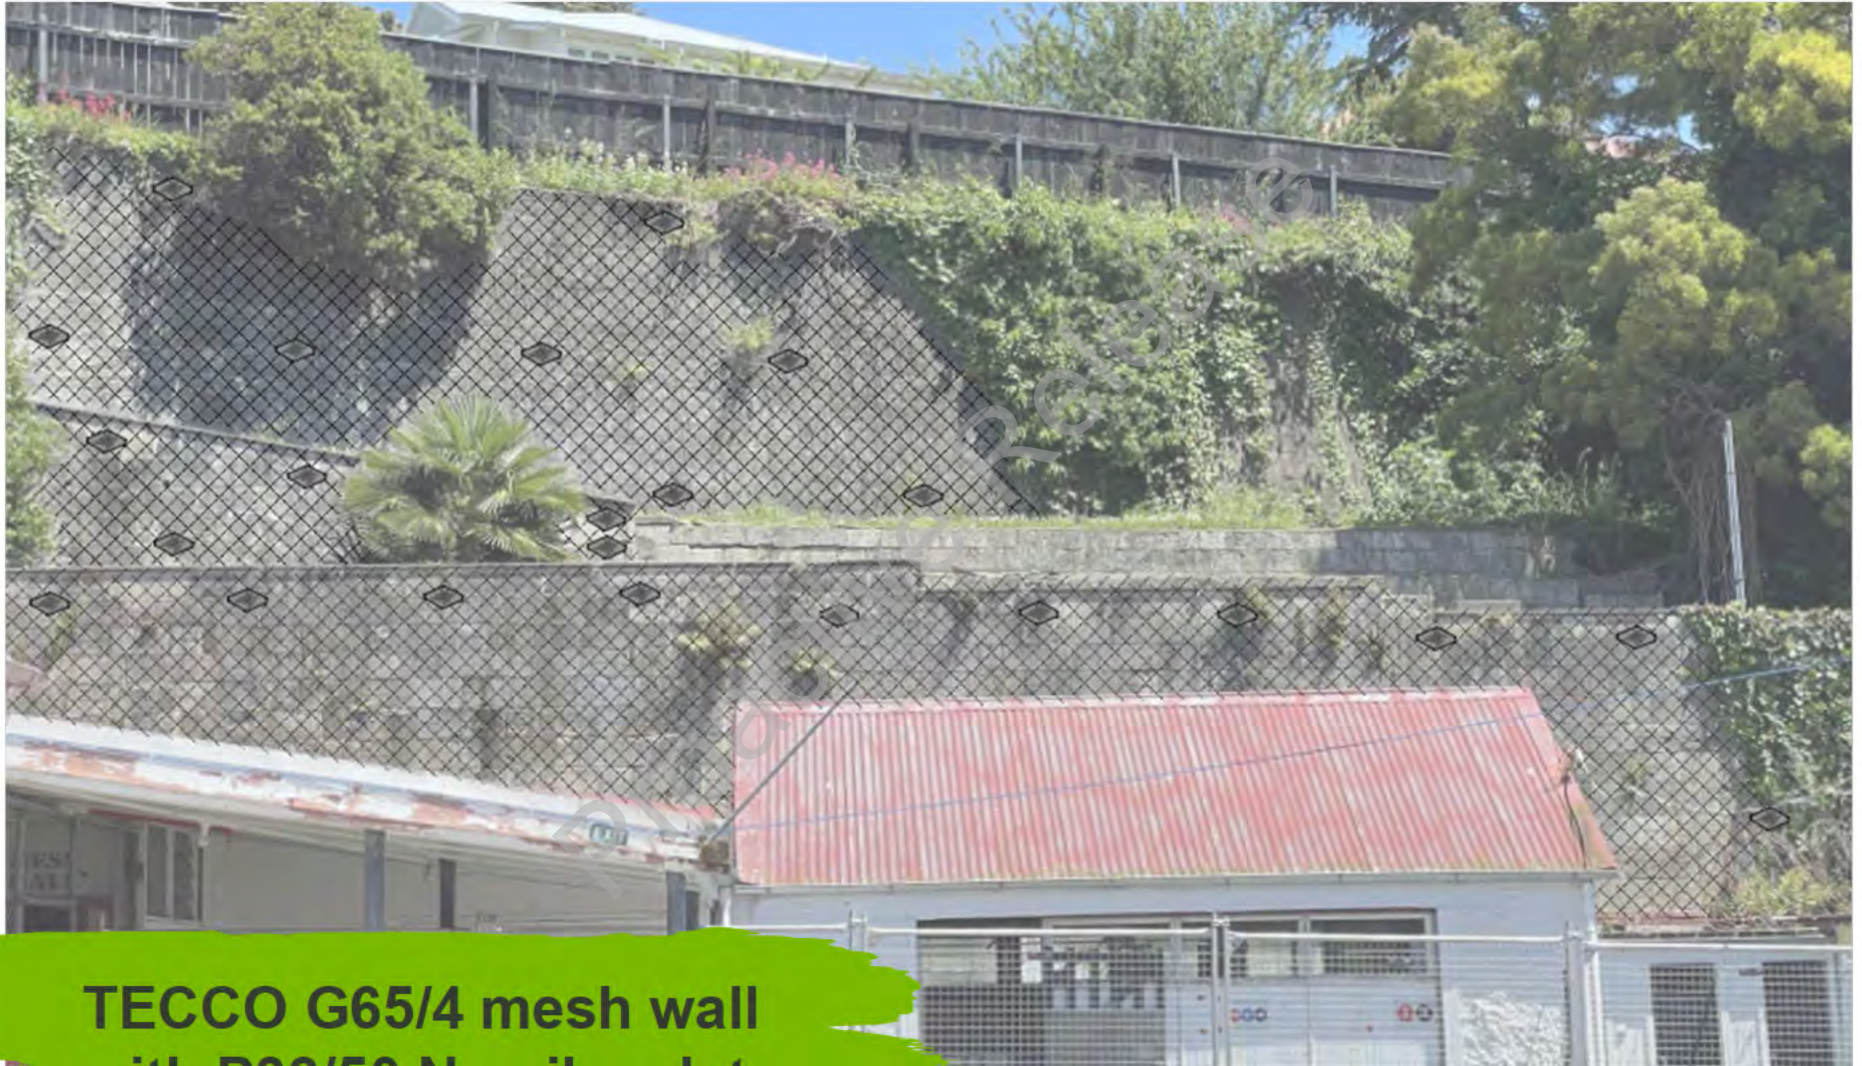
**TECCO G65/4 mesh wall  
with P33/50 N spike plates**

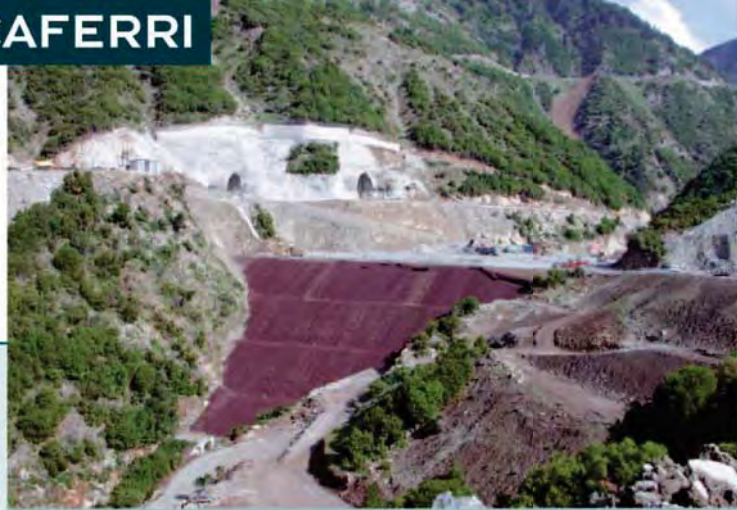
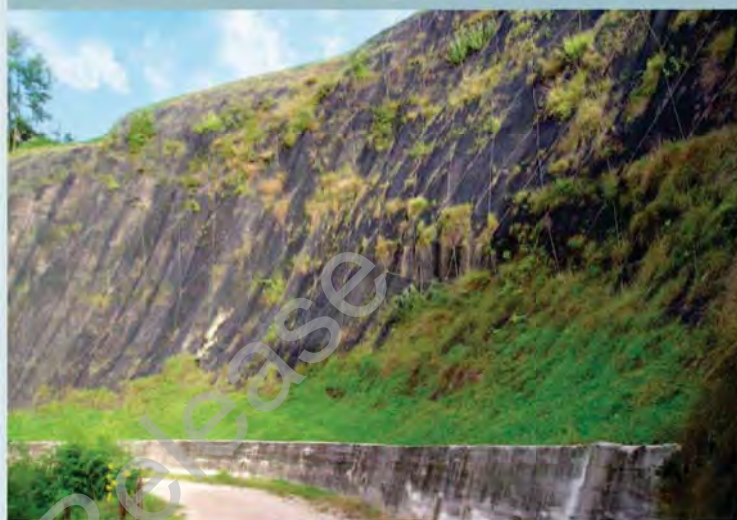
- The double twist wire mesh protects the geomat from any potential damage limiting those to a single mesh opening.
- The steel reinforcement provides high stiffness to the geocomposite and an uniform adherence to the subsoil providing better protection of the covered surface.

- It may be easily fixed to any thicker lining or bottom protection (gabions, mattresses, etc.) providing a better and continuous protection and anchorage where the erosion is usually more critical or the stresses are concentrated.

- The combined use of a geocomposite reduces by 50% the installation costs.
- The steel wire mesh provides the lining with a high punch resistance (20-25 kN) and offer a very strong barrier to any wild animal (like coypu) that will burrow through the composite causing damage along river banks.

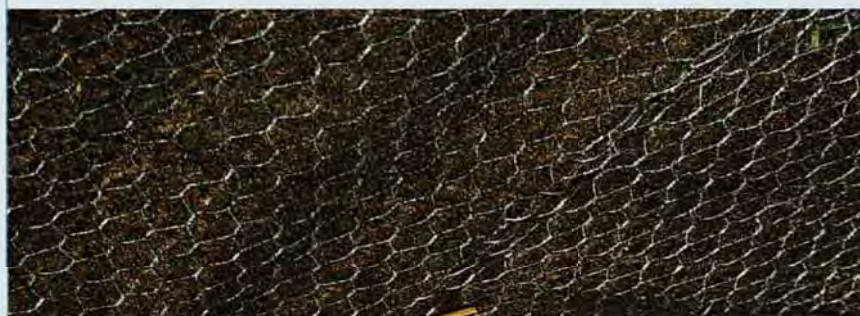
**MacMat® R** increase the soil's resistance to erosion by providing an environment that enhances the growth of vegetation through the mat. Initially the geomat blanket works to shield the soil slope from the effects of wind and rainfall, preventing the soil from washing out before the vegetation has a chance to become established. Then, as the vegetation matures, the roots anchor the mat to the soil to provide a superior soil reinforcement strength, capable of handling steeper embankment slopes and higher run-off flow velocities. In soil-veneer application on smooth sliding surfaces the reinforcement of the geocomposite provides the additional structural function to guarantee the required strength to achieve the equilibrium in long term service conditions. Due to the high roughness and permeability of the geocomposite **MacMat® R**, the pretreated surface allows for a more natural deposition of sediment discharged by the flow and offers a good retention to hydroseeding, without altering the natural existing conditions.

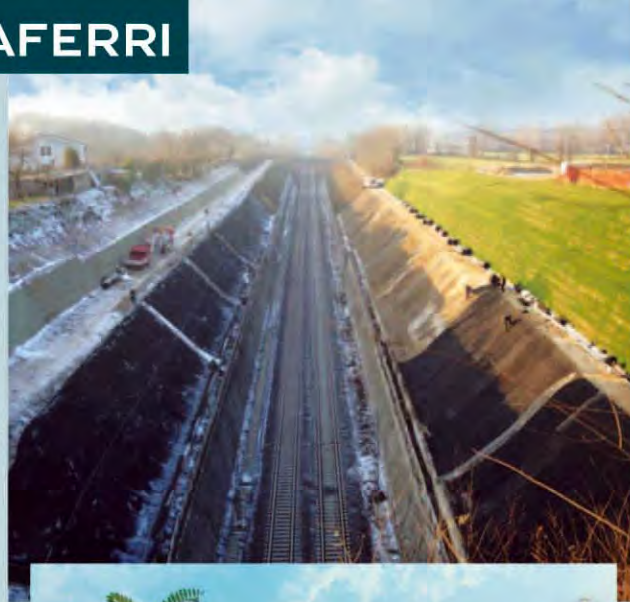
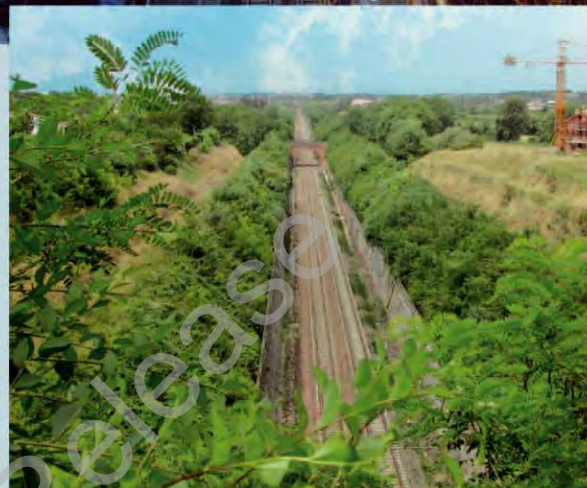
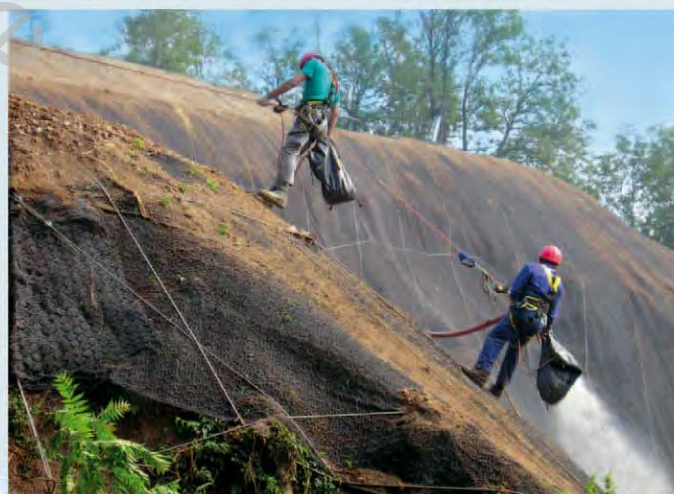
**MacMat®R** facilitates the installation on steep slopes using soil nails or anchors.

The strength of the mesh allows the intermediate anchor points to be widely spaced over the surface of the revetment and can provide reinforcement efficiency to the slope when laid in combination with nails and other soil reinforcement technologies.

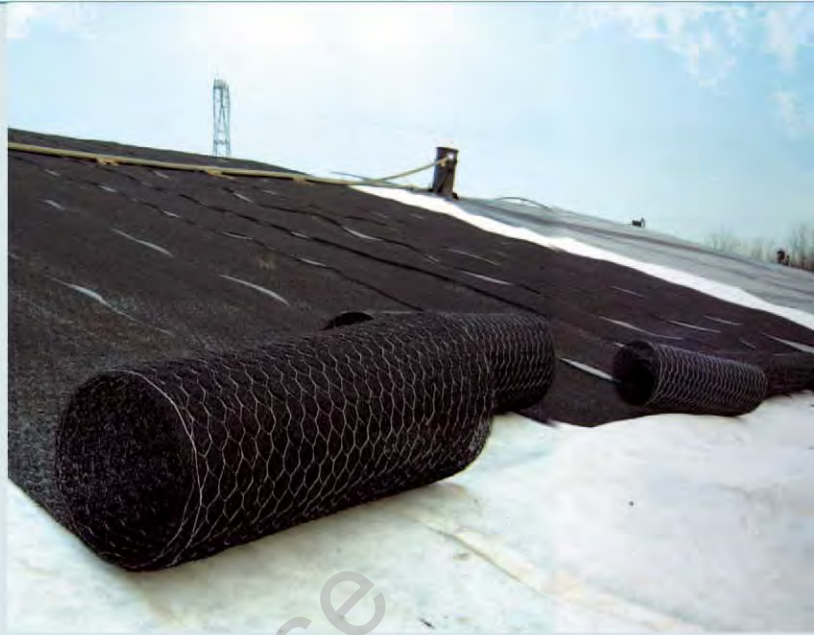
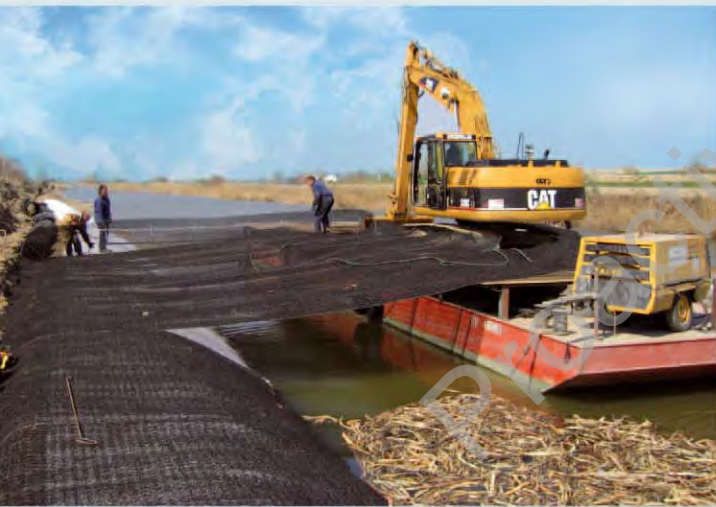
The stabilisation of soil on smooth inclined surfaces is a very typical problem to be faced during the design of a cover of a landfill site. In such a situation the contribution of the friction between the soil and the membrane is very low (up to limit values of 8-10°) and tensile strength and retention capacity is required for the composite to be placed on top of the geomembrane. In addition to this primary structural function the geocomposite provides an efficient protection of the geomembrane itself against puncture damage occurring during the soil placement.

**MacMat®R** improves the efficiency of the lining system by:

- *Increasing the shear resistance along the soil 's surface;*
- *providing the strength required to guarantee the equilibrium conditions;*
- *minimising the stress applied directly to the geomembrane from external loadings;*
- *protecting the geomembrane from puncturing damage during the soil placement;*
- *allowing the growth of vegetation in order to provide an environmentally friendly aspect and an efficient UV protection to the sealing membrane.*

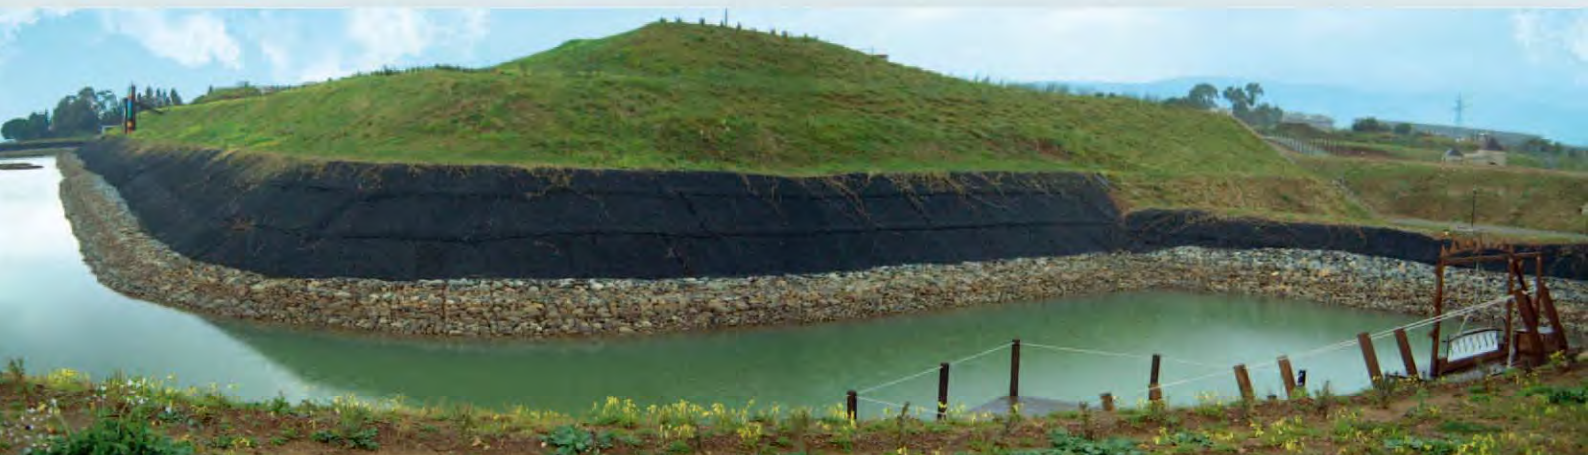
Channel erosion is the result of a slow deterioration of the soil bank as a direct result of the hydraulic shear stresses acting on the soil's surface.

- *increasing the shear resistance along the soil 's surface;*
- *reducing the velocity of flow along the channel section;*
- *limiting the loss a fine soil particles;*
- *protecting the bank integrity from wild animal intrusion.*

**MacMat®R** provides also a good support for vegetative soil on smooth surface working as stabilization layer on Geomembrane and Geocomposite barriers used currently in waterproofing applications.

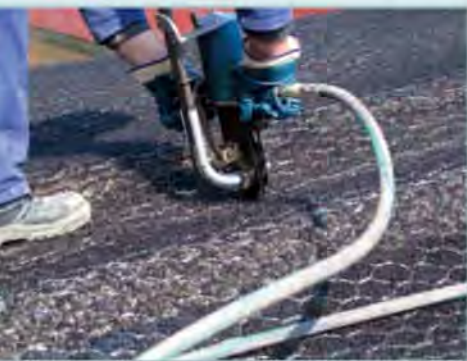
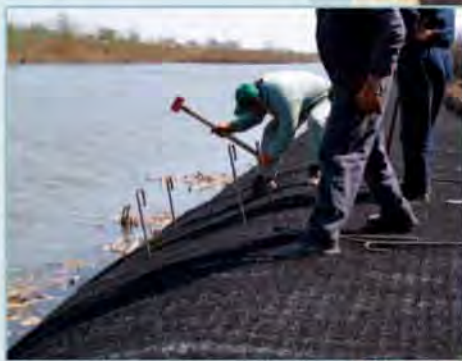
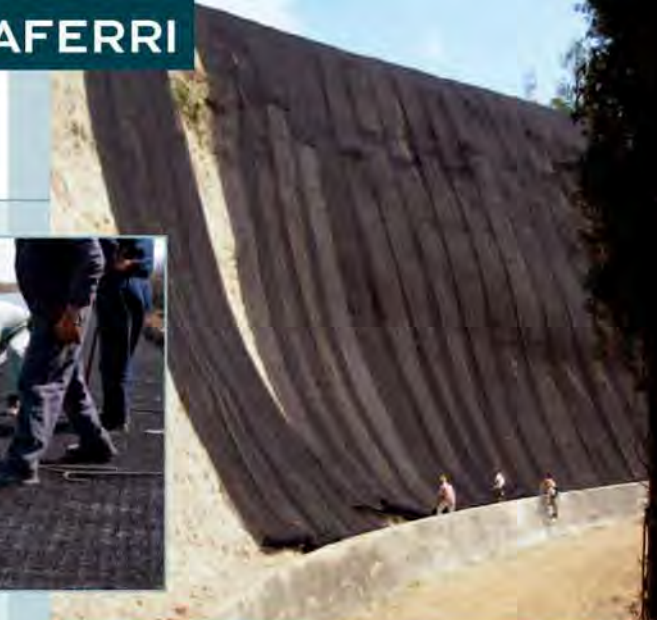
## MacMat® R

**MacMat® R** is manufactured with a surface having both a rough and a smooth side. The material shall be unrolled along the slope having the smooth side in contact with the soil. Before the placement of the mat the sub-soil will be well graded and finished to achieve a smooth even surface leaving the last 4/5 cm of sub-base soil loose (eventually a seeding will be done in this phase). The mat will be anchored to the soil with metallic or timber pins according to the application.
