Site Inspection Record

Project Number	520969	Date	7 March 2023
Project Name	Ex Napier Prison	From	[REDACTED]
Client	LINZ	Total Pages	3
Weather	Fine

SUBJECT Retaining Wall Inspection

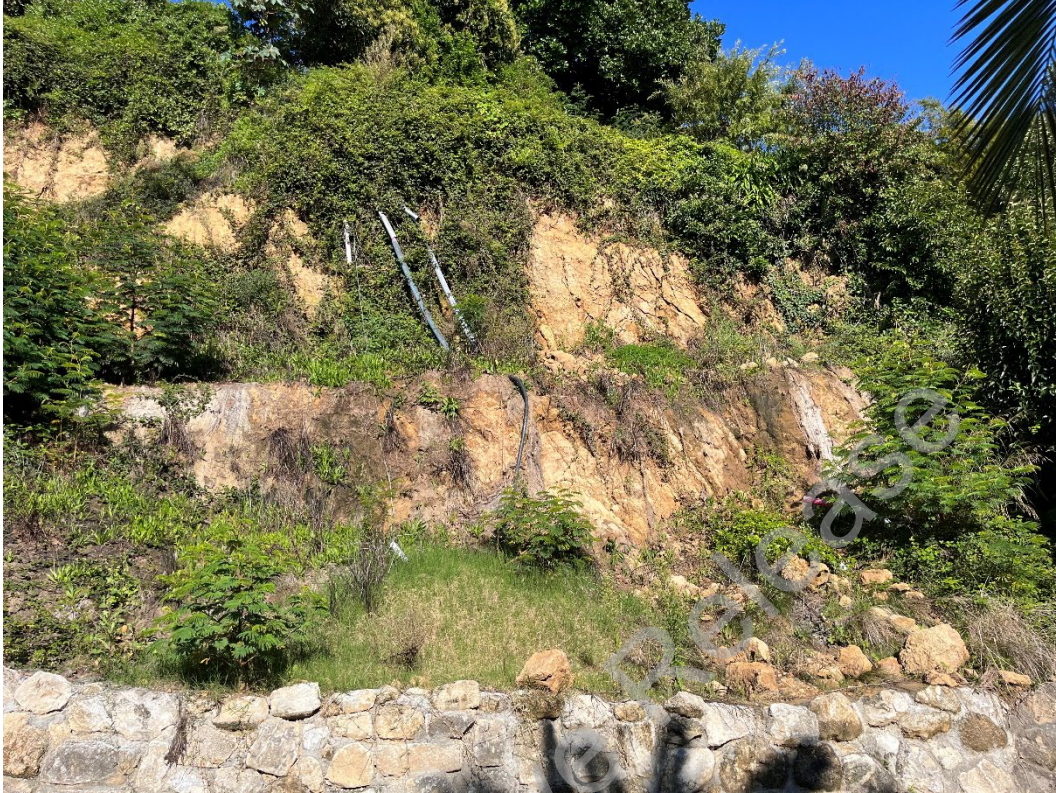
- The retaining walls appeared in a similar visual condition to previous inspections.
- The slope above the site access driveway and retaining wall RW6 had released minor rockfall onto the top of the wall and driveway. Most of the debris was retained at the top of the wall (Photo 1). The rockfall boulders were approximately 100mm to 400mm in diameter.

Photo 1 – Rockfall debris above RW6. Photo taken 03.03.23, looking west.

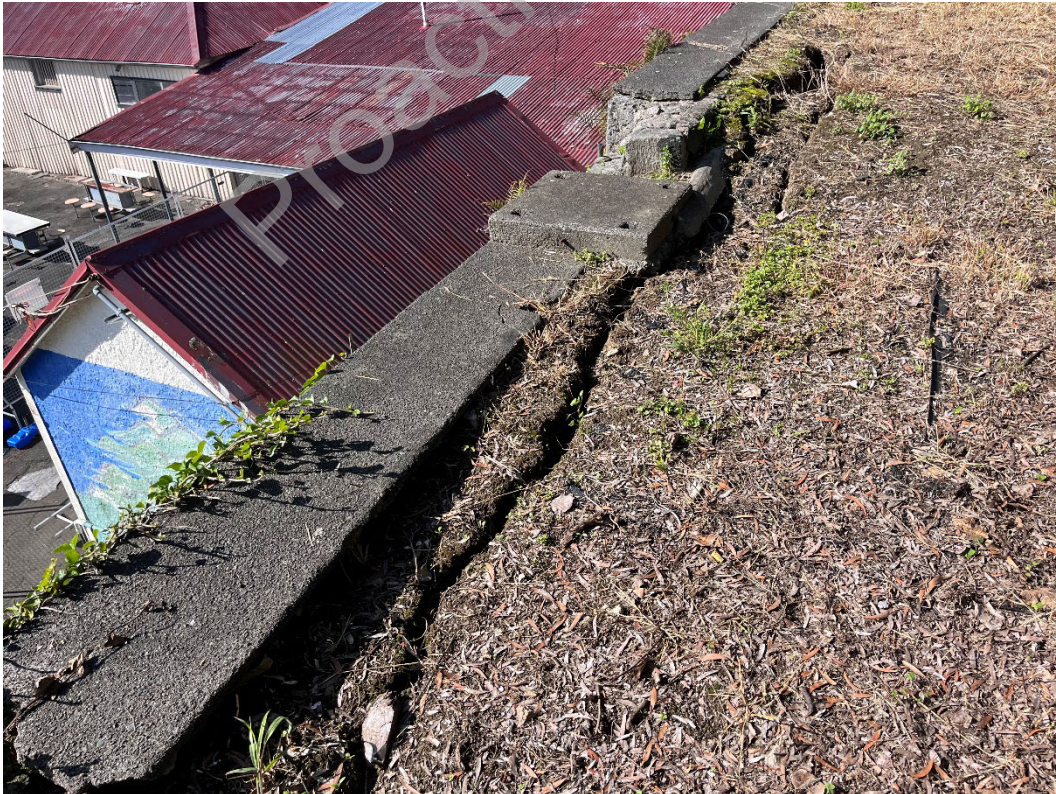
- Tension cracks were observed above retaining wall RW10, approximately 400mm back from the top of wall, and approximately 50mm wide (Photo 2). These cracks appeared similar to those observed during the previous inspections.

Photo 2 – Tension cracks behind RW10. Photo taken 03.03.23, looking southeast.

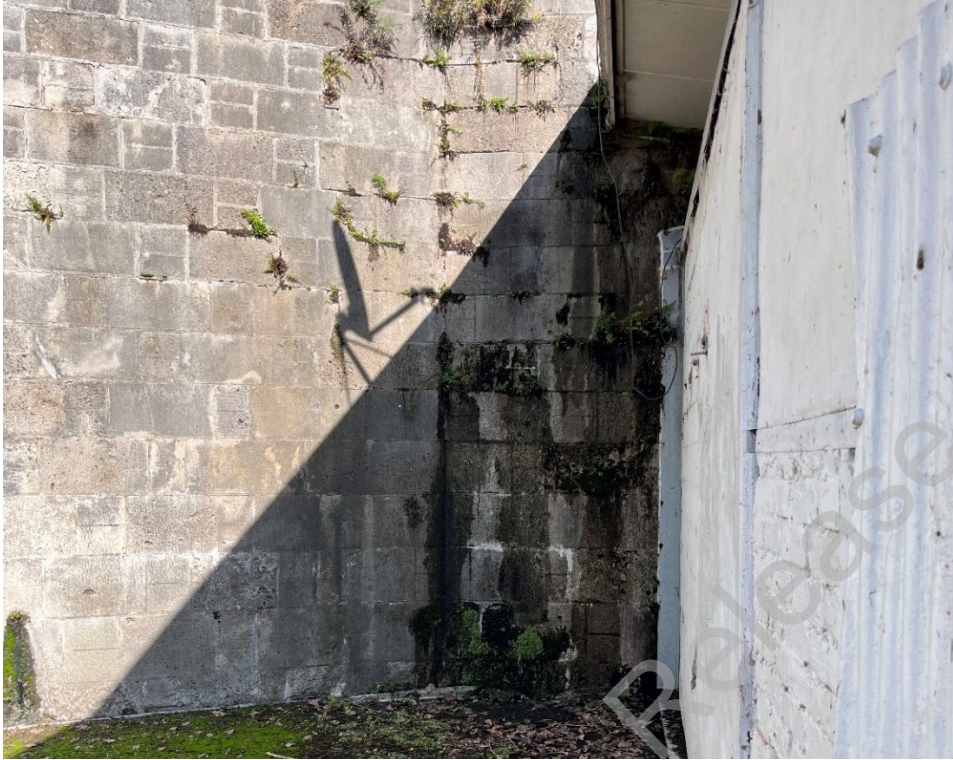
- Retaining wall RW10 had an area of seepage approximately 2m up the wall in the rear yard (Photo 3).
- Several areas of the site had been fenced off to prevent the public from entering the areas directly beneath the retaining walls.

Photo 3 – Seepage from RW10. Photo taken 03.03.23, looking west.

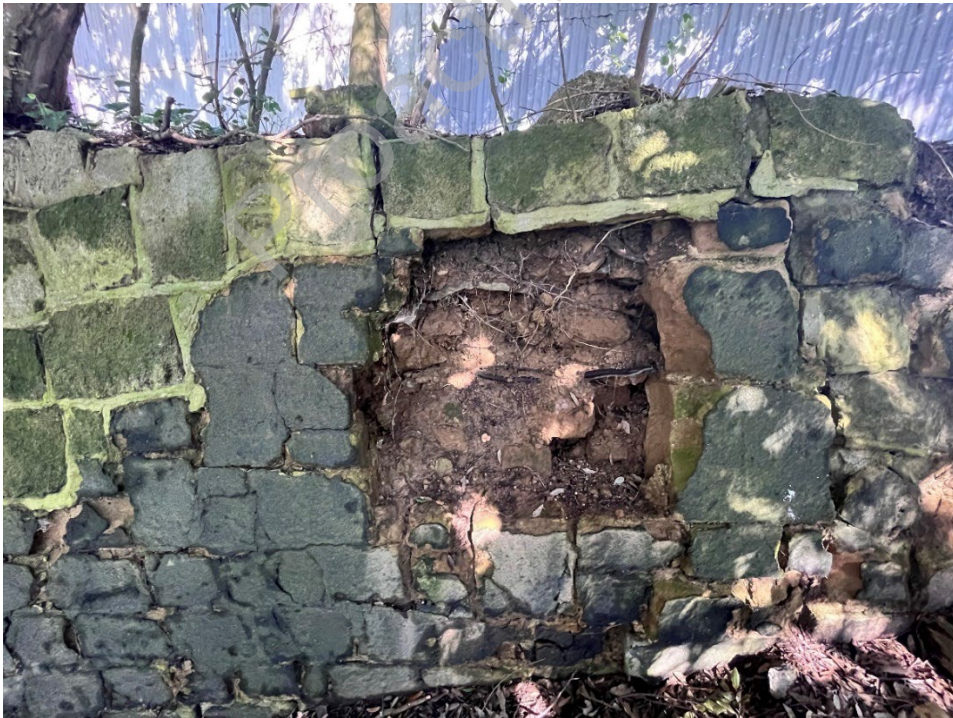
- Retaining walls RW19 and RW20 had several areas of damage where the sandstone wall facing had dislodged from the wall, exposing the material behind the wall (Photo 4). However, these walls appeared in similar conditions to previous site inspections.

Photo 4 – Section of damage at RW19. Photo taken 03.03.2023, looking west.
