FORMER TOKANUI PSYCHIATRIC HOSPITAL
DEMOLITION AND REMEDIATION
EXISTING DISPOSAL SITE REPAIR AND UPGRADE WORKS
REPORT

Project No.	33097	Approved for Issue	
Version No.	5	Name	Sean Finnigan
Status	Final	Signature	 
Authors	T Bohles, S Finnigan	Date	21/11/2024
Reviewer	S Finnigan

This report describes the proposed repair and upgrade works for the closed landfill (existing Disposal Sites¹) at the former Tokanui Psychiatric Hospital (FTPH, the Site).

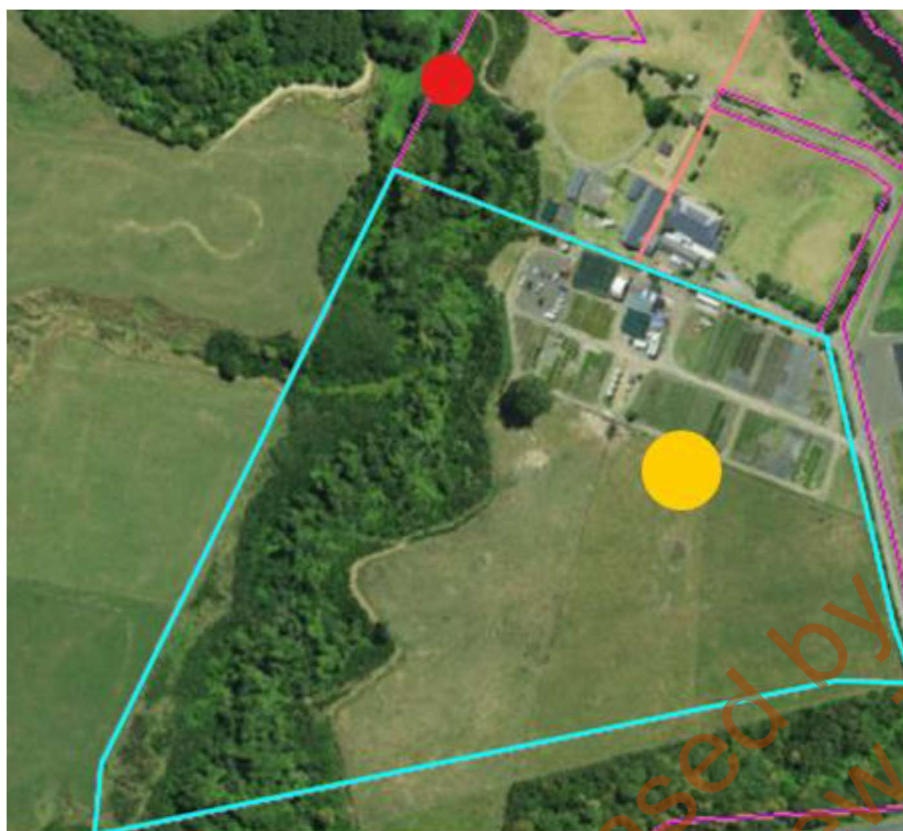
Pūniu River Care have a resource consent AUTH144702.01.01 valid till October 2037 to take water from the Wharekōrino Stream for irrigation of a 3ha plant nursery during September-March inclusive, based on a daily maximum take of 100m³ and total annual take of not more than 10,000m³. The inlet structure is located on the Wharekōrino Stream at the location shown below. The ANZECC 2000 water quality guidelines refer to an agricultural irrigation water long term trigger value for boron of 0.5g/m³, which the stream water quality monitoring data in Figure 5 readily complies with, indicating that using the stream water in the plant nursery should not adversely affect the health of the plants.

Figure 9: Pūniu River Care Surface Water Take Inlet Location (red dot) on Wharekōrino Stream; yellow dot is location of their bore which is no longer used

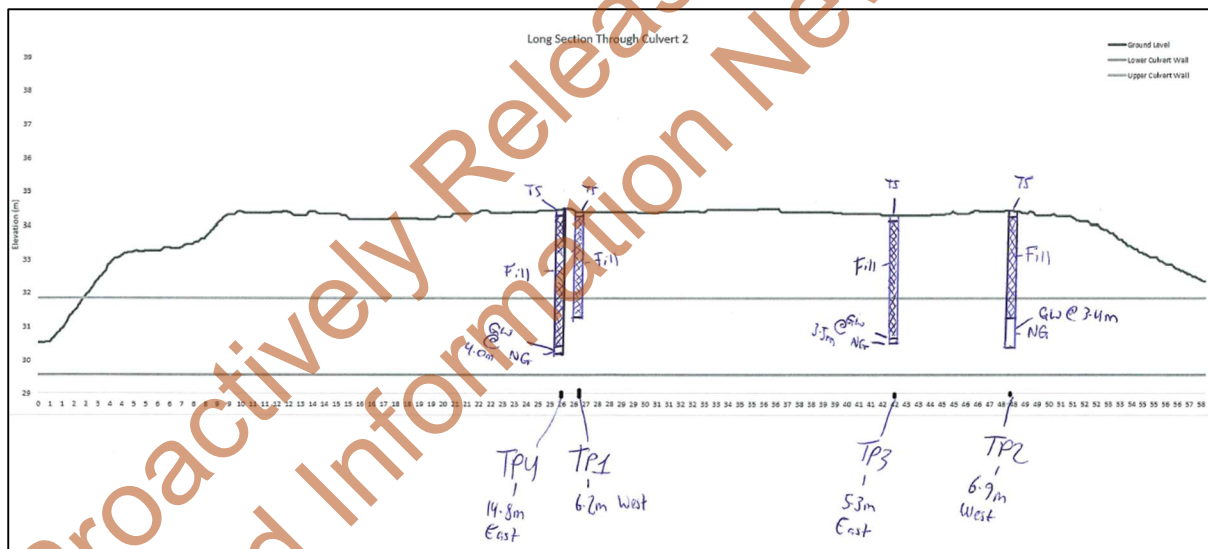
Review of relevant test pit information from the FTL intrusive investigation has found that refuse does extend to the depth zone within which the pipe is located but likely not below the lower 10-20% of the pipe or pipe base. However, no test pits were undertaken directly above or adjacent to this pipe to verify this. Hence, it is not clear if the culvert is founded in good ground and backfilled with good material over its entire depth or may be in contact or near contact with some landfilled materials, particularly between the top and bottom sections. Refer Figure 14 for offset test pit logs superimposed on the culvert long-section.

Figure 14: Long-section showing culvert depth relative to test pit logs from nearby intrusive investigation test pits

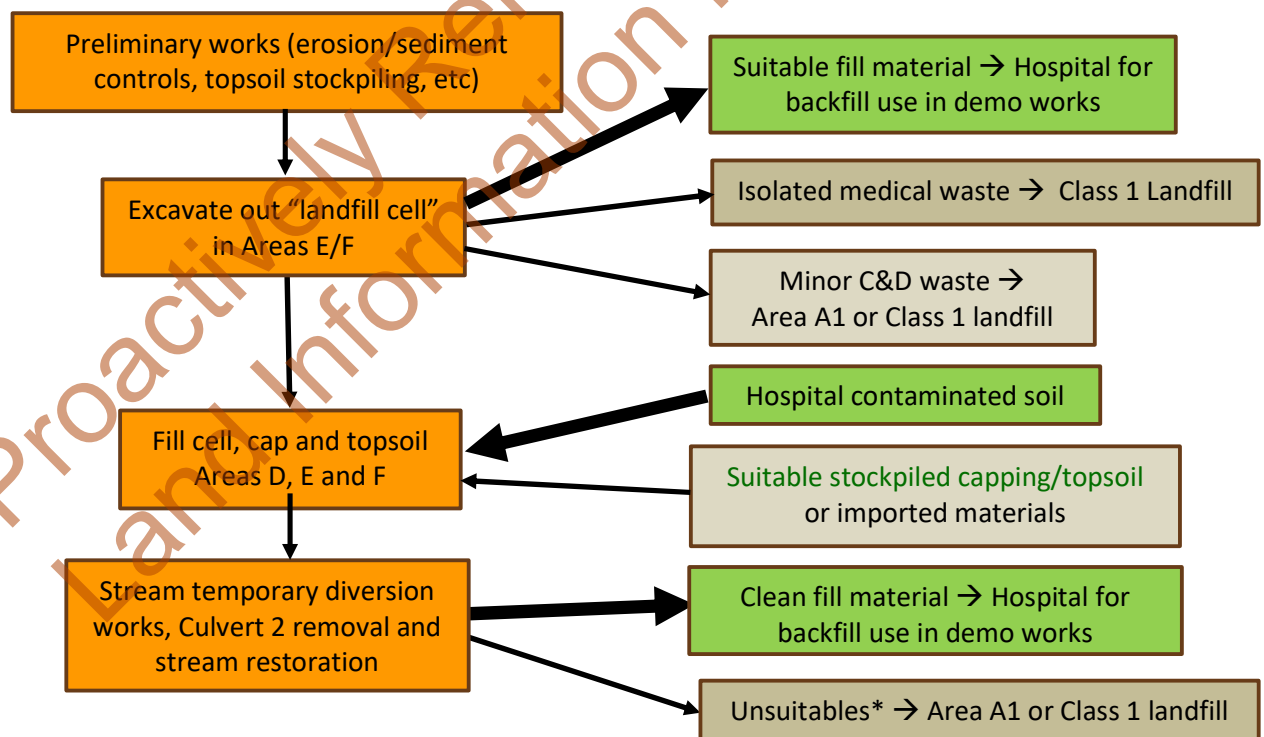
The works will be divided into two stages, covering Areas D-F and A-C + H. No remediation works are proposed for Area G, as no fill or contamination was found in this area. These stages are shown below.

Figure 18: Stage 1: Area D-F and Culvert 2 (unsuitables = alluvial or soft materials that need to be undercut prior to filling on top of them; orange shows main works process; green represents internal movement of materials within hospital; grey represents imported materials or off-site disposal)

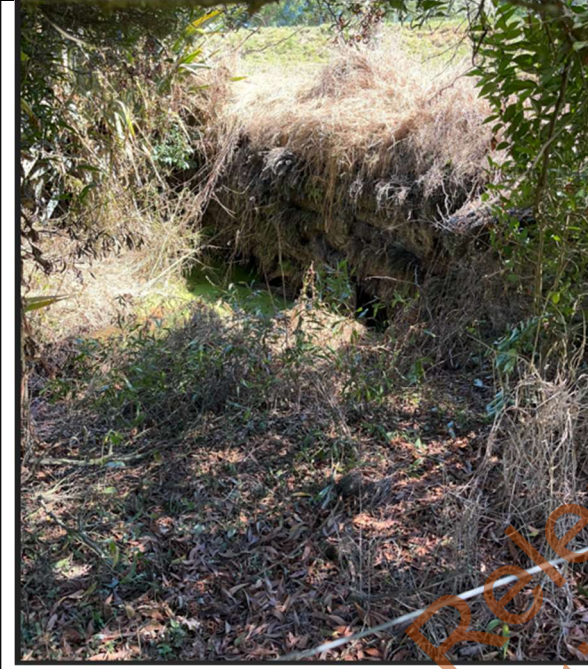
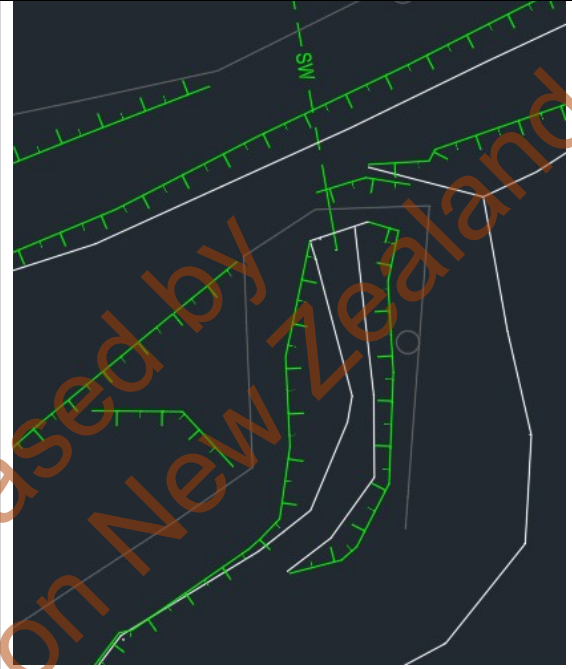
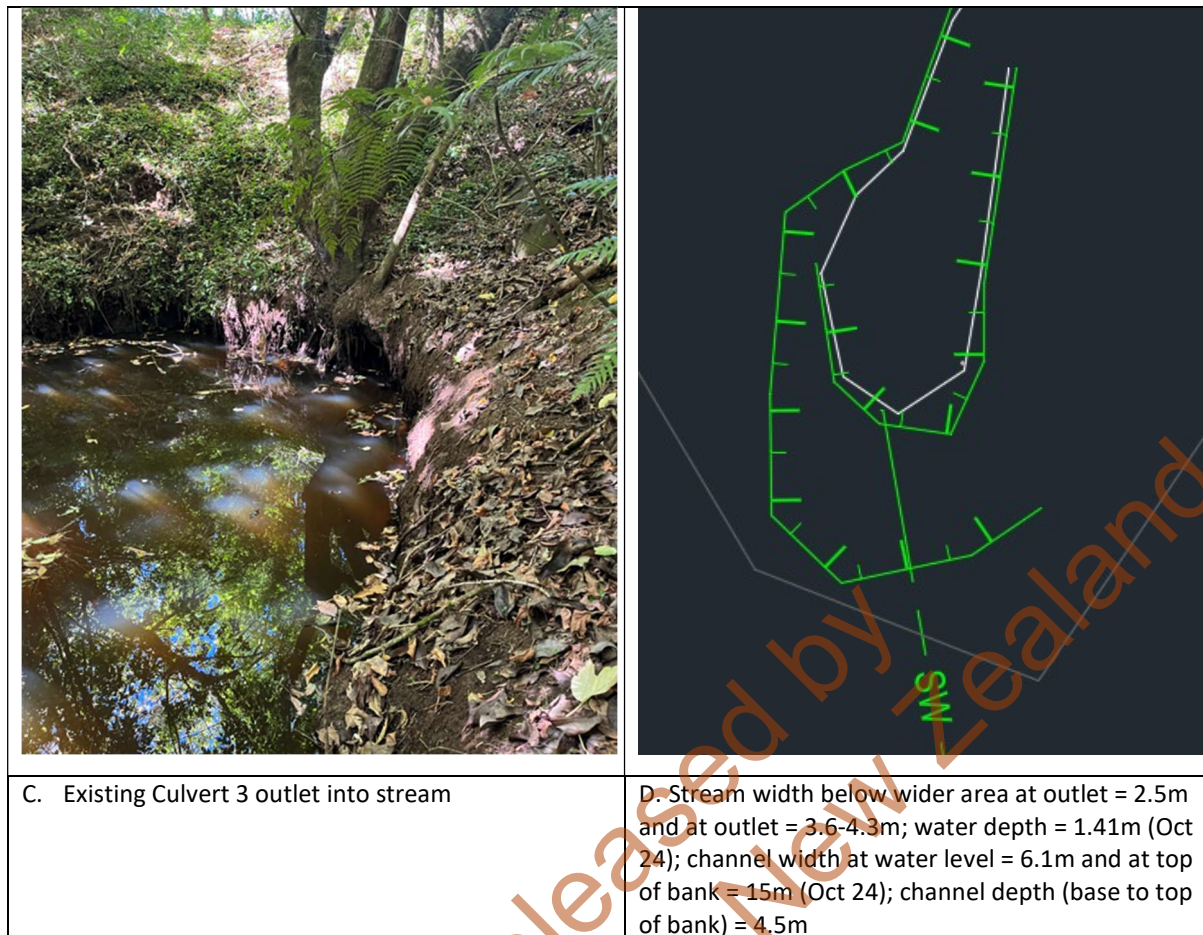
<p>A. Culvert 3 inlet - top of pipe just visible, indicating water depth of around 1200-1250mm depth. At recent Oct 24 visit, water depth measured at 1.15m but pipe was not visible, possibly due to overgrown vegetation.</p>	<p>B. Stream width at culvert inlet = 2.85m. Minimum width = 1.4m (slightly upstream); average = ~2.2m. Channel width at water level = 4.78m and at top of bank = 7.67m (Oct 24); channel depth (base to top of bank) = 3.20m</p>

Figure 21: Culvert 3 Inlet and Outlet Photos and corresponding survey data
