146 TE MAWHAI ROAD,
FORMER TOKANUI
PSYCHIATRIC HOSPITAL, TE
AWAMUTU

FORMER TOKANUI PSYCHIATRIC HOSPITAL
DEMOLITION AND REMEDIATION
EXISTING DISPOSAL SITES – INTRUSIVE INVESTIGATION REPORT

Project No.	33097	Approved for Issue	
Version No.	4	Name	Sean Finnigan
Status	Final	Signature	 
Authors	E Bish, T Bohles, S Finnigan		
Reviewer	S Finnigan	Date	28/06/2024

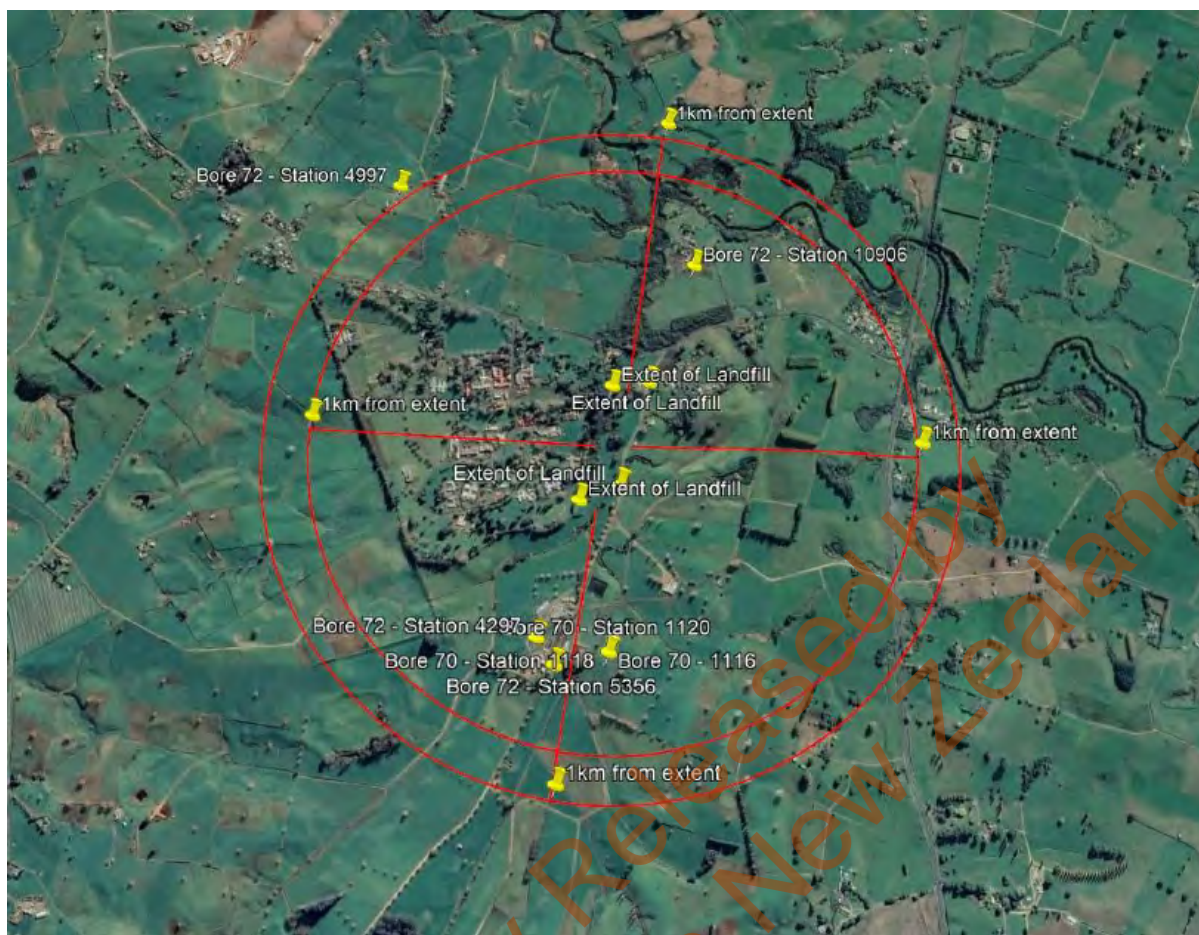
Figure 1: Environment Waikato Groundwater Bore Database Search Results

An Environment Waikato database search was done for all groundwater bores within 1km radius of the landfilling area, the results of which are shown on Figure 1, and attached as Appendix F. This search showed there are six groundwater bores within 1km of the site, of which only one is located downgradient (north) of the landfill. This bore (Bore 72, Station 10906) uses water for nursery irrigation. There is one further downgradient bore just outside the 1km limit - Bore 72, Station 4997 – which takes water for household supply and stock watering purposes, according to the Environment Waikato database.

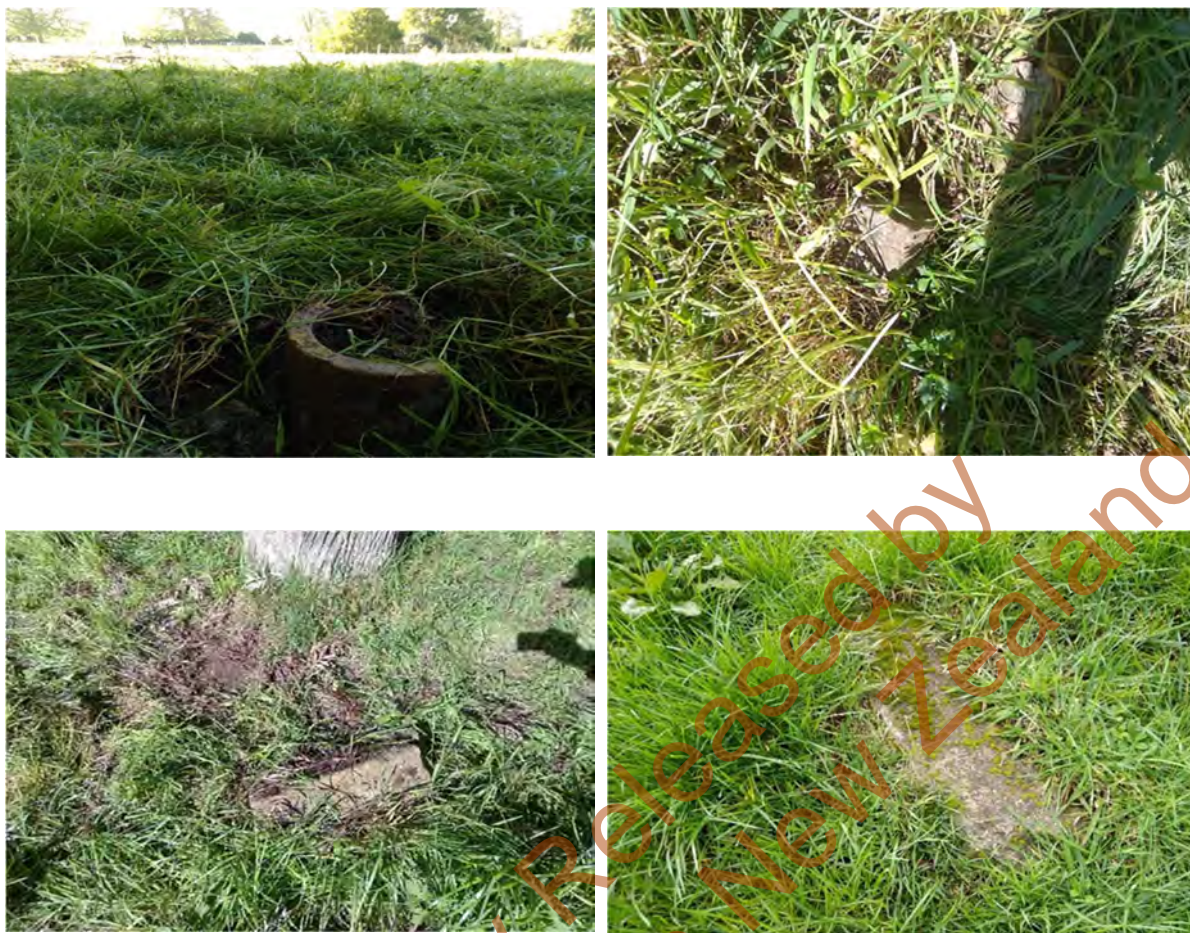
During the 2022 annual walkover survey (refer separate report for details and Appendix B for grid walkover findings), it was found that there were various instances of individual refuse items (e.g., wooden posts, planks, cement blocks) protruding through the landfill surface, consistently around the edges of the landfill areas (refer Figure 8, below). There was one area which showed small localised damage to the landfill cap of the landfill (refer Figure 9, below). These observations mainly apply to Areas A and D. They mean that the landfill cap has been breached in a number of locations. The protruding objects should be removed and the landfill cap reinstated.

Figure 8: Refuse protrusion across the site (ceramic pipe (B3), wooden post (E4), brick (D4, concrete (D4)) – for grid references, refer Appendix B for grid locations

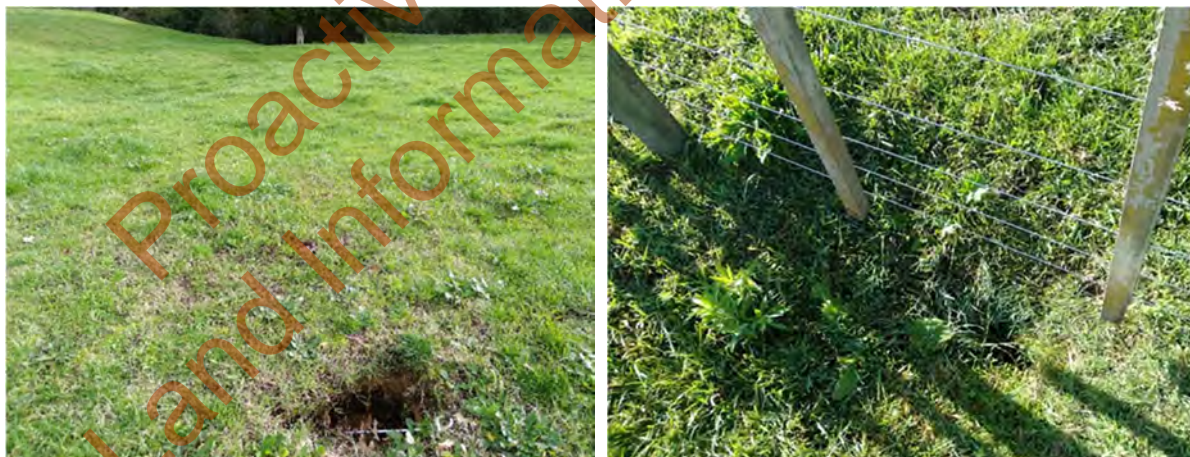
Across the existing disposal sites, there were various areas showing minor localised patchiness/die off. Some kanuka trees adjacent to the landfill (western side of existing disposal sites) also showed signs of dieback. There were various instances of individual refuse pieces protruding through the cap at the extents of the landfill. In addition, there was one area which showed small localised damage to the cap of the landfill.

Figure 9: Evidence of damage to landfill cap in Area E and at extent of Area A (Left N7, Right A3)

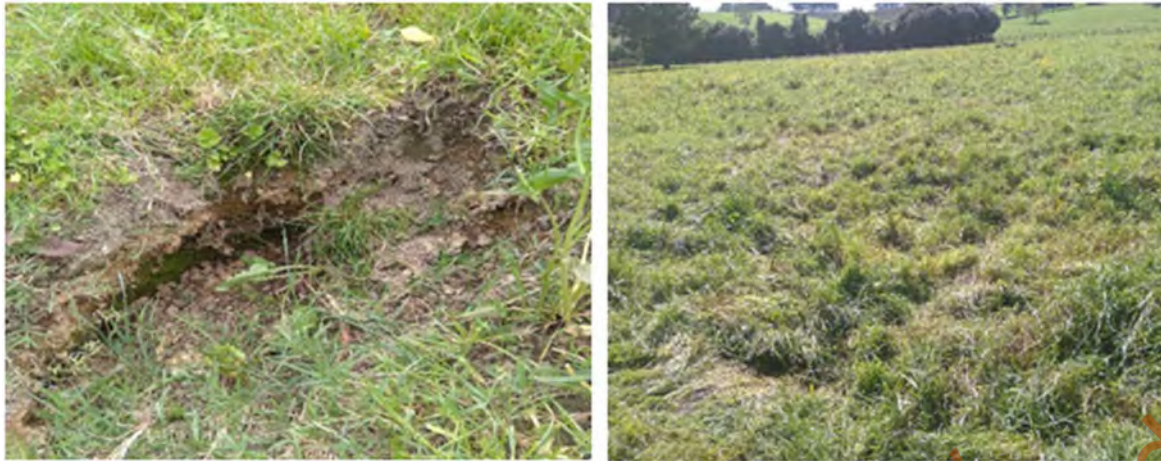
- Area D was observed as having very uneven topography including patches of settlement. Significant subsidence was observed at grid N7.
- Area E was primarily in good condition. The only feature of note was general sloping settlement of the land. Previous visits have noted ponding filling this settled area, but none was observed during 2022.

Figure 10: Instances of subsidence visible on site at areas E and A respectively (Left N7, Right E4)

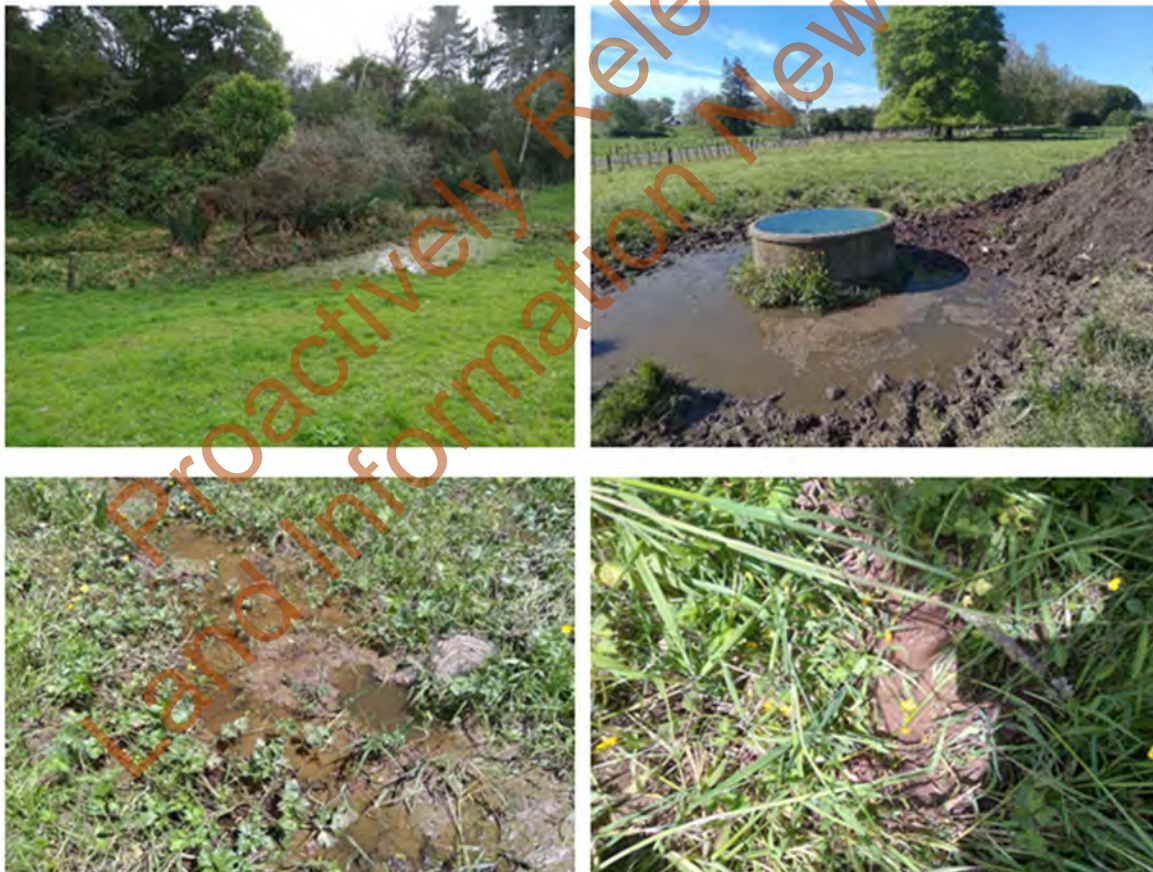
There appears to be minor to moderate settlement and ponding in some areas, which has appeared largely unchanged from previous investigations. Area C has continued to show frequent ponding conditions.

As stated earlier, landfill settlement will occur over time as a result of refuse consolidation and decomposition, which can create ponding areas depending on the nature of the surface grading and particularly if differential settlement occurs. Refuse burning would have reduced the amount of settlement expected through waste decomposition. As the last landfilling areas was closed over 20 years ago, it is expected that most settlement would have occurred by now.

Figure 11: Areas of ponding observed across the landfill site (Top Left H4, Top right D7, Bottom Left K4, Bottom Right I7)

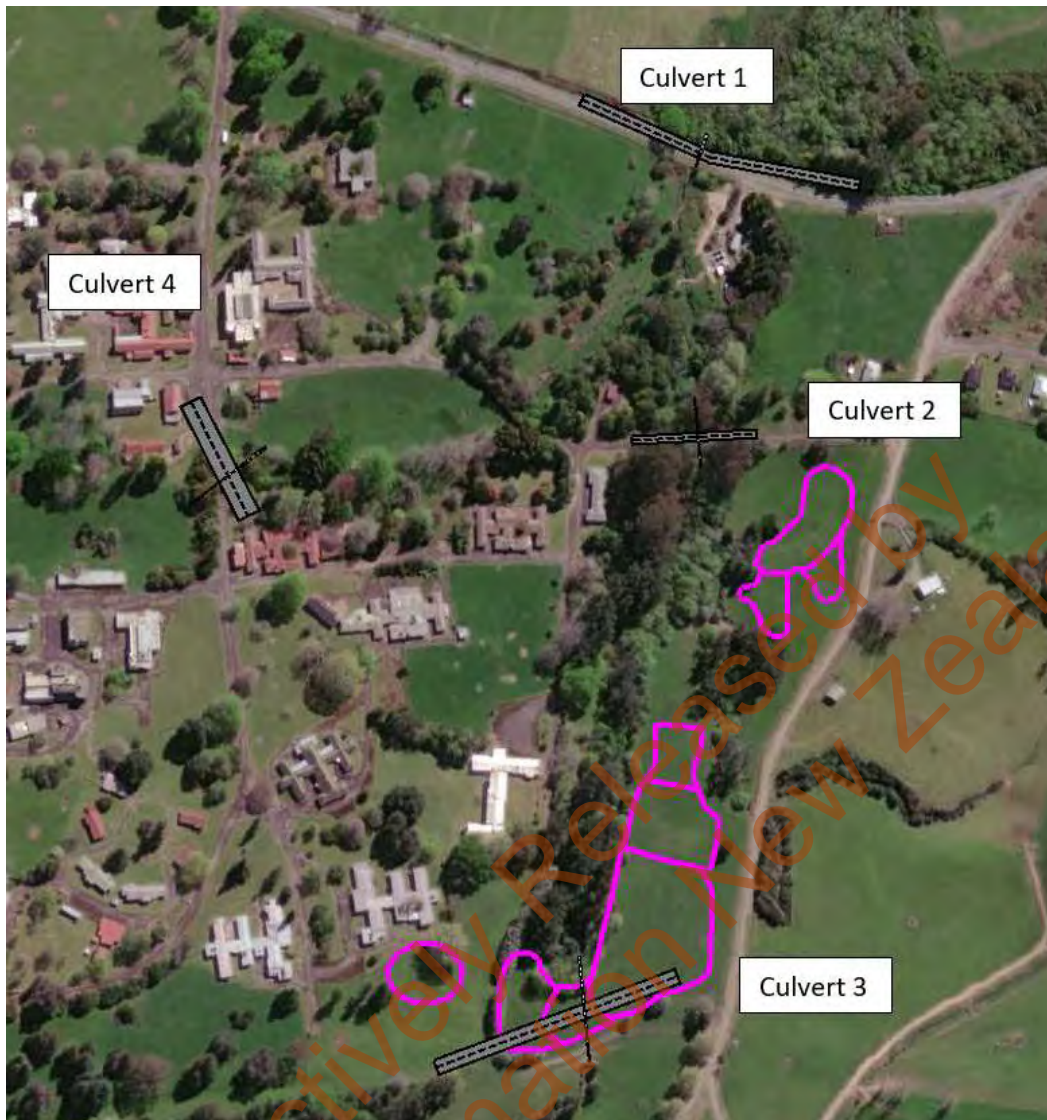
Figure 14: Culvert locations relative to the landfill areas

- Culvert 3 (1350dia) pipes the Wharekōrino Stream through Area H of the landfill. This culvert is estimated to be 44-65 years old and could be subject to differential settlement from landfill activity, leading to leaking joints and ultimately possible pipe failure. Attempts have been made to CCTV this culvert but have not been successful to date, due to significant flows through the culvert.

Below Culvert 1, the stream flows approximately 700m before entering the considerably larger Pūniu River. Mangatoatoa Marae is located on the eastern side of the stream before the confluence with the Pūniu River. There are no other buildings along this section of the stream. Downstream effects of culvert 2 removal are considered likely to be less than minor, as the Marae is approximately 9m above the level of the stream, and as such should not be affected by an increase in the stream flows. This can be checked as part of further design work for removal of this culvert.

Landfill area A effectively dams the stream, with culvert 1 passing under it. Modelling has shown this area to be inundated during a 1% AEP event, with the culvert being overtopped and flood waters flowing overland through Areas A & H. Velocities over the bunded area where the culvert passes may be quite high. This could result in localised scour/erosion along the overland flow path, potentially exposing the underlying landfill materials, and in the worst case, uplifting some of these materials and carrying them into the stream. This effect has not been quantified as part of the modelling done to date.

- Repair (e.g. lining), replacement or removal of Culvert 3. With culvert removal, this would involve transferring buried refuse in this area to another portion of the landfill, outside the floodplain.
- Removal of culvert 2, which will significantly lower flood levels adjacent to the landfill, subject to further investigation, design and an assessment of potential effects on upstream and downstream neighbours.
- Replacement of the landfill cap with a low permeability cap, complying with the consent conditions and/or current best practice. Associated ponding, settlement/subsidence areas would be repaired at the same time.
- Possible installation of a groundwater cut-off trench or similar to divert upgradient groundwater from passing through the landfill, so that it is no longer in contact with buried refuse.

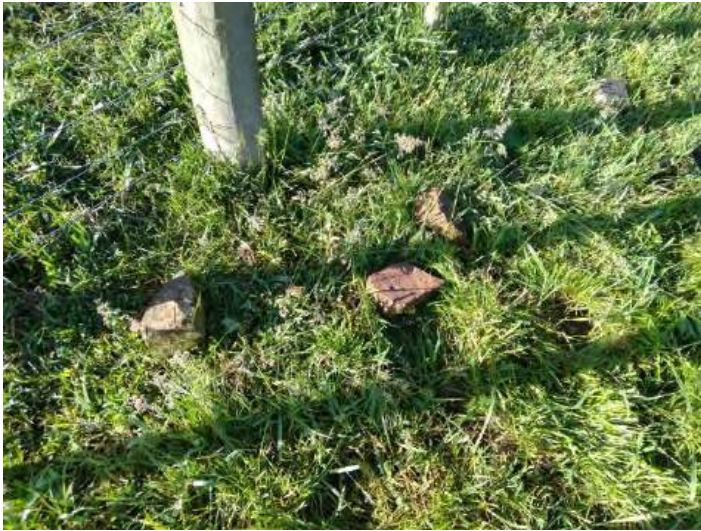
B4 – loose brick debris

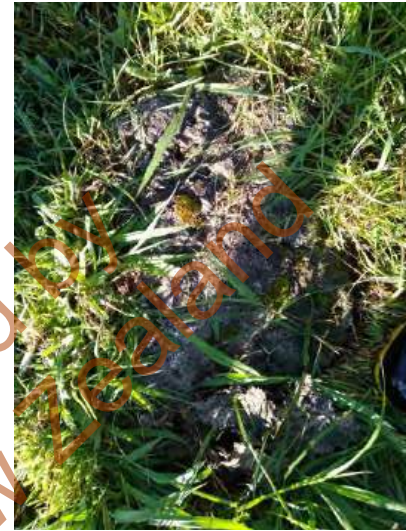
B4 – cement block protruding

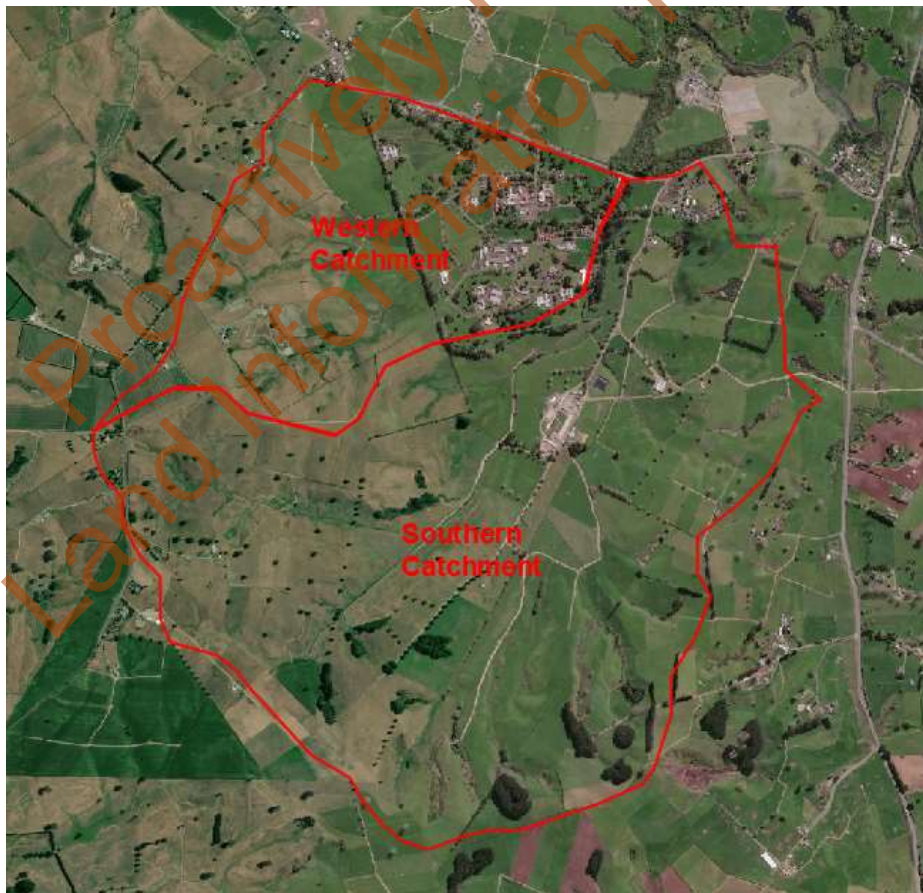
Figure 1: Catchment Locations

Stormwater catchments were delineated from the LINZ LiDAR survey for the immediate area, and 2007-2008 Waikato LiDAR data for the catchment area outside of the site. Two main catchments were delineated, referred to as the southern and western catchments in this Memo. The southern catchment (440ha) drains to the main stream, which flows through it in a south to north direction. The western catchment (166ha) drains through the hospital site's detention storage areas and enters the main stream near Te Mawhai Road. Refer Figure 1 for catchment locations.
