TOKANUI CLOSED LANDFILL, WHAREKORINO STREAM & BORE WATER SAMPLING, WATER QUALITY ANNUAL REPORT - 2024

FORMER TOKANUI PSYCHIATRIC HOSPITAL CLOSED LANDFILL, TE AWAMUTU WHAREKŌRINO STREAM & BORE WATER SAMPLING WATER QUALITY ANNUAL REPORT – 2024

Toitū Te Whenua Land Information New Zealand Landfill Grid Walkover Survey Tokanui Closed Landfill, Te Awamutu Wharekorino Stream & Bore Water Sampling Water Quality Annual Report - 2024

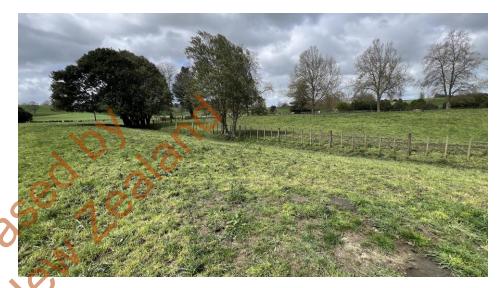
B4 Patchy Vegetation Growth

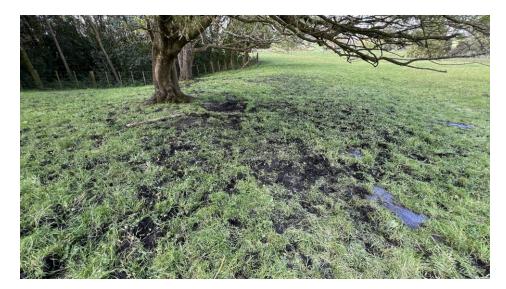
C2 Minor Ponding

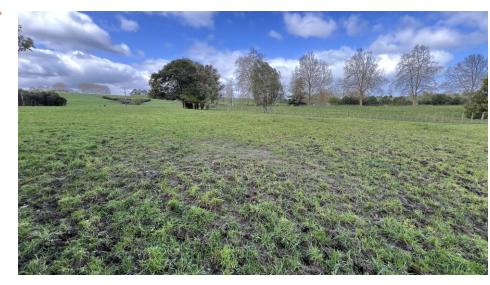
C4 Patchy Vegetation Growth

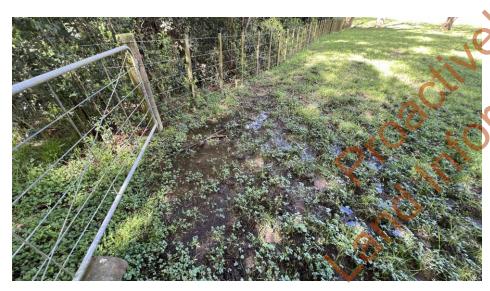
D2 Ponding D2

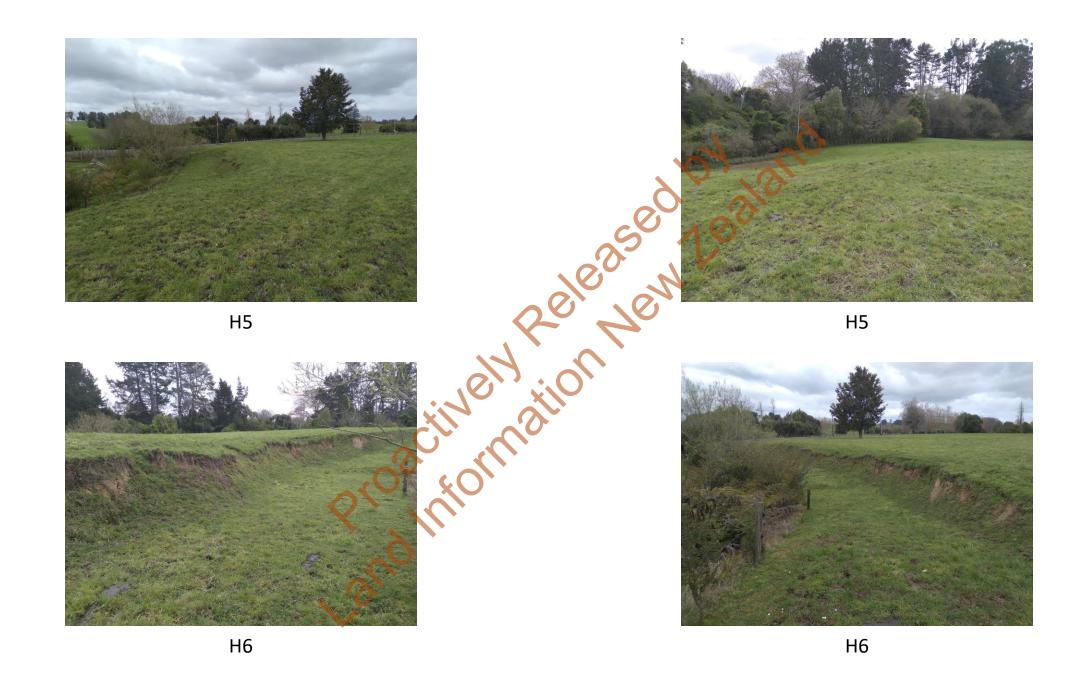
H6 Debris

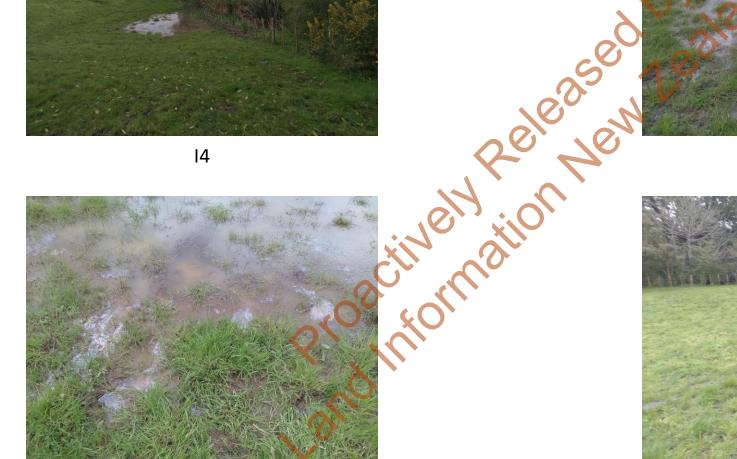
No leachate springs/seeps were observed during the inspection, or during the 2022, 2023, or 2024 inspections. There is one area in grid I4 (Appendix A, pg 23) where ponded water was brown in colour with a surface sheen, but it is suspected this is a natural phenomenon due to iron oxide bacteria, rather than an indicator of leachate seepage.

14 Ponding sheen

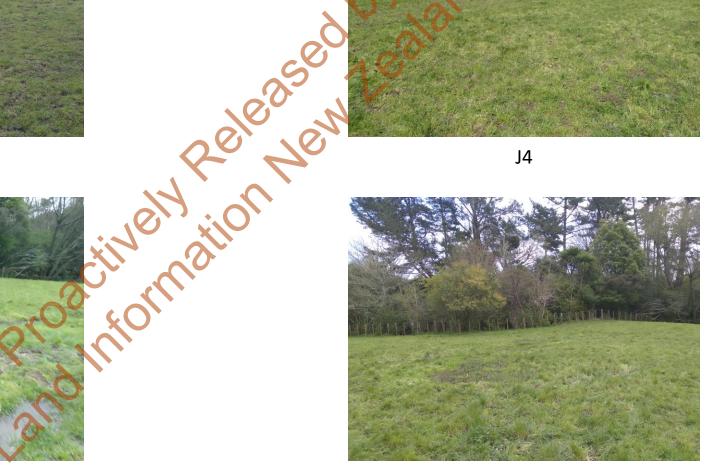
J5 Ponding

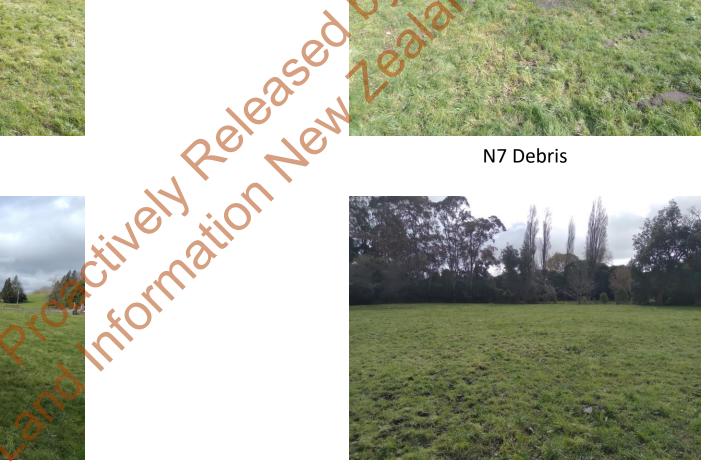
N7 Debris
