# **Pre-Application Meeting Notes**

**Application ref:** PG/0034/24

Site address: 149 Te Mawhai Road, Tokanui

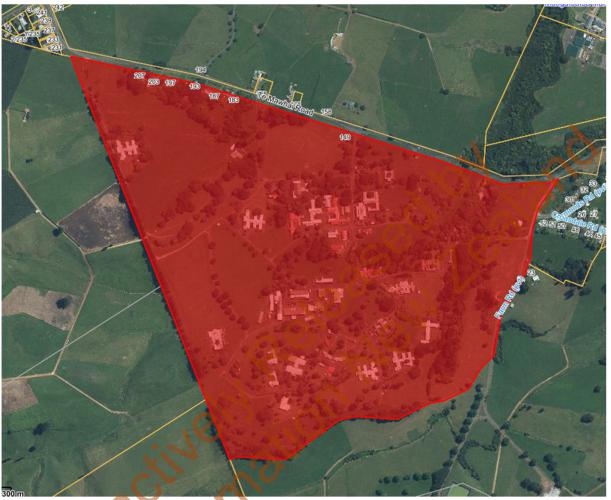
Figure 1: Aerial photograph of site

Located on the southern side of Te Mawhai Road, approx. 4.3km south of Te Awamutu and 2.7km south of Kihikihi, and west of State Highway 3, is the former Tokanui Hospital Site. Located on approx. 80ha, the site includes 84 buildings/structures, a swimming pool, eight substations, substantial underground services, a closed landfill and substantial roading infrastructure. The buildings former uses include wards, dentist, pharmacy, workshops, a laundry, kitchen, fuel station and boiler house. The hospital activity closed in 1998 and has remained unoccupied. Along the northern boundary are seven dwellings which are occupied. The eastern parcel boundary

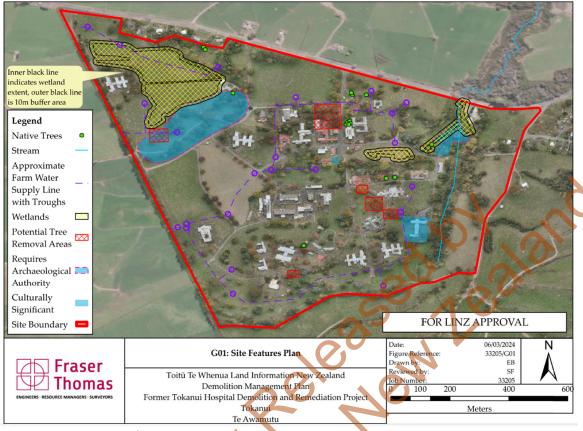
Figure 3: Site Features Plan

In terms of works on site it is proposed to demolish all 84 buildings which are all single storey timber structures and excavate to a depth of approx. 800mm for most of the infrastructure removal, with depths of up to 1200mm where manholes are located. An exception to these depths is one area which will be 3m deep due to the depth and topography surrounding one of the concrete steam ducts. Approximately 13ha or roading is to be removed, and over 30km of pipelines/infrastructure. Following building and infrastructure removal, the site will be grassed with some roading areas returned to a farm track status.

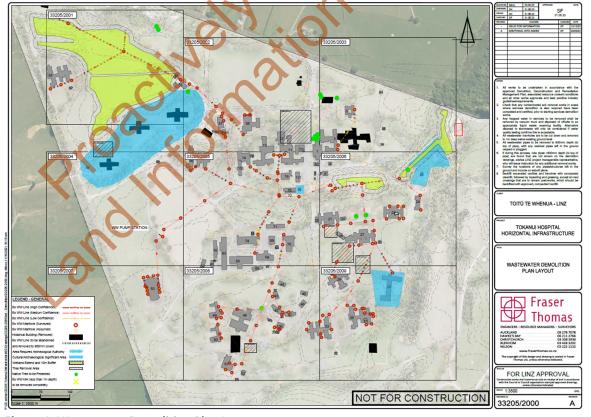
Figure 4: Wastewater Demolition Plan Layout

- Wastewater: The extent of the wastewater network to be removed is shown above in Figure
   4. The existing wastewater pump stations are not being removed.

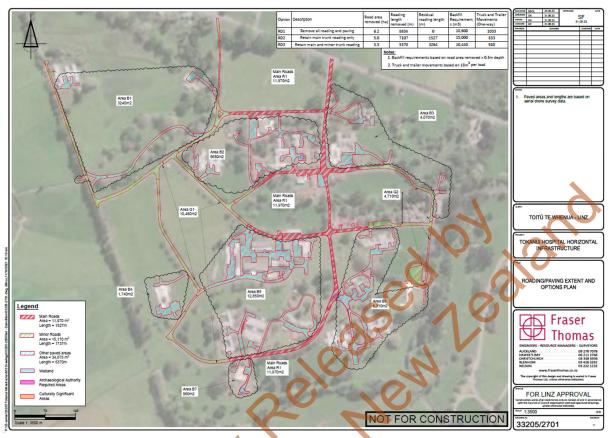
Figure 9: Roading/Paving Extent and Options Plan

- Some of the main and minor roads will be retained and repurposed as farm tracks.
  - In ground reticulated infrastructure removed to 800mm depth below ground level (bgl), except for manholes, which will be removed to 1000mm bgl.
