146 TE MAWHAI ROAD, TE
AWAMUTU

FORMER TOKANUI HOSPITAL
DEMOLITION AND REMEDIATION
REMEDIAL ACTION PLAN – CONTAMINATED SOIL

Project No.	33097	Approved for Issue	
Version No.	3	Name	Sean Finnigan
Status	Final	Signature

REMEDIAL ACTION PLAN - CONTAMINATED SOIL

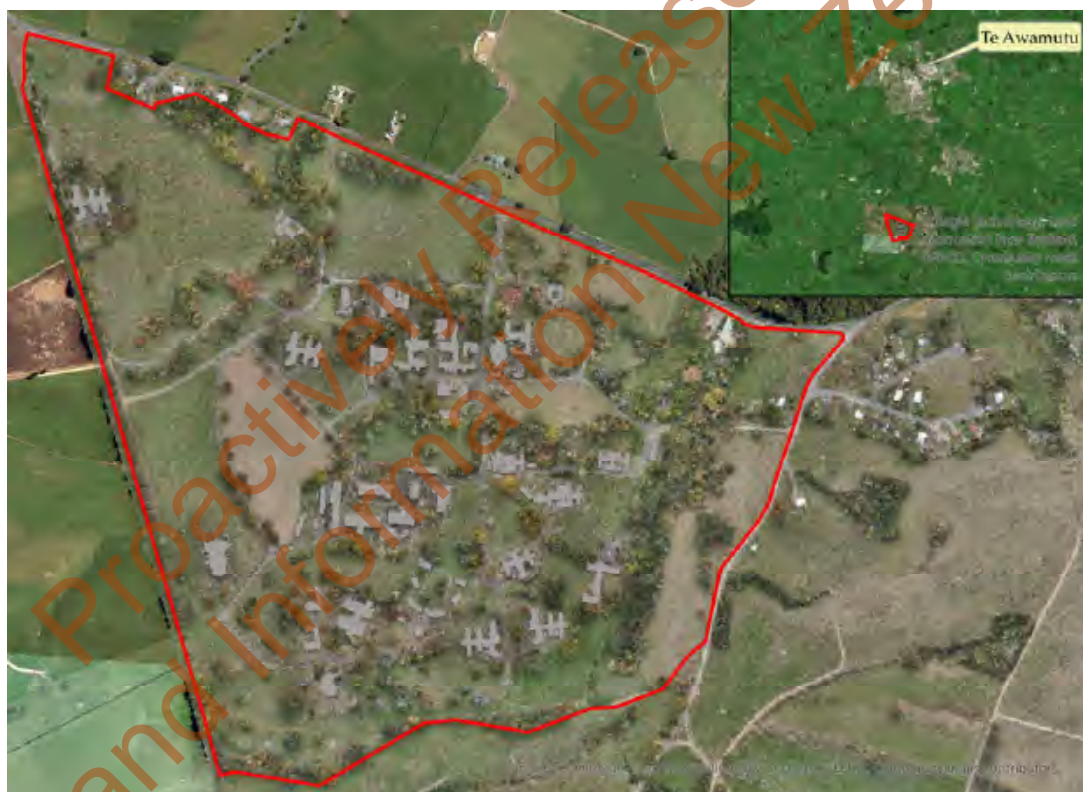
Figure 1: Site location and extent

The former Tokanui Psychiatric Hospital (the site) is approximately 80 hectares (ha) in area and is located roughly 14 km southeast of Te Awamutu, Waikato. The site was developed in 1912, and operated through to 1998. It contains 74 buildings, a decommissioned wastewater treatment plant (WWTP), swimming pool, eight substations, closed landfill (also referred to as the 'existing disposal site') and substantial roading and underground infrastructure and services. The site location and extent are shown in Figure 1 below.

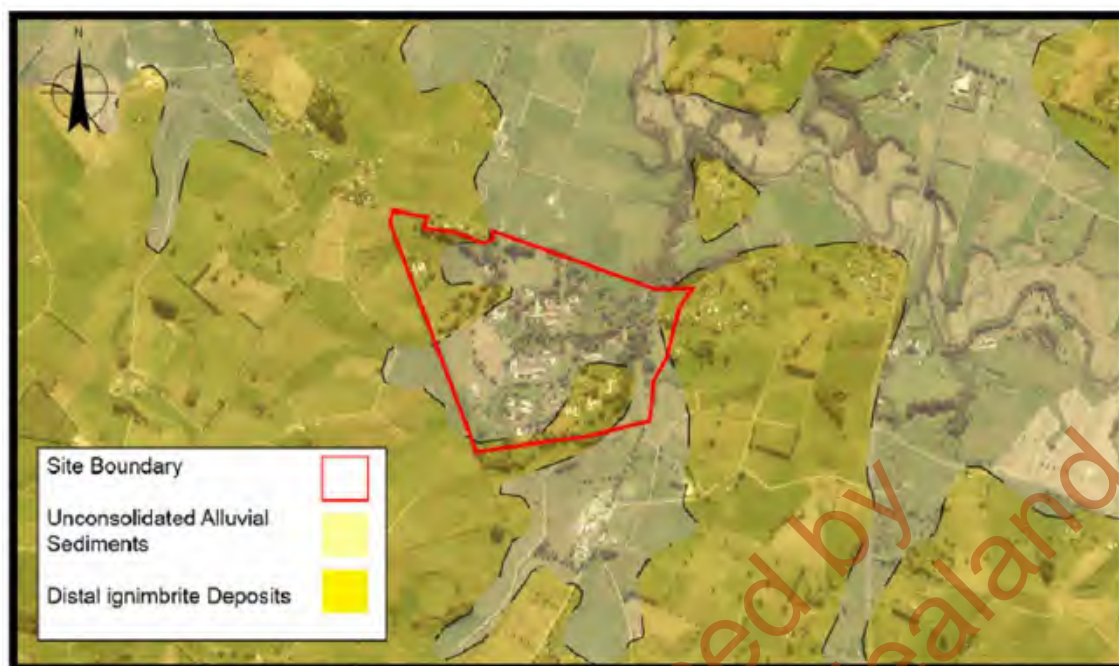
Figure 4: Published Geology Map (source: GHD, PSI, May 2022)

Figure 4 below shows the underlying geology of the area.

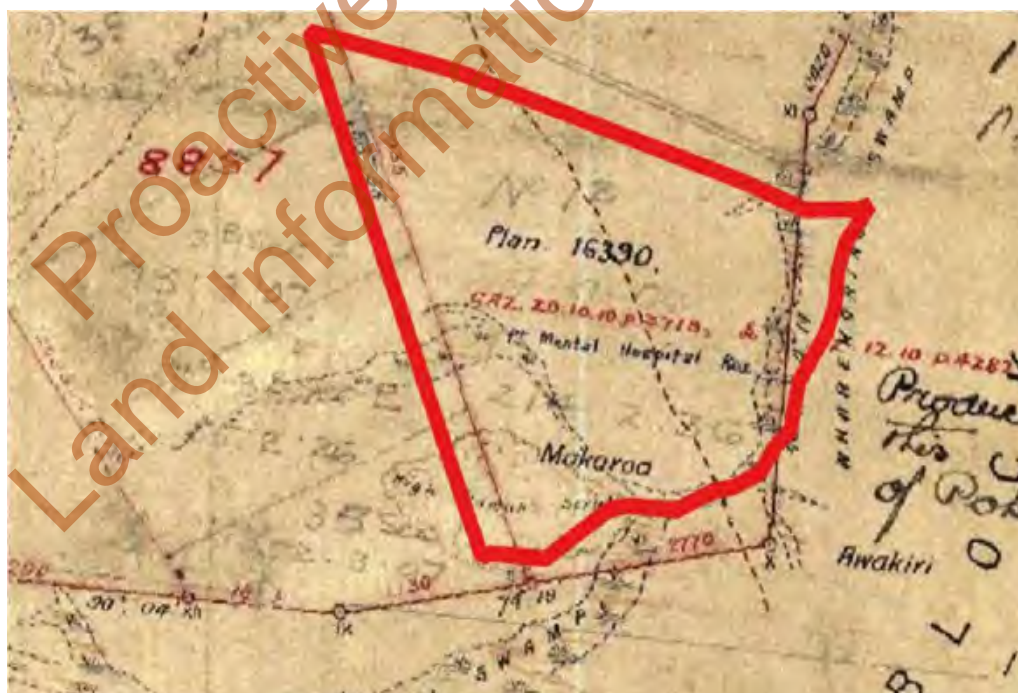
Figure 6: Tokanui Hospital Site – Historical Plan showing former swamps (from CFG, July 2024)

CFG Heritage Ltd (CFG) (July 2024) refer to the hospital site being located at the junction of three waterways, noted in ML 6748 drawn in 1889 as Makaroa, Tarutahi and Wharekōrino Swamps as shown in Figure 6.

Of these swamps, the Wharekōrino Stream is still present and flows through the site from south to north, separating the hospital area from the historical existing disposal site area, which is located on the eastern portion of the Site. This stream includes swamp like features, while the Tarutahi Swamp appears to be part of the Wharekōrino Stream above the site, and the Makaroa Swamp is no longer present.

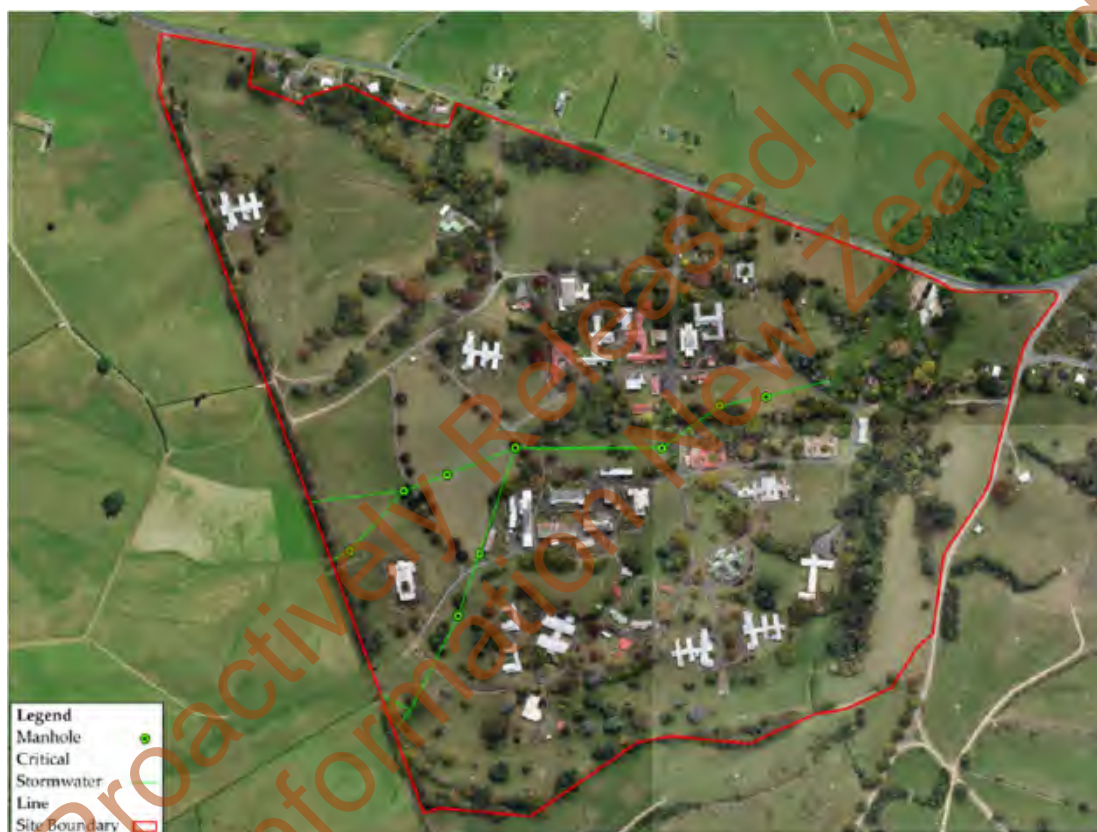
Figure 7: Tokanui Hospital Site – Current Trunk Stormwater Reticulation conveying upgradient runoff through Site

Investigation of the Site's stormwater system has found that runoff from upgradient farmland to the west of the site has been piped through the site as shown in Figure 7 below, meaning these historical watercourses have been infilled and also realigned as the stormwater pipe system alignment differs from the historical swamp/watercourse alignment.

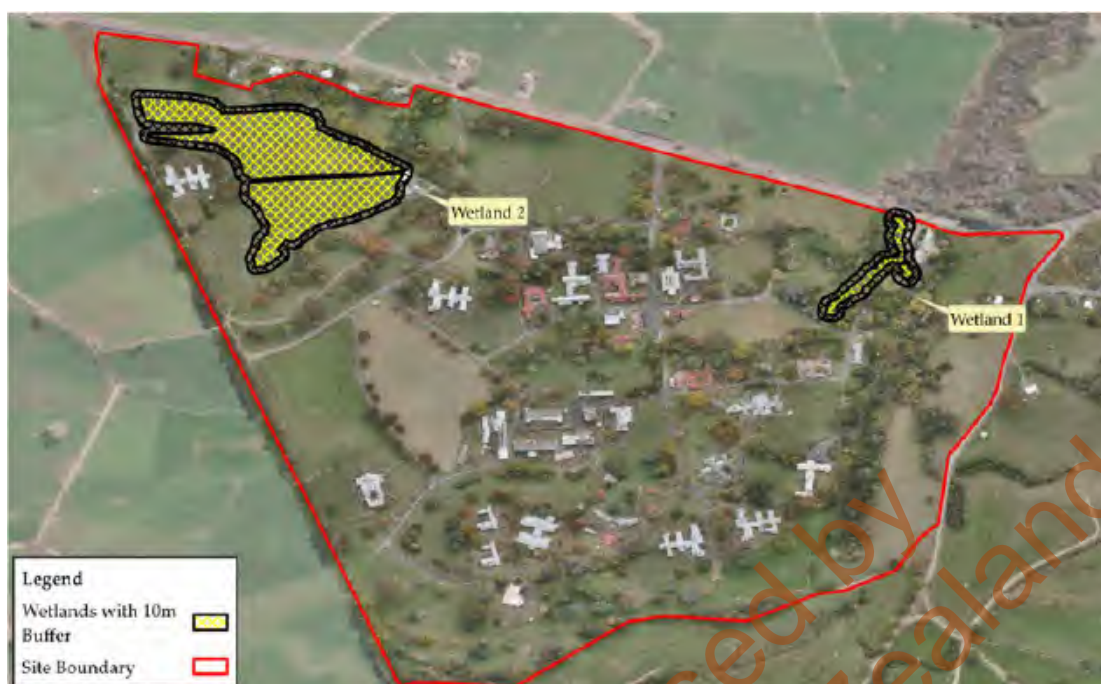
Figure 8: Tokanui Hospital Site – Natural Wetland Extents from SLR Ecological Assessment

Wetlands identified on the site from the ecological investigation (SLR, 2024), taking into account the latest definition of what is a natural inland wetland from the National Policy Statement - Freshwater Management (January 2024) are shown in Figure 8.

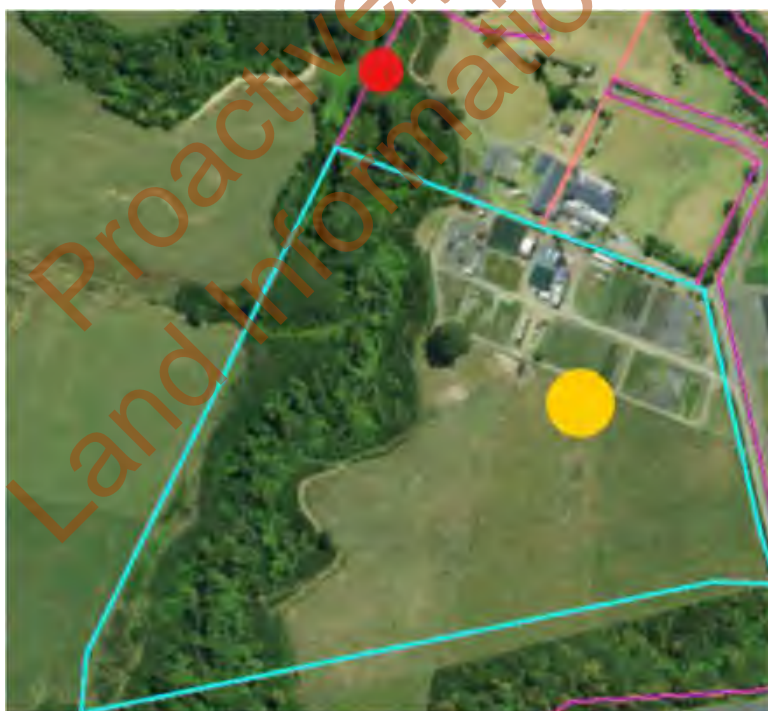
Figure 9: Pūniu River Care Surface Water Take Inlet Location (red dot) on Wharekōrino Stream; yellow dot is location of their bore which is no longer used

Pūniu River Care have a resource consent AUTH144702.01.01 valid till October 2037 to take water from the Wharekōrino Stream for irrigation of a 3-ha plant nursery during September-March inclusive, based on a daily maximum take of 100 m³ and total annual take of not more than 10,000 m³. The inlet structure is located on the Wharekōrino Stream at the location of the red dot shown below in Figure 9, with Bore 72, Station 10906, indicated by a yellow dot.

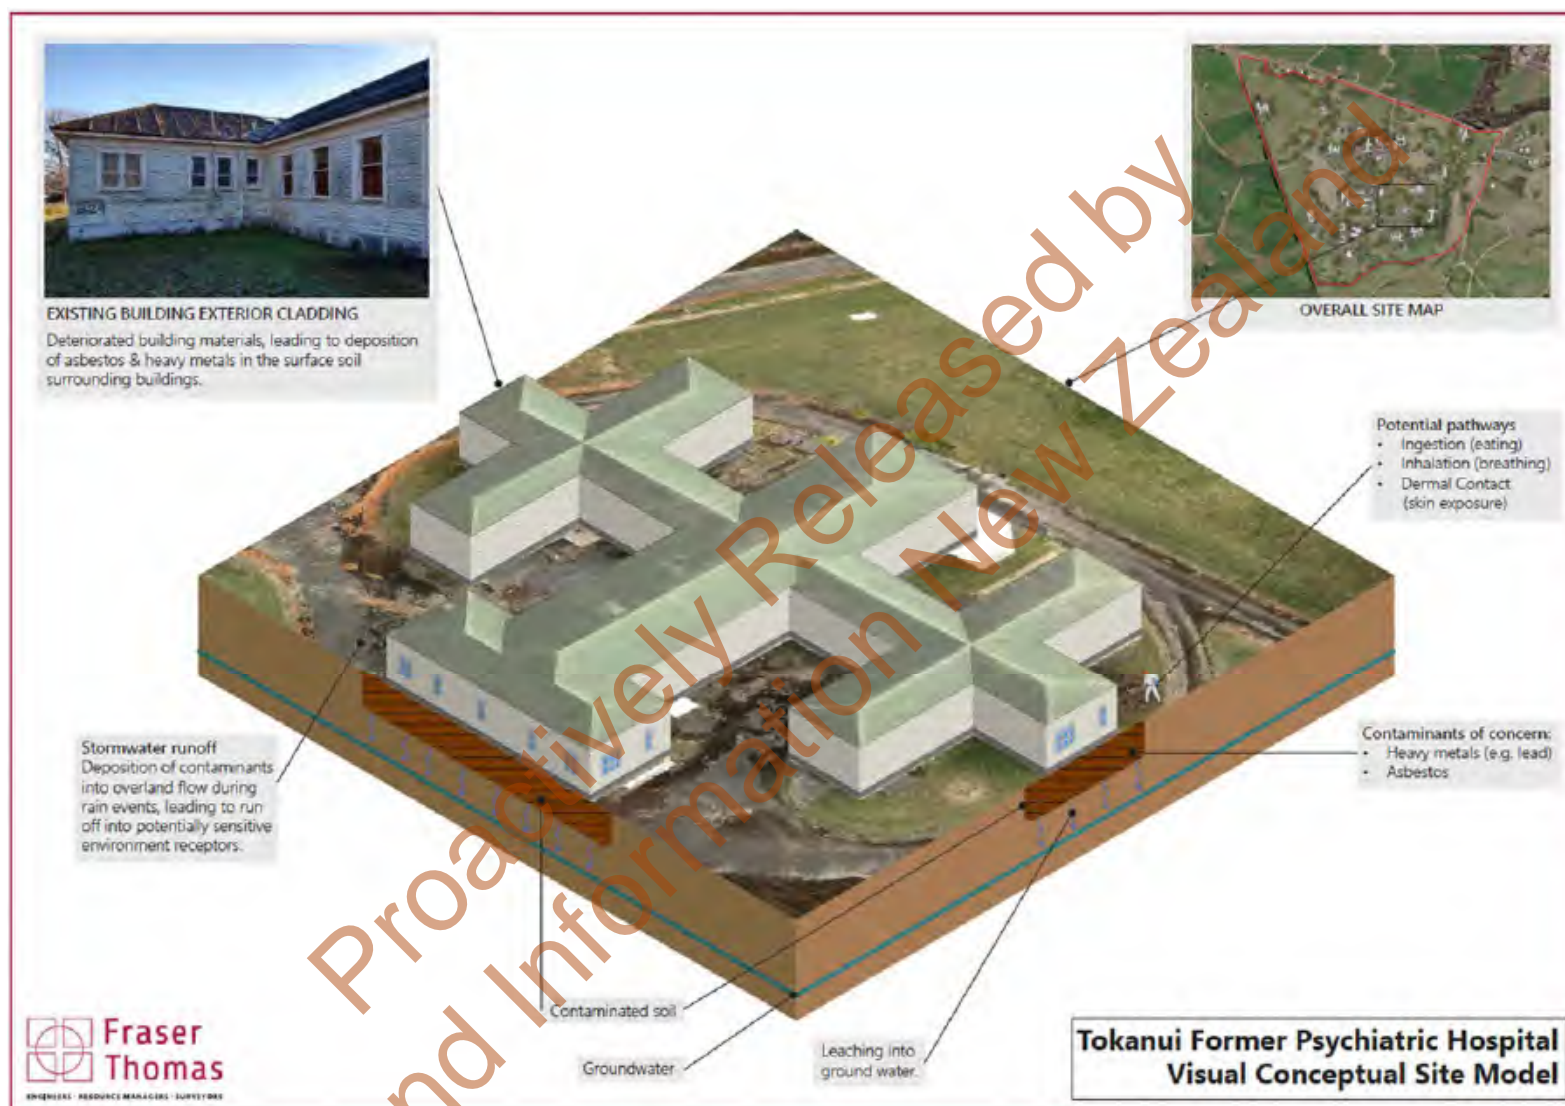
Figure 10: Visual CSM

Stormwater runoff	Ecological receptors (flora and fauna)	Complete	Incomplete	Site has extensive stormwater drainage system (catchpits & pipes) that collects site runoff and discharges it to a small stream that flows into the Wharekōrino Stream near the former wastewater treatment plant, just upstream of Te Mawhai Road. Stream sediment sampling found slightly elevated levels of heavy metals, including cadmium, copper, lead and zinc, but well within ANZECC ISQG-low trigger values, other than two marginally elevated zinc concentrations (250 and 260 mg/kg vs trigger of 200 mg/kg) without allowing for any dilution. Removal of site buildings and soil remediation will eliminate this source. Sediment found in the stormwater system during demolition works should be tested for contamination and disposed of accordingly.
			Future site users	Potentially	Incomplete	Remedial works will address soil contamination issues and eliminate contamination sources through removal of hospital buildings and infrastructure, making site fit for purpose for future users.

Off-site residents	Potentially	Incomplete	Remedial works will address soil contamination issues and eliminate contamination sources through removal of hospital buildings and infrastructure, making site fit for purpose for future users.
		Leaching of contaminants to groundwater	Downgradient water users;	Incomplete	Incomplete	Testing has shown both lead and zinc are not readily leached from site soils under natural conditions. As there is only one groundwater abstraction bore within 1km downstream of the site where water is consented for use for nursery irrigation at the Mangatoatoa Marae, it is considered unlikely that any potential contaminant migration via groundwater would pose an unacceptable risk to human health. Remedial works will eliminate contamination sources through removal of hospital buildings and infrastructure.
			Ecological receptors (flora and fauna)	Incomplete	Incomplete	Shallow groundwater from the site is likely to flow into the Wharekōrino Stream, with potential ecological effects covered above under stormwater.

Ecological receptors	Incomplete	Incomplete	Shallow groundwater from the site is likely to flow into the Wharekōrino Stream, with potential ecological effects covered above under stormwater.

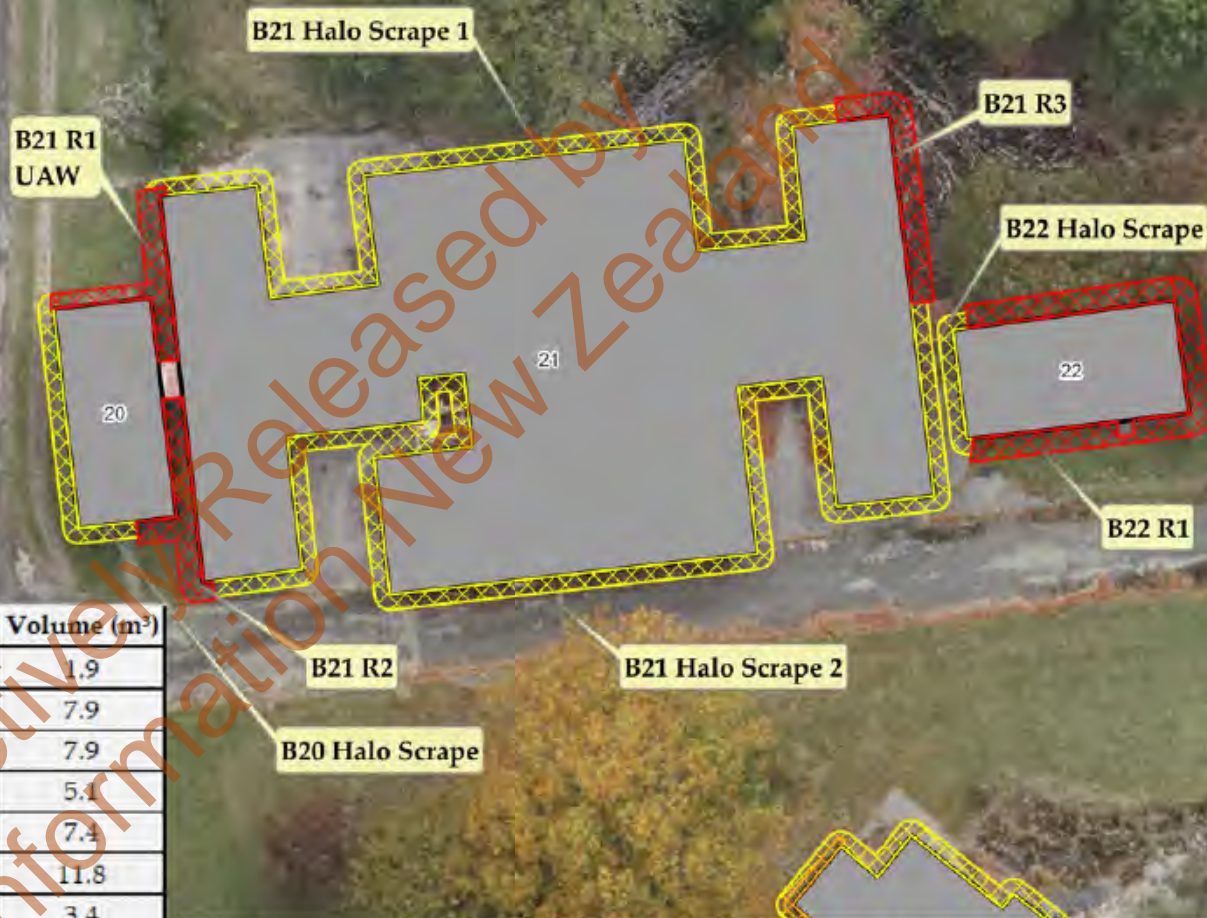
Building	Remedial/Management Area	Area (m ²)	Depth (m)	Volume (m ³)
B20	Halo Scrape	19.8	0.1	1.9
B21	R1	22.8	0.35	7.9
	R2	22.8	0.35	7.9
	R3	25.7	0.2	5.1
	Halo Scrape 1	73.9	0.1	7.4
	Halo Scrape 2	118.2	0.1	11.8
B22	Halo Scrape	33.7	0.1	3.4
	R1	56.1	0.2	11.2
Total Area/Volume		373	-	56.6

FIGURE SCALE = 1:500 AT A4
MEASURE BUILDING BUFFERS OFFSET FROM BUILDING WALL CLADDING

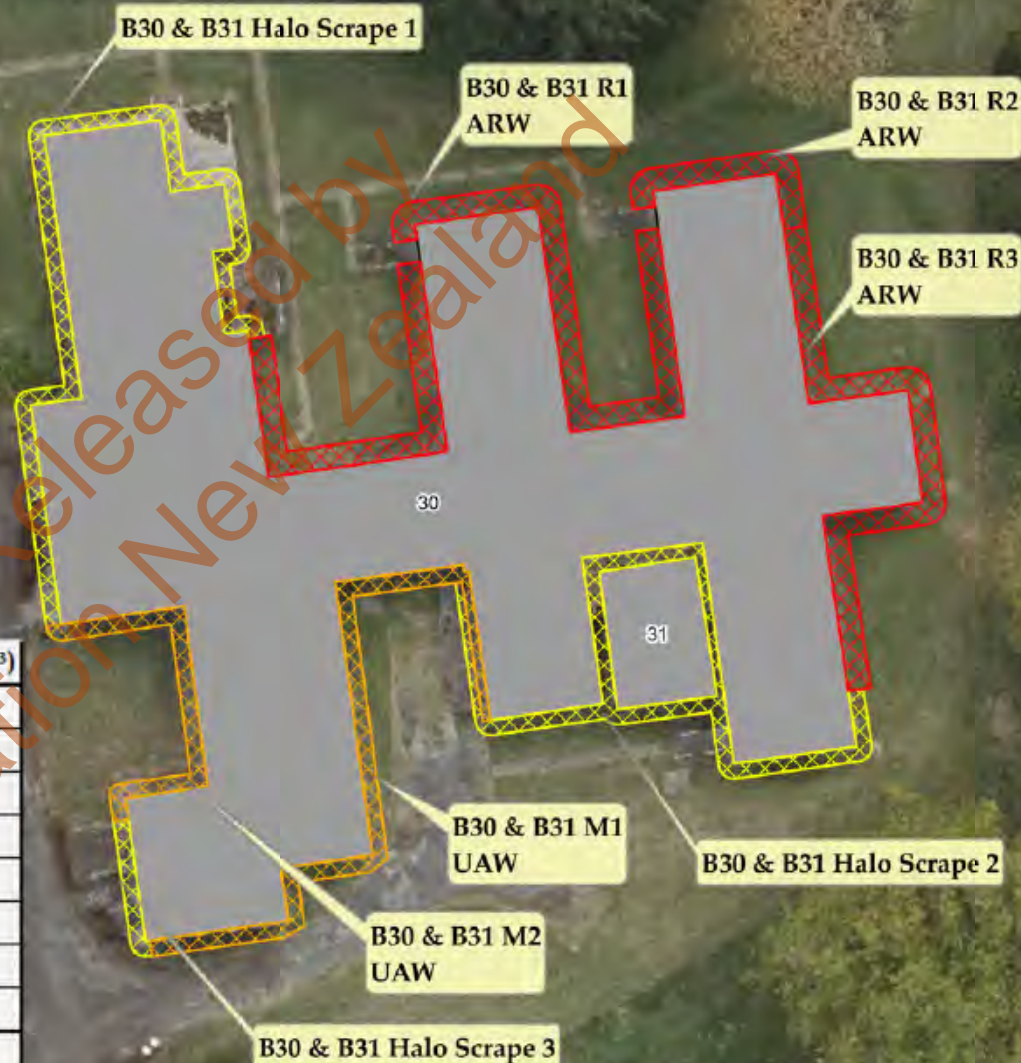
Building	Remedial/Management Area	Area (m ²)	Depth (m)	Volume (m ³)
B30 & B31	R1	111.8	0.3	33.5
	R2	22.8	0.35	8.0
	R3	65	0.35	22.8
	M1	51.6	0.15	7.7
	M2	27.1	0.4	10.8
	Halo Scrape 1	65.6	0.1	6.6
	Halo Scrape 2	58.2	0.1	5.8
	Halo Scrape 3	9.2	0.1	0.9
Total Area/Volume		411.3	-	96.2

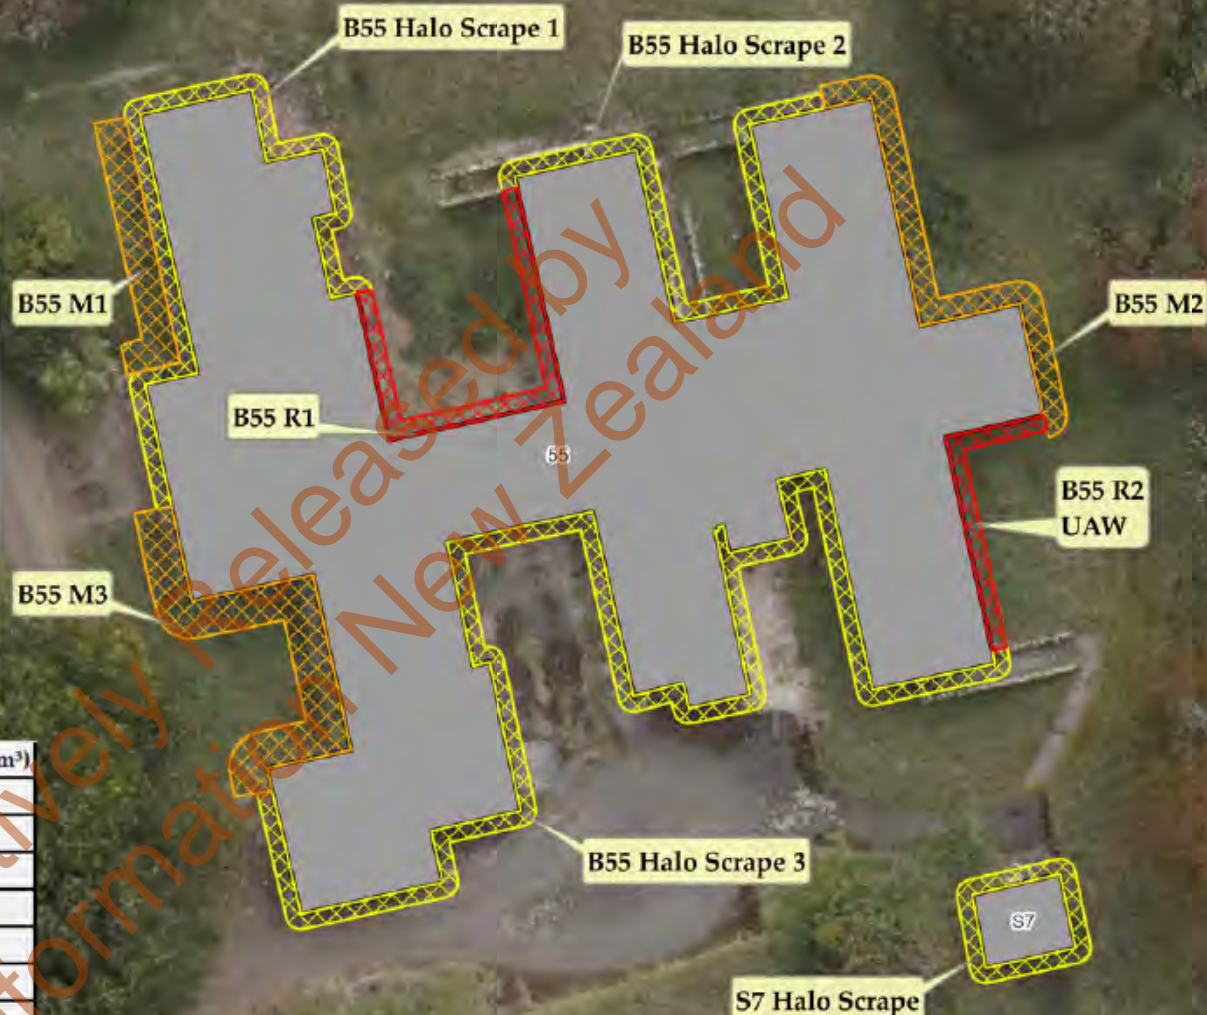
Building	Remedial/Management Area	Area (m ²)	Depth (m)	Volume (m ³)
B55	R1	35.4	0.15	5.3
	R2	20.1	0.4	8.0
	M1	35.1	0.2	7.0
	M2	52.1	0.15	7.8
	M3	80.8	0.2	16.2
	Halo Scrape 1	57.7	0.1	5.8
	Halo Scrape 2	45.3	0.1	4.5
	Halo Scrape 3	125	0.1	12.5
S7	Halo Scrape	25.1	0.1	2.5
Total Area/Volume		476.6	-	69.7

FIGURE SCALE = 1:500 AT A4
MEASURE BUILDING BUFFERS OFFSET FROM BUILDING WALL CLADDING

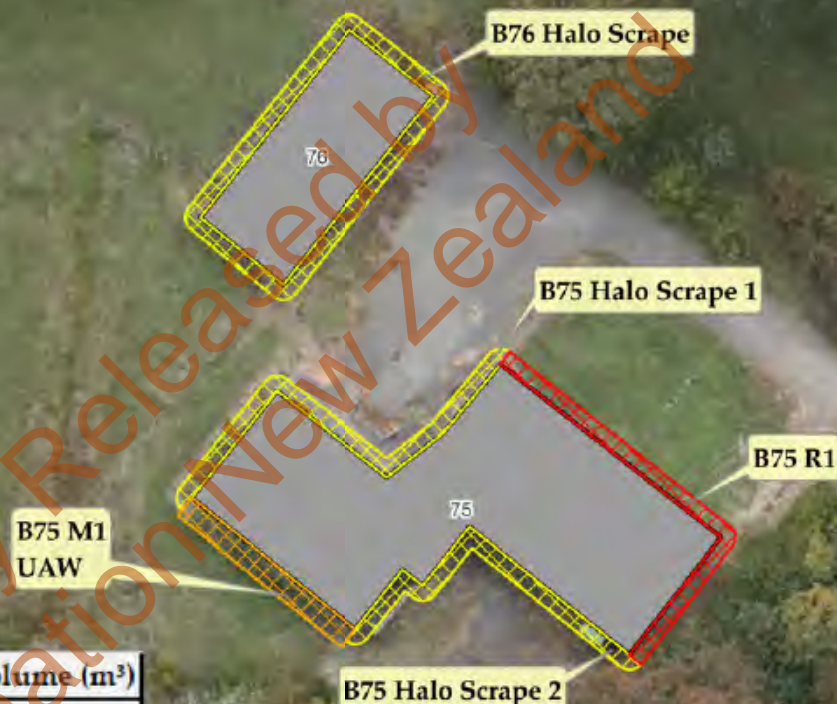
Building	Remedial/Management Area	Area (m ²)	Depth (m)	Volume (m ³)
B75	R1	28.2	0.2	5.6
	M1	20.8	0.2	4.2
	Halo Scrape 1	30.5	0.1	3.1
	Halo Scrape 2	25.4	0.1	2.5
B76	Halo Scrape	49	0.1	4.9
Total Area/Volume		153.9	-	20.3

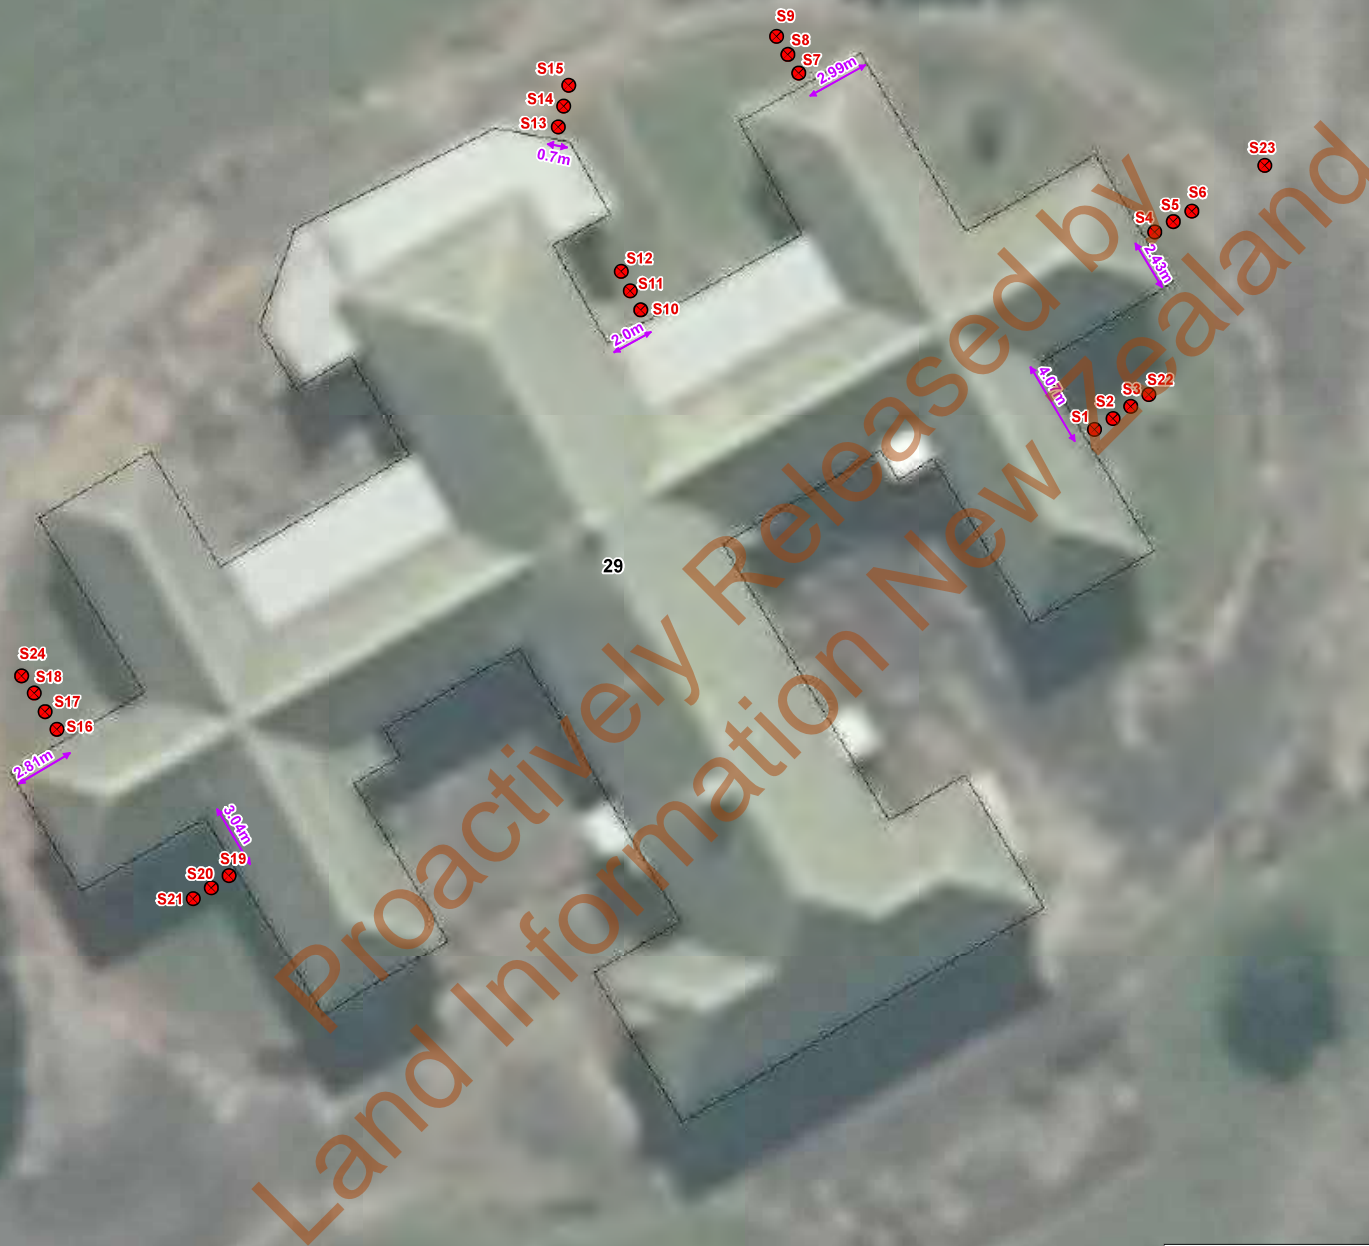
SAMPLE ID	DISTANCE FROM THE BUILDING
S1	0.5m
S2	1.5m
S3	2.5m
S22	3.5m
S4	0.5m
S5	1.5m
S6	2.5m
S23	6.5m
S7	0.5m
S8	1.5m
S9	2.5m
S10	0.5m
S11	1.5m
S12	2.5m
S13	0.5m
S14	1.5m
S15	2.5m
S16	0.5m
S17	1.5m
S18	2.5m
S24	3.5m
S19	0.5m
S20	1.5m
S21	2.5m
