# Ecological Impact Assessment

## Tokanui Hospital Remediation

### Land Information New Zealand

**SLR Consulting New Zealand**

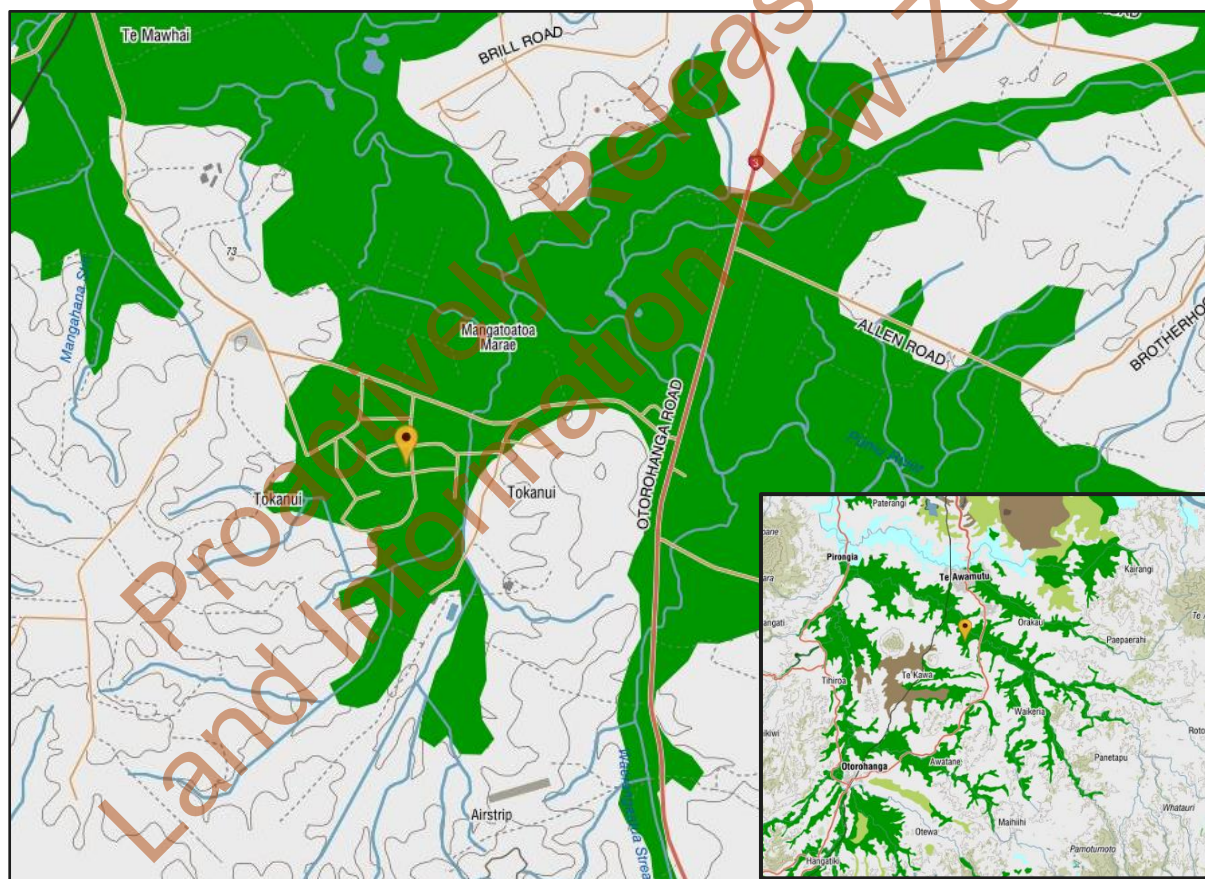
**Figure 3: Historic wetland extent in and surrounding the site. Centre of site shown as an orange marker.**

Natural vegetation cover across the site would predominantly have been mixed podocarp-broadleaved forest with dominant species comprising rimu (*Dacrydium cupressinum*) and tawa (*Beilschmiedia tawa*). Wetlands throughout the area would have been a combination of swamp, marsh, bog, and fen and kahikatea (*Dacrycarpus dacrydioides*) forest would have been common. A large swamp wetland that connected to the Pūniu River and associated catchments was part of a larger network of connected wetland habitat. This wetland extended over the Tokanui Hospital site (Figure 3).

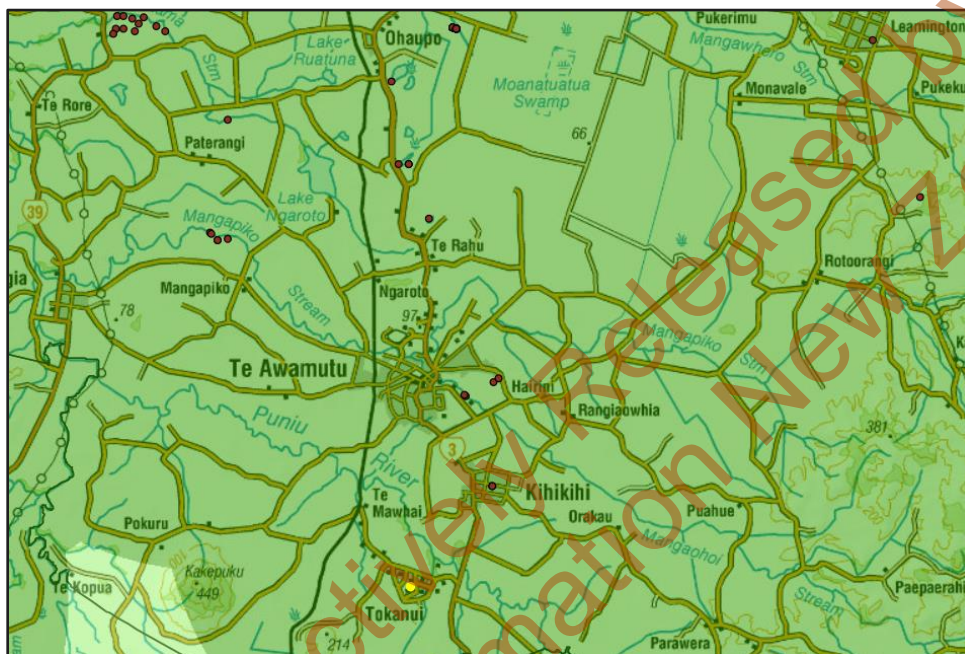
**Figure 5: Long-tailed bat detections (red points) and bat habitat (dark green) surrounding the site (yellow point).**

Initial bioacoustic monitoring detected four long-tail bat vocalisations at the southern-most monitor (ABM 1). This confirms the presence of long-tailed bats within the site. Additional monitoring undertaken for the Tokanui Bat Management Plan (BMP) detected vocalisations across the site as well as numerous areas with appropriate roosting, commuting, and foraging habitat.

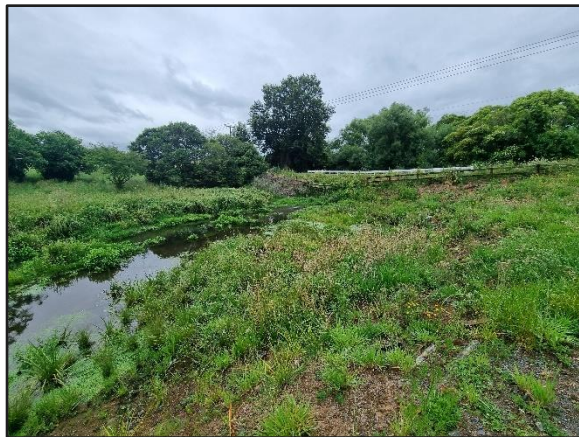
**Photo 5: Upstream of Culvert 1.**

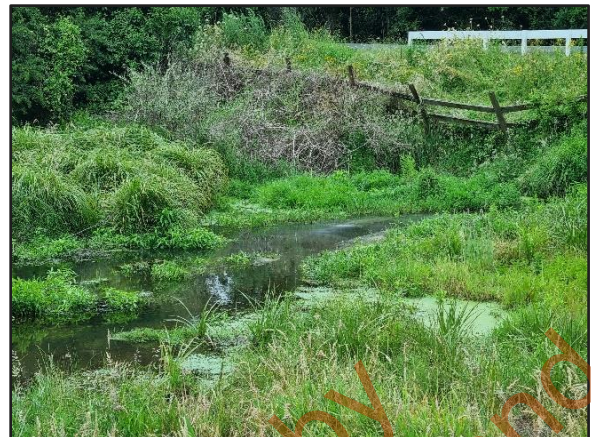
**Photo 6: Pooling above Culvert 1.**

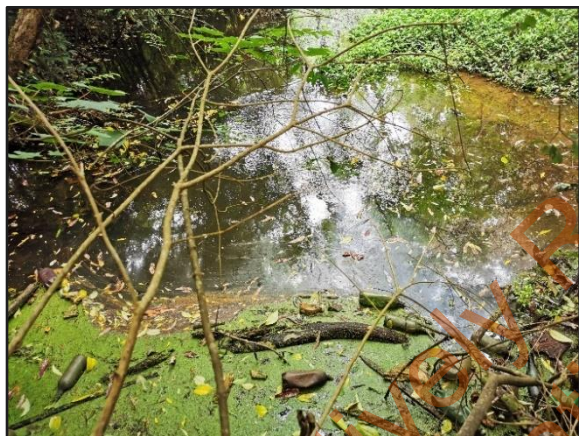
**Photo 7: Downstream Culvert 2. Pooled water and debris visible.**

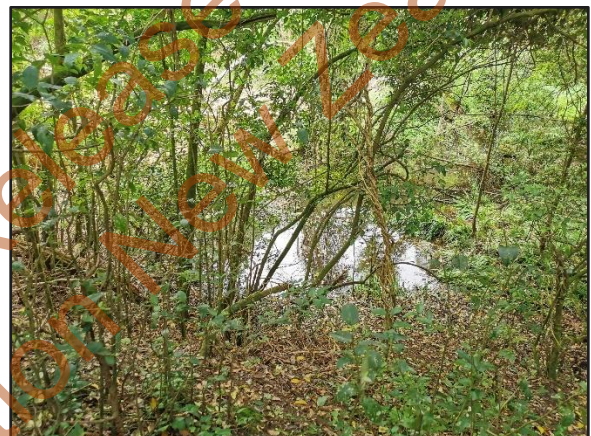
**Photo 8: Upstream of Culvert 2, no flow evident.**

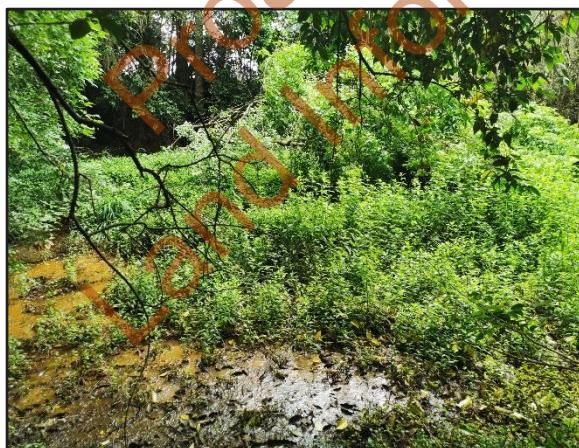
**Photo 9: Downstream of Culvert 3.**

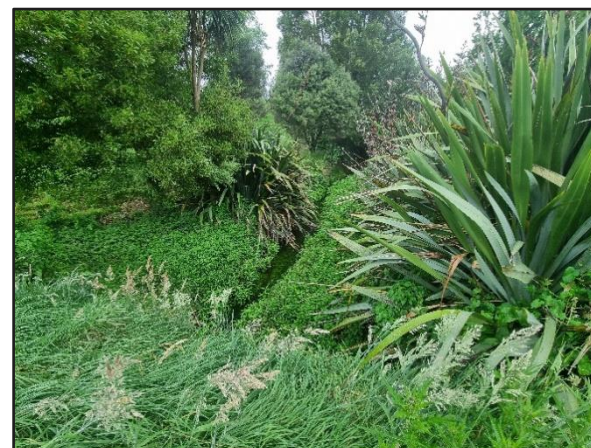
**Photo 10: Upstream of Culvert 3.**

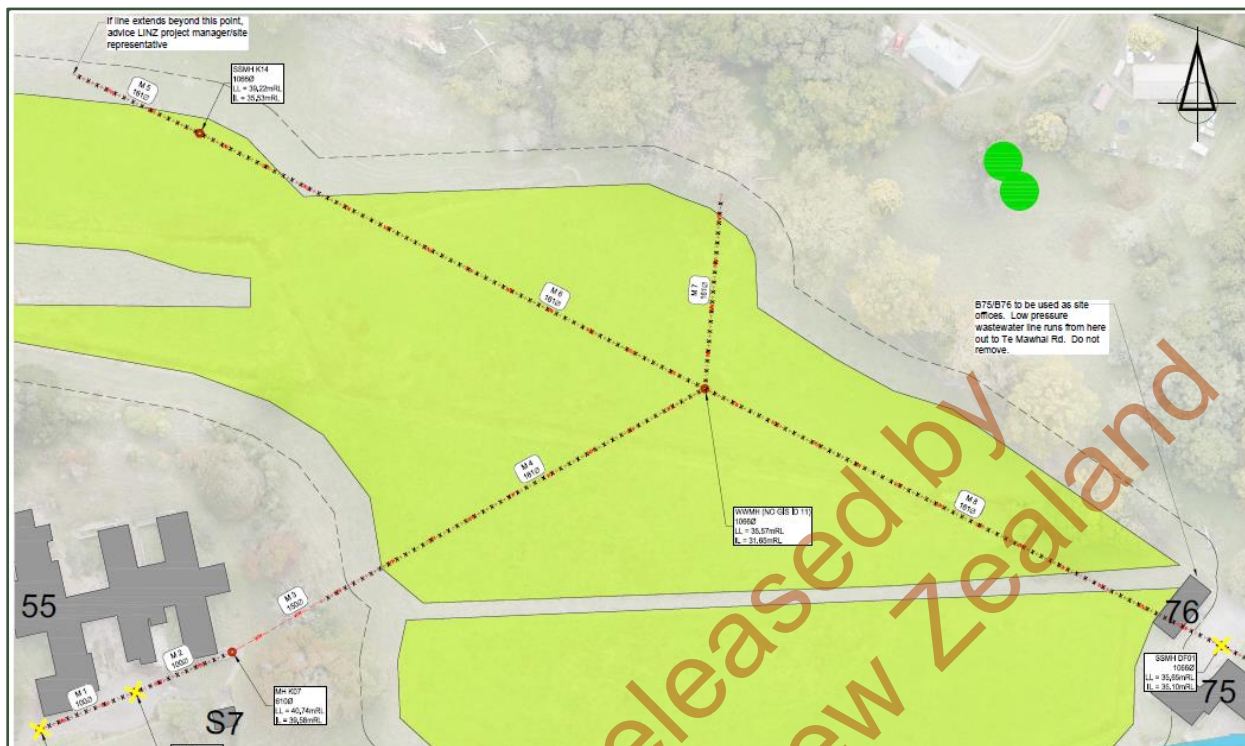
Figure 7: Wastewater lines to be removed within wetland 2 (green area).

Within wetland 2 above ground wastewater lines and supports, below ground electricity cables, and a building and waterpipe adjacent to the wetland are all being removed (Figure 7 and Figure 8). All works will be conducted during an extended dry period with a small excavator travelling along swamp mats with works being done in sections. Backfilled trenches and damaged vegetation will be reseeded/replanted with appropriate vegetation.

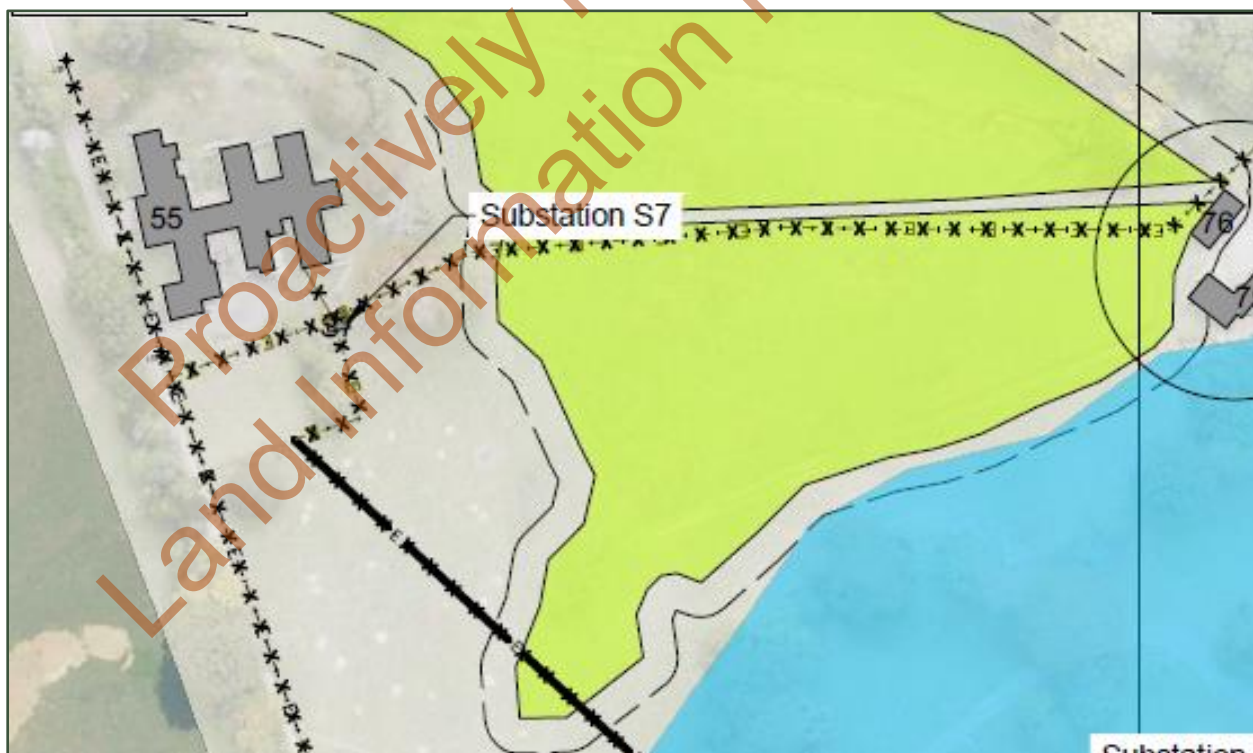
Figure 8: Power line to be removed across wetland 2 (green area).

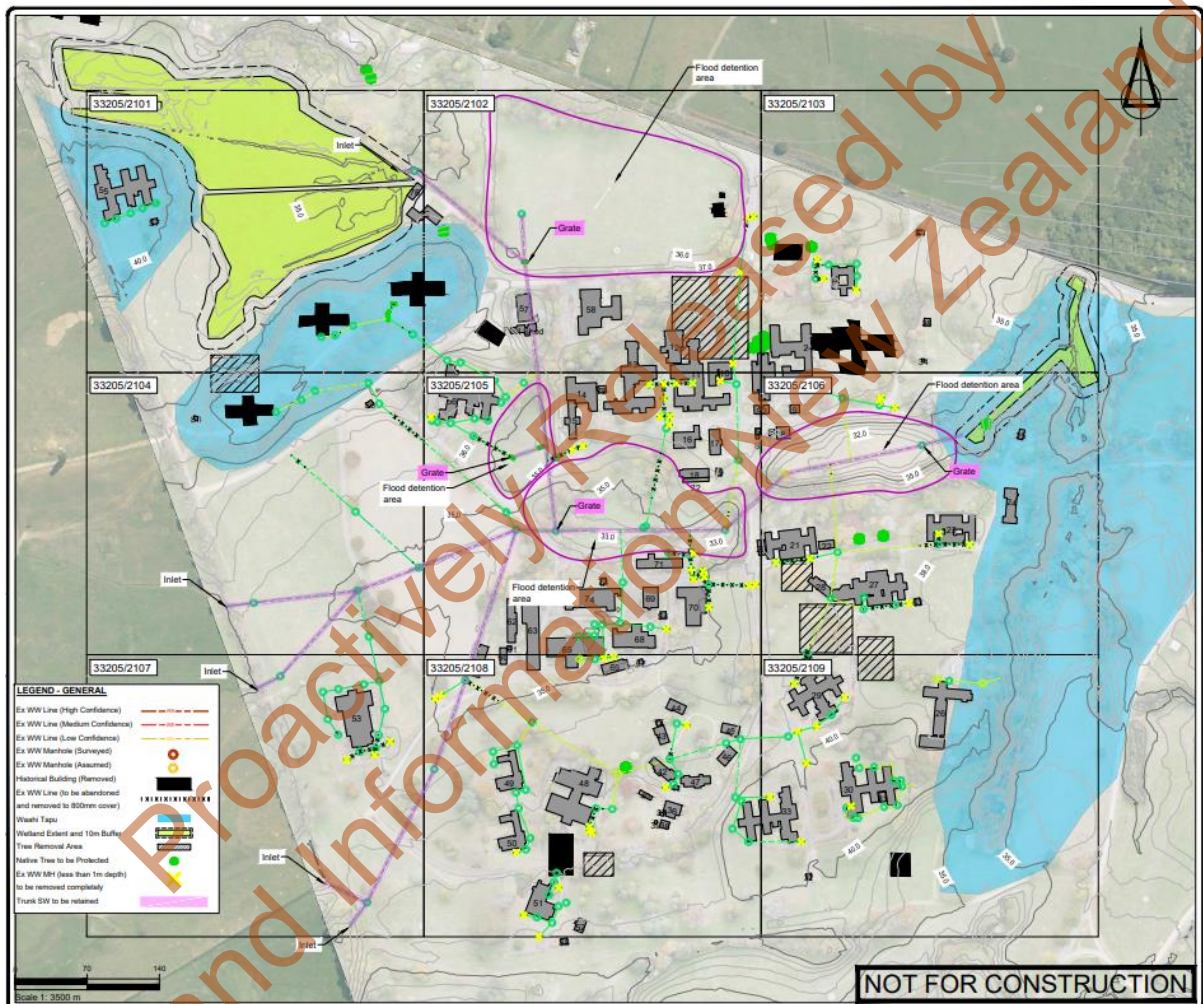
Figure 9: Stormwater infrastructure proposed to be upgraded (purple)

The trunk stormwater pipe system receives runoff from areas off-site and drains some flood detention areas within the site. It discharges to a tributary of the Wharekōrino Stream. During site investigations, it was found that the trunk stormwater pipes were in moderate to poor condition with major cracking at certain locations. To ensure that stormwater flow from upgradient properties could continue across the site, upgrades are required (Figure 9). This will involve lining the trunk stormwater system with an internal sleeve to extend its life by at least 50 years. During the upgrading works, sand bagging or similar will be installed at the outlet to the Wharekōrino Stream. This dam would remain in place for the duration of works. An “outlet pump” will be installed upstream to divert flows around works. Once works are completed all dams and pumps will be removed.

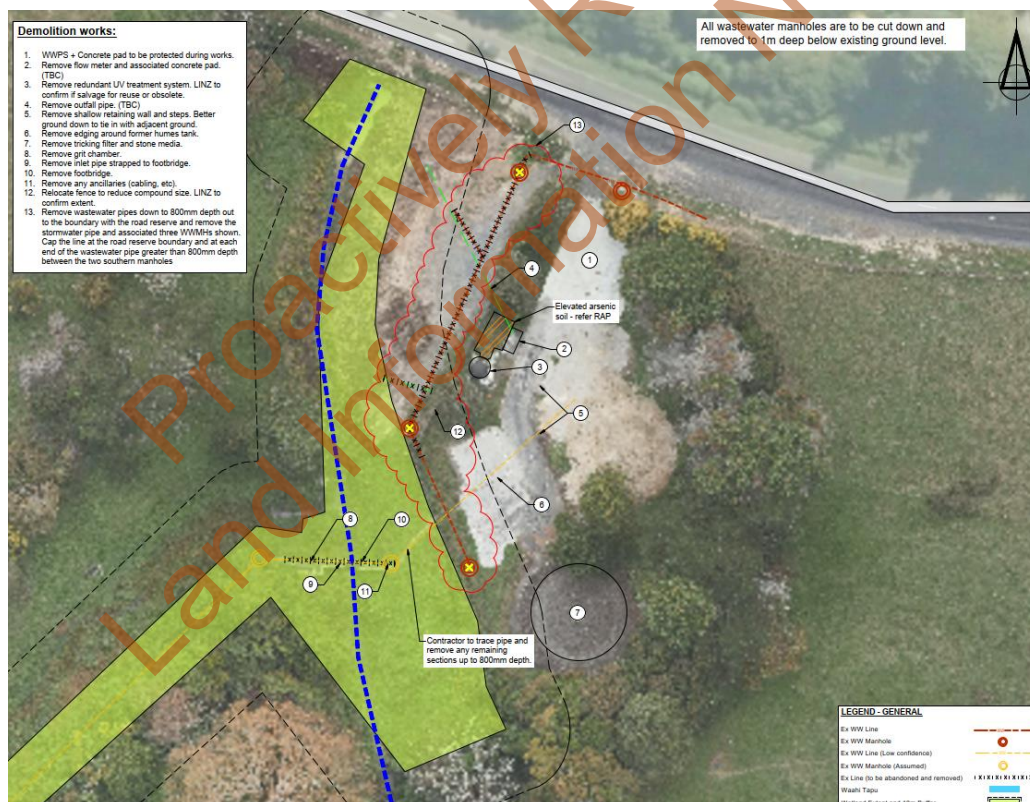
Figure 10: Aerial view of works within wetland 1 and within 10 m of wetland 1.

These works will be done during an extended summer dry period. Where required, a small excavator will travel along swamp mats to minimise the potential for damage to the wetland area. Where possible, works will be done manually from the foot bridge or with a large excavator located outside the wetland area. Earthworks during pipe removal is estimated to require a maximum of 20 m long x 300m wide x 0.8 m depth trench. The trench would be topped up with topsoil and be replanted with appropriate grass/plants to match the current vegetation in the wetland area. Any damaged areas of vegetation would also be replanted. Appropriate sediment controls will be implemented during works.

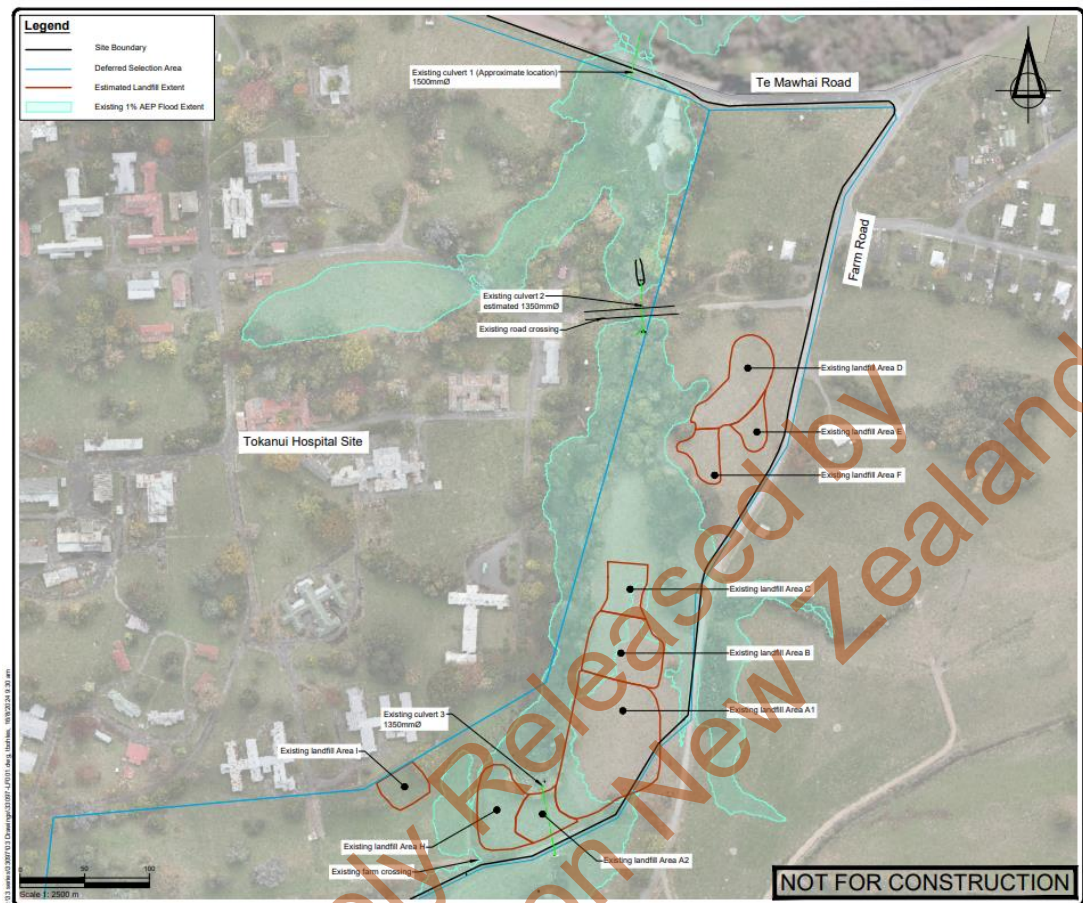
Figure 11: Historic landfill (red) area adjacent to the Wharekōrino Stream.

The 1.8 ha area of landfill sites adjacent to the Wharekōrino Stream have been identified as requiring repair (Figure 11). Additionally, contaminated soils on sites are proposed to be disposed of in these areas. Upgrading works will involve a number of tasks including (but not limited to):

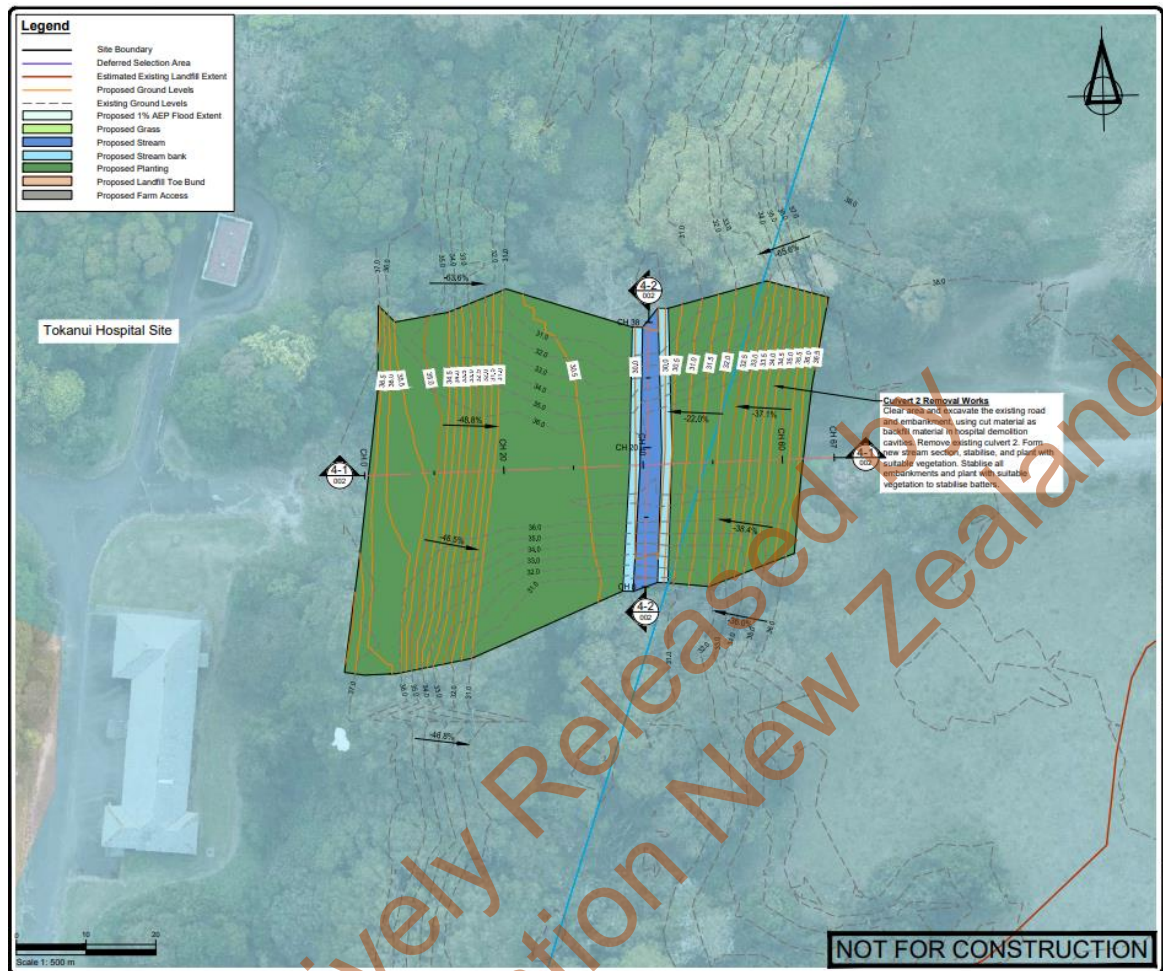
**Figure 12: Proposed removal of road embankment and Culvert 2 intersecting the Wharekōrino Stream.**

- Establishment of erosion and sediment controls; including temporary damming of the stream and a diversion of stream by pumping of water.
- Undertake fish relocation as per the Fish Management Plan (FMP; Appendix F).
- Removal of vegetation, infrastructure and soil. This is to be disposed of or reused where appropriate.
- Trim stream banks to tie in with existing stream profile.
- Place clean topsoil along stream batters (100 – 150 mm thick) and cover with biodegradable matting.
- Undertake planting as per the Planting and Management Plan (PMP, Appendix E).
- Remove temporary dams and erosion/sediment controls.

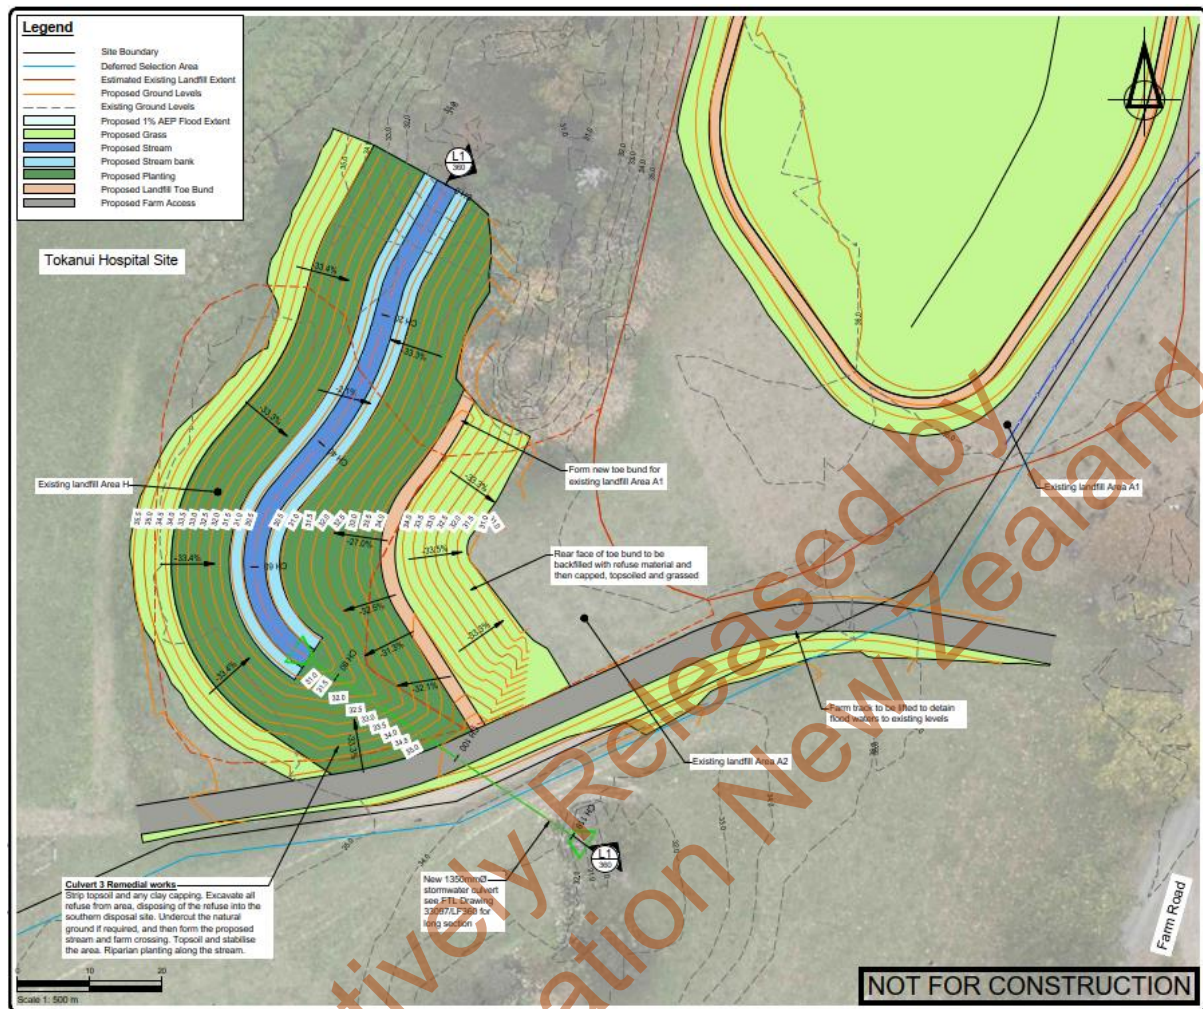
**Figure 13: Proposed Culvert 3 replacement.**

The 60 m Culvert 3 at the southern extent of the Wharekōrino Stream within the site bounds runs through the historic landfill. This culvert is estimated to be 44-65 years old and could be subject to differential settlement from landfill activity, leading to leaking joints and ultimately possible pipe failure, which would likely lead to refuse washout down the stream. Therefore, it is proposed that the culvert be replaced. The culvert will be replaced with a shorter structure (approximately 44 m) and realigned at an approximate northwest-southeast alignment, running beneath the existing farm track. The culvert will discharge to a new 75 m section of stream, which will be constructed in conjunction with the culvert replacement works. The existing culvert will be filled in and the stream diverted through the new culvert. The culvert replacement will result in a section of the natural stream (28 m) being lost, as the new section of stream will reconnect to the existing channel approximately 28 m downstream of the existing culvert outlet. However, this 28-m section of channel will still receive stormwater from overland flows and, therefore, will likely continue to function as an ephemeral flowpath. (Figure 13). Works will be similar to Culvert 2 removal and include implementing management plans where appropriate.

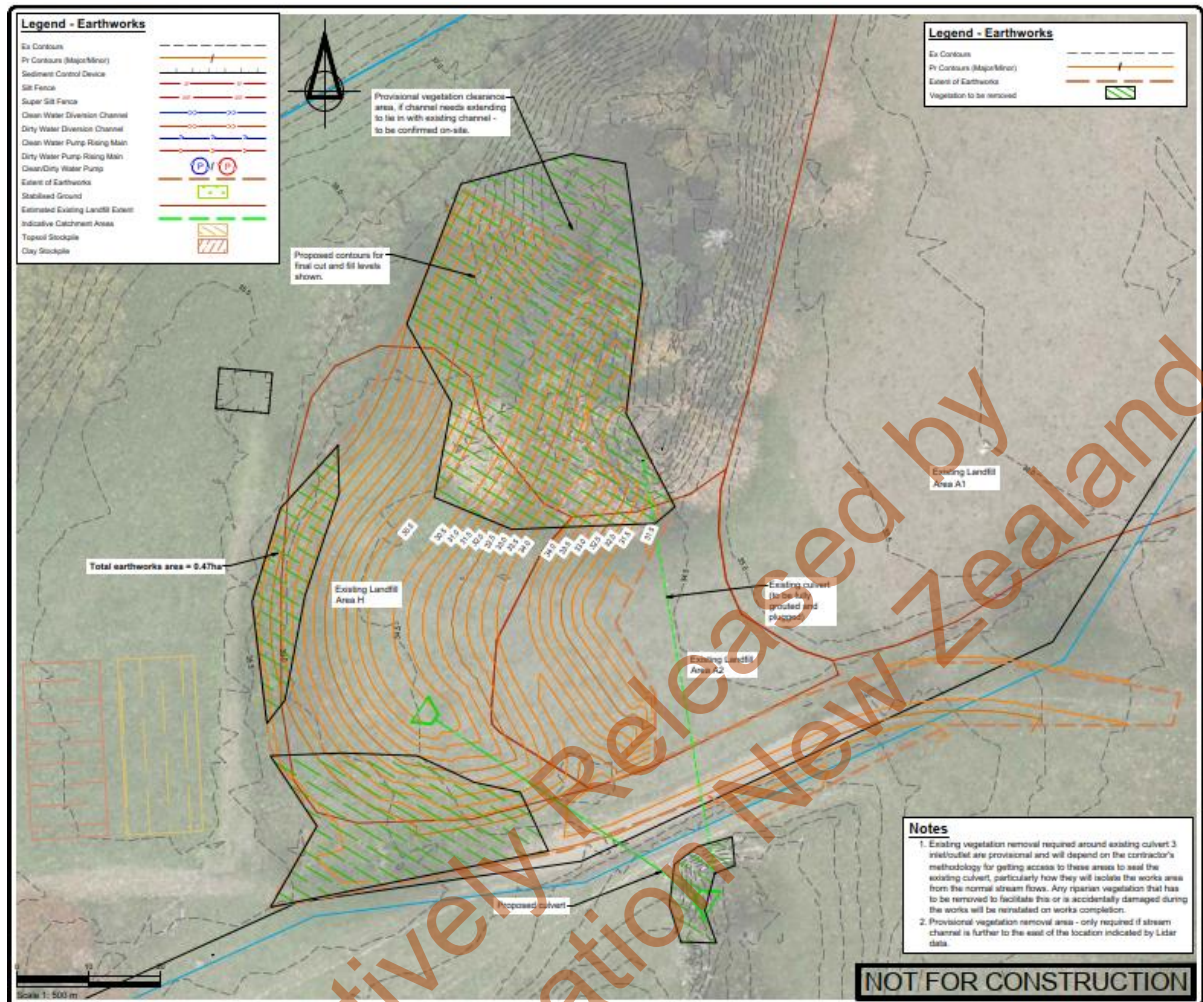
Figure 14: Culvert 3 works vegetation removal area.

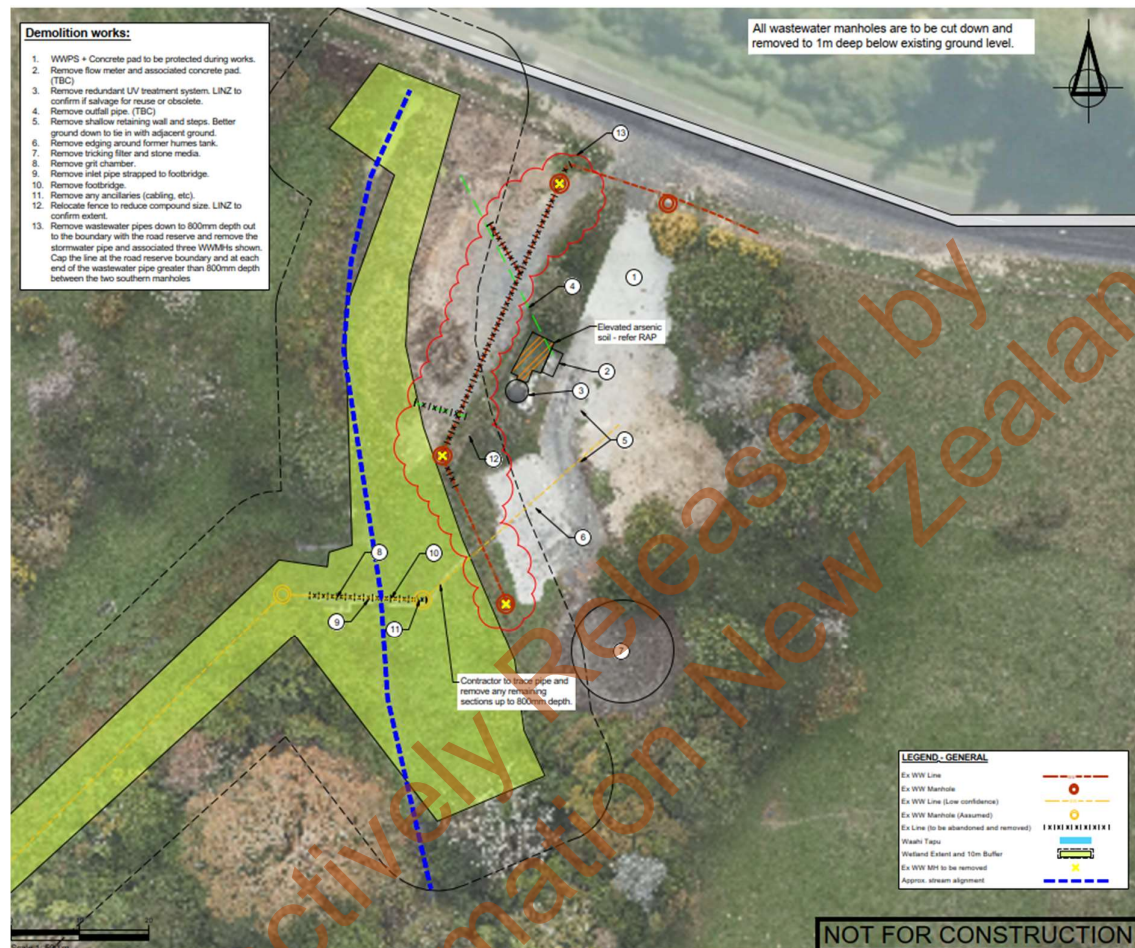
Figure 2: Works within or within 10m of Wetland 1 (excerpt of plan 33205/2010)

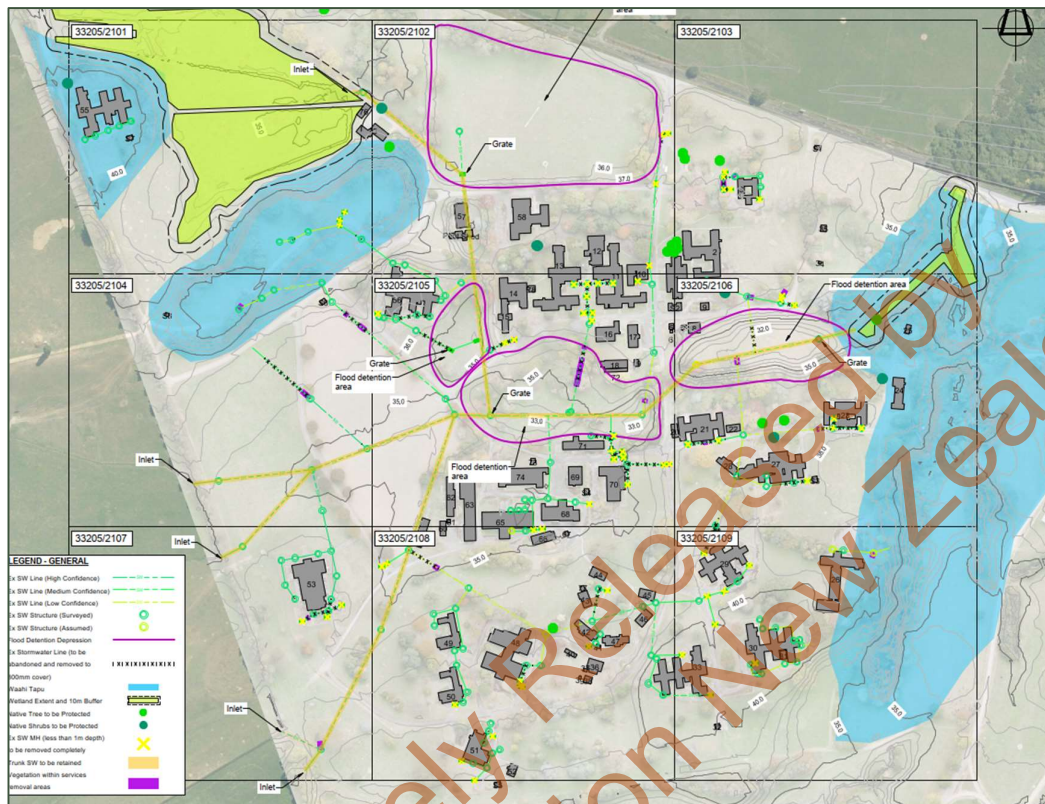
**Figure 3: Overview of stormwater line locations (trunk in yellow, other in green)**

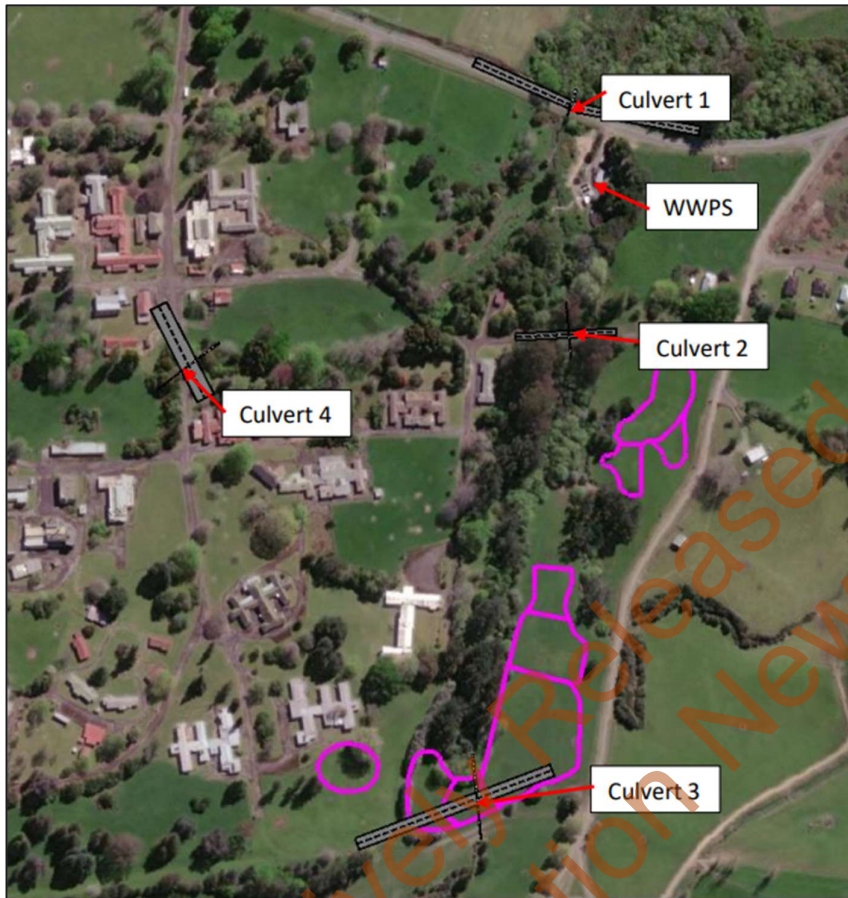
**Figure 4: Culvert locations**

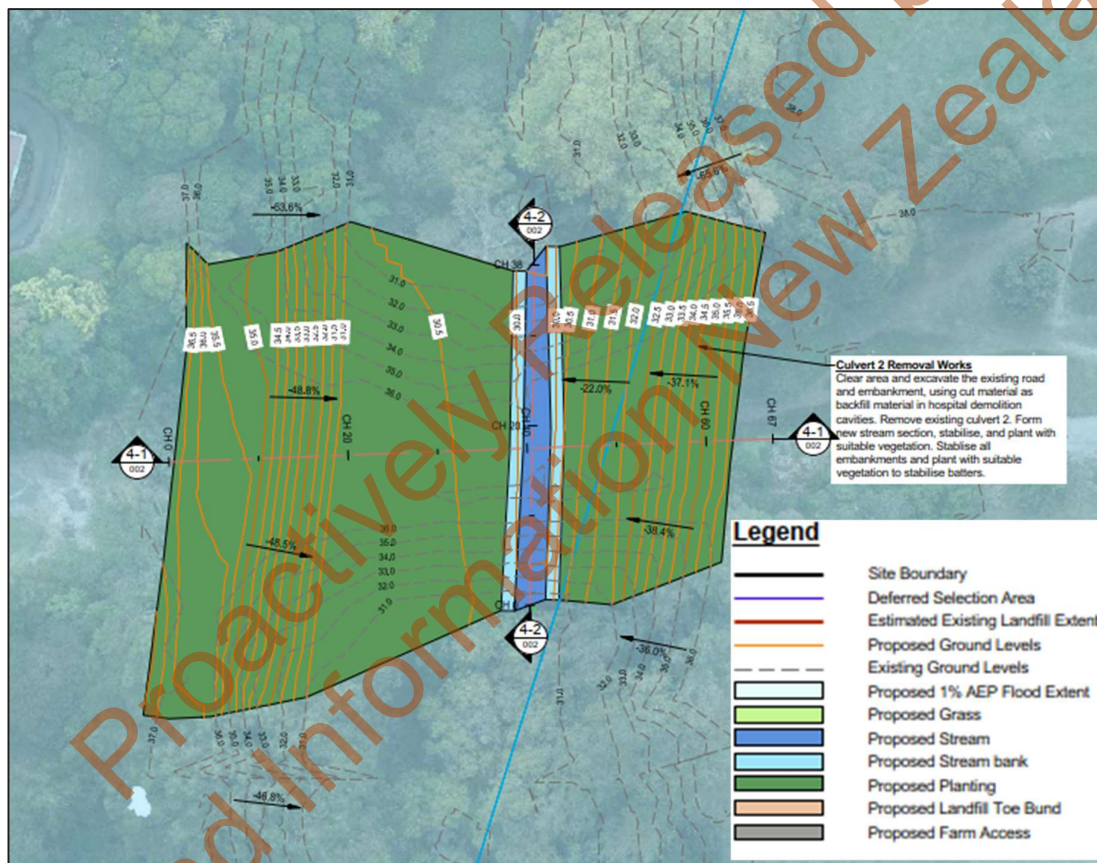
**Figure 5: Works area for Culvert 2 removal**

The road embankment is approximately 6m wide (at the top) by 50-60m long. It is relatively high, with an estimated height of 5.5m from the stream bed to the embankment crest. This culvert has a significant influence on flood levels affecting the existing disposal site (highlighted in pink on Figure 4 above) while the road embankment acts as a dam, affecting stream flow patterns and ecology.

- (d) Remove road embankment (assumed soil material) to stockpile. Reuse suitable materials on-site for backfill material and dispose of excess spoil off-site to appropriate facility;
- (e) Remove culvert and associated inlet/outlet structures;
- (f) Trim stream banks to tie in with existing stream profile (3,000m<sup>2</sup>);
- (g) Place clean topsoil along stream batters – estimated 100-150mm thick and cover with biodegradable coir matting or similar;
- (h) Grass upper stream banks and plant lower stream banks as per the Planting and Management Plan (PMP); and
- (i) Remove temporary dams and erosion/sediment controls.

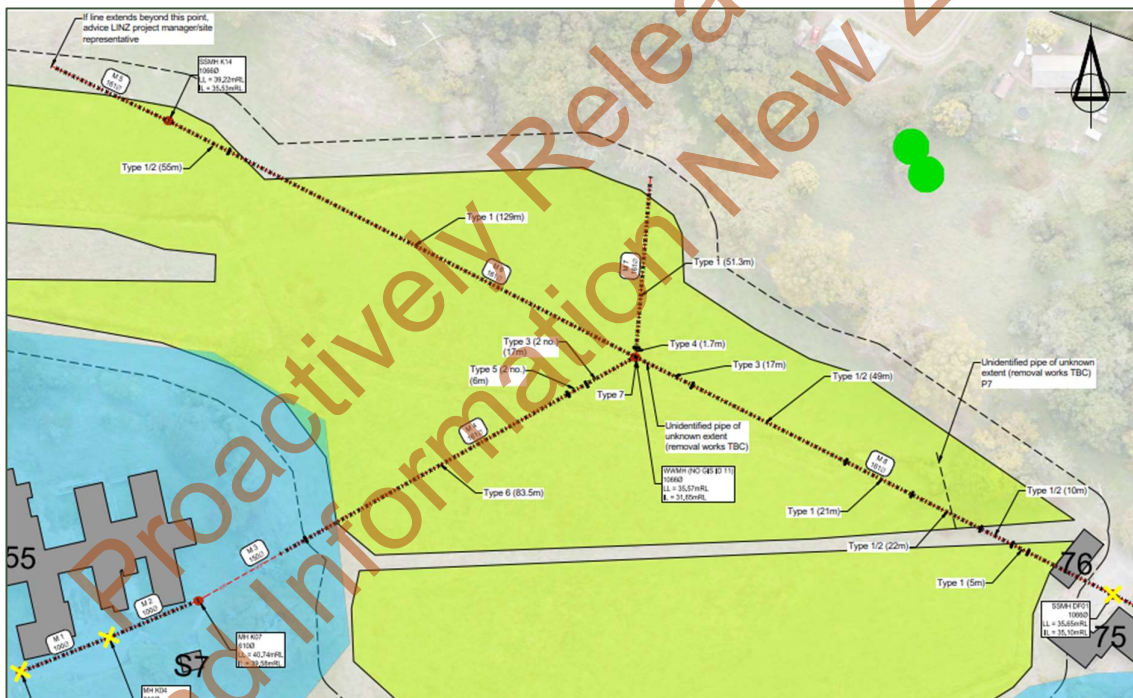
Figure 6: Wastewater demolition plan in Wetland 2

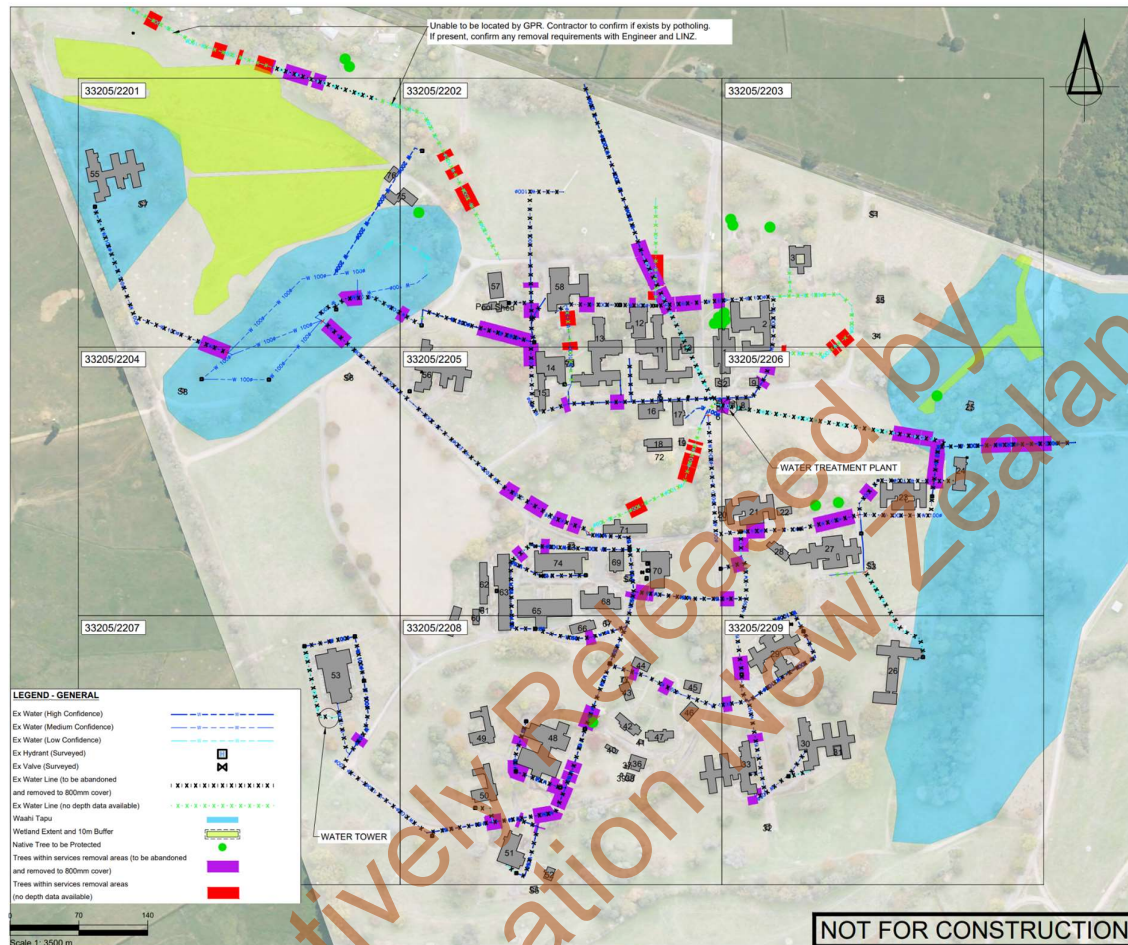
**Figure 7: Potential location of the underground water pipe along the northern edge of Wetland 2**

- Historical plans show an underground water pipe running adjacent to Wetland 2 along the northern boundary (Figure 7). However, Ground Penetrating Radar (GPR) was unable to locate this pipe. Potholing will be undertaken to confirm whether it exists. If so, and the pipe is asbestos or buried less than 800mm deep to the top of pipe, there may be minor earthworks and vegetation clearance within 10m of the northern edge of the wetland. The intention is to minimise any disturbance to the wetland, including vegetation removal, to the extent possible. Should this occur, the area will be reinstated with soil and vegetation similar to that removed.

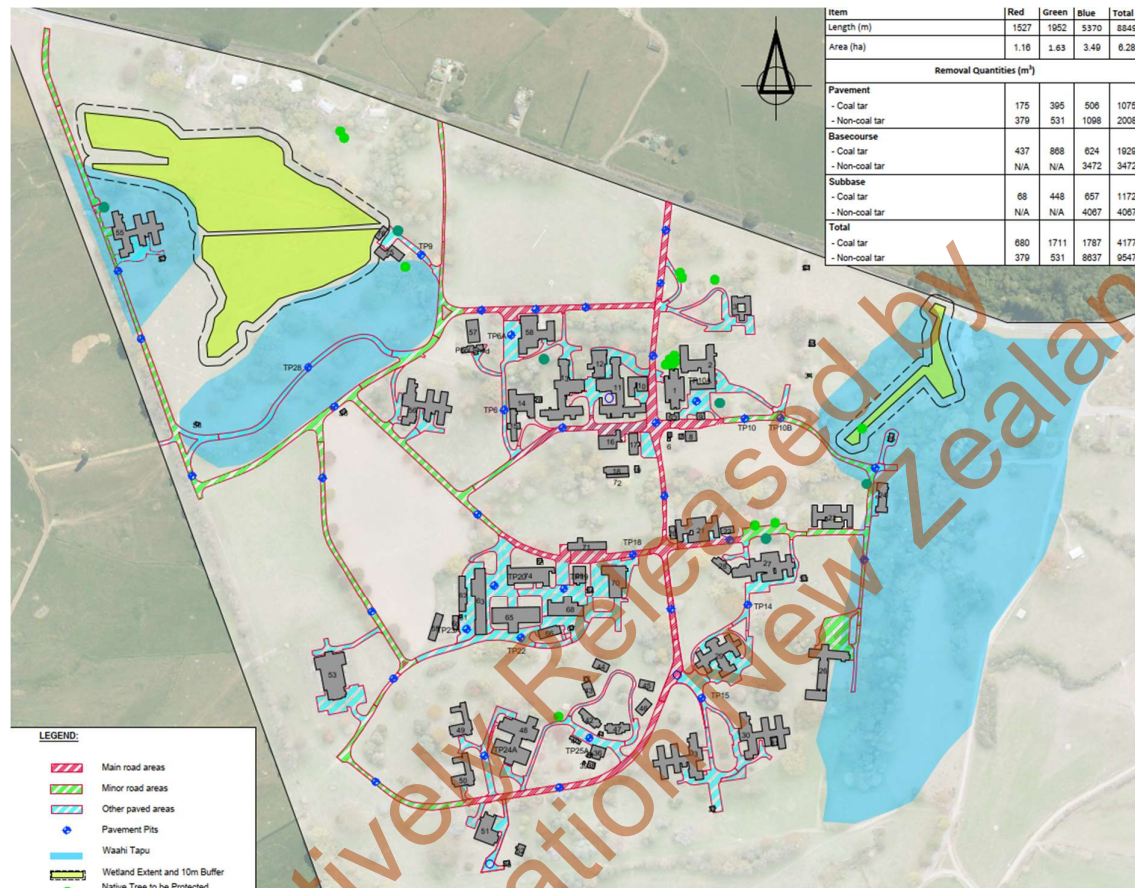
**Figure 8: Overview of roads to be repurposed as farm track (red and green) and to be removed (blue)**

The road network is approximately 8.8km in length, and has expanded over the lifetime of the hospital and been subject to ongoing repairs, resealing and maintenance works over the years.

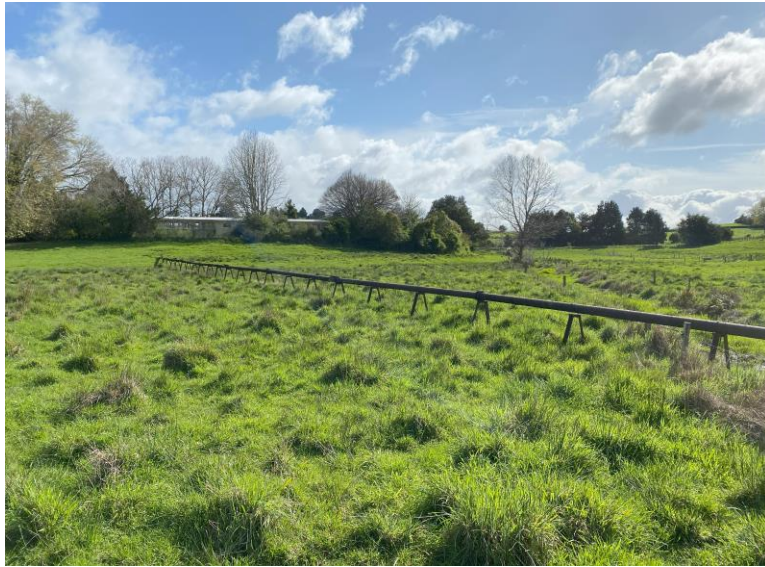
Southern pipeline with footings

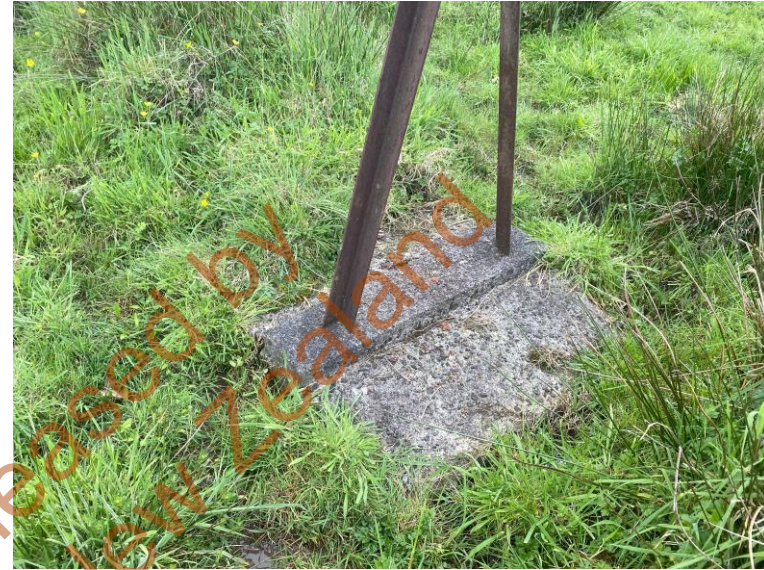
Southern pipeline footings and concrete foundation

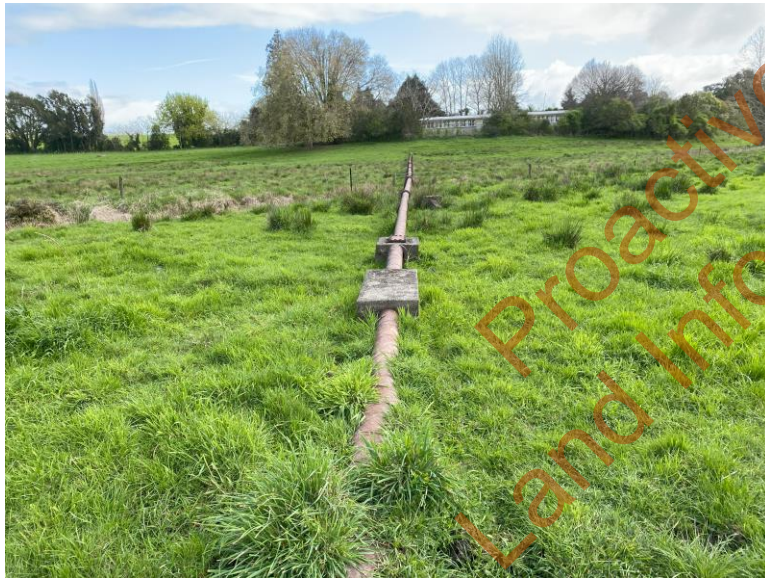
Southern pipeline with concrete casing

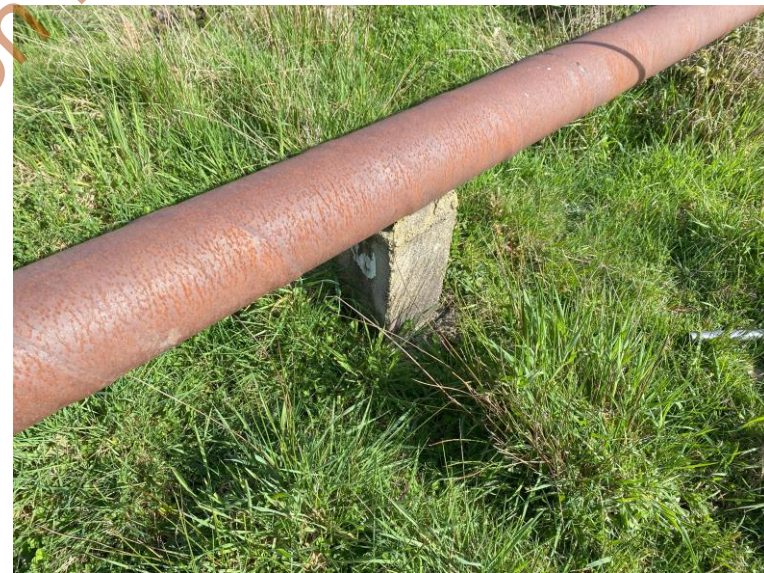
Southern pipeline with concrete pile

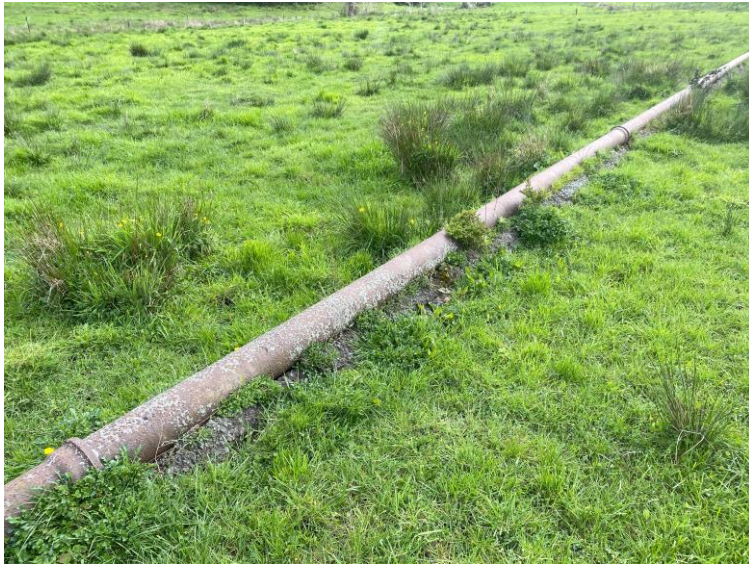
Pipeline situated on concrete foundation
