# Ecological Impact Assessment

## Tokanui Hospital Remediation

### Land Information New Zealand

**SLR Consulting New Zealand**

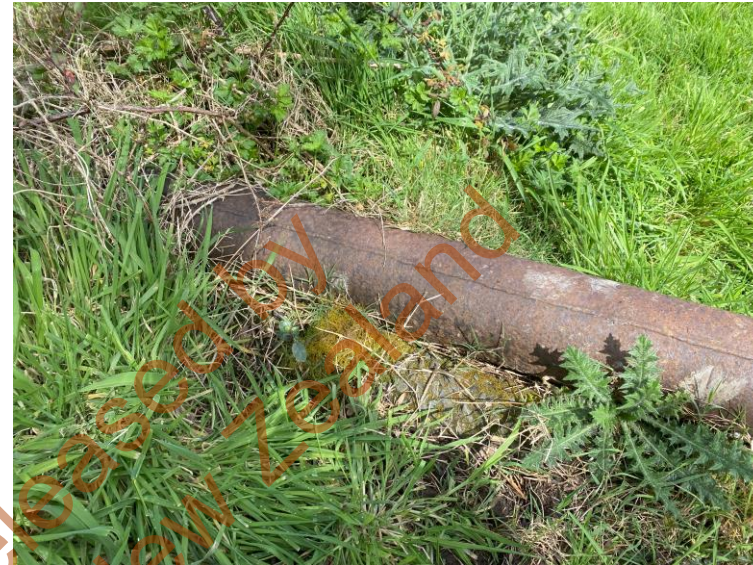
Pipeline situated on concrete foundation

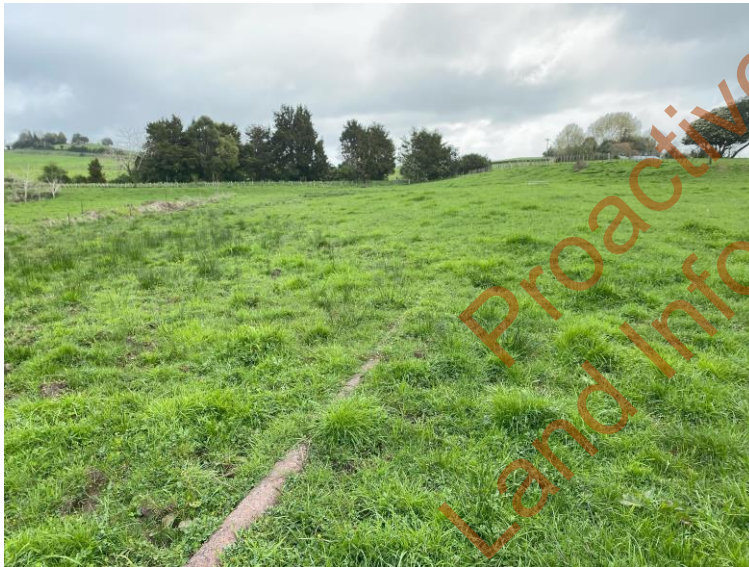
Westernmost pipeline below ground level

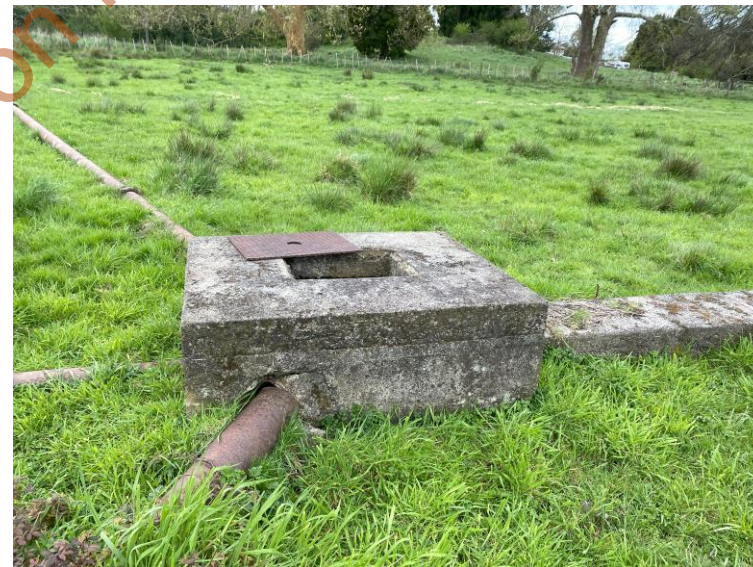
Concrete chamber connecting all four pipelines

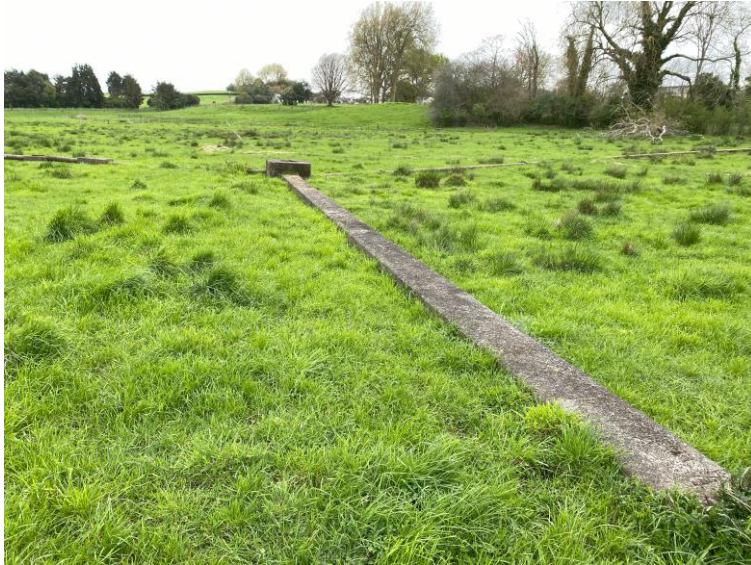
Eastern pipeline within concrete chamber

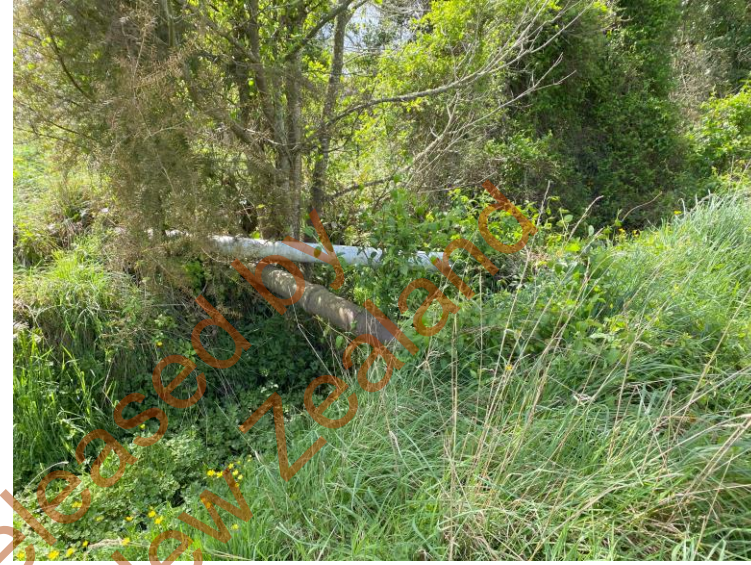
Additional pipeline underlying eastern pipeline

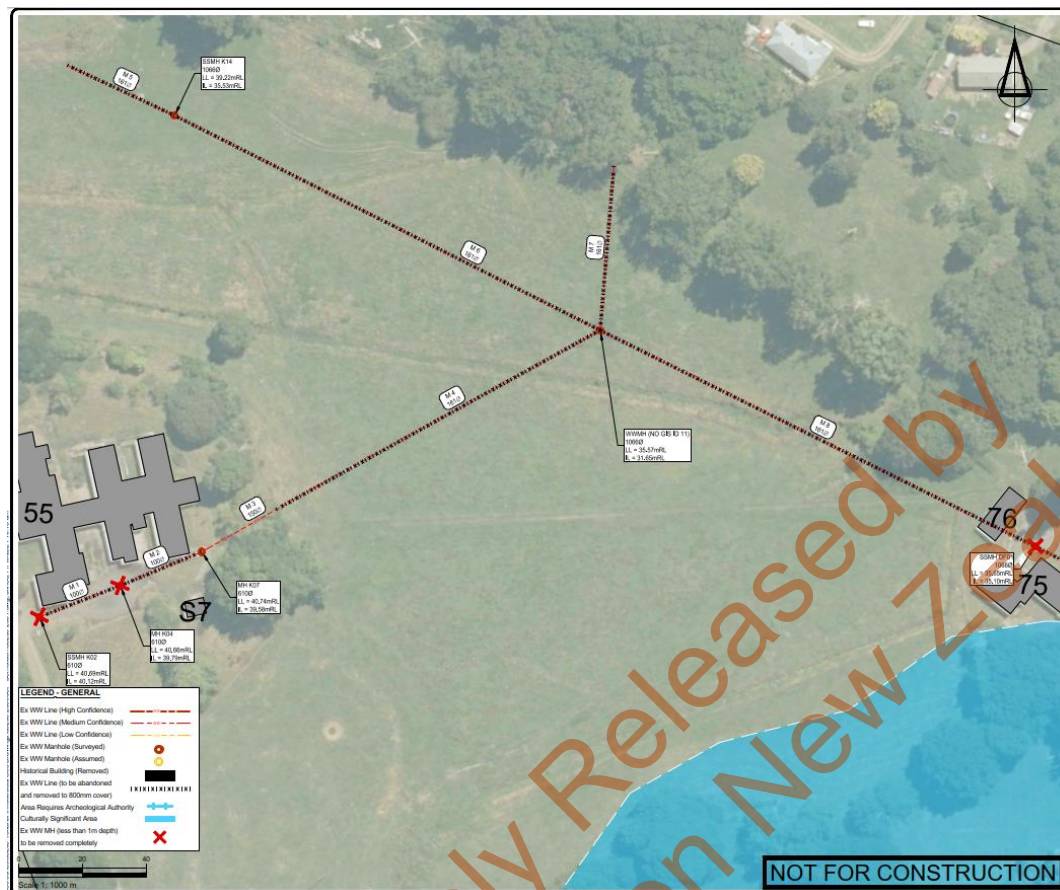
Figure 3: Wastewater lines to be removed within Wetland 2.

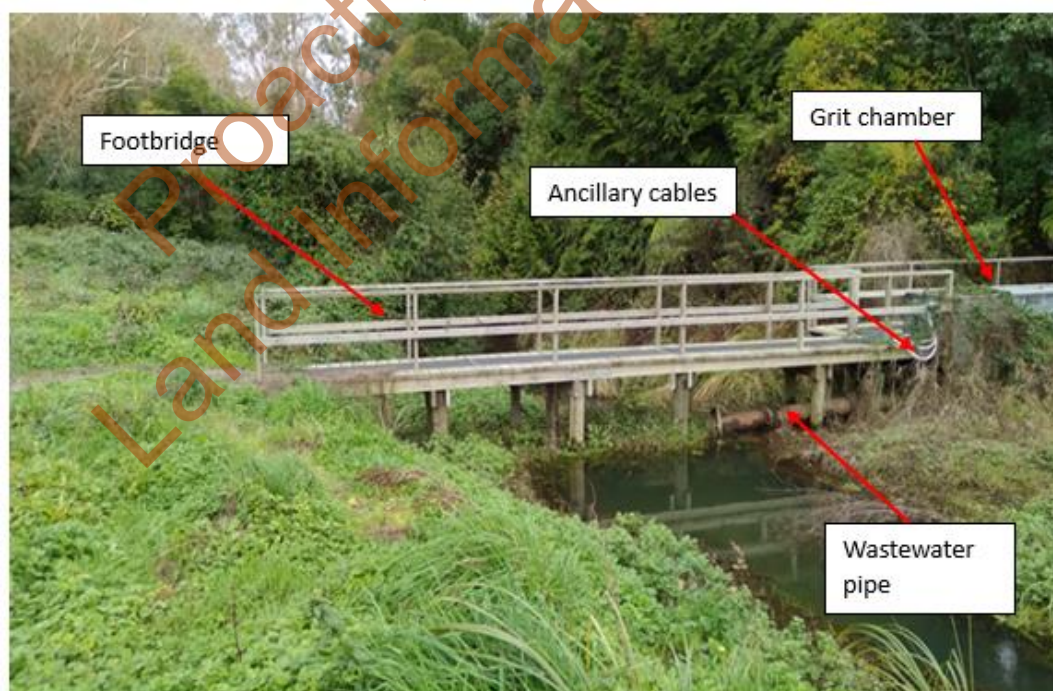
Figure 4: Infrastructure to be removed within the Wharekōrino Stream wetland.

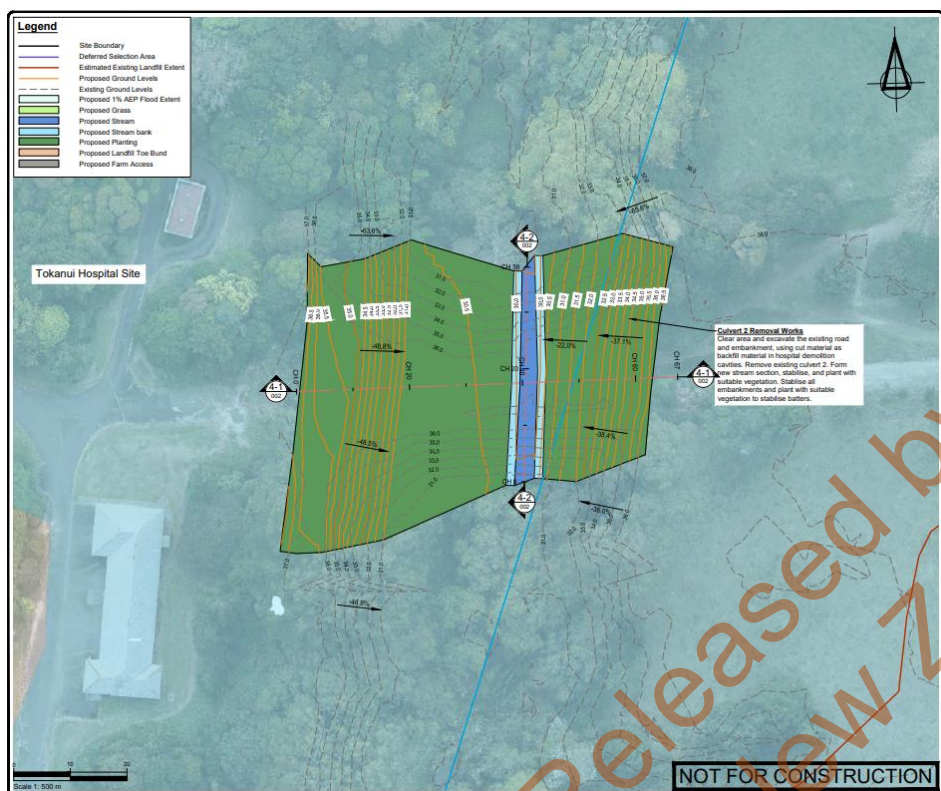
Figure 2: Proposed removal of road embankment and Culvert 2 intersecting the Wharekōrino Stream.

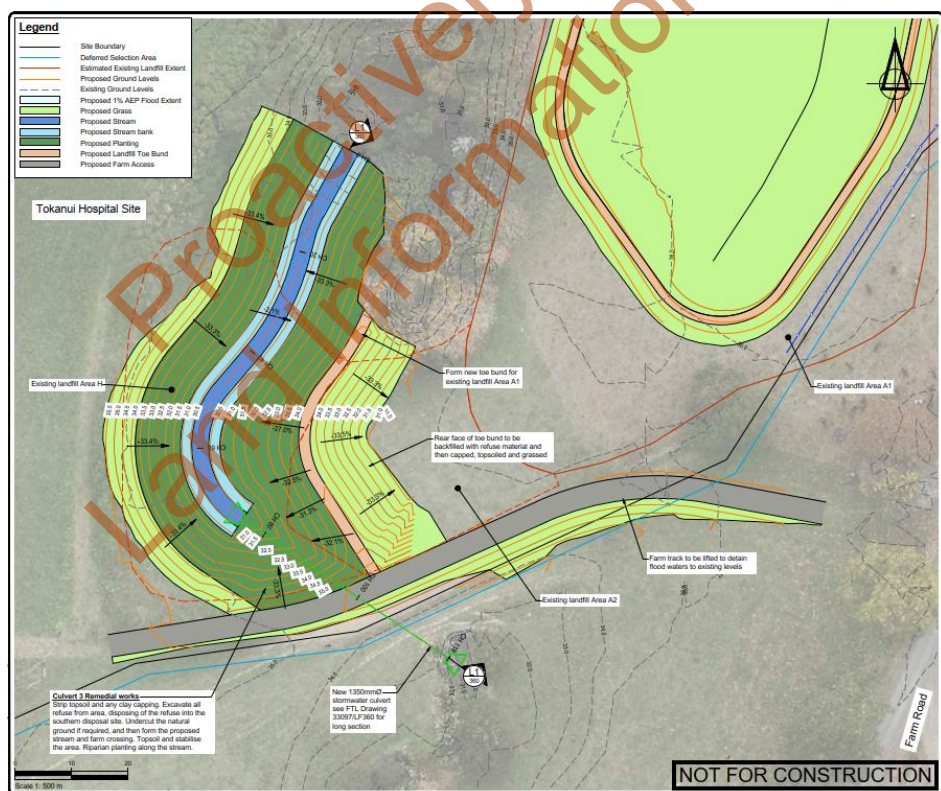
Figure 3: Proposed Culvert 3 replacement and stream creation.

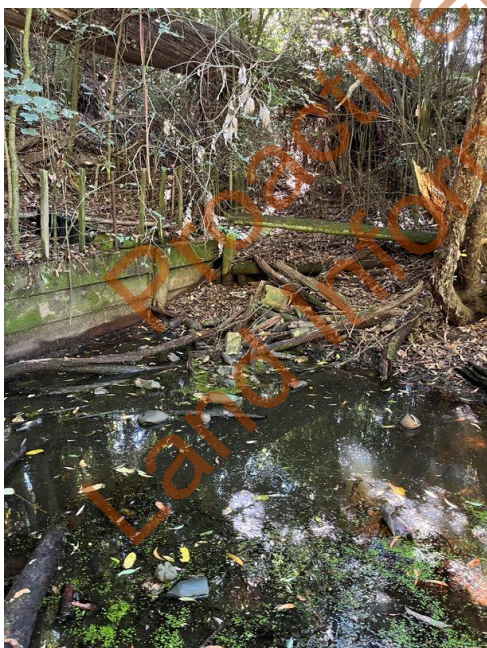
**Figure 5: Inlet of Culvert 2 with Pooled water and debris directly upstream.**

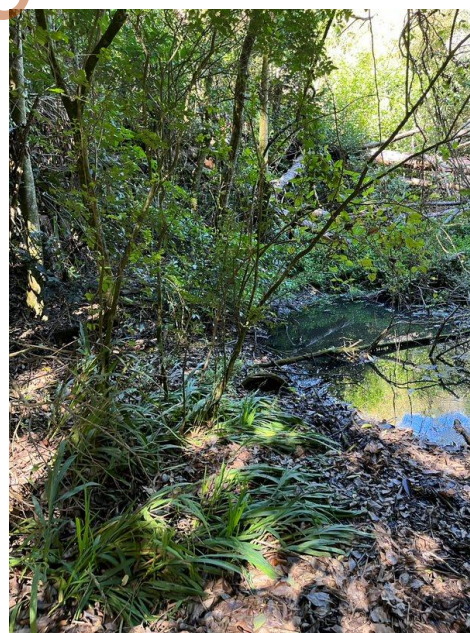
**Figure 6: Culvert 2 outlet.**

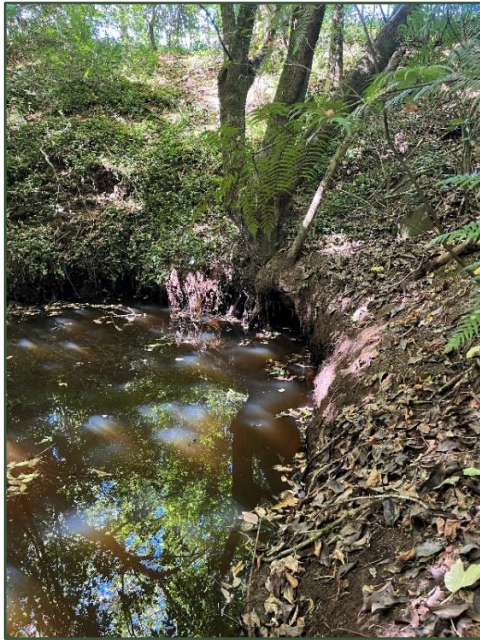
**Figure 7: Culvert 3 outlet**

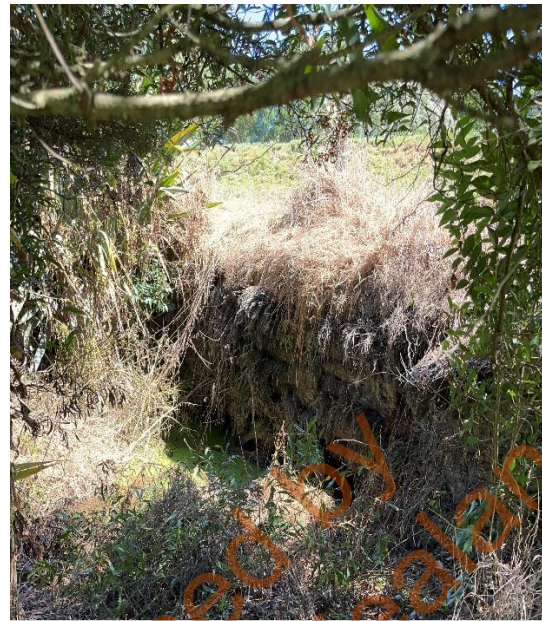
**Figure 8: Culvert 3 inlet.**
