**RE: Information Requested – APP146952 Multiple Certificates for Land Remediation and Landfill Upgrade of Tokanui Hospital**

# Tokanui Hospital

## Bat Management Plan

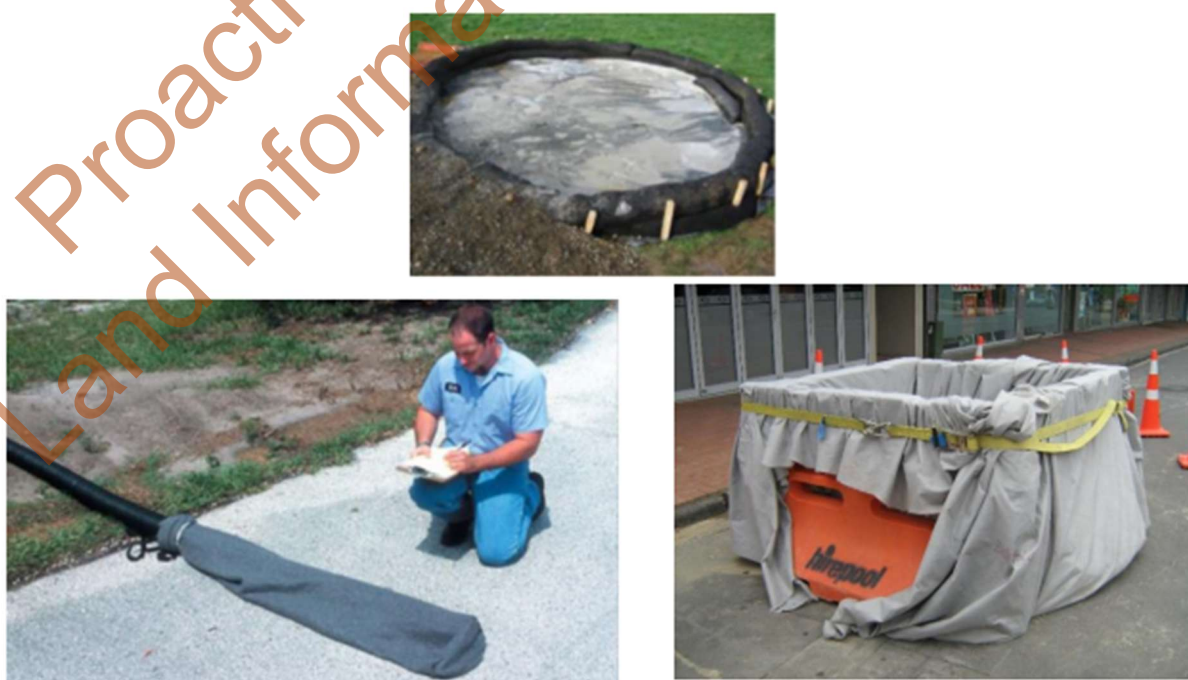
**Figure 2: Top - Turkey’s nest made from filter socks; Bottom left: dewatering bag and pipe sock; Bottom right: mobile “turkey’s nest.**

Any direct rainfall into trenches will be allowed to soak into the underlying ground, or if this may impede or delay the works, a portable pump will be used to pump out water collected in the trench with this being pumped into a “turkey’s nest” or similar device and then allowed to disperse across adjacent grassed areas. In any locations where this is not possible, the water would be collected by sucker truck and taken to the on-site SRP for treatment or pumped out into an intermediate bulk container (IBC) for transfer to the on-site SRP or disposal off-site.

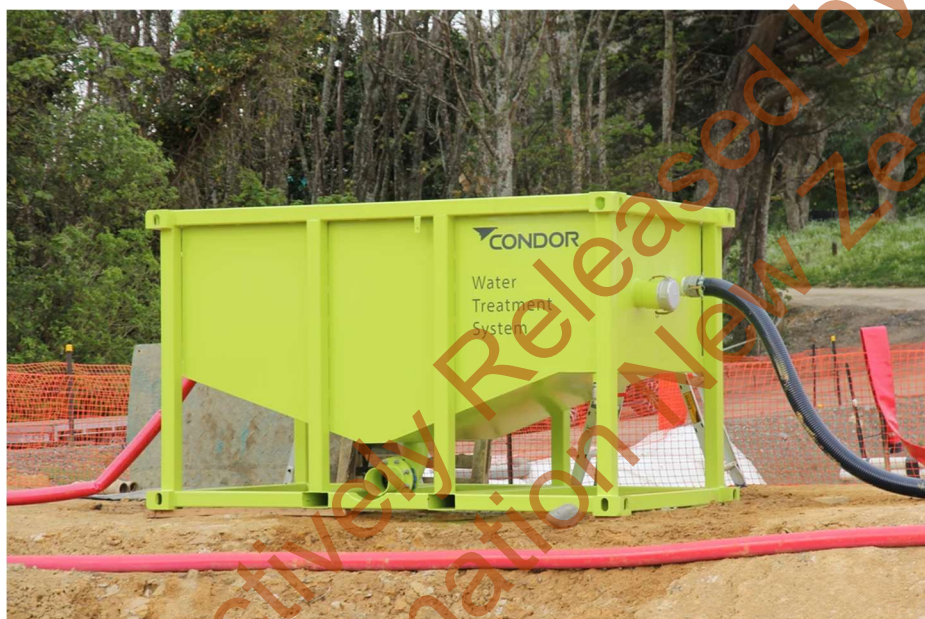
**Section 6.17 – Portable Sediment Removal Devices:** Various suppliers provide mobile lamella clarifiers, where sediment is pumped into a tank and then passes over a baffle, with water being forced up through coalescing media where solids are settled out. Typically, these solids are then passed through dewatering bags (1T in size) to further reduce the water content to make them suitable for reuse and/or transport off-site. This system has a smaller footprint than DEBs or SRPs and may need to be used in areas where a DEB can not be installed. Some systems also provide for automated flocculant dosing and real-time Total Suspended Solids (TSS) monitoring.

Figure 4: Example of Mobile Sediment Removal Device

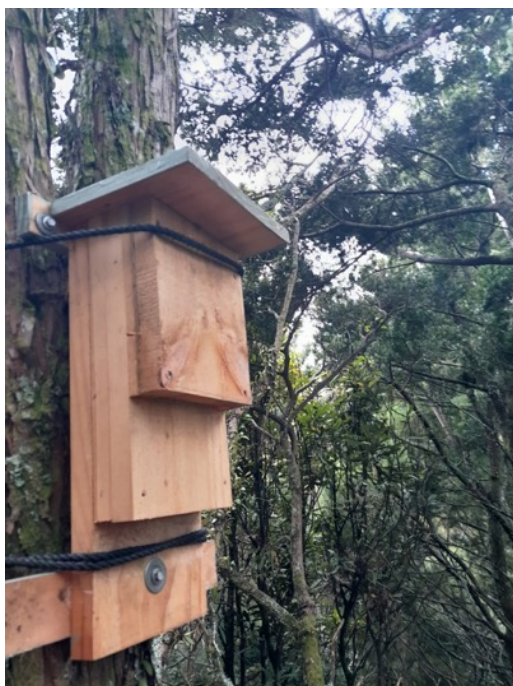
*Figure 5. Artificial Bat Roost*

To address the loss of roosting habitat from vegetation clearance, artificial bat roost boxes can be installed as temporary replacements until new trees mature (refer to Figure 5). These boxes should ideally be placed within 150 meters of waterways, mounted at least 15 meters high with predator bands around the tree to deter mammals. A survey of all trees requiring removal will determine the number needed, and installation will occur before removing high-risk trees. For at least 5 years, annual inspections will ensure the boxes and predator exclusion bands are maintained in good order and assess whether they are occupied, with reports submitted to the council on their usage.

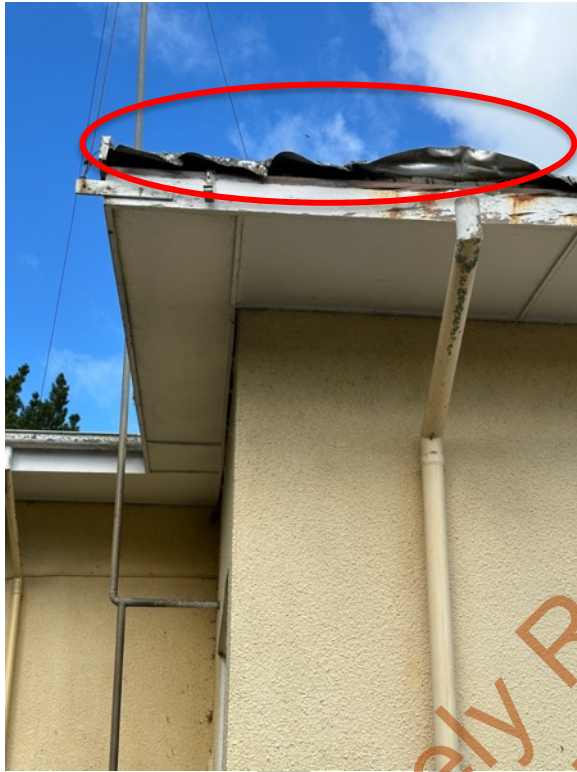
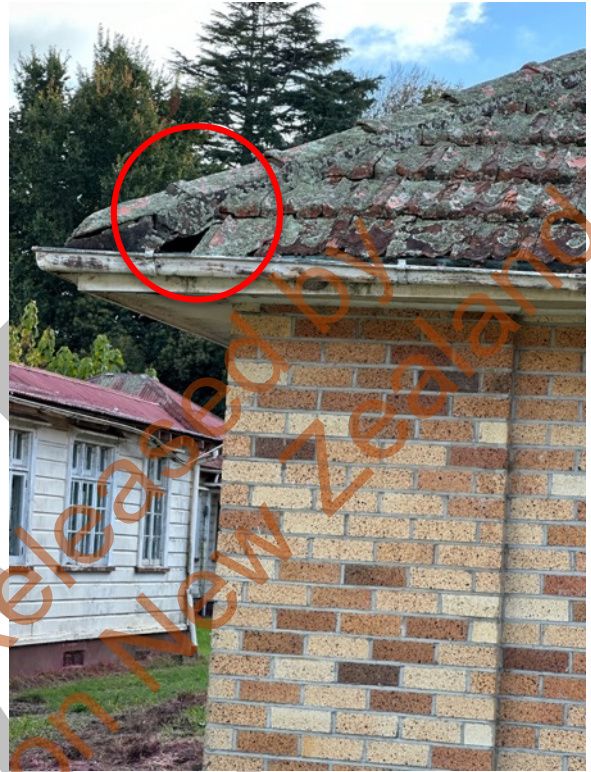
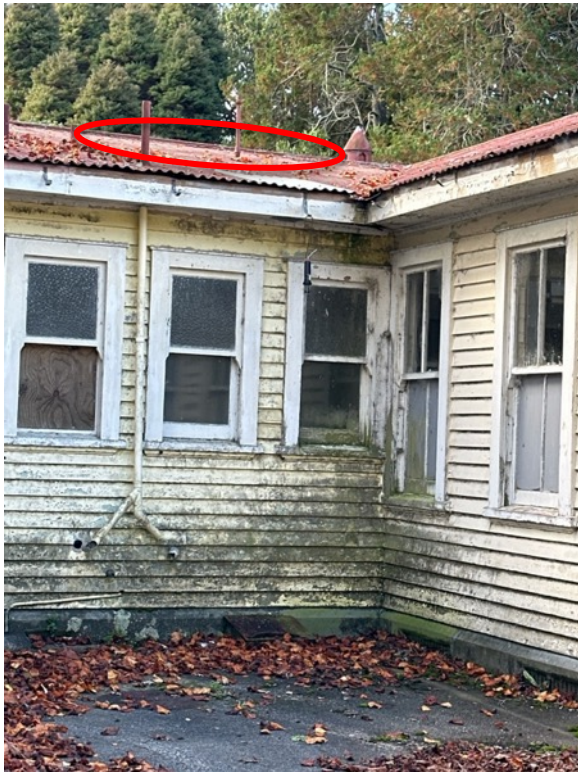
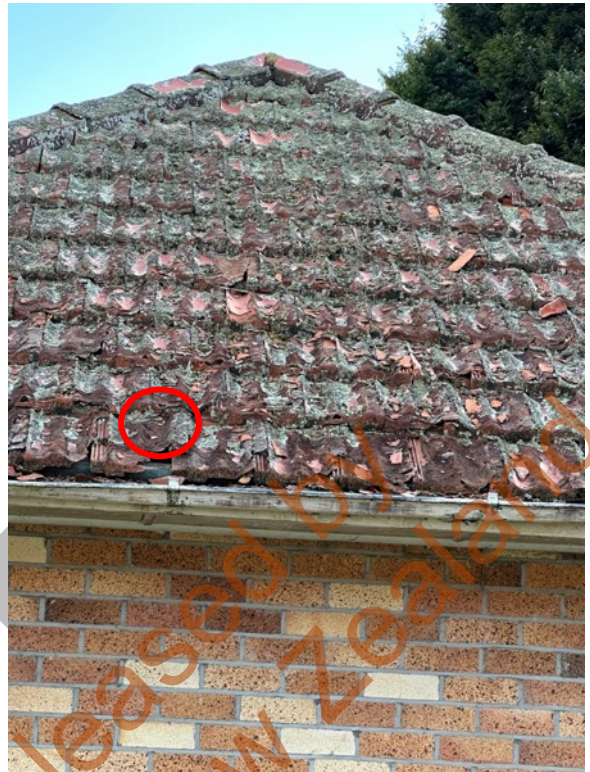
### Buildings with potential roosting features

The buildings on site are old and dilapidated, having remained unused since the 1990s. The findings from these evaluations revealed that every building on the site possesses characteristics highly conducive to bat roosting. These characteristics include structural conditions that provide adequate shelter and protection for bats. The consistent presence of these features across all assessed buildings highlights the critical importance of incorporating careful consideration and implementing appropriate mitigation measures in any proposed development or demolition activities to ensure the conservation of bat populations and compliance with relevant wildlife protection regulations. However, evidence of rats, possums, and mice was observed both inside and outside the buildings during the survey, with rat sounds recorded on the bat monitors, rat and mouse scats found, and a dead possum discovered (refer to Appendix I).

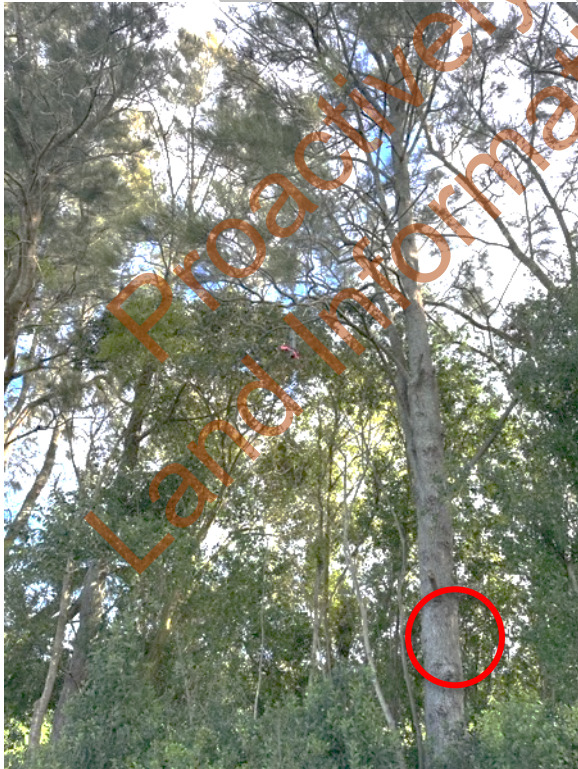
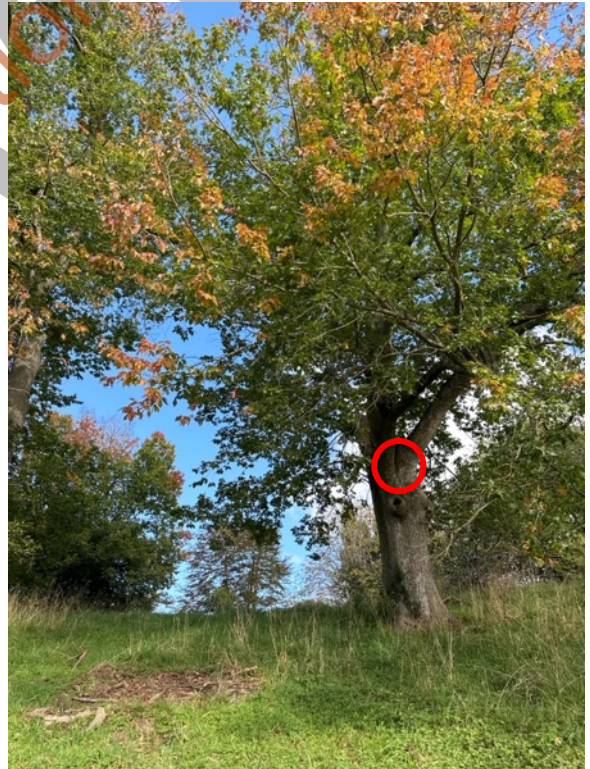
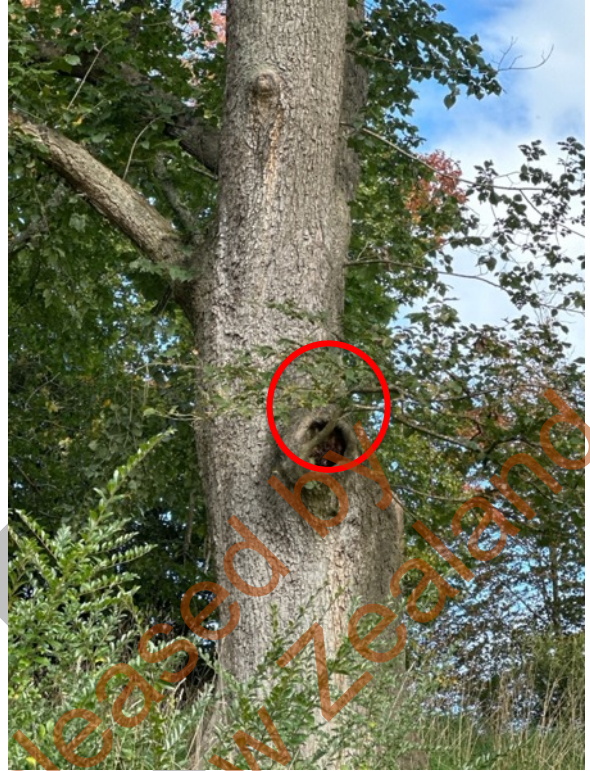
Trees with potential roosting features

In addition to assessing buildings, a randomised selection of large trees was examined to evaluate their potential as bat roosts. Key characteristics assessed included the presence of cavities, loose bark, cracks, and hollows, which provide the sheltered conditions favoured by bats (refer to Appendix I).

The habitat assessment revealed diverse vegetation including mature trees and various shrubs that potentially support bat populations. Specific tree characteristics conducive to bat roosting—such as cavities and loose bark—were prevalent among the randomly selected trees. Shrubs provide essential foraging opportunities for bats, attracting a wide range of insects, providing a rich food source for the insectivorous long-tailed bats.
