Appendix A: Map outputs and descriptions

For maps sourced from the CGD, the accompanying descriptions and methodology have been copied from the CGD Map Layer Descriptions report (CGD, 2014).

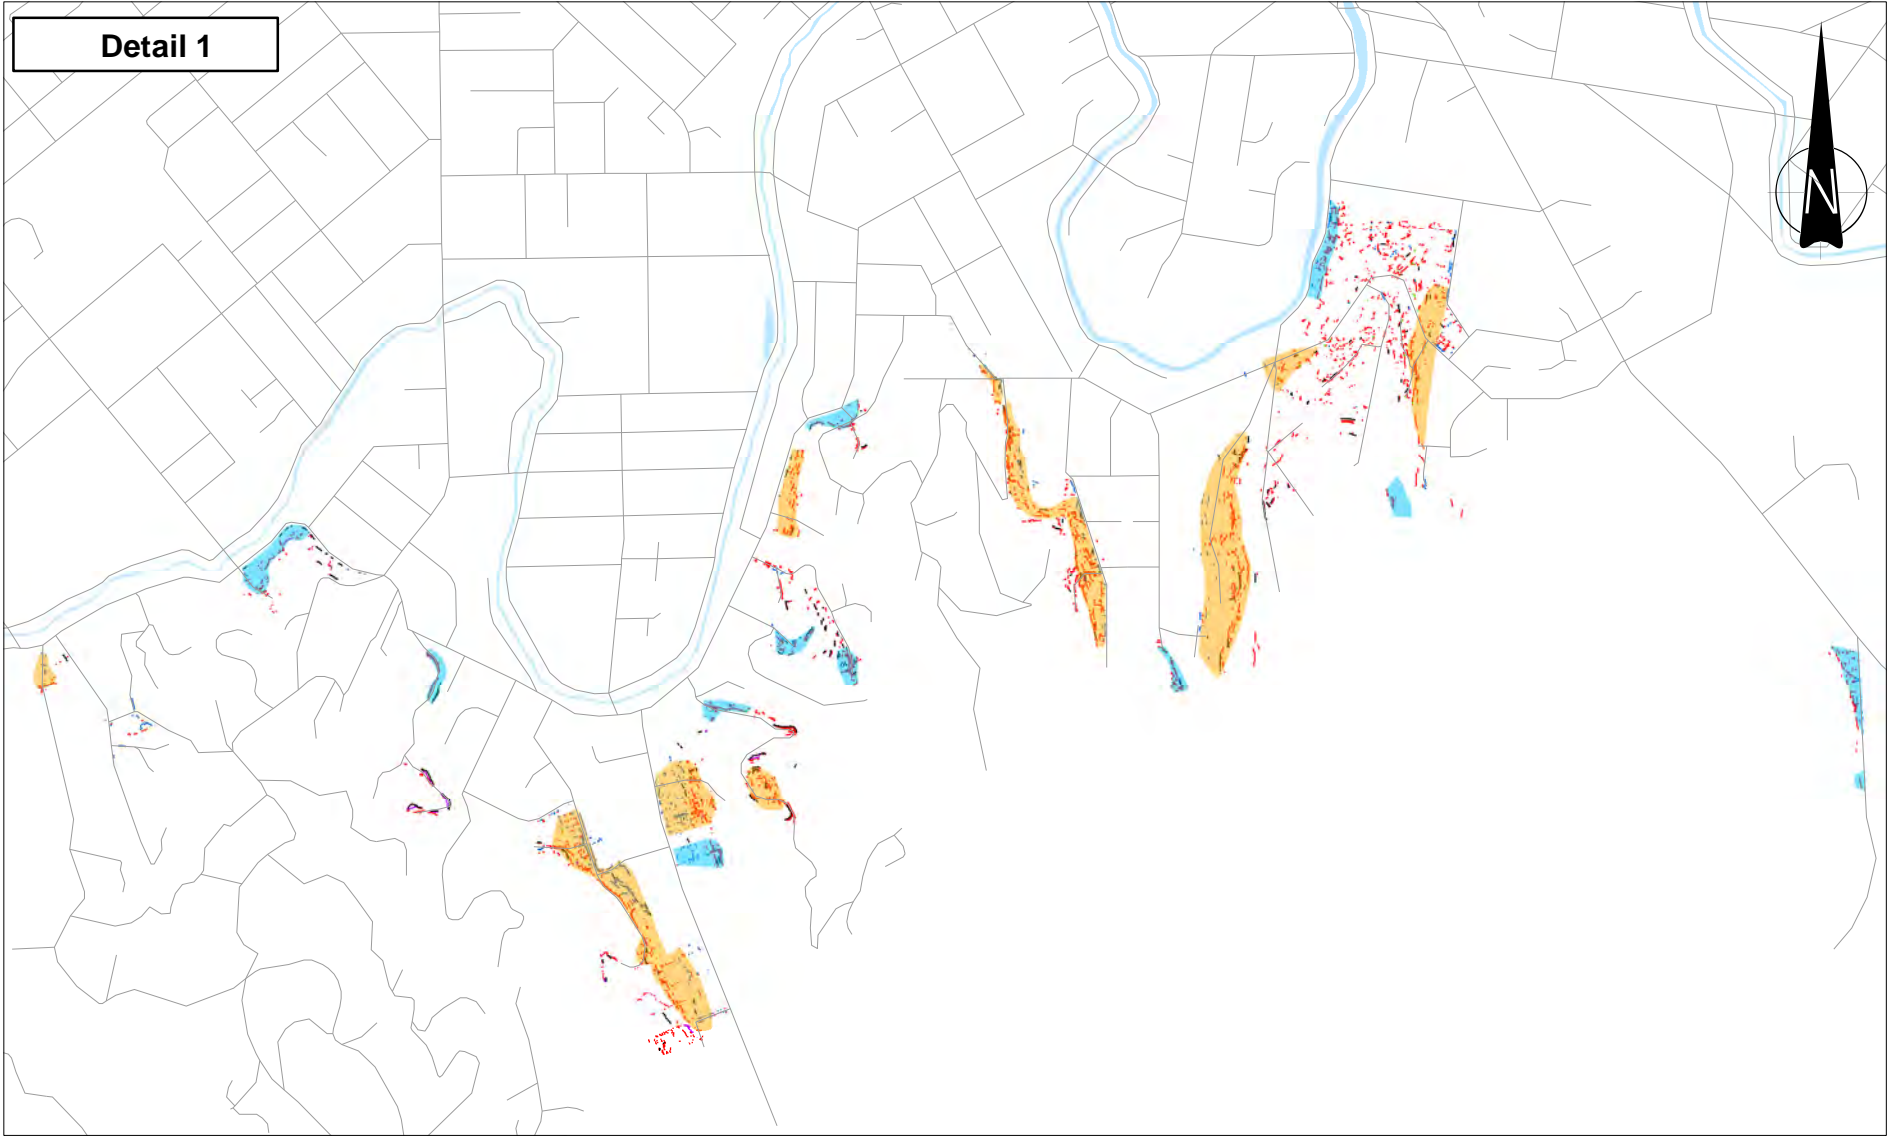
Relative hazard exposure categories for slope stability and surface deformations for the GNS Science mapped mass movements within the Port Hills, Christchurch.

The two map layers were created by the Christchurch City Council from an interpretation of the mass movement maps provided within the GNS Science series of reports on Port Hills Slope Stability and the report on the findings from investigations into areas of significant ground damage (see references below).

Cracks related to subsurface movement at 34 potential mass movement areas associated with the Canterbury Earthquake sequence were collected during fieldwork between 4 December 2010 and January 2013. Cracks were mapped during site walkover inspections, with an approximate location accuracy of ± 5 m. Both cracking (extension) and localised uplift (contraction) were recorded in the field at all sites where safe, owner agreed, access was possible. Where crack extension was observed, the maximum relative vertical and horizontal displacement across the crack was estimated to the nearest 0.01 m. Crack widths often varied spatially so the estimates are those considered as most representative of the entire crack length. Only the spatial extents were recorded for contraction features. Only cracking considered to be related to subsurface ground movement was recorded in order to minimise the contribution of features such as localised foundation damage within the mass movement deformations.

Superseded boundaries for mass movement areas that were identified by GNS Science based on field mapping and the combined areal extent of tensions cracks, contraction zones and other mass-movement landforms. The total movement of these areas was estimated to be greater than 0.1 m relative to its surrounding ground. The boundaries have an approximate accuracy of ± 10 m and only encompass areas where ground movement was identified during the mapping (October 2012 to January 2013). They do not include areas where debris could run-out down-slope (where the hazard would be debris inundation) or areas where movement and cracking could retrogress up-slope from the currently mapped limits.
