Re-establishment of cadastral boundaries following the 2010-2011 Canterbury earthquakes

Mark Smith, Mack Thompson, and Don Grant

Office of the Surveyor General
Land Information New Zealand
PO Box 5501

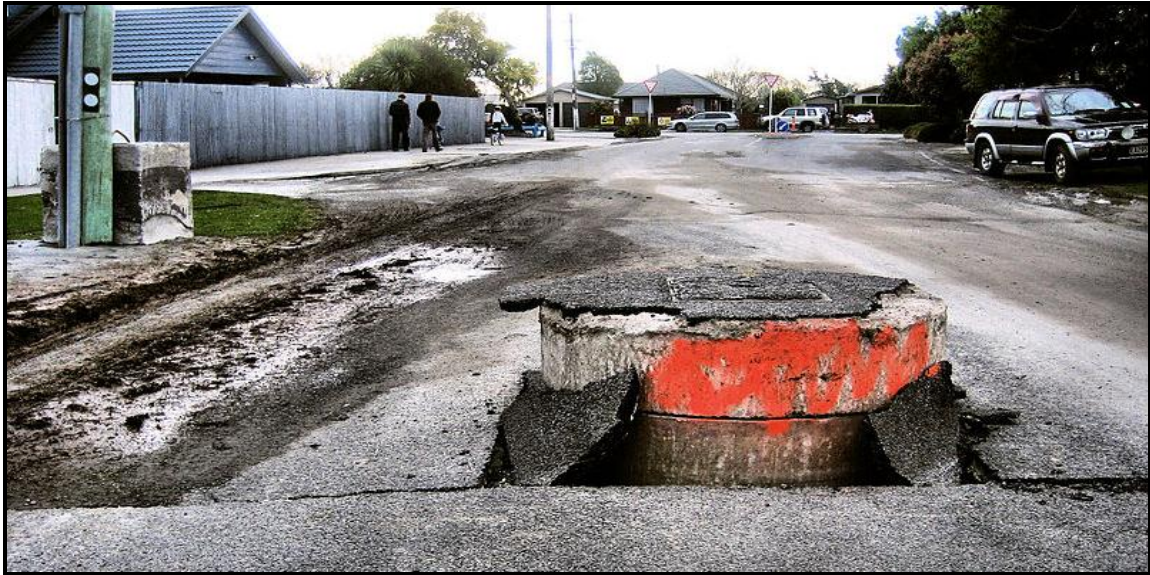
Figure 2 illustrates the extrusion of a stormwater manhole structure through the road surface due to the effect of liquefaction.

Figure 2 – A storm water manhole raised by liquefaction (Photo - Wikipedia)

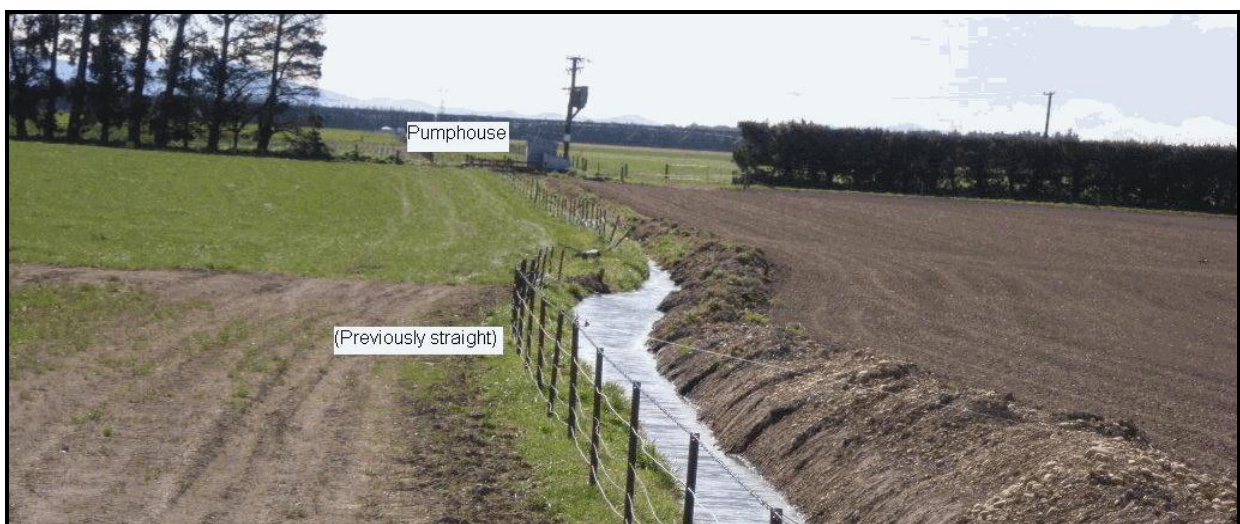
Figures 3 and 4 illustrate the effect of the fault rupture on a water race, a fence and a road formation, all of which were previously straight.

Figure 3 – Effects of fault rupture on previously straight fence and water race. (Photo - Survus Consultants)

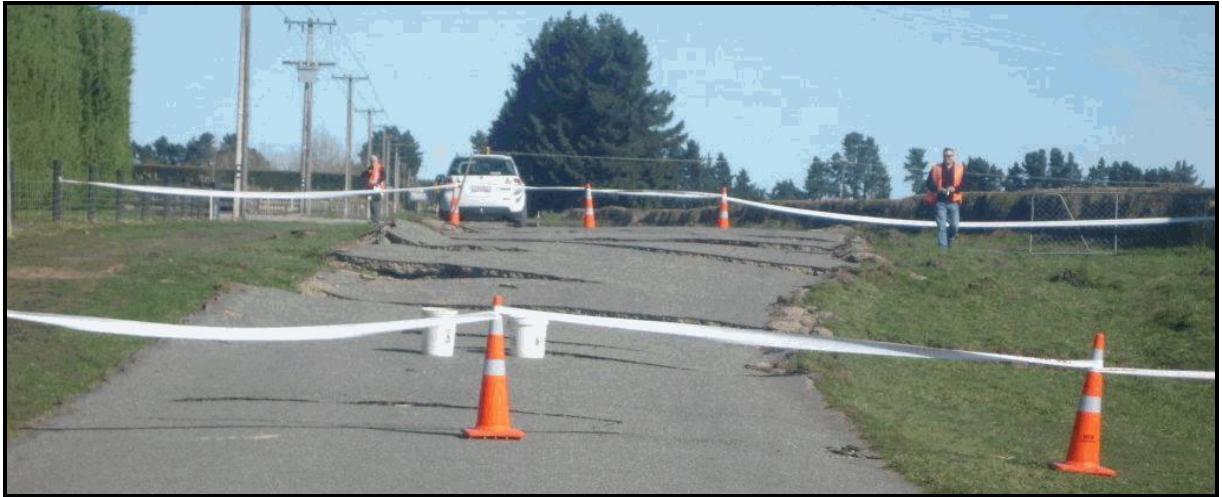
Figure 4 – Effects of fault rupture – previously straight road (Photo - Survus Consultants)

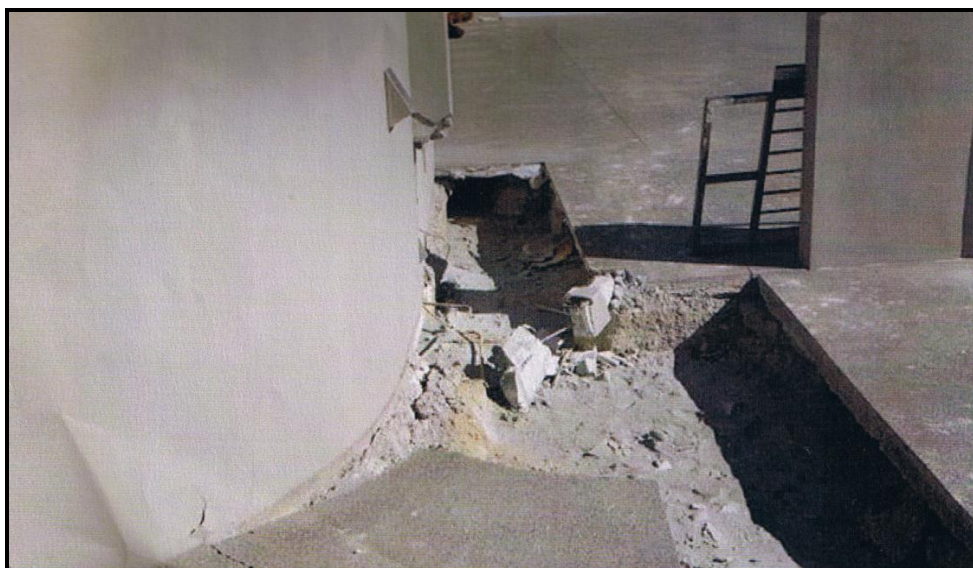
Figure 5 is an example of a rift between buildings and paving which were originally adjacent. This rift was caused by surface flow of material as a result of liquefaction.

Figure 5 – Displacement due to liquefaction (Photo- Eliot Sinclair and Partners)

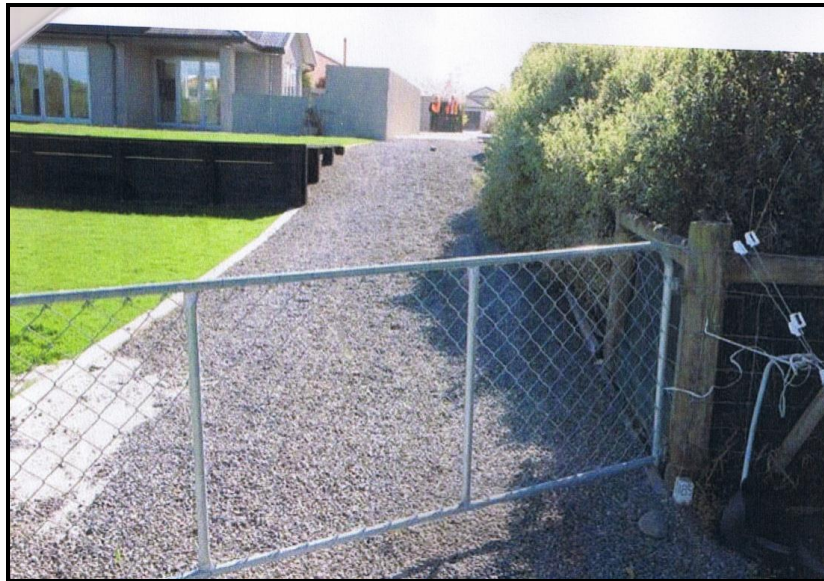
Figure 6 is a photograph of a gate at the rear of a property giving access to a riverside recreation area. The white peg at the base of the post is a legal boundary monument. These features appear undisturbed yet after the earthquake they had moved 2.8 metres away from the roadside which was only 80 metres away.

Figure 6 – Boundary point has moved 2.8 metres due to lateral spreading as a result of liquefaction (Photo - Eliot Sinclair and Partners)
