### **2010 Mt Burke Station Foreshore Investigation Report**

# MT BURKE STATION FORESHORE INVESTIGATION

## **MT BURKE STATION SHORELINE – INVESTIGATION REPORT**

#### **DEFINITION OF THE BED OF UNCONTROLLED LAKES - MT BURKE**

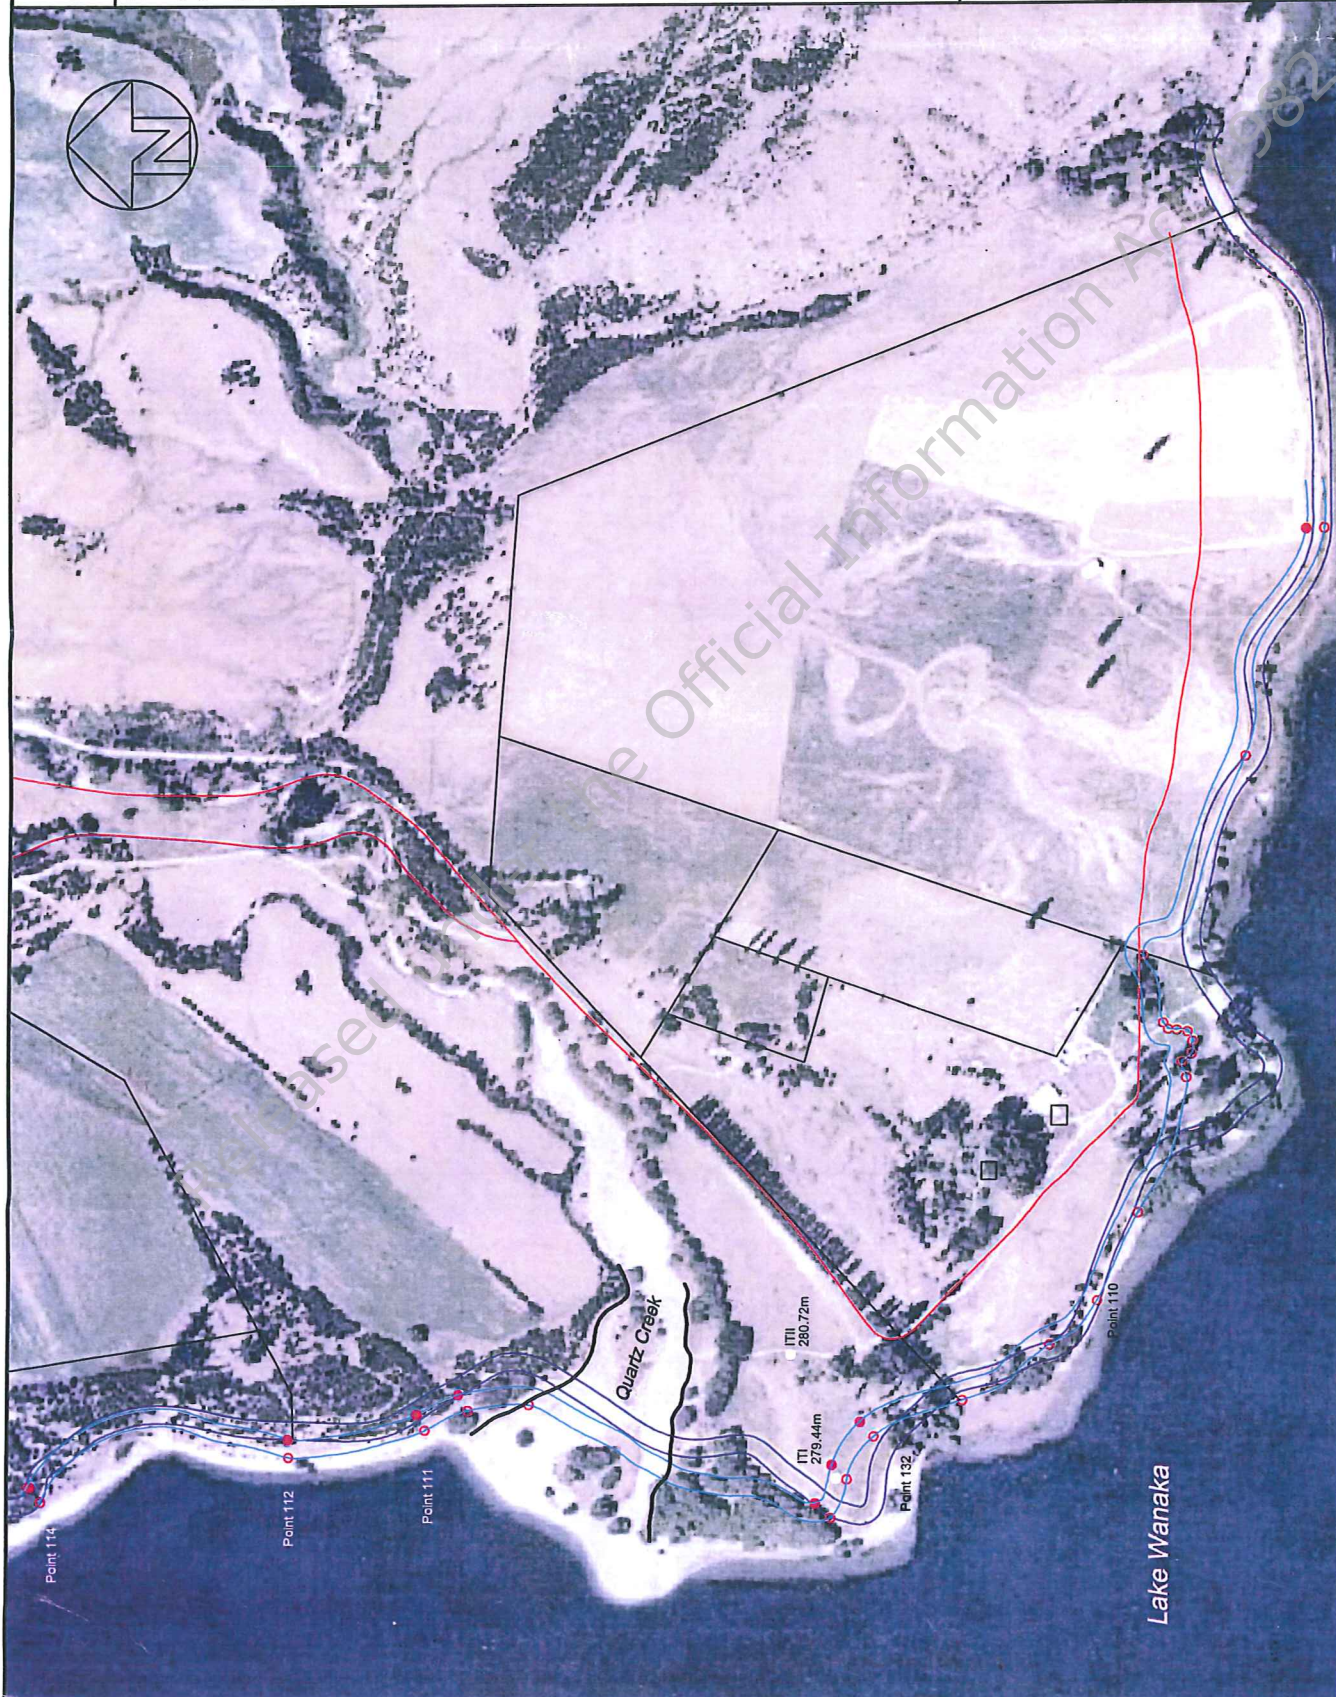
Prepared For: Opus International	NOTE: All dimensions and areas are subject to final survey Fence lines, the road centre lines and the Sec 24(3) marginal strip as shown have been digitized from SO968.		Drawing Title: Lake Wanaka Foreshore Investigation Mt Burke Station Pt Run 800	
	<ul style="list-style-type: none"><li>Bench Mark</li><li>Point on 279.3m contour</li><li>Stake placed 20.12 back from 279.3m contour</li><li>Foreshore SO968</li><li>Approximate foreshore based on 279.3m contour</li></ul>		Total Area	Comprised in
			<div><div></div><div>Survey Services</div></div> <div><div></div><div>Surveying Consultants</div></div> <div>TL Survey Services Limited</div>	
			Lower Ground Floor Sport Obigo House - 184 High St. PO Box 901 DUNEDIN 9053 Phone (03) 477 1135 Fax (03) 477 1127	
			Drawing File Mt Burke Investigation	TL Job Number 10135

LAND DISTRICT	OTAGO	LAKE WANAKA FORESHORE INVESTIGATION MT BURKE STATION	TERRITORIAL AUTHORITY QUEENSTOWN-LAKES DC Prepared by TL SURVEY SERVICES LTD Scale 1:6000@A3 Date September 2010
---------------	-------	---	--

However, the report found the contour level of 279.3m is generally in close agreement with the fixed marginal strip. The report also notes that one area is markedly different from the fixed marginal strip boundary but does not go further to determine the position of that boundary.

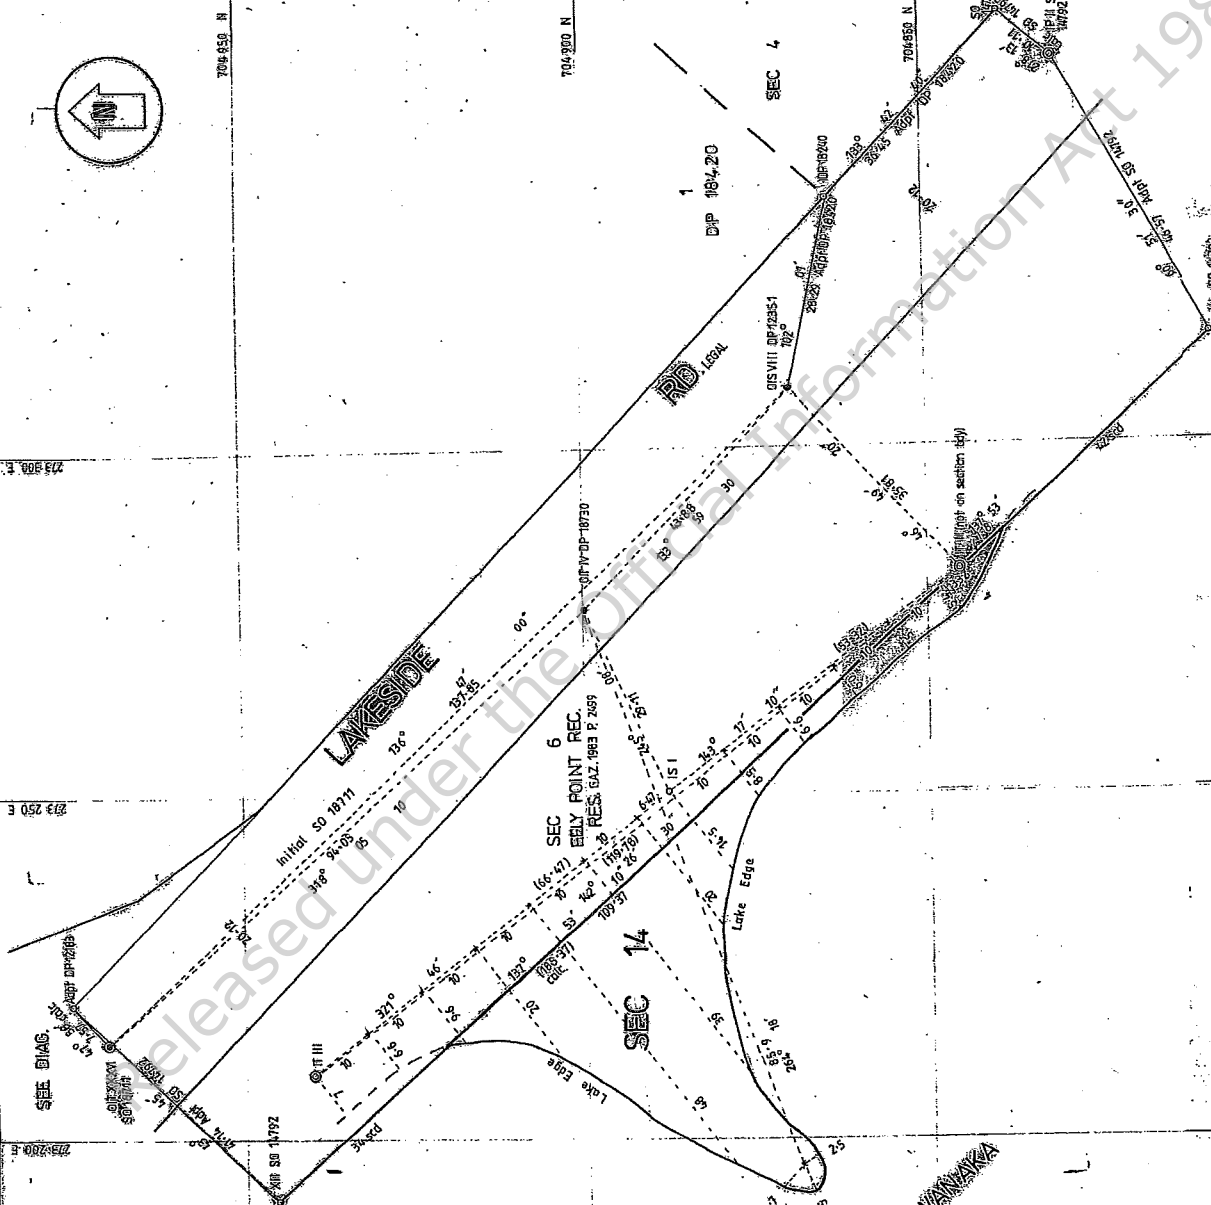
FORMER BED OF LAKE WANAKA

Taking a close look at SO968 and superimposing the reserve strip around the edge of the property onto modern photography there appears to be very little difference in the shape of the shoreline. The only noticeable difference is at the Quartz Creek delta where over 90 years of flooding has deposited gravel beyond the surveyed line established in 1916. I have not had the opportunity to examine the field book containing, what I assume to be, a compass traverse of the Lake Wanaka foreshore. From the close match of the shape of the foreshore from 1916 to today I think that it can be assumed that the fix was quite good – at least good enough to show that the developed land and homestead block is above the normal flood level of the lake. The aerial overlay attached to this report shows the digitized topographical features shown on SO968 superimposed onto modern photography using these same features as control.

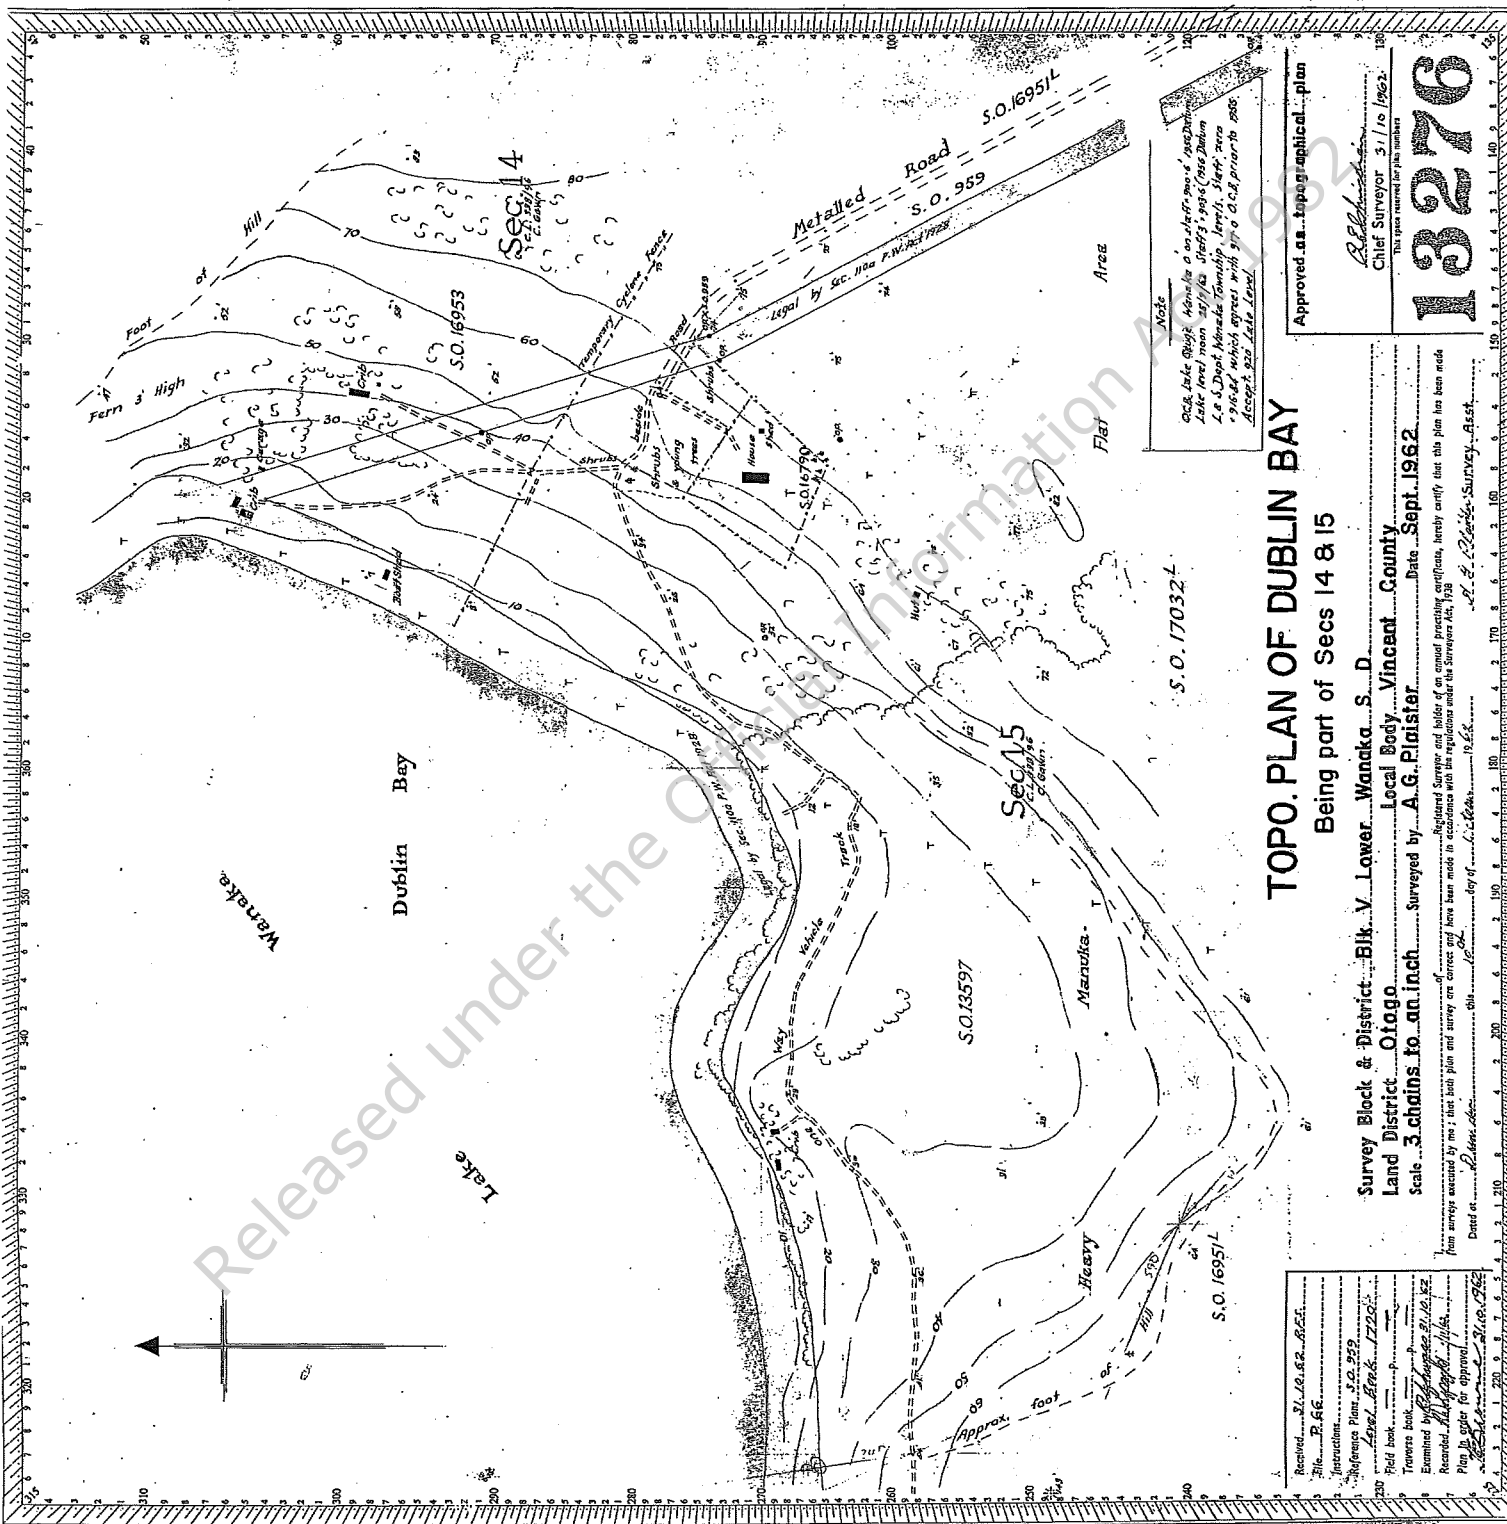
# TOPO. PLAN OF DUBLIN BAY

**Note**  
 On the Lake Right, known as a no-shaft well, 1962  
 Lake level mean 27/1/62 Staff's 1962 (1962 Datum  
 1.6 to 2.0 ft. above Township level, Staff's 1962  
 1962, which agrees with 1962 O.C.D. prior to 1962  
 Accept 1962 Lake Level

SO13276, SO13597 and SO21827 are all plans fronting the foreshore of Lake Wanaka. Unfortunately SO21827 doesn't record a level for the definition of Section 14 shown on that plan. The other two plans record levels of the lake that appear to be well above the recognized flood level of the lake ie 920ft = 280.42m on SO13276. Both SO13276 and SO13597 are in terms of heights that were later adjusted in 1965. We have documentary evidence from our work with Lake Hawea that the heights on plans prior to 1965 should be adjusted by -1.89m to bring into terms of the Dunedin Vertical Datum 1958.

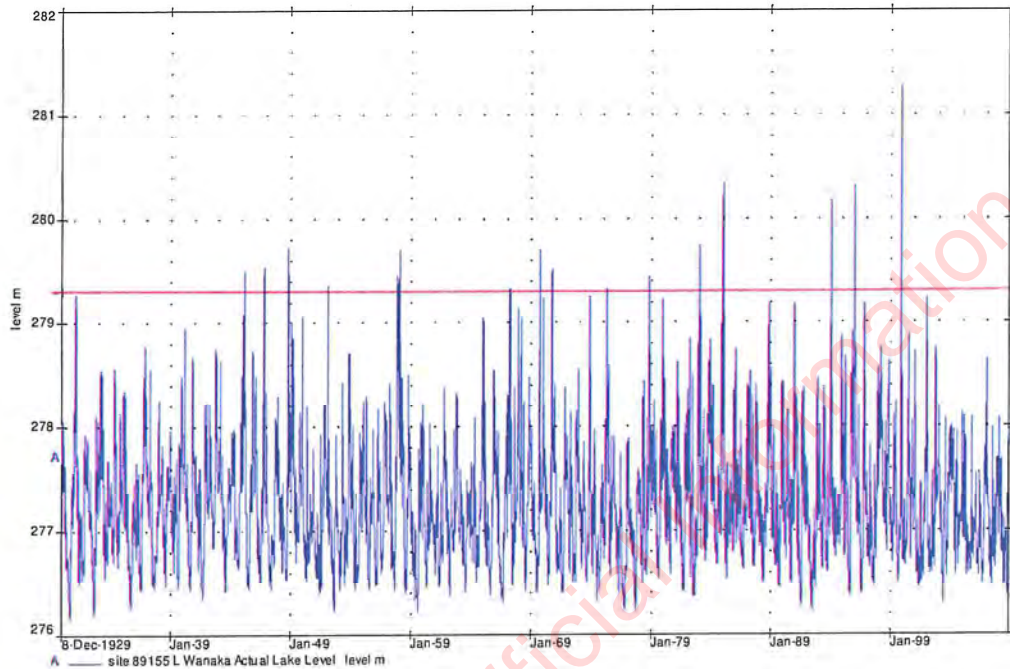
Figure 3.7 Lake Wanaka Level Record (m) 1929 to 2008

The lake level recorder is located at the Wanaka Township. The earlier lake level records (1929 to 1933) were from a staff gauge installed on the wharf in Roy's Bay (Pembroke Wharf). This gave poor readings as the wharf gradually subsided. A monthly Kent chart recorder was installed near the wharf on 1 February 1933, using the wharf staff gauge as the external staff gauge. This gauge was replaced in 1952 by a new installation approximately 250m northwest of the wharf. This new site began recording in October 1952 with another monthly Kent chart recorder. This continued operating until it was replaced with a Fisher and Porter punched tape recorder in May 1975.

The Lake Wanaka level record is shown in Figure 3.7, and as a strip in Figure 3.8 for more detail.

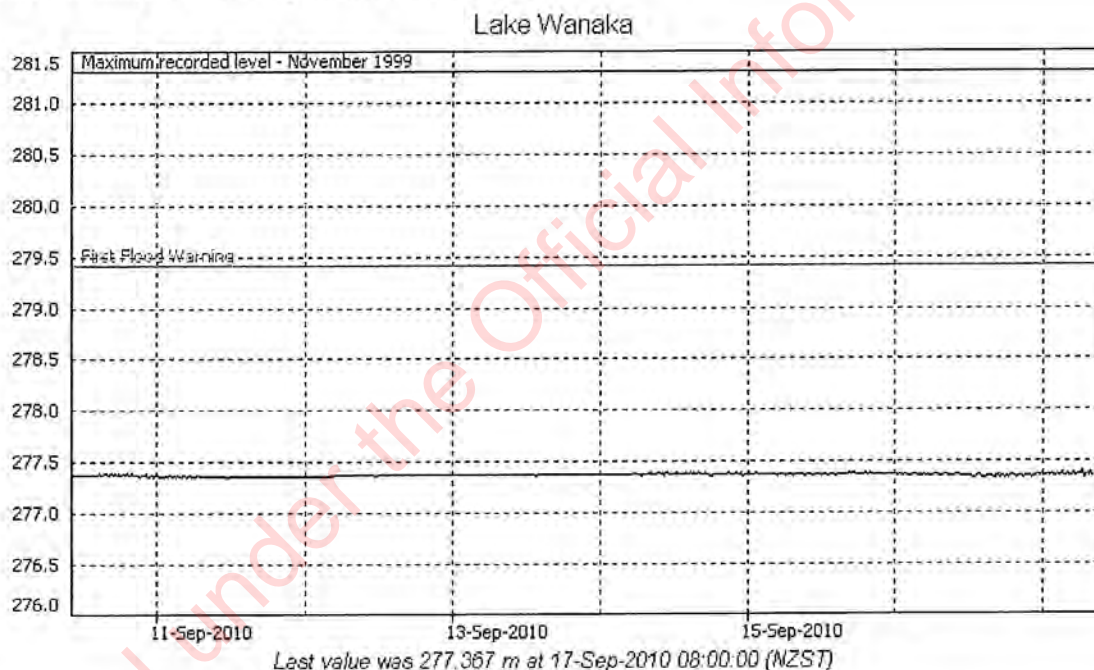
Graph showing the last 7 days water level in metres

Alert Title	Alert Details	Alert Type	Alert Threshold Level
Flood	First Flood Warning	High Level	279.400
Flood	Maximum recorded level - November 1999	High Level	281.300
Flood	Possible flooding in Wanaka	High Level	280.000

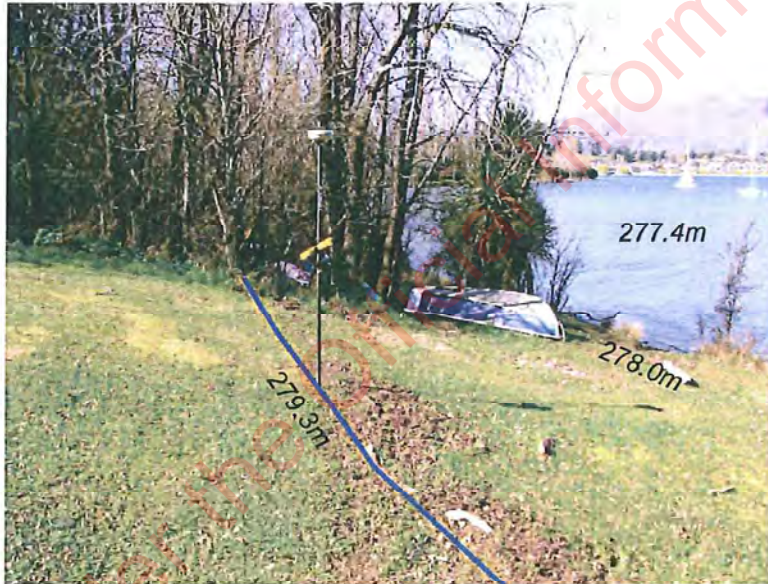
All at point 104

A point was taken on the foreshore opposite the main shopping complexes. The top of the crest approximates the 280m level that would flood low lying areas of the town. Three fixes were taken to grass covered banks close to the waters edge giving an average level of 278m. This bank approximates the vegetation line in this vicinity but this level was considered to be too low when compared to other banks at Mt Burke Station. I do not believe this level satisfies the interpretation of a lake-bed as described in the legislation.

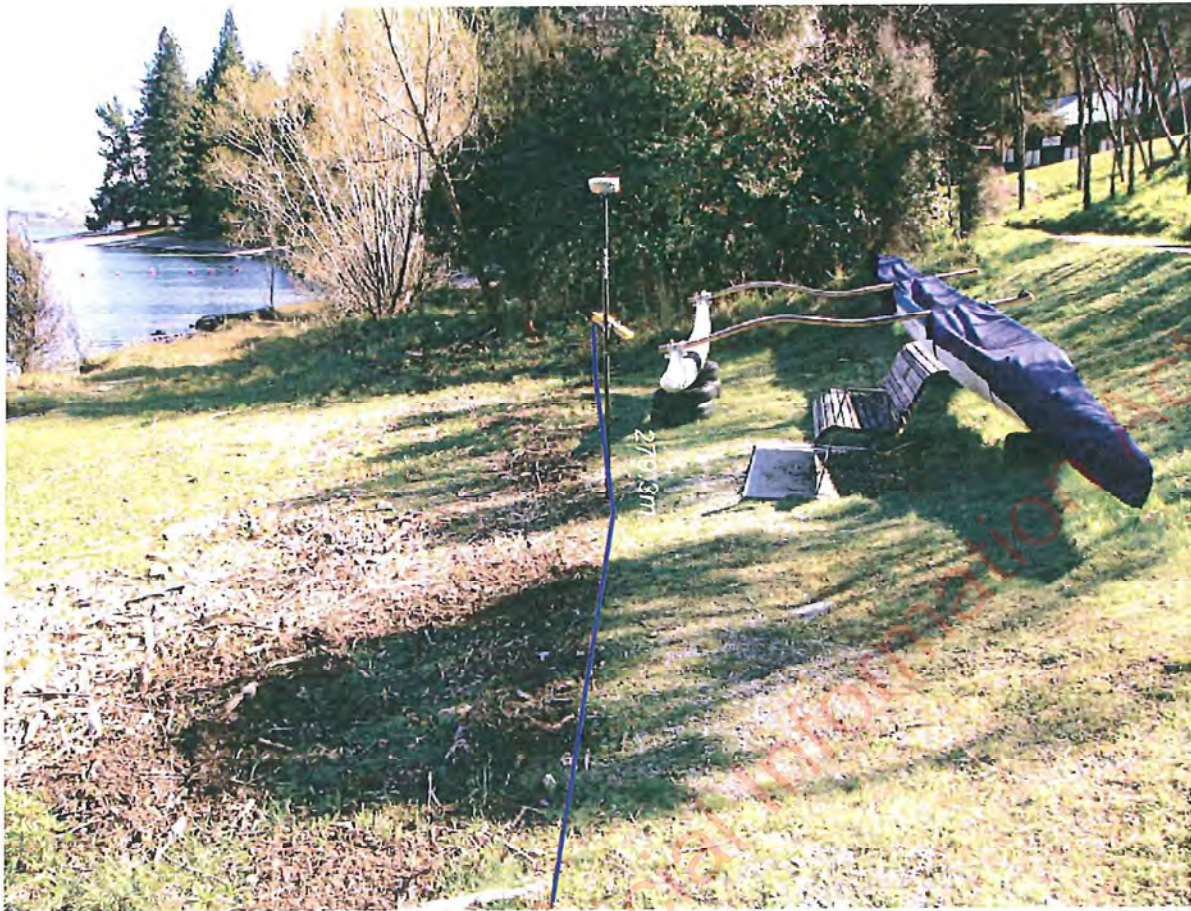
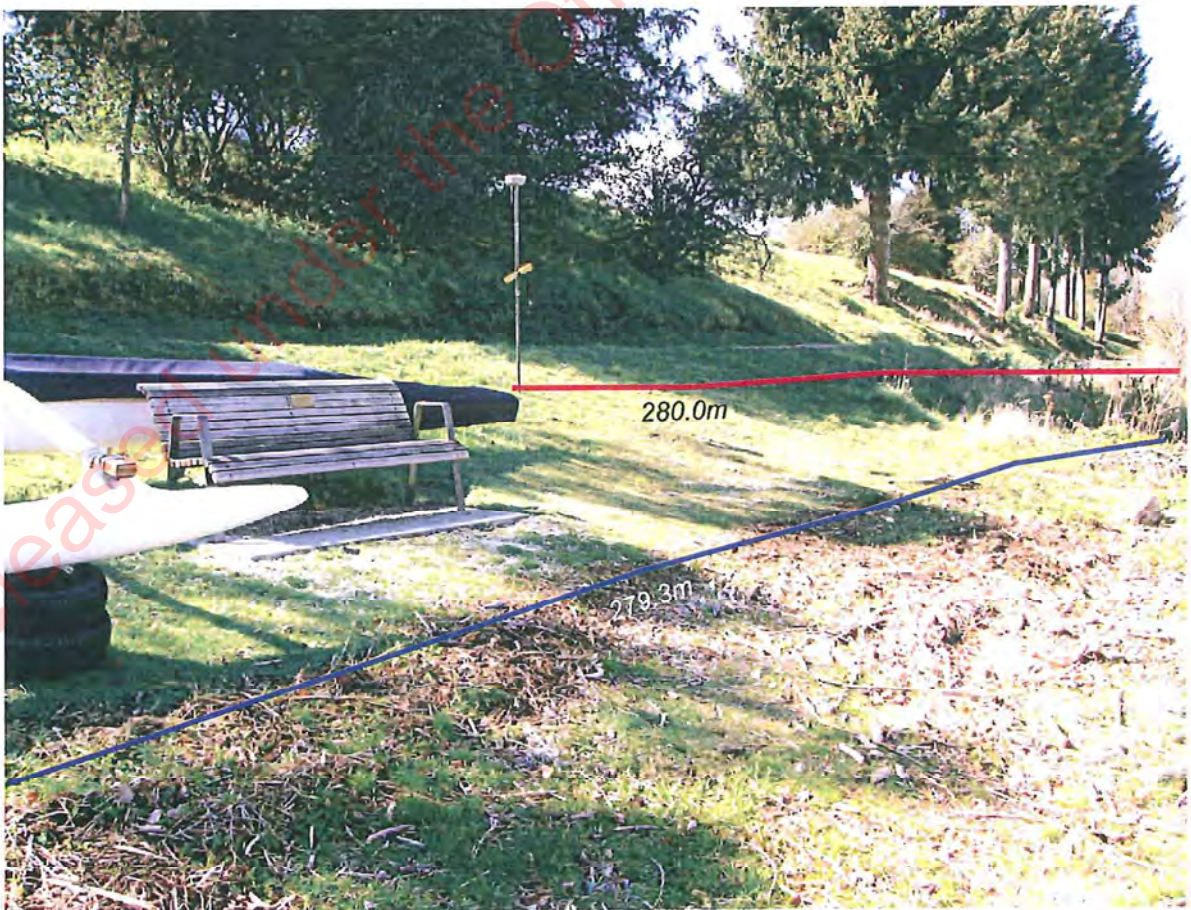
At point 105

Three separate areas were then evaluated adjoining Lakeside Road generally in the vicinity of Mackay and Winders St. In all three locations there was a clear flotsam line of old leaves and small bits of wood that was left behind following flooding in May 2010. This flood level can be seen in the graph on page 2 of 2 of Water Info/Upper Clutha Catchment attached to this report. A series of photos have been taken of these areas showing the GPS pole on both this contour and the 280m contour. Of significance in these photos is the presence of stored boats and well-established trees below the flotsam line and also seats and walking tracks between the flotsam line and the 280m contour. There was little evidence of banks at either contour along this edge only a slight terrace that had been formed below the seat at point 105. Measurements to this flotsam line ranged between 279.2 to 279.4m with an averaged of 279.3m.

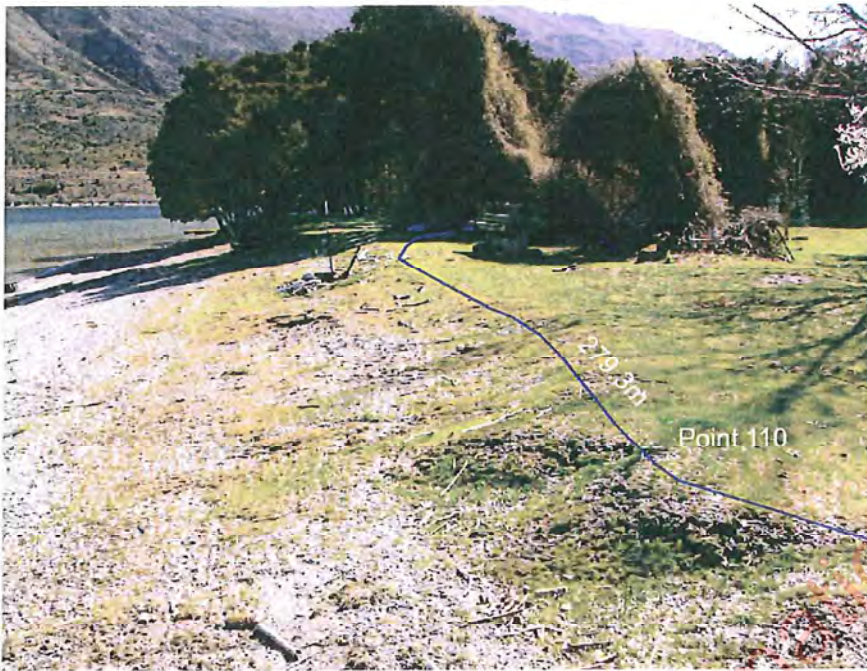
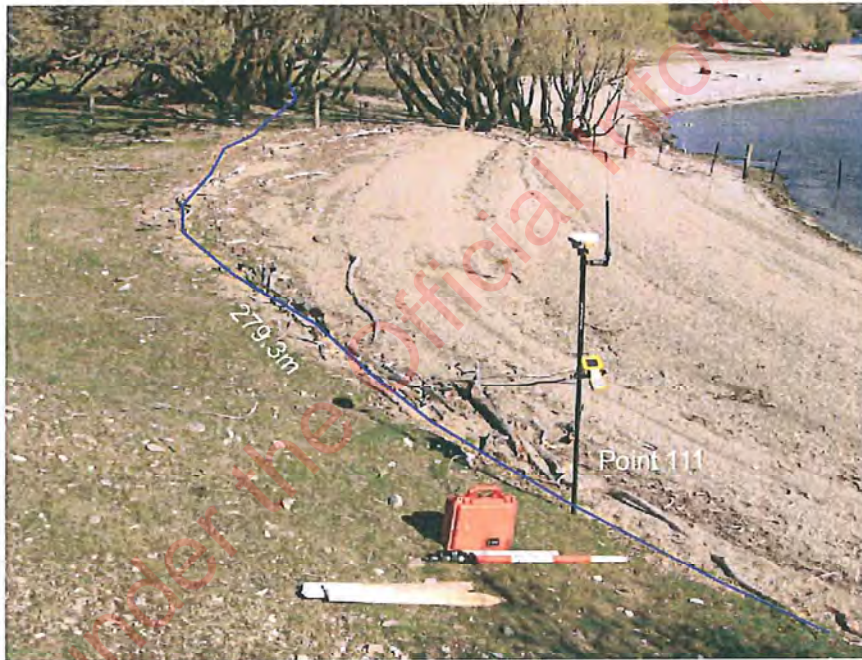
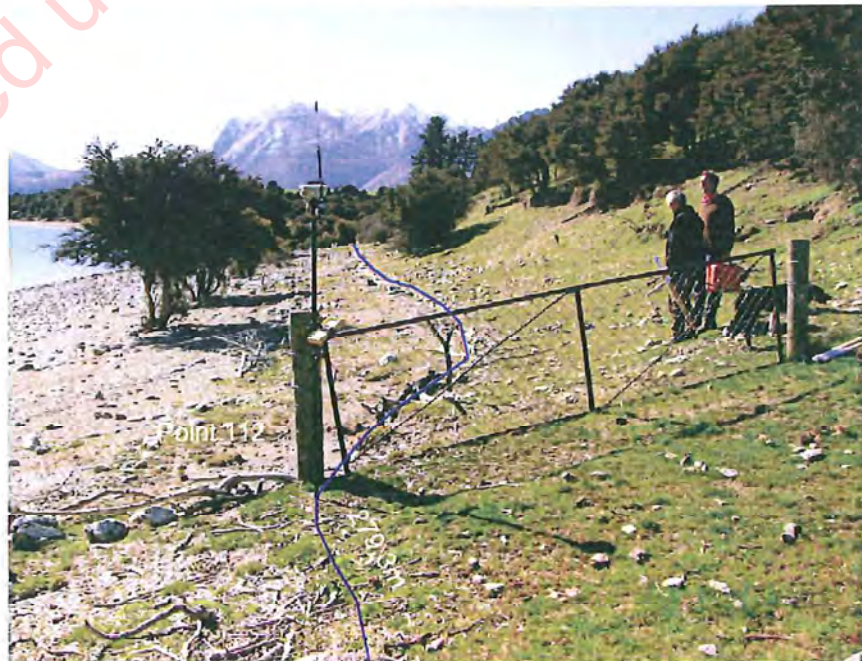
MT BURKE FORESHORE INVESTIGATION  
MT BURKE PHOTOS

North of the Quartz Creek delta three such positions were marked out with stakes being placed on the sloping vegetated ground around the foreshore. Refer to photos of points 111-114. A reasonably definitive line can be seen especially in the photos of point 111 where the grass stops at the 279.3m contour to give way to the gravel and sand of the beach surrounding the lake. Looking around the lake this line could be clearly seen as the boundary between land that could be considered lake-bed and land that was clearly covered in long term vegetation and pasture.

ITI is situated in a paddock locally known as the Flax Paddock. This paddock is very low lying and has a gradient of approximately 1:150. Three sets of stakes were placed to define the Sec24(3) marginal strip in this vicinity. Refer to photos of point 132.

An area of considerable concern to Tim Burdon was the area in the immediate vicinity of his killing shed, and the concrete boat ramp in the bay to the south-east of the homestead. This area is undulating with some higher mounds but generally below the 279.3m contour. This definition is markedly different from the definition shown on SO968.

In order to move forward with the investigative process it was agreed that this level of 279.3m would be used in the interim to place a number of stakes in key locations where both public access and farm management purposes could be seen to be in conflict.

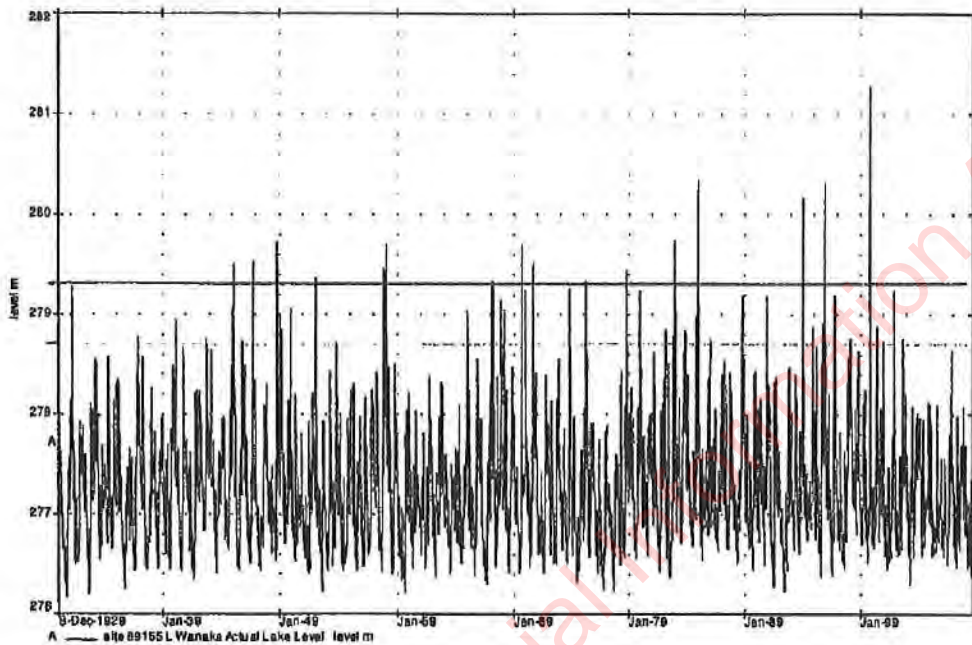
Figure 3.7 Lake Wanaka Level Record (m) 1929 to 2008

The Lake Wanaka level record is shown in Figure 3.7, and as a strip in Figure 3.8 for more detail.

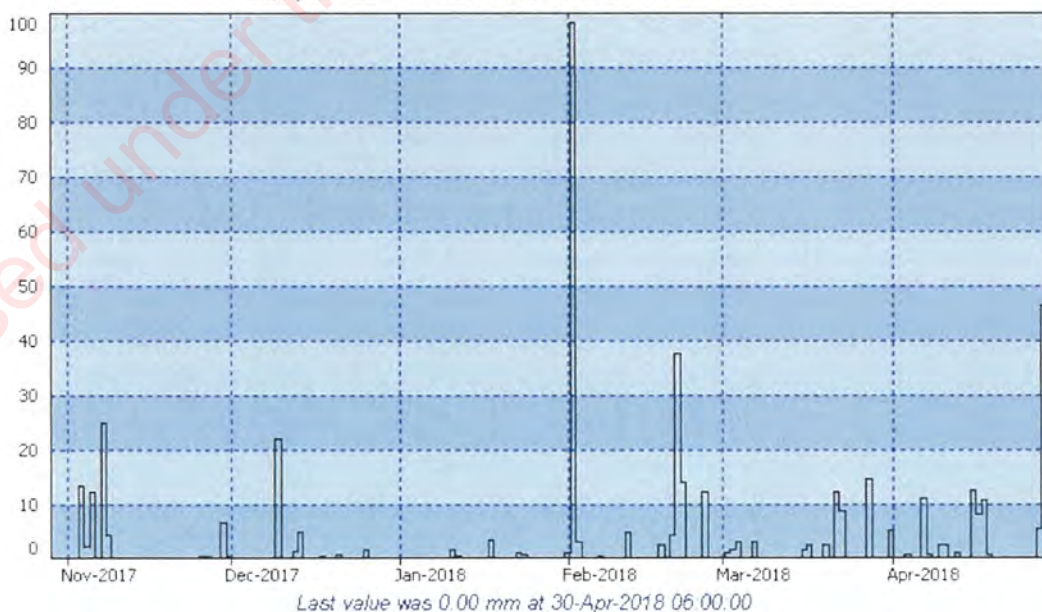
Daily rainfall for Matukituki River at West Wanaka

The weather was fine at the time of inspection. The last recorded rainfall was 12mm around April 16th, 2018 and the last significant fall being 38mm in late February. The streams were running high and clear and within their normal flood banks.

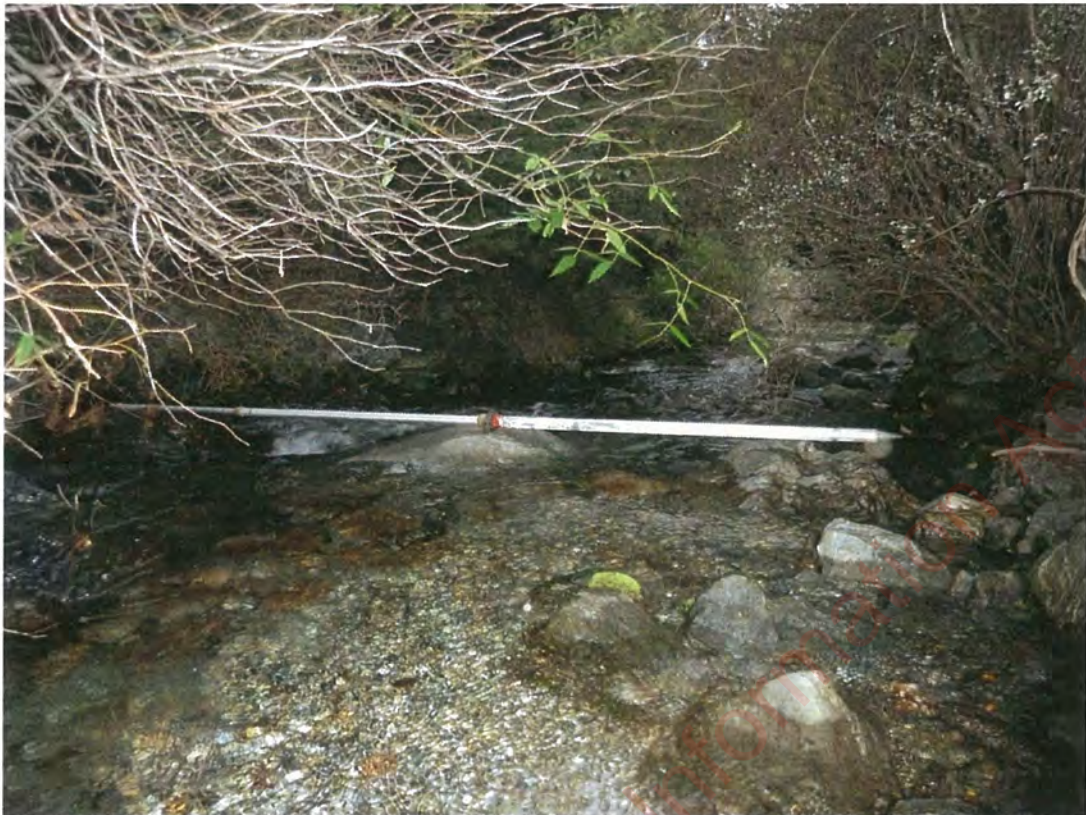
This waterway drains southwest from Mt Burke and Mt Gold and joins the Stevenson's Arm of Lake Wanaka north of Stevenson's Island. The waterway is generally well confined in a steep sided gorge with very limited access due to thick vegetation. Approximately 1500m upstream of the lake the stream splits into two branches. No measurements were possible in the right branch but a visual inspection from the air would suggest that this branch would not qualify. Measurements taken above the confluence on the left branch suggest that this branch will qualify to the confluence at waypoint 4.

On the day of the inspection, there was a good flow of water in the stream suggestive of a qualifying flow. The banks were well established and stable.

Waypoint 1, a typical section under bush canopy, good water flow and stable well-developed banks with an average width of 3-4m.

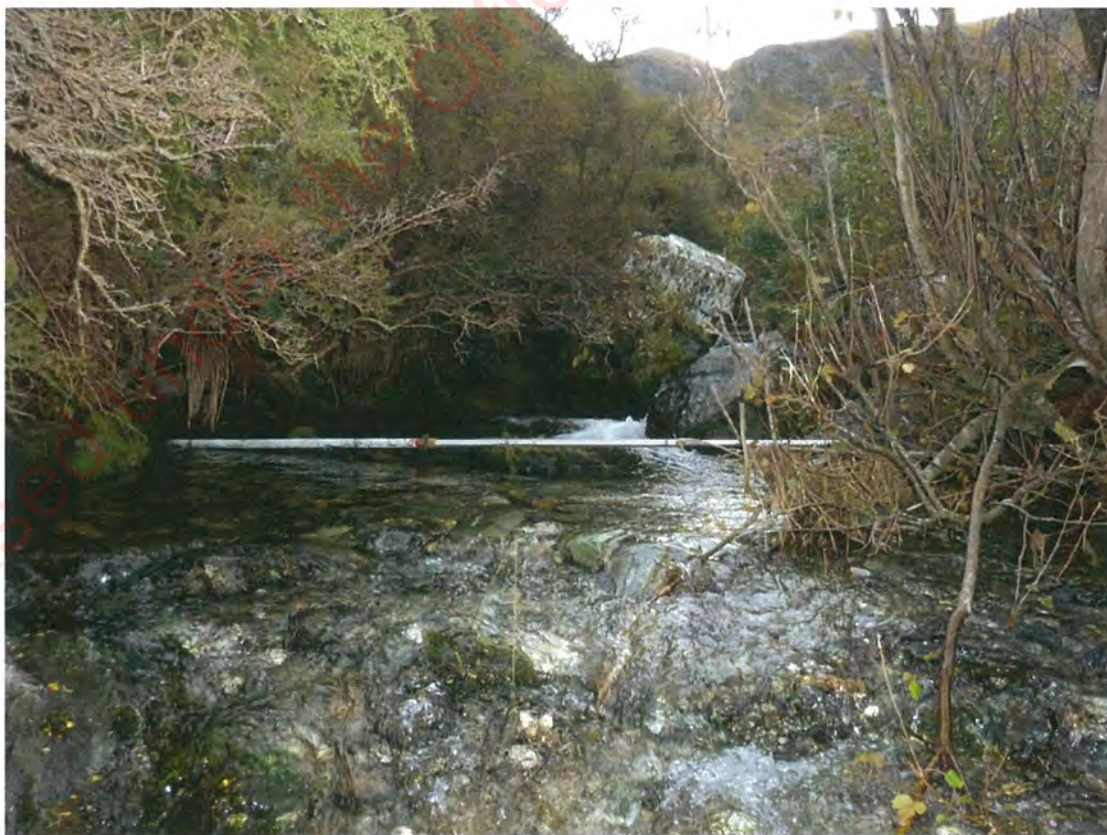
Waypoint 3, a typical section with good water flow and stable well-developed banks with an average width of 3-3.5m.

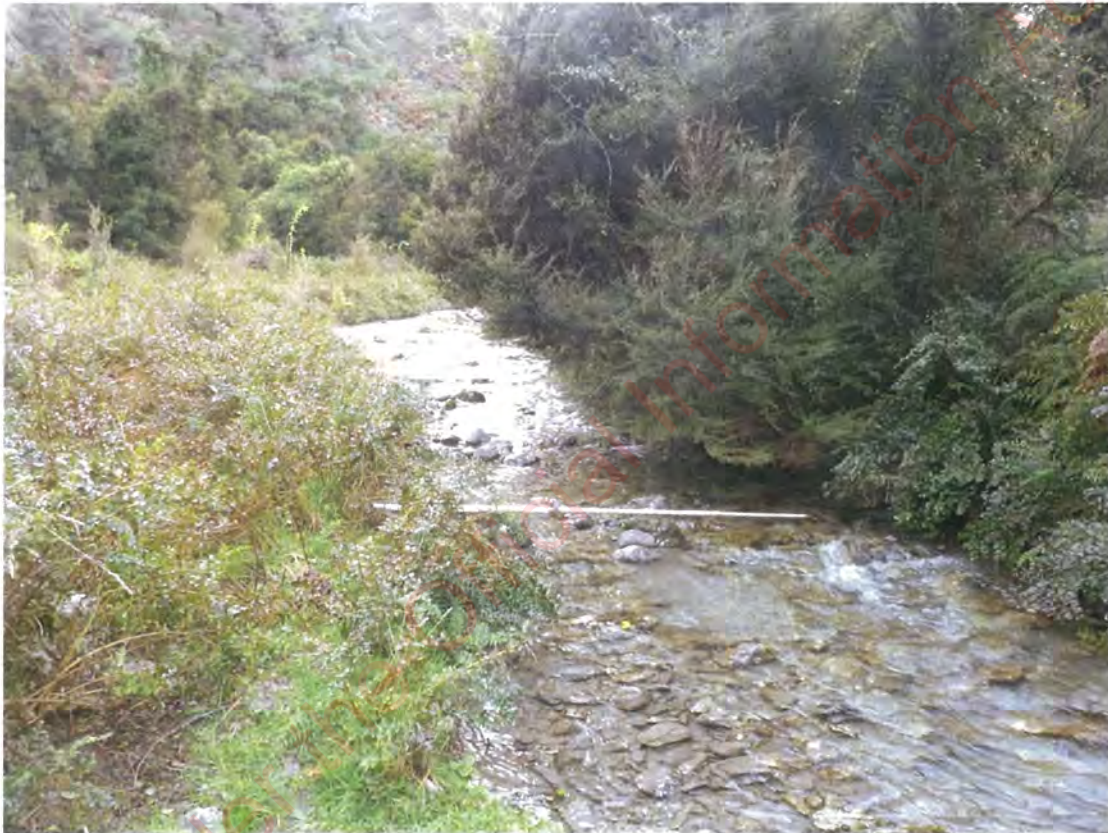
This creek is the largest waterway on the property. There are two named branches being the west and east branch and both drain in a southwest direction to join the lake near the homestead. It was obvious from the air that the lower section was well qualifying being an estimated 6-8m wide. The west branch is significantly smaller than the east branch and was only visually inspected from the air. Measurements taken on the east branch suggest that the upstream terminal is at the confluence of branches at waypoint 8.

*Waypoint 5, a typical section with good water flow and stable well-developed banks with an average width of 3.5-4m.*

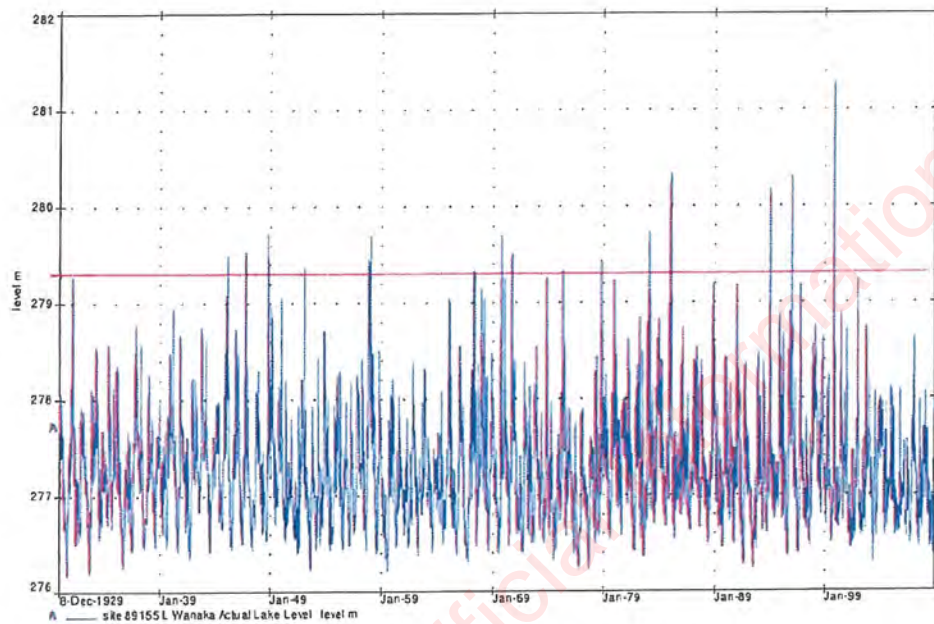
Figure 3.7 Lake Wanaka Level Record (m) 1929 to 2008

The Lake Wanaka level record is shown in Figure 3.7, and as a strip in Figure 3.8 for more detail.

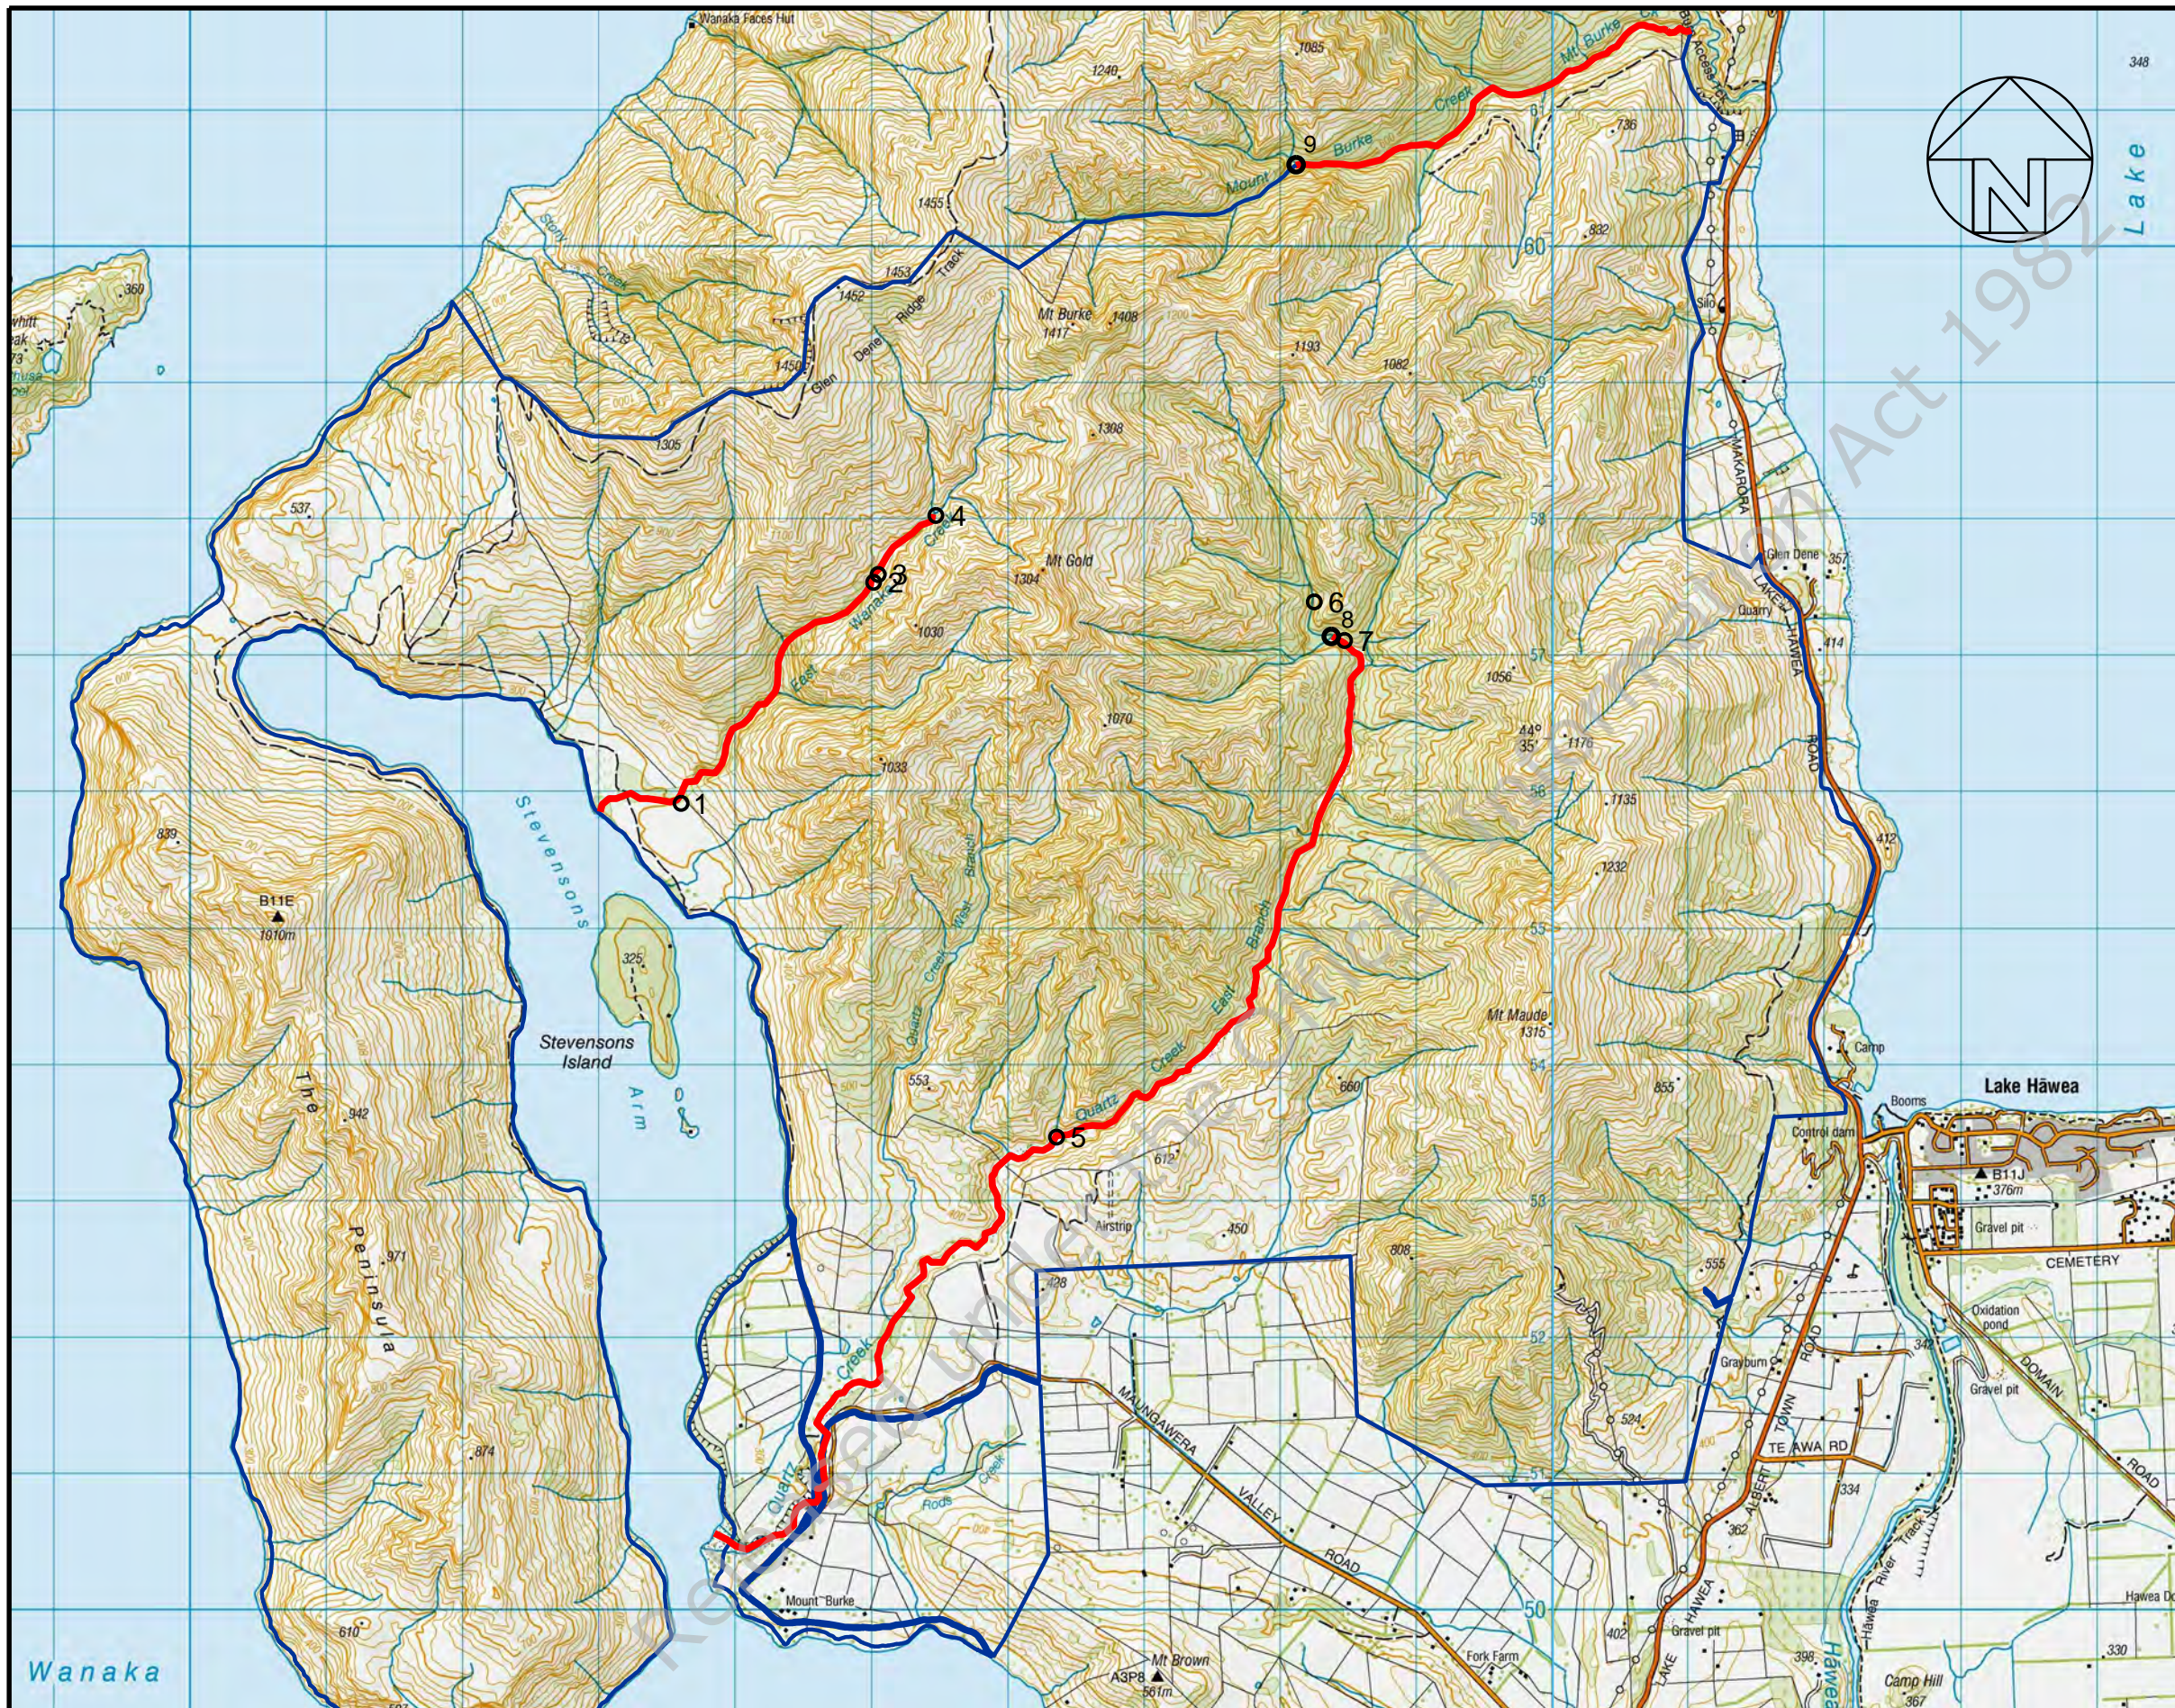
Prepared For:  
LINZ - Crown Property & Investment - Pastoral

Waterways that are 3m or more in width at time of survey inspection will qualify for marginal strips upon disposition pursuant to Section 24 of the Conservation Act 1987.
