Ground Contamination Desktop Assessment

Te Motu Kairangi

Prepared for
Land Information New Zealand

Prepared by
Tonkin & Taylor Ltd

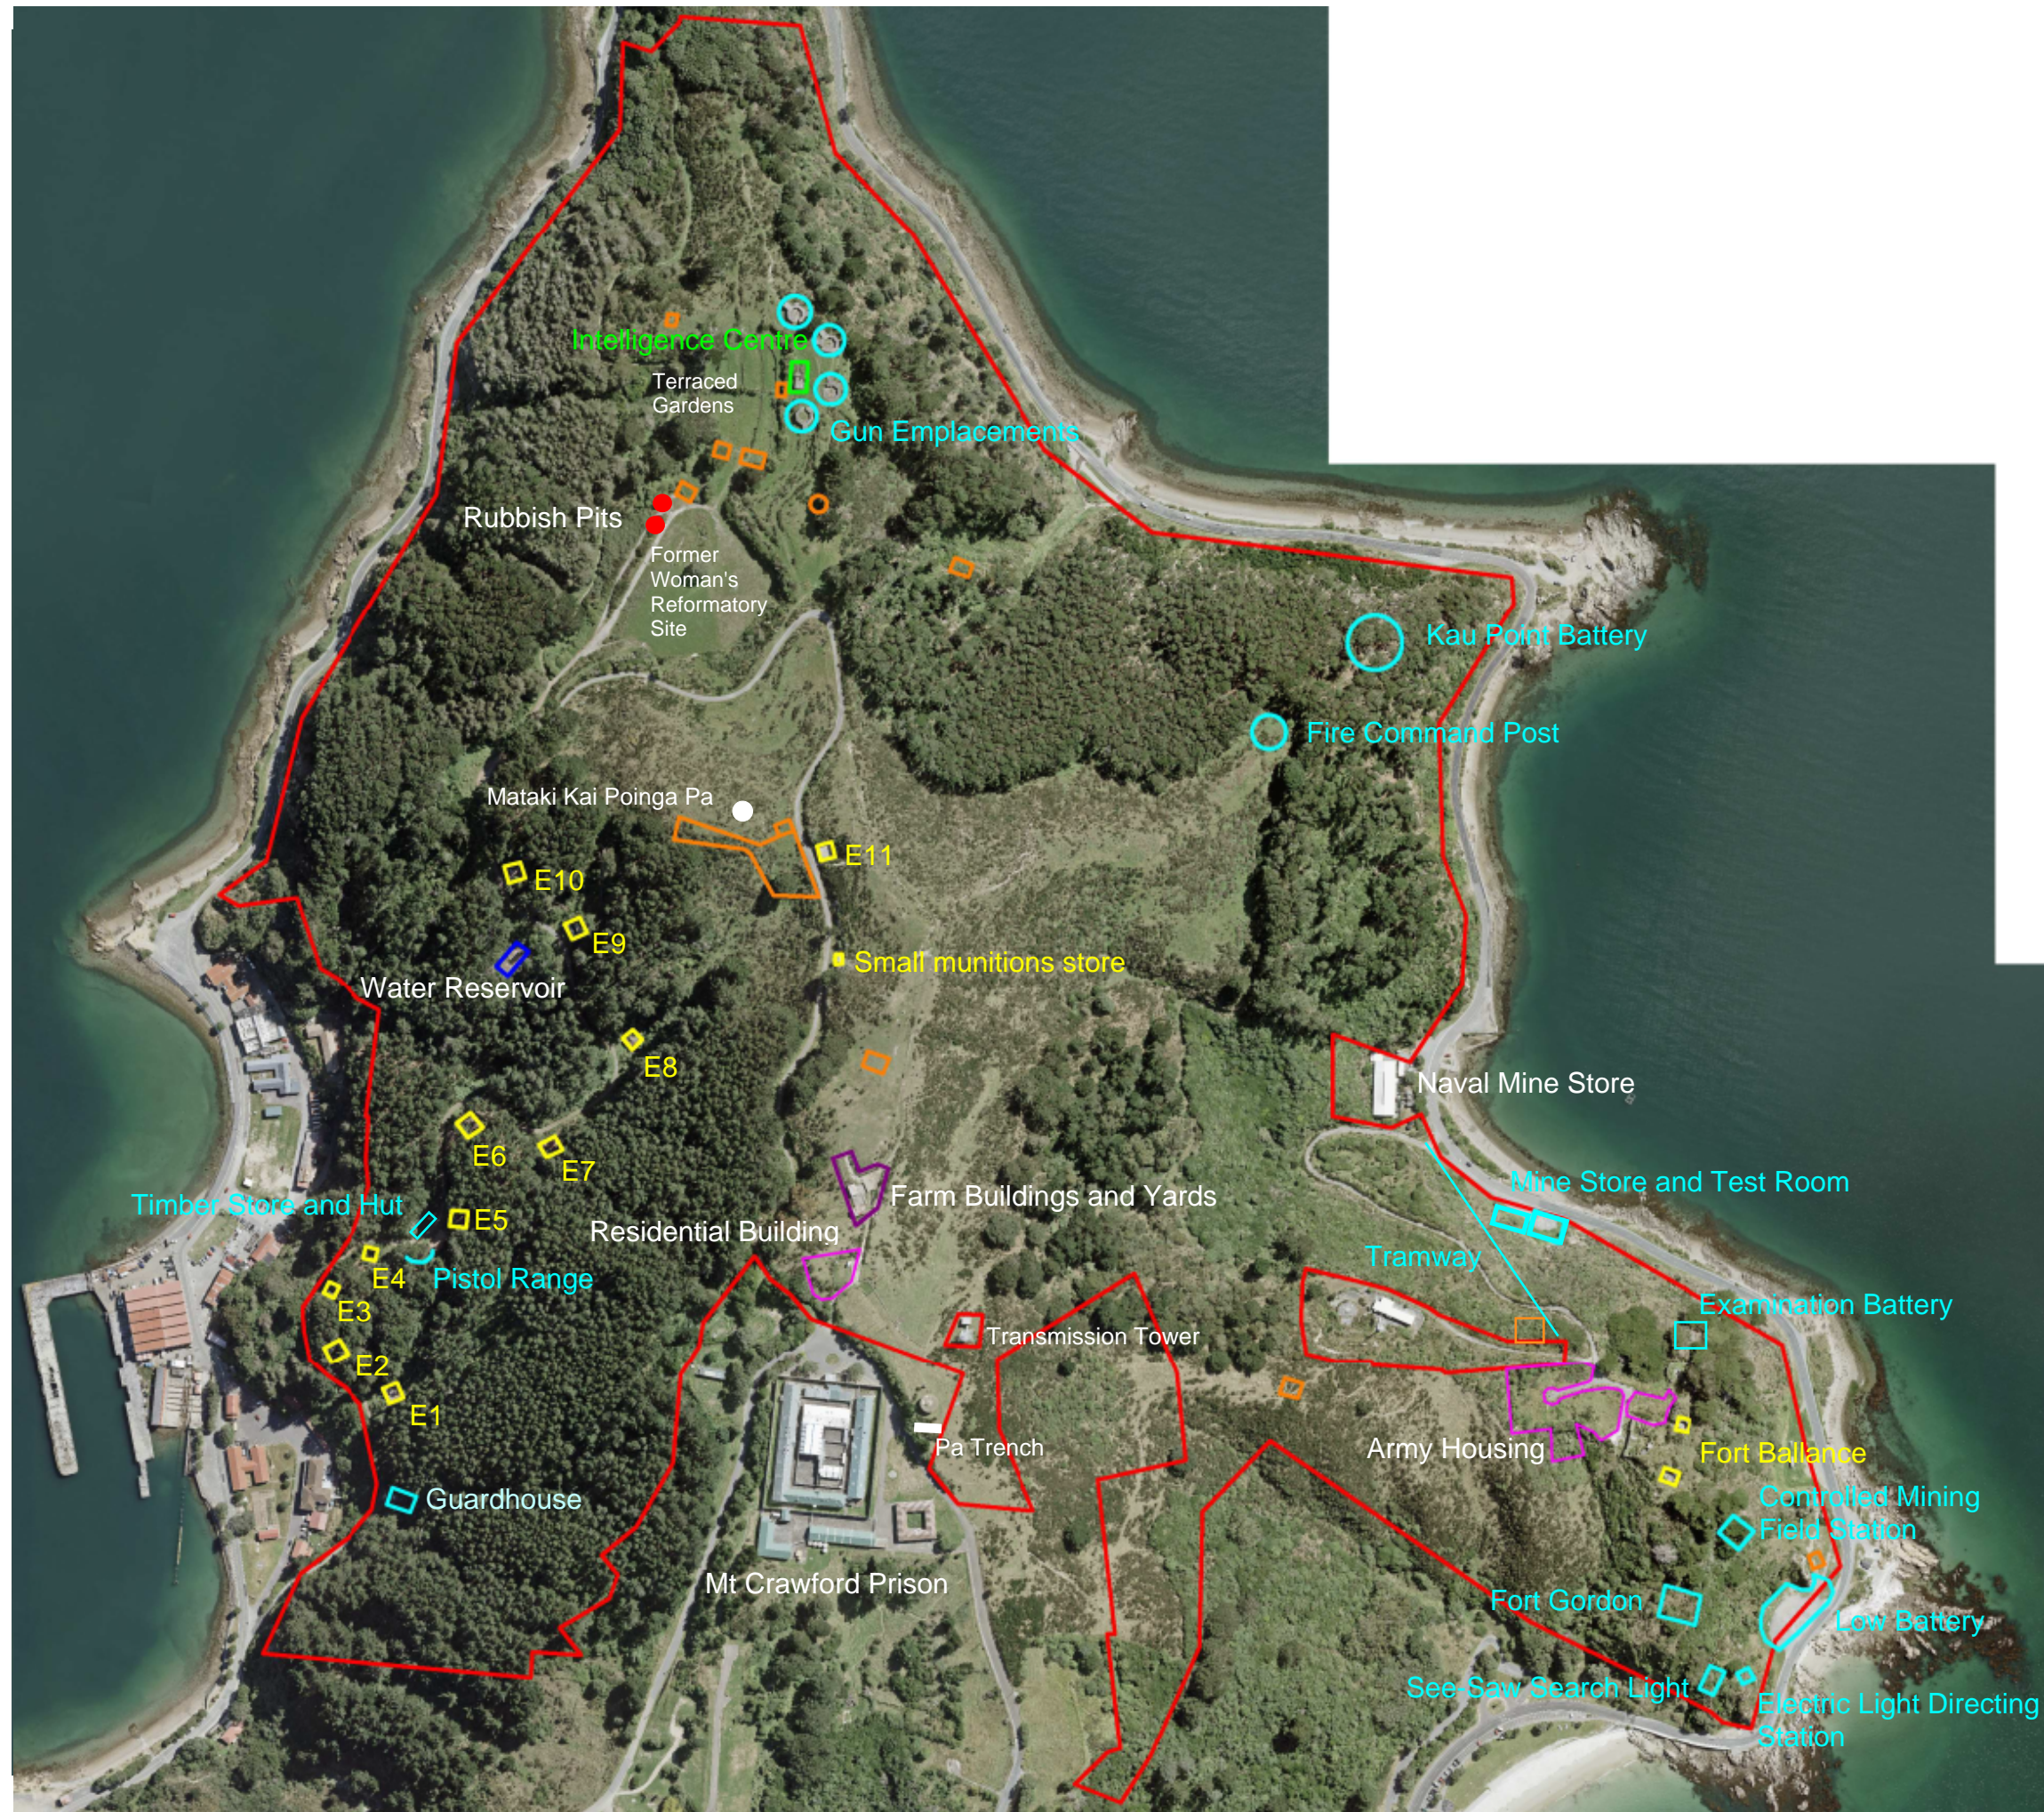
The property is currently used for grazing and recreation and the following features were observed during the initial site visit (refer to **Figure A.1, Appendix A**):

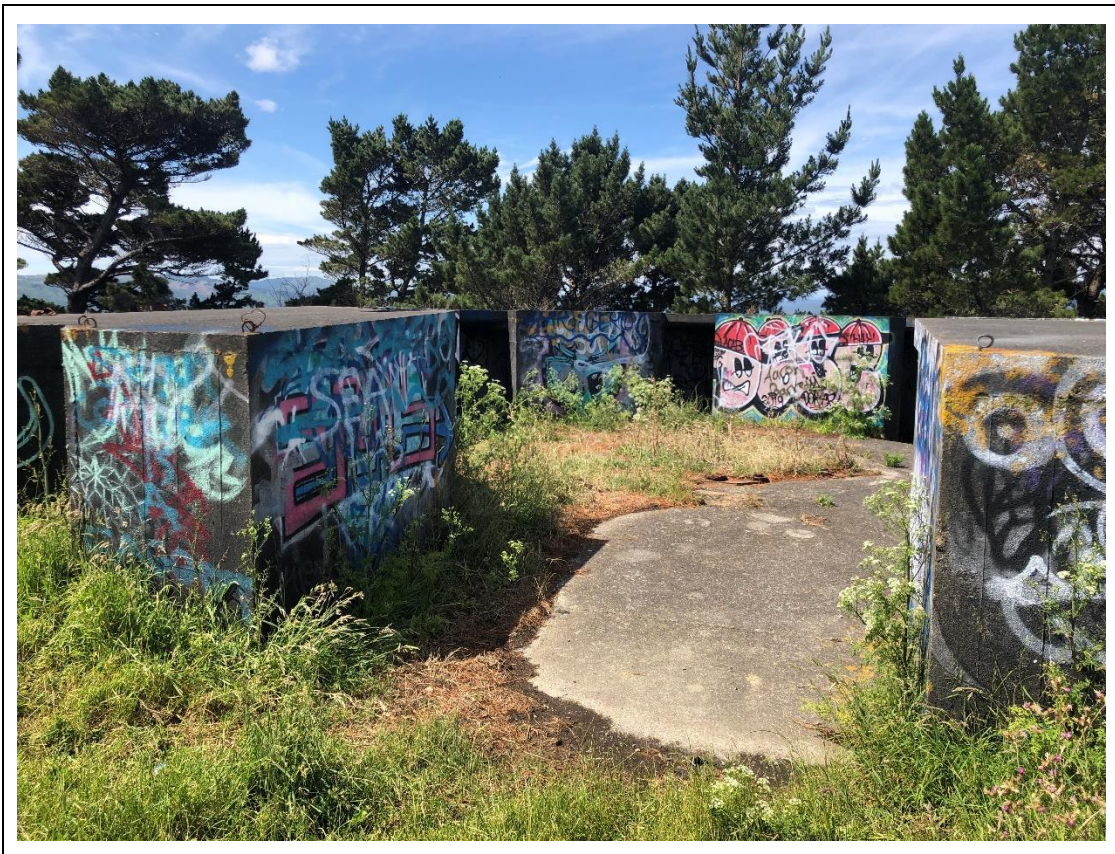
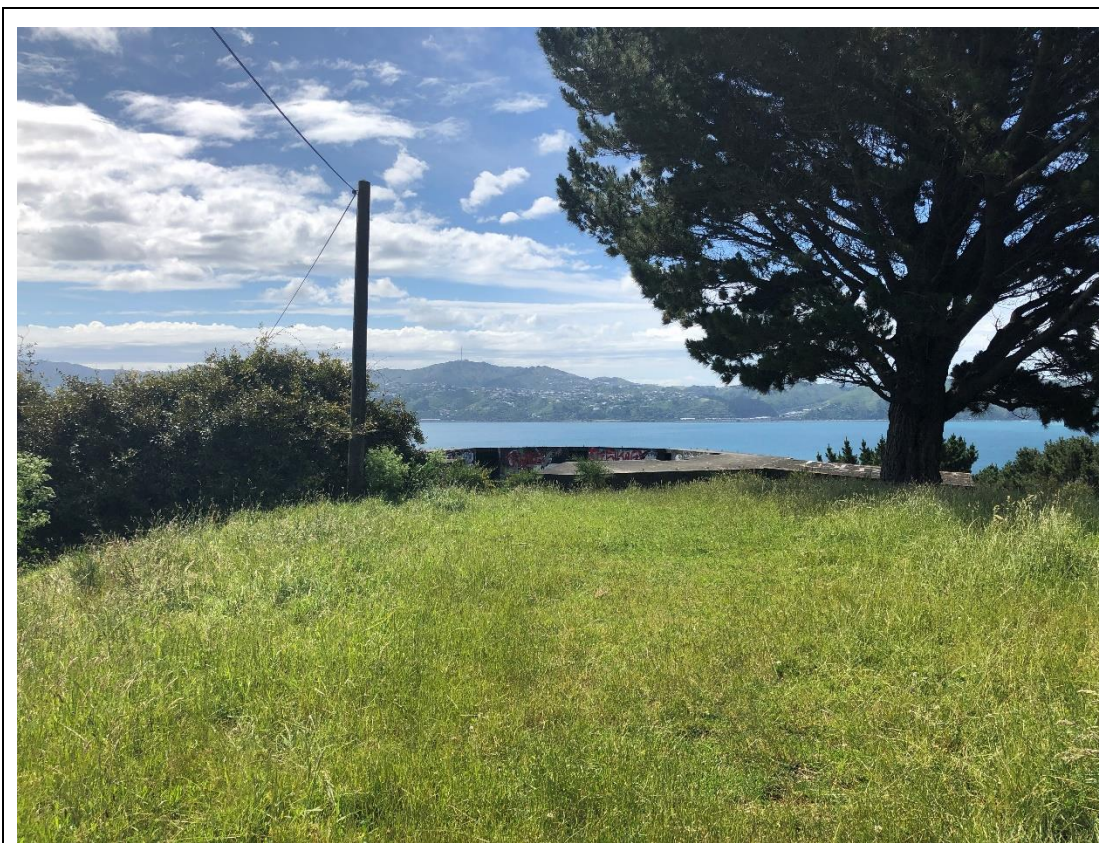
- Disused gun emplacements on the northern portion of the site were observed and have been vandalised (with tagging), see Photographs 1 and 2;
- A broken sheet of asbestos roofing was observed in the area of the former 'Intelligence Centre' on the northern portion of the site. The roofing appeared to have been used as a form of small retaining wall (see Photograph 3);

Photograph 1 Appendix B.1: Gun emplacement on northern portion of site

Photograph 2 Appendix B.1: Northernmost gun emplacement looking to the North beyond site

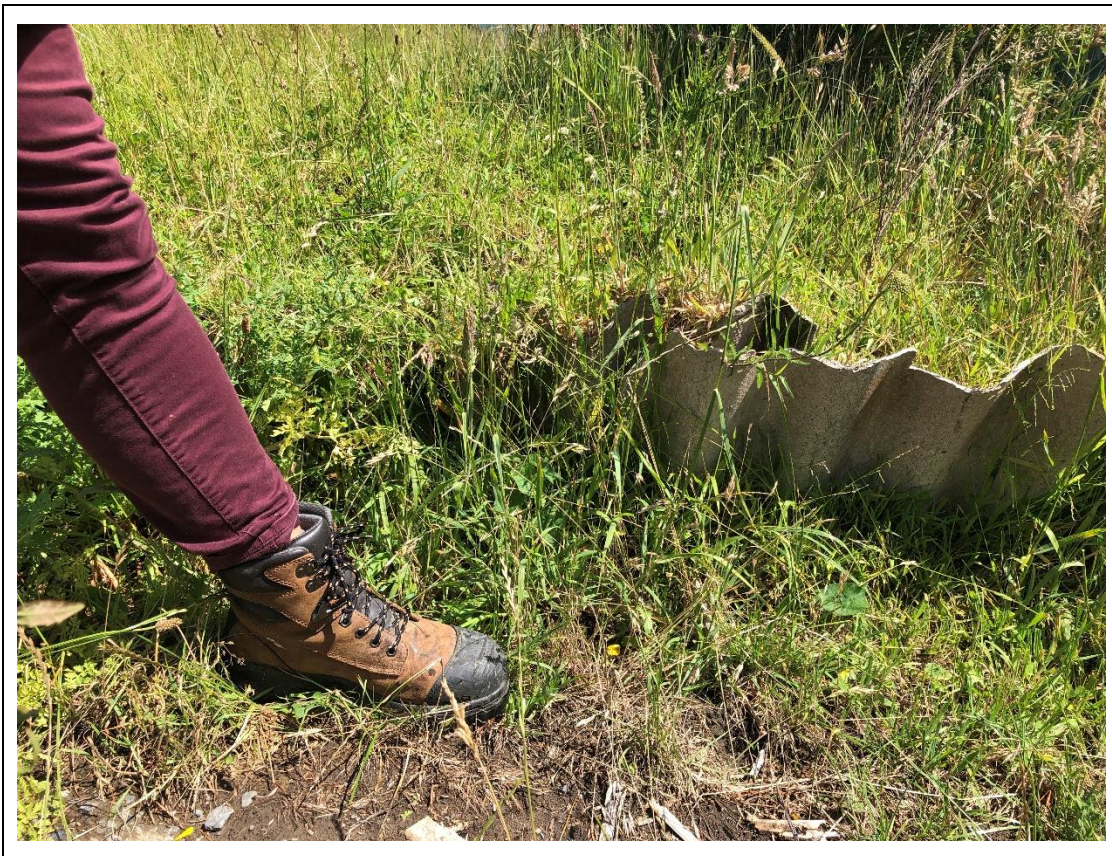
Photograph 3 Appendix B.1: Broken Super-Six sheet used as retaining wall

An assessment and record of the asbestos containing building products is recommended. We understand that a 'refurbishment survey' is to be completed which will assess the presence and condition of asbestos within buildings on site. An intrusive investigation of the soils surrounding the buildings containing ACM products, and in locations where asbestos fragments have been found, is recommended to assist in determining appropriate asbestos related controls prior to any disturbance/restoration works.

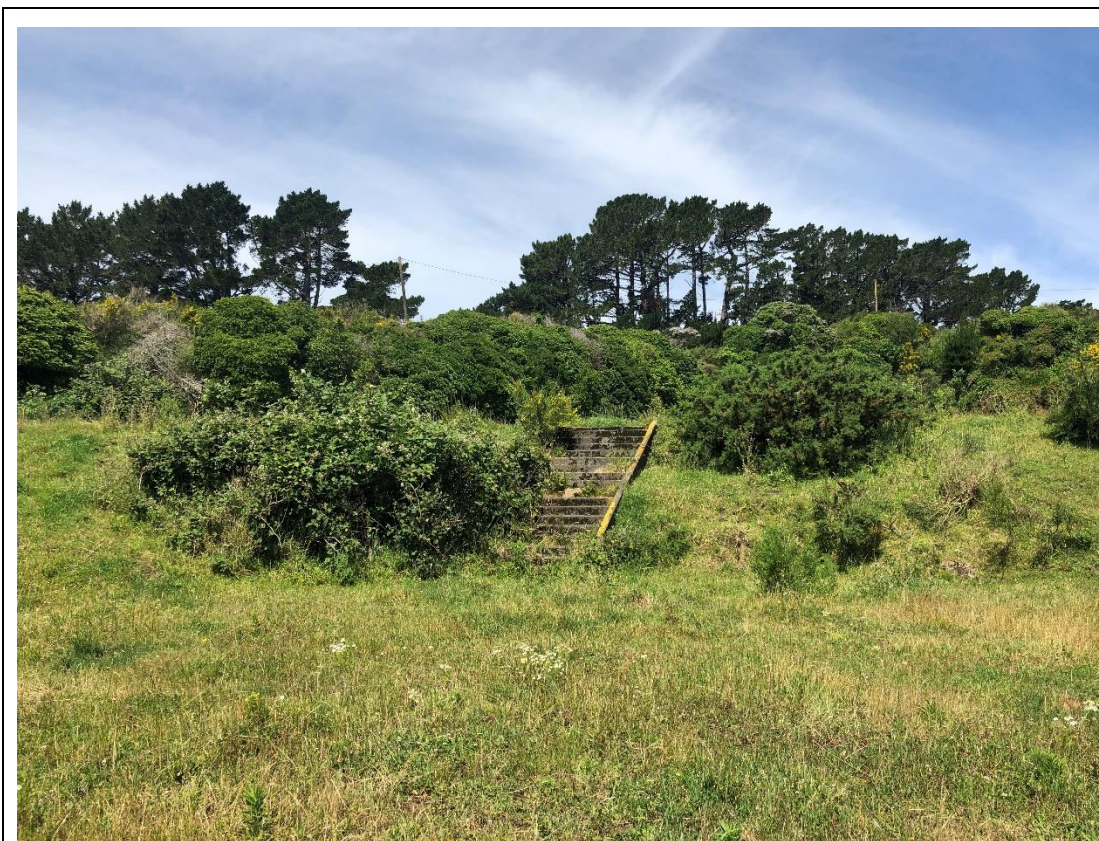
- A mostly level clearing where the former woman's reformatory was located contains remnant structures, including a concrete staircase in the centre of the site (see Photograph 4). This area has also been occupied by film sets with various temporary buildings appearing in aerial images between 2009 to 2013 (see **Appendix D** for historical aerial images);

Photograph 4 Appendix B.1: Remnant of the Woman's reformatory

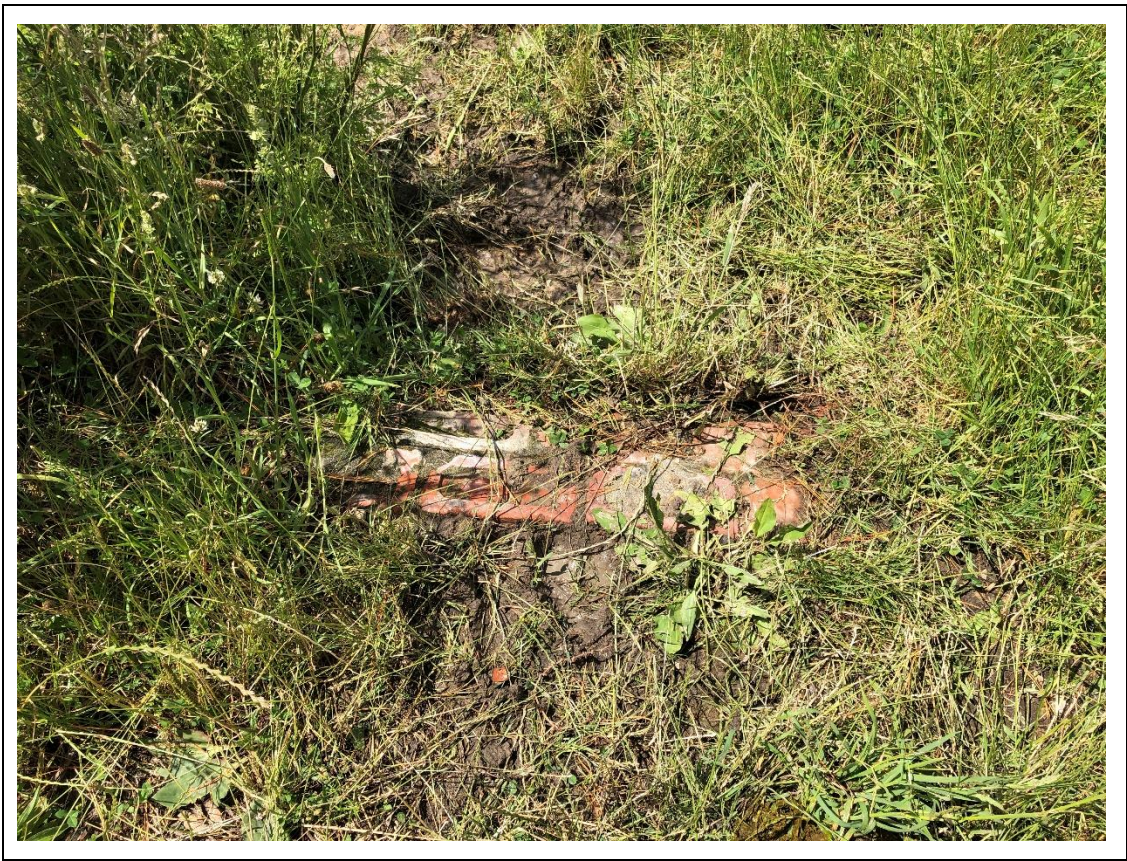
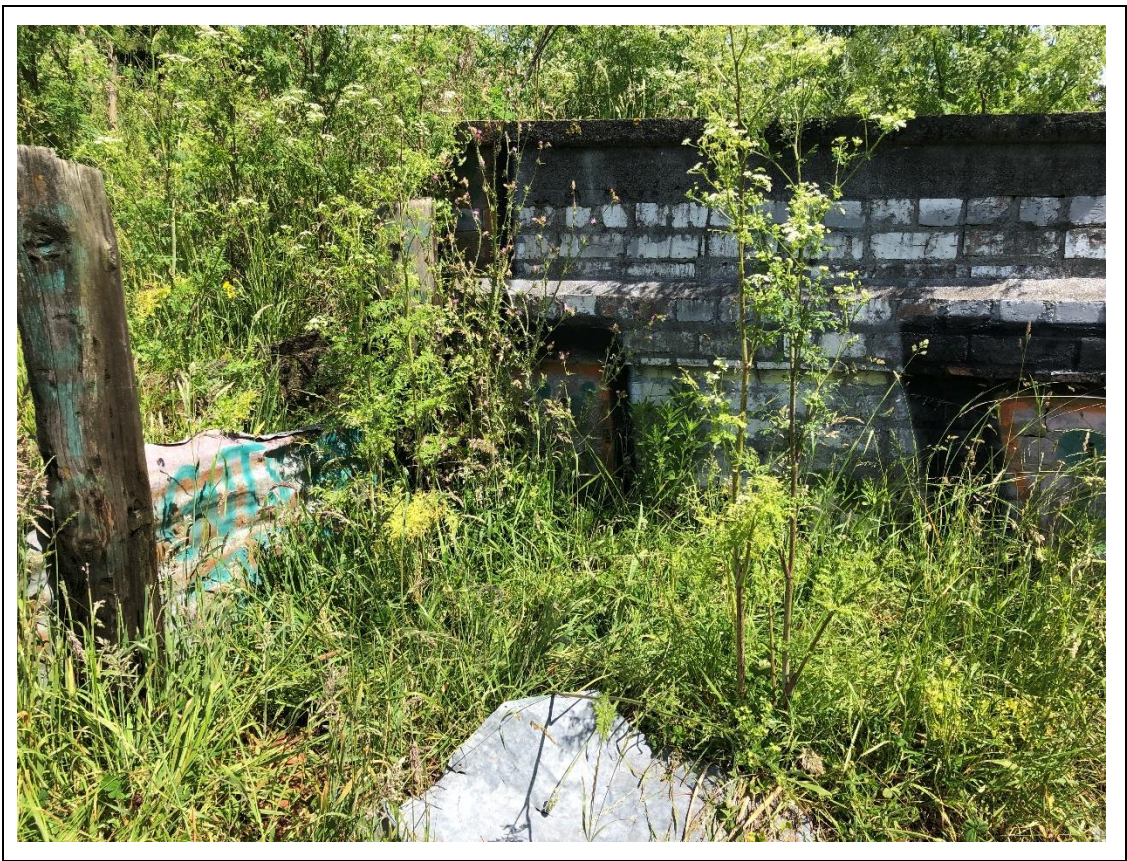
- Remnants of brick walls were observed in the terraced garden area. The end of a large cement pipe was also seen in this area (see Photographs 5 and 6);

Photograph 5 Appendix B.1: Remnant of brick wall in terraced garden area

Photograph 6 Appendix B.1: Remaining brick wall in terraced garden area

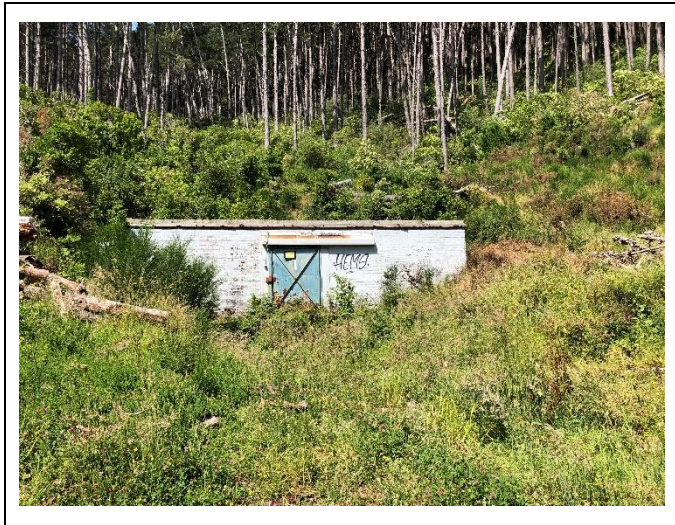
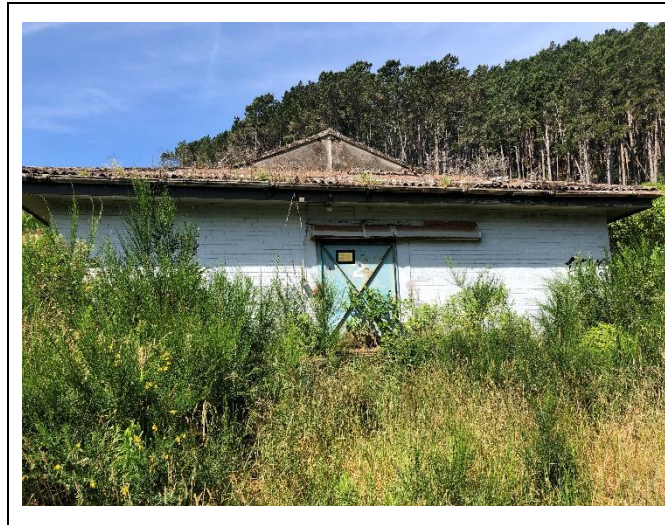
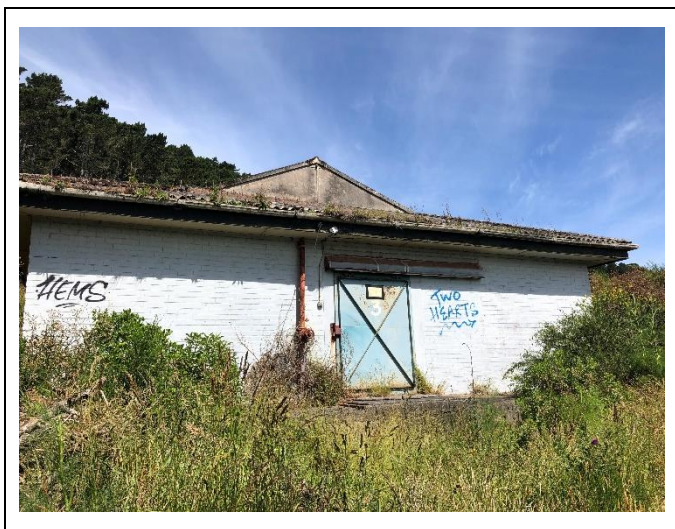
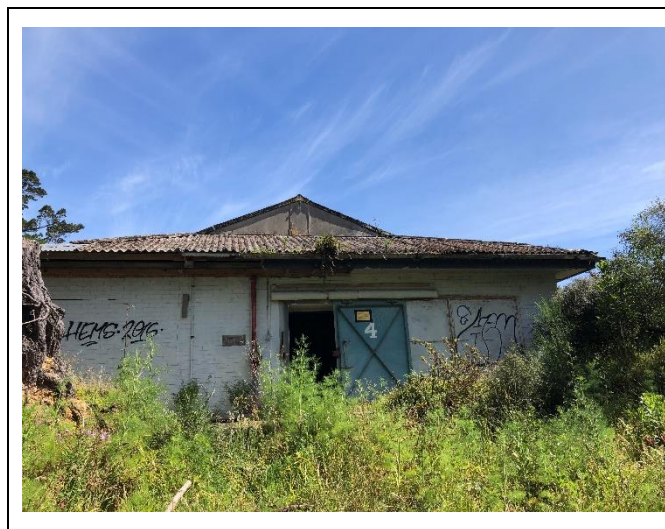
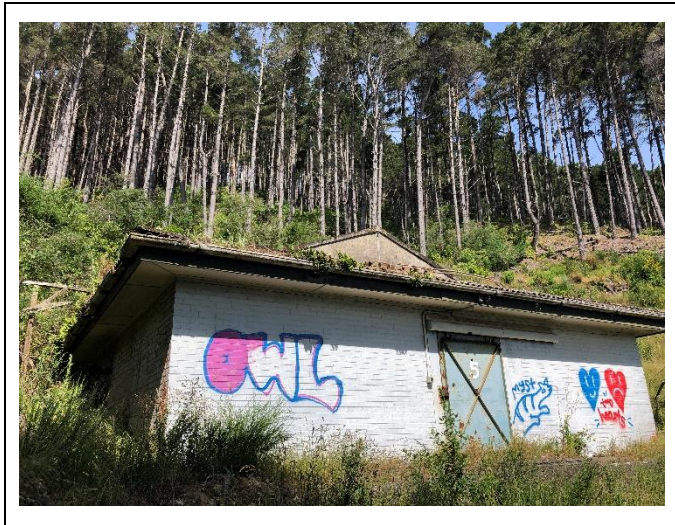
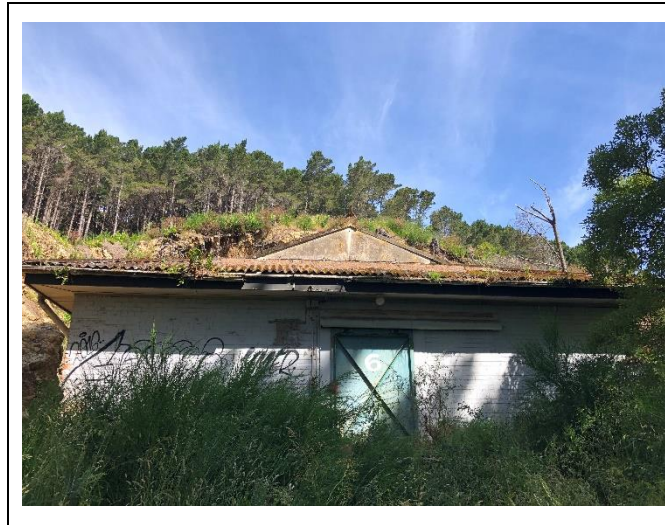
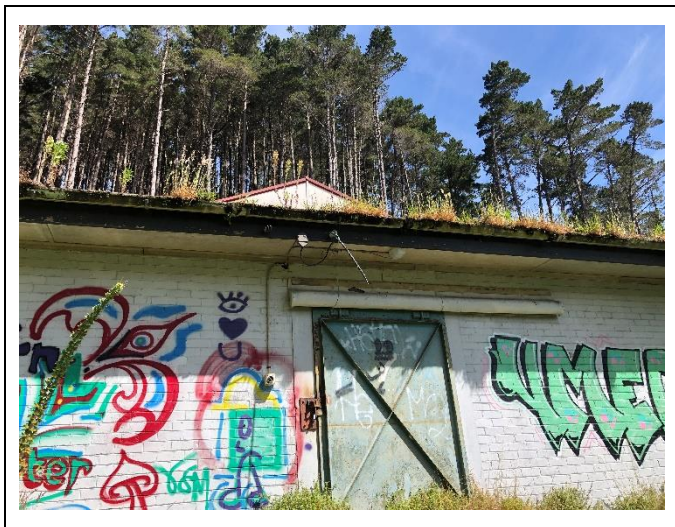
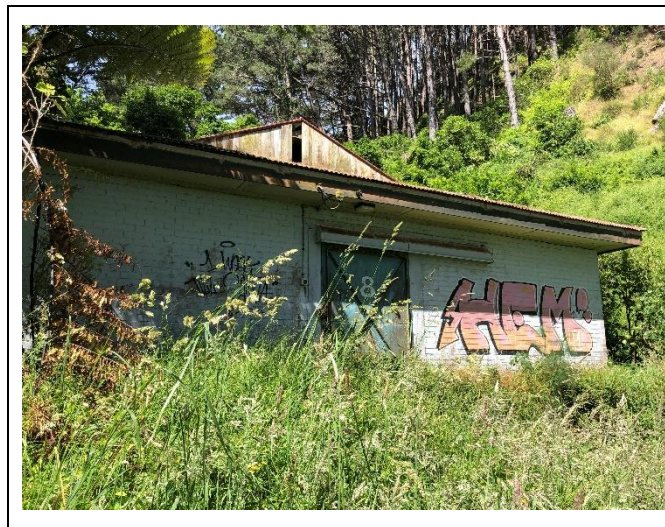
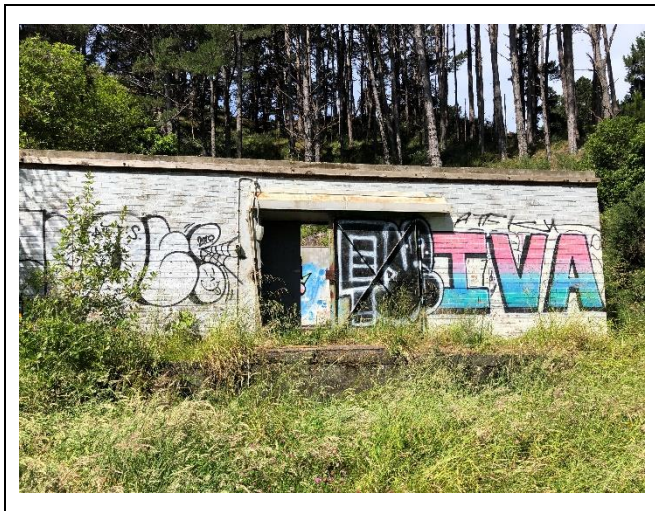
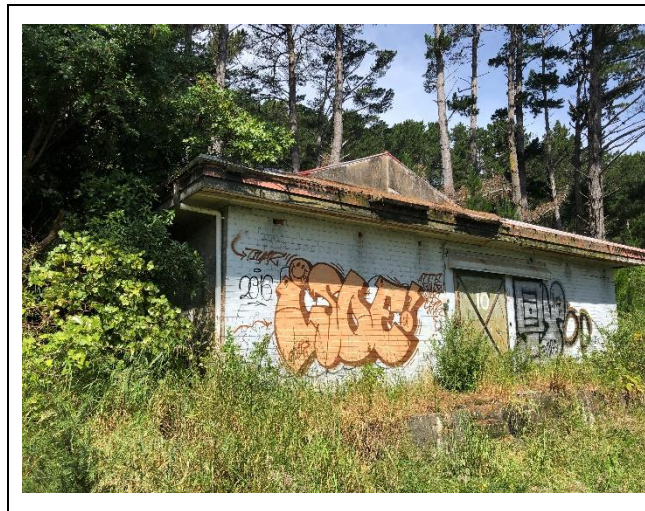
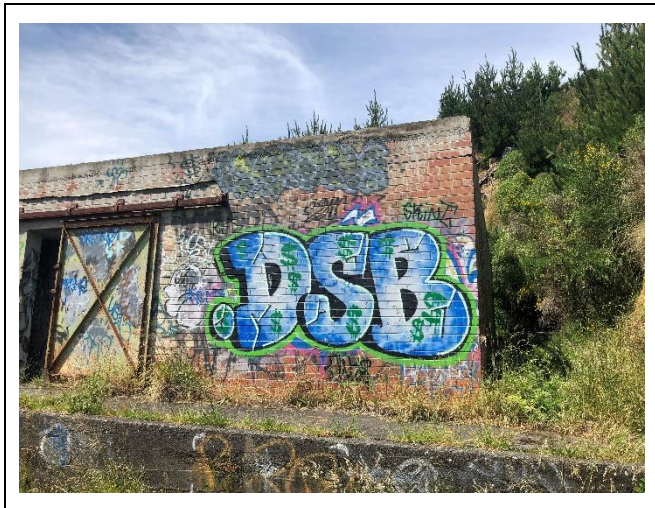
- Buildings (herein referred to as the magazines) are present on the site that have previously stored explosives, munitions and other equipment associated with the former military history of the site (see Photographs 7-17). The majority of the magazine buildings (labelled as E1-E11) were observed to have asbestos roofing, the roofs of some of the buildings have been replaced with corrugated iron sheets. The buildings also were also observed to have asbestos

Building ID	ACM Products Observed	Other Notes
E1	<ul style="list-style-type: none"> No roof 	<ul style="list-style-type: none"> Building is earthquake prone Electrical wire Building likely to have previously had ACM roof, gable, gutters, soffits and downpipes
E2	<ul style="list-style-type: none"> Super-Six roof ACM soffits, gutters and gable boards 	<ul style="list-style-type: none"> Building is earthquake prone Exposed electrical wire observed on front of building Building likely to have had ACM down pipe
E3	<ul style="list-style-type: none"> Super-Six roof ACM soffits, gutters and gable boards 	<ul style="list-style-type: none"> Building is earthquake prone Electrical wire observed on front of building Building likely to have had ACM down pipe Pipework associated with the fire -fighting system on building
E4	<ul style="list-style-type: none"> Super Six roof: Northwest corner was damaged during tree felling works; corner has been replaced with corrugated iron ACM soffits, gutters and gable boards 	<ul style="list-style-type: none"> Building is earthquake prone Electrical wire observed on front of building Building likely to have had ACM down pipe Pipework associated with the fire -fighting system on building

E5	<ul style="list-style-type: none"> Super-Six roof ACM soffits, gutters and gable boards 	<ul style="list-style-type: none"> Electrical wire observed on front of building Building likely to have had ACM down pipe
E6	<ul style="list-style-type: none"> Super-Six roof ACM soffits, gutters (broken), down pipe and gable boards 	<ul style="list-style-type: none"> Electrical wire observed on front of building
E7	<ul style="list-style-type: none"> Roof has been replaced with corrugated iron 	<ul style="list-style-type: none"> Electrical wire observed on front of building Gable looks more recent than others, unconfirmed whether it is ACM Building likely to have previously had ACM roof, gable, gutters, soffits and downpipes
E8	<ul style="list-style-type: none"> Roof has been replaced with corrugated iron 	<ul style="list-style-type: none"> Electrical wire observed on front of building Gable is comprised of timber boards Building likely to have previously had ACM roof, gable, gutters, soffits and downpipes

E9	<ul style="list-style-type: none"> No roof 	<ul style="list-style-type: none"> Electrical wire observed on front of building Building likely to have previously had ACM roof, gable, gutters, soffits and downpipes
E10	<ul style="list-style-type: none"> Roof has been replaced with corrugated iron ACM soffits, gutters (broken), partial down pipe and gable boards 	<ul style="list-style-type: none"> Electrical wire observed on front of building Building likely to have previously had ACM roof
E11	<ul style="list-style-type: none"> No roof 	<ul style="list-style-type: none"> Building likely to have previously had ACM roof, gable, gutters, soffits and downpipes

The Asbestos Regulations will apply when works to restore or demolish the buildings containing asbestos is undertaken. Further assessments of asbestos containing products within the structures and to determine whether asbestos is present in soil are recommended prior to any developments or restorative works, as the results will determine the appropriate controls under the Asbestos Regulations. We understand that a 'refurbishment survey' is to be completed which will assess the presence and condition of asbestos within buildings on site.

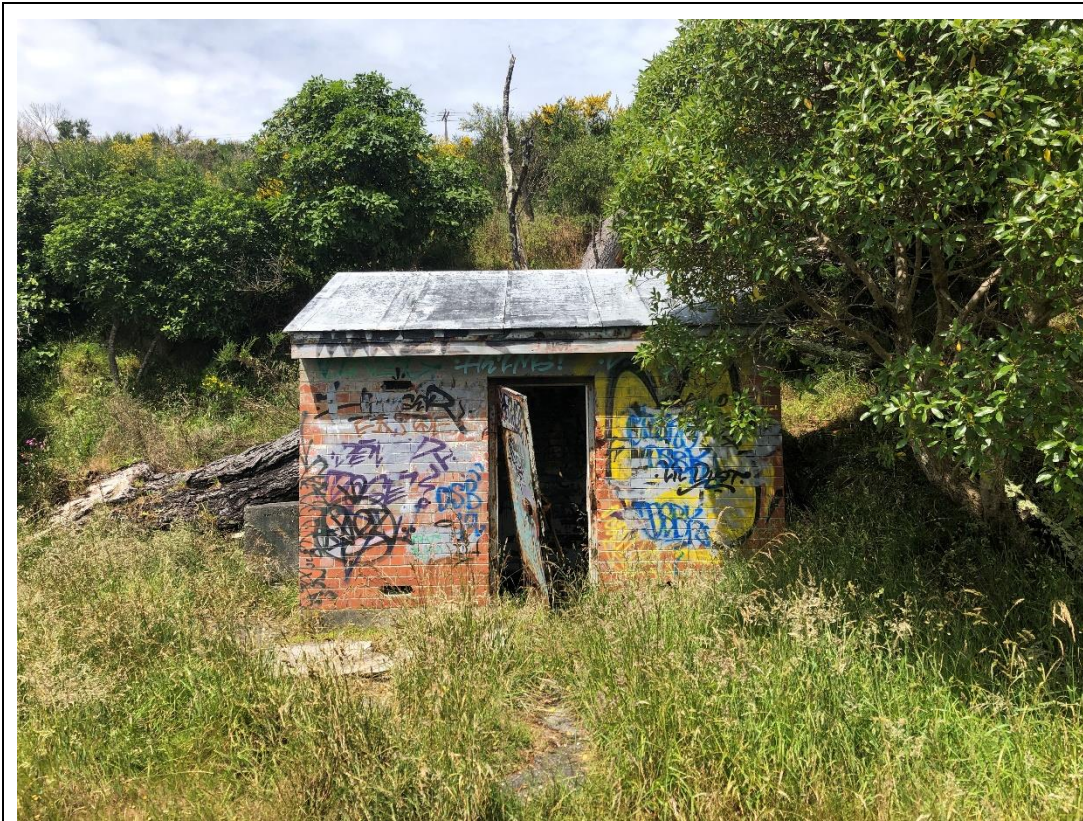
- Old film (assumed to be photographic film) which was highly flammable was reportedly stored in some of the magazine buildings;
- Litter consisting of bottles and cans, as well as a reel of wire and potentially asbestos fragments, was observed in the small munitions store building (see Photographs 18 and 19). The building is located south of Magazine E11, on the accessway up to the Mt Crawford Prison;

Photograph 18 Appendix B.1: Small munitions store building

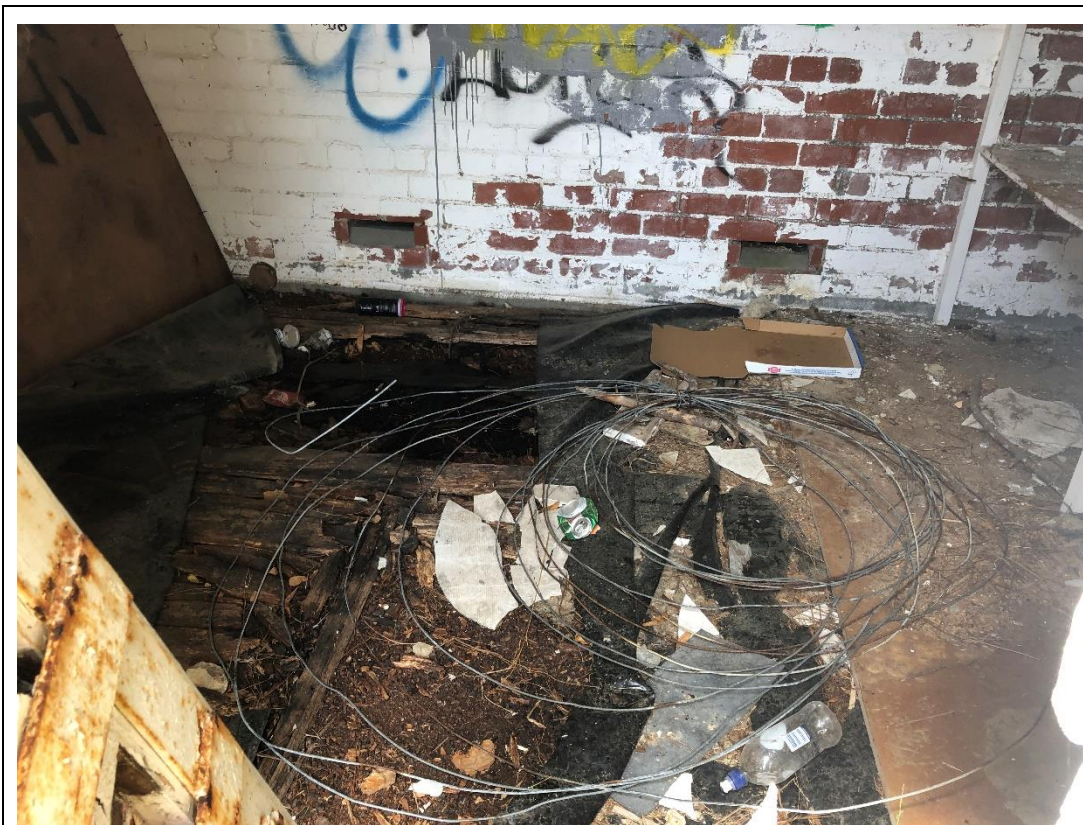
Photograph 19 Appendix B.1: Building materials within small munitions store building

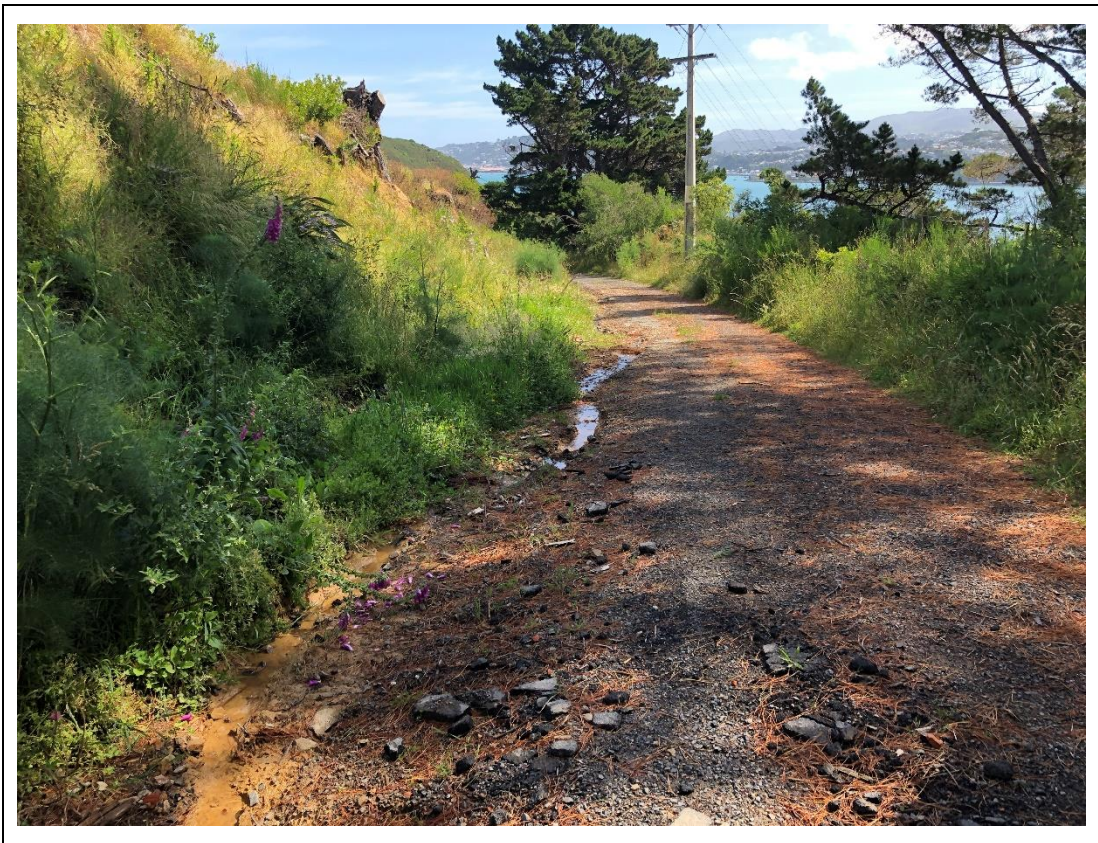
Photograph 20 Appendix B.1: looking south towards Shelly Bay Road. Note: brick fragments in unpaved section

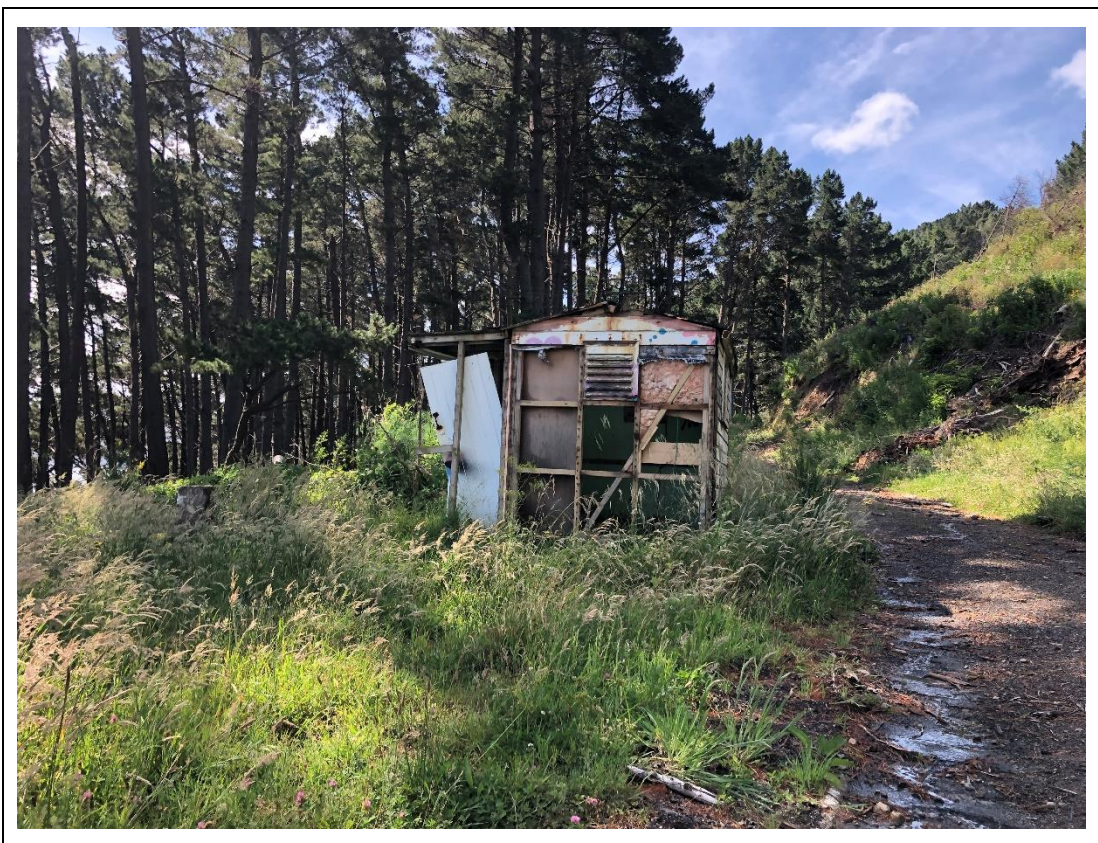
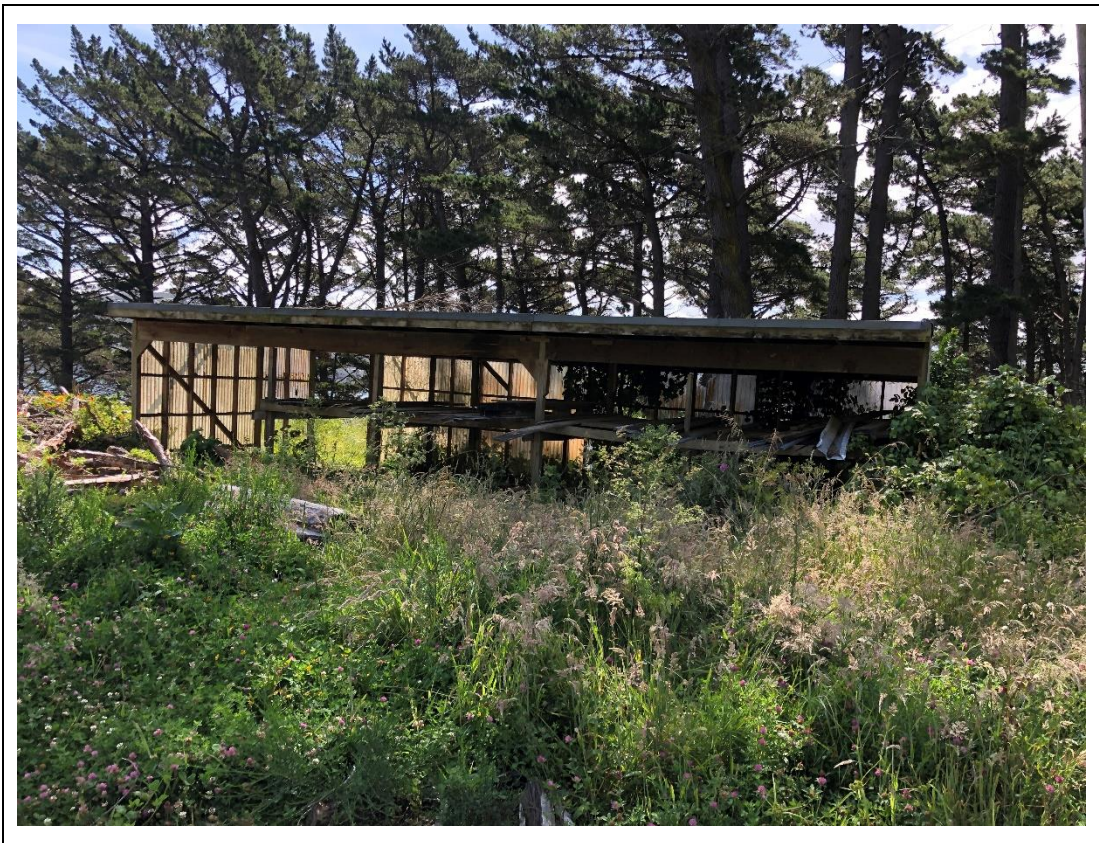
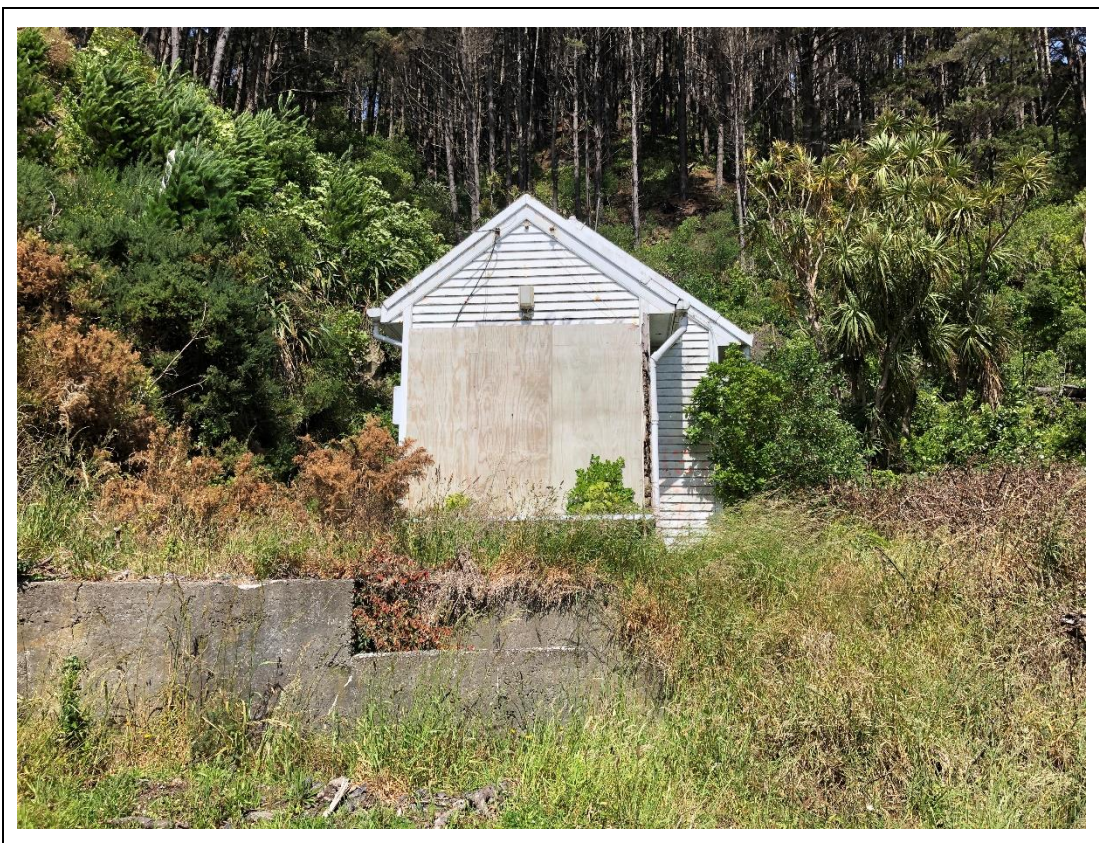
- The hut and the former timber store were observed across the accessway from Magazine E5 and the guardhouse was observed just before the Shelly Bay Road entrance, the buildings were vacant and in a deteriorating condition (Photographs 21-23);

Guardhouse	<ul style="list-style-type: none"> ACM roof 	<ul style="list-style-type: none"> Building boarded up, interior was not observed, exterior appeared to be constructed of timber

Photograph 21 Appendix B.1: Small hut across accessway from Magazine E5

Photograph 22 Appendix B.1: Woodshed across accessway from Magazine E5

Photograph 23 Appendix B.1: Guardhouse near to the entrance from Shelly Bay Road

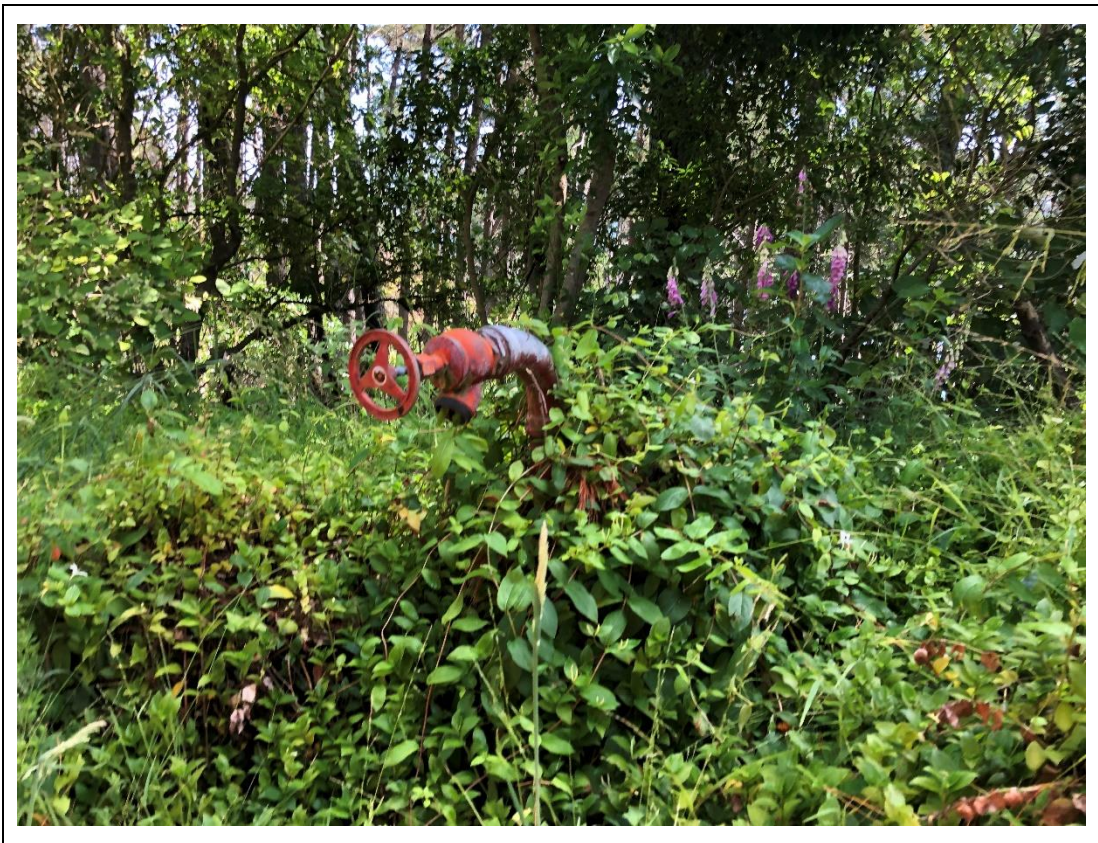
- Valves (hydrants) from the former fire-fighting system were seen along the side of the accessway from Shelly Bay Road, with pipework also observed on some magazine buildings (see Photographs 9 and 24). The water reservoir which fed the system was not observed during the walkover;

Photograph 24 Appendix B.1: Remnant valve from the former fire suppression system, visible from accessway across from Magazine E8

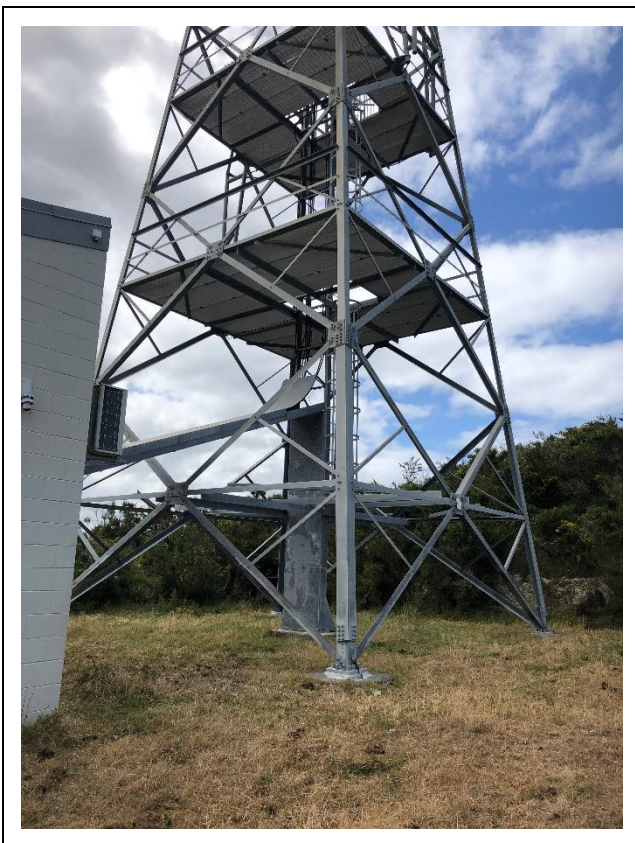
- A telecommunications transmission tower (owned by Chorus New Zealand Limited) and small building are located within the small property parcel that is within the site boundary near to the Mt Crawford Prison (see Photograph 25 and 26);

Photograph 25 Appendix B.1: Transmission tower near Mt Crawford Prison
