Ground Contamination Desktop Assessment

Te Motu Kairangi

Prepared for
Land Information New Zealand

Prepared by
Tonkin & Taylor Ltd

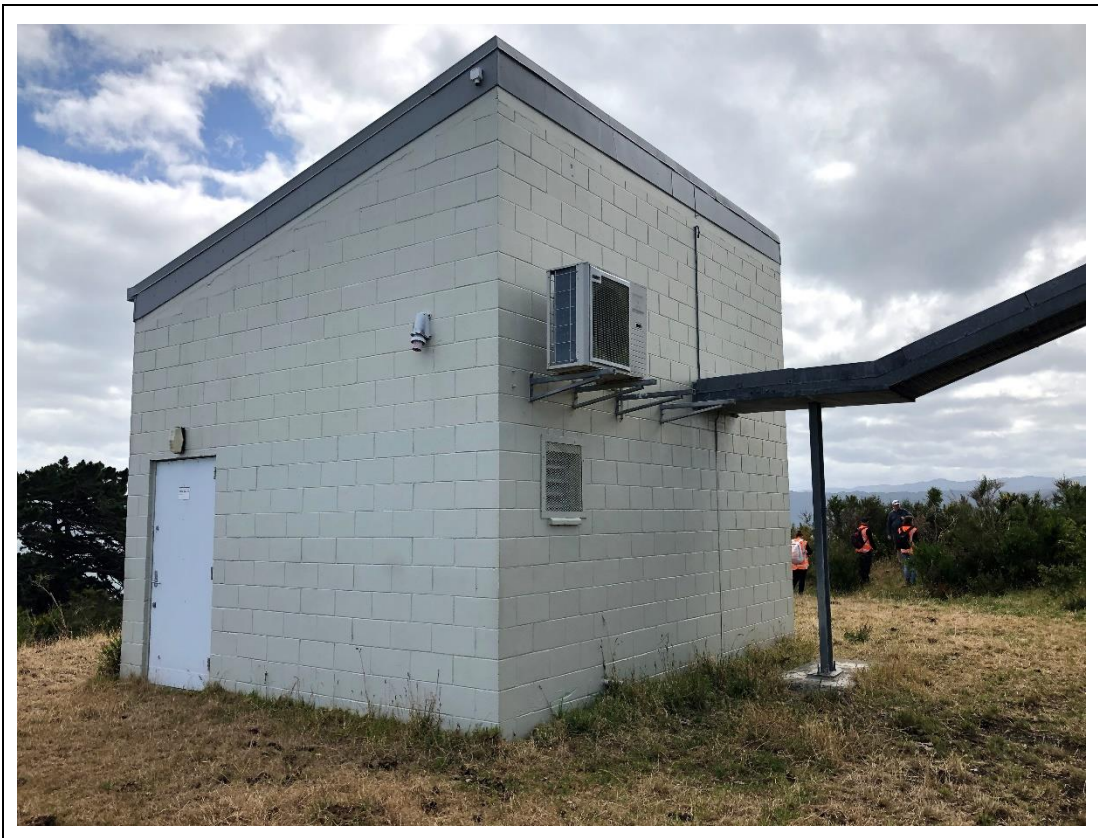
- A telecommunications transmission tower (owned by Chorus New Zealand Limited) and small building are located within the small property parcel that is within the site boundary near to the Mt Crawford Prison (see Photograph 25 and 26);

Photograph 26 Appendix B.1: Building connected to transmission tower near Mt Crawford Prison

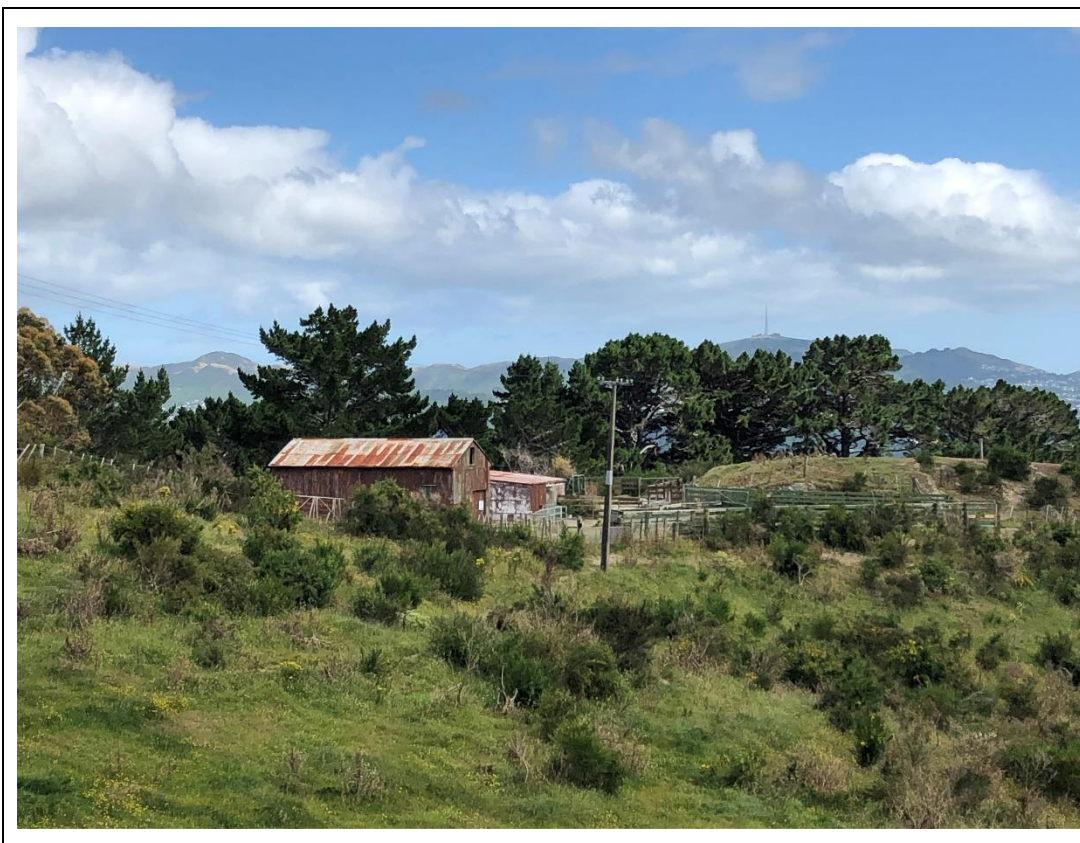
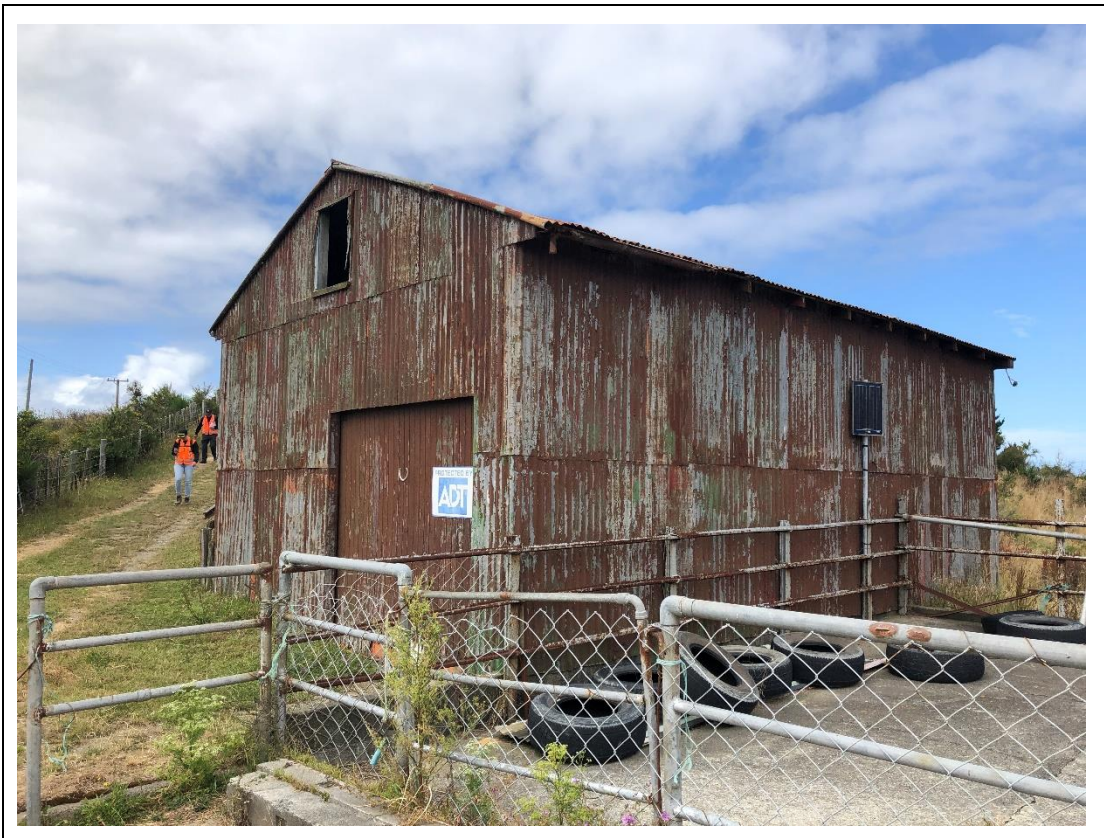
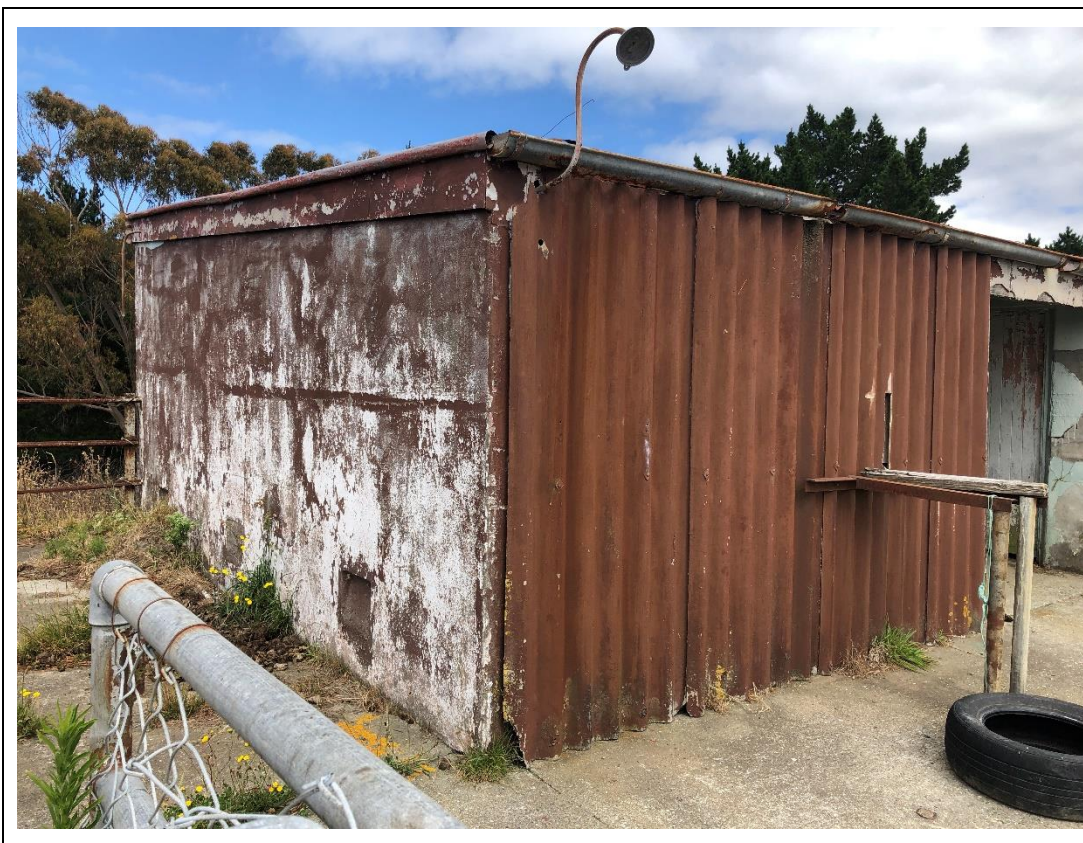
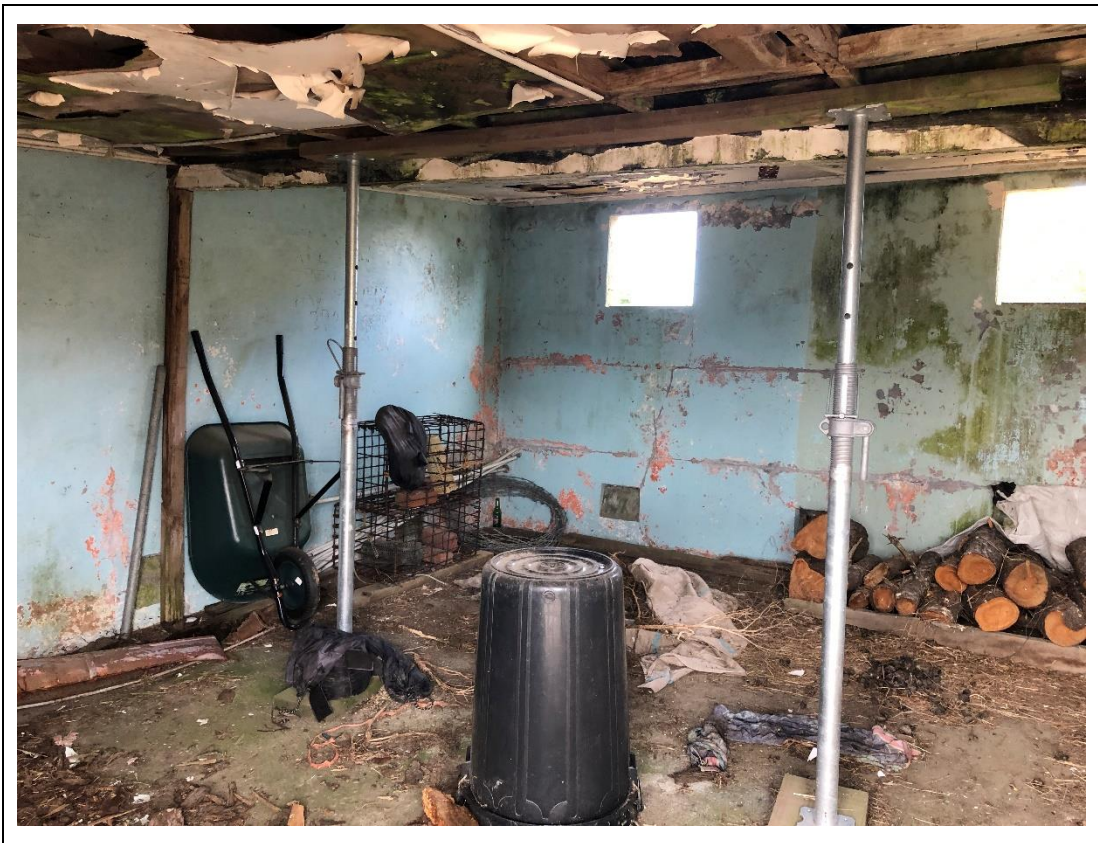
- The farm buildings on the southern portion of the site are in a deteriorating condition with paint peeling from the internal walls and ceilings. The smaller of the buildings has asbestos roofing sheets (Super Six) as cladding on the eastern external wall - the sheets were painted and in some areas were damaged. The building also had an asbestos fascia around all visible sides (see Photographs 27-30);

Large Farm Building	<ul style="list-style-type: none"> Unconfirmed 	<ul style="list-style-type: none"> Interior of building was not observed
Small Farm Building	<ul style="list-style-type: none"> ACM fascia around building Super-Six sheeting on external wall towards yard, some sections damaged with fragments missing 	
Small Munitions Store	<ul style="list-style-type: none"> Potentially ACM fragments observed in building rubble within building 	
Hut	<ul style="list-style-type: none"> Unconfirmed 	<ul style="list-style-type: none"> Roof looks to be corrugated iron, although due to the age of the building it is possible that asbestos has been, or is, present in building materials
Timber store	<ul style="list-style-type: none"> Unconfirmed 	<ul style="list-style-type: none"> Corrugated plastic is visible on the western and southern external walls, panels are noted on northern wall (composition unconfirmed, possibly plywood or asbestos sheeting) Roof composition unknown

Photograph 27 Appendix B.1: Farm buildings and yards viewed from the South

Photograph 28 Appendix B.1: Large farm building constructed of corrugated iron

Photograph 29 Appendix B.1: Smaller farm building with Super-Six sheets on external wall and ACM sheeting on fascia

Photograph 30 Appendix B.1: Within smaller farm building. Note: paint peeling from ceilings and walls.

An assessment and record of the asbestos containing building products is recommended. We understand that a 'refurbishment survey' is to be completed which will assess the presence and condition of asbestos within buildings on site. An intrusive investigation of the soils surrounding the buildings containing ACM products, and in locations where asbestos fragments have been found, is recommended to assist in determining appropriate asbestos related controls prior to any disturbance/restoration works.

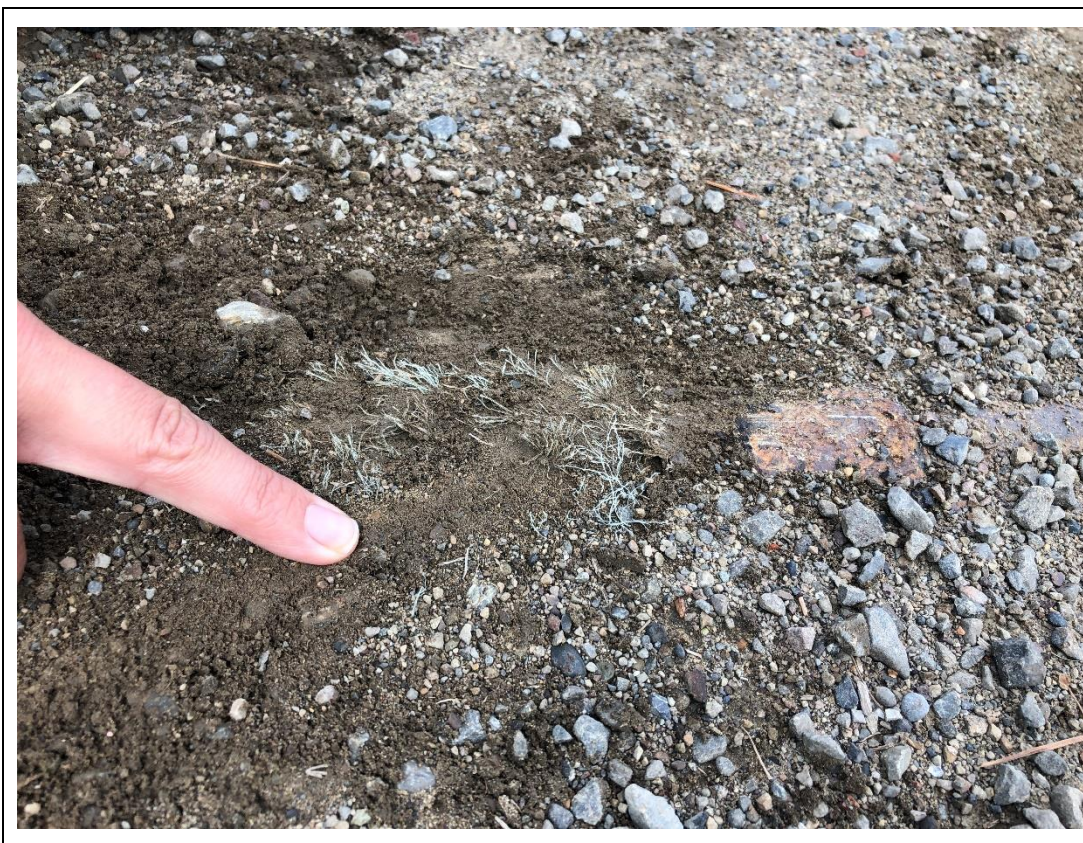
- A steel pipe was observed at surface level in the gravels of the yard adjacent to the farm buildings. The pipe ran from the middle of the western side of the yard and turned to the

Photograph 31 Appendix B.1: Pipe with synthetic twine at join observed in farm yard

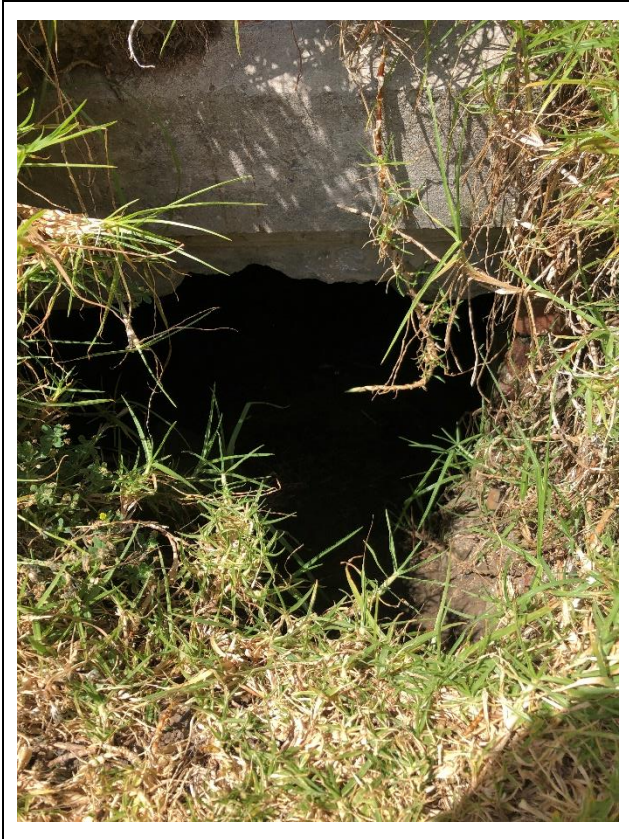
- The gun from Fort Gordon was reportedly located and removed from the area to the south of its former location in 2013;
- On the northern side of the point to the north of Shelly Bay, and down the slope from Fort Ballance, within a carparking area off Massey Road there are two openings in the side of the bank leading to a former ammunition store. The visible portion of the store appeared to be approximately 2 m deep, 2 m wide and 3-4 m in height, there appeared to be an entranceway at the back of the room extending to the west (see Photographs 32 and 33);

Photograph 32 Appendix B.1: Opening in carparking area off Massey Road leading to munitions store

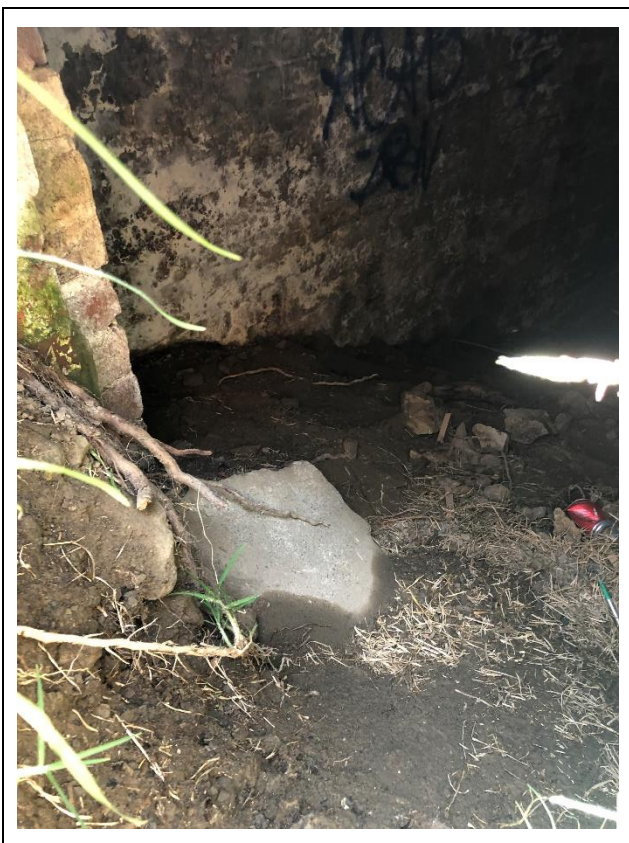
Photograph 33 Appendix B.1: Within the former munitions store viewed from opening

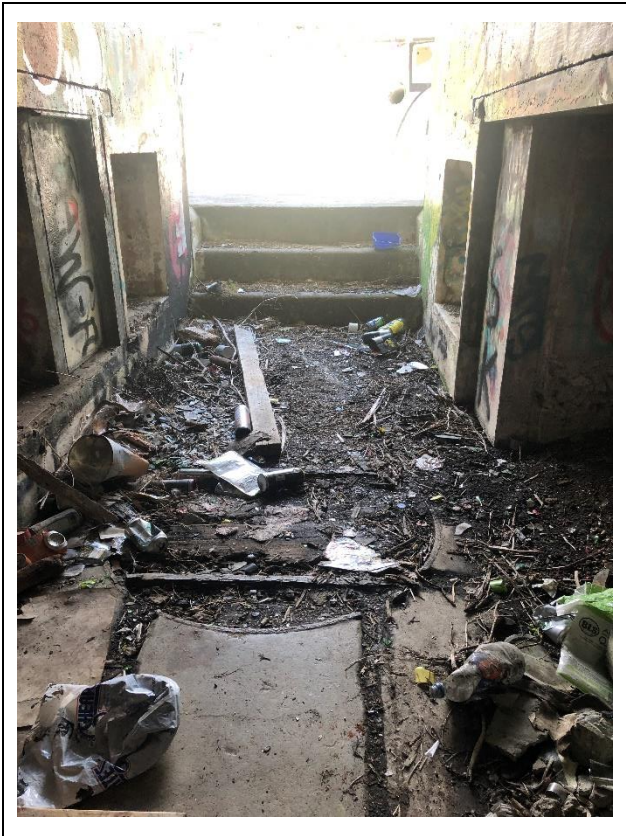
- The remaining structures at Fort Ballance are constructed of concrete and are largely covered with spray-painted graffiti. There was a significant amount of litter including spray-paint cans and alcohol bottles/cans scattered throughout the observed areas of the former magazines (see Photograph 34). An asbestos fragment was found in the vicinity of Fort Ballance, by the client during a previous site walkover;

Photograph 34 Appendix B.1: Example of litter seen within Fort Ballance structures

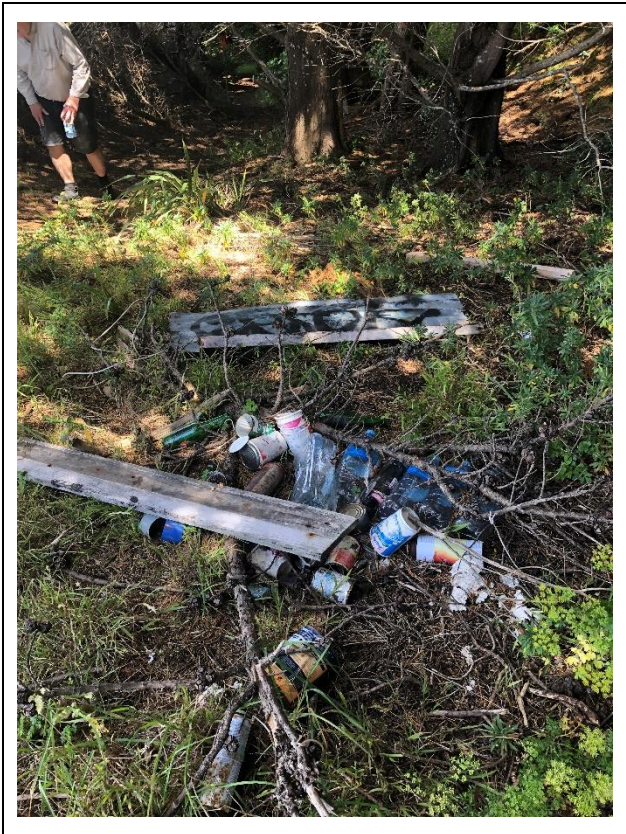
- A pile of litter, containing glass bottles, food cans, spray paint cans and building materials (timber, corrugated iron and wire) was observed slightly down slope of Fort Ballance (see Photograph 35);

Photograph 35 Appendix B.1: Litter observed East of Fort Ballance

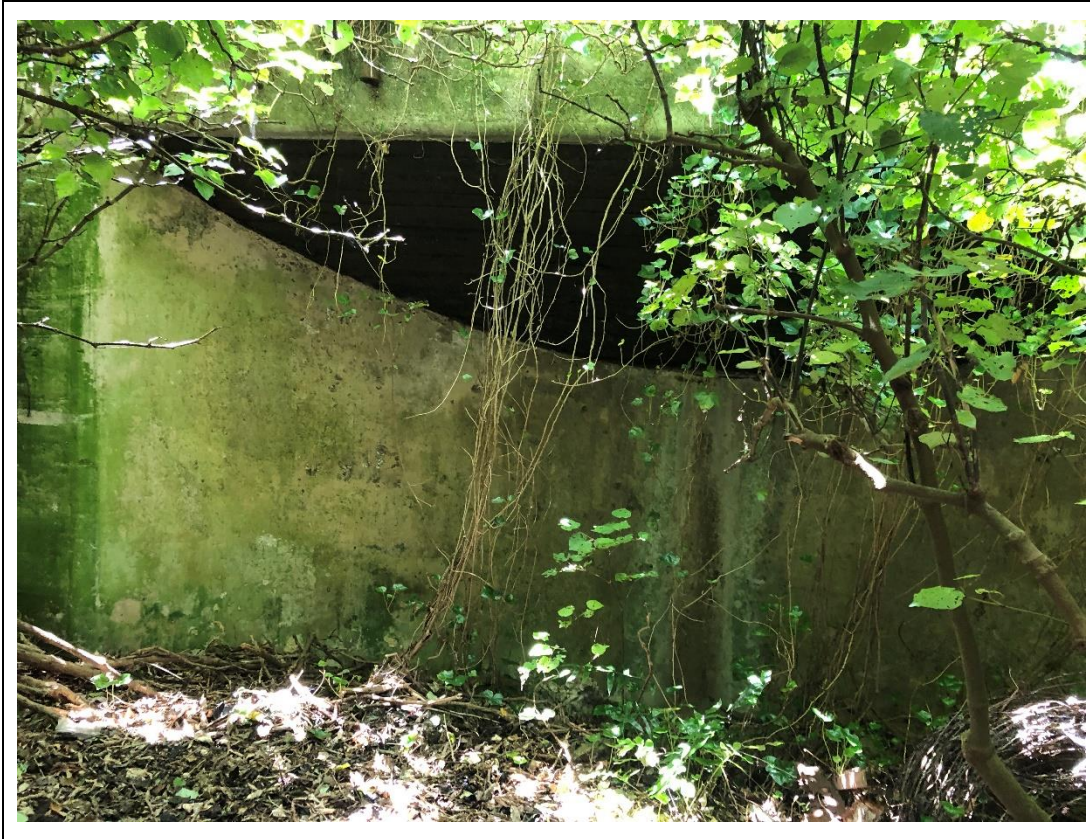
- Remnants of the see-saw search light were observed to be predominantly constructed of concrete and railway irons. During operation, the light was located in the semi-circular indentation within the structure and shone towards a large mirror (no longer remaining), it could then be directed towards the shore. A large reel of corroded barbed wire (according to one of the archaeologists the wire potentially dates back to WWII) was seen in the area (see photograph 36); and

Photograph 36 Appendix B.1: Remaining structure of the 'see-saw' search light constructed of concrete and railway iron. See reel of barbed wire in bottom right corner of image
