# Former Tokanui Hospital

## Preliminary Site Investigation

Toitū Te Whenua - Land Information New Zealand

12 May 2022

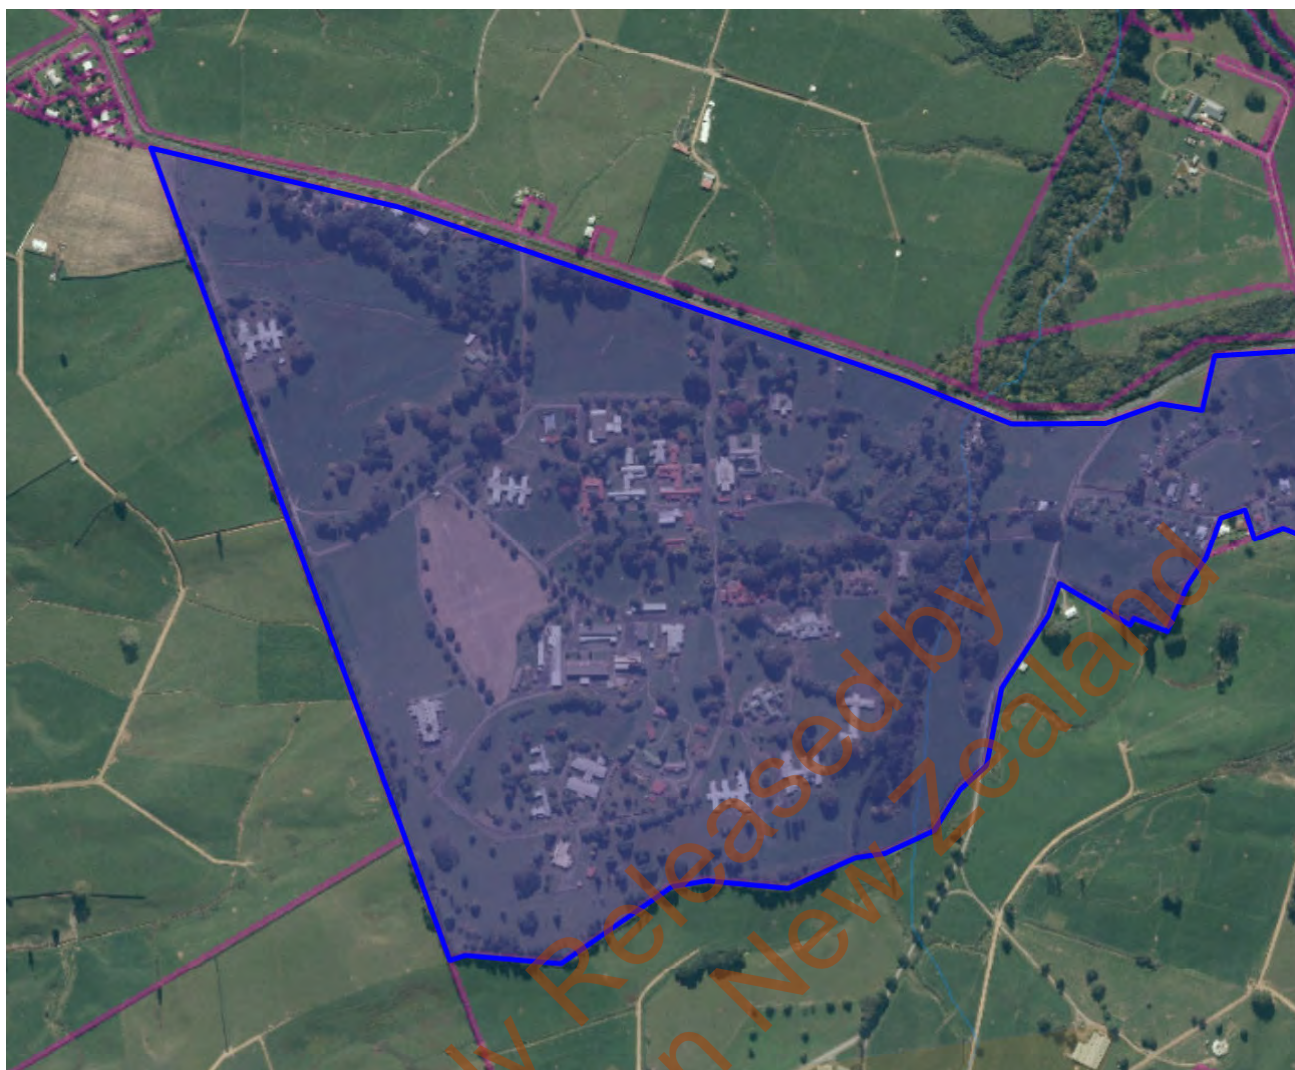
The area shaded blue above appears on the Land Use Information Register as LUI03403 with a classification of 'Verified HAIL – limited sampling' due to past land HAIL activities: **A14**. Pharmaceutical manufacture; **A17**. Storage tanks or drums for fuel, chemical or liquid waste; **F4**. Motor vehicle workshop; **F7**. Service Station; and **G3**. Landfill sites associated with Tokanui Hospital.
