FORMER TOKANUI HOSPITAL  
DEMOLITION AND REMEDIATION  
HORIZONTAL INFRASTRUCTURE ASSESSMENT REPORT

Project No.	33205	Approved for Issue	
Version No.	3	Name	Sean Finnigan
Status	Final	Signature	 
Authors	D Khoo / S Finnigan		
Reviewer	S Finnigan	Date	09/11/2023

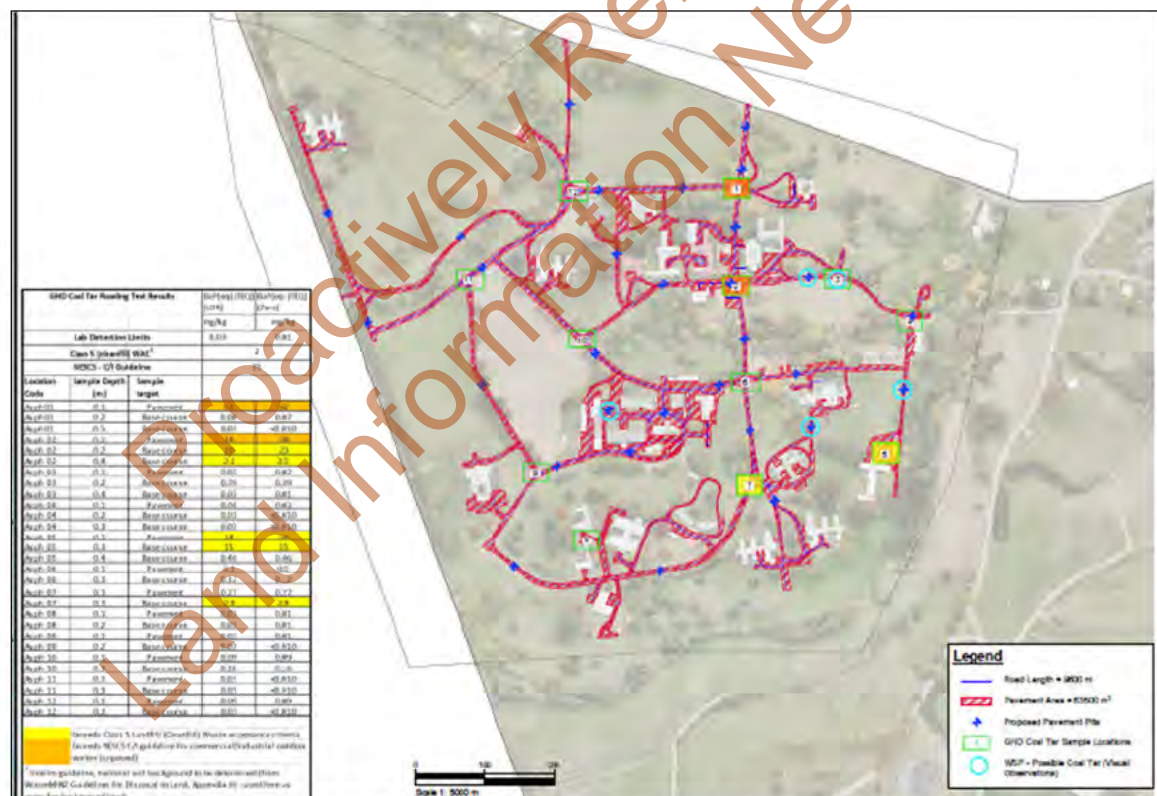
Figure 3 shows that the areas with elevated BAP(eq) concentrations are generally located along the main entrance road, running north to south (except for location 6) and at one location around the eastern road. During their pavement pit investigation, WSP also noted “possible coal tar” at five locations as highlighted in the pale blue circles below.

Figure 3: Visual Observations – Confirmed or Potential Coal Tar (refer drawing 33205/1701 for higher resolution image)

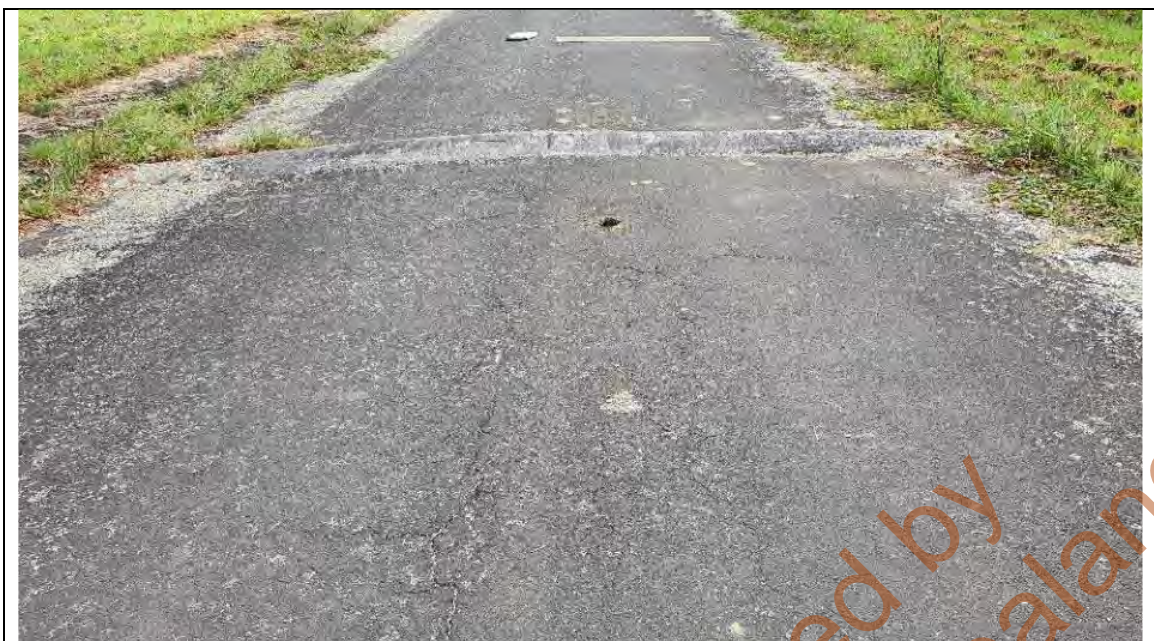
**Figure 9: Typical speed hump**

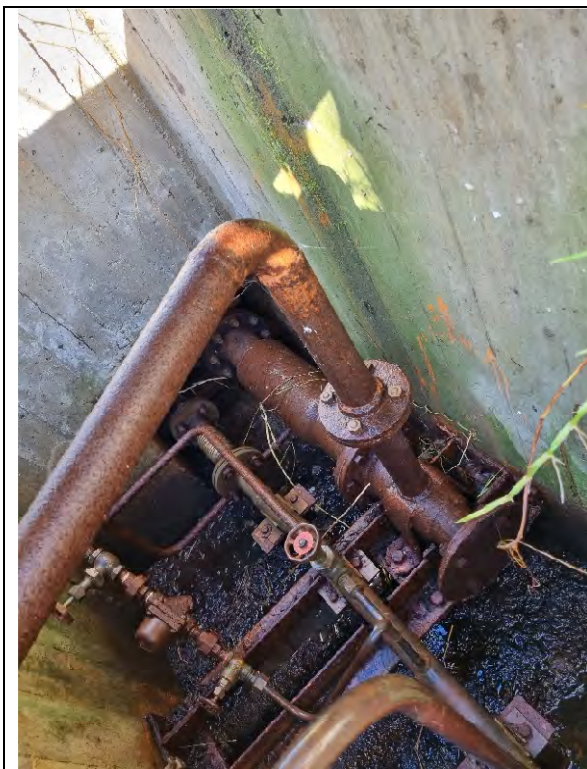
- It was expected there might be some lagging around the steam pipes but there were no signs of any lagging in all the access chambers inspected. It was not possible to check for lagging in the ducting between chambers.

Chamber – LID K01 located at B55 Ward K

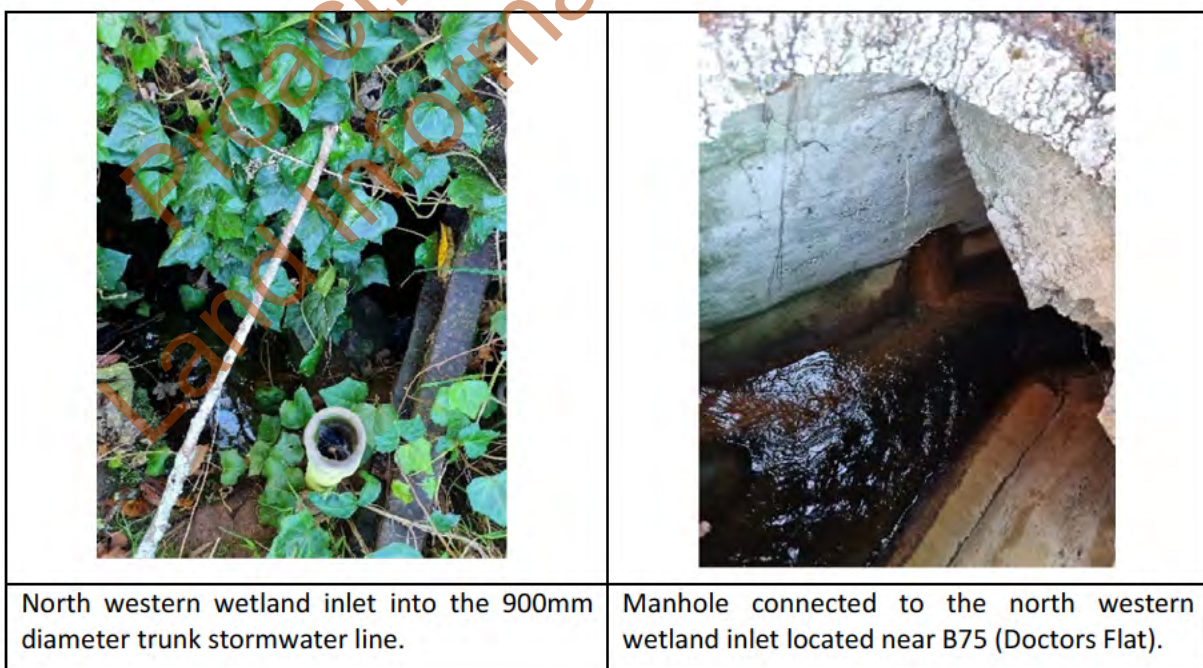
**Figure 27: Stormwater Trunk System Photos**

<p>Grated lid at manhole L.O where the trunk sewer forms a junction towards the east.</p>	<p>Benching and running water inside manhole L.O where the trunk 900mm diameter stormwater pipes form a junction.</p>

<p>Trunk main grated inlet from eastern detention area to the stream (flooded possibly from a blockage or backwater).</p>	<p>View of the stream which the outlet discharges to (standing on the road looking down).</p>

The system's eastern flood detention area comprises a flooded grated inlet, possibly from a pipe blockage or backwater effects. It could be seen that the grated inlet connects into a 900mm pipe which bends down into the ground which indicates that the 900mm trunk main runs under the grated inlet, which is consistent with the archived design drawing for this area.

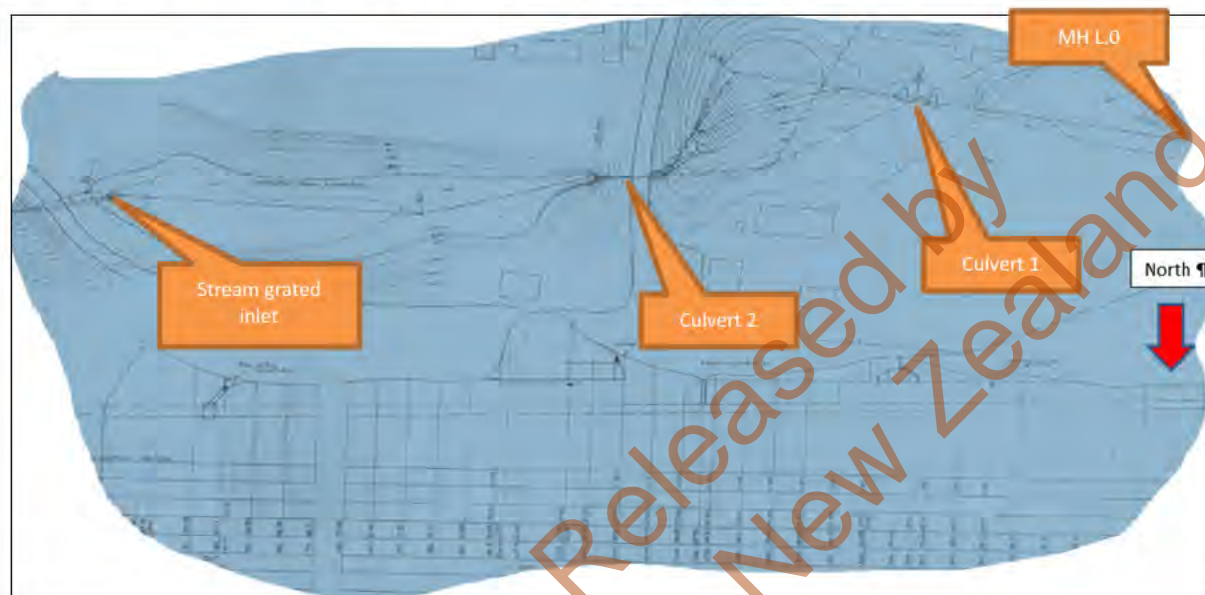
**Figure 29: Snip of the archived stormwater long section drawing**

As shown on Figure 29, the CCTV and our site investigation findings were different to the archived drawing which has a long section detail of the trunk stormwater main. The archived drawings shows that the flood detention areas in the middle of the site (at manhole L.0 location) and at the trunk main

stream outlet (see Figure 27 photos) were connected together via two culverts (labelled culvert 1 and 2 in the figure below). These two culverts were not found during our site investigation and are unlikely to be there, particularly culvert 1, the location of which is now an open field.

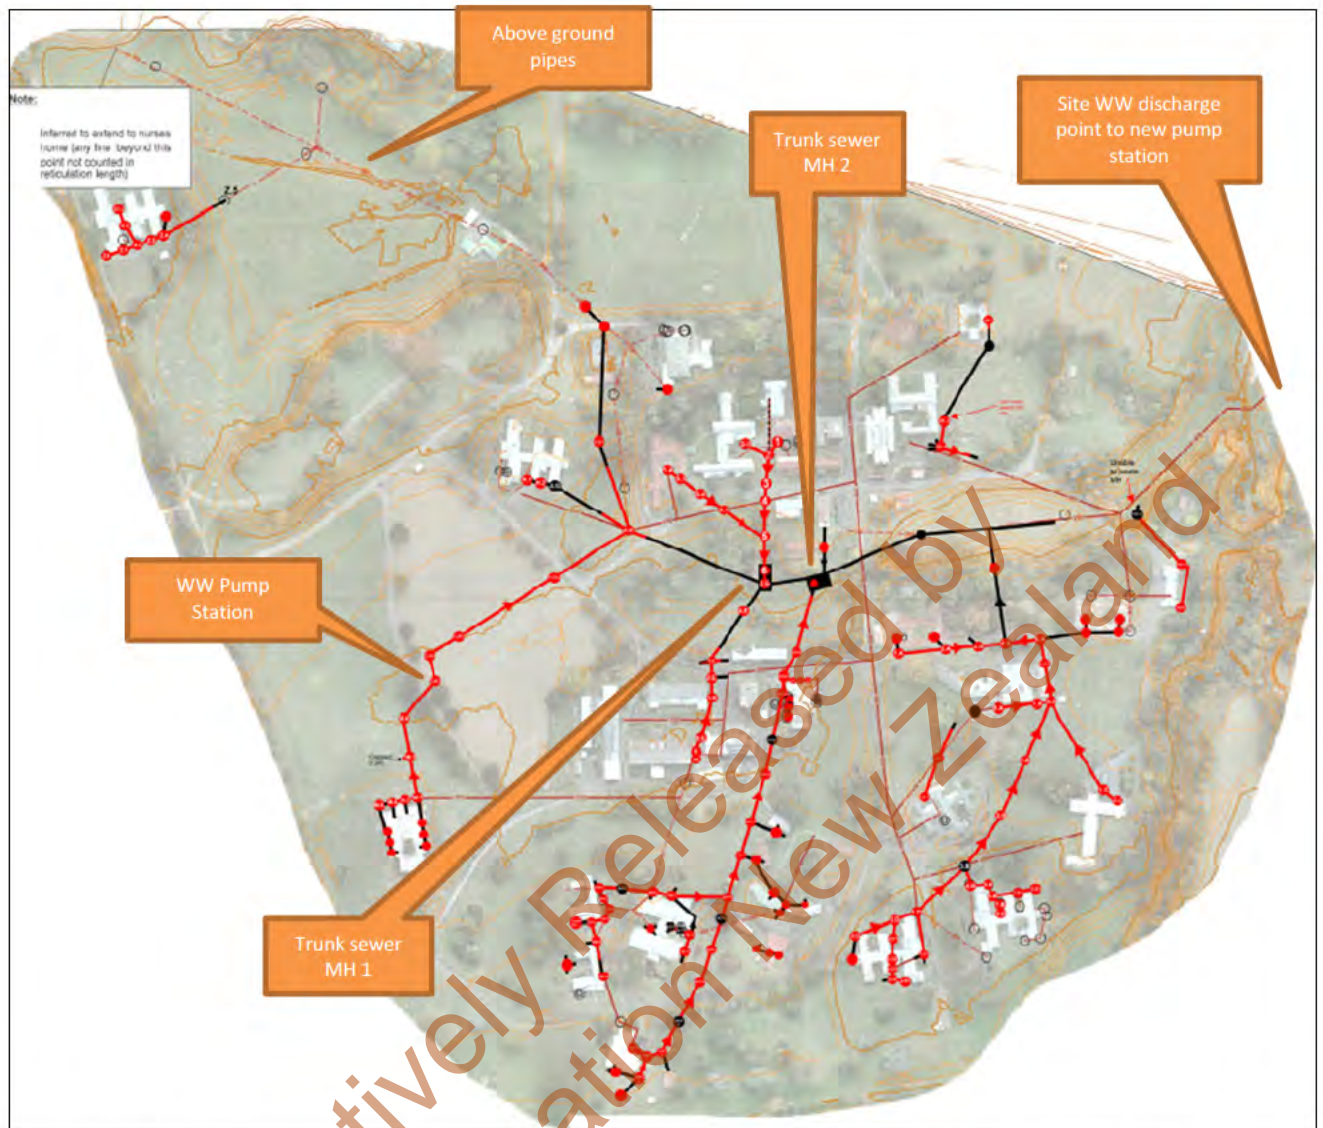
**Figure 32: CCTV as-built map of the existing wastewater on the subject site (black = show flooded MHs and pipes)**

Figure 32 displays the CCTV as-built map for the existing wastewater found on the site.

The wastewater trunk sewer traversing through the middle of the site was investigated on site (labelled as MH 1 and MH 2 above) and was found to be very deep (approximately 4m). MH 1 was found to be a multi chamber with a lateral connection drop into the deep sewer pit as shown in Figure 33 below. MH 2 was unable to be assessed as the pit was filled with water.

Table 15 provides a summary of the wastewater assets inventory and condition assessment. Most of the wastewater pipes were found to be in a poor or very poor condition with cracking, joint defects both laterally and longitudinally with evidence of infiltration ingress into the system.

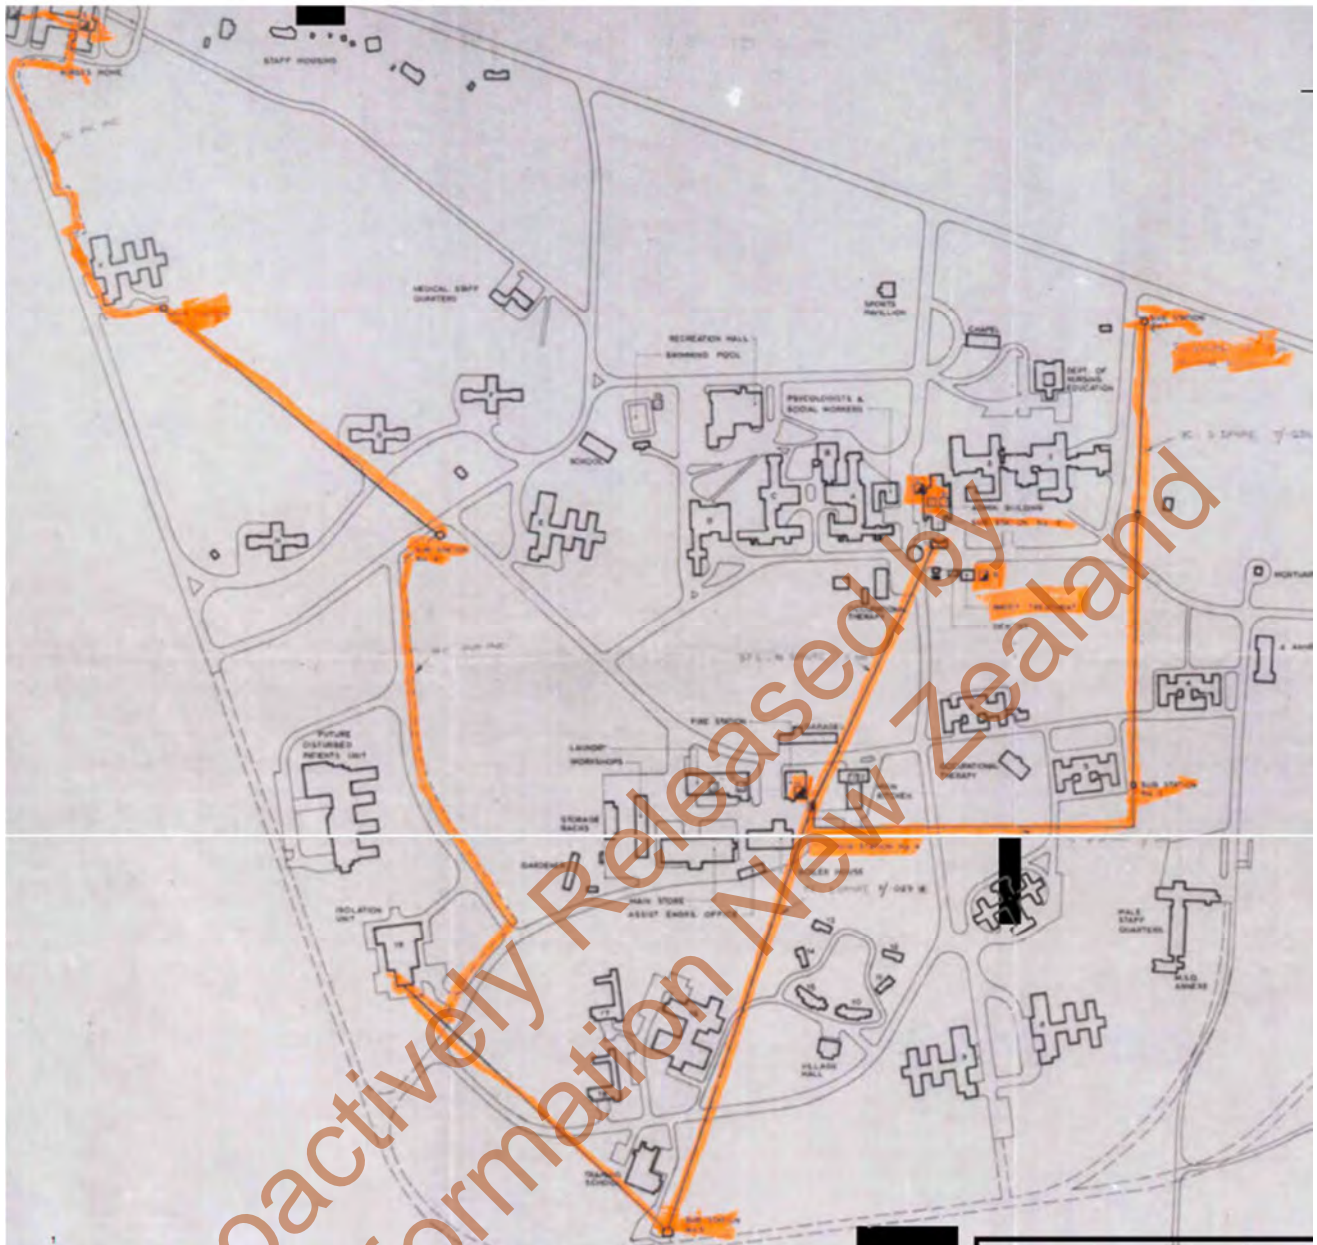
**Figure 35: Power cable as built plan**

However, the archived plan BD234.41 showed a significantly different power supply layout, linking all of the eight substations on the site. This layout is reproduced below in Figure 35, with orange highlighting added for emphasis.

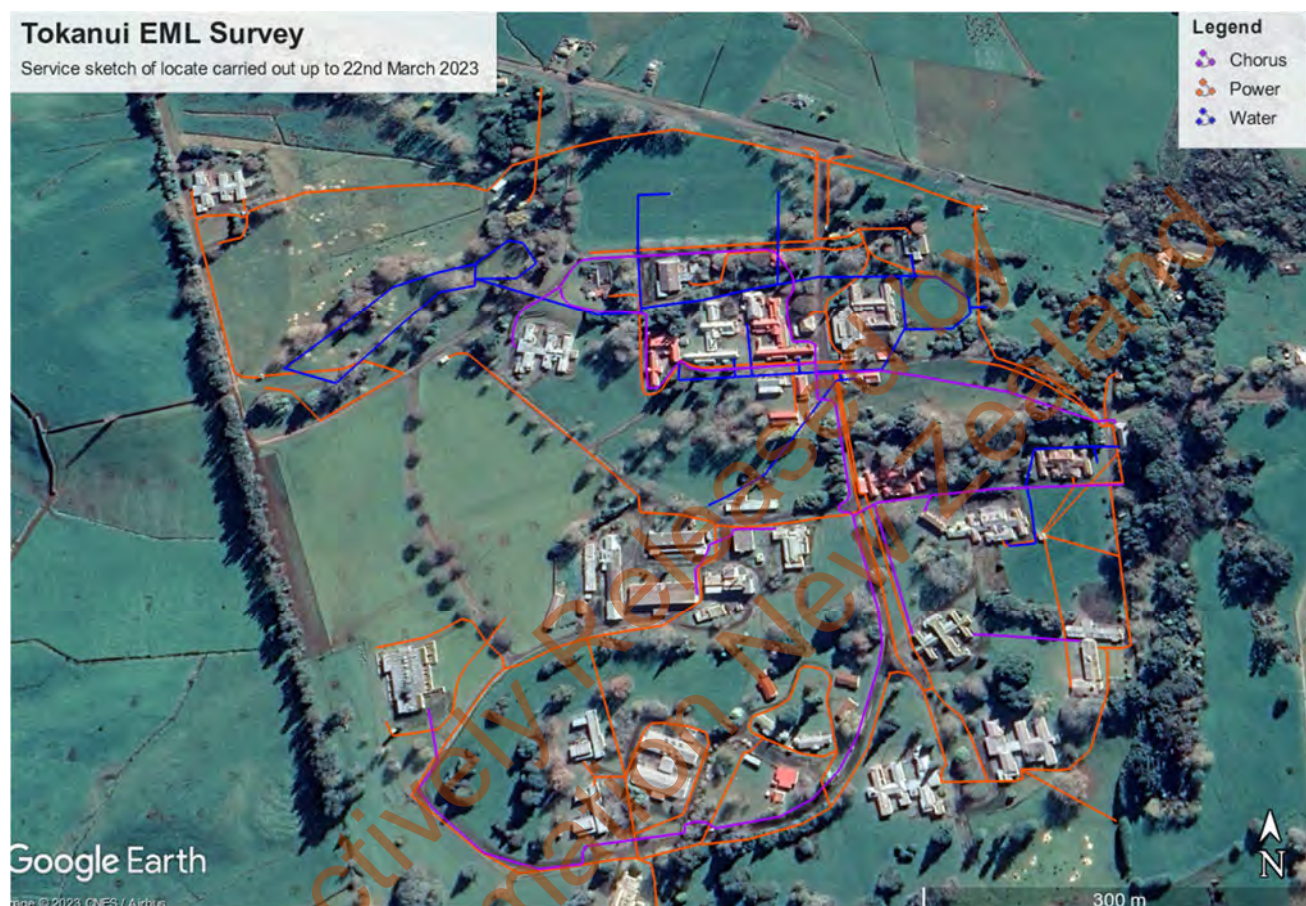
**Figure 36: EML Service scan sketch**

EML service scans found underground power and comms throughout the site quite successfully. Further to this, the topographical survey picked up all existing light poles on the site along with the power poles and comms pits. Overhead power lines were also present and recorded. Figure 36 below displays the service scanning map showing the water, power and telecom (Chorus) lines found.

Civtec also conducted hydroexcavation on the power and comms at 37 locations on site to check for any asbestos cement (AC) ducting in Oct/Nov 2023. It was found that most of the power and comms cables were direct buried with occasional power cables being ducted in steel pipes and comms in 100mm PVC ducts. No asbestos cement ducting was found for the existing power and comms. Refer to Appendix E for the associated Civtec documentation.

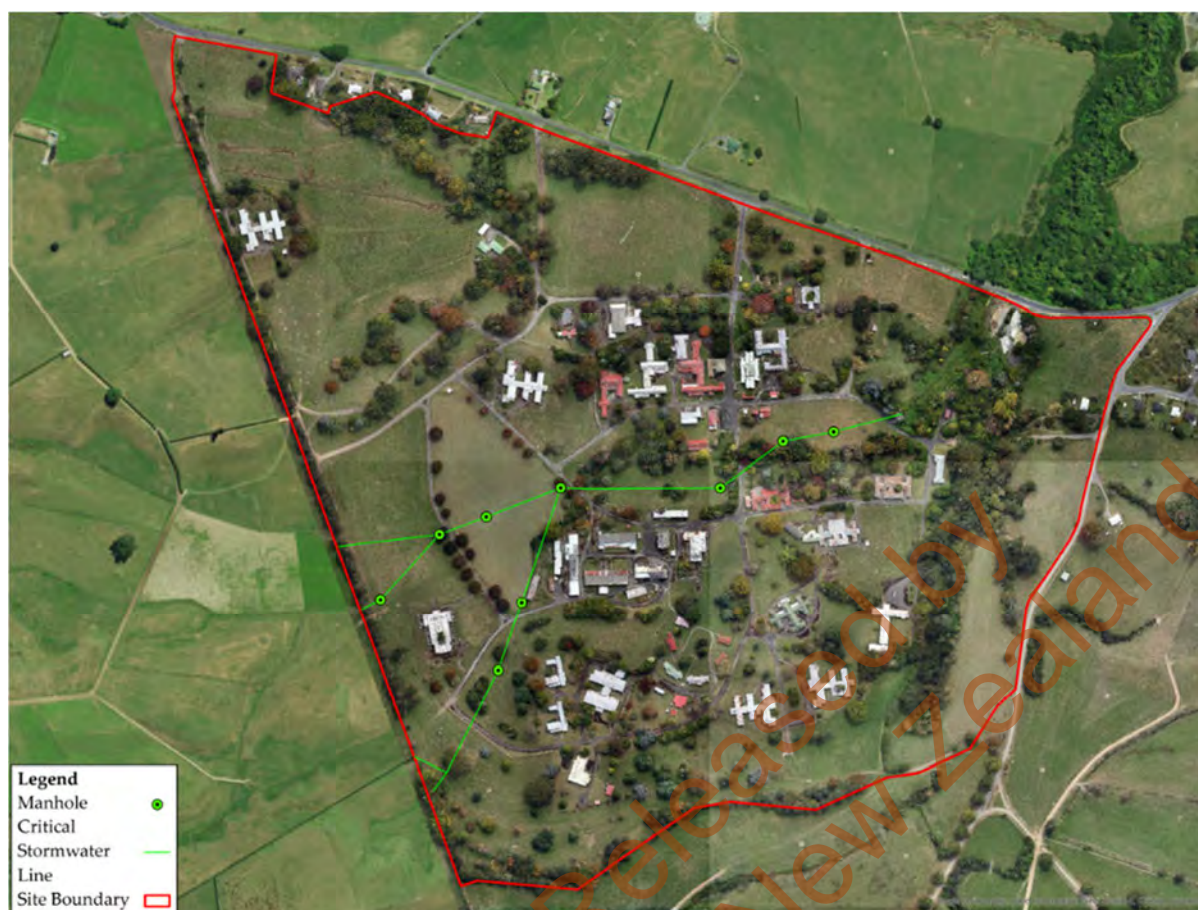
**Figure 42: Tokanui Hospital Site – Current Trunk Stormwater Reticulation conveying upgradient runoff through Site**

Investigation of the Site's stormwater system has found that runoff from upgradient farmland to the west of the site has been piped through the site as shown in Figure 42 below, meaning these historical watercourses have been infilled and also realigned as the stormwater pipe system alignment differs from the historical swamp/watercourse alignment.

CCTV investigation has shown that these stormwater pipes are in relatively moderate to poor condition. Under the common law right of 'natural servitude', a duty exists for a lower landowner to accept the natural flow of water from a higher landowner. This means that as the properties to the west are higher than the Tokanui site, they are entitled to allow water from their property to flow onto the Tokanui site and the Site landowner will not be able to stop the water flow or claim nuisance against them (unless the runoff wasn't caused by the ordinary use of their land). This means that it would be sensible to ensure that there is infrastructure on the Tokanui site to manage that water flow. This means that the existing stormwater pipe "trunk main" drainage system will either need to be repaired, replaced or removed and a stream reinstated along its current alignment or the historic alignment (the latter practice is known as "stream daylighting").
