Former Tokanui Hospital

Preliminary Site Investigation

Toitū Te Whenua - Land Information New Zealand

12 May 2022

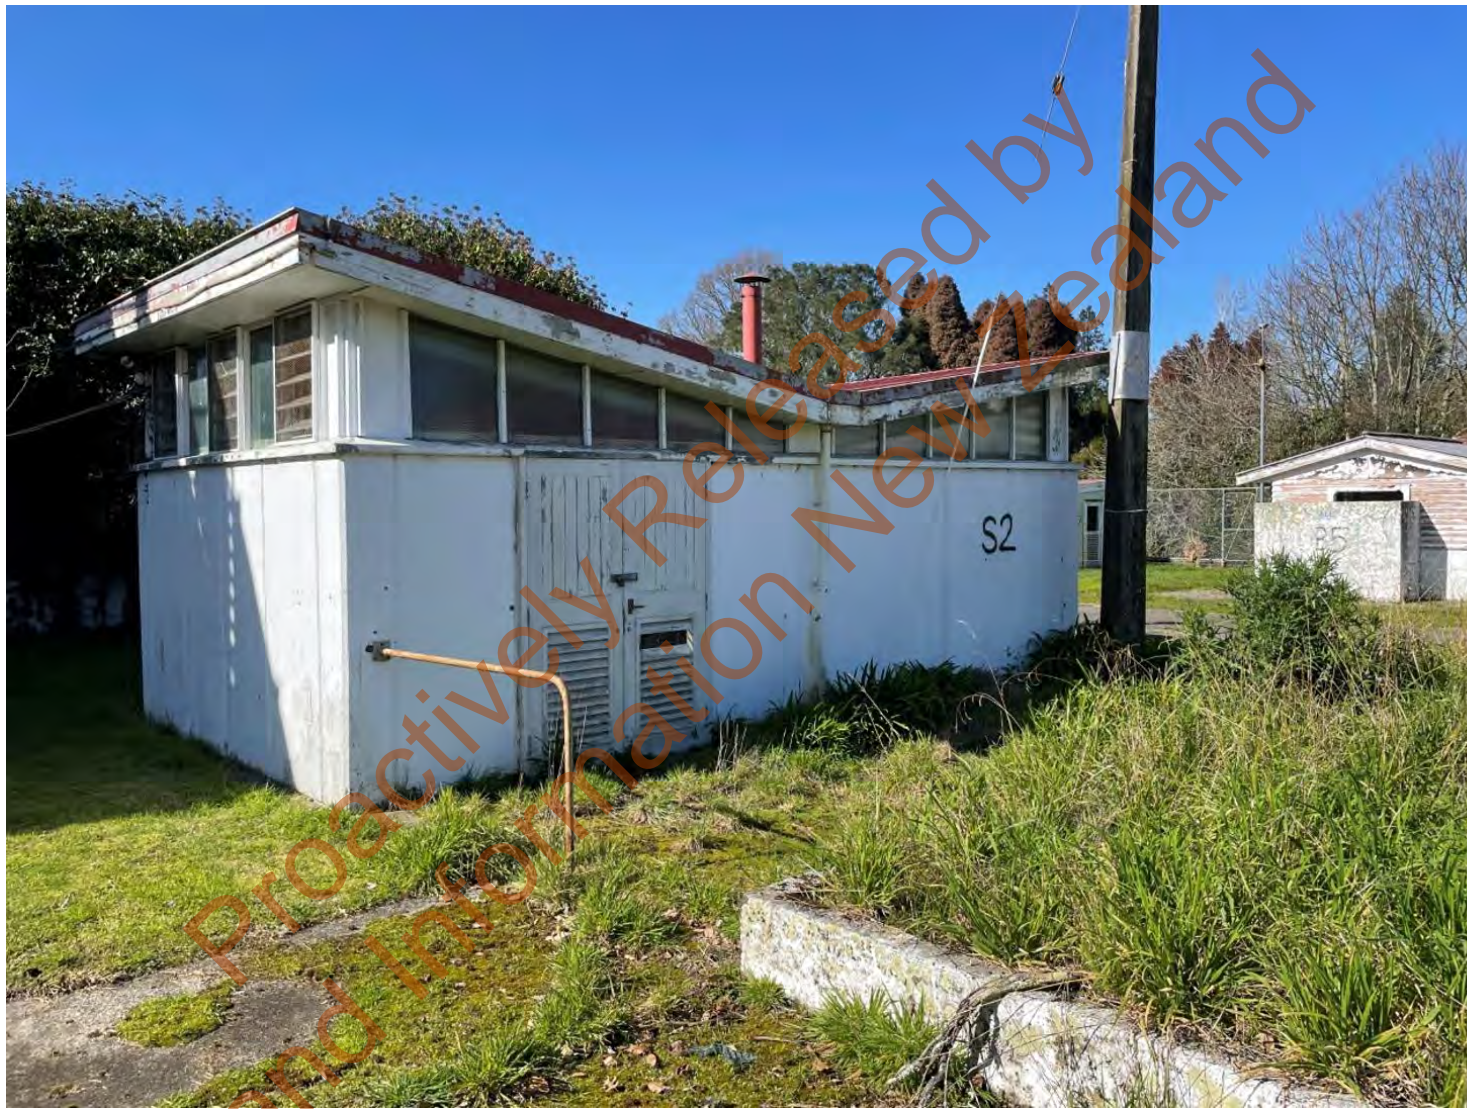
Photo 12:
S2
Substation 2
11/08/2022

S2: Substation 2	Chicken wire is placed across the door. Equipment, including transformers can be observed inside.
Gully to the south of B8	The gully has a culvert which enters from the eastern side. Appears to be a surface water collection area. This location was sampled by AECOM as part of their site investigation.
B59: Gardeners Shed	Contains old, empty Intermediate Bulk Containers (IBCs) and drums. Currently used by the farmer for storage. An old concrete pad near the door with weed spray storage signage on it on the eastern side.
B61: Shed 11	A small square building in the commercial area of the Site. It has no windows and has vents on the outside. Initially not accessible at time of initial site inspection, but subsequent access has shown it contains a small above ground tank (potentially an air compressor) and associated pipework. Its exact use is unknown. The current utility service plans for the area do not show a piped connection to this building. Some minor oil staining on the internal floor was evident.

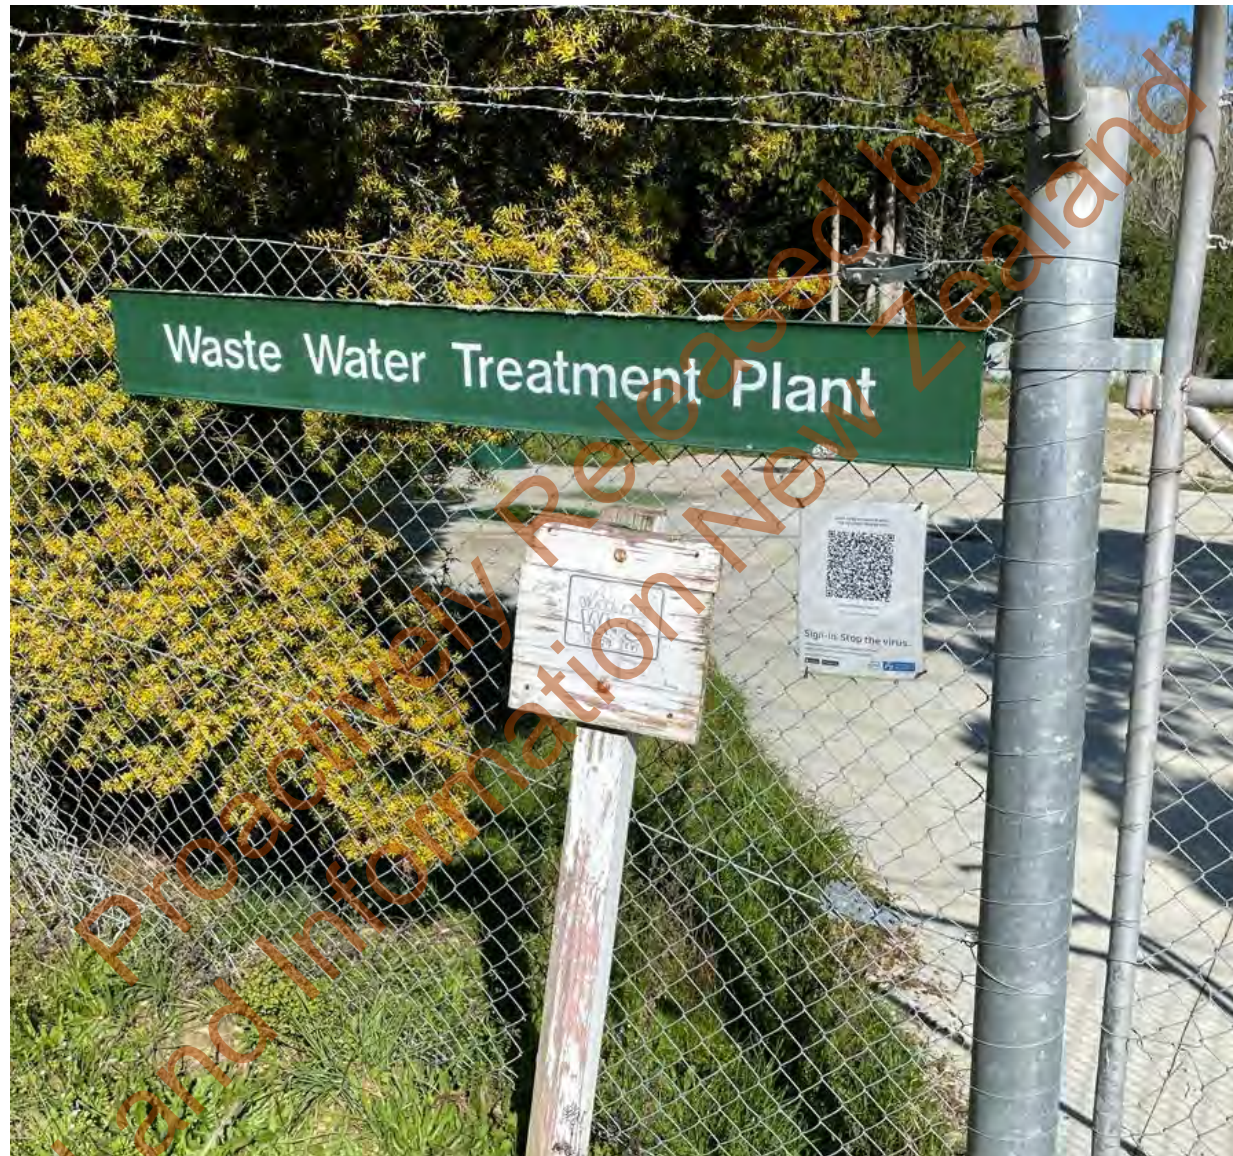
Photo 60:
WWTP
11/08/2022

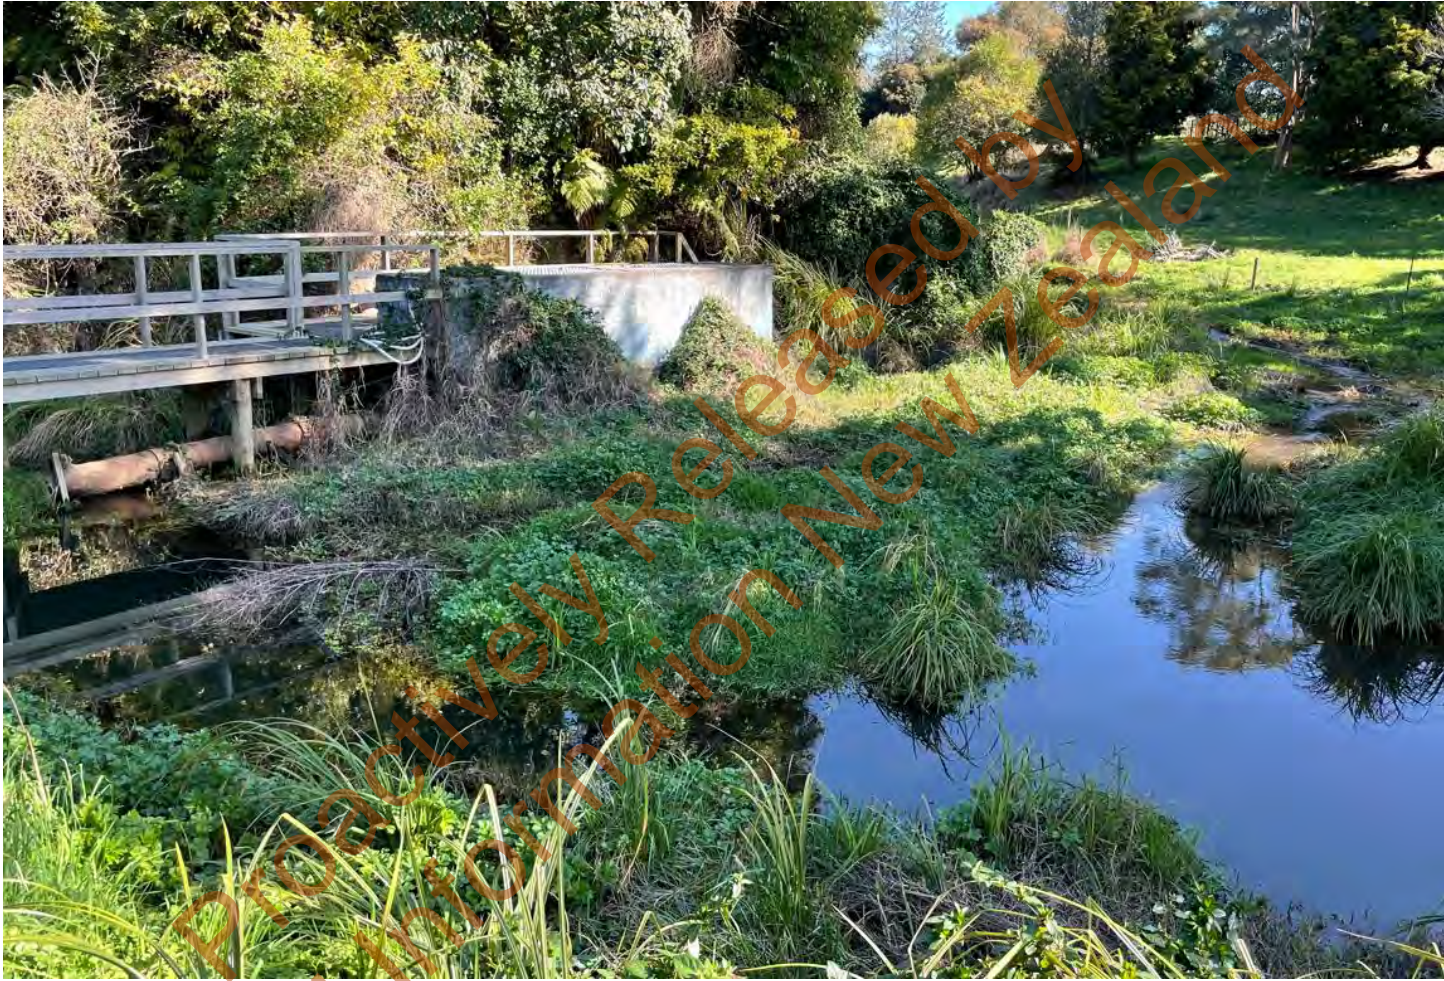
Photo	Photograph
<p data-bbox="193 235 359 349">Photo 63: WWTP 11/08/2022</p>

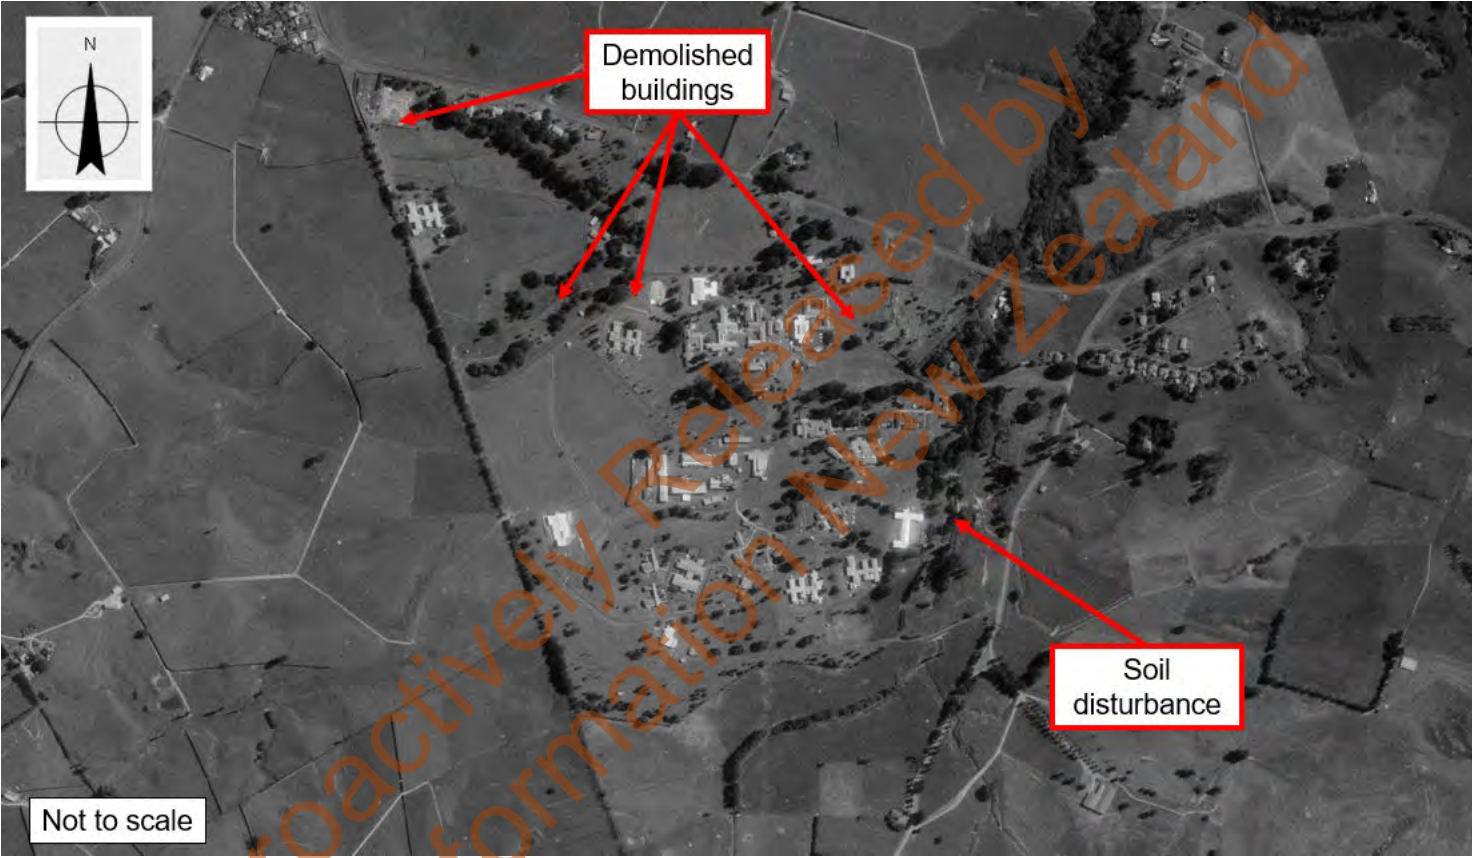
Year/ Source	Photograph
1995 Retrolens

<p data-bbox="961 310 1138 386">Demolished buildings</p> <p data-bbox="1423 922 1608 998">Soil disturbance</p> <p data-bbox="407 1073 575 1114">Not to scale</p>

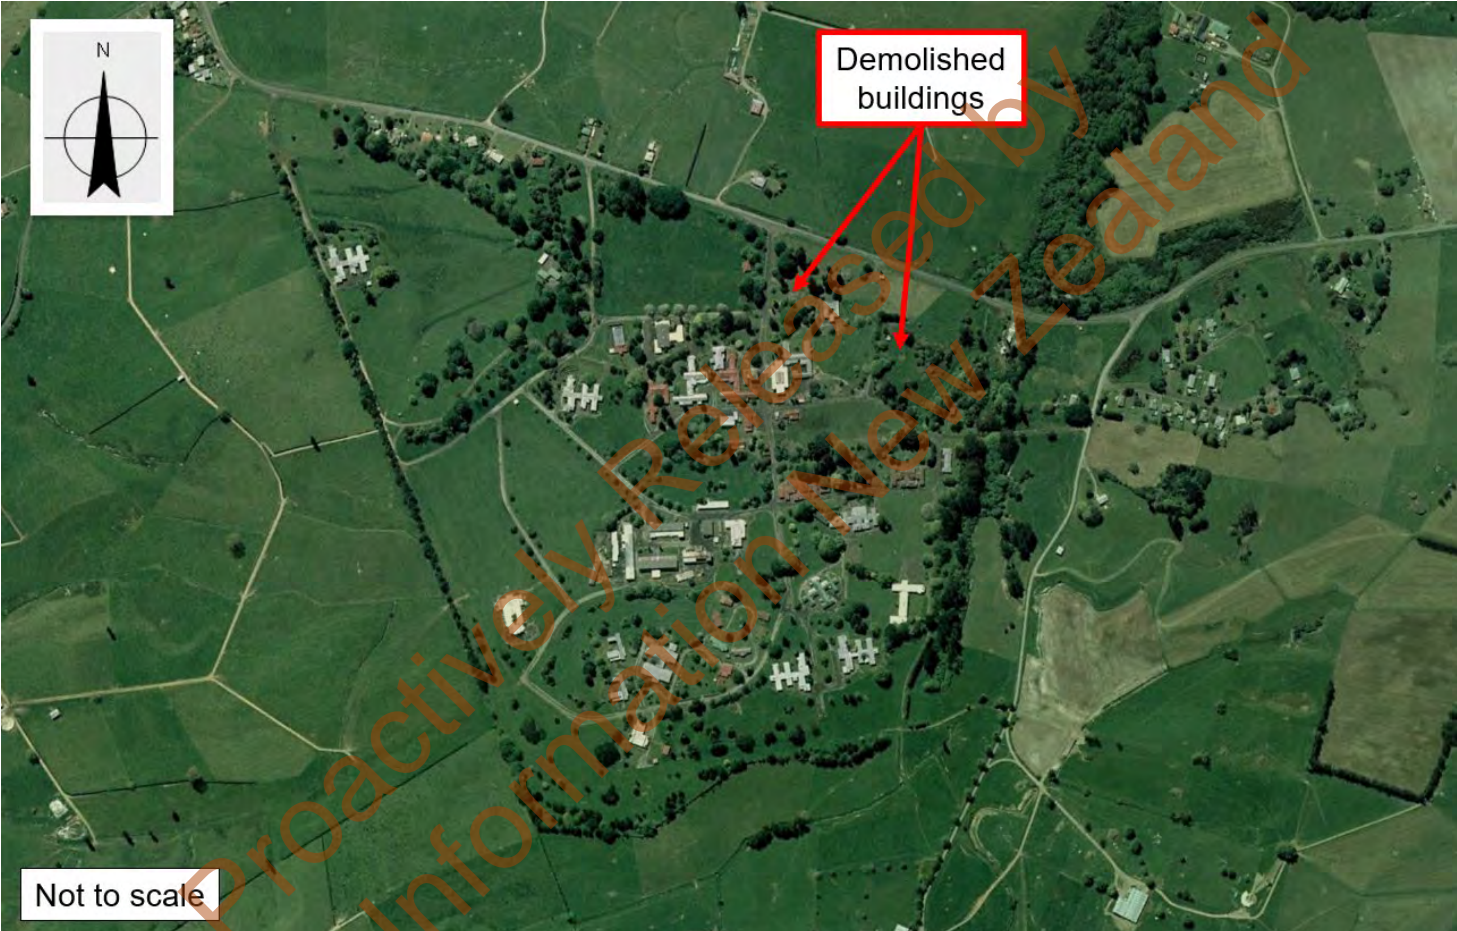
Year/ Source	Photograph
2007 Google Earth

<p data-bbox="1188 310 1388 399">Demolished buildings</p> <p data-bbox="401 1146 590 1187">Not to scale</p>

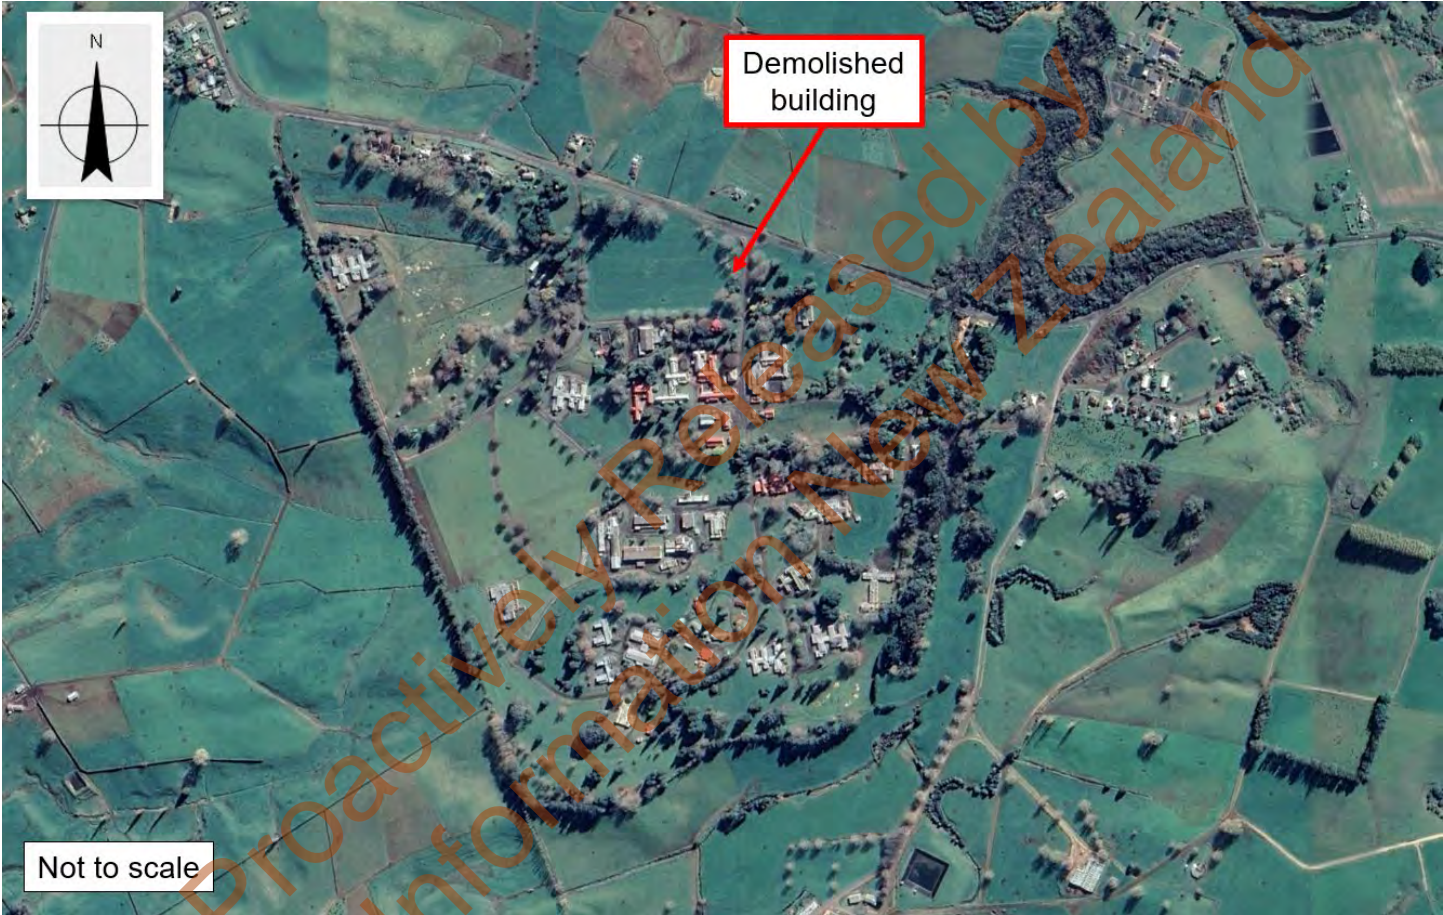
Year/ Source	Photograph
2020 Google Earth

<p data-bbox="401 289 533 472">N</p> <p data-bbox="1094 315 1289 399">Demolished building</p> <p data-bbox="401 1117 583 1159">Not to scale</p> <p>The photograph is an aerial view of a rural landscape. It shows a central cluster of buildings, likely a farm or small village, surrounded by green fields and patches of trees. A red arrow points to a specific location within this central cluster, which is enclosed in a red rectangular box. The text 'Demolished building' is written in black inside this box. In the top-left corner of the photograph, there is a small white square containing a black compass rose with the letter 'N' above it. In the bottom-left corner, there is a white rectangular box with the text 'Not to scale'. A large, diagonal, semi-transparent watermark in orange text reads 'Proactively Released by Land Information New Zealand' across the entire image.</p>

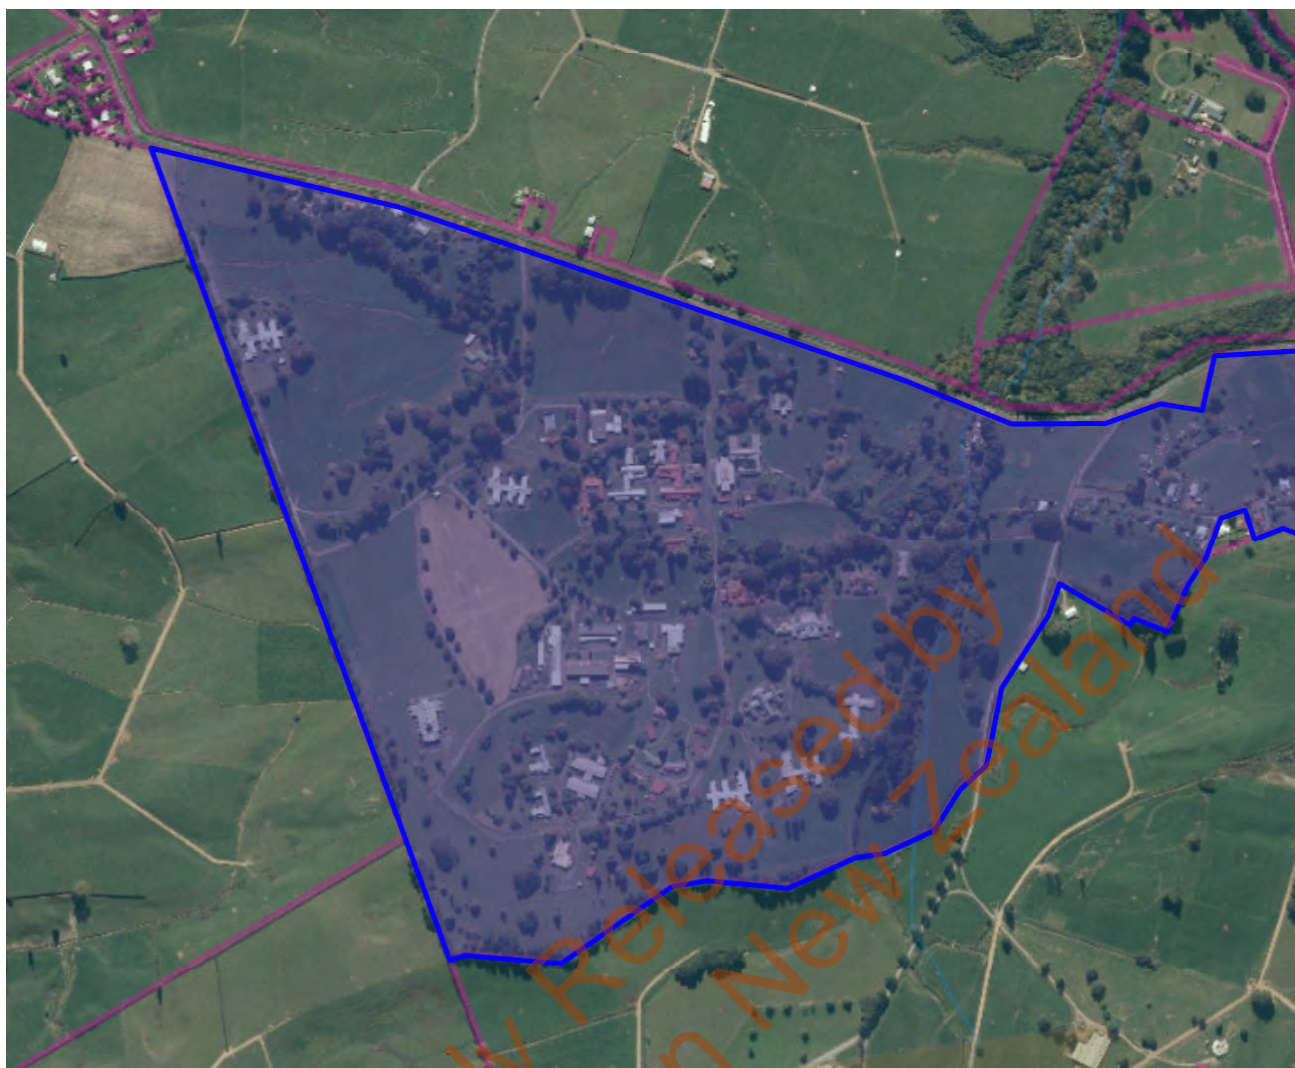
This property: I can confirm that this property **does** appear on the Land Use Information Register, as indicated by the map below.

The area shaded blue above appears on the Land Use Information Register as LUI03403 with a classification of 'Verified HAIL – limited sampling' due to past land HAIL activities: **A14**. Pharmaceutical manufacture; **A17**. Storage tanks or drums for fuel, chemical or liquid waste; **F4**. Motor vehicle workshop; **F7**. Service Station; and **G3**. Landfill sites associated with Tokanui Hospital.
