Watts Peninsula, Wellington

Heritage and condition assessment

Report Prepared for Toitū Te Whenua Land Information New Zealand

Submitted: December 2022

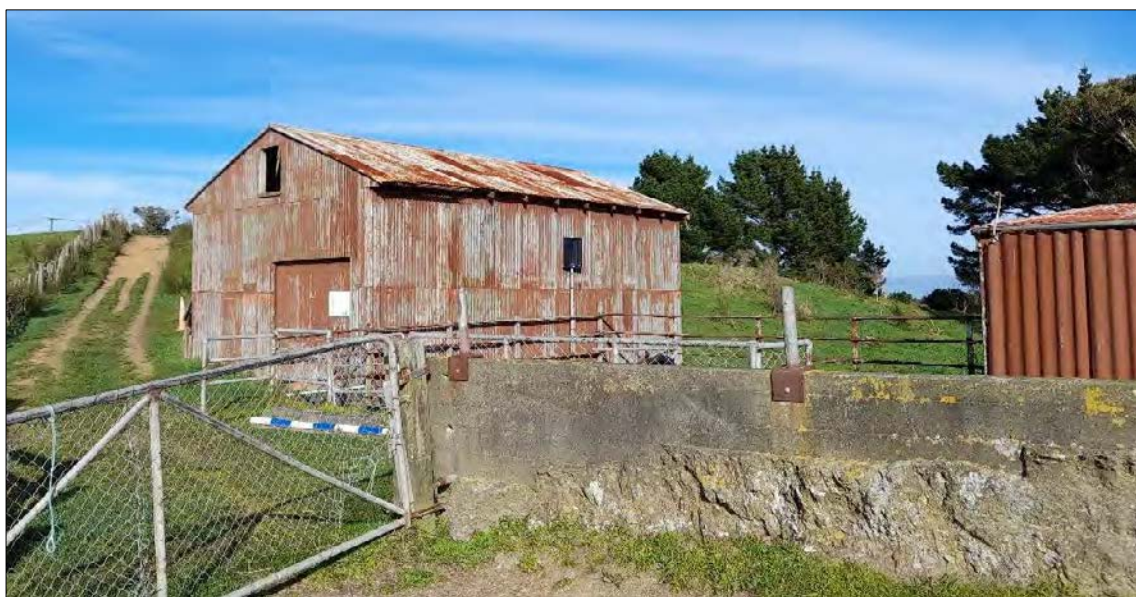
Figure 25: View of the large barn with the smaller milking shed to the RHS (NZHP, 2022).

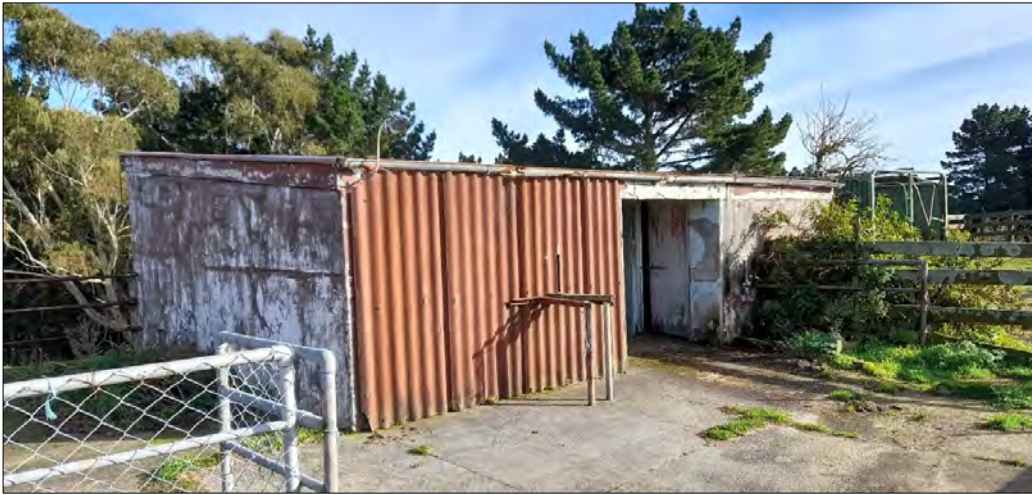
Figure 26: View of the milking shed (NZHP, 2022).

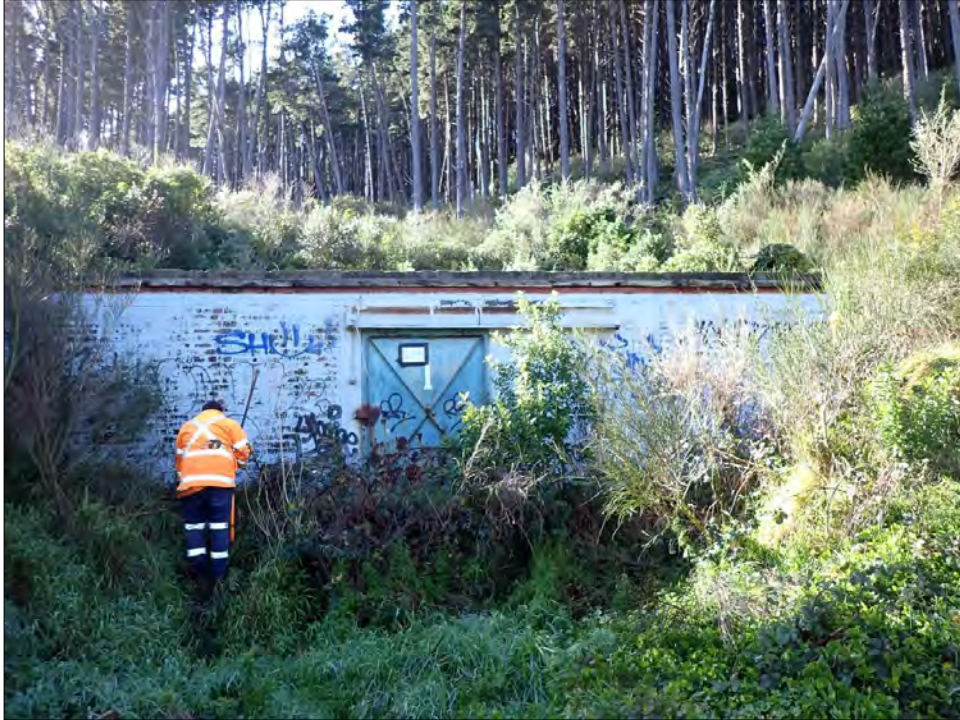
Figure 82. Feature 1: Magazine 1. Looking towards the western (front) elevation. Graffiti is present. The roof is missing.

- Consider reinstating the missing roof. New roof and associated rainwater disposal to match the design and profiles of the original roofs, and to match the materiality and finish of roofed magazine structures.

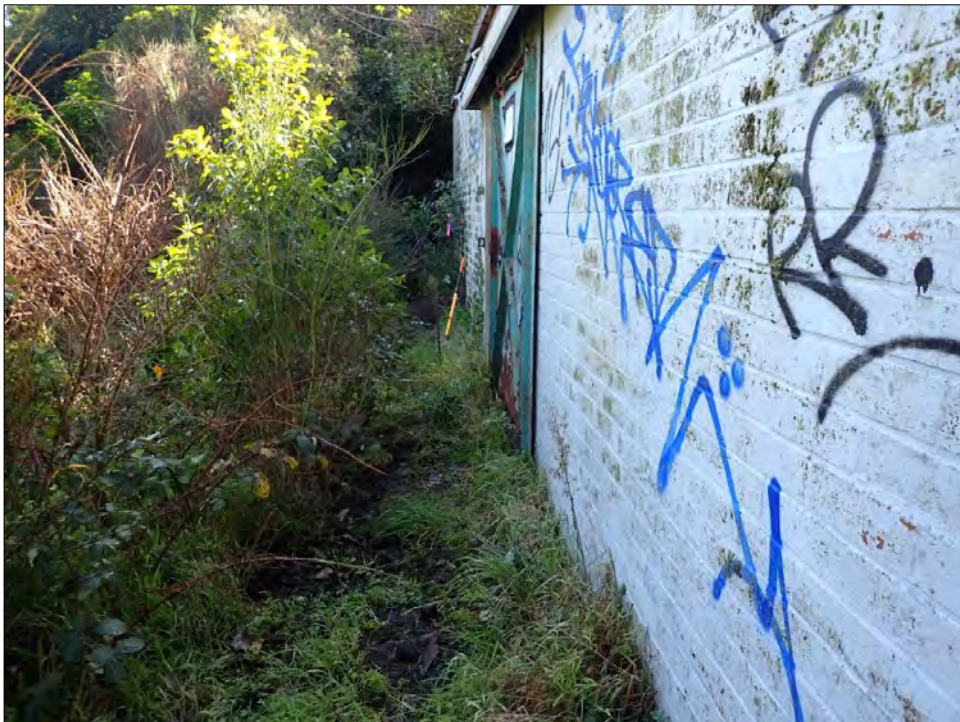
Figure 83. Feature 1: Magazine 1. Looking north across the overgrown, narrow loading deck that extends across the front elevation.

- Service the external roller door to ensure it is fully functional and operates with ease.
- Fully expose the narrow loading deck by removing debris and vegetation growth. Once cleared, structural engineer to assess any cracking to the deck supporting wall. Consider making good the deck platform in keeping with the original concrete finish.

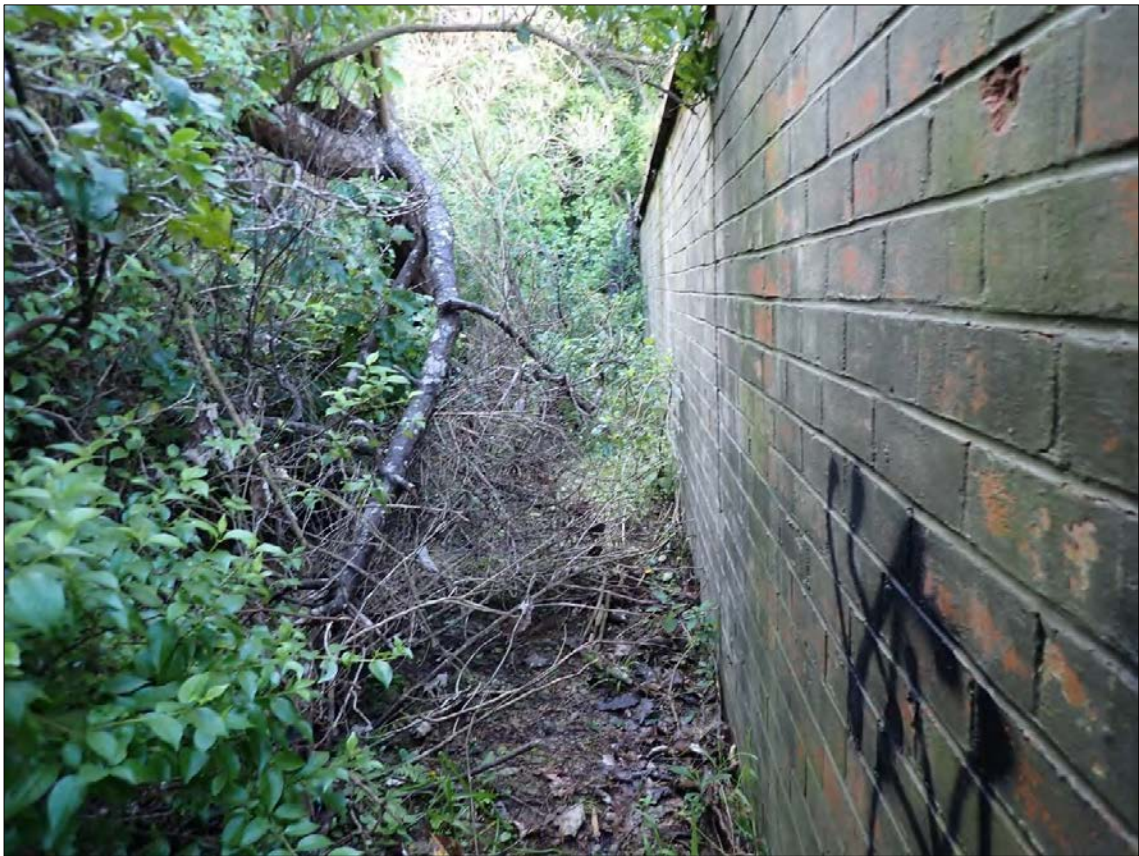
Figure 84. Feature 1: Magazine 1. Looking along the northern (side) elevation. Graffiti is present. A slip has occurred to the rear, and vegetation and debris has accumulated against the side of the structure.

- The accumulation of overgrowth and debris can both conceal decay and cause decay. Clear all overgrowth and debris from around the structure and expose the original concrete footpath perimeter. Clearance should include any debris from recent and more historical 'slips'. Following clearing, it may be appropriate to regrade the natural ground level to ensure that rainwater drains away from the structure. Dependant on the extent of regrading works, an archaeological authority may not be required. Investigate the introduction of suitable plantings, or engineered solutions, to facilitate ground stabilisation above the cutting as this will assist with future maintenance.

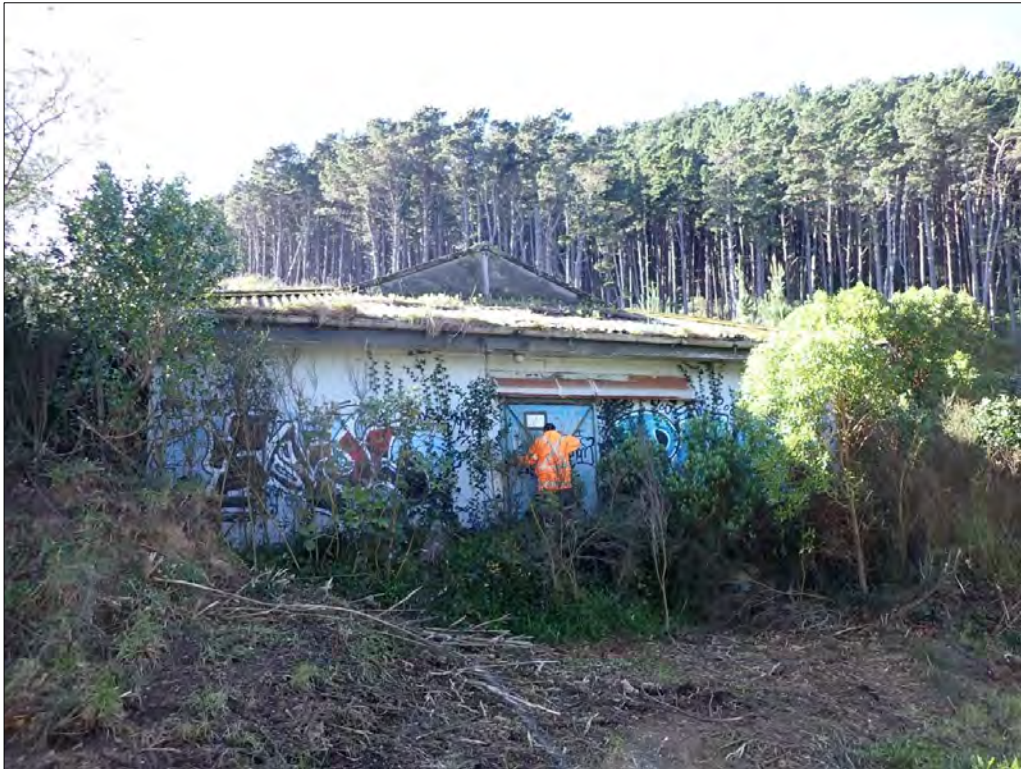
Figure 87. Feature 2: Magazine 2. Looking towards the western (front) elevation. Graffiti is present. There is vegetation on the roof and in the gutters, and the narrow loading deck is being ‘colonised’ by vegetation.

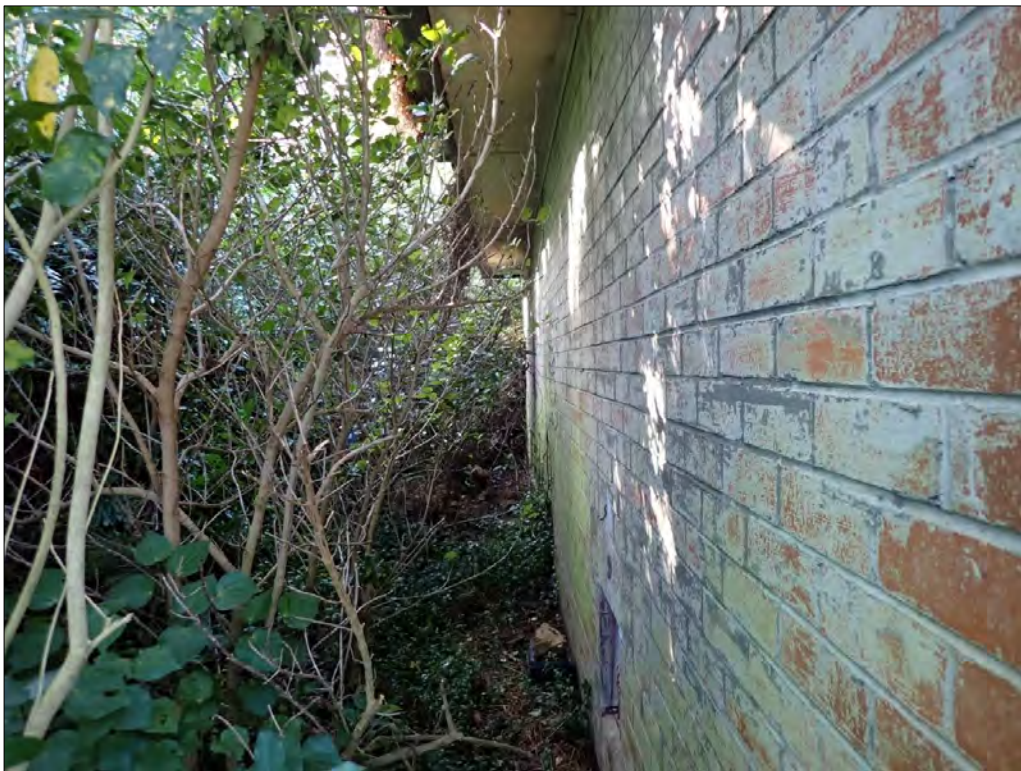
Figure 88. Feature 2: Magazine 2. Looking along the northern (side) elevation. A slip has occurred to the rear; and vegetation and debris has accumulated against the side of the structure.

- The accumulation of overgrowth and debris can both conceal decay and cause decay. Clear all overgrowth and debris from around the structure and expose the original concrete footpath perimeter. Clearance should include any debris from recent and more historical 'slips'. Following clearing, it may be appropriate to regrade the natural ground level to ensure that rainwater drains away from the structure. Dependant on the extent of regrading works, an archaeological authority may not be required. Investigate the introduction of suitable plantings, or engineered solutions, to facilitate ground stabilisation above the cutting as this will assist with future maintenance.

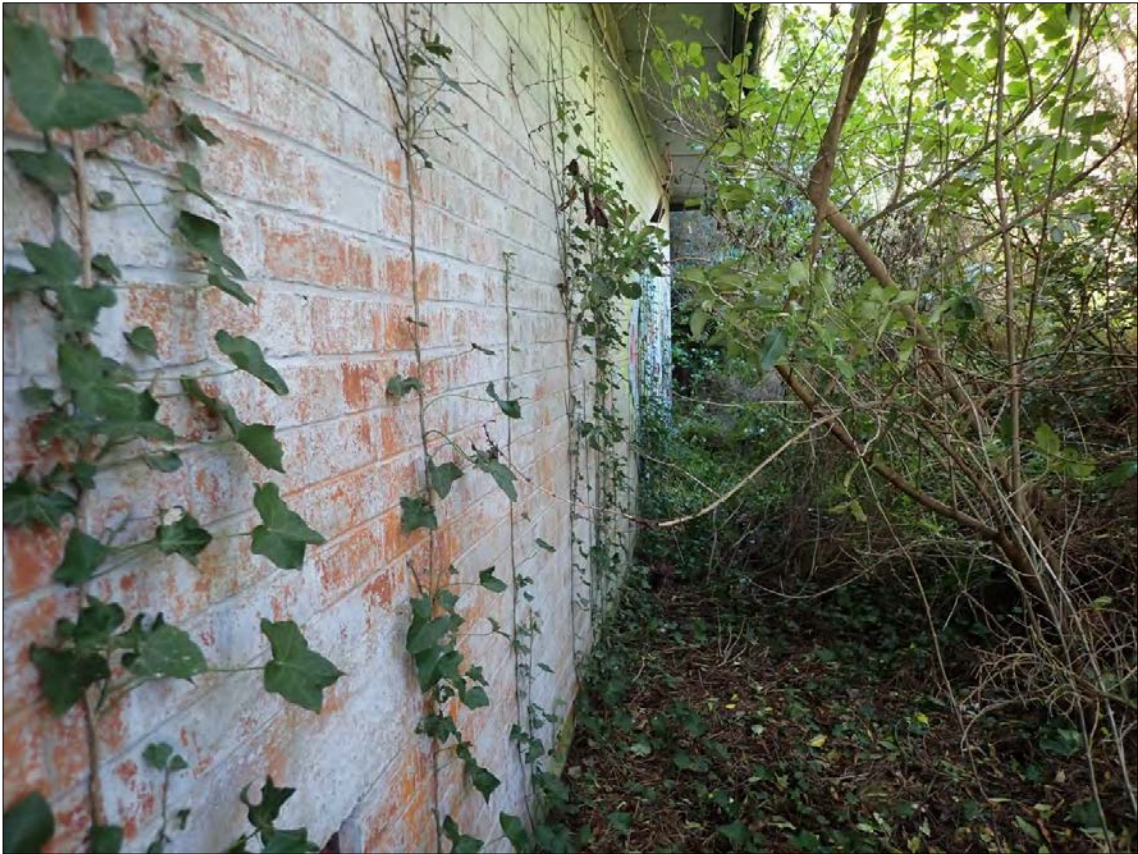
Figure 89. Feature 2: Magazine 2. Looking along the southern (side) elevation. Ivy is growing up the wall, and vegetation and debris has accumulated against the side of the structure.

- Poison the ivy ensure that it is dead prior to removing gently from walls. Ensure that brickwork and mortar is not damaged during the process
- Remove plant matter (debris and new growth) from roof surface.

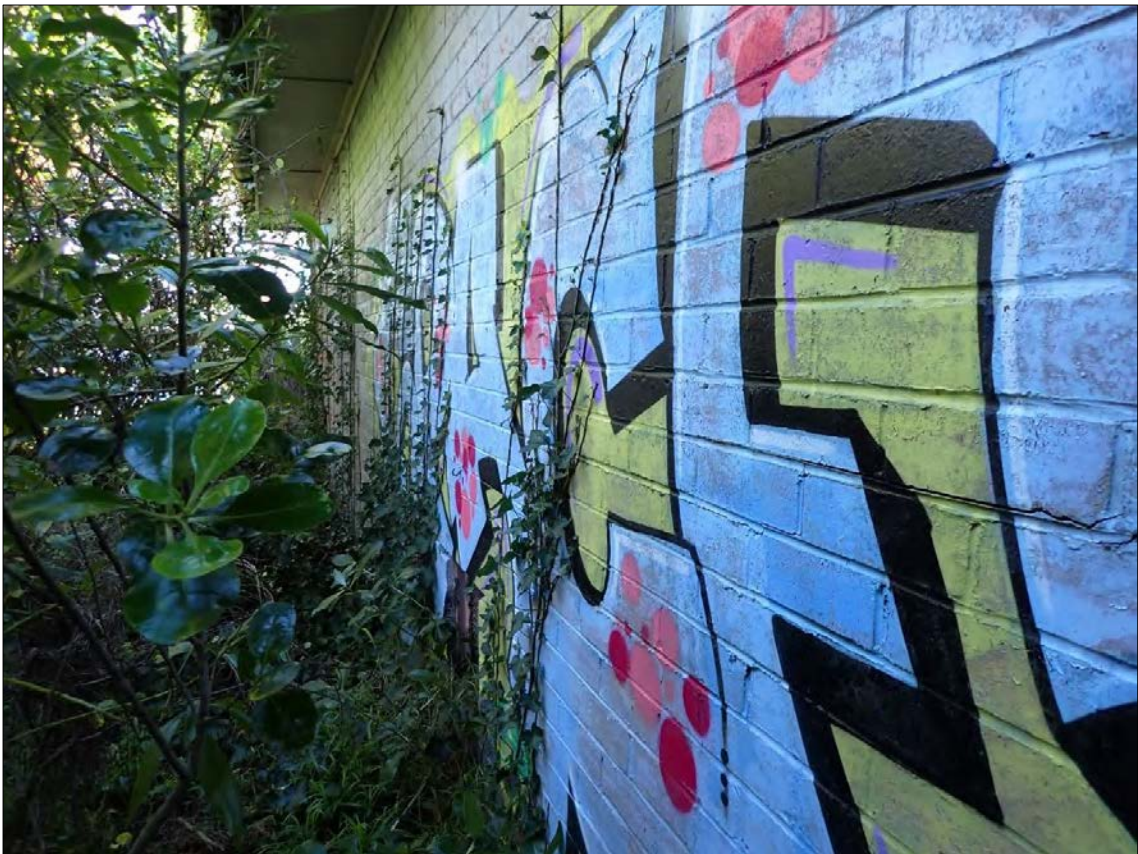
Figure 90. Feature 2: Magazine 2. Looking along the southern (side) elevation. Ivy is growing up the wall and graffiti is present.

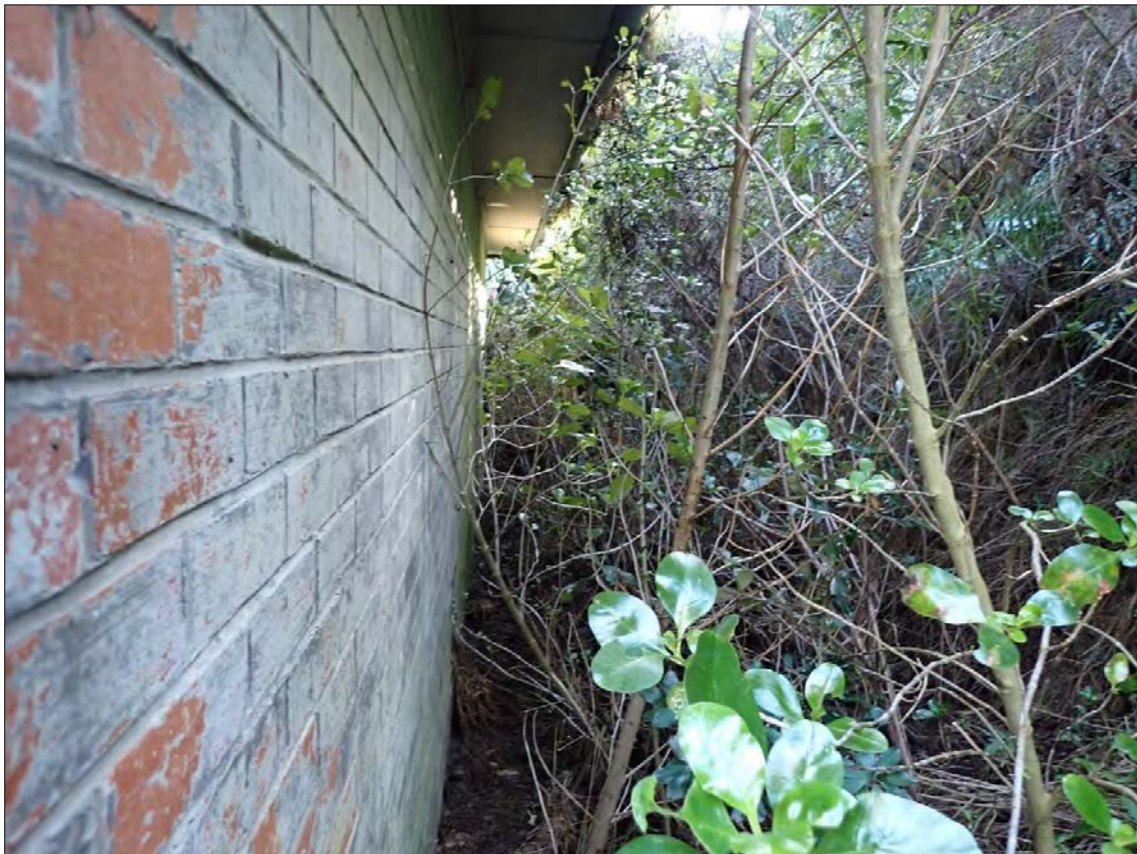
Figure 91. Feature 2: Magazine 2. Looking along the eastern (rear) elevation. A slip has occurred to the rear, and vegetation and debris has accumulated against the side of the structure.

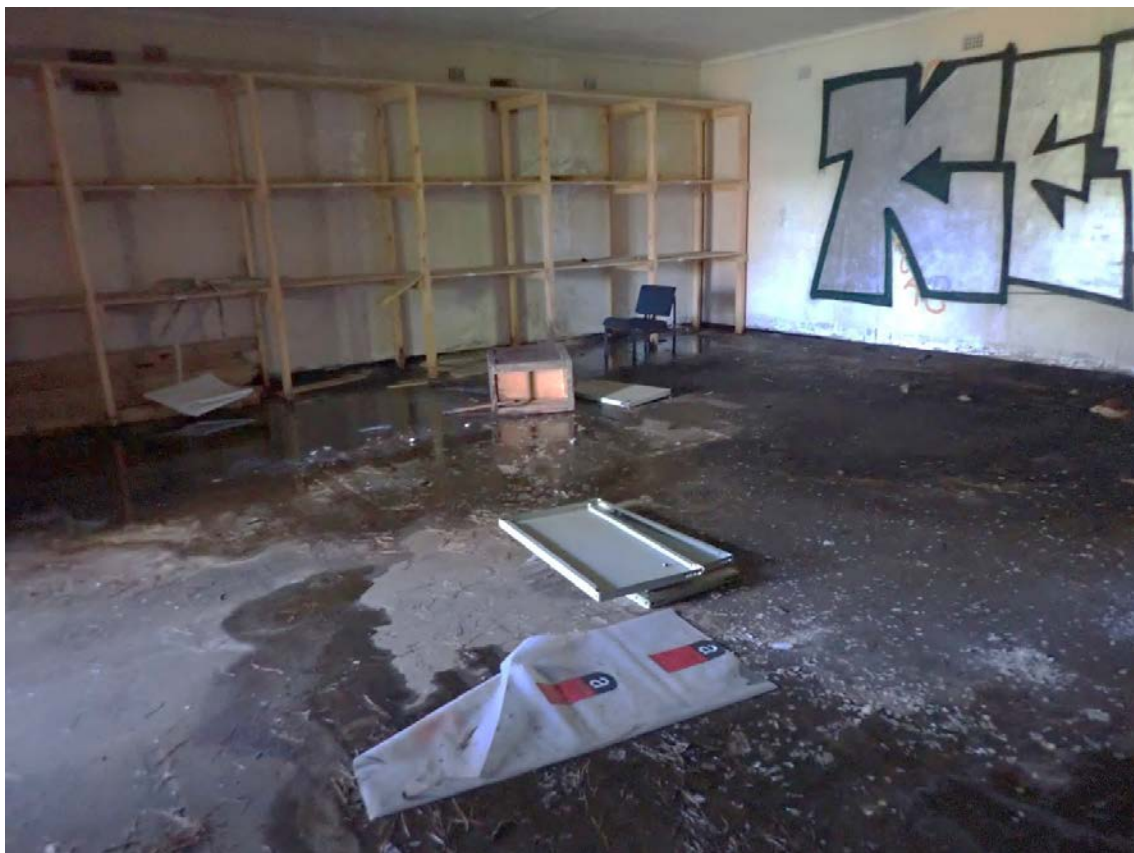
Figure 92. Feature 2: Magazine 2. Interior – Water is entering the structure and graffiti is present. Some material goods associated with the most recent occupation remain within the structure.

- Investigate the build-up of water within the structure and remediate. Water penetration may be the result of roof failure, impeded rainwater goods, the accumulation of debris against the structure, inappropriate falls to the natural ground level, or a combination of all these factors.

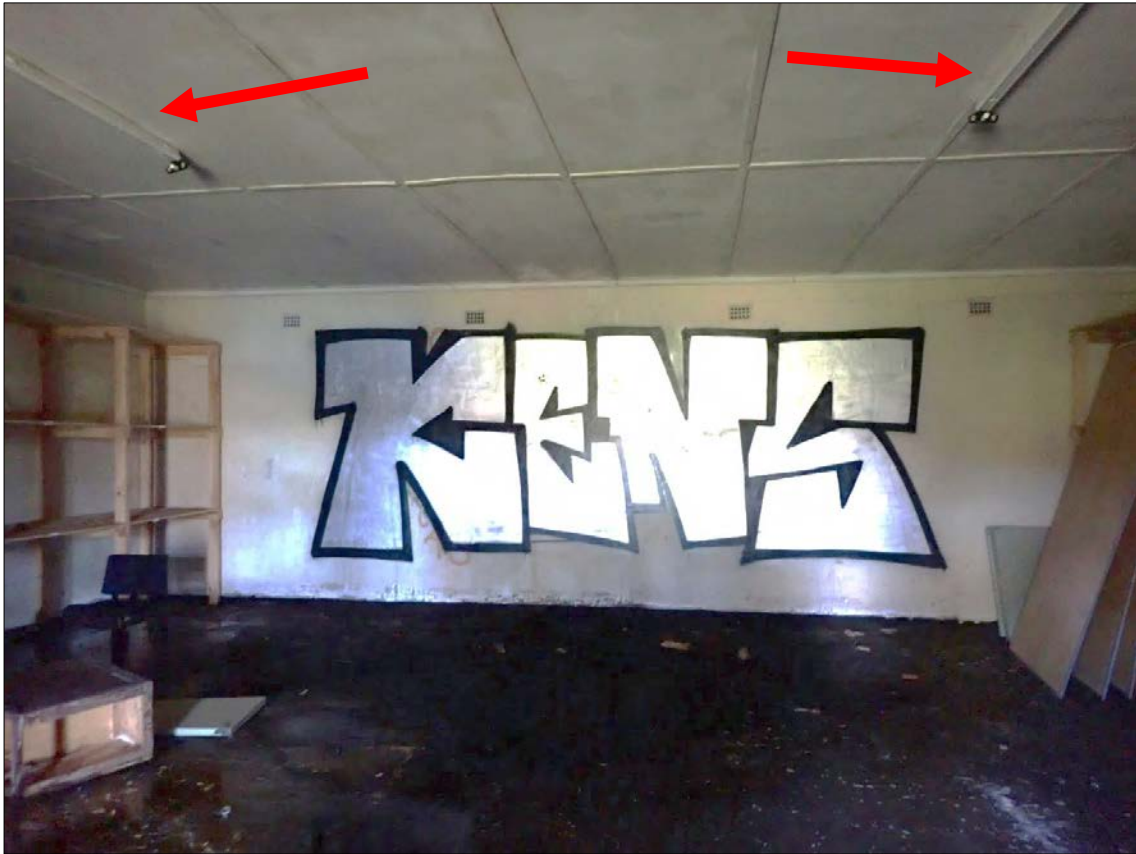
Figure 93. Feature 2: Magazine 2. Interior – Ceilings are present and fluorescent light fittings are indicated.

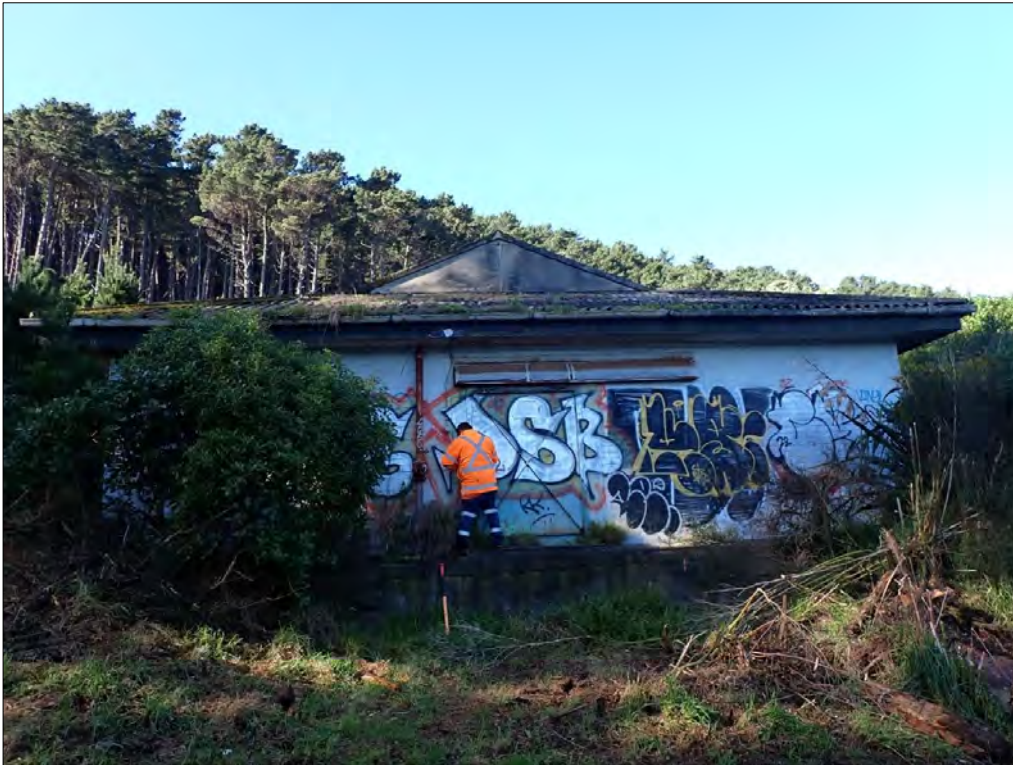
Figure 94. Feature 3: Magazine 3. Looking towards the western (front) elevation. Graffiti is present and there is vegetation in the gutters. The narrow loading deck is overgrown on the outer perimeters.

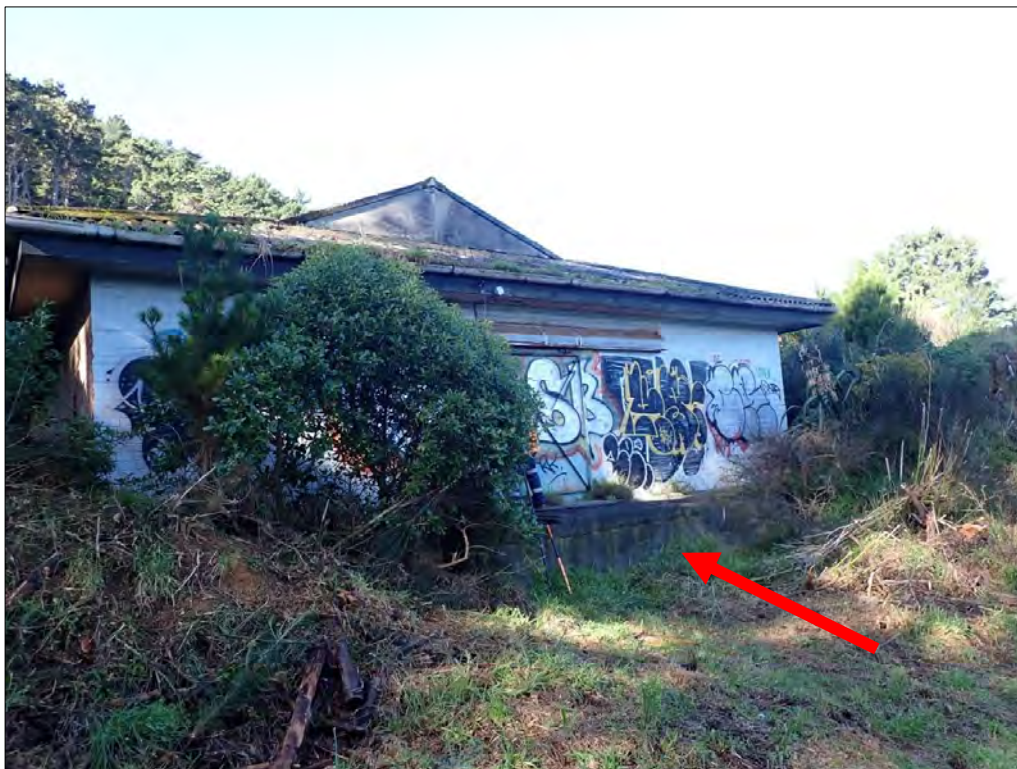
Figure 95. Feature 3: Magazine 3. Looking towards the western (front) elevation. Horizontal cracking beneath the loading deck concrete slab is indicated.

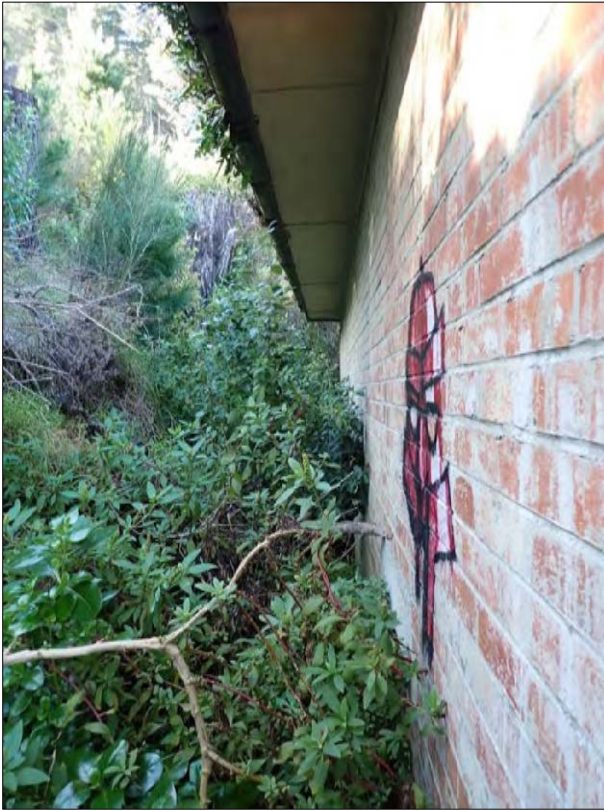
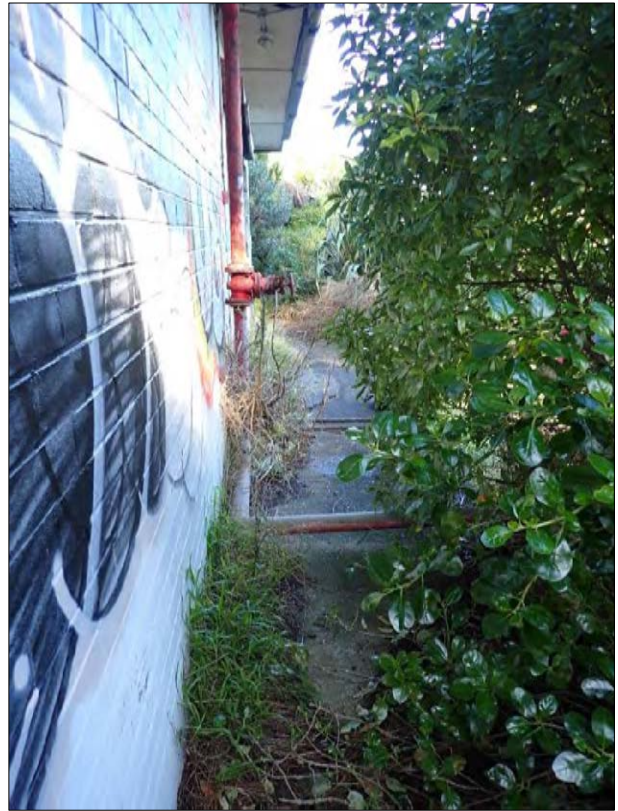
Figure 96. Feature 3: Magazine 3. Looking along the northern (side) elevation. Graffiti is present. Vegetation is also present against the side of the structure, particularly towards the rear (LHS image). Original firefighting system and concrete perimeter around the magazine are evident (RHS image).

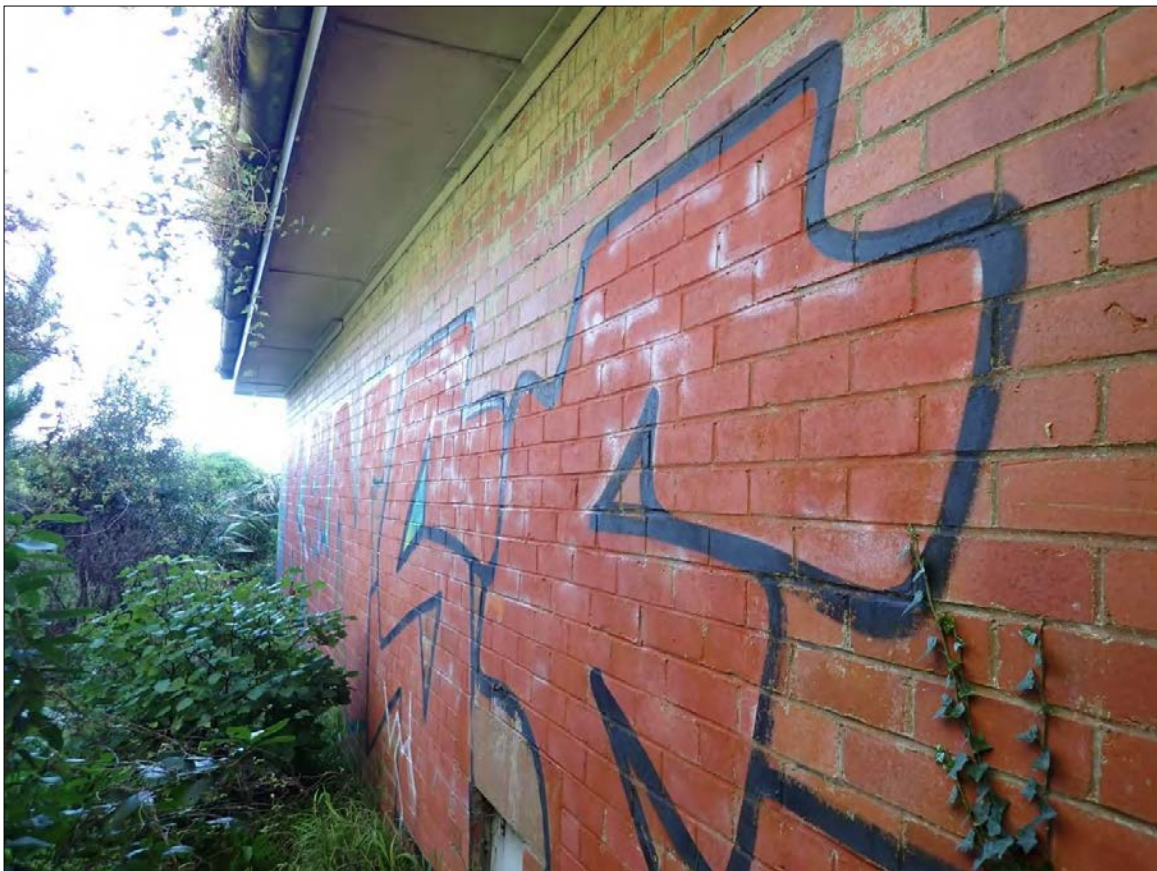
Figure 97. Feature 3: Magazine 3. Looking along the southern (side) elevation. Vegetation is present against the side of the structure; ivy is growing up the wall and graffiti is present.

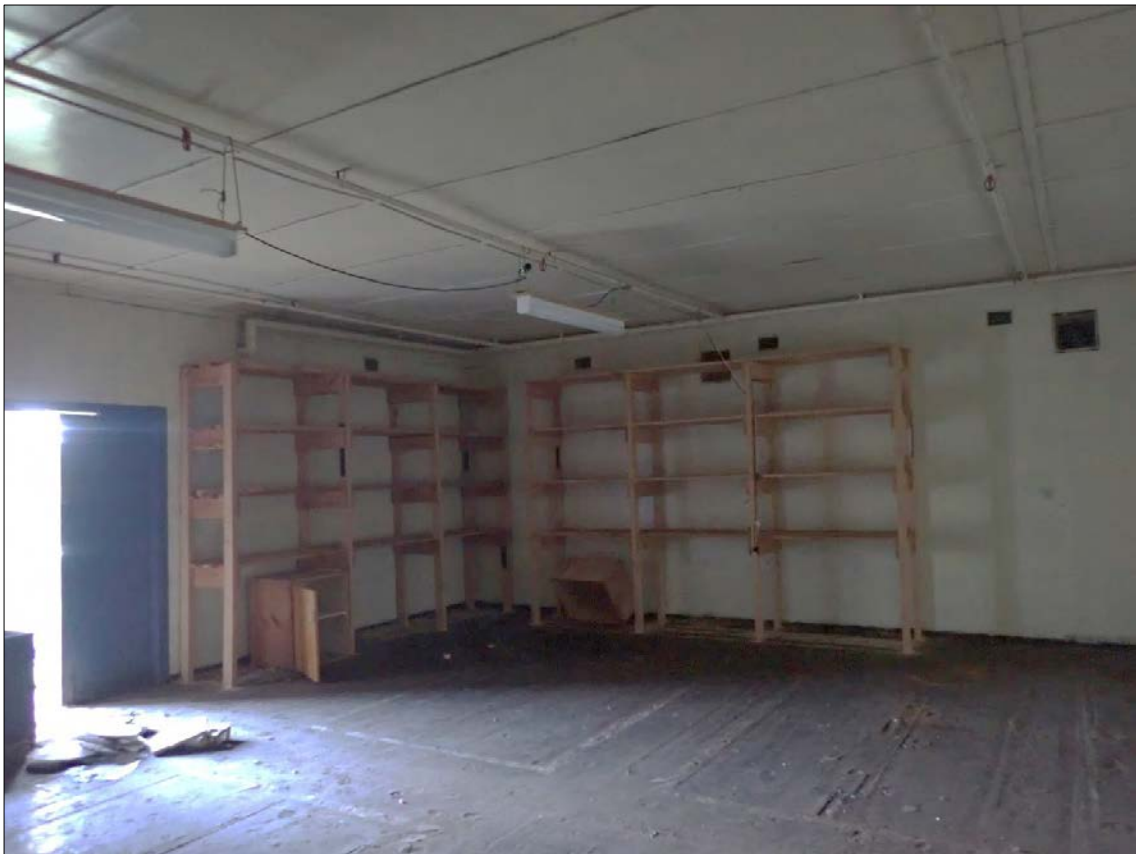
Figure 101. Feature 3: Magazine 3. Interior – Fluorescent lights are suspended from the sprinkler system. Water penetration is not evident. Some material goods associated with the most recent use remain within the structure.

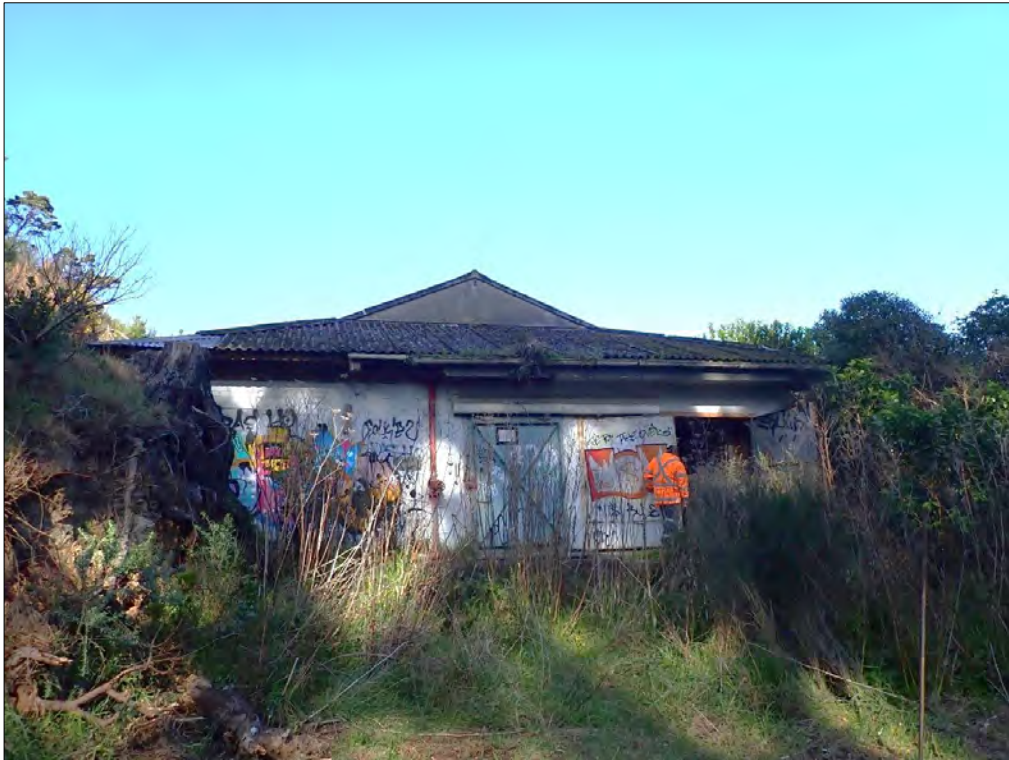
Figure 102. Feature 4: Magazine 4. Looking towards the northern (front) elevation. Graffiti is present and there is vegetation in the gutters. Some of the gutter is missing. The narrow loading deck is becoming 'colonised' by vegetation.

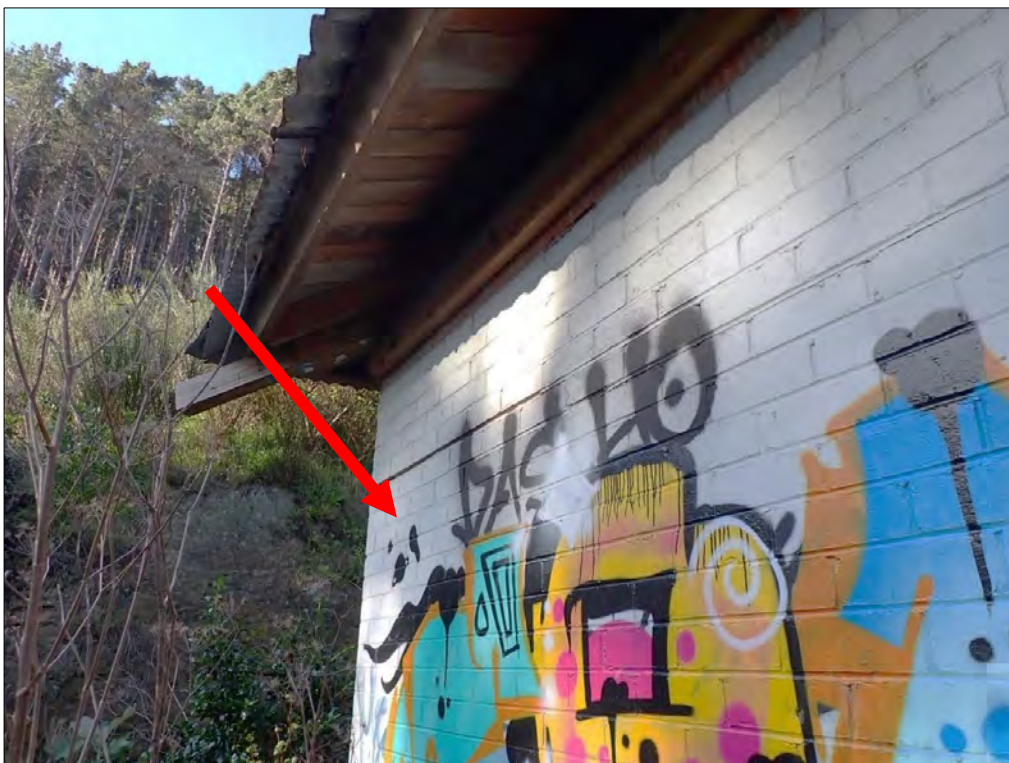
Figure 103. Feature 4: Magazine 4. Looking along the northern (front) elevation. Typical horizontal crack is indicated at the corner. Boarding to the closed eaves has come away and rainwater goods are missing.

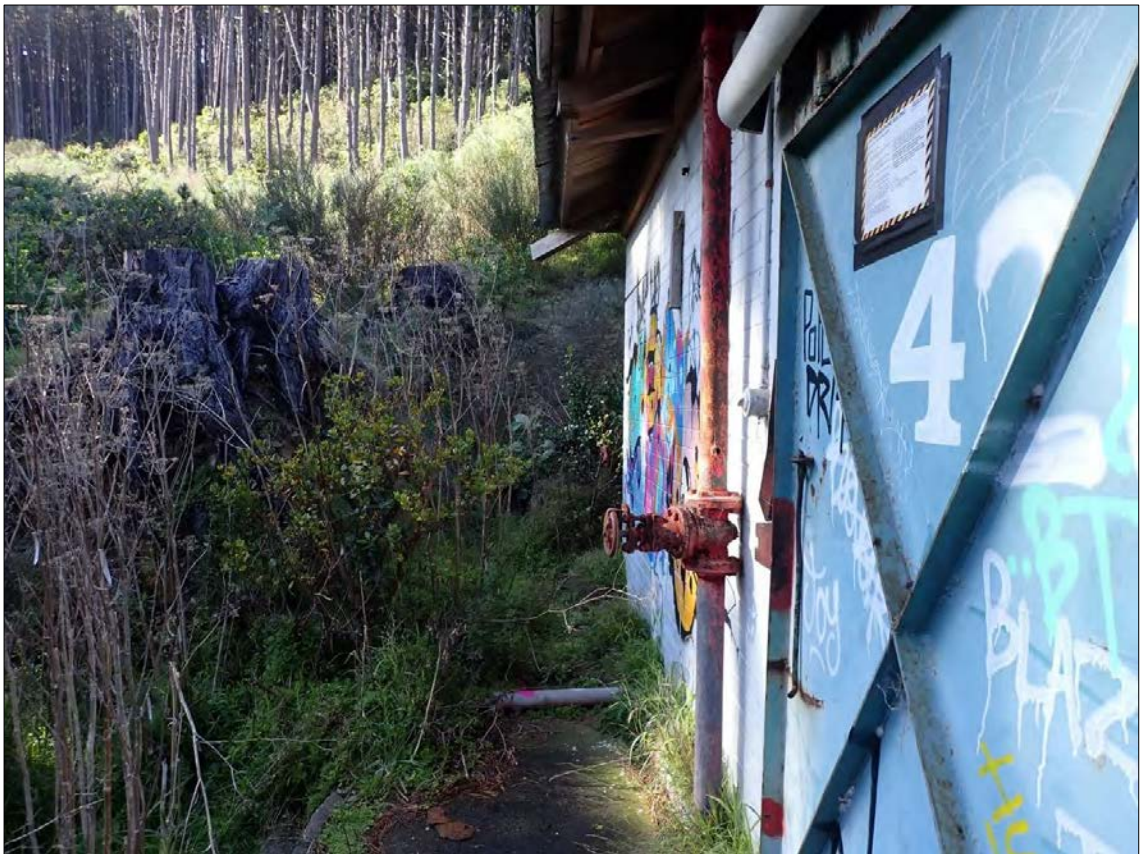
Figure 105. Feature 4: Magazine 4. Looking along the northern (front) elevation. Original firefighting system is evident.

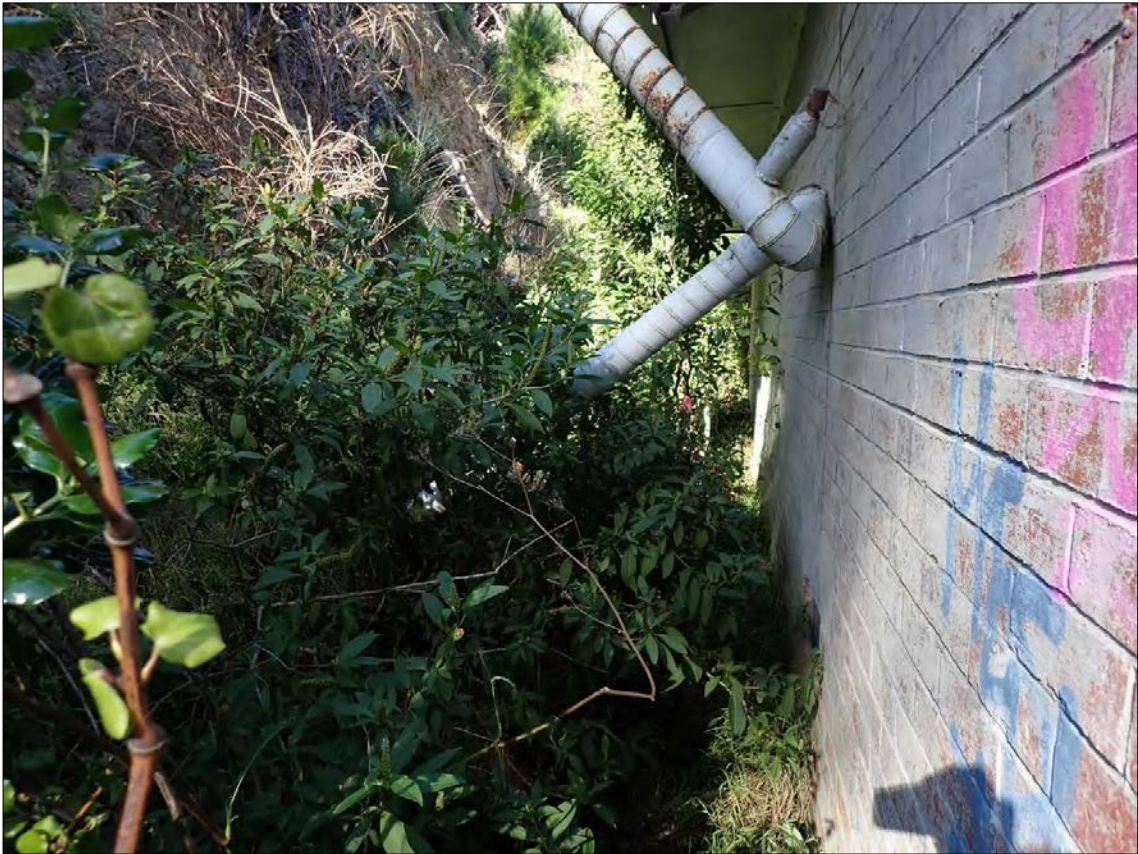
Figure 106. Feature 4: Magazine 4. Looking along the western (side) elevation. Debris and vegetation have accumulated against the structure. Graffiti is present.

- The accumulation of overgrowth and debris can both conceal decay and cause decay. Clear all overgrowth and debris from around the structure and expose the original concrete footpath perimeter. Clearance should include any debris from recent and more historical 'slips'. Following clearing, it may be appropriate to regrade the natural ground level to ensure that rainwater drains away from the structure. Dependant on the extent of regrading works, an archaeological authority may not be required. Investigate the introduction of suitable plantings, or engineered solutions, to facilitate ground stabilisation above the cutting as this will assist with future maintenance.

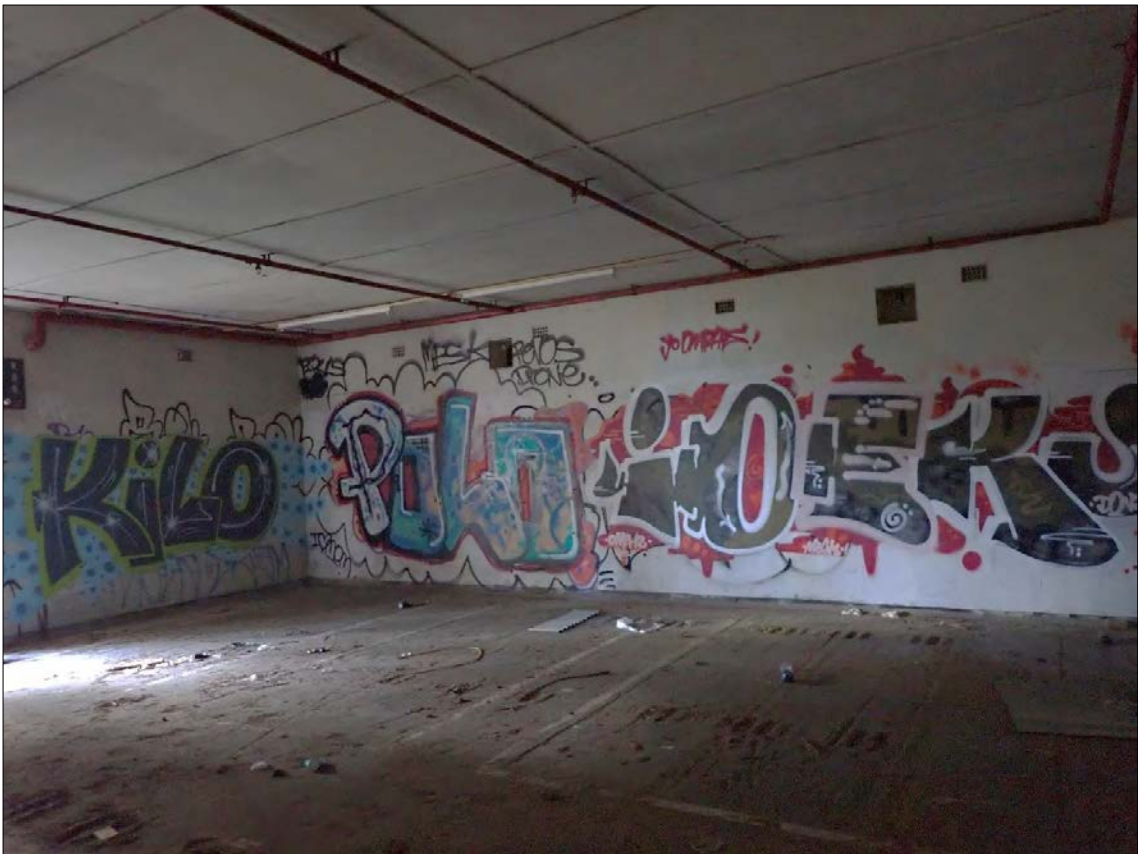
Figure 107. Feature 4: Magazine 4. Interior – Ceiling is present and fluorescent lights and sprinkler system remain. Graffiti is present. Water penetration is not evident.

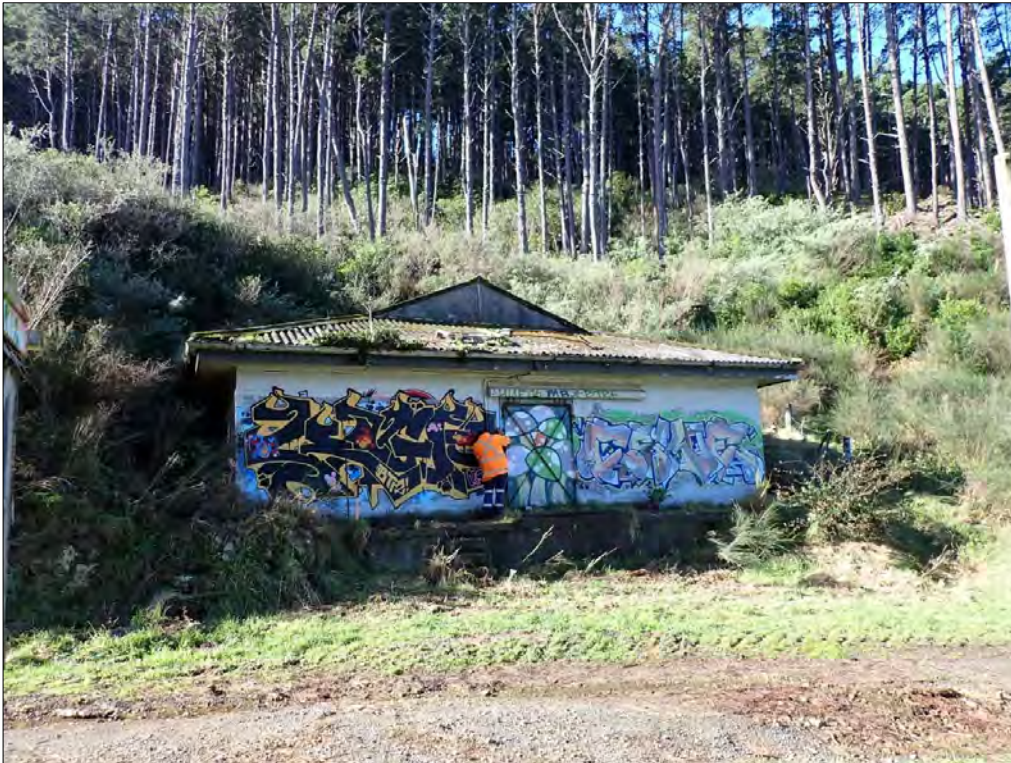
Figure 110: Feature 5: Magazine 5. Looking towards the western (front) elevation. Graffiti is present and there is vegetation in the gutters.

- The accumulation of overgrowth and debris can both conceal decay and cause decay. Clear all overgrowth and debris from around the structure and expose the original concrete footpath perimeter. Clearance should include any debris from recent and more historical ‘slips’. Following clearing, it may be appropriate to regrade the natural ground level to ensure that rainwater drains away from the structure. Dependant on the extent of regrading works, an archaeological authority may not be required. Investigate the introduction of suitable plantings, or engineered solutions, to facilitate ground stabilisation above the cutting as this will assist with future maintenance.

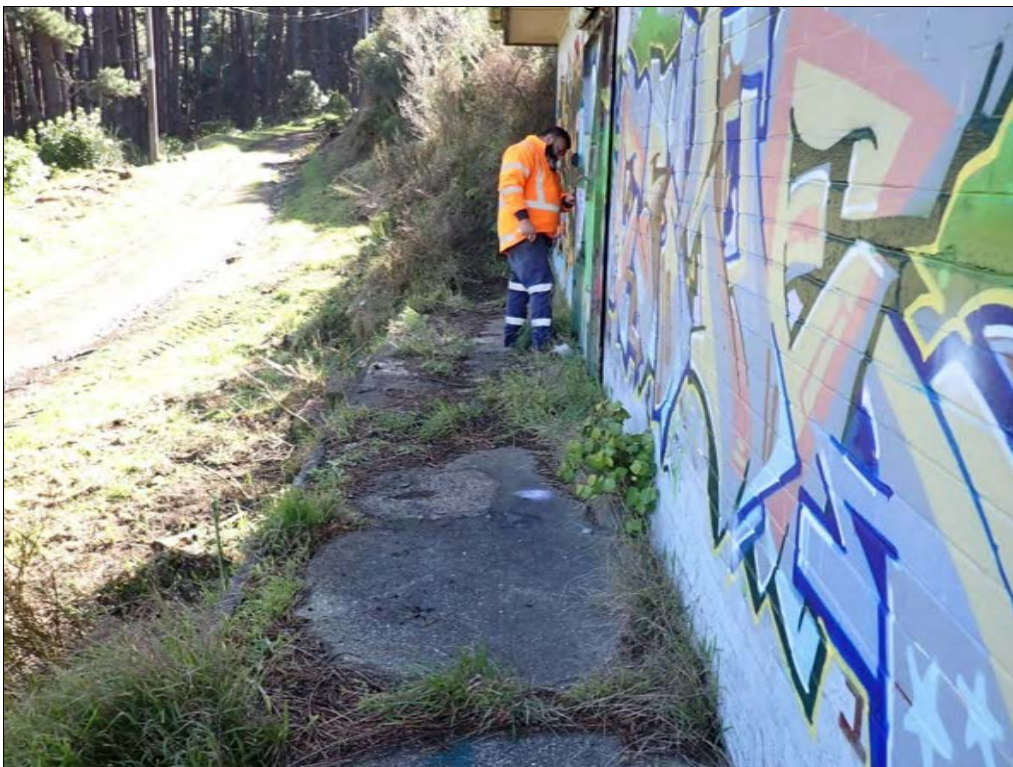
Figure 111. Feature 5: Magazine 5. Looking along the western (front) elevation – image cropped. Vegetation is starting to ‘colonise’ the cracked loading deck.
