Watts Peninsula, Wellington

Heritage and condition assessment

Report Prepared for Toitū Te Whenua Land Information New Zealand

Submitted: December 2022

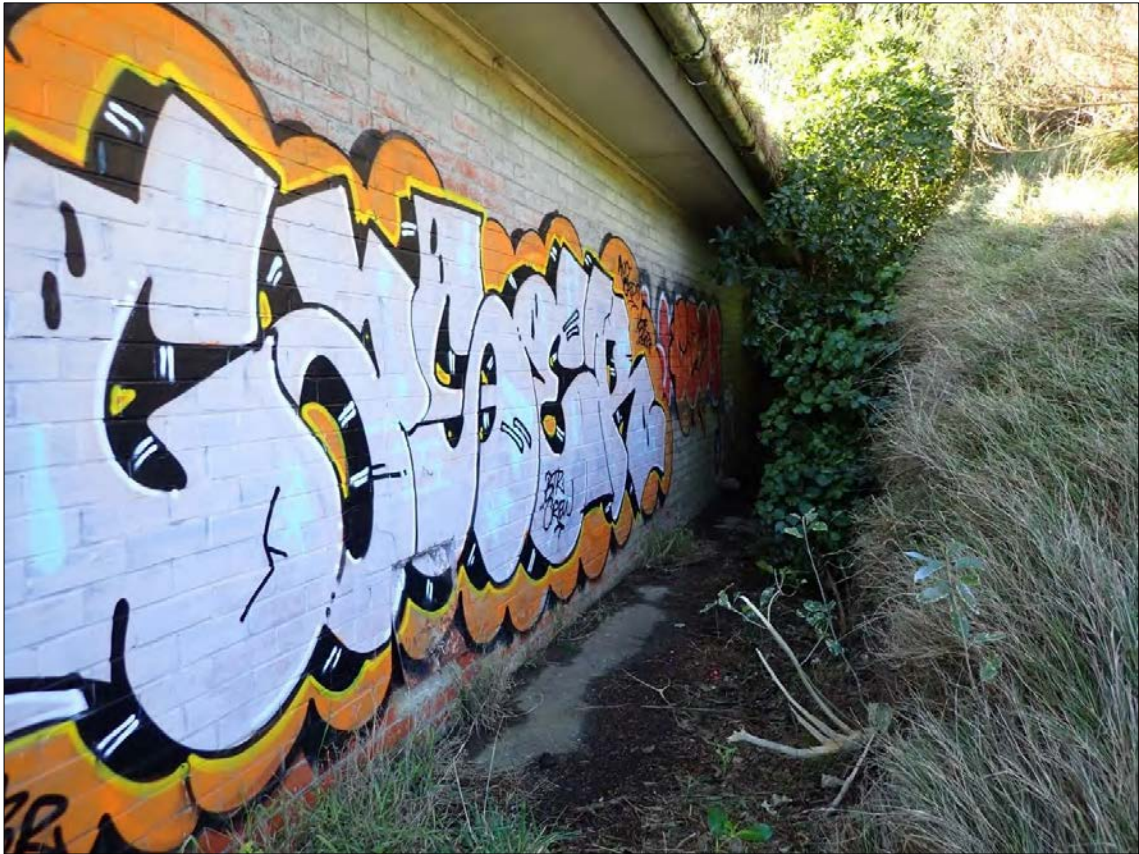
Figure 112. Feature 5: Magazine 5. Looking along the southern (side) elevation. A concrete perimeter to the structure is evident, and graffiti is present.

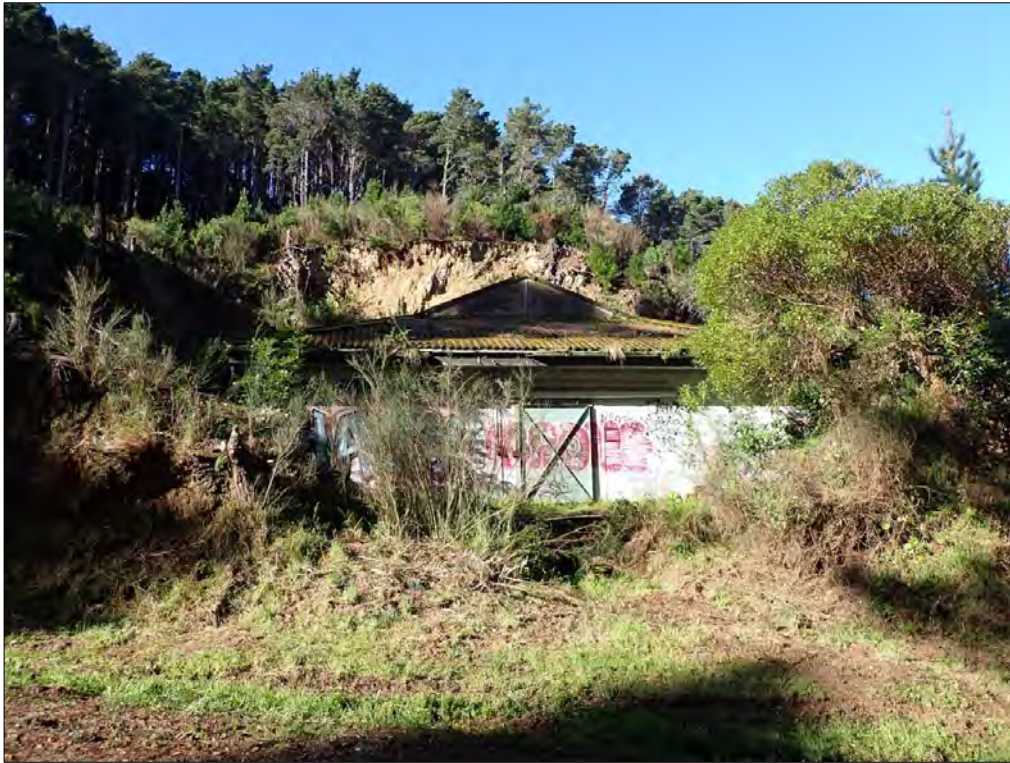
Figure 115. Feature 6: Magazine 6. Looking towards the northwestern (front) elevation. Graffiti is present and there is vegetation in the gutters

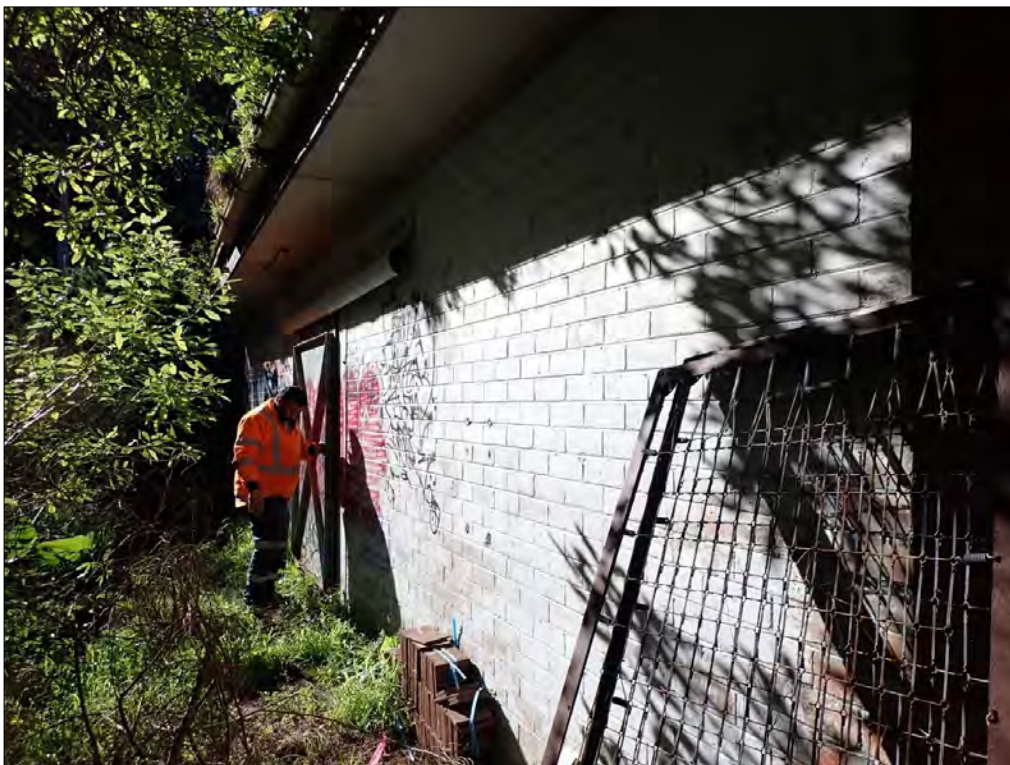
Figure 116. Feature 6: Magazine 6. Looking along the northwestern (front) elevation. Vegetation is starting to ‘colonise’ the cracked loading deck.

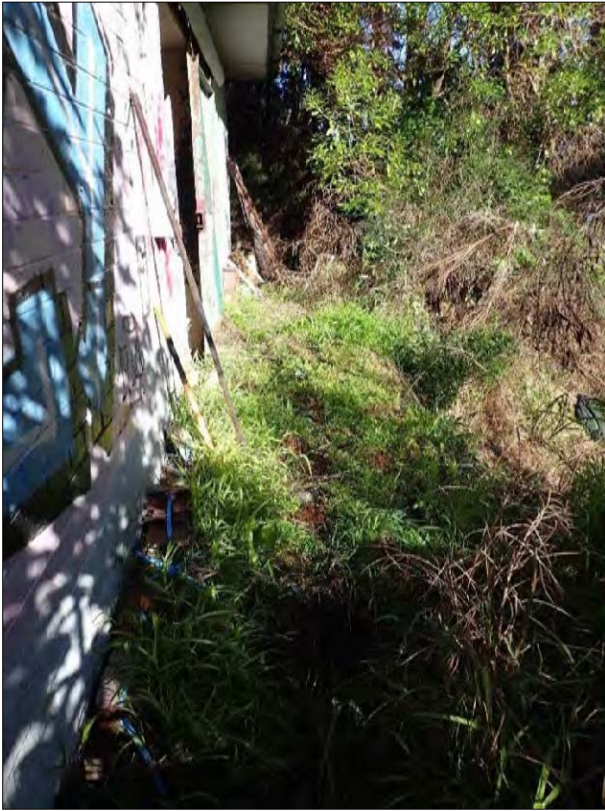
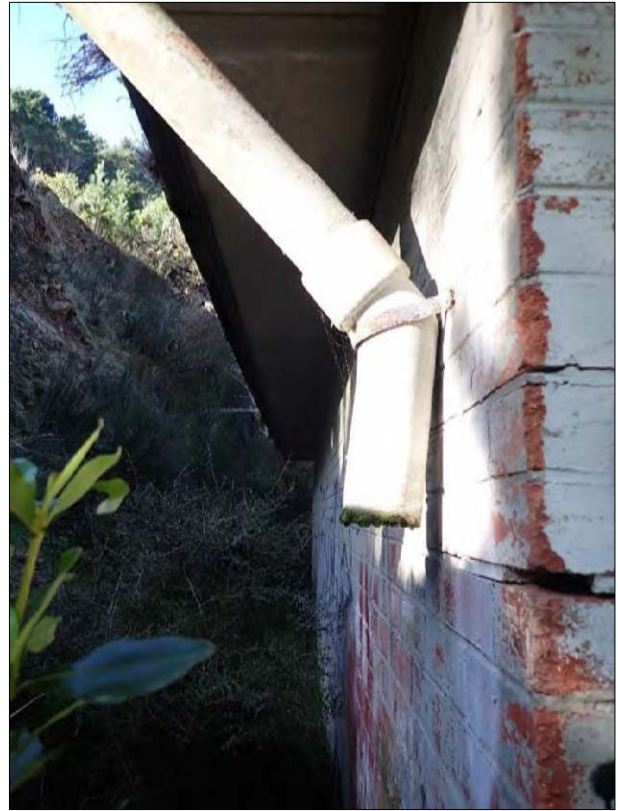
Figure 117. Feature 6: Magazine 6. Looking along the northwestern (side) elevation. Graffiti is present. Vegetation and debris are present against the side of the structure (LHS image). A rainwater downpipe is broken (RHS image).

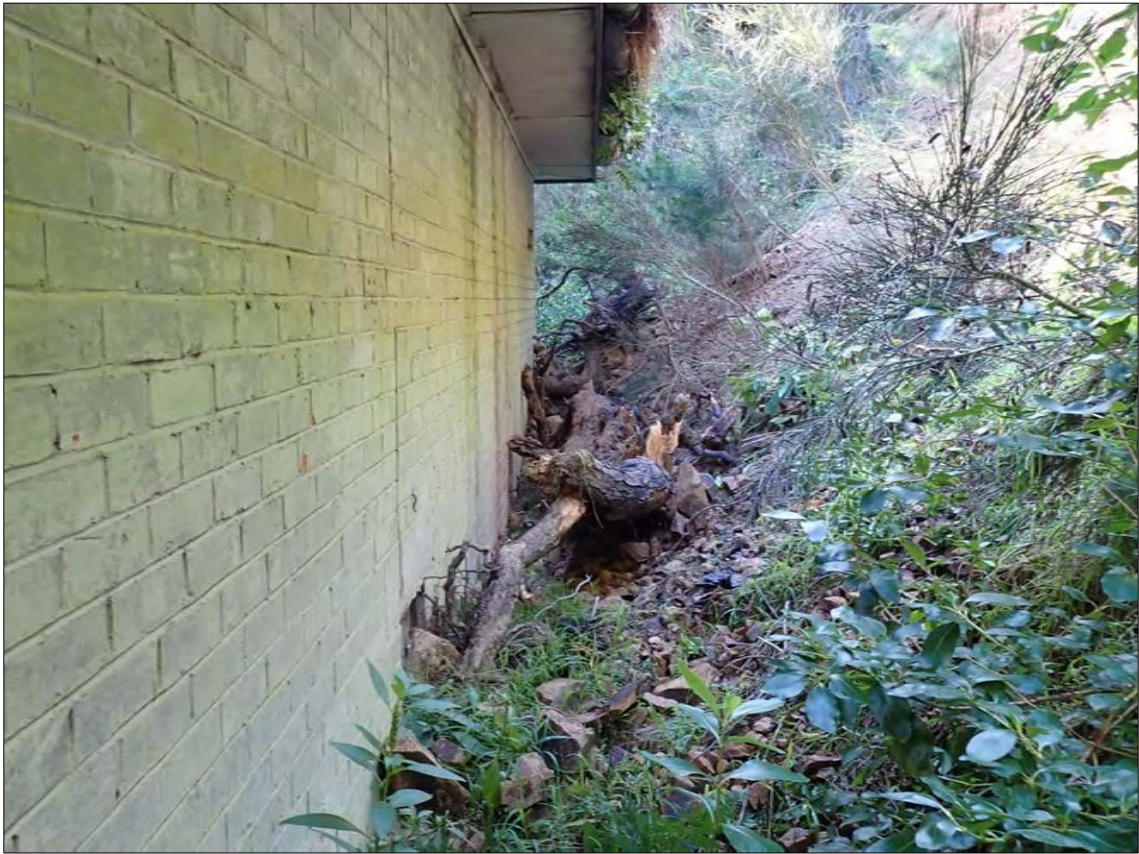
Figure 119. Feature 6: Magazine 6. Looking along the southeastern (rear) elevation – image cropped. A slip has occurred, and debris has accumulated against the structure.

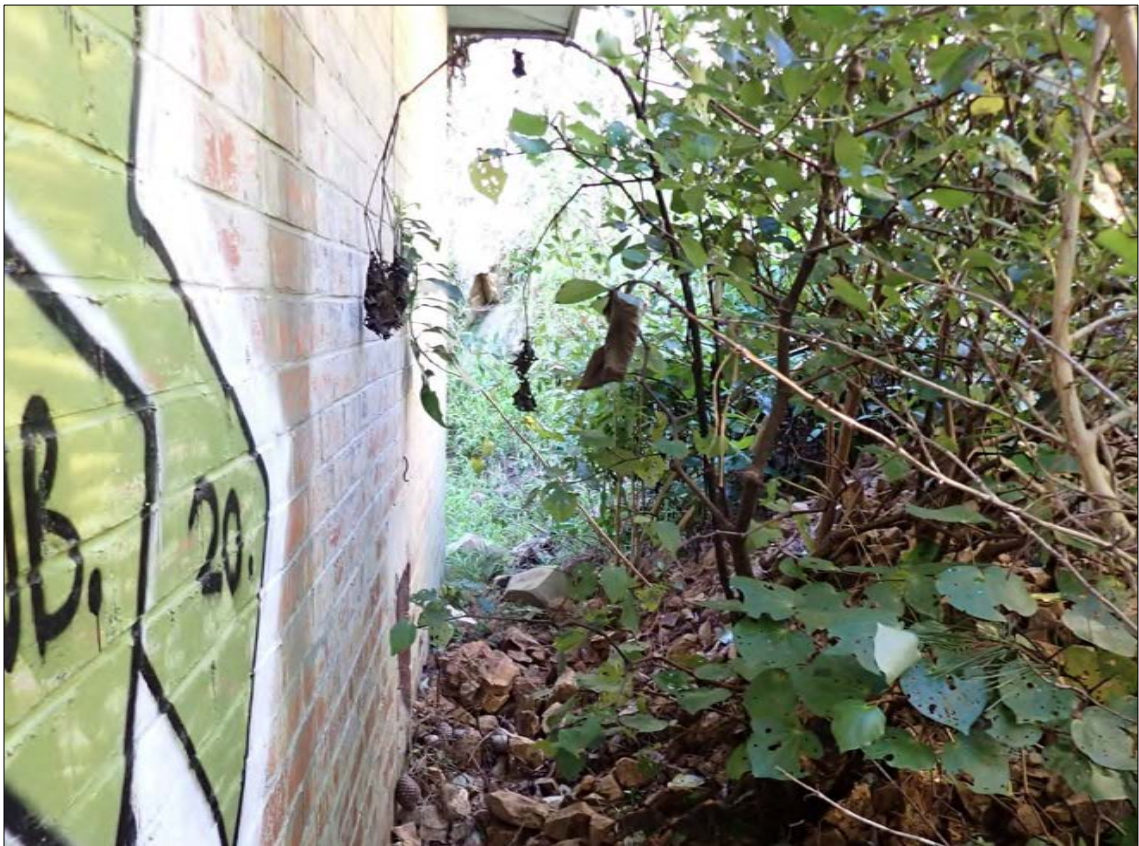
Figure 120. Feature 6: Magazine 6. Looking along the southeastern (rear) elevation – image cropped. Graffiti is present.

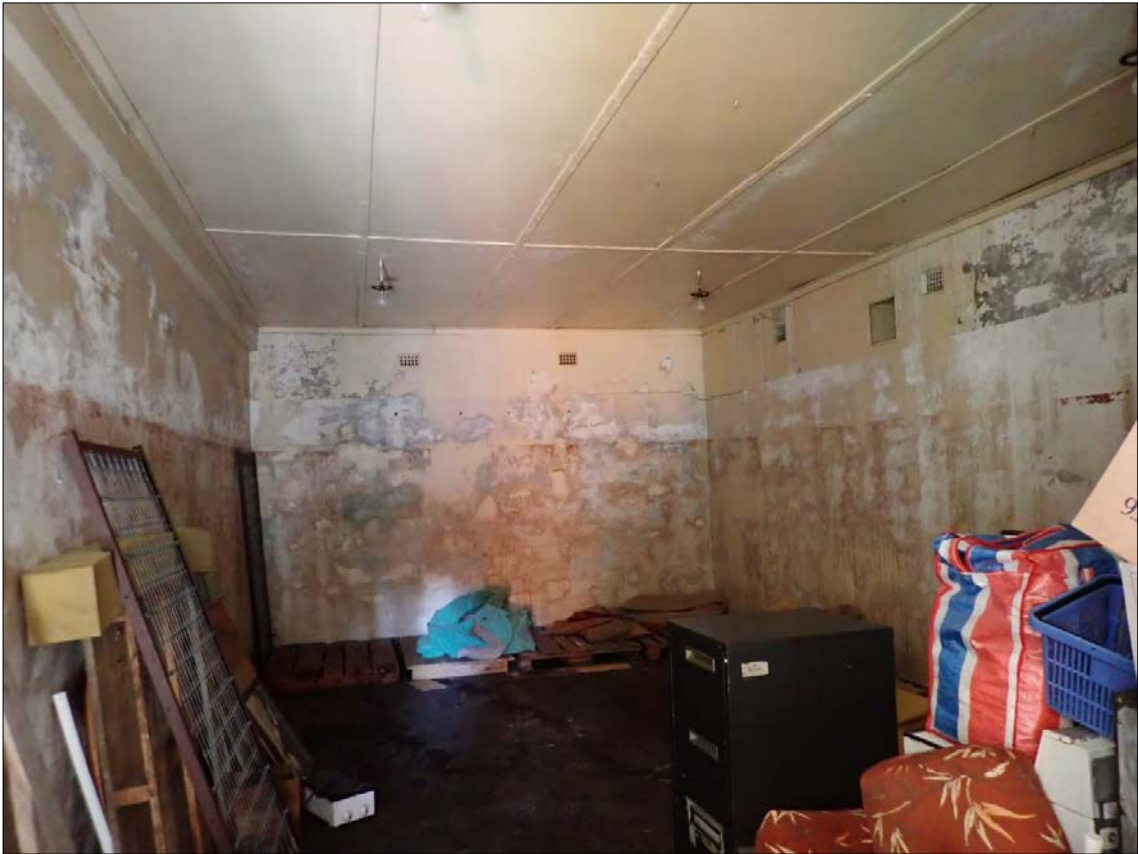
Figure 121. Feature 6: Magazine 6. Interior – Water penetration is evident. Some material goods remain within the structure.

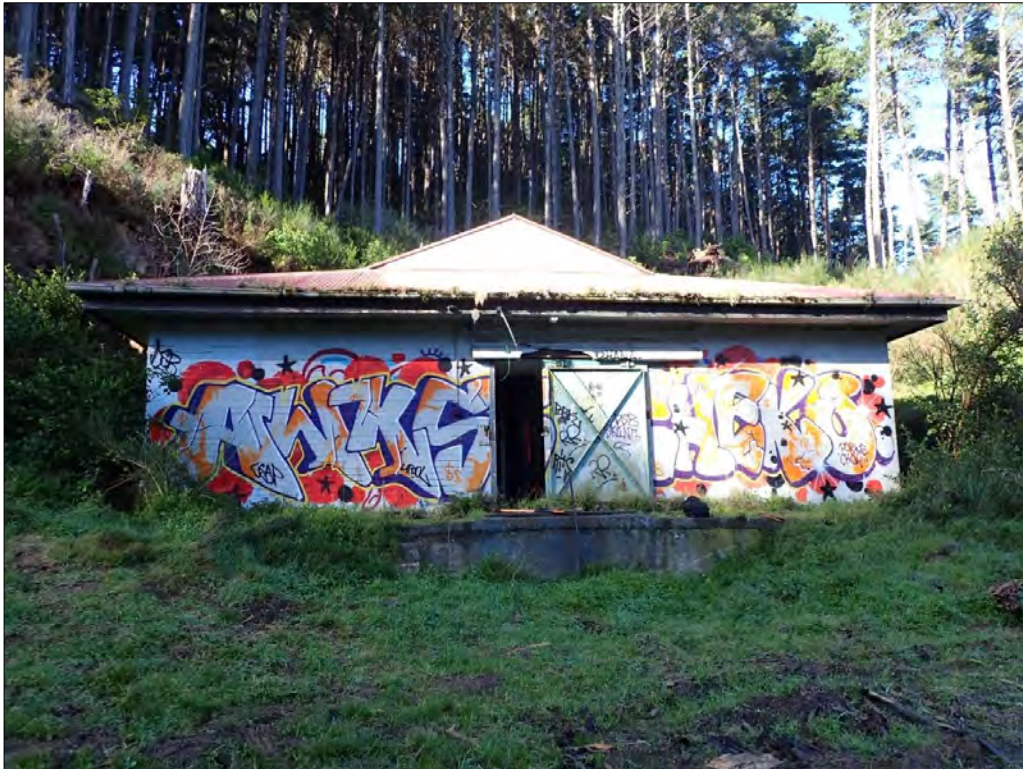
Figure 123. Feature 7: Magazine 7. Looking towards the northern (front) elevation. Graffiti is present. There is vegetation in the gutters.

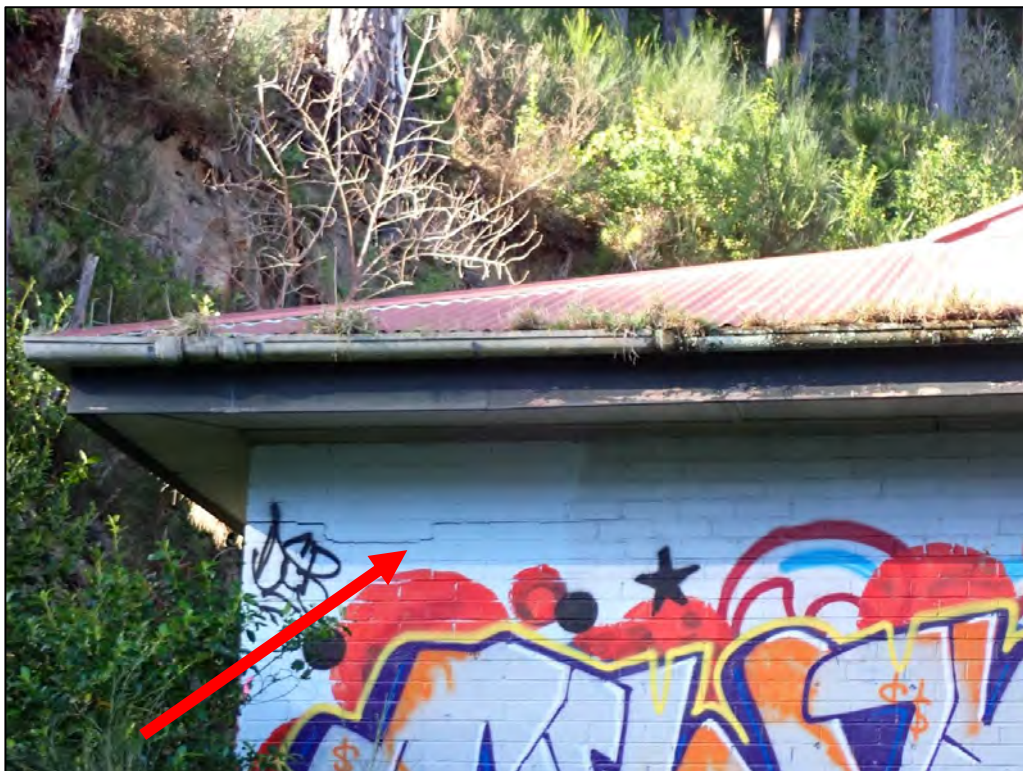
Figure 124. Feature 7: Magazine 7. Northern (front) elevation. Typical horizontal corner crack is indicated.

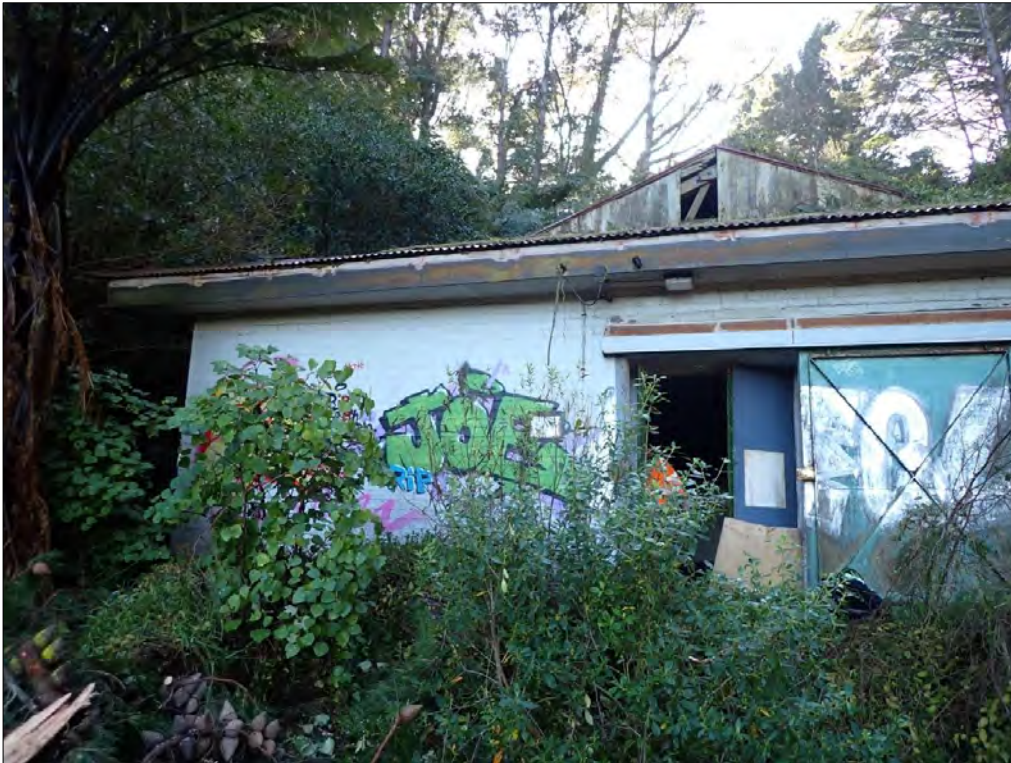
Figure 129. Feature 8: Magazine 8. Looking towards the western (front) elevation. Graffiti is present, the hipped gable is damaged, there are no gutters, and the narrow loading deck is being 'colonised' by vegetation.

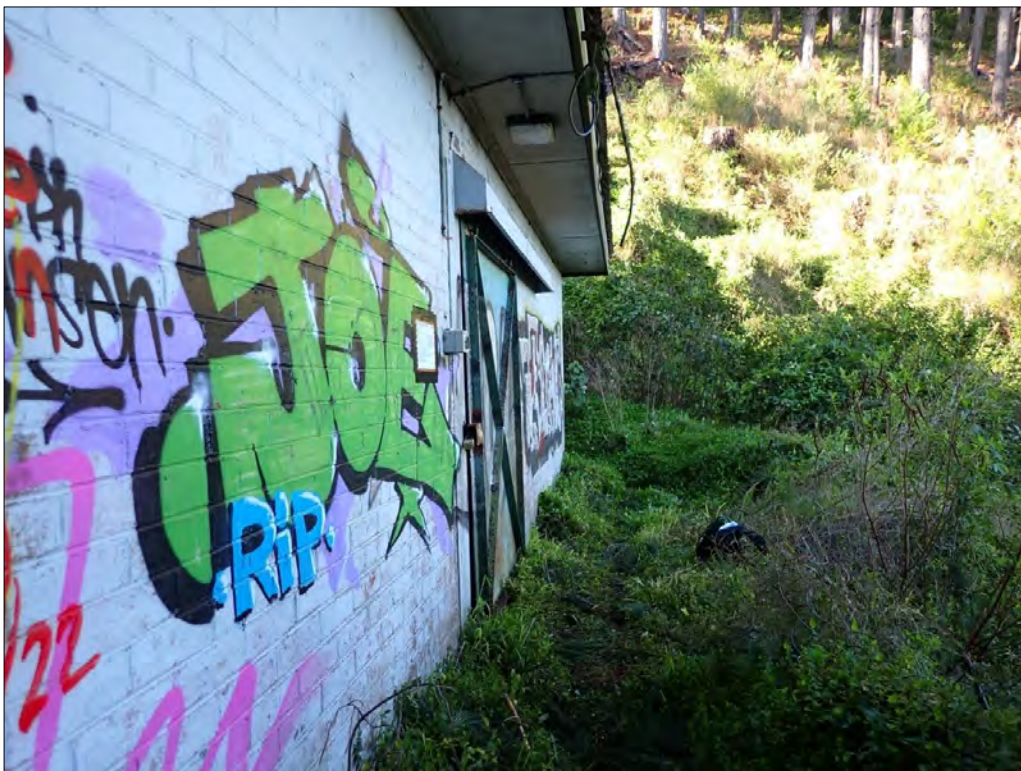
Figure 130. Feature 8: Magazine 8. Looking along the western (front) elevation. Vegetation is 'colonising' the loading deck.

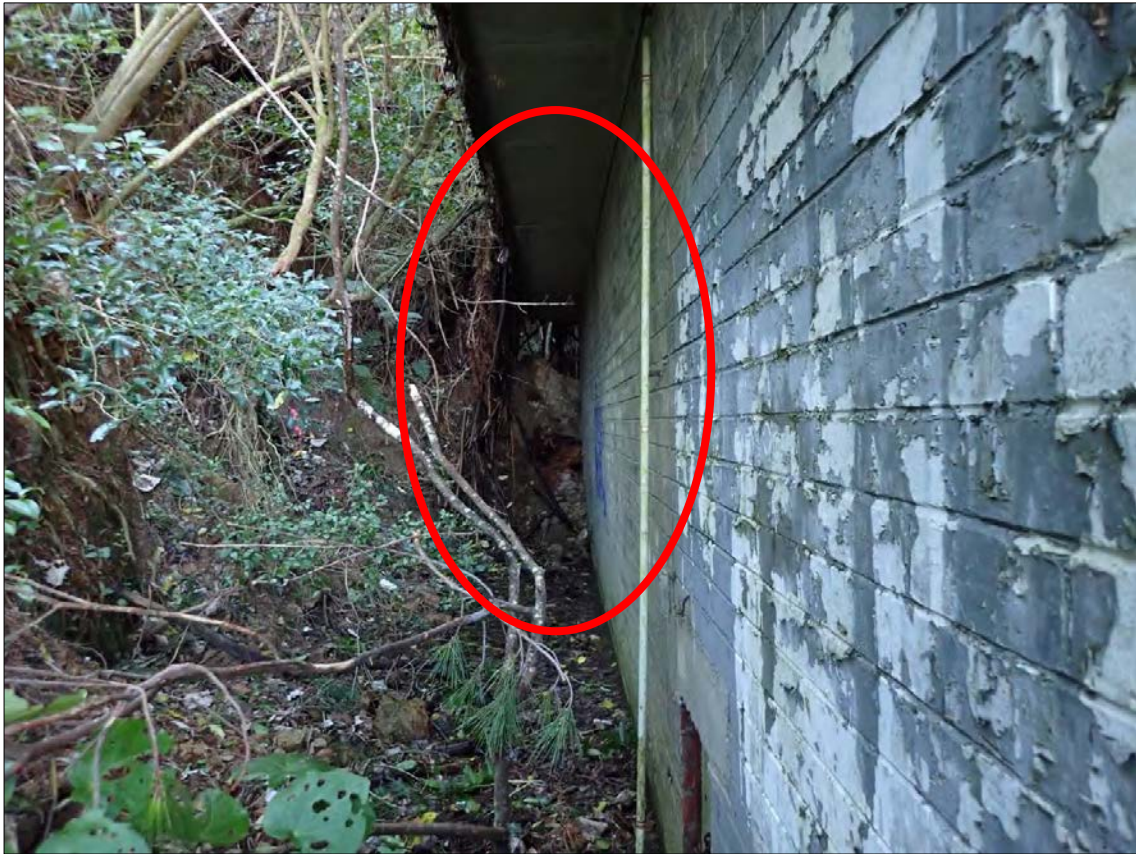
Figure 131. Feature 8: Magazine 8. Looking along the northern (side) elevation. Graffiti is present, and vegetation and debris are accumulating against the side of the structure. A slip is visible towards the rear.

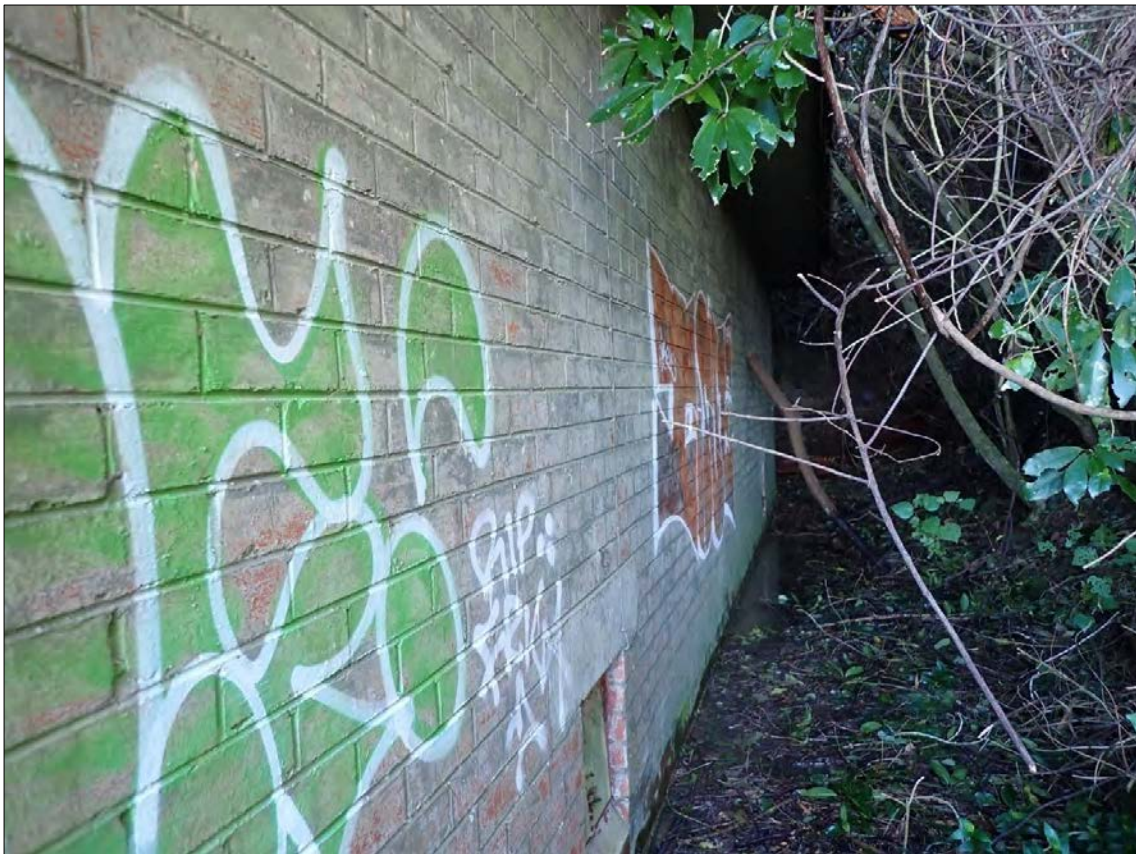
Figure 132. Feature 8: Magazine 8. Looking along the southern (side) elevation. Graffiti is present and water is ponding at the base of the structure.

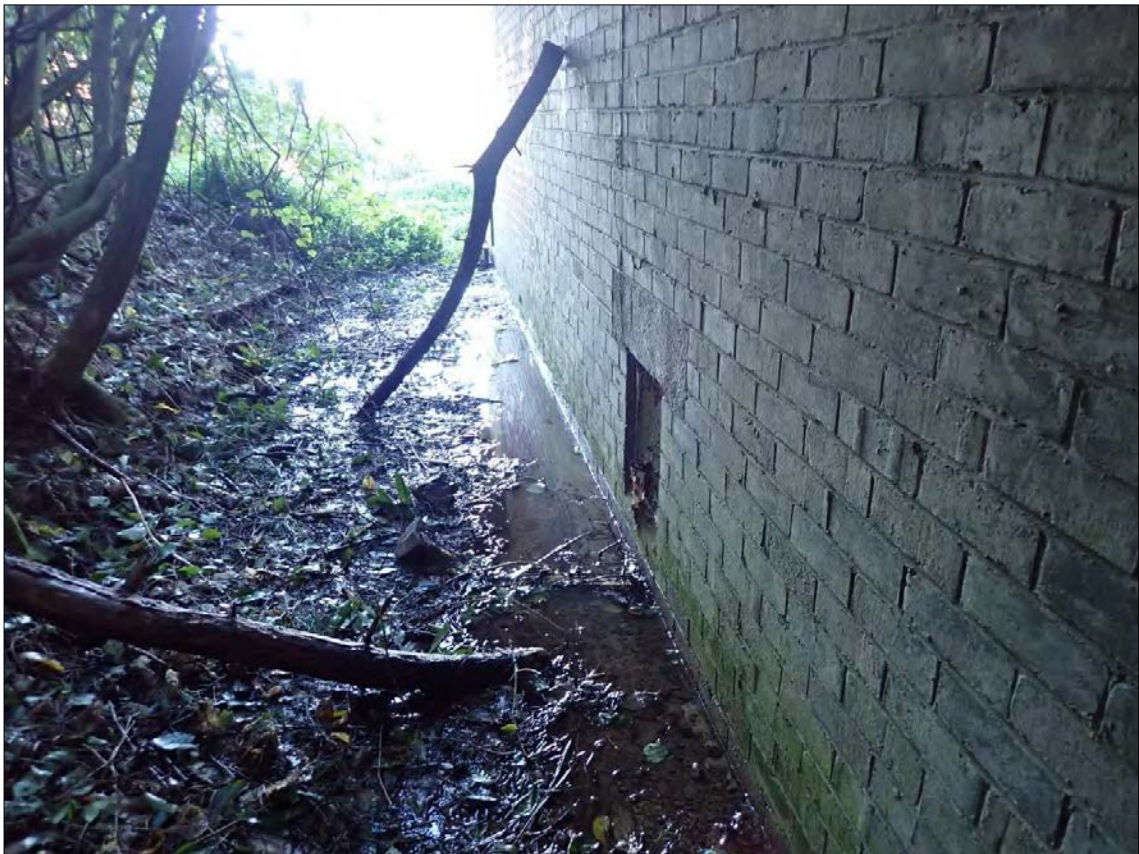
Figure 135. Feature 8: Magazine 8. Looking along the eastern (rear) elevation. Ponding is evident.

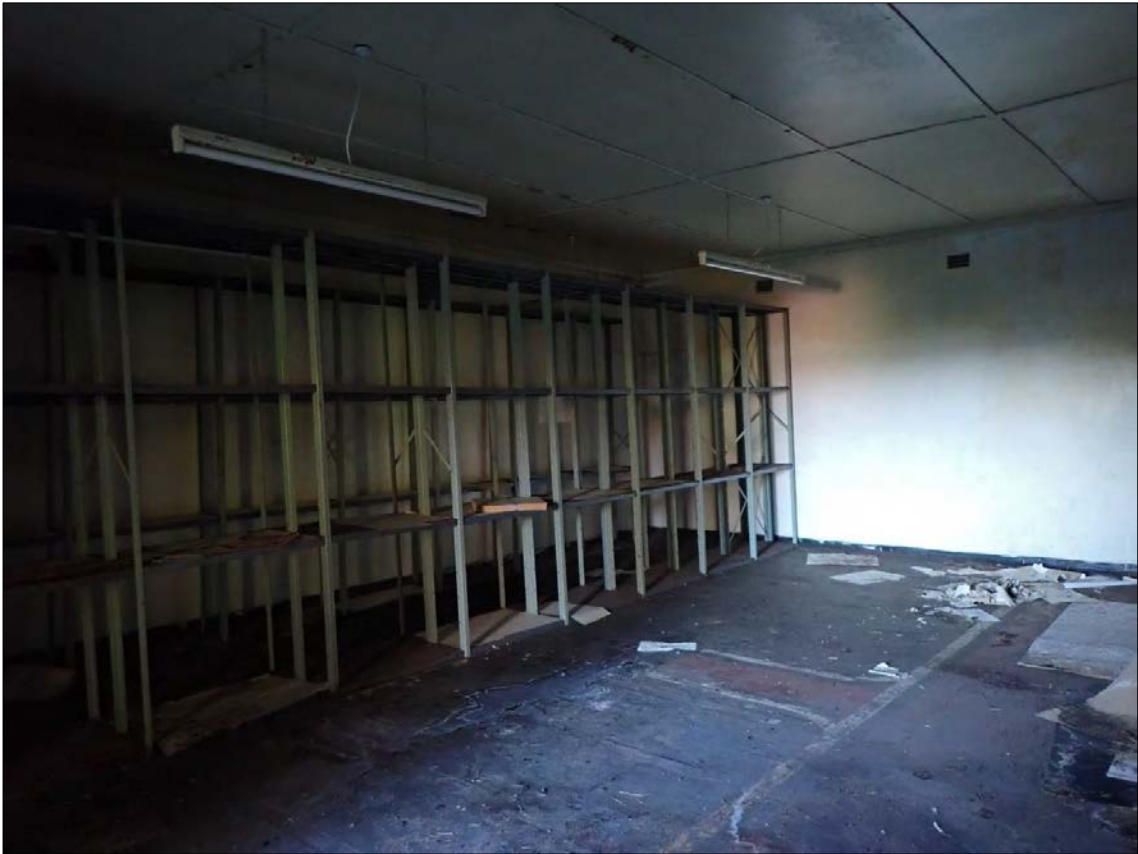
Figure 137. Feature 8: Magazine 8 Interior – Ceiling and fluorescent lights are present. Material goods associated with the most recent use remain within the structure.

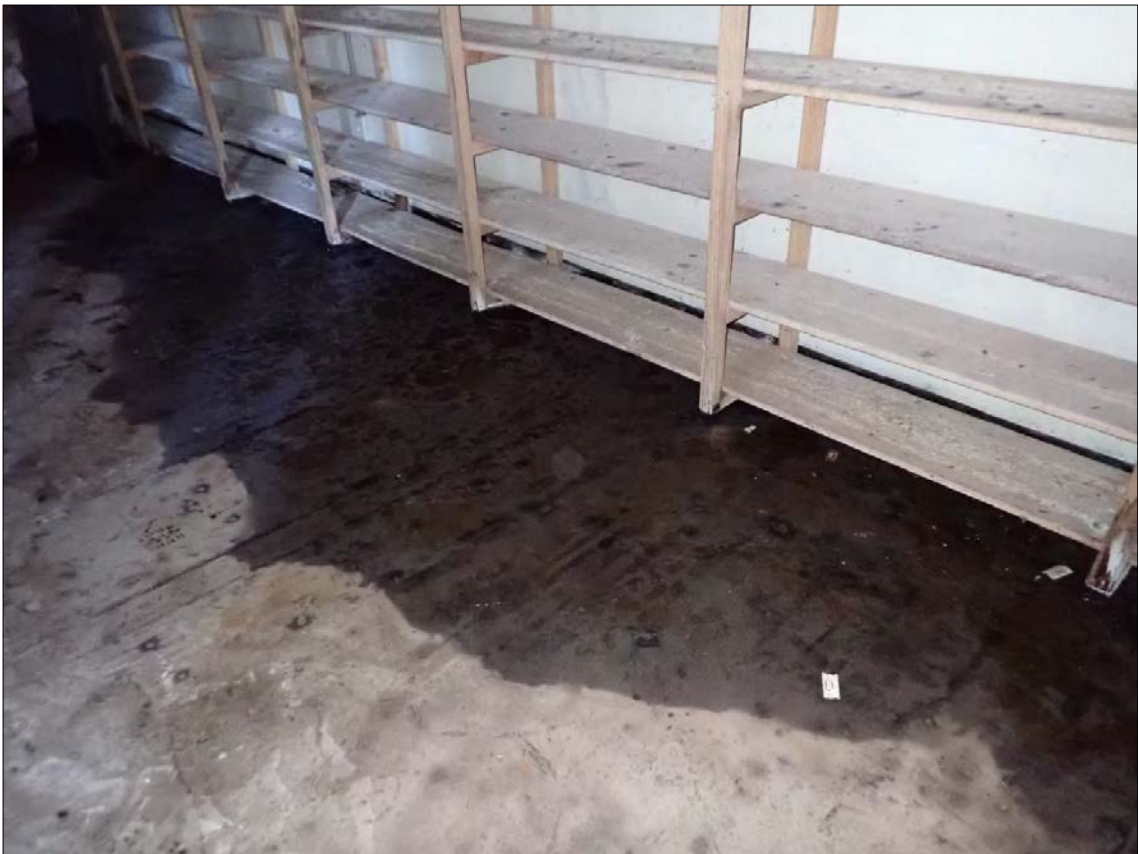
Figure 138. Feature 8: Magazine 8 Interior – Water is entering the structure.

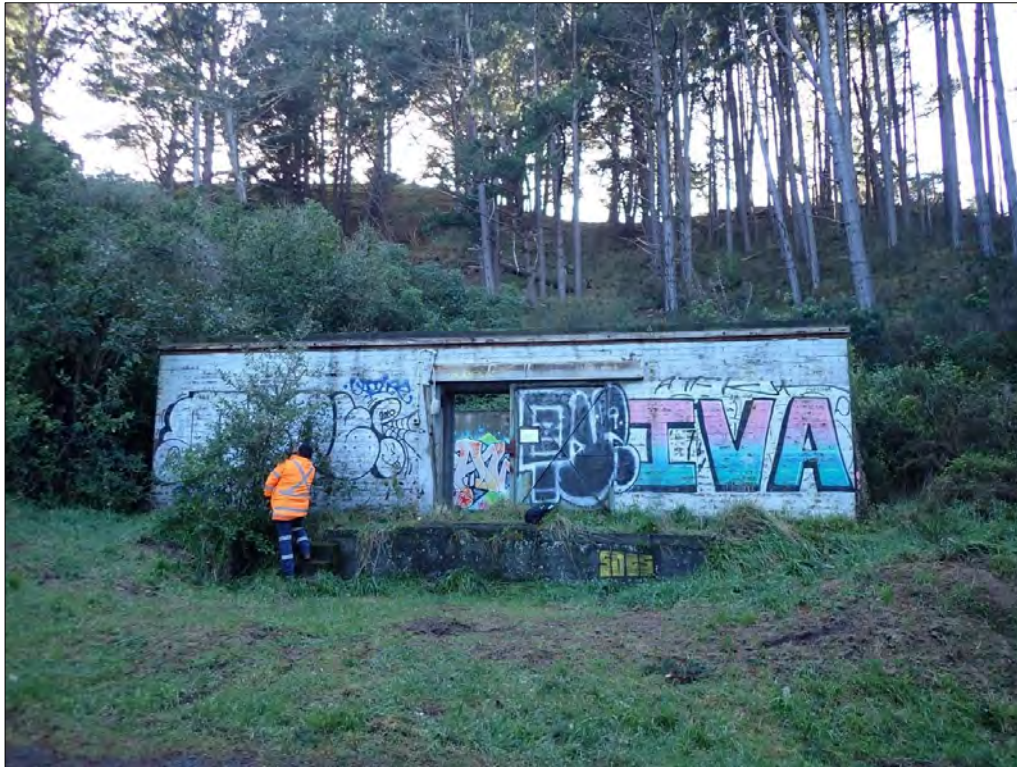
Figure 140: Feature 9: Magazine 9. Looking towards the western (front) elevation. Graffiti is present. The roof is missing.

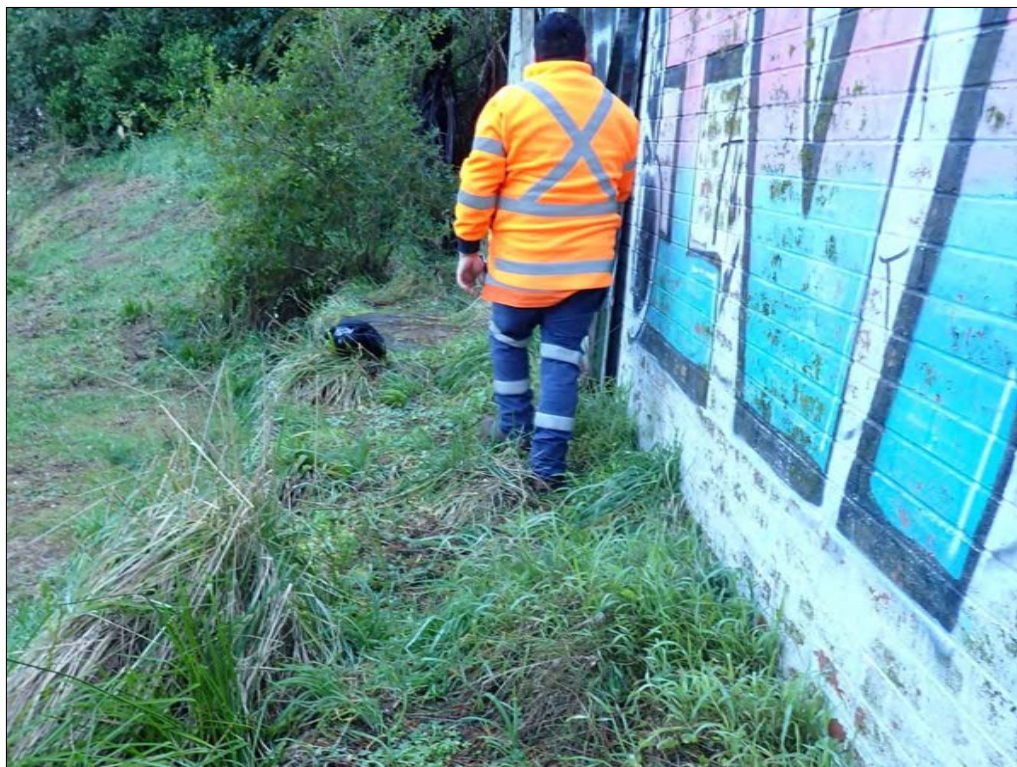
Figure 141. Feature 9: Magazine 9. The narrow loading deck at the western (front) elevation is becoming 'colonised' by vegetation.

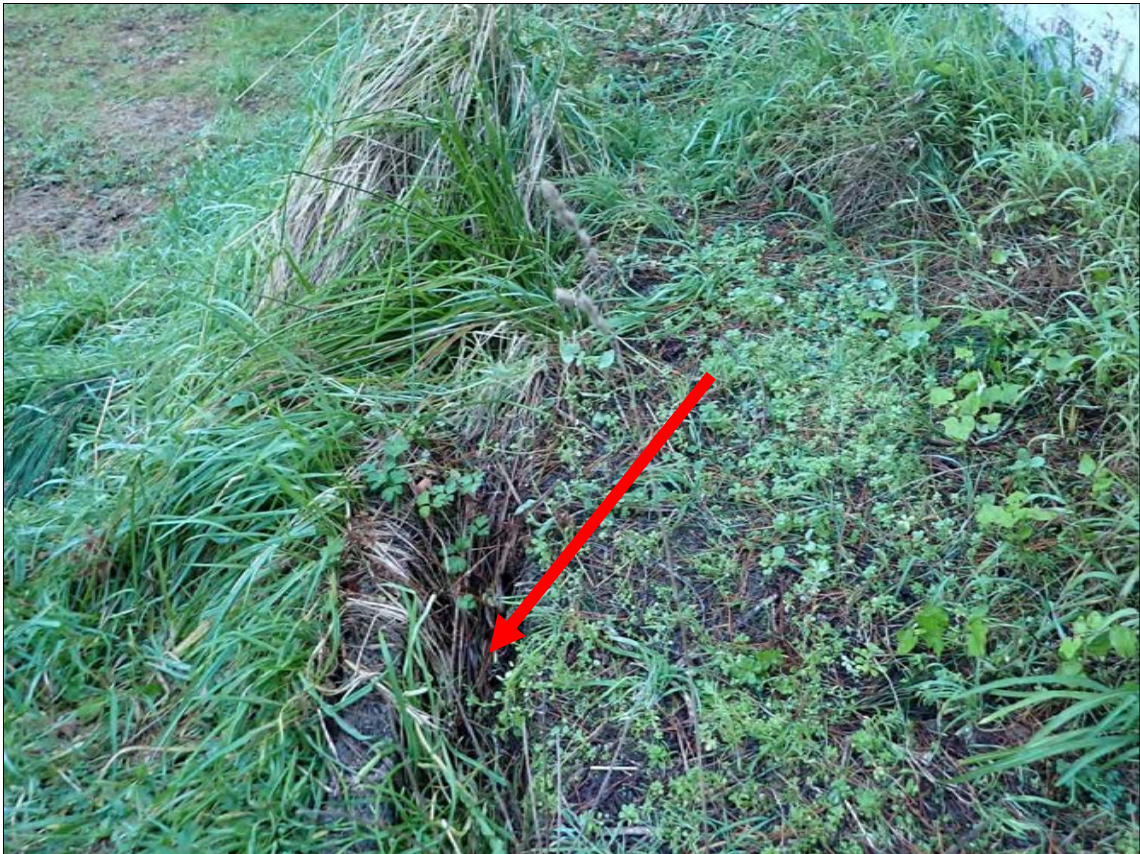
Figure 142. Feature 9: Magazine 9. The retaining wall to the front of the narrow loading deck is overturning – image cropped.

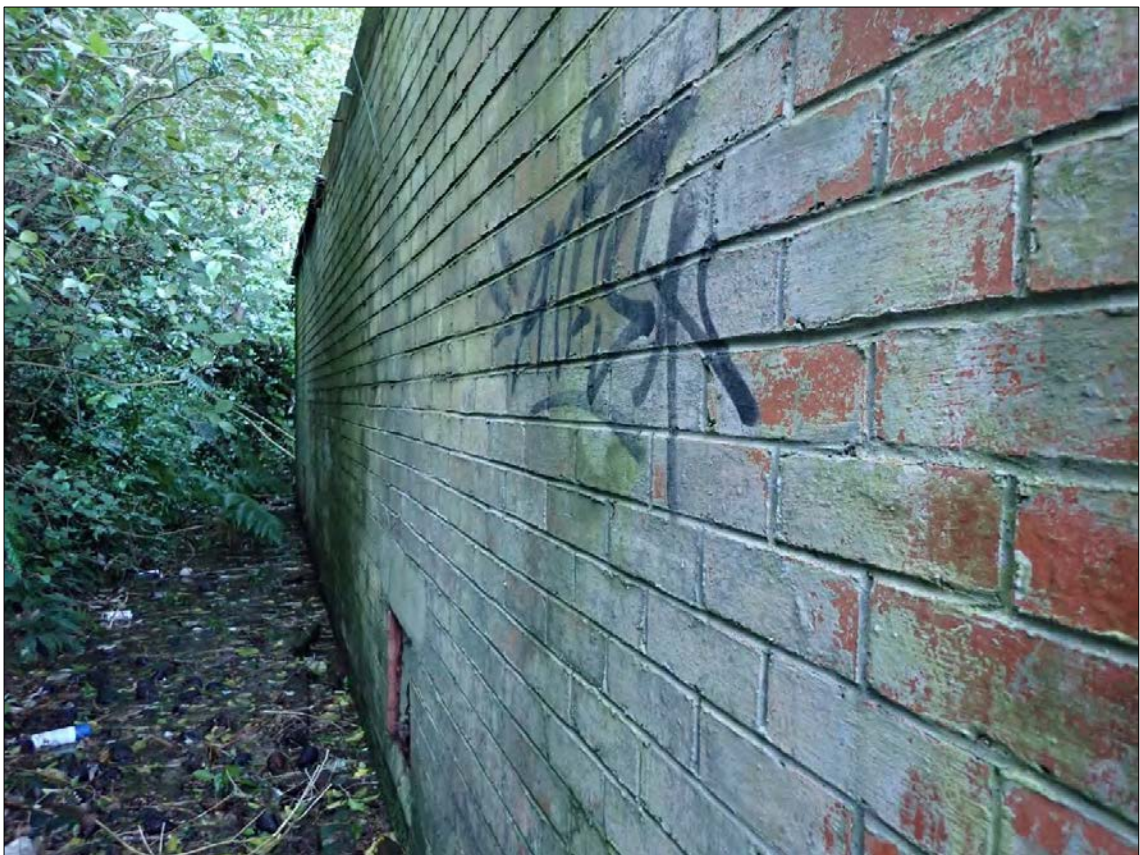
Figure 143. Feature 9: Magazine 9 Looking along the northern (side) elevation. Graffiti is present and water is ponding against the side of the structure.

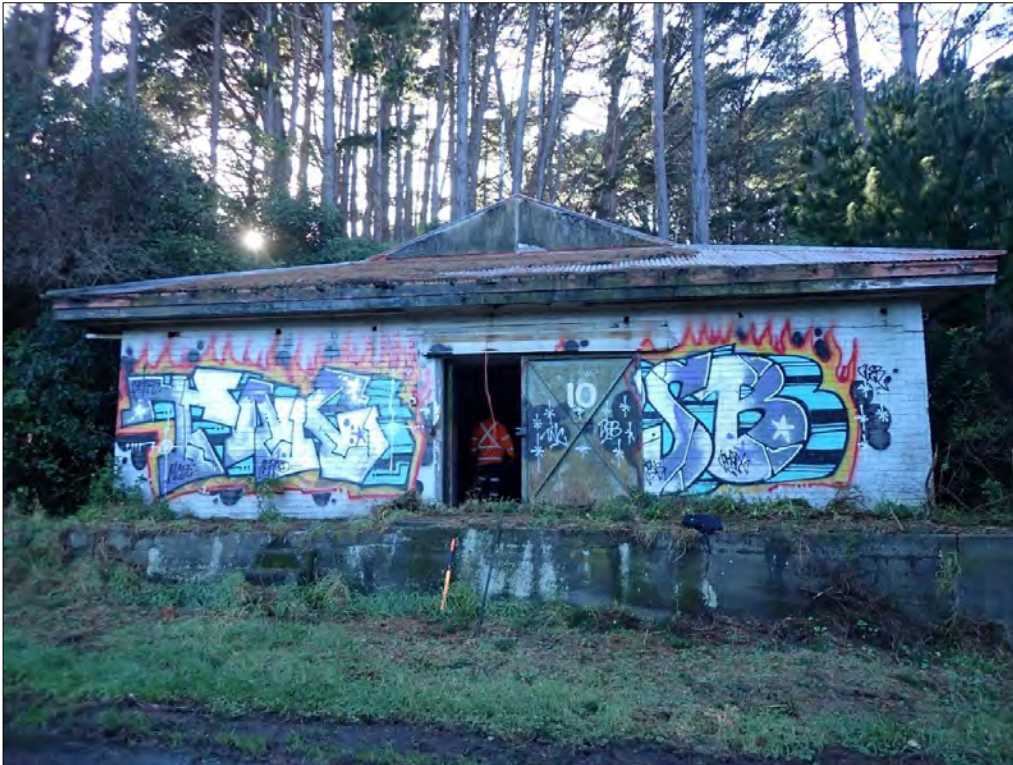
Figure 148. Feature 10: Magazine 10. Looking towards the western (front) elevation. Graffiti is present. The gutters are missing, and the narrow loading deck is being 'colonised' by vegetation.

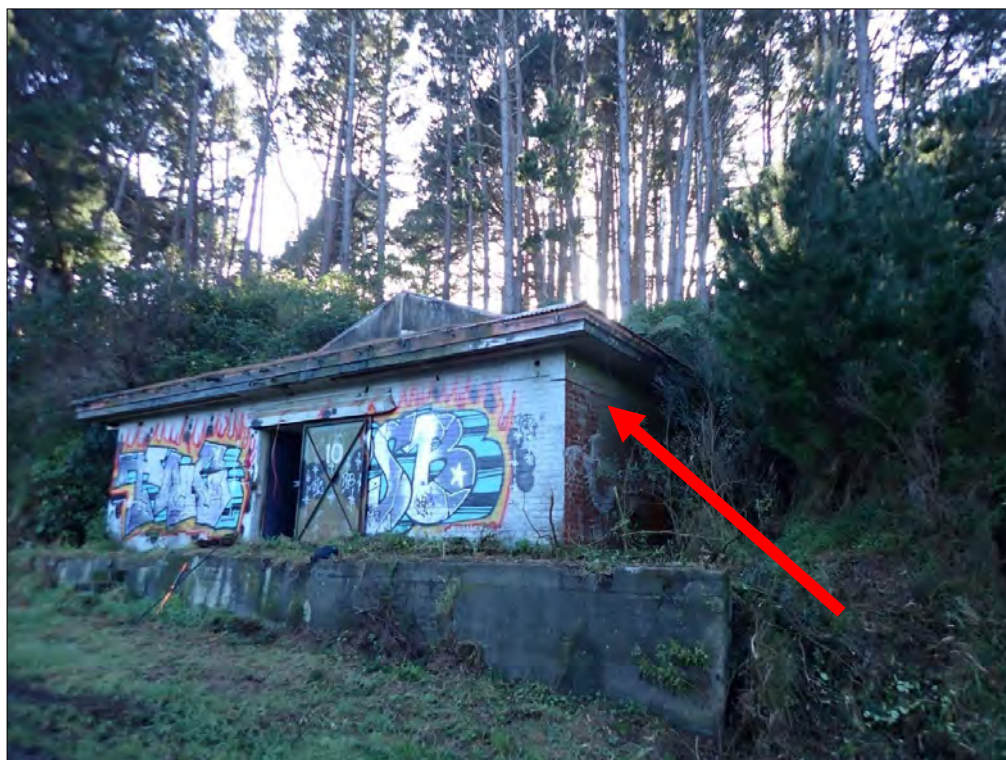
Figure 149. Feature 10: Magazine 10. Looking east towards the western (front) elevation. Typical horizontal corner crack is indicated.

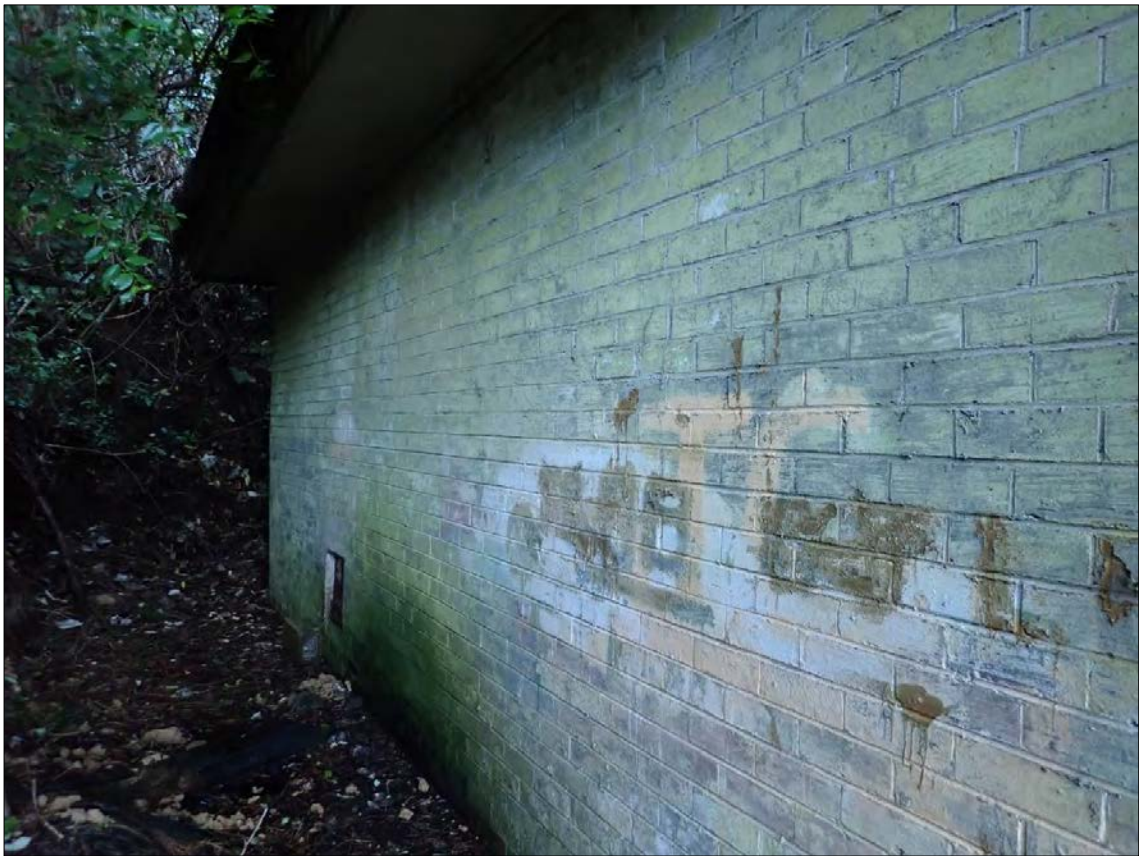
Figure 150. Feature 10: Magazine 10. Looking along the northern (side) elevation. Anti-graffiti coating is present.

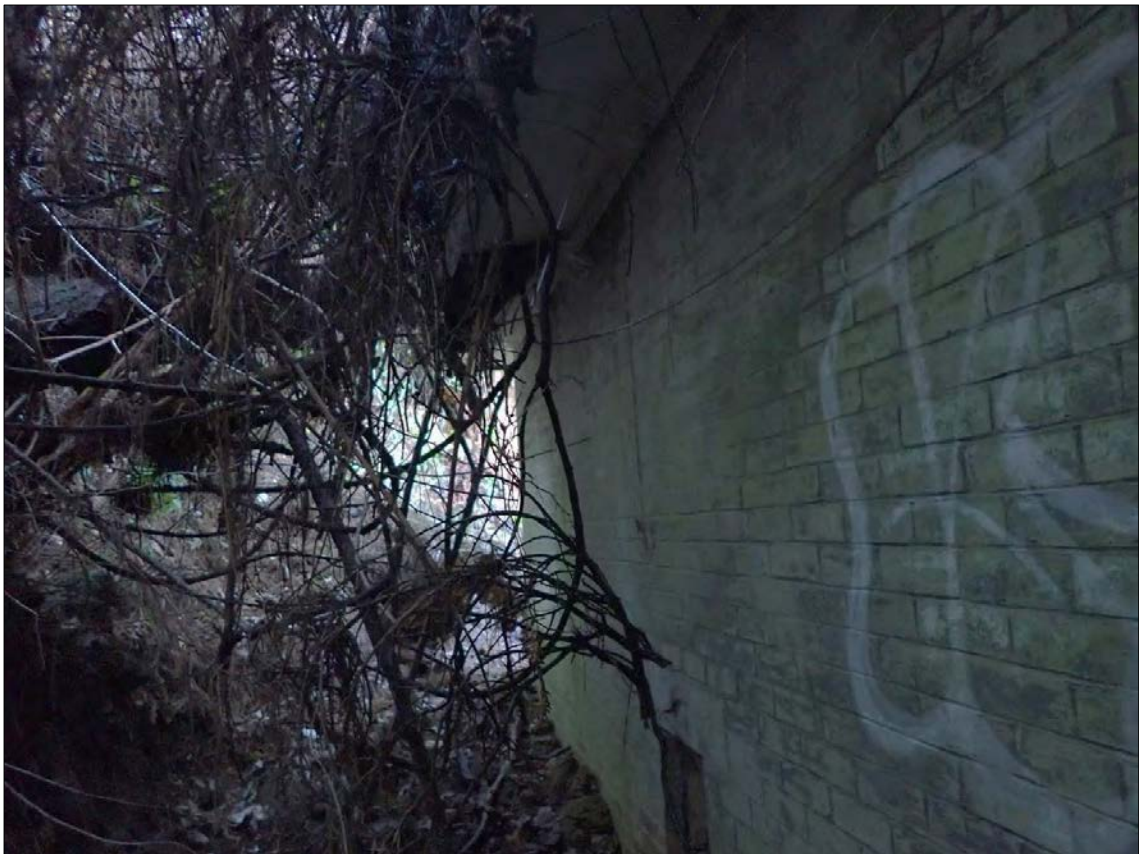
Figure 153. Feature 10: Magazine 10. Looking along the eastern (rear) elevation. Vegetation and debris have accumulated against the side of the structure. Graffiti is present.
