Watts Peninsula, Wellington

Heritage and condition assessment

Report Prepared for Toitū Te Whenua Land Information New Zealand

Submitted: December 2022

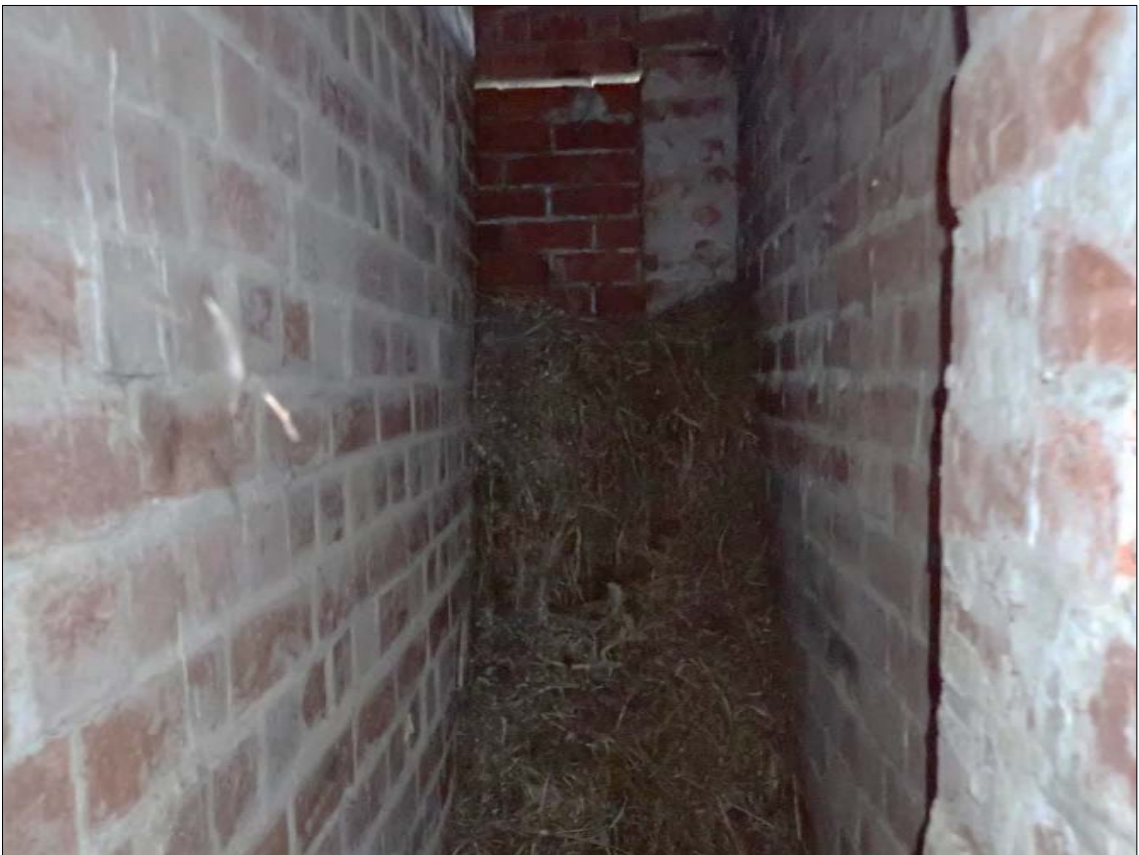
Figure 155. Feature 10: Magazine 10. Interior – Accumulation of straw(?) in the narrow passageway between the outer wall and the inner room – image cropped.

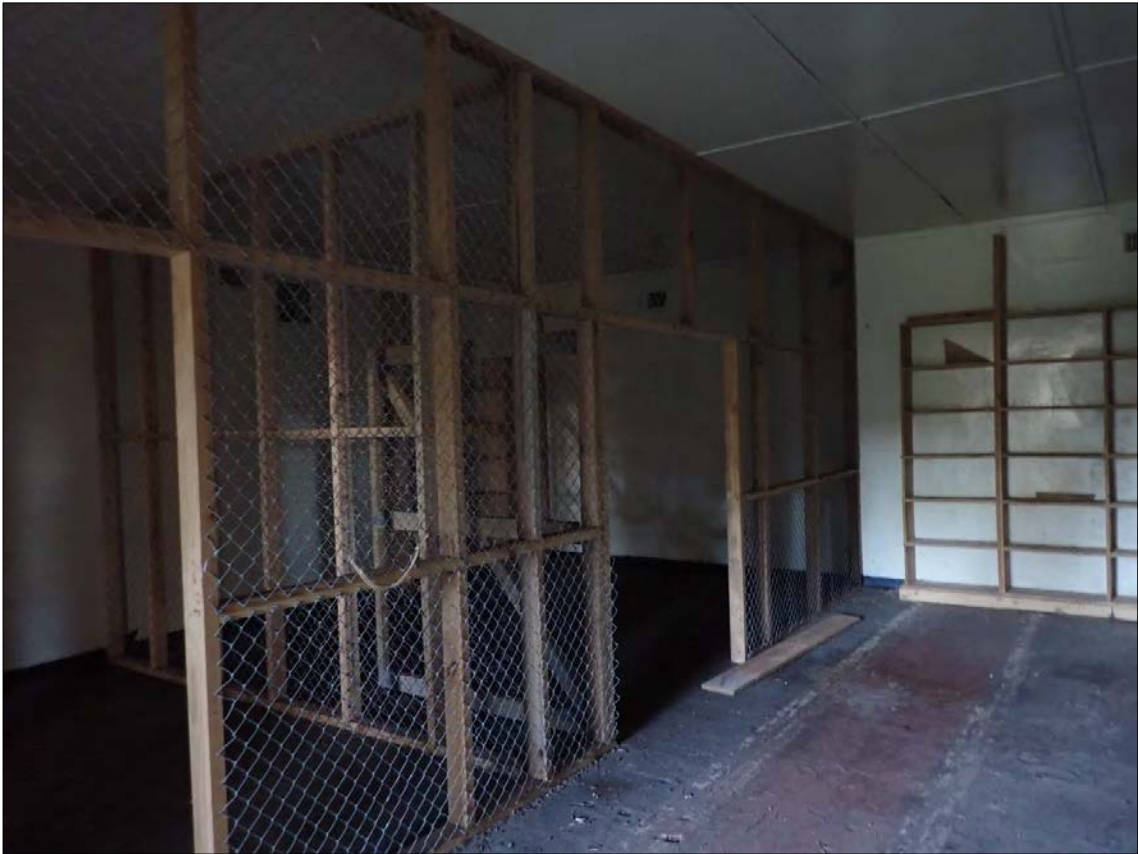
Figure 156. Feature 10: Magazine 10. Interior – Ceiling is present. Room dividers associated with the most recent use remain within the structure.

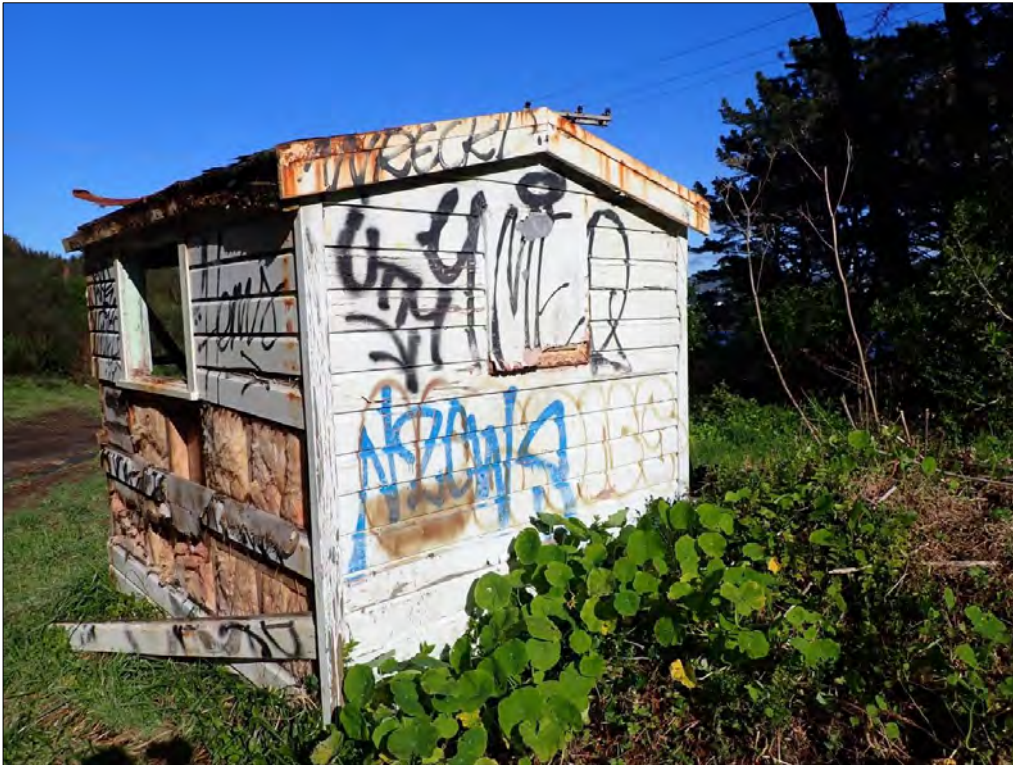
Figure 158. Feature 11: Hut (former use unknown). Looking southwest. Graffiti is present, weatherboards are coming away and rainwater goods are no longer in position.

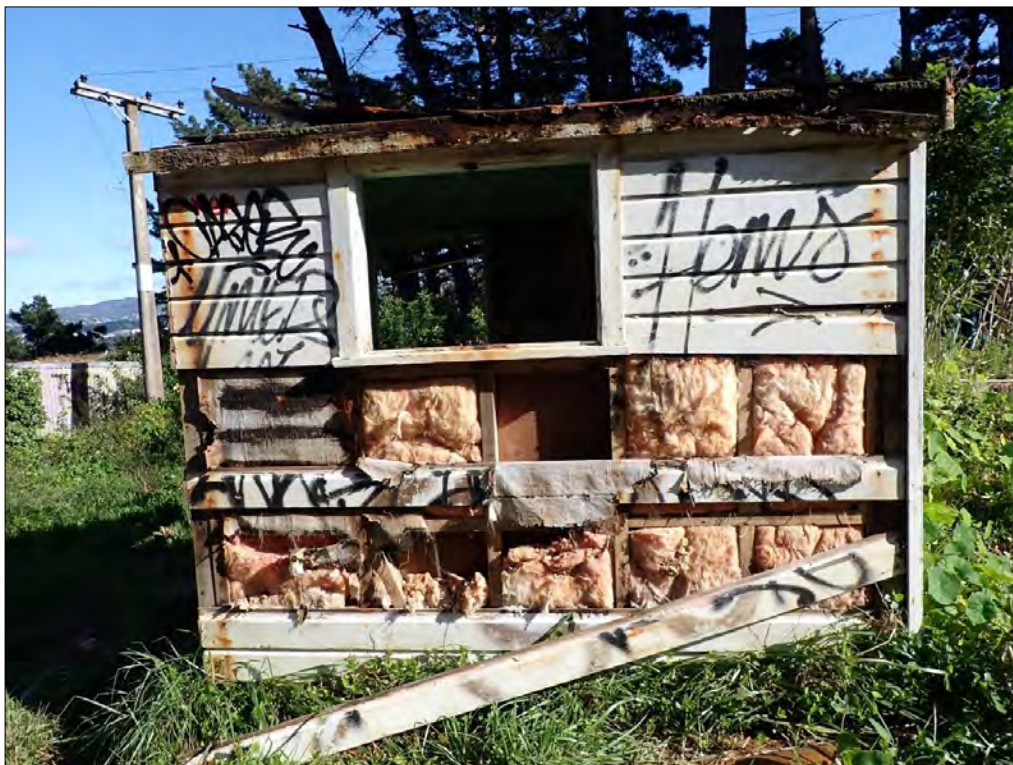
Figure 159. Feature 11: Hut (former use unknown). Looking towards the western elevation. Graffiti is present, weatherboards are coming away, window and rainwater goods are no longer in position.

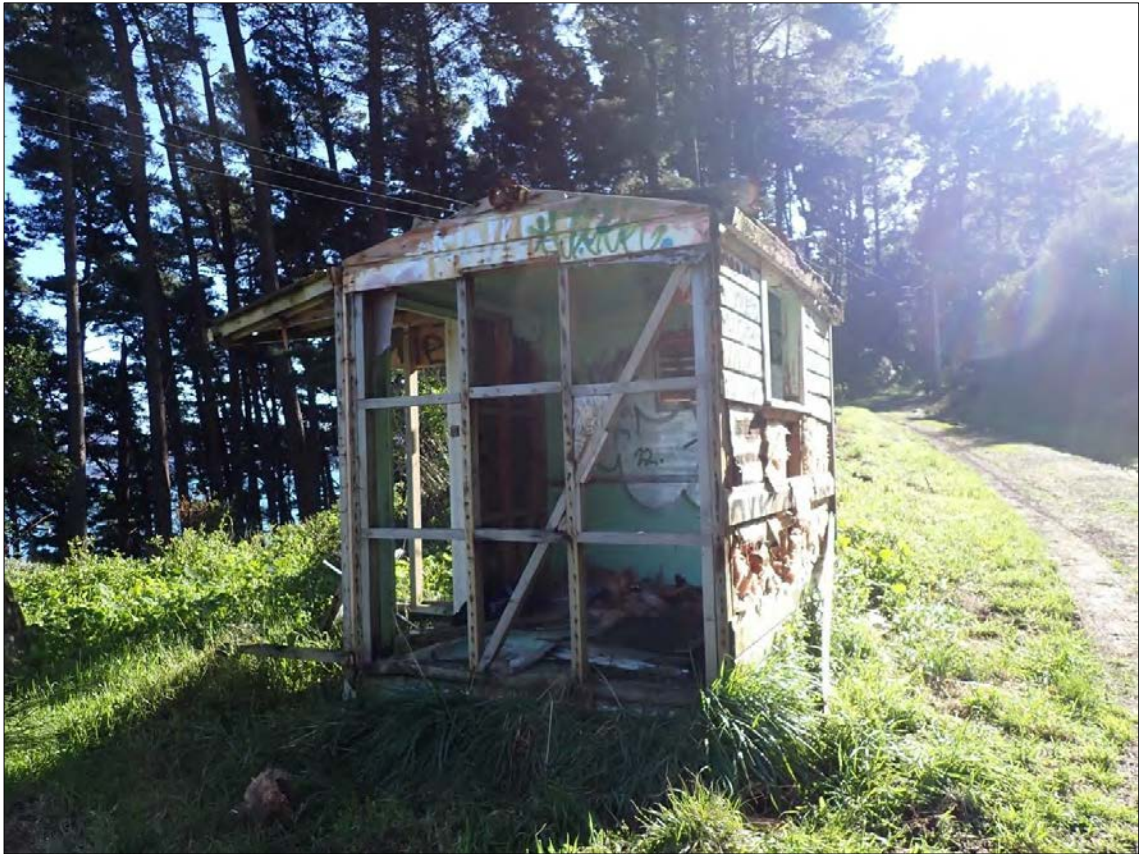
Figure 160. Feature 11: Hut (former use unknown). Looking towards the northern elevation. The weatherboards have come away and the remains of a small entrance porch is visible to the RHS.

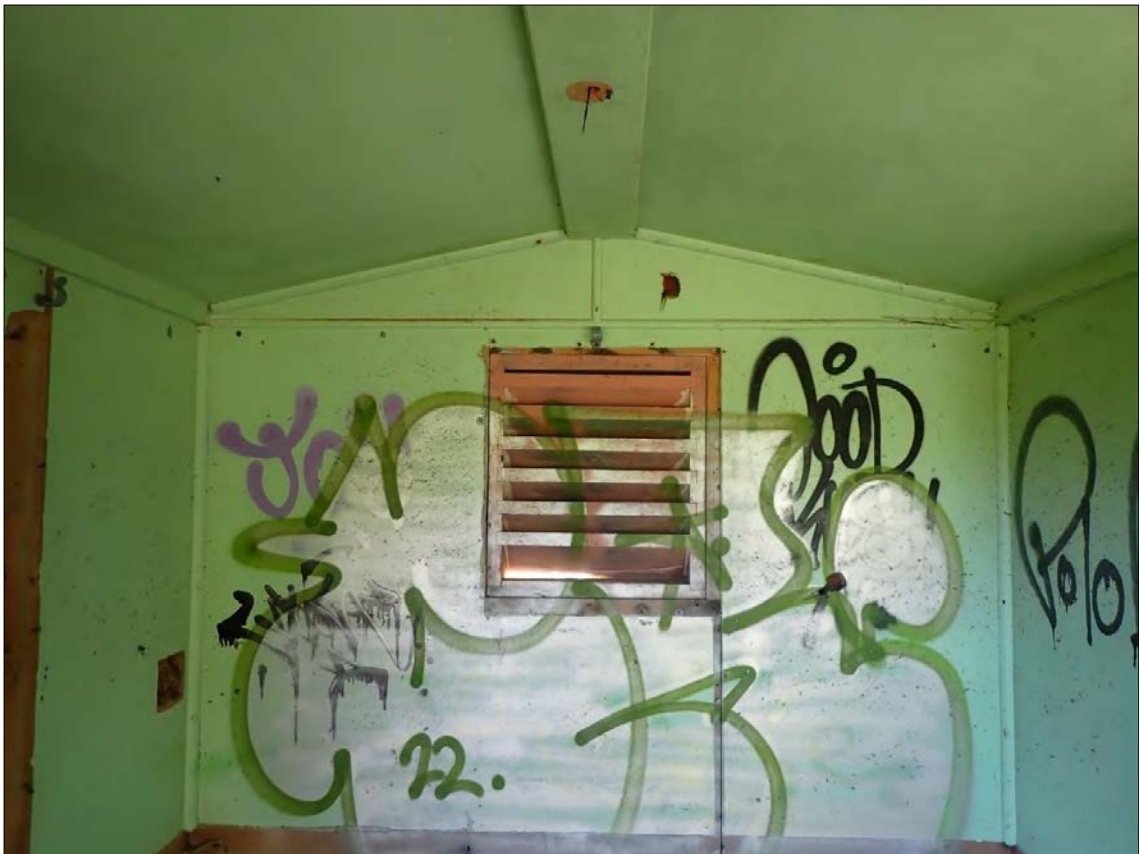
Figure 161. Feature 11: Hut (former use unknown). Interior – Timber louvre in northern elevation. Graffiti is present. Wall panelling has half round coverstrips.

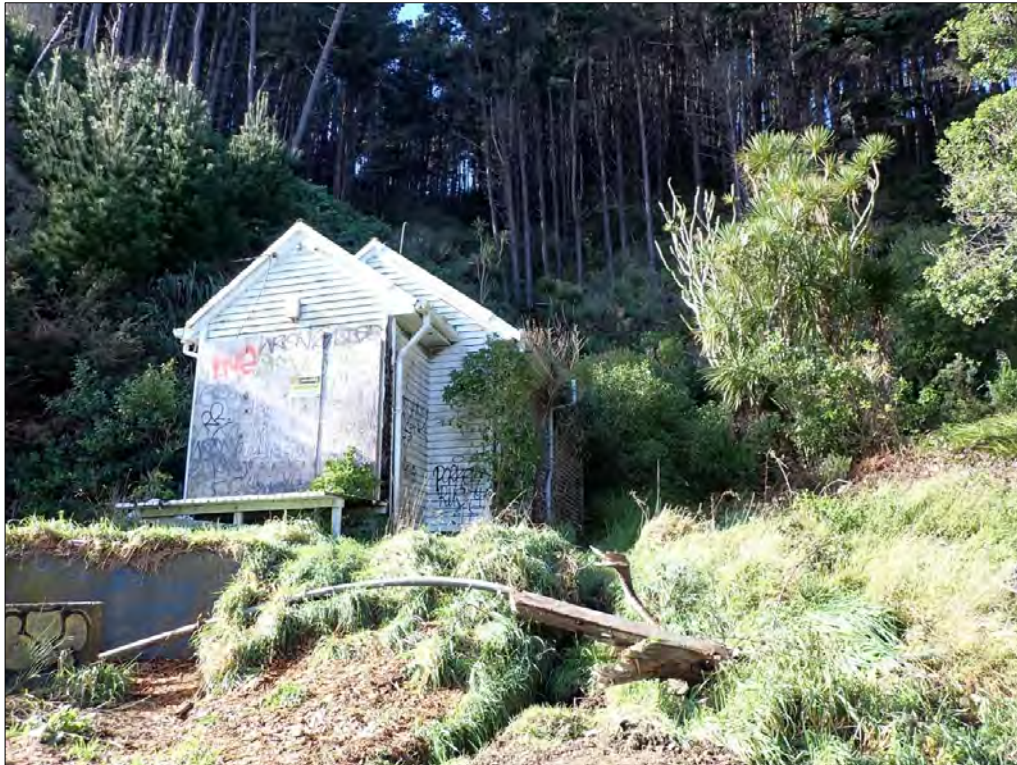
Figure 162. Feature 12: Former sergeant's house. Looking towards the western (front) elevation. Graffiti is present and openings have been boarded up. Vegetation is encroaching onto the house.

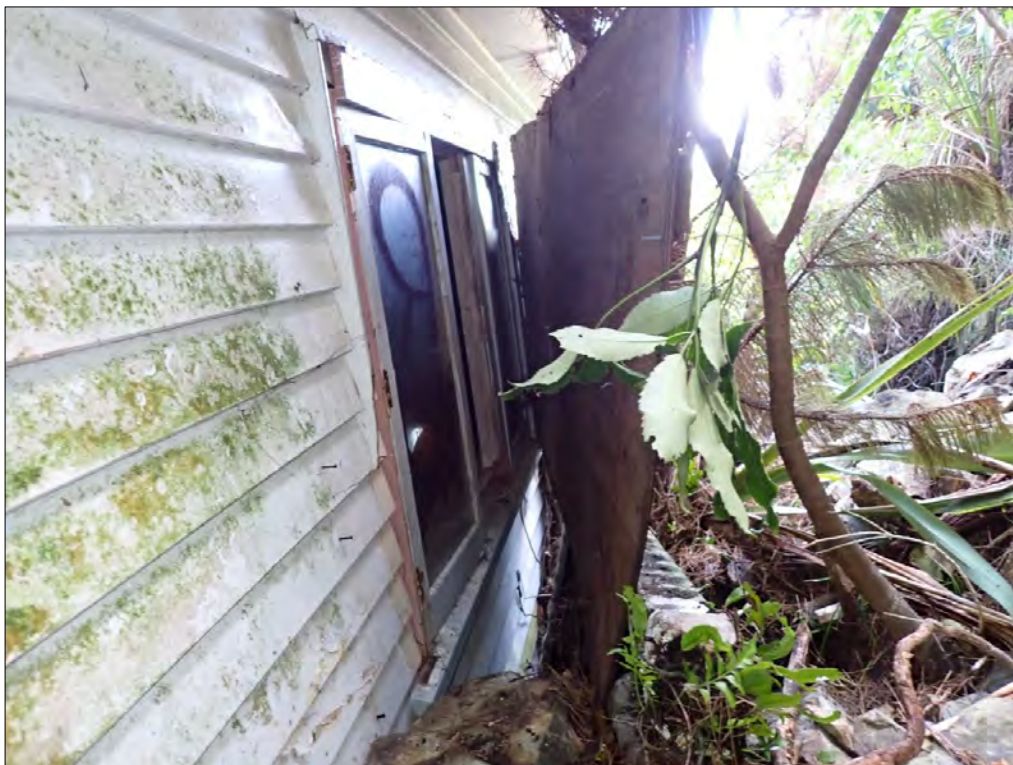
Figure 163. Feature 12: Former sergeant's house. Looking along the northern (side) elevation. Window boarding has been partially removed and access to the house is possible. Debris, the result of a slip, has accumulated against the house.

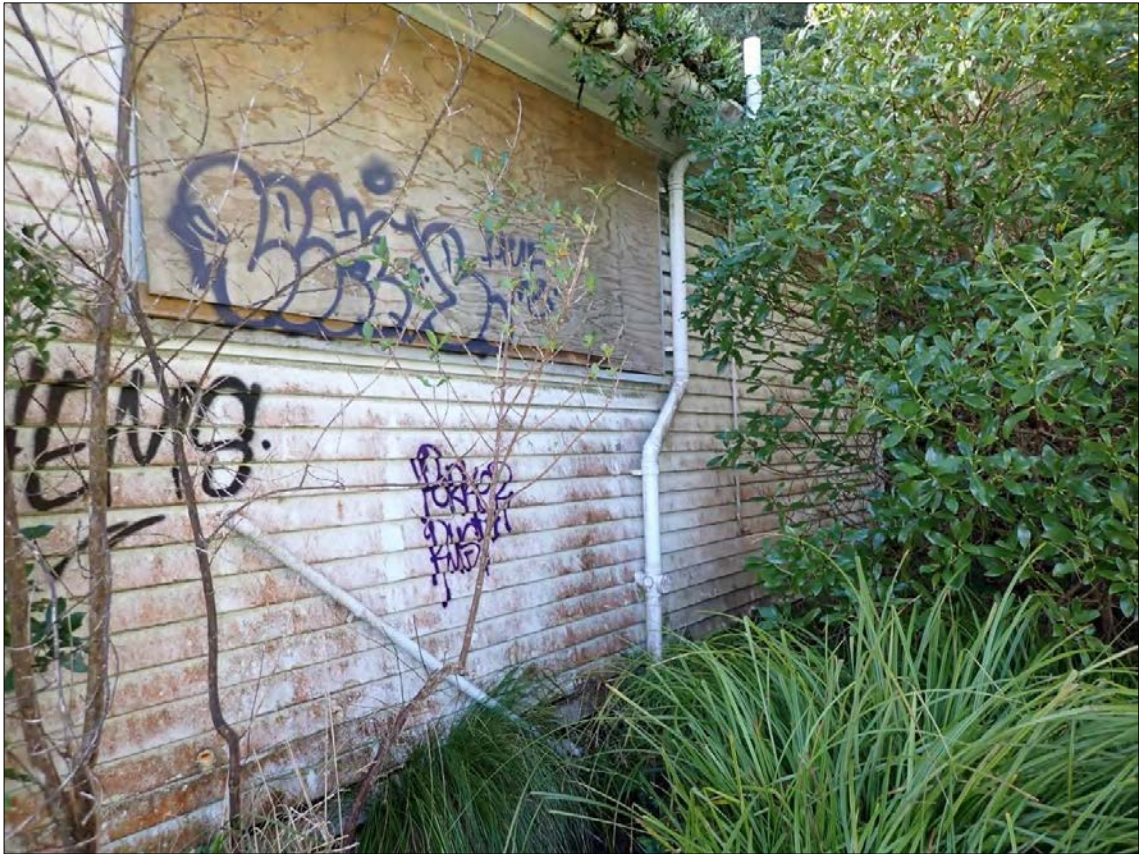
Figure 164. Feature 12: Former sergeant's house. Looking along the southern (side) elevation. Graffiti is present and openings have been boarded up. Vegetation is encroaching onto the house and there is vegetation in the gutters.

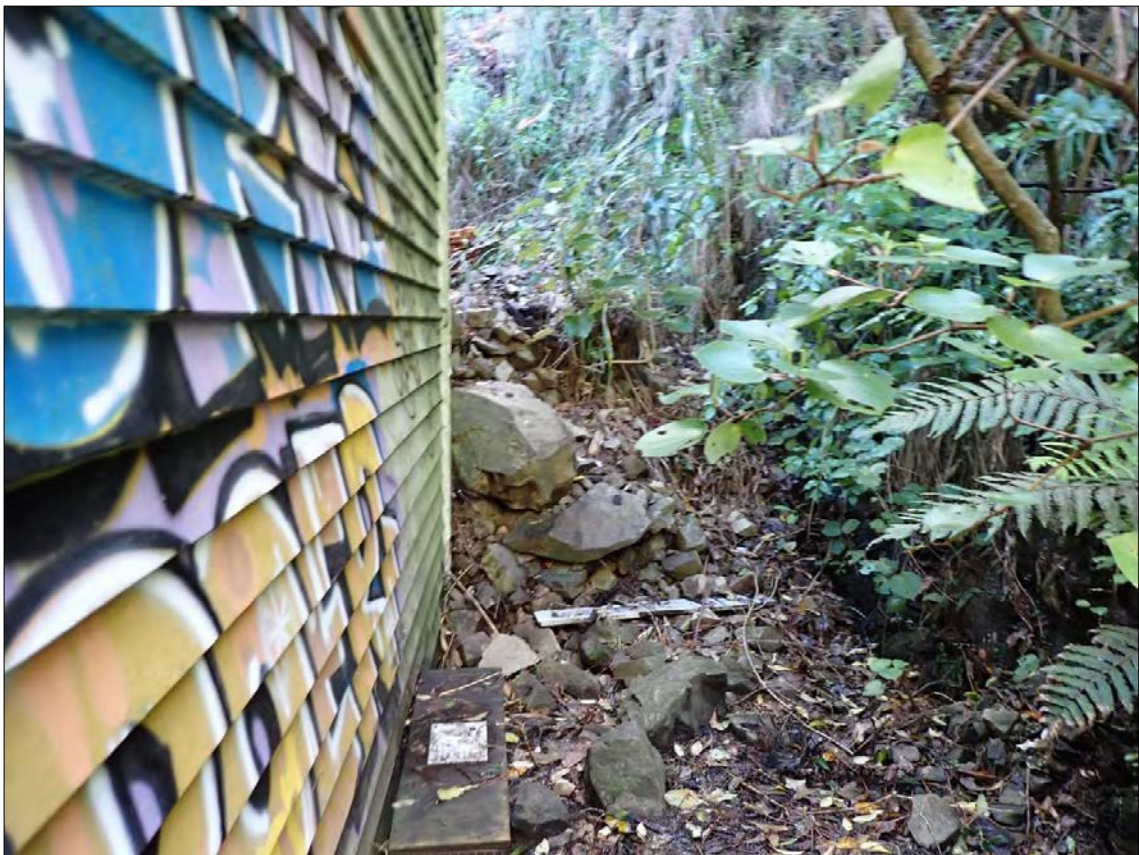
Figure 165. Feature 12: Former sergeant's house. Looking along the eastern (rear) elevation. A slip has occurred, and debris and vegetation have accumulated against the structure. Graffiti is present.

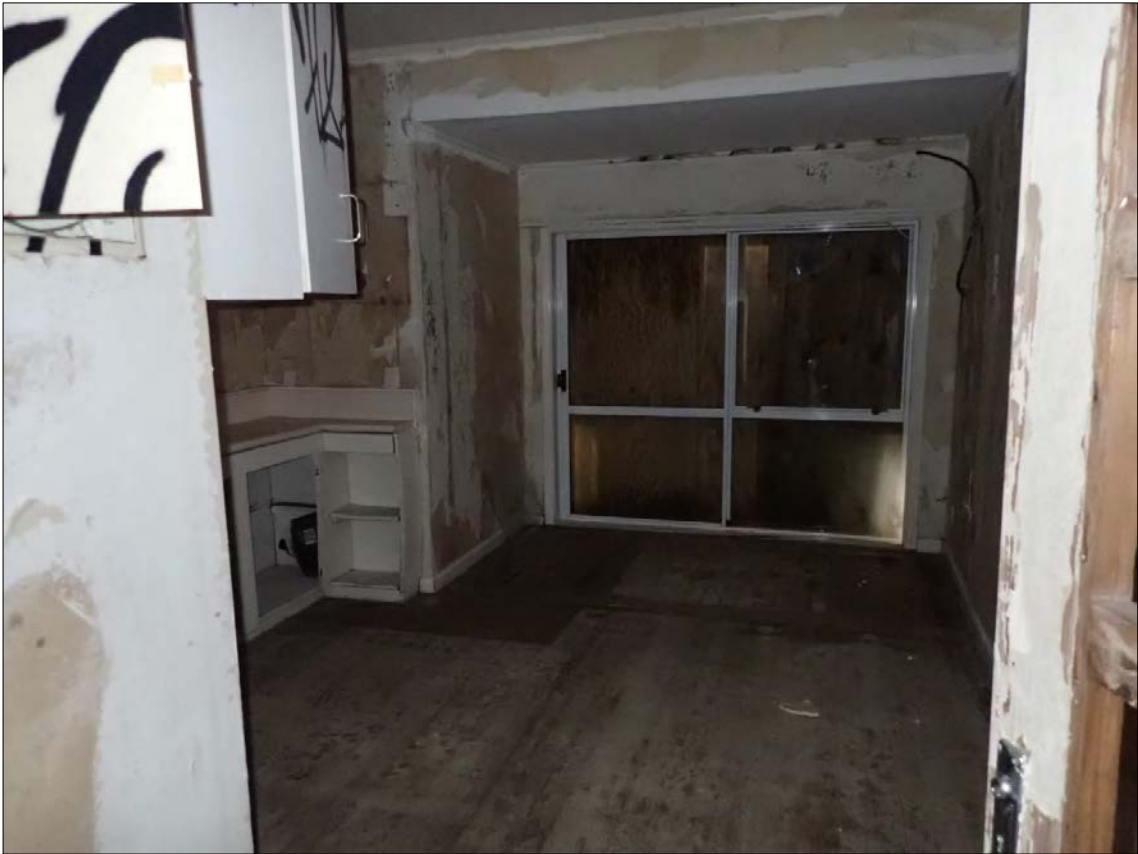
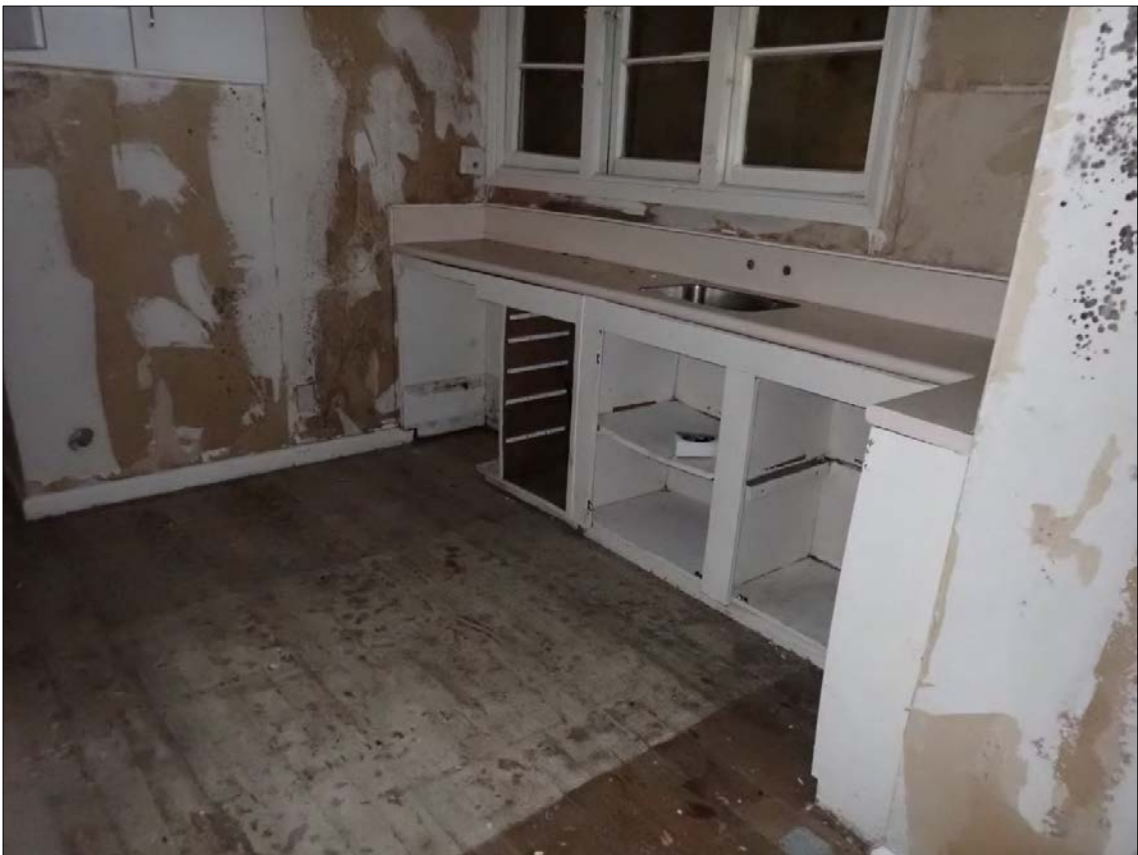
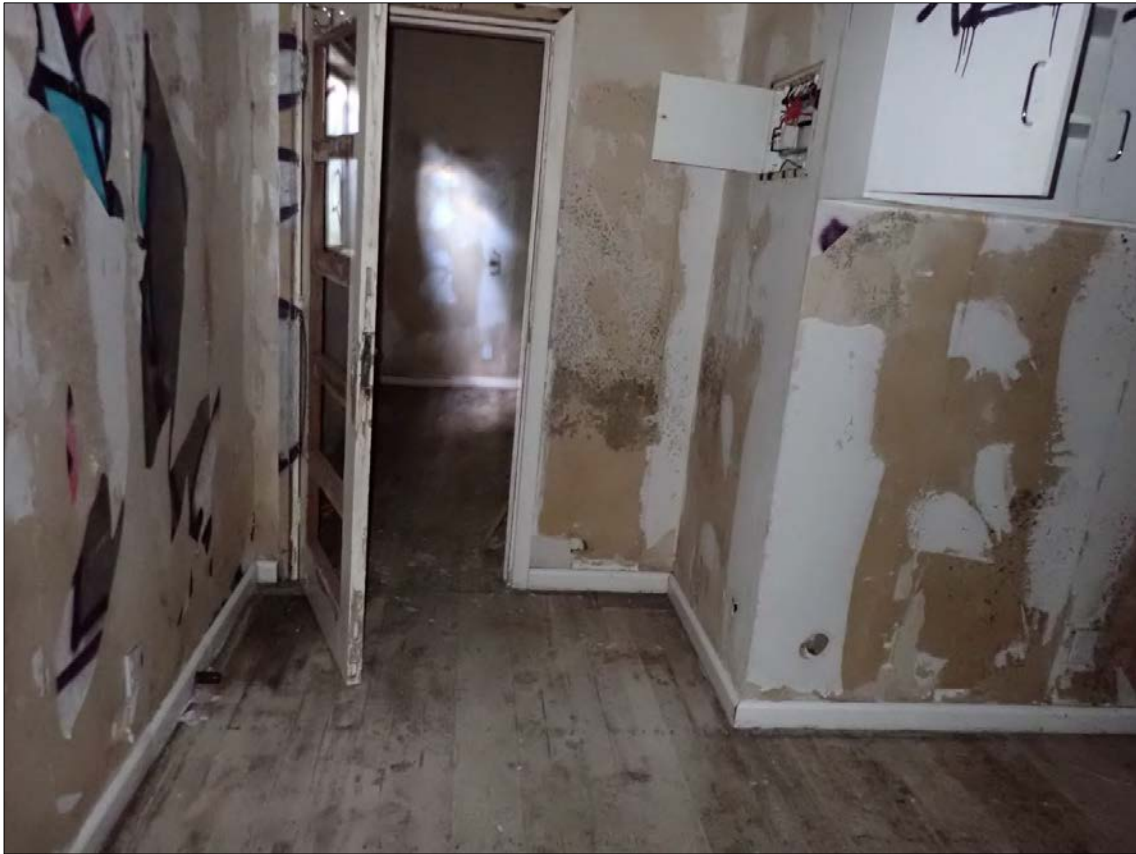
Figure 166. Feature 12: Former sergeant's house. Interior.

Figure 167. Feature 12: Former sergeant's house. Interior.

Figure 168. Feature 12: Former sergeant's house. Interior.

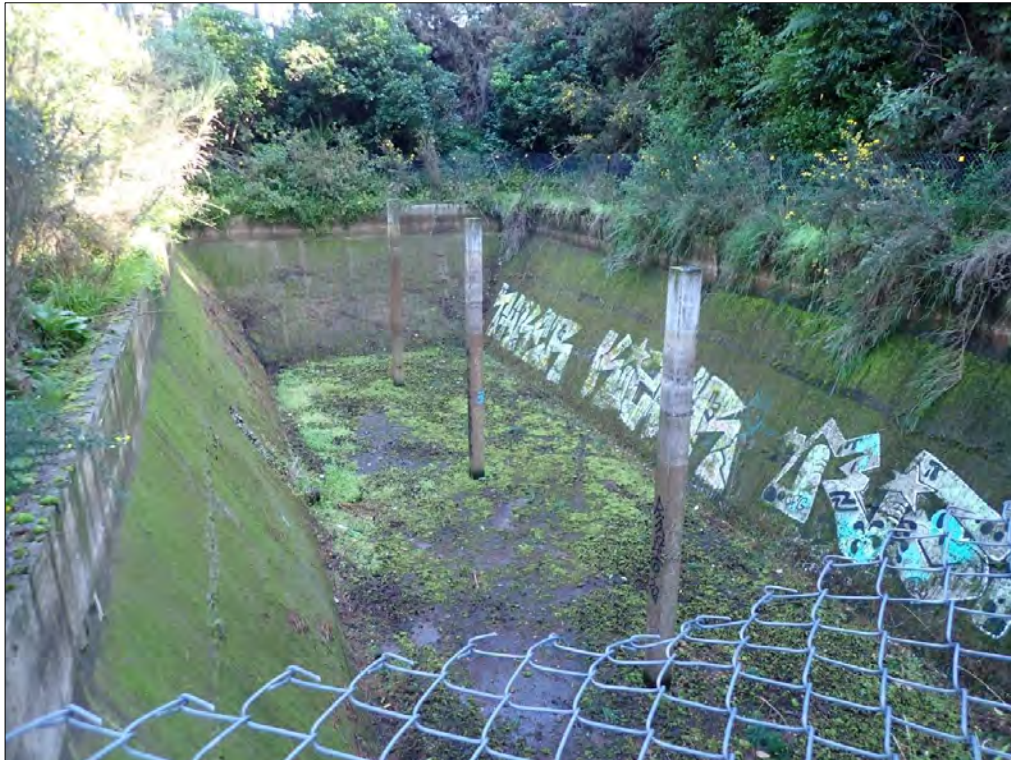
Figure 169. Feature 13: Reservoir. Graffiti is present.

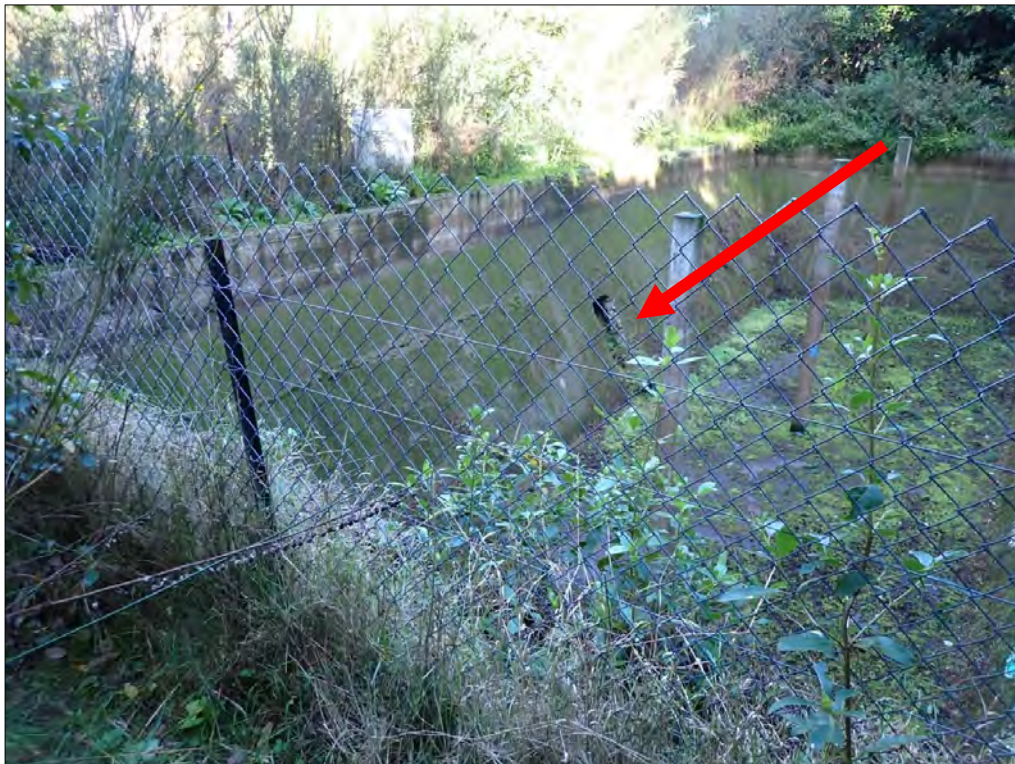
Figure 170. Feature 13: Reservoir has been fenced off and the indicated opening has been created to facilitate access.

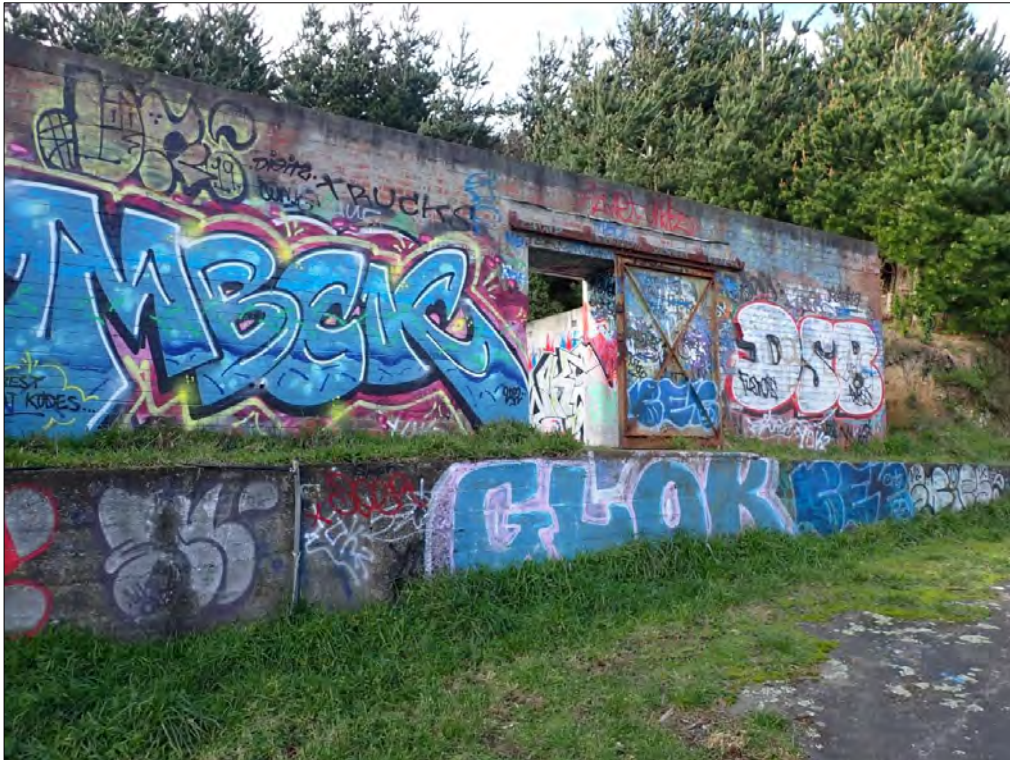
Figure 171. Feature 14: Magazine 11. Looking towards the western (front) elevation. Graffiti is present. The roof is missing.

- Consider reinstating the missing roof. New roof and associated rainwater disposal to match the design and profiles of the original roofs, and to match the materiality and finish of roofed magazine structures.

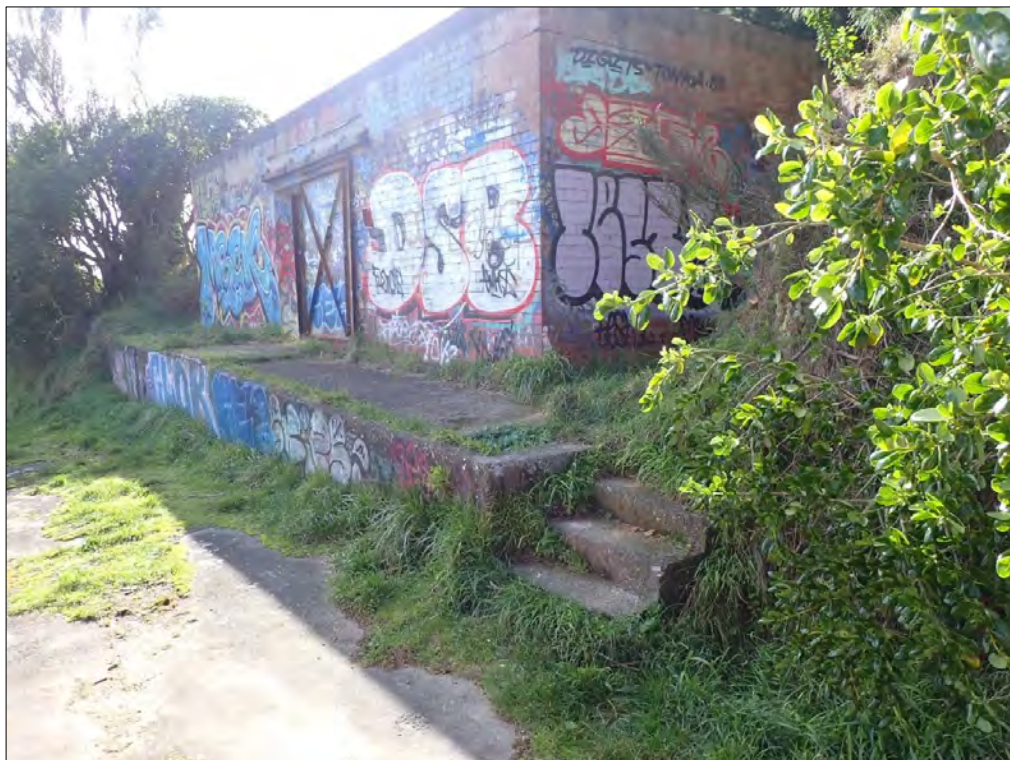
Figure 172. Feature 14: Magazine 11. Looking north across the narrow loading deck that extends across the front elevation.

- Service the external hanging door to ensure it is fully functional and operates with ease. Service the internal door, as necessary.
- Fully expose the narrow loading deck by removing debris and vegetation growth. Once cleared, structural engineer to assess any cracking to the deck supporting wall. Consider making good the deck platform in keeping with the original concrete finish.

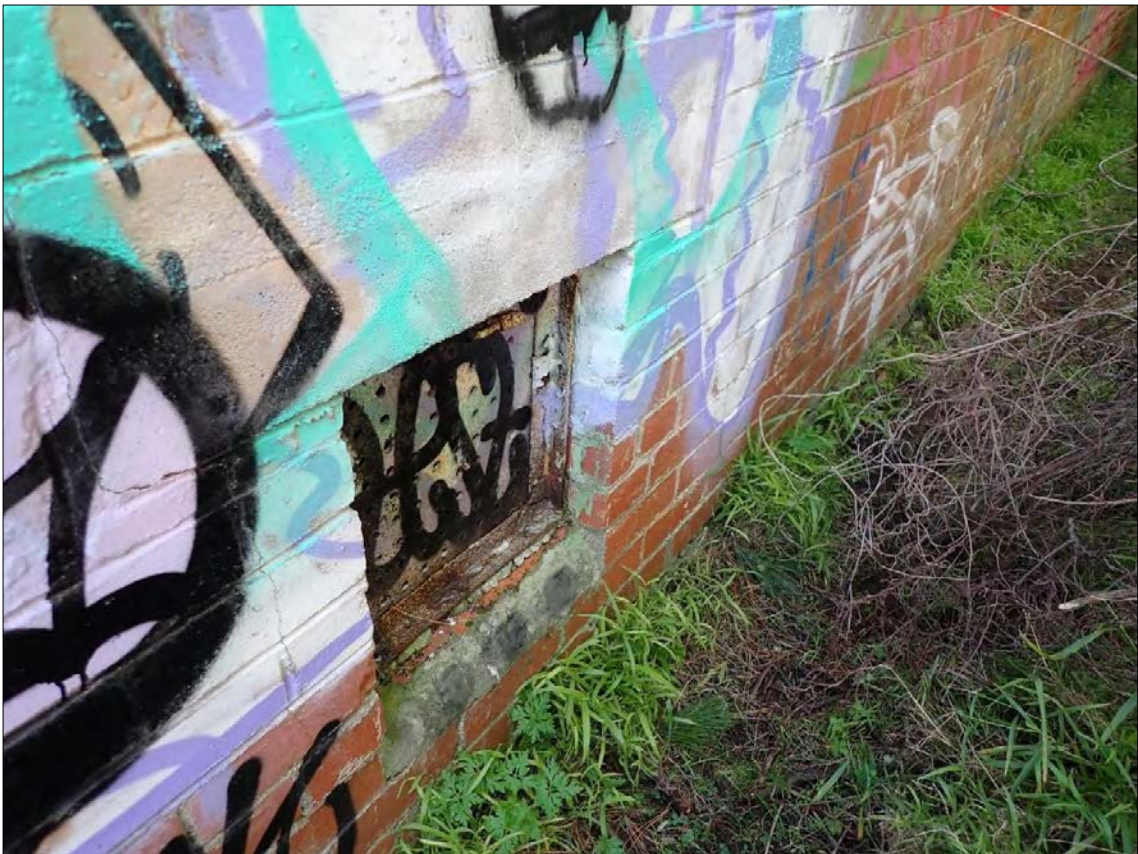
Figure 176. Feature 14: Magazine 11. Example of vermin proofing to vent between inner and outer wall of structure.

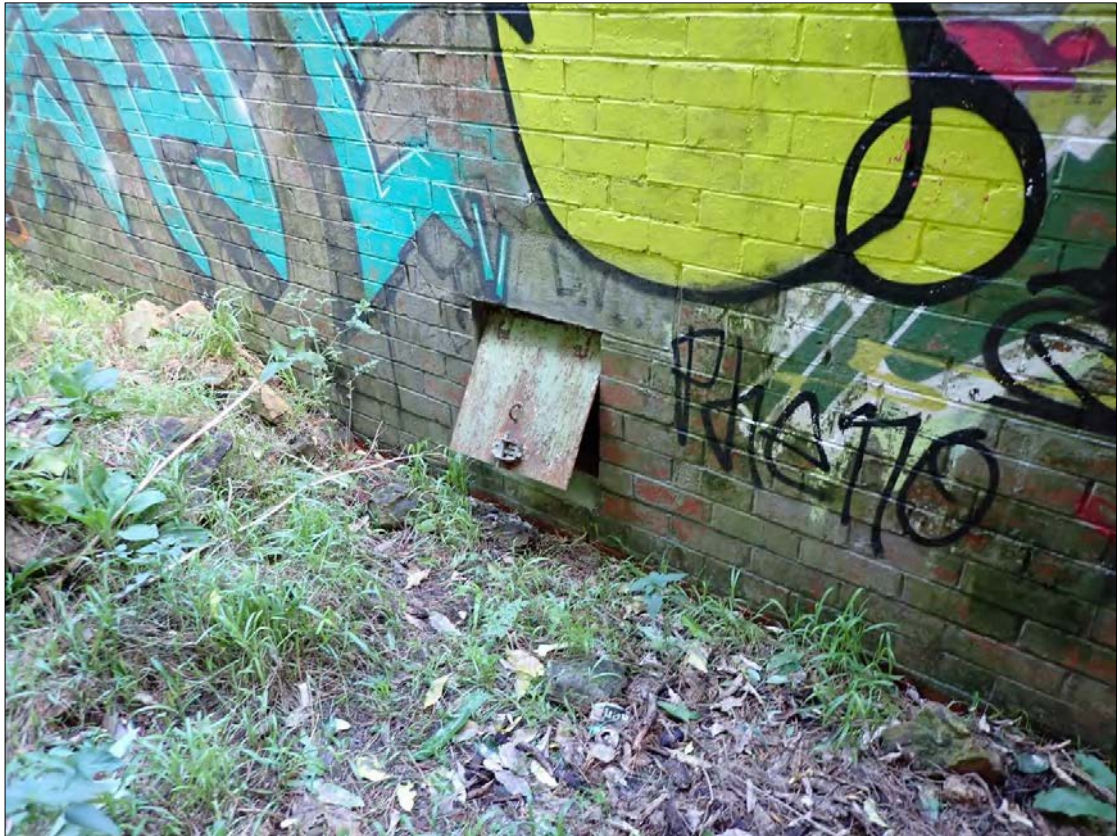
Figure 177. Feature 14: Magazine 11. Example of cover to vent between inner and outer wall of structure.

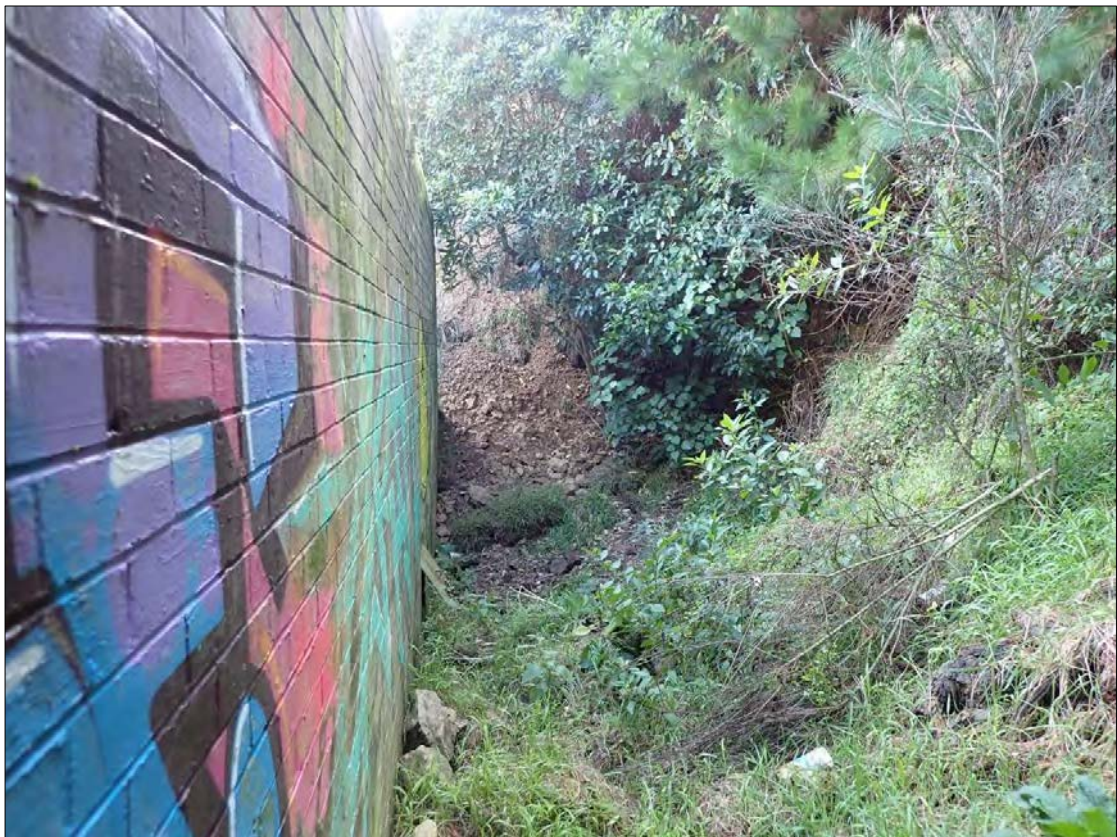
Figure 178. Feature 14: Magazine 11. Looking along the eastern (rear) elevation. A slip has occurred to the rear; and vegetation and debris has accumulated against the side of the structure.

- The accumulation of overgrowth and debris can both conceal decay and cause decay. Clear all overgrowth and debris from around the structure and expose the original concrete footpath perimeter. Clearance should include any debris from recent and more historical 'slips'. Following clearing, it may be appropriate to regrade the natural ground level to ensure that rainwater drains away from the structure. Dependant on the extent of regrading works, an archaeological authority may not be required. Investigate the introduction of suitable plantings, or engineered solutions, to facilitate ground stabilisation above the cutting as this will assist with future maintenance.

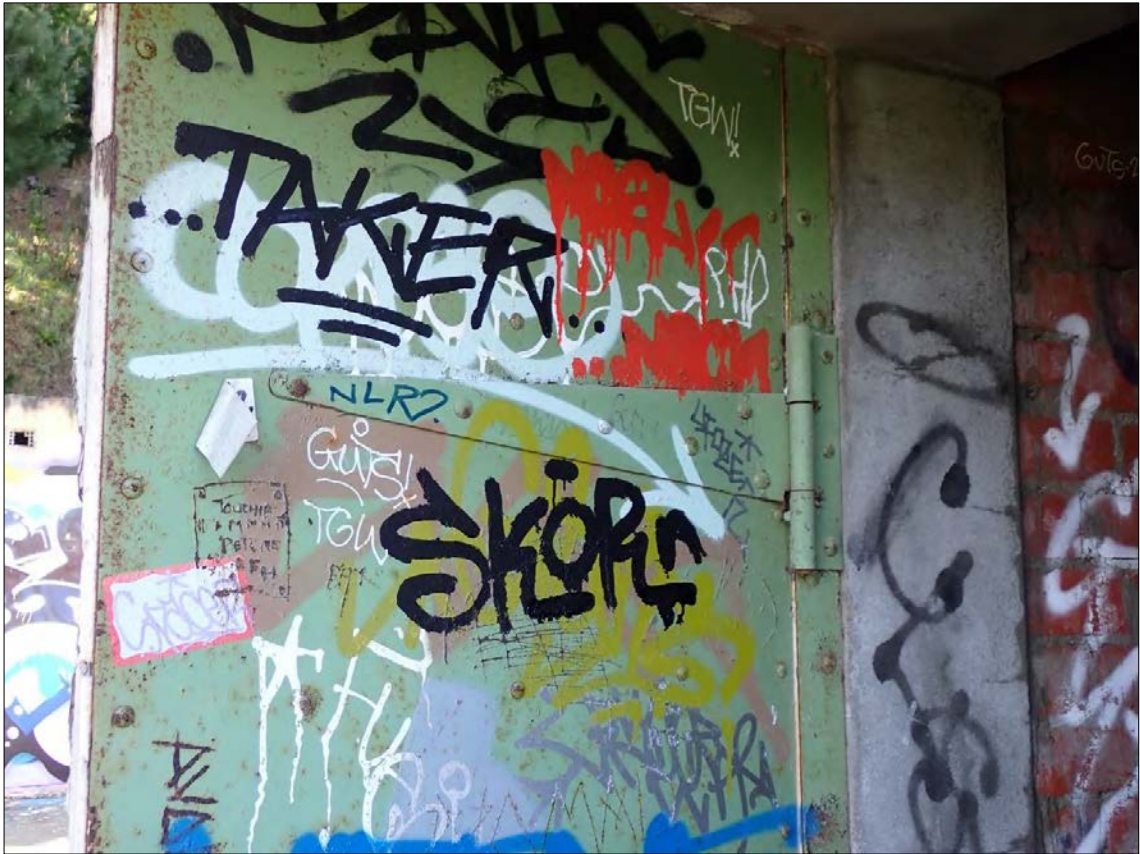
Figure 179. Feature 14: Magazine 11. Interior – Internal door to the structure. Graffiti is present.

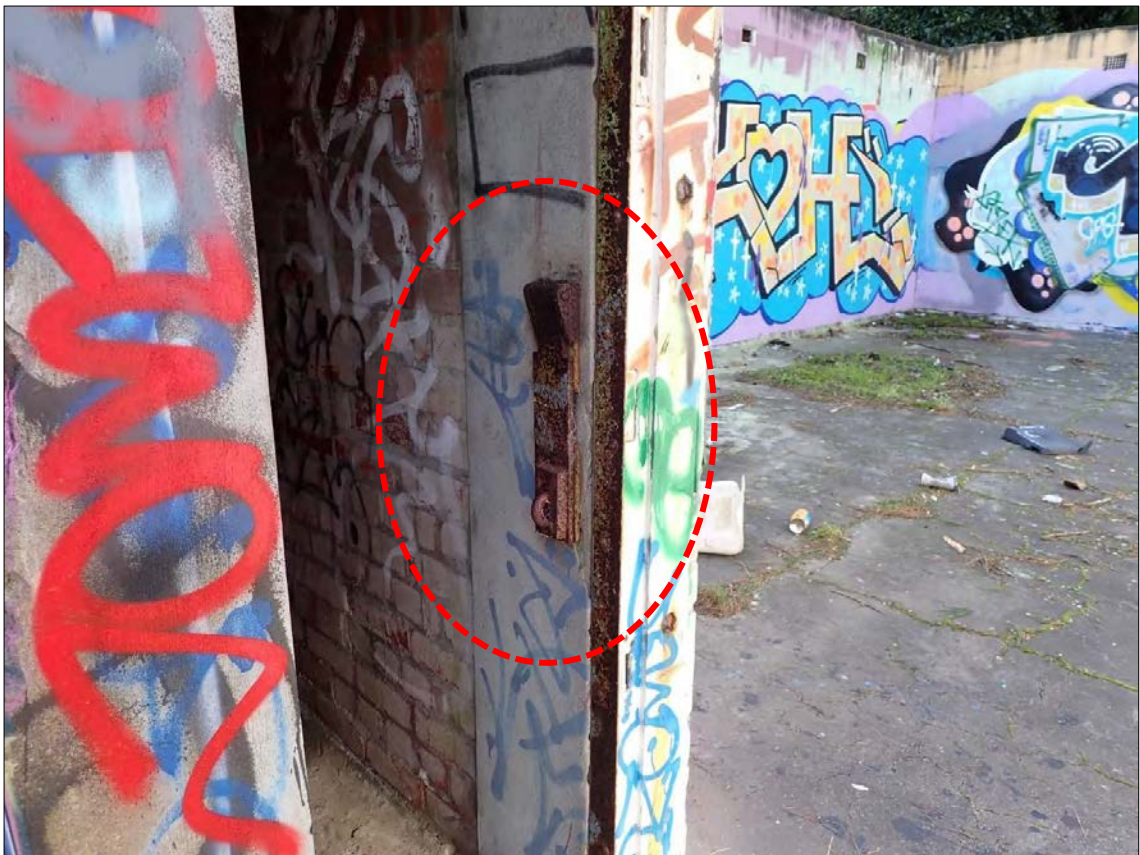
Figure 180. Feature 14: Magazine 11. Looking towards the interior. Door barricade to internal door indicated.

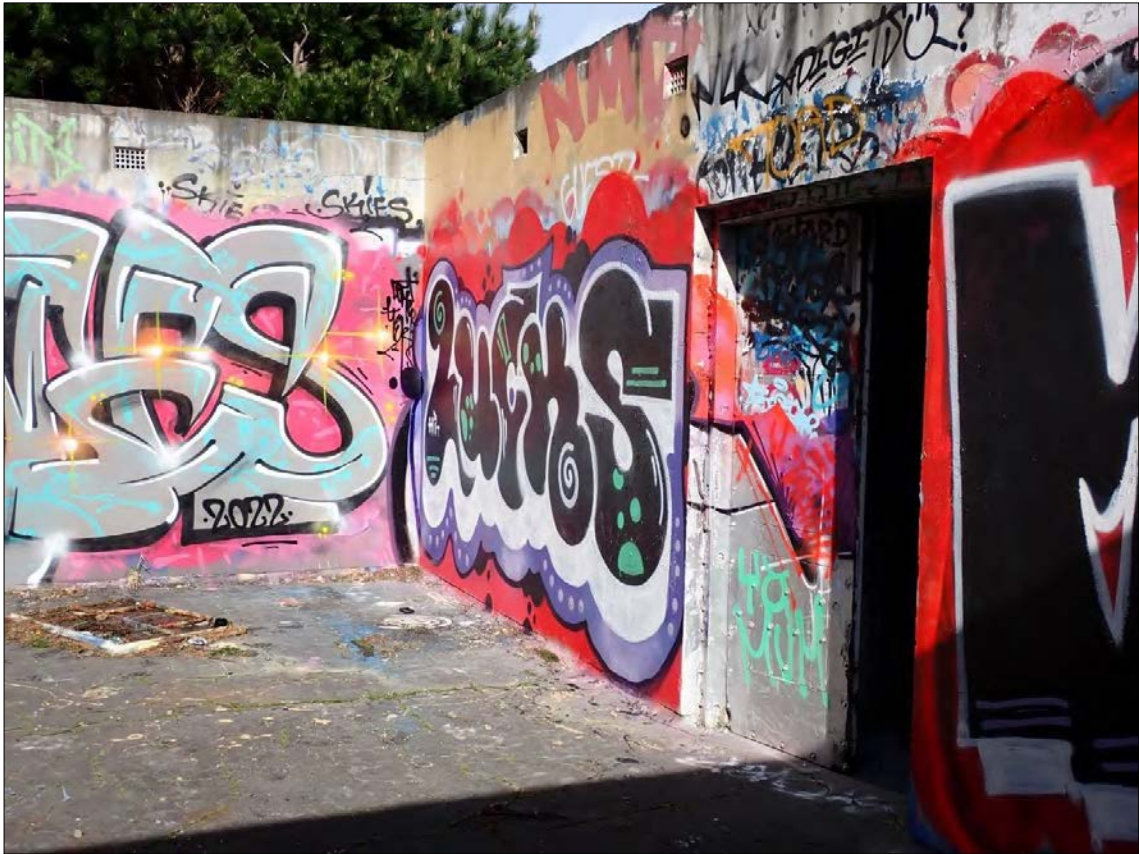
Figure 181. Feature 14: Magazine 11. Interior – Graffiti is present.

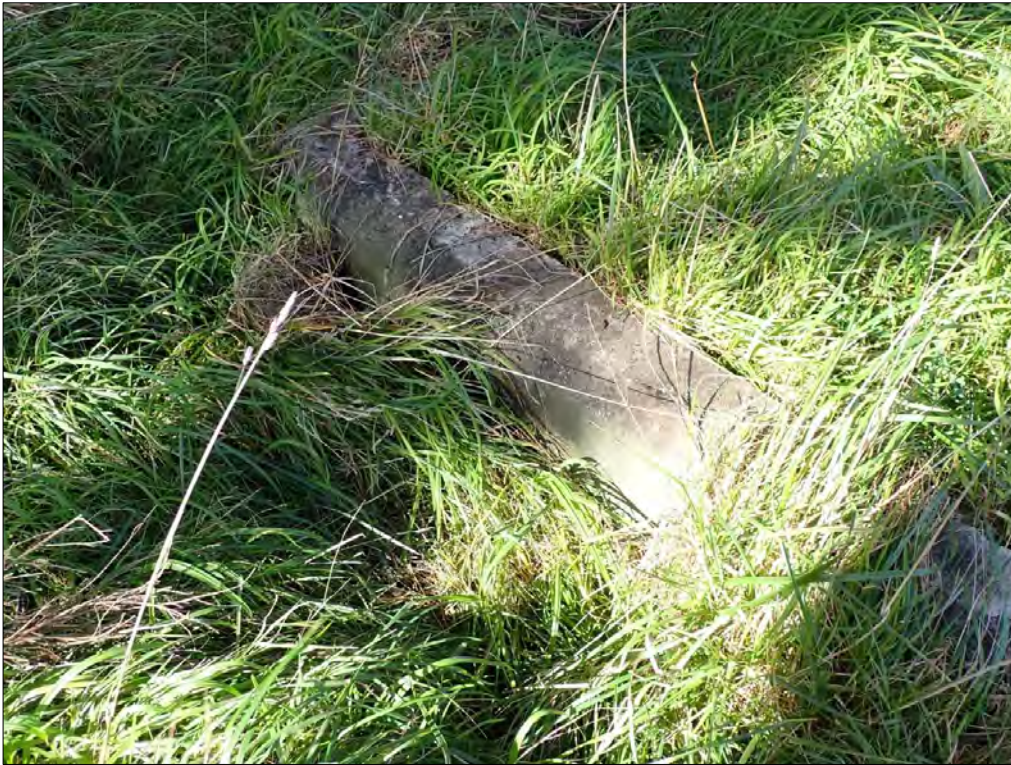
Figure 183. Feature 15: Wall plinth remnant north of the arms store.
