Watts Peninsula, Wellington

Heritage and condition assessment

Report Prepared for Toitū Te Whenua Land Information New Zealand

Submitted: December 2022

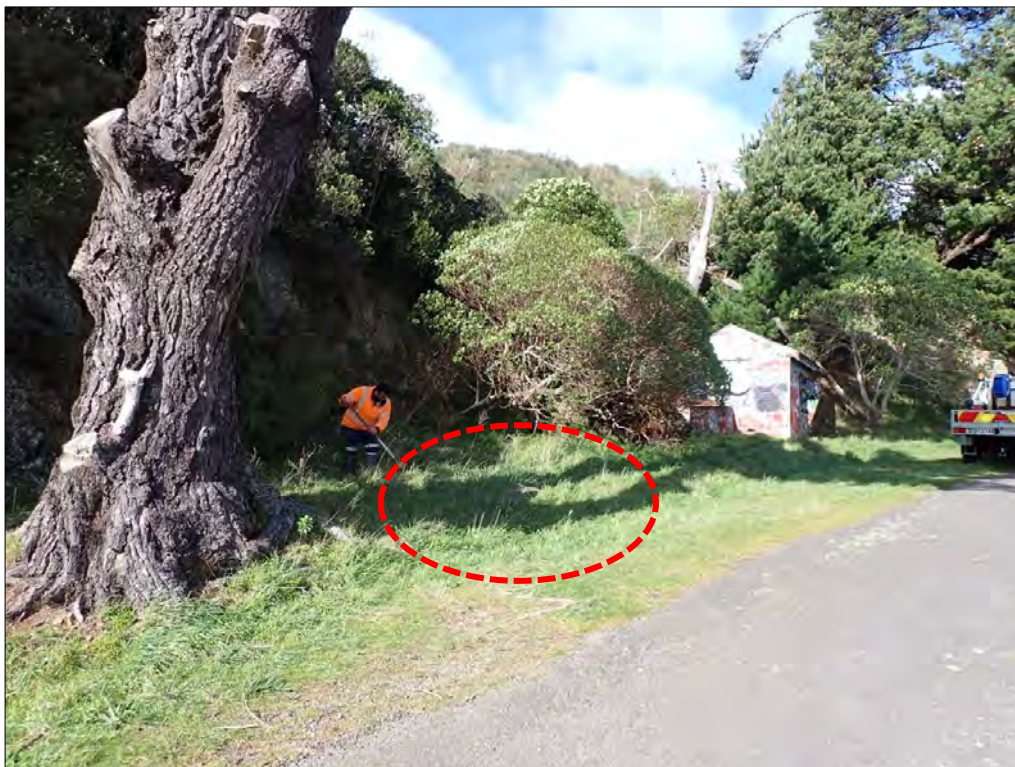
Figure 184. Feature 15: Location of the wall plinth remnant relative to the arms store.

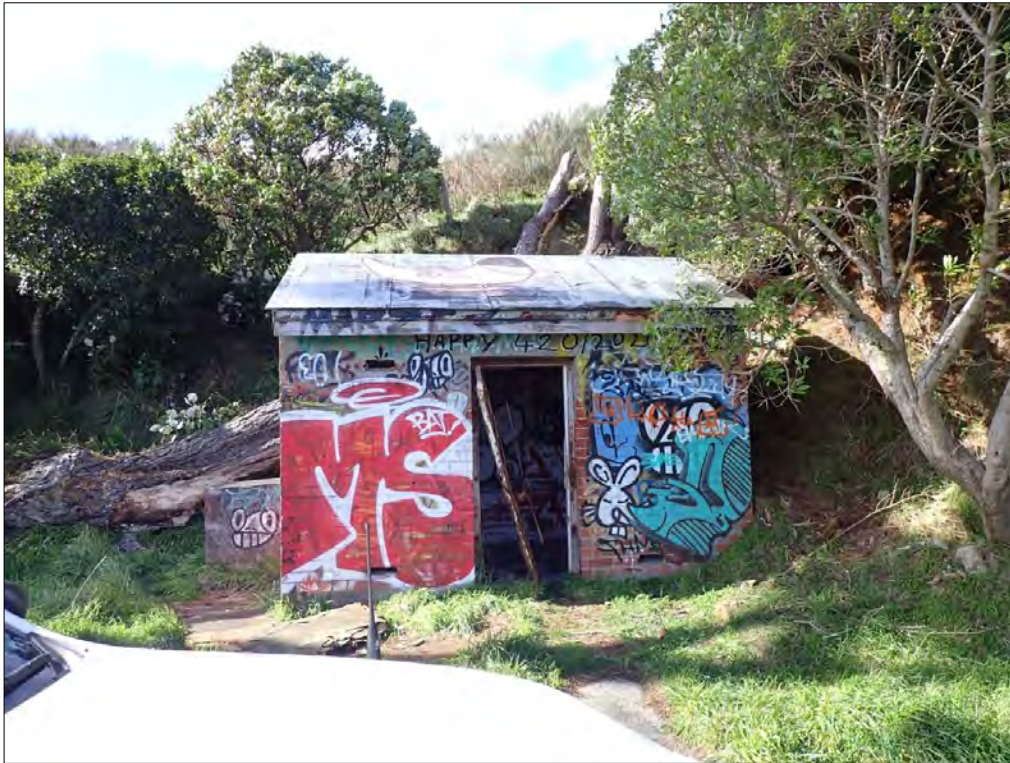
Figure 185. Feature 16: Arms store. Looking towards the western elevation. Graffiti is present and the entrance door has come off its hinges.

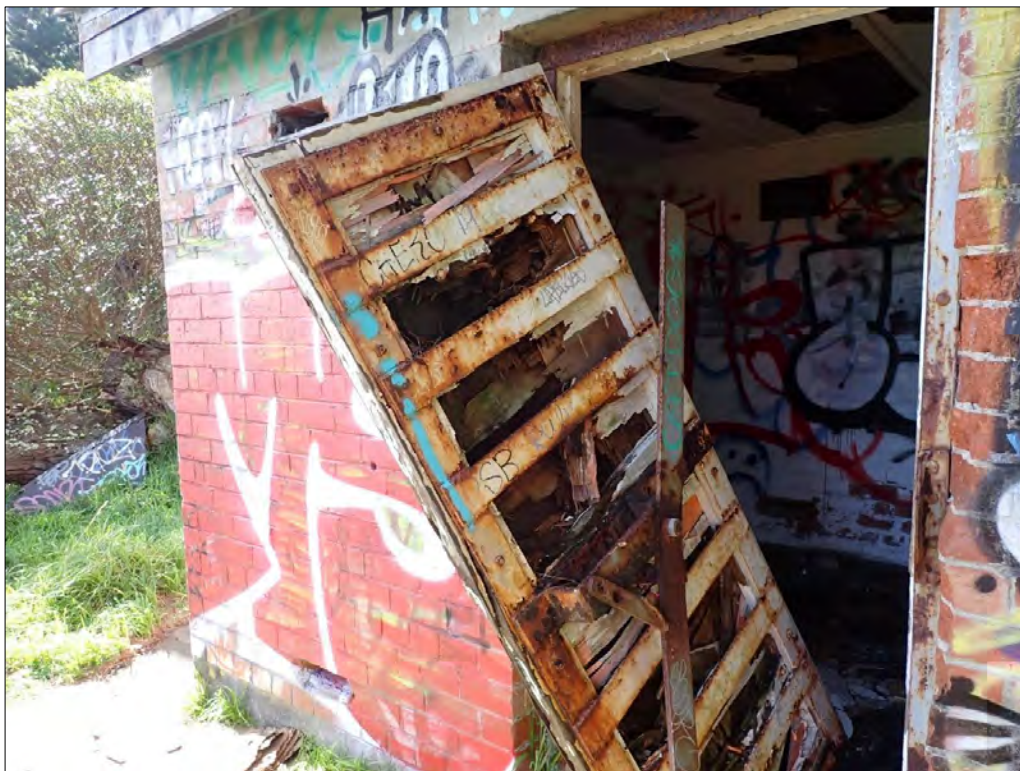
Figure 186. Feature 16: Arms store. Looking towards the western elevation. The entrance door has come off its hinges.

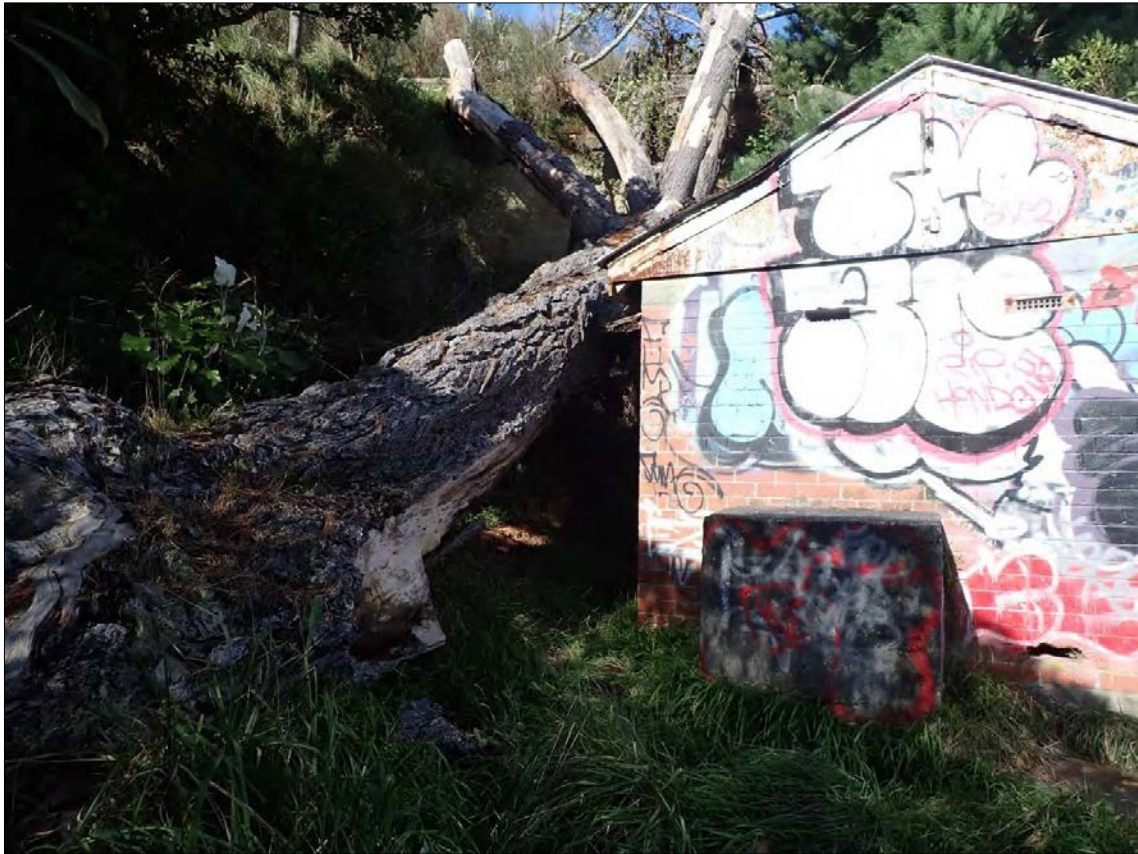
Figure 187. Feature 16: Arms store. Looking at the northern elevation. Graffiti is present and a large has fallen to the rear.

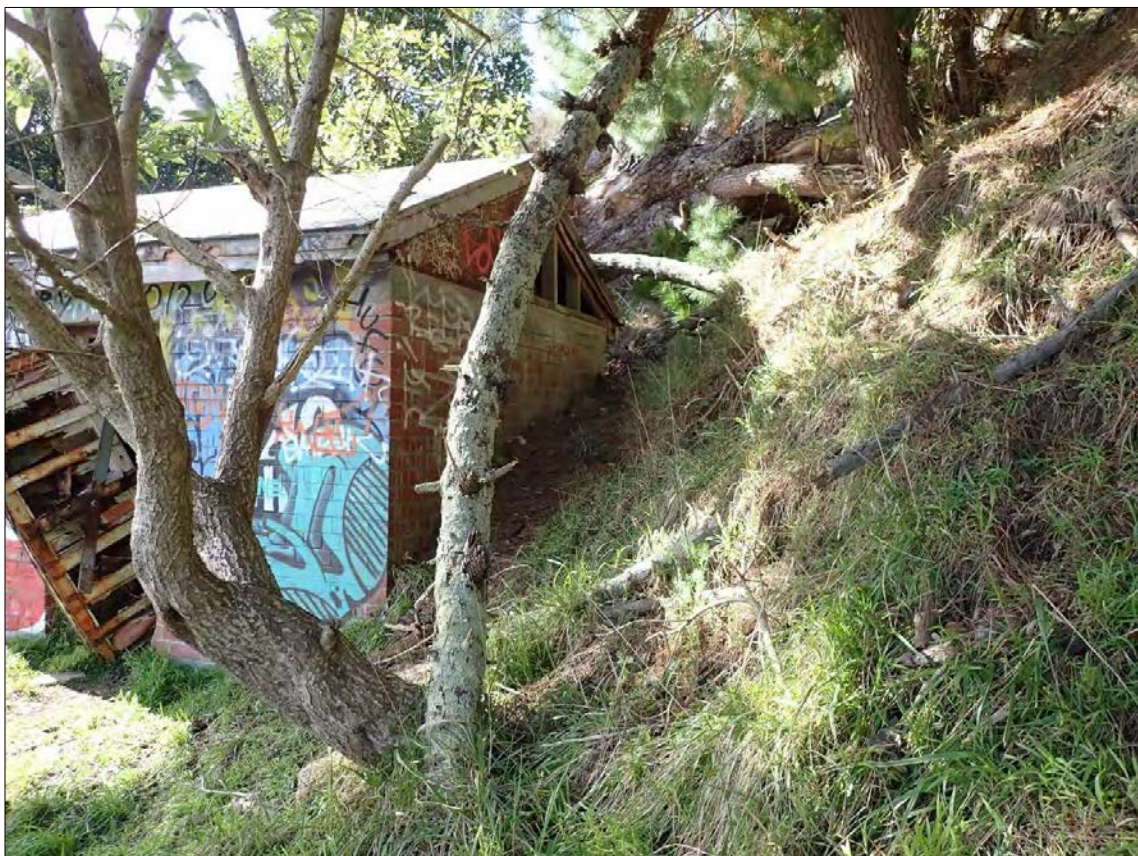
Figure 188. Feature 16: Arms store. Looking at the southern elevation. A slip has occurred, and vegetation and debris are accumulating against the side of the structure.

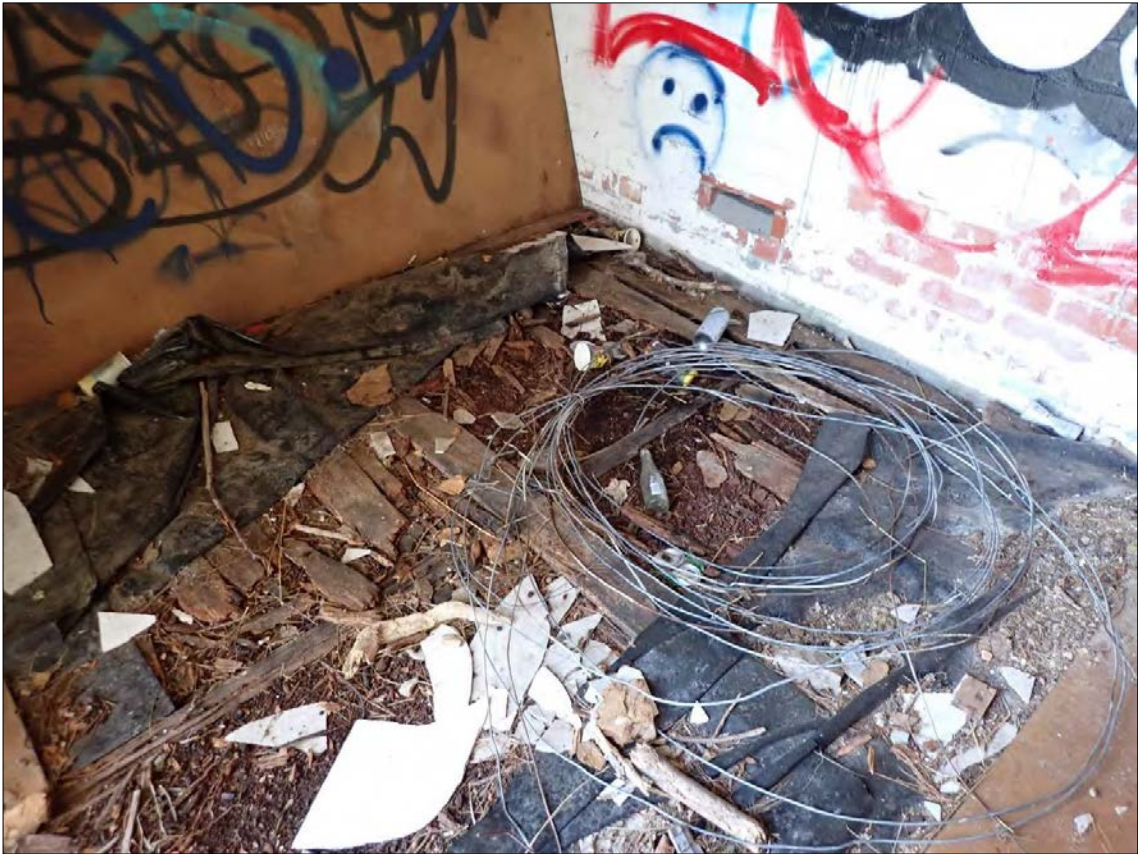
Figure 189. Feature 16: Arms store. Interior - Remnant timber strip flooring. Graffiti is present.

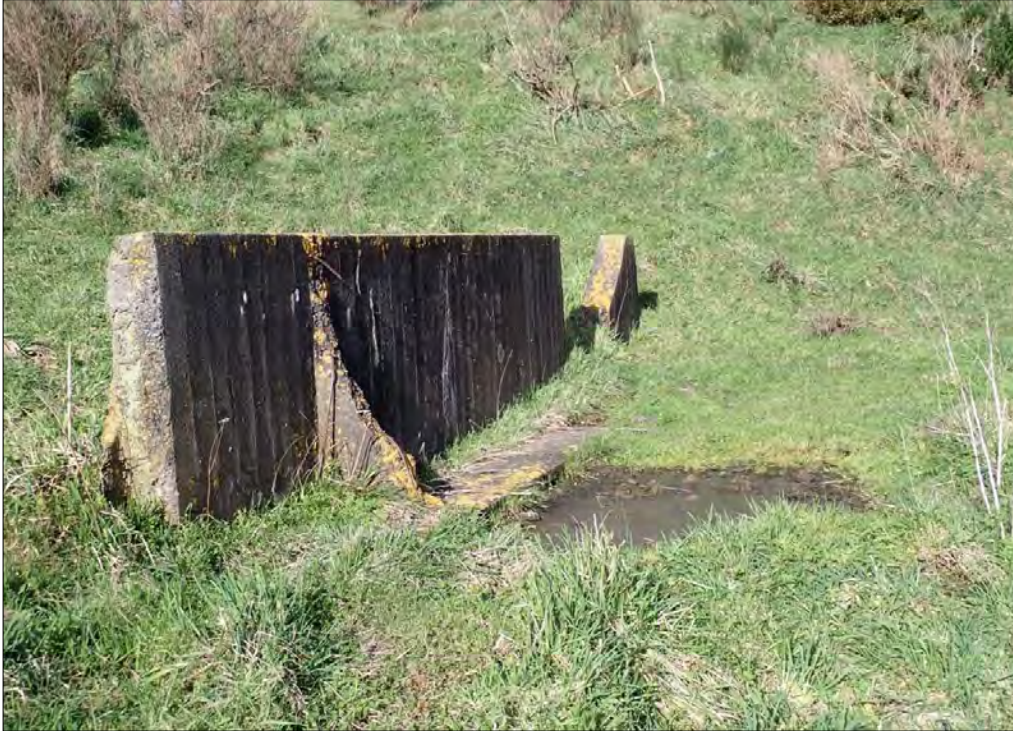
Figure 191: Feature 17: Wall remnant southeast of Former Women's Reformatory

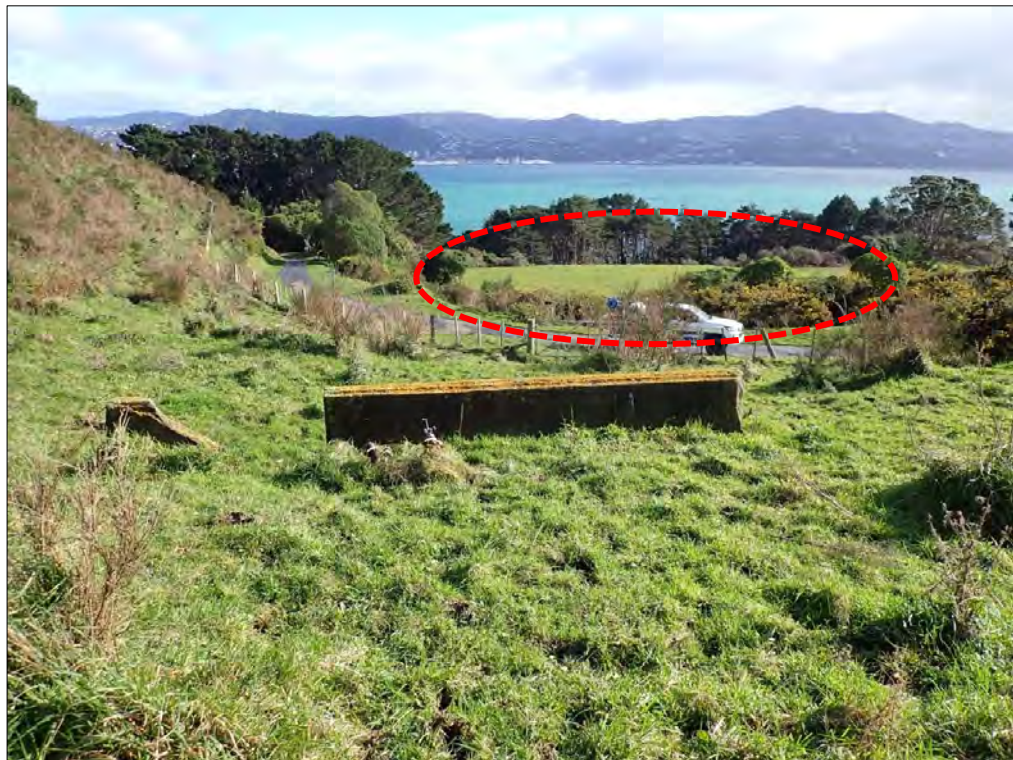
Figure 192: Feature 17: Wall remnant. The location of the Former Women's Reformatory is indicated.

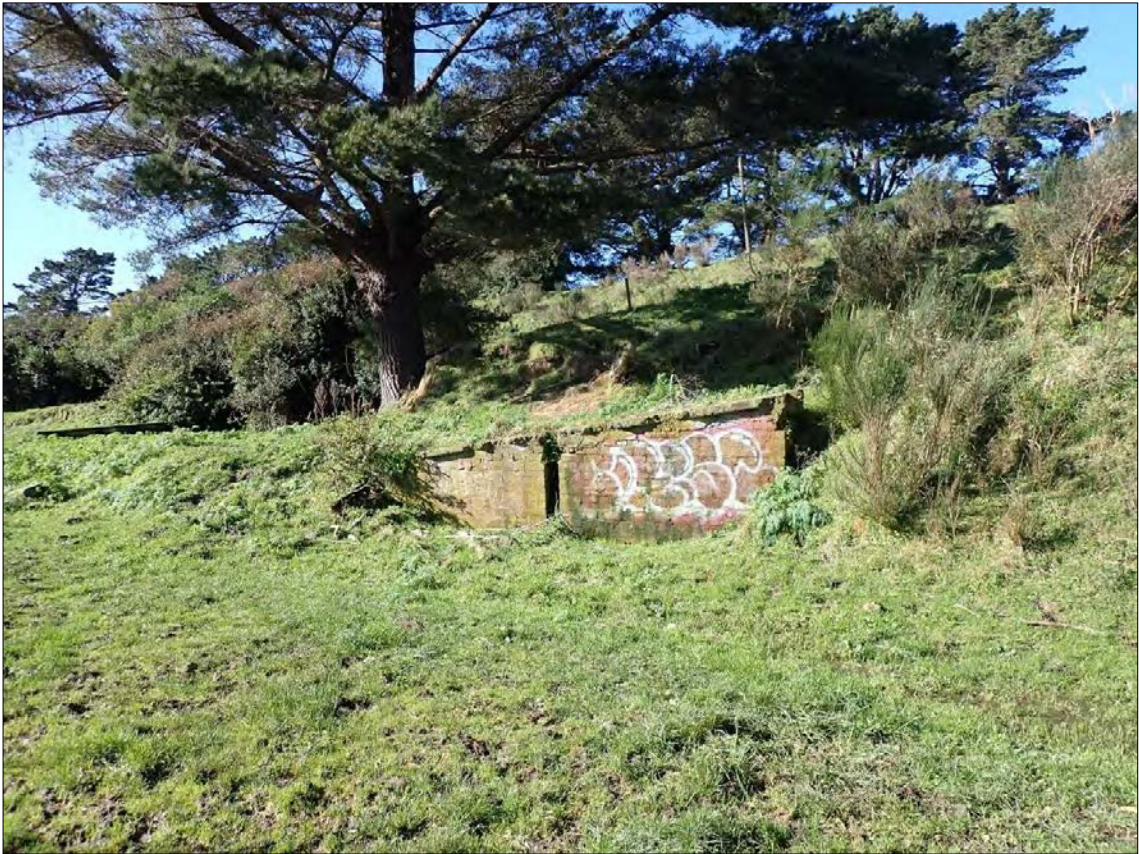
Figure 197. Feature 18: Former Point Halswell Women's Reformatory. Looking east, between the former reformatory and the vegetable garden, towards a brick wall remnant. The wall is being vandalised with graffiti.

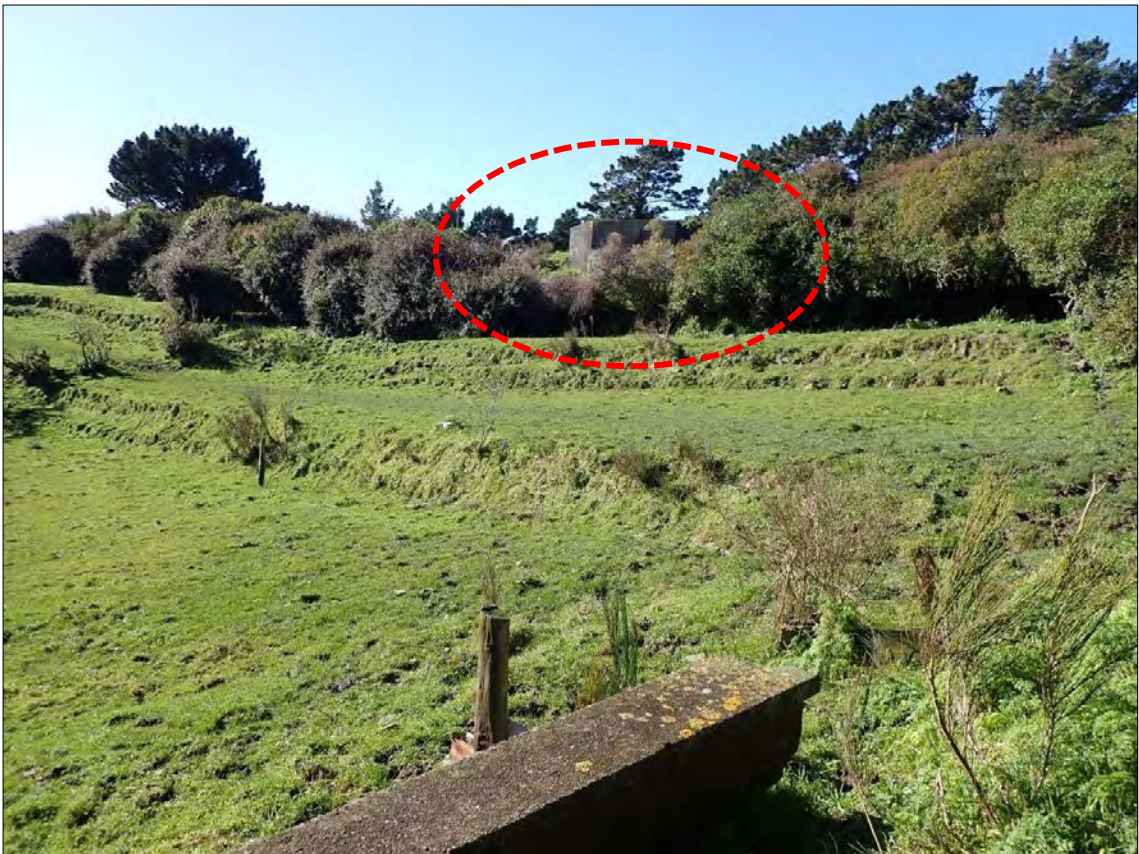
Figure 198. Feature 18: Former Point Halswell Women's Reformatory. Looking north towards terracing associated with the former vegetable gardens. The Mount Crawford Anti-Aircraft Battery is indicated. A wall remnant is visible in the foreground.

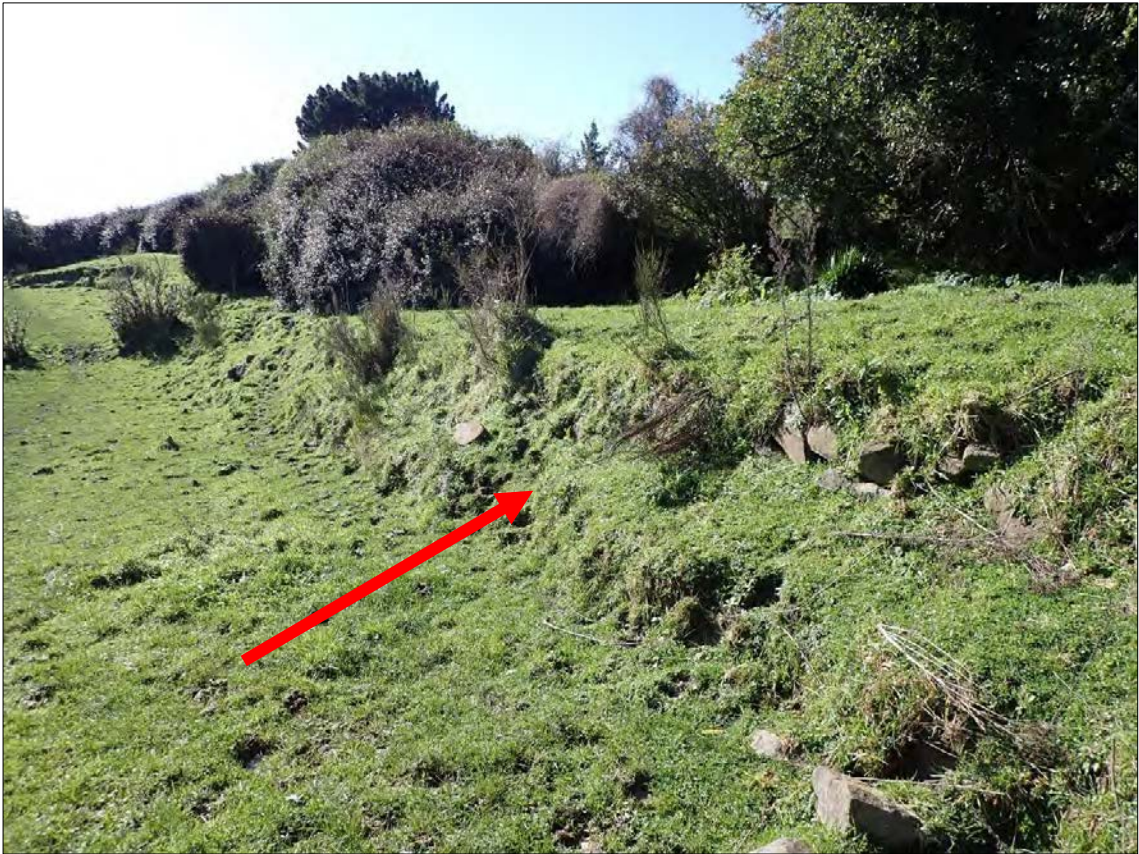
Figure 199. Feature 18: Former Point Halswell Women's Reformatory. Looking north along a vegetable garden terrace. Remnant stone retaining structure is indicated, it is accentuated by a hedgerow.

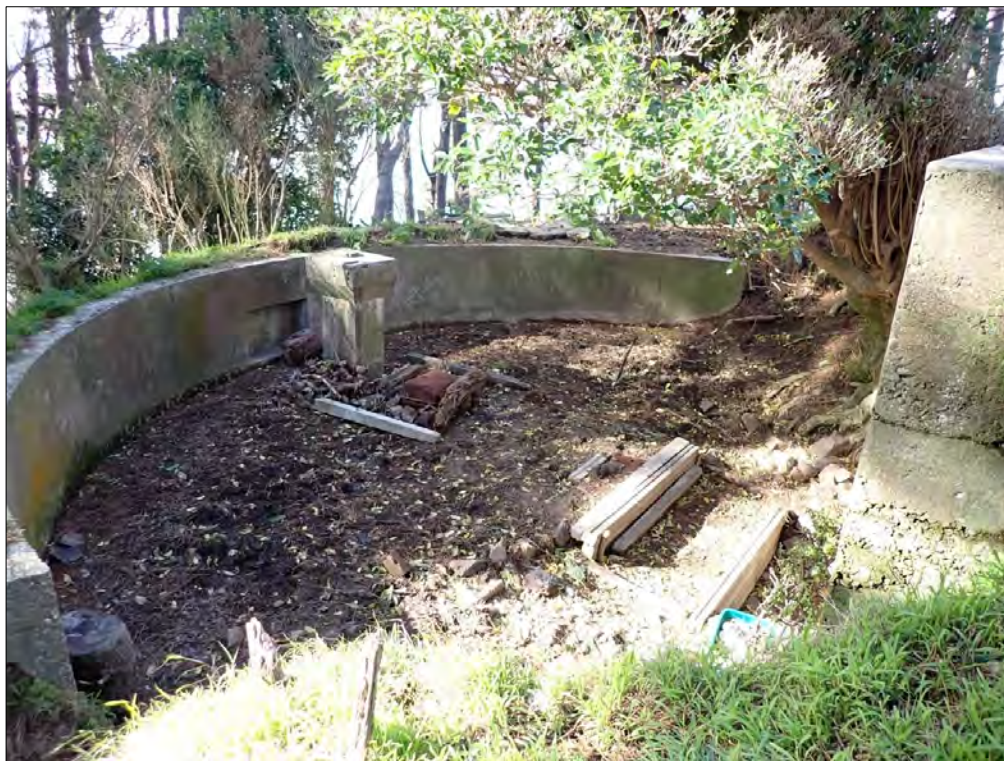
Figure 203. Feature 19: Kau Point Battery. Excavated pit to the front of the telephone room at the Battery Observation Post.

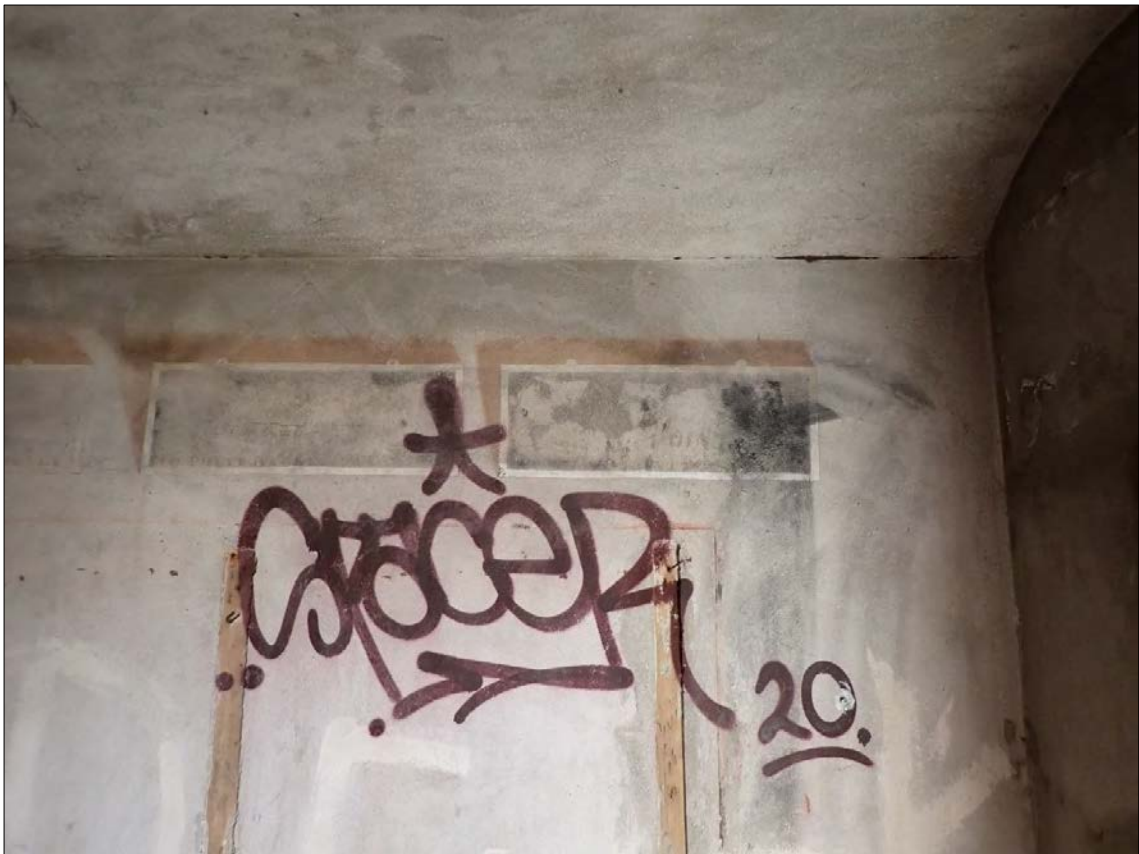
Figure 206. Feature 19: Kau Point Battery. Other defensive positions painted on the walls of the telephone room at the Battery Observation Post. Graffiti is present.

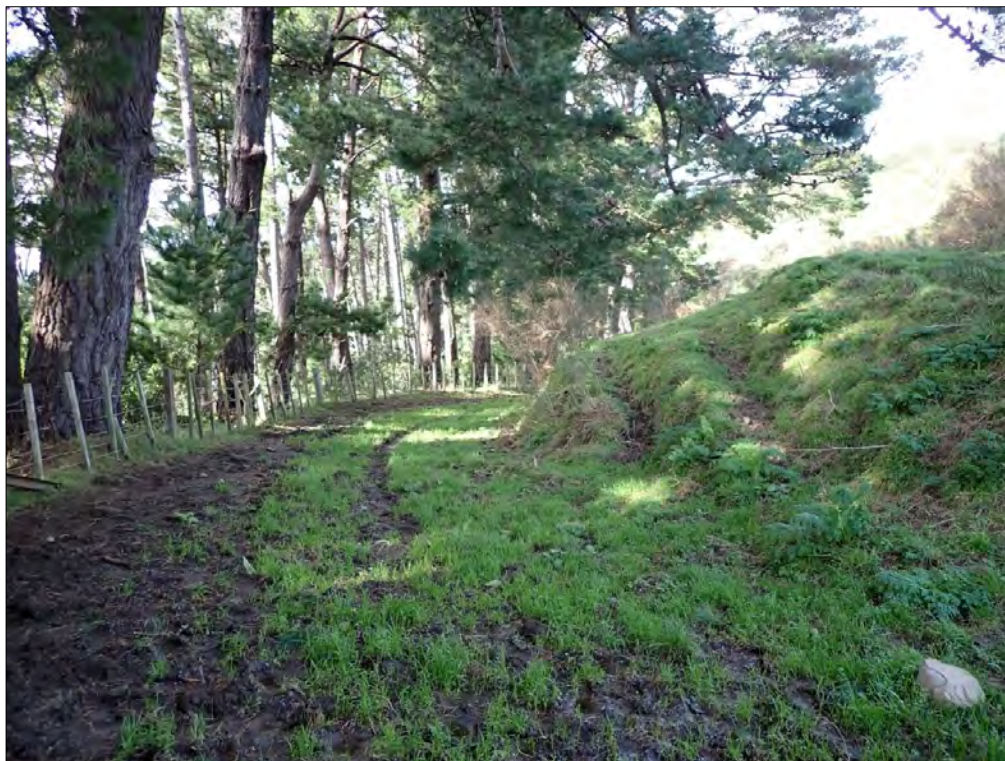
Figure 211. Feature 21: A section of the original military road to Kau Point Battery.

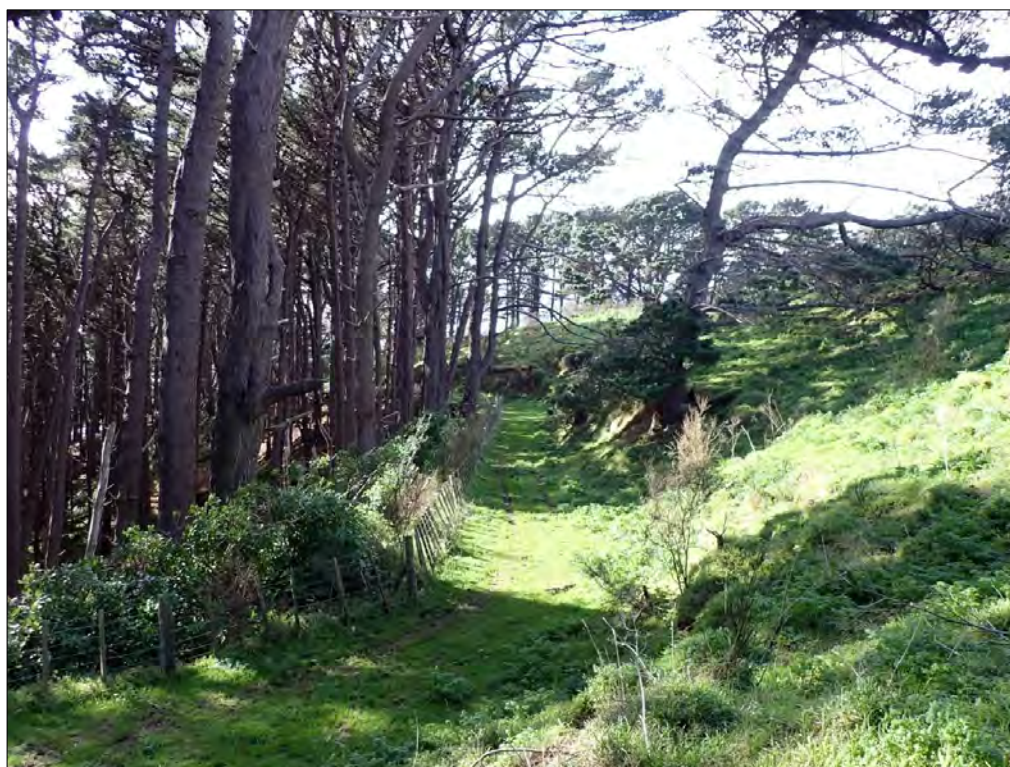
Figure 212. Feature 21: A section of the original military road to Kau Point Battery.

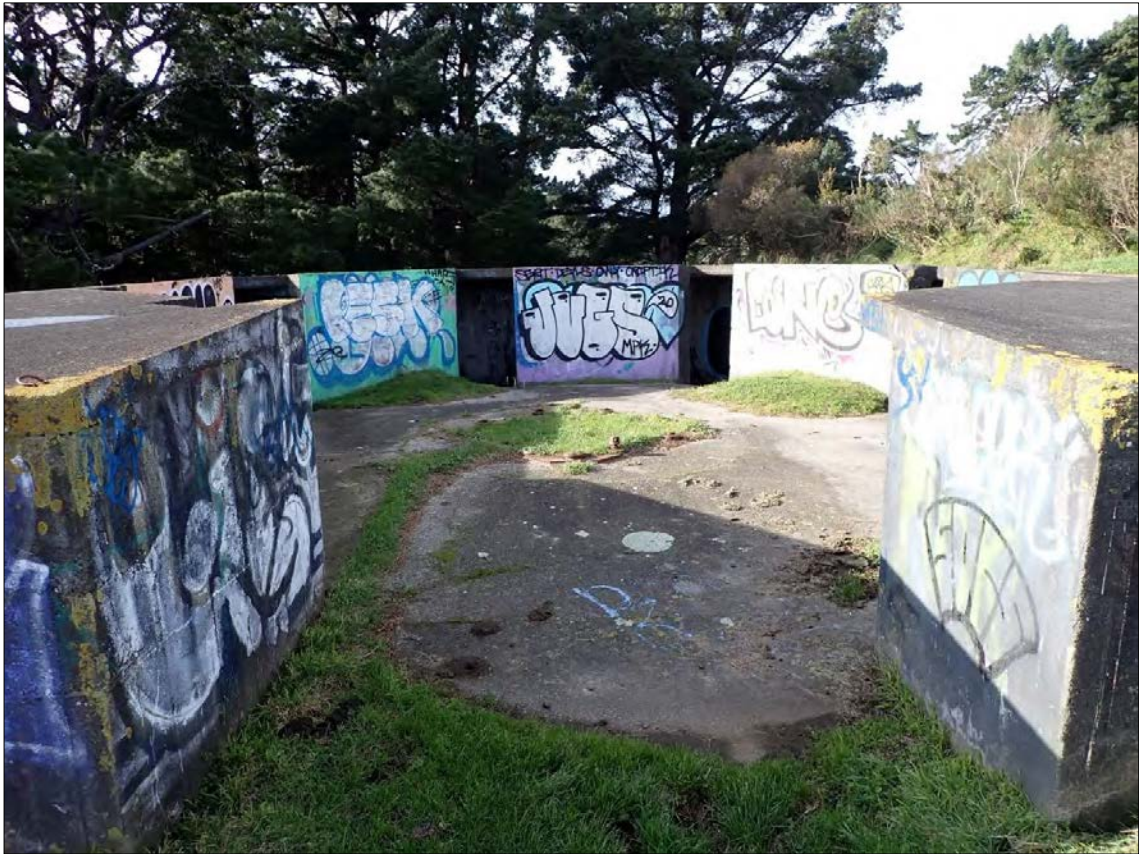
Figure 217. Feature 22: Mount Crawford Anti-Aircraft Battery gun emplacement example. Looking over the base for the gun towards the chambers. Graffiti is present.

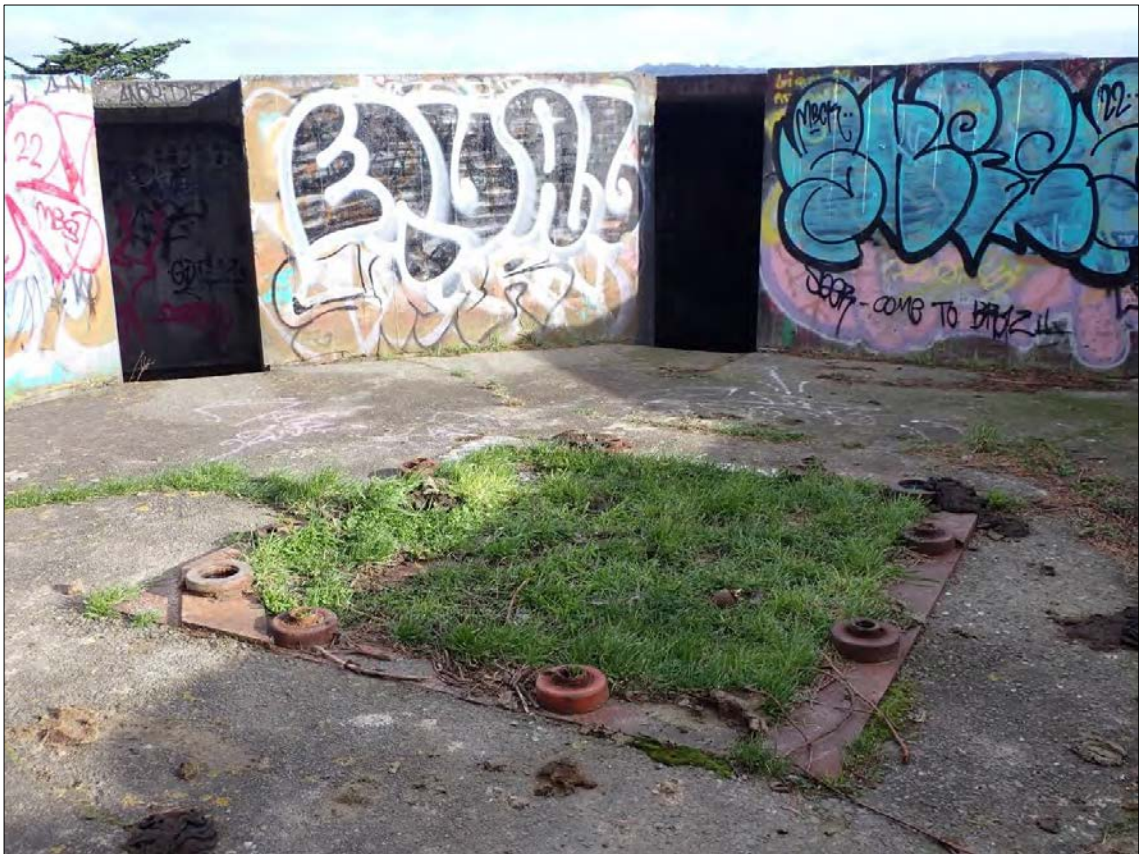
Figure 218. Feature 22: Mount Crawford Anti-Aircraft Battery gun emplacement example. Looking over the base for the gun towards the chambers. Graffiti is present.

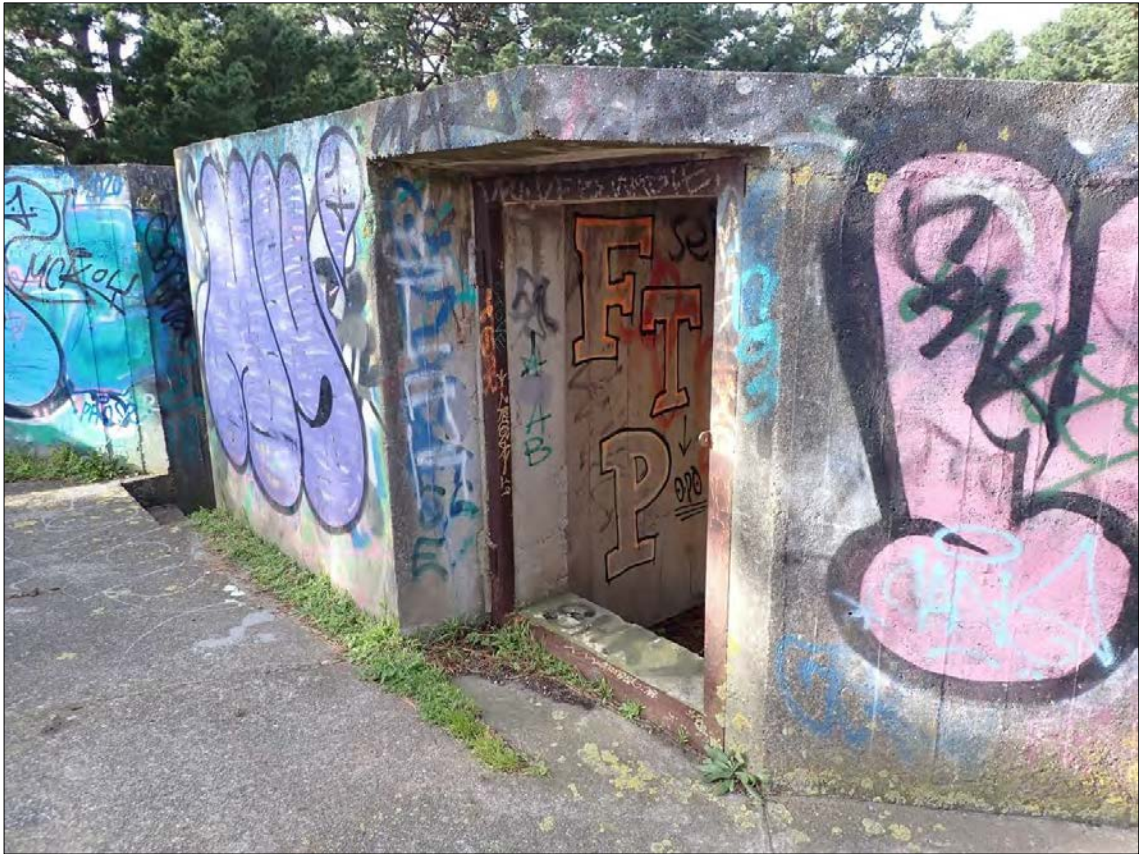
Figure 219. Feature 22: Mount Crawford Anti-Aircraft Battery gun emplacement example. Looking towards the chambers. Graffiti is present.

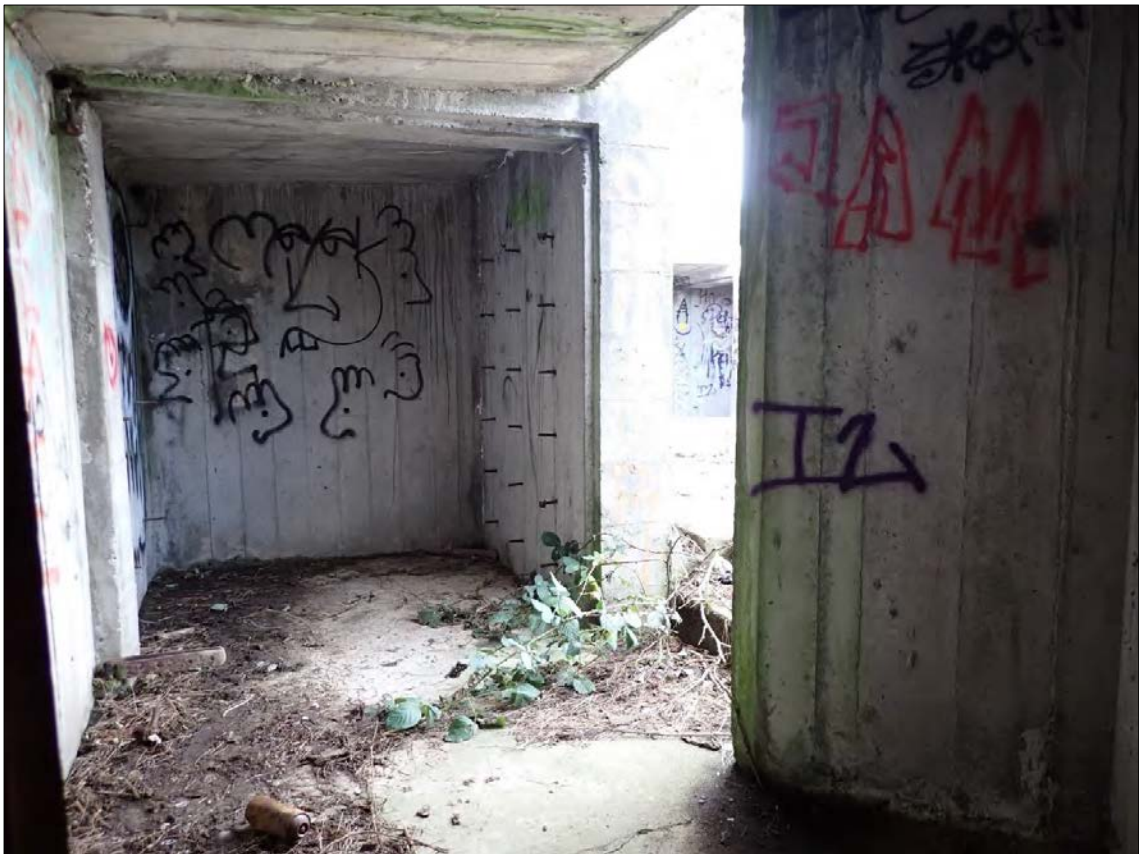
Figure 220. Feature 22: Mount Crawford Anti-Aircraft Battery gun emplacement. typical example of a chamber interior. Graffiti is present.

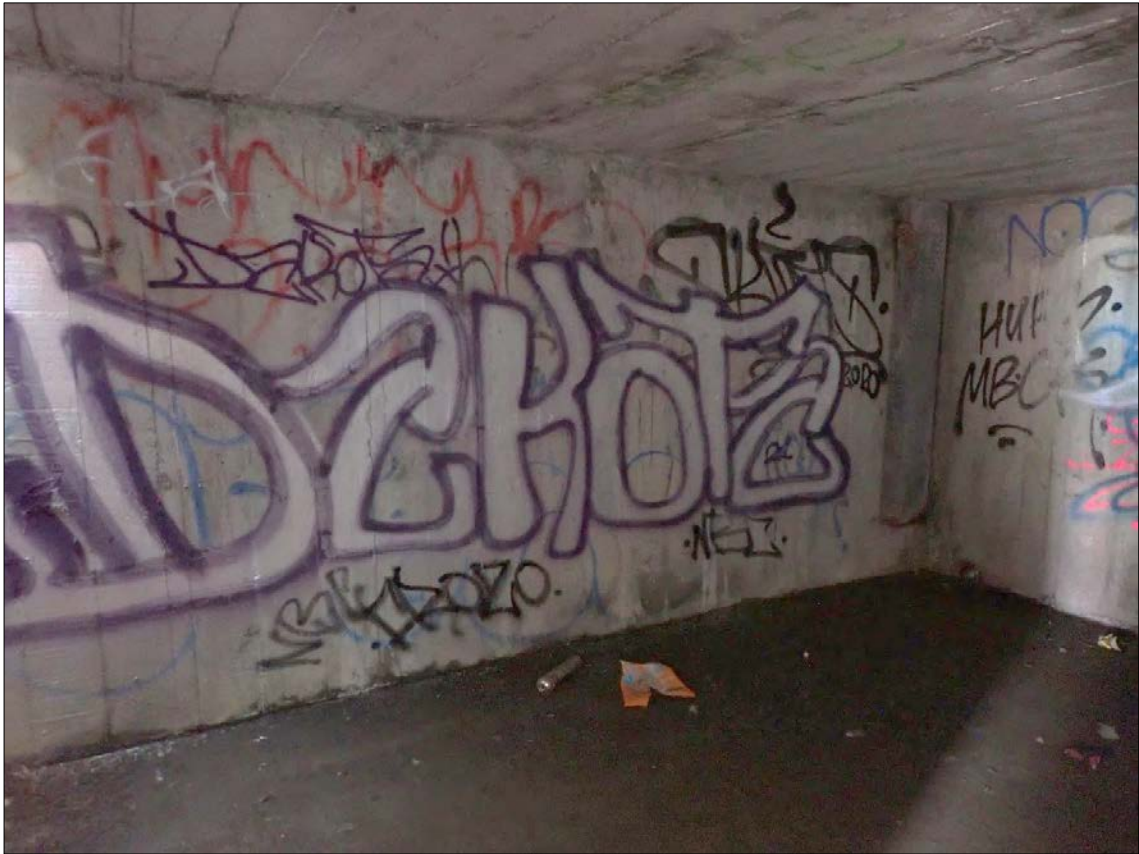
Figure 221. Feature 22: Mount Crawford Anti-Aircraft Battery gun emplacement. typical example of a chamber interior. Graffiti is present.

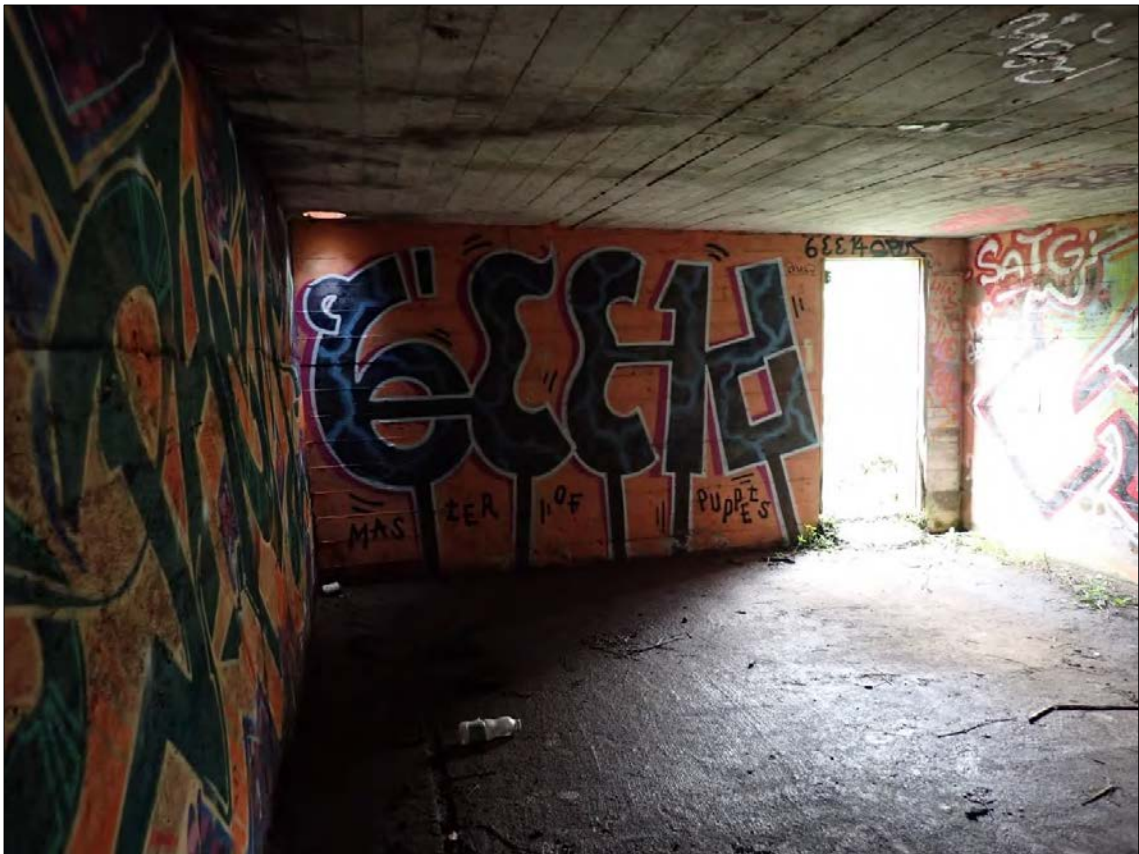
Figure 222. Feature 22: Mount Crawford Anti-Aircraft Battery gun emplacement. typical example of a chamber interior. Graffiti is present.

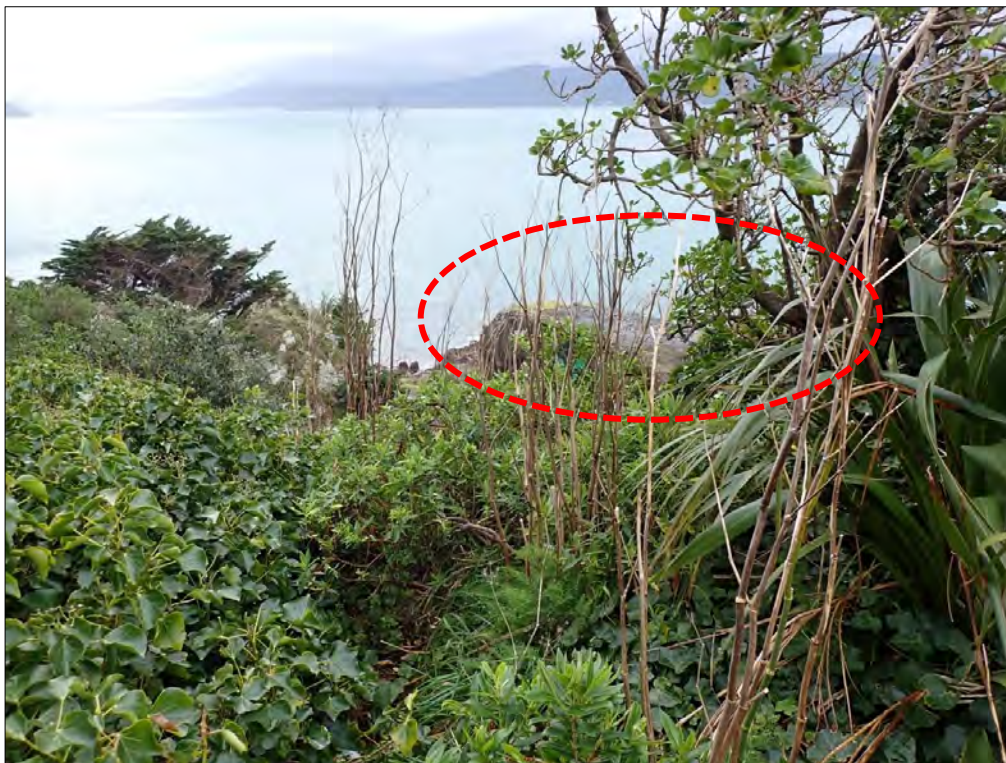
Figure 228. Feature 24: Fort Gordon magazine concealed by vegetation.

- Overgrowth around the structure can conceal decay and cause decay. Overgrowth can also obscure a structure, assisting with the protection from vandalism. If it is preferred that the structure be interpreted more fully, investigate the removal of saplings and/or the installation of tree root barriers in areas of risk. Such work should be advised by an arborist. The arborist will also be able to provide advice on pruning so as to restrict overgrowth.
- It is not necessary to remove moss or lichen from the structure. Moss and lichen contribute to the historical setting.
- Should the feature be vandalised with graffiti in the future, remove immediately using a paint stripper such as Soy Gel or Peel Away. Do not use any high pressure removal treatments and do not apply anti-graffiti coatings.

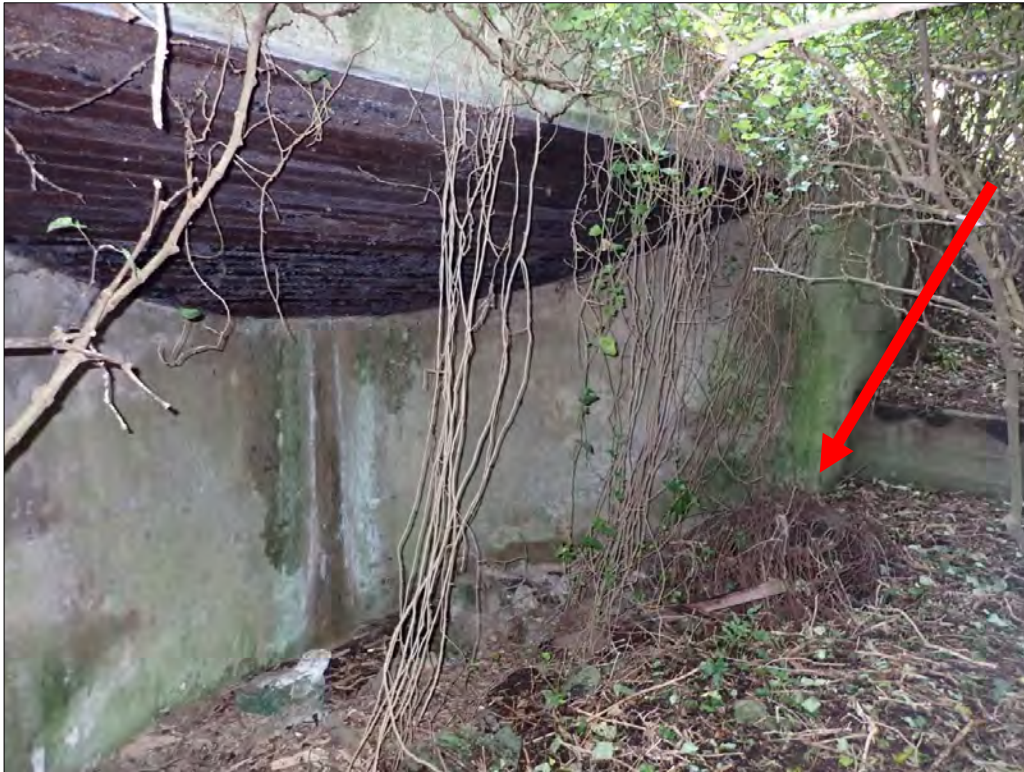
Figure 230. Feature 25: Fort Ballance. Looking east. See-saw searchlight concealed by vegetation. A roll of barbed wire is indicated.

- Overgrowth around the structure can conceal decay and cause decay. Overgrowth can also obscure a structure, assisting with the protection from vandalism. If it is preferred that the structure be interpreted more fully, investigate the removal of saplings and/or the installation of tree root barriers in areas of risk. Such work should be advised by an arborist. The arborist will also be able to provide advice on pruning so as to restrict overgrowth.

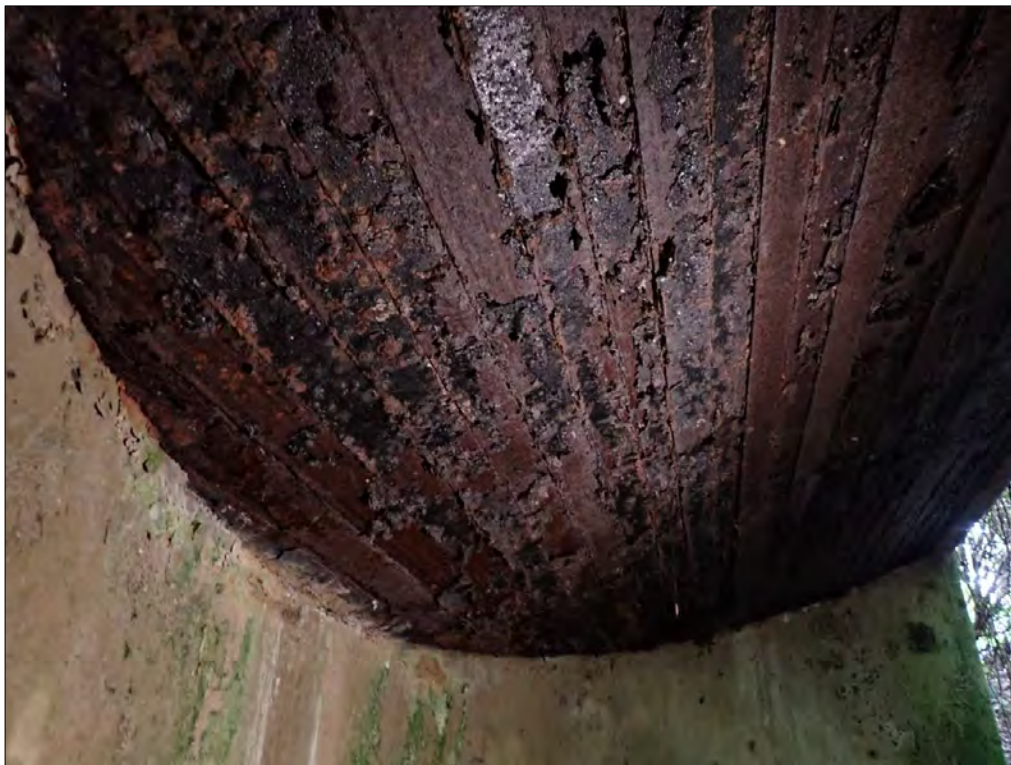
Figure 231. Feature 25: Fort Ballance. Steel formwork/reinforcement to underside see-saw searchlight structure.

- Cracking of the structure and the rusting of structural steel is evident. Undertake a structural assessment of the structure. If considered appropriate, the rust could be stabilised using a treatment such as fish oil. Following stabilisation, fish oil should then be reapplied regularly.
