Watts Peninsula, Wellington

Heritage and condition assessment

Report Prepared for Toitū Te Whenua Land Information New Zealand

Submitted: December 2022

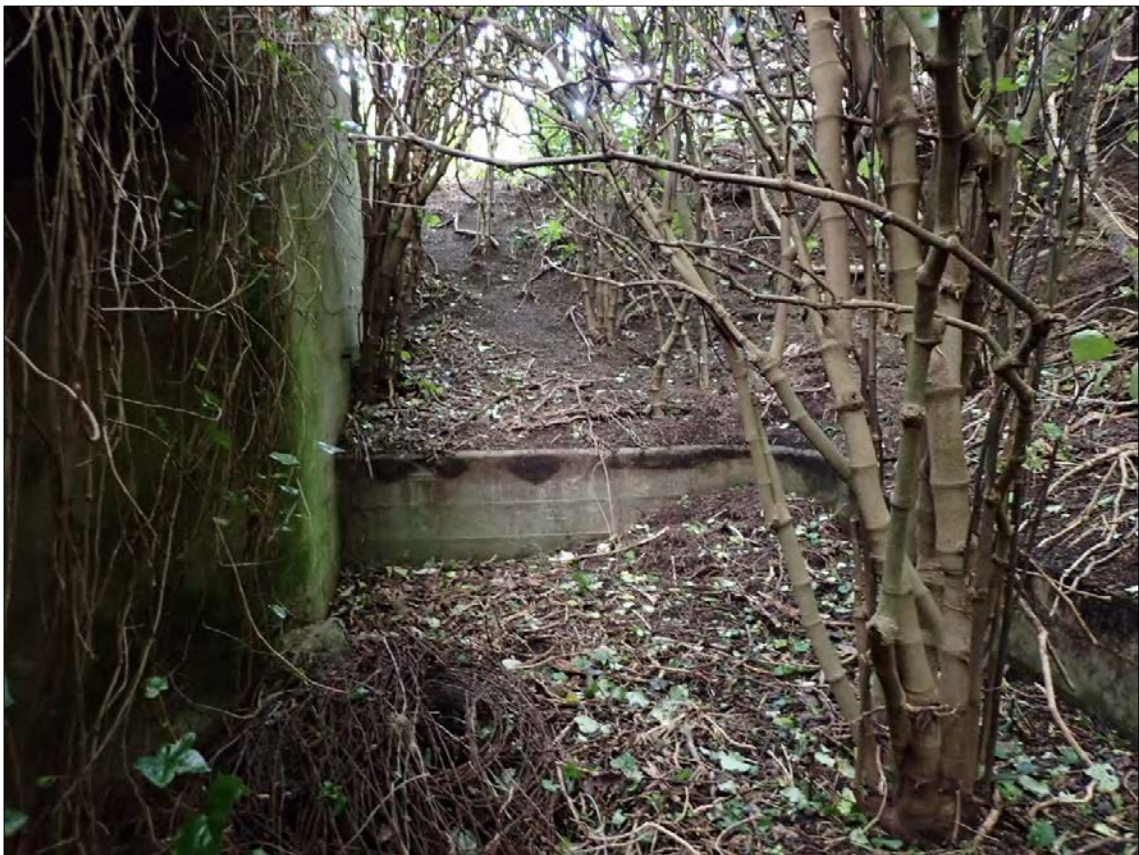
Figure 233. Feature 25: Fort Ballance. Looking south. See-saw searchlight concealed by vegetation.

- Overgrowth around the structure can conceal decay and cause decay. Overgrowth can also obscure a structure, assisting with the protection from vandalism. If it is preferred that the structure be interpreted more fully, investigate the removal of saplings and/or the installation of tree root barriers in areas of risk. Such work should be advised by an arborist. The arborist will also be able to provide advice on pruning so as to restrict overgrowth.

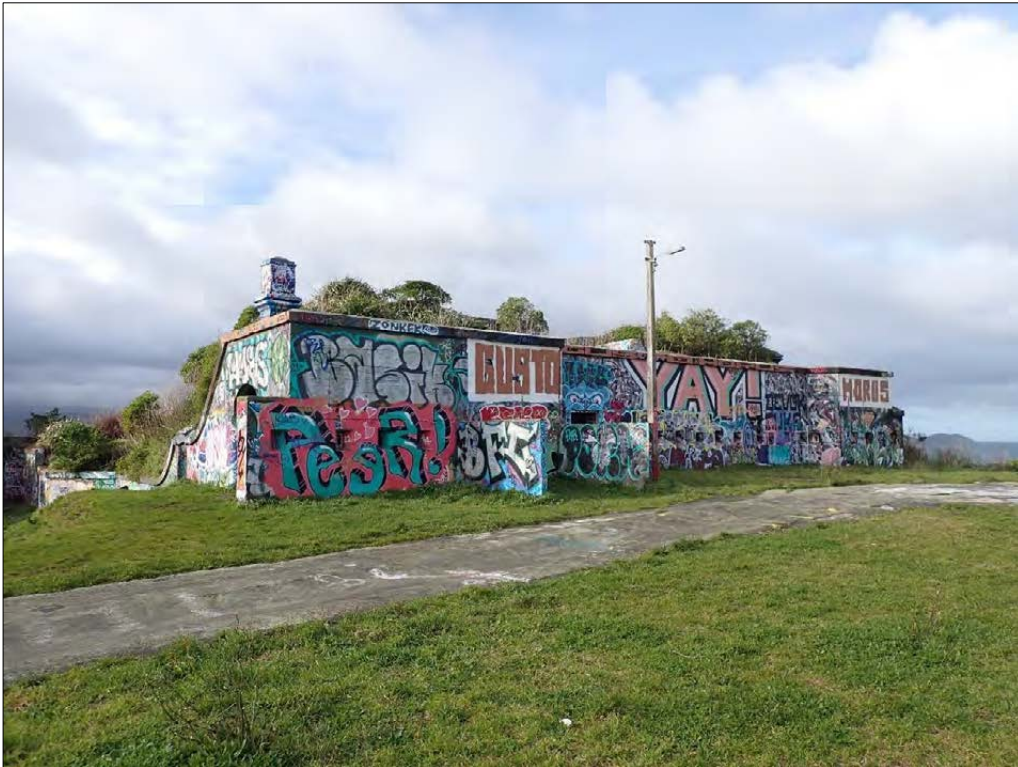
Figure 236. Feature 27: Fort Ballance. Looking east towards the artillery barracks. The structure has been extensively graffitied.

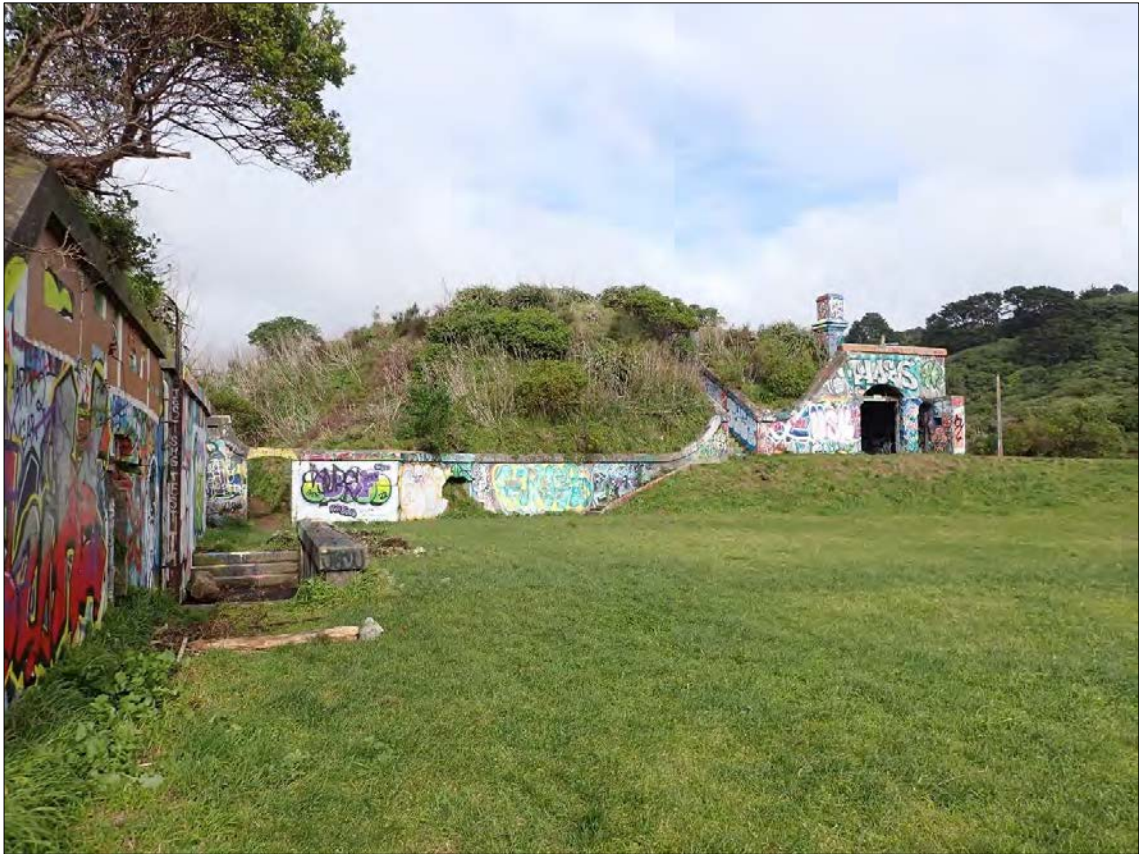
Figure 238. Feature 27: Fort Ballance. Looking south towards the artillery barracks from the shell and cartridge stores. The structures have been extensively graffitied.

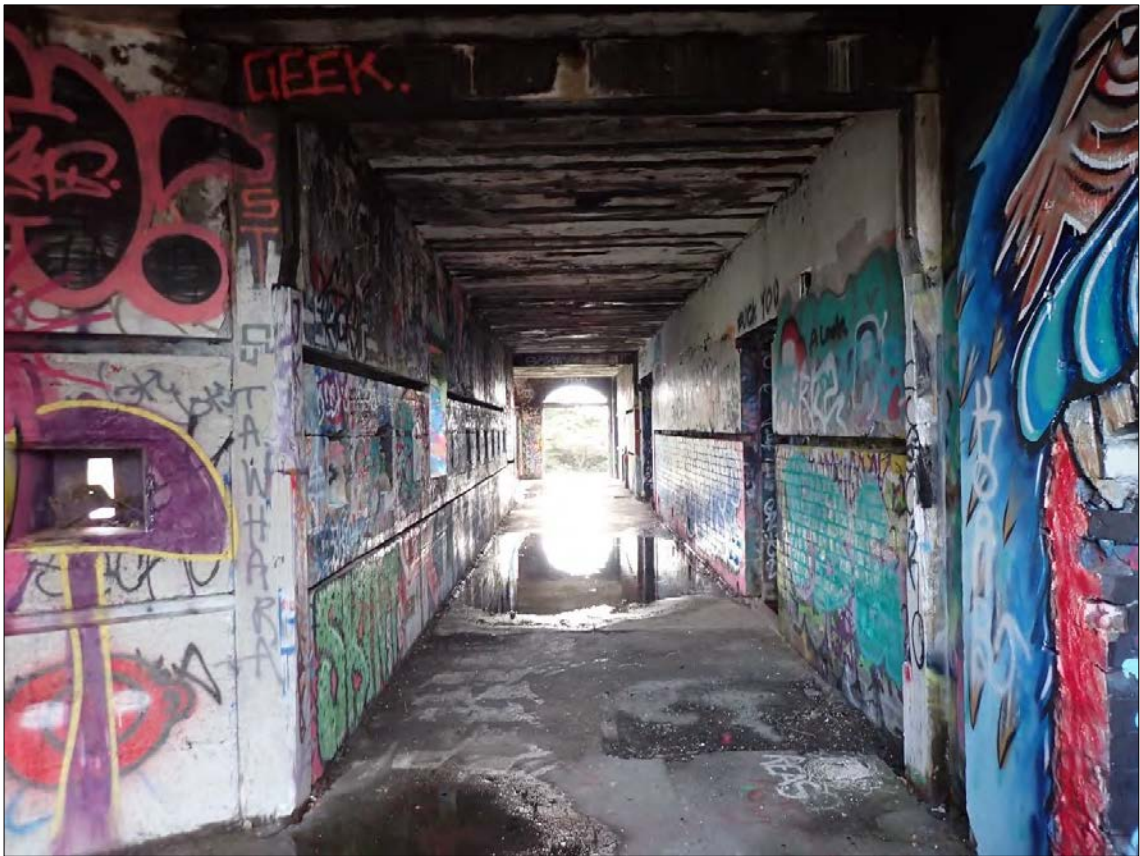
Figure 242. Feature 27: Fort Ballance. Artillery barracks. Water is ponding internally, and graffiti is present.

- Investigate ponding within some structures. Ponding may be the result of failed roof waterproofing, structural cracking, ground level heights and falls, windblown rain, or a combination of all these factors. It is essential that 'ponding', external and internal to the structure, does not occur.

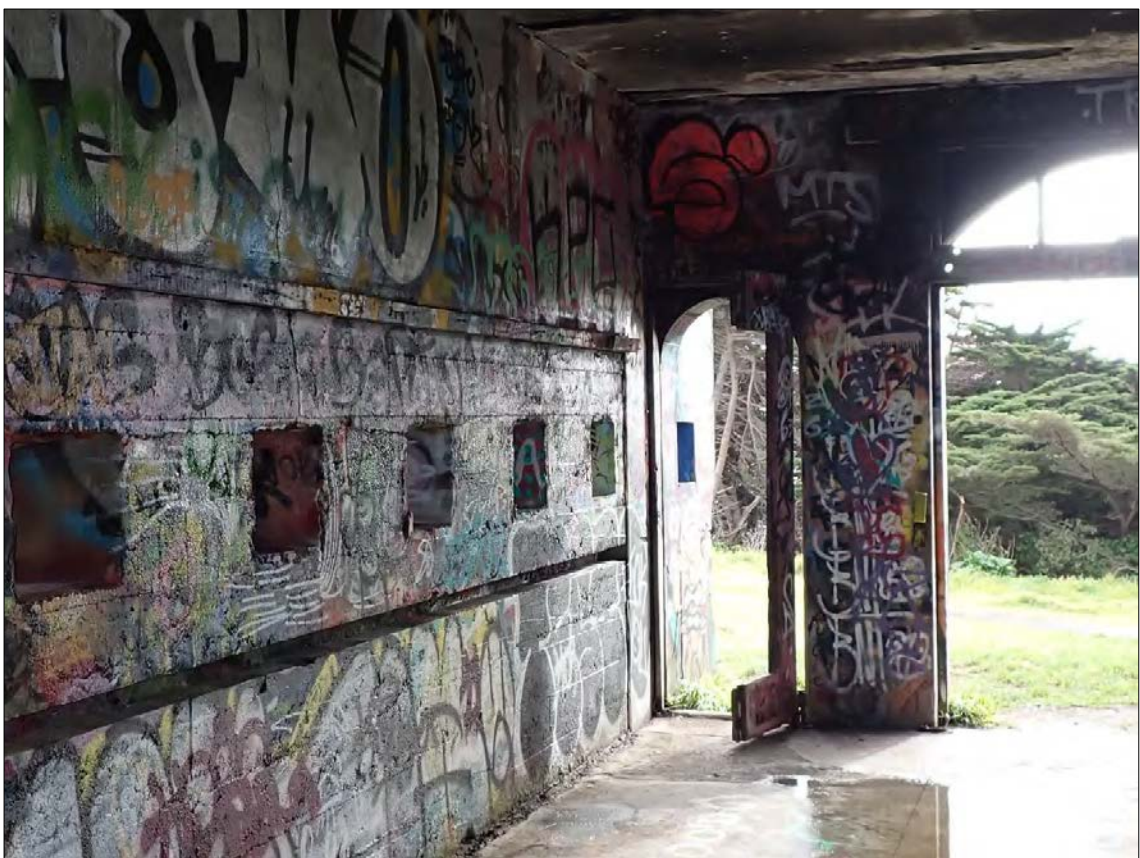
Figure 243. Feature 27: Fort Ballance. Artillery barracks. There is extensive graffiti to the interior.

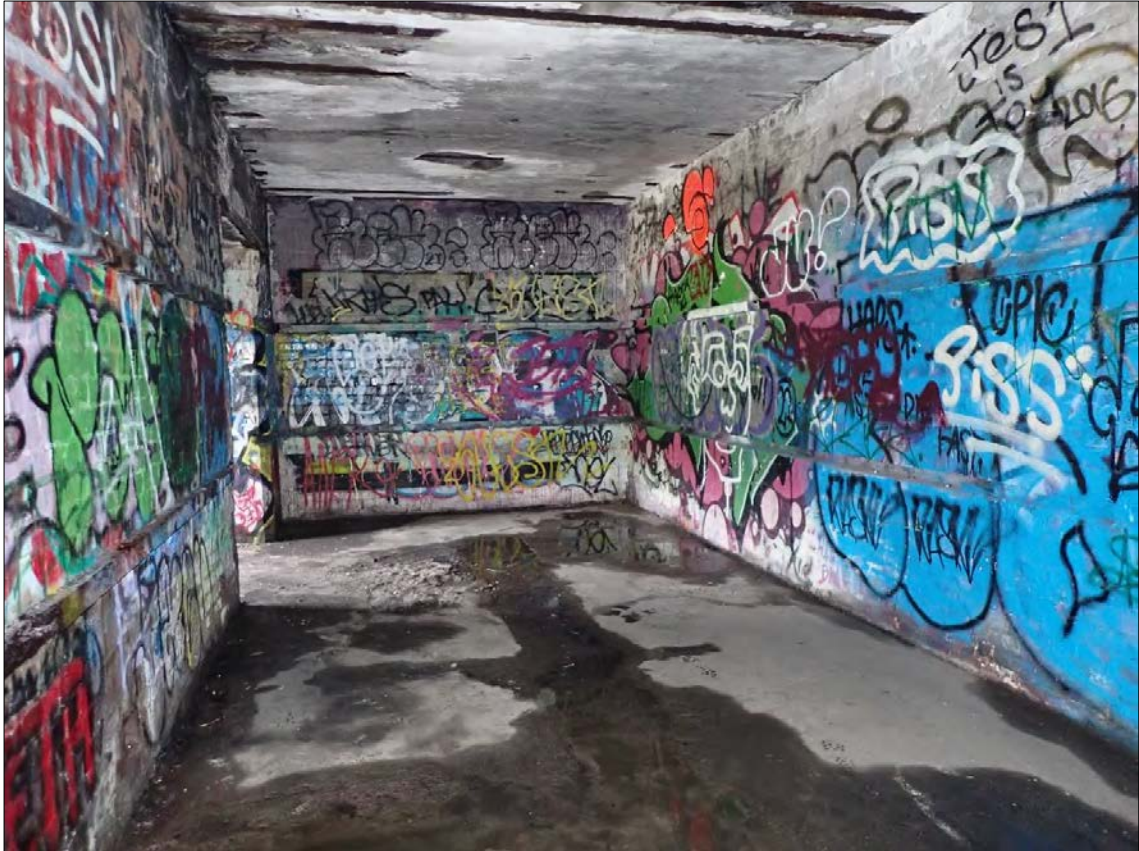
Figure 247. Feature 27: Fort Ballance. Artillery barracks. There is extensive graffiti and ponding to the engine room.

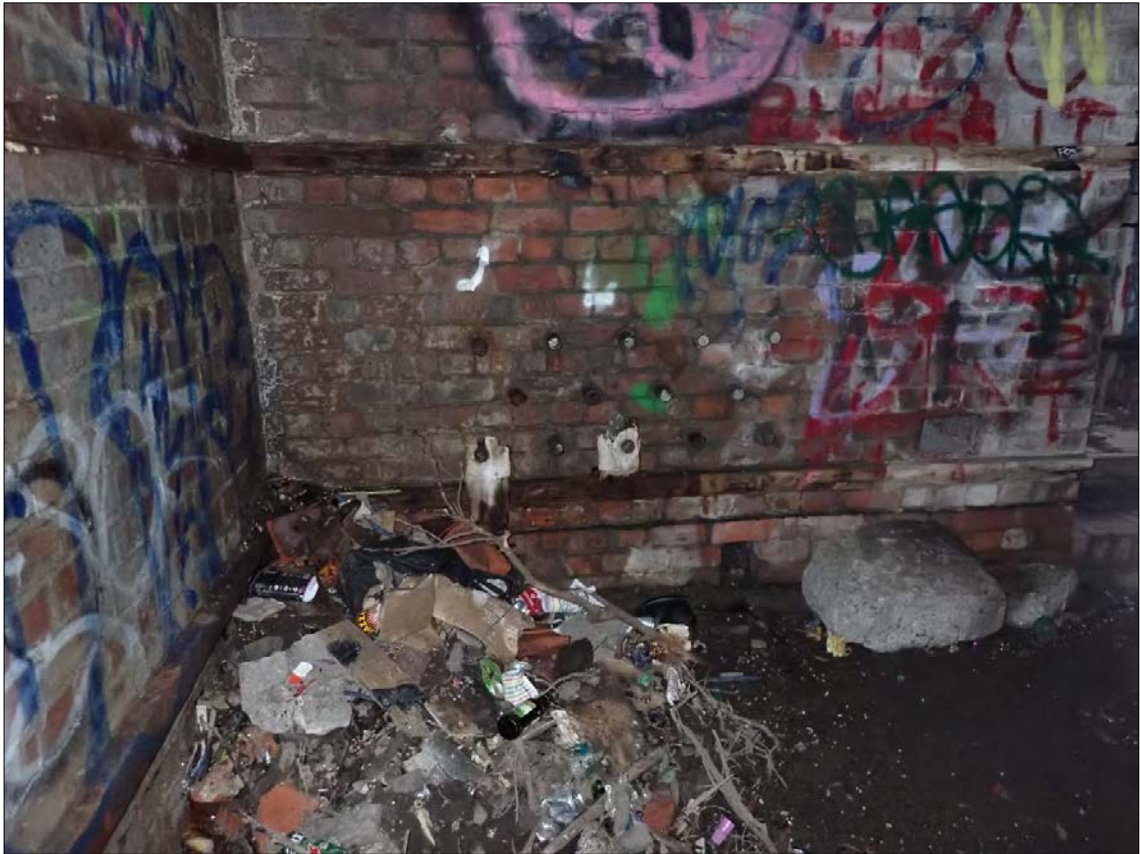
Figure 248. Feature 27: Fort Ballance. Artillery barracks. Accumulation of rubbish in room adjacent to the engine room.

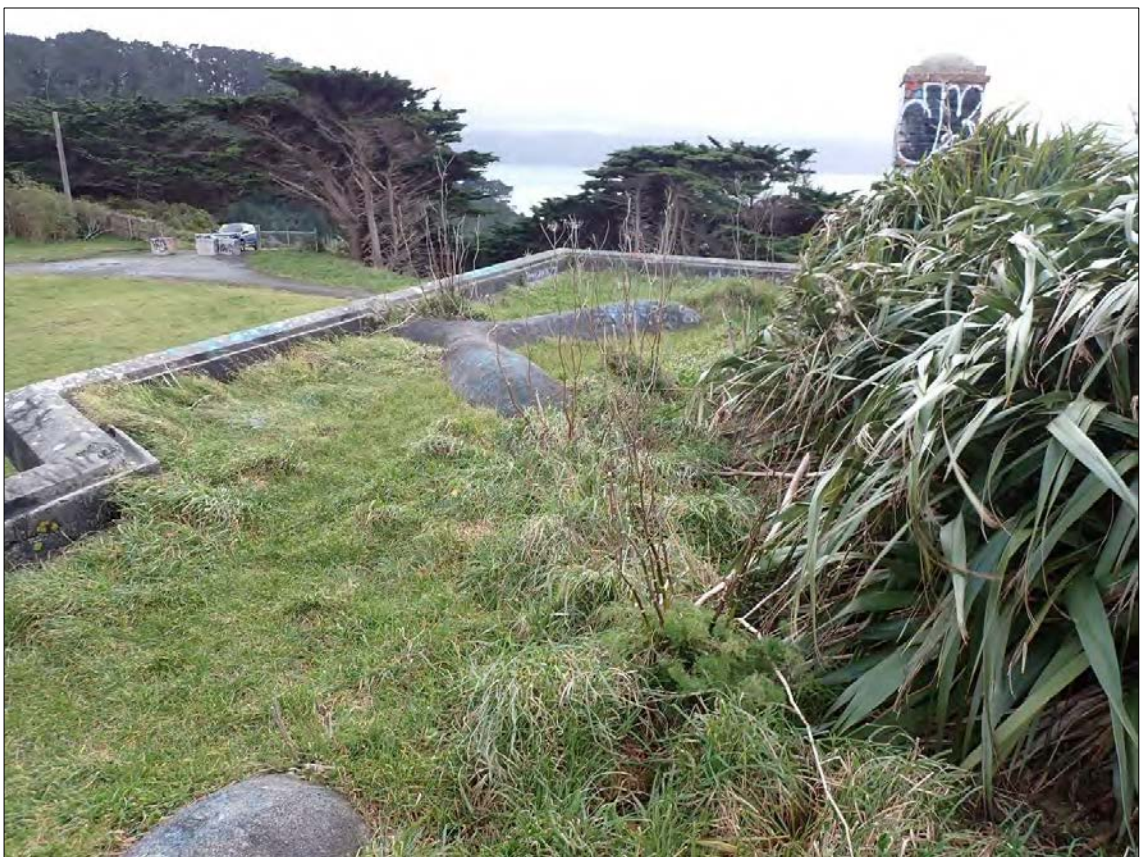
Figure 249. Feature 27: Fort Ballance. Artillery barracks roof planting.

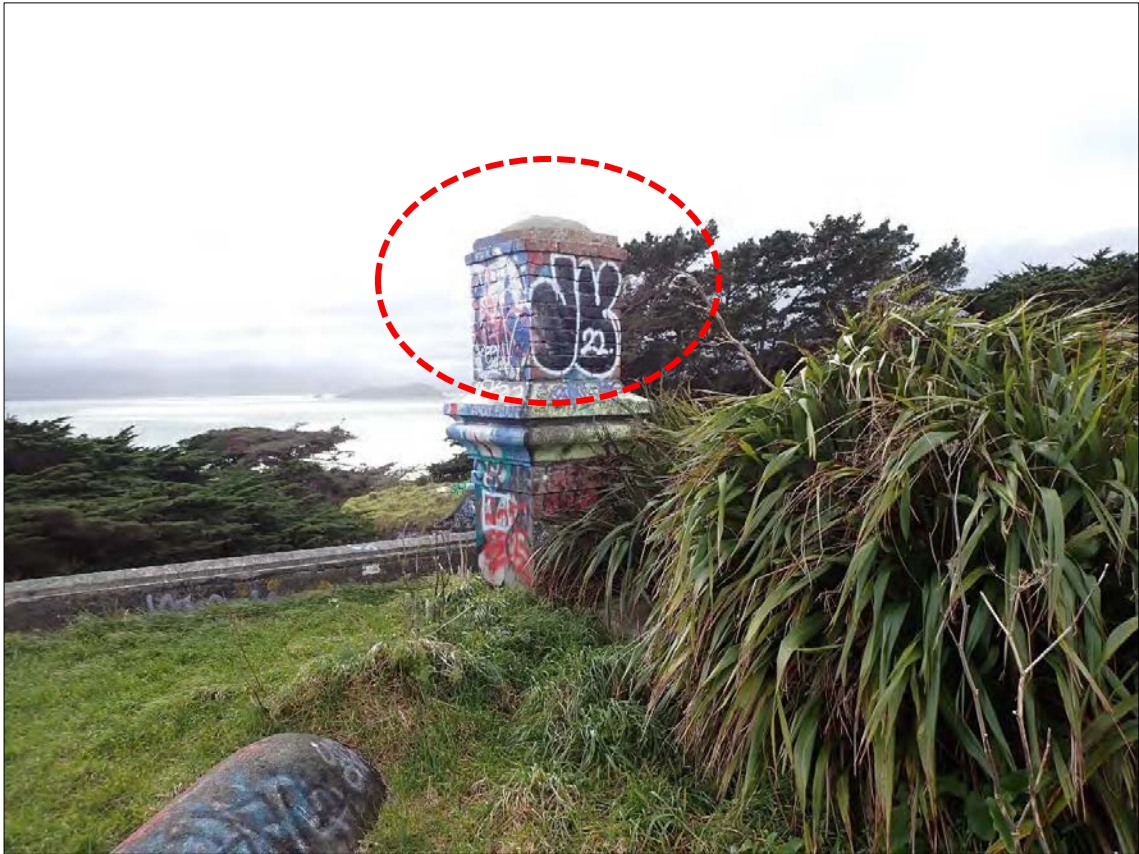
Figure 250. Feature 27: Fort Ballance. Artillery barracks roof. Original chimney has been increased in height.

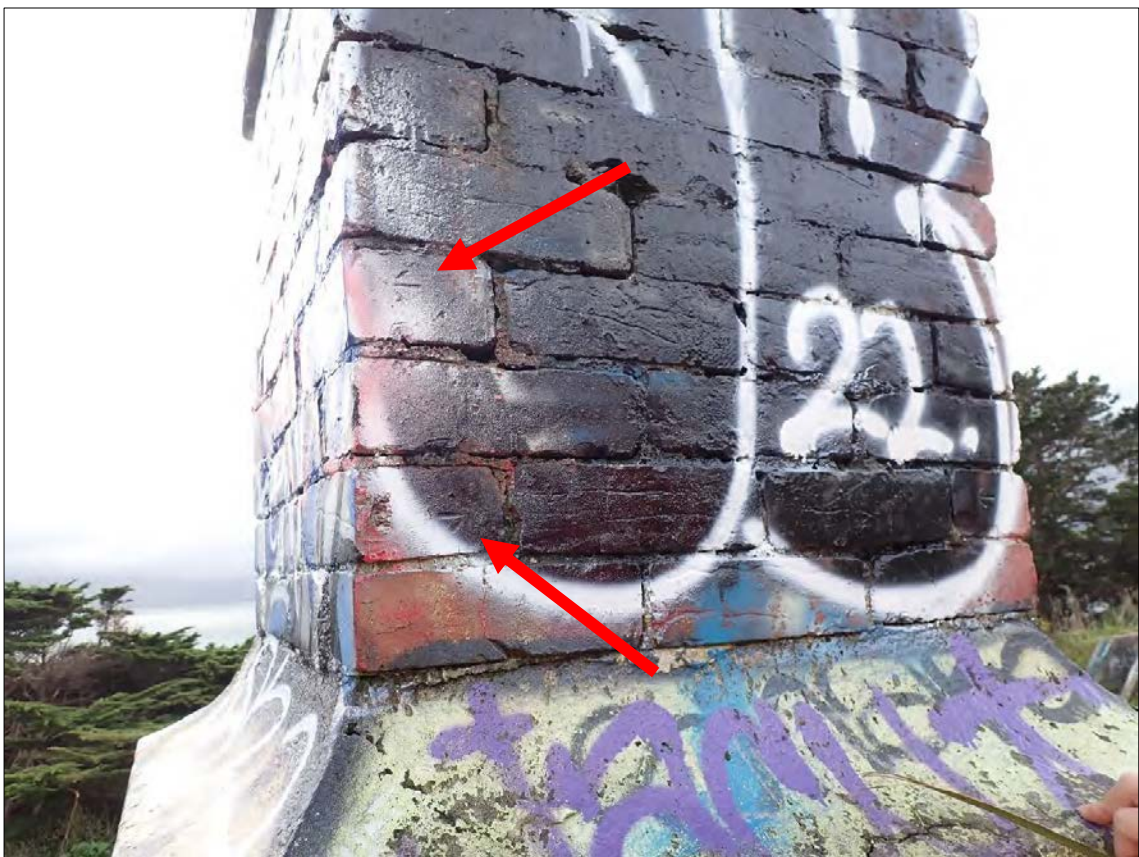
Figure 251. Feature 27: Fort Ballance. Artillery barracks roof. Original chimney increased in height using 'prison' bricks.

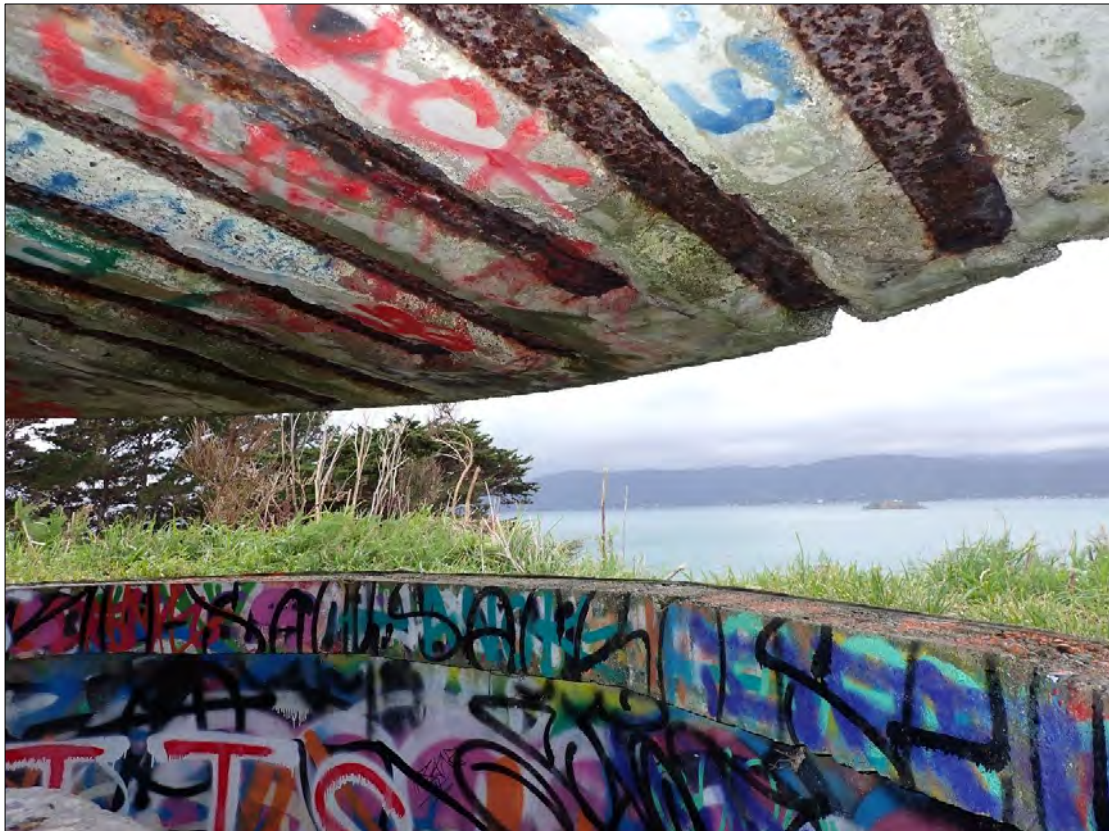
Figure 253. Feature 27: Fort Ballance. Pit B lookout. Underside slab reinforcement corroding and spalling of concrete, and extensive graffiti.

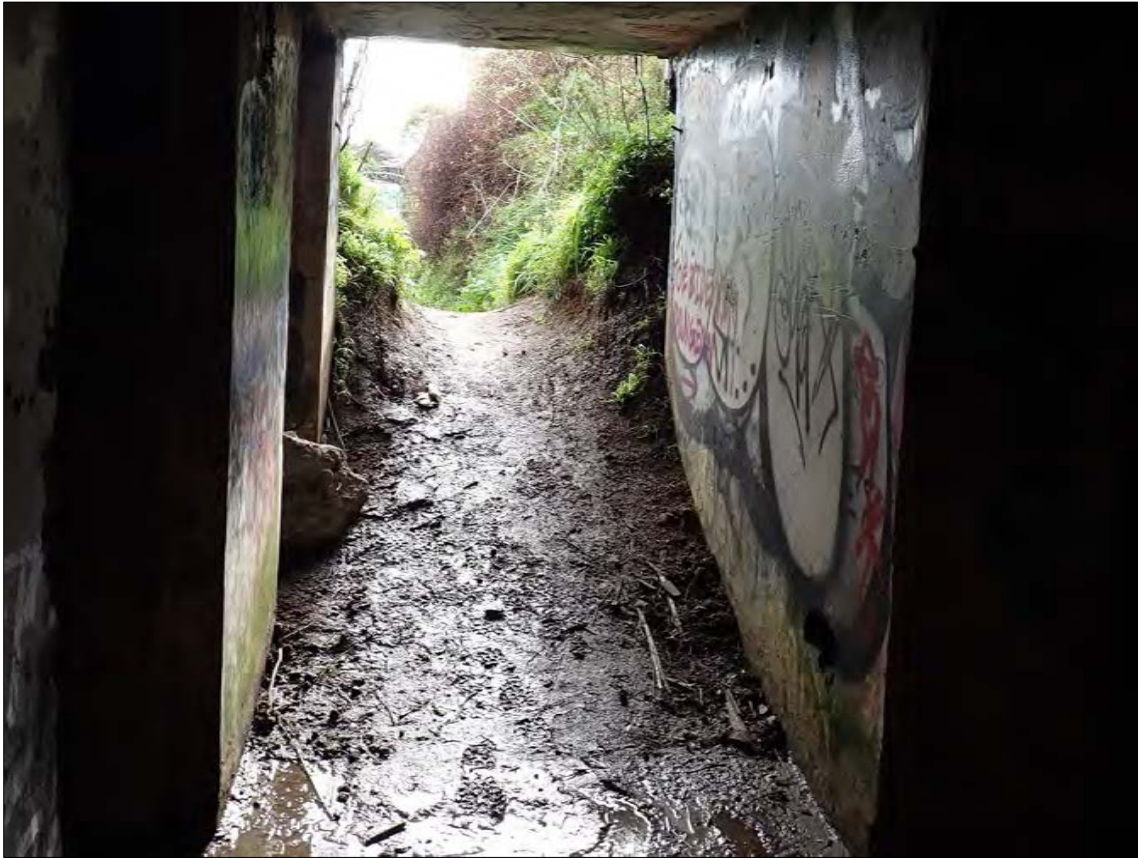
Figure 256. Feature 27: Fort Ballance. Earth build-up at tunnel entrance to the disappearing gun at 6inch BLHP (Pit A).
Image cropped.

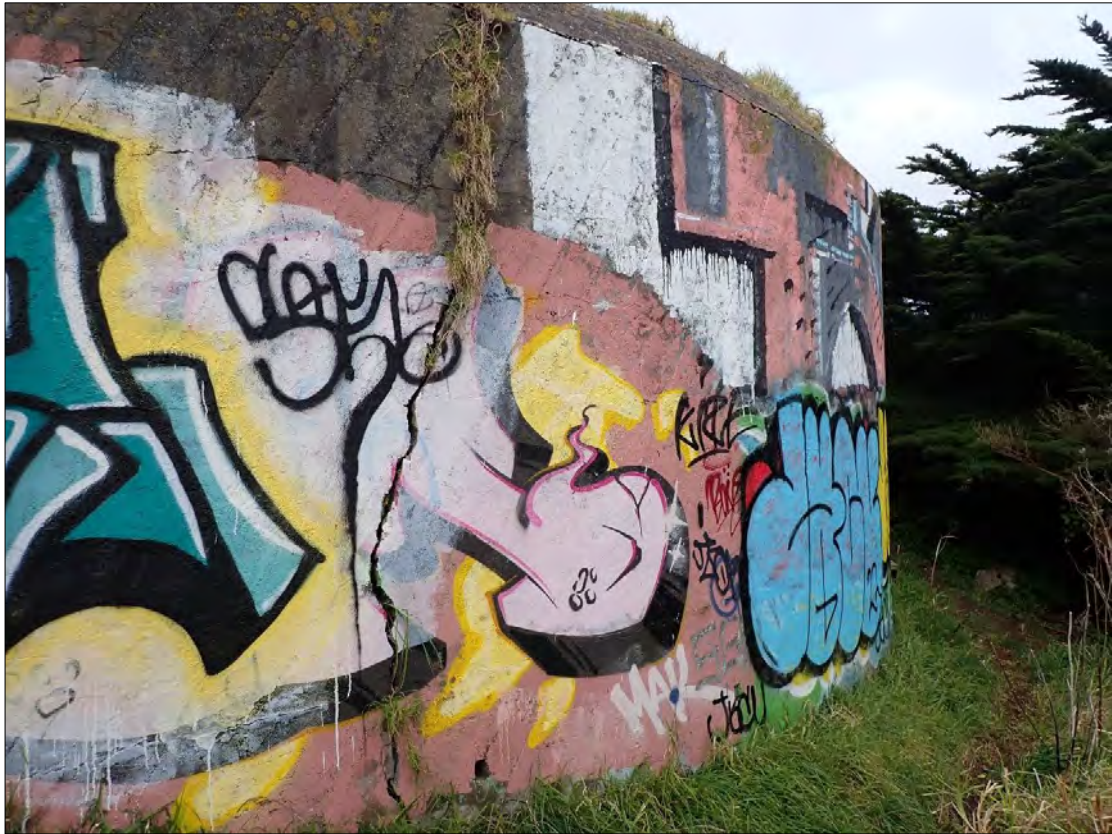
Figure 260. Feature 27: Fort Ballance. Example of cracking to walls.

- Clear the washout debris from the tunnel entrance to the disappearing gun at 6inch BLHP (Pit A).
- Many of the structures feature large cracks and show signs of displacement. Undertake a structural assessment of all the structures.

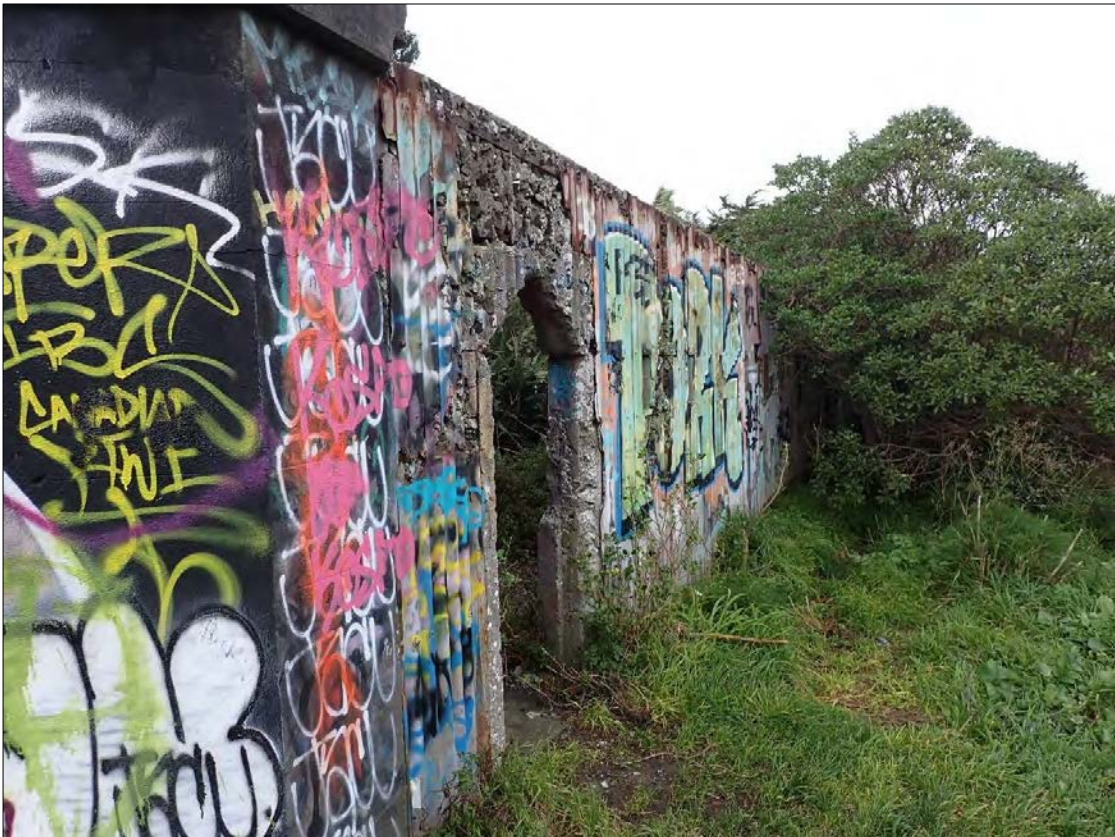
Figure 261. Feature 27: Fort Ballance. Loopholed wall to the east of the artillery barracks. Some corrugated metal formwork remains in position. The wall has been extensively graffitied.

- Cracking of the structures, spalling, and the rusting of structural and non-structural metal is evident. Undertake a structural assessment of the structures. If considered appropriate, the rust could be stabilised using a treatment such as fish oil. Following stabilisation, fish oil should then be reapplied regularly.

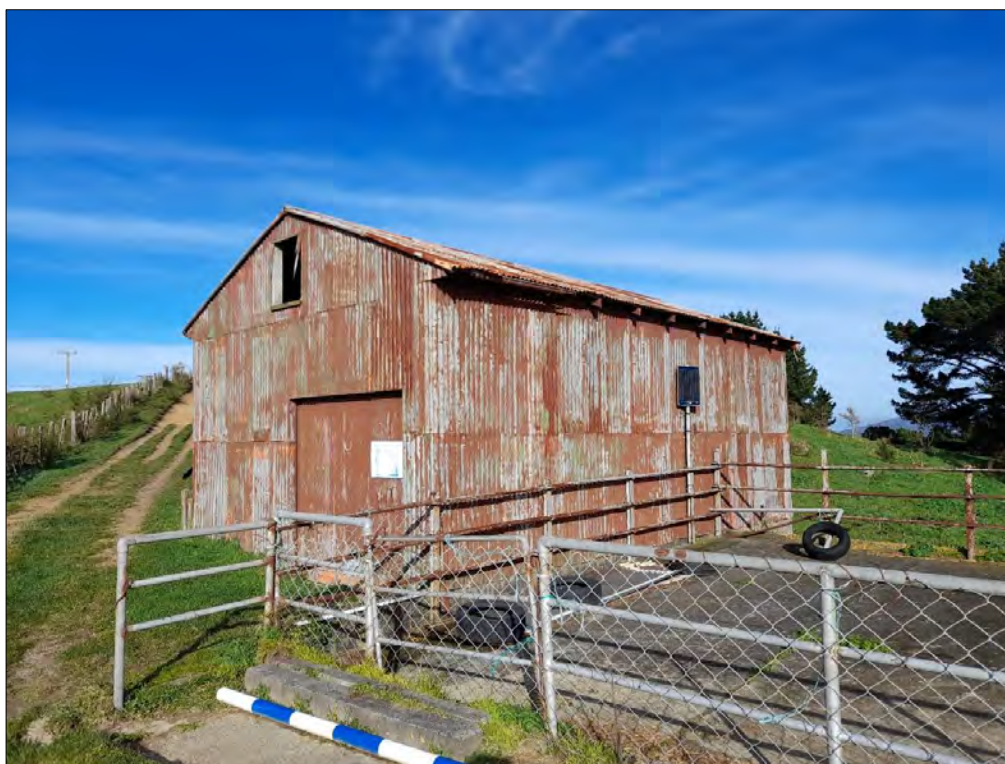
Figure 263. Feature 28: Farmstead. Shed built using salvaged material. Date of construction not known.

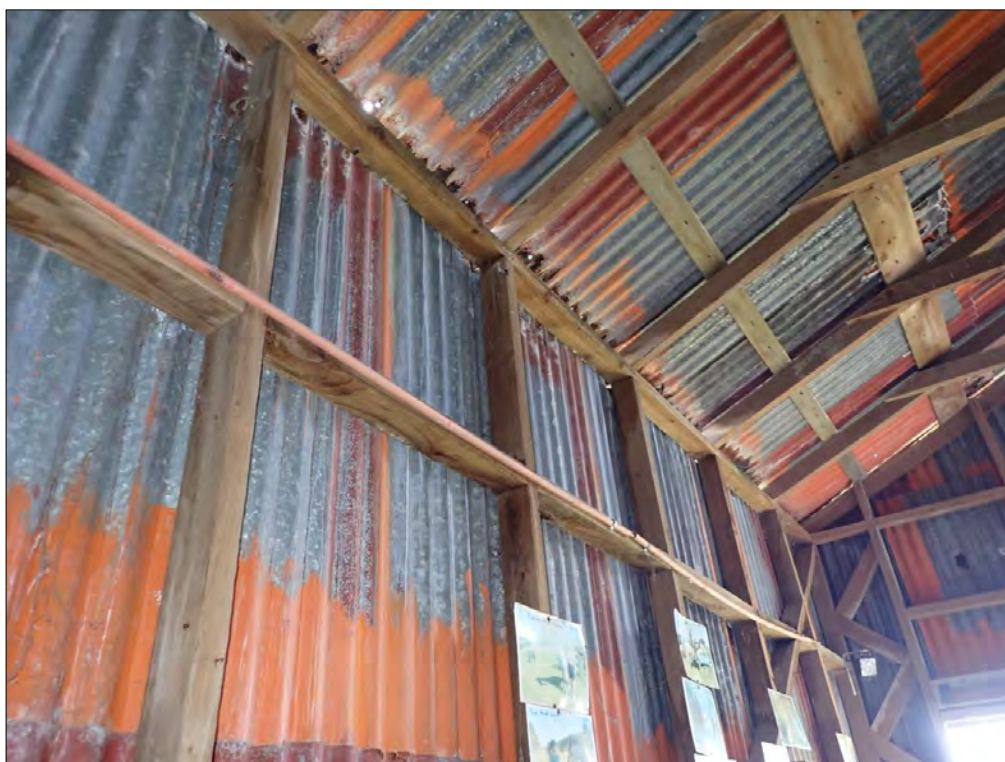
Figure 264. Feature 28: Farmstead. Shed interior

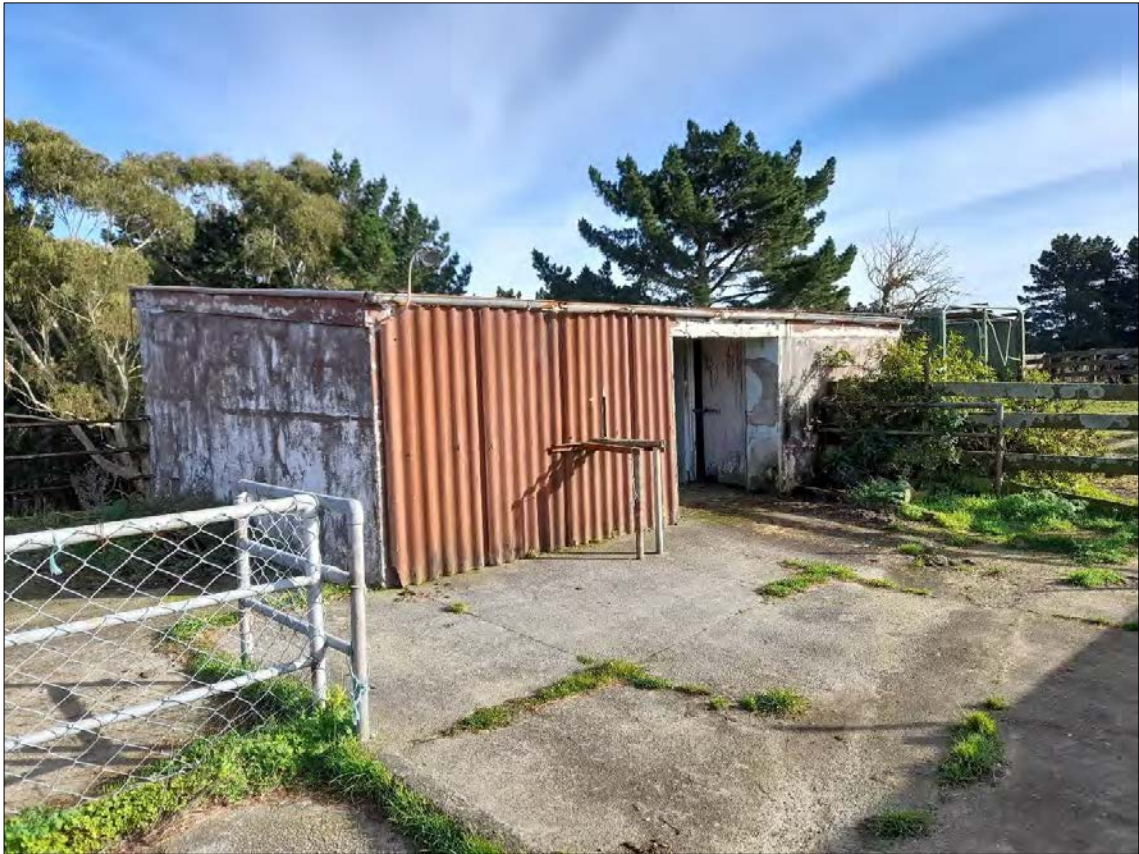
Figure 265. Feature 28: Farmstead. Original milking shed.

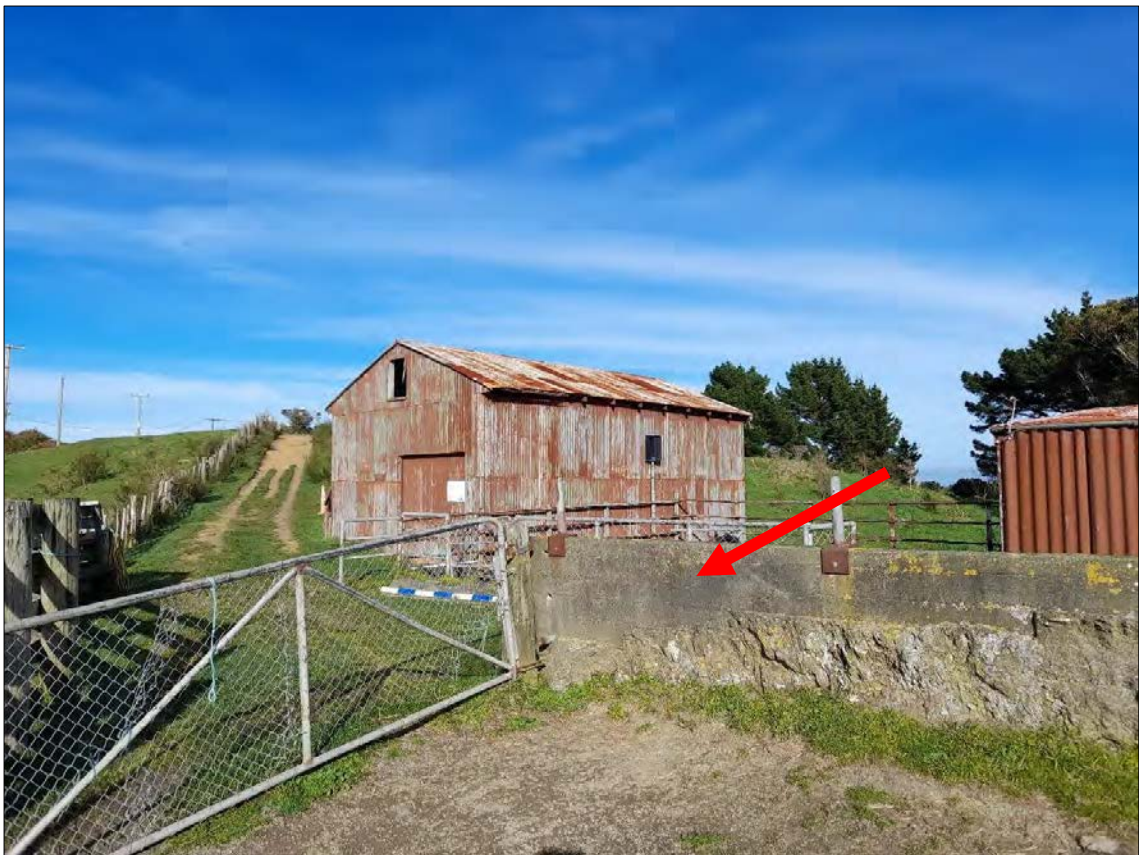
Figure 268. Feature 28: Farmstead. A remnant concrete wall is indicated. The milking shed is the RHS.

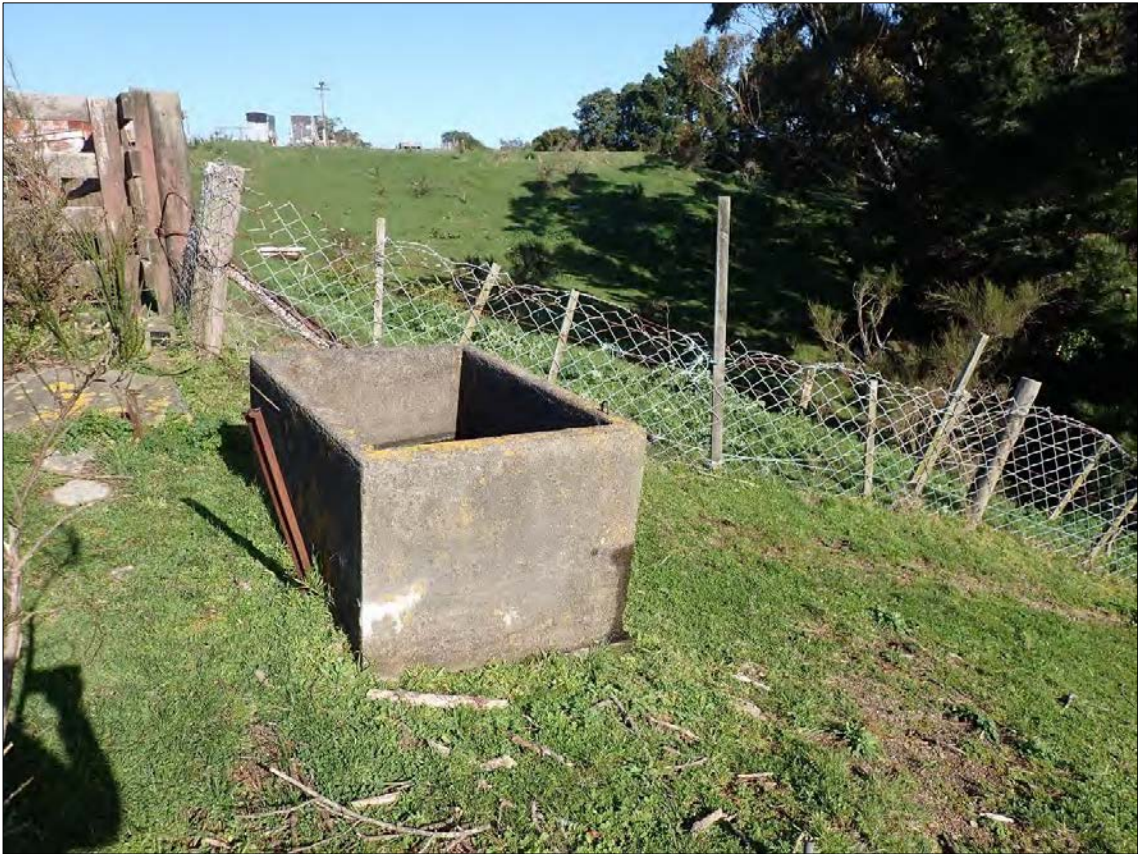
Figure 269. Feature 28: Farmstead. Concrete water trough.

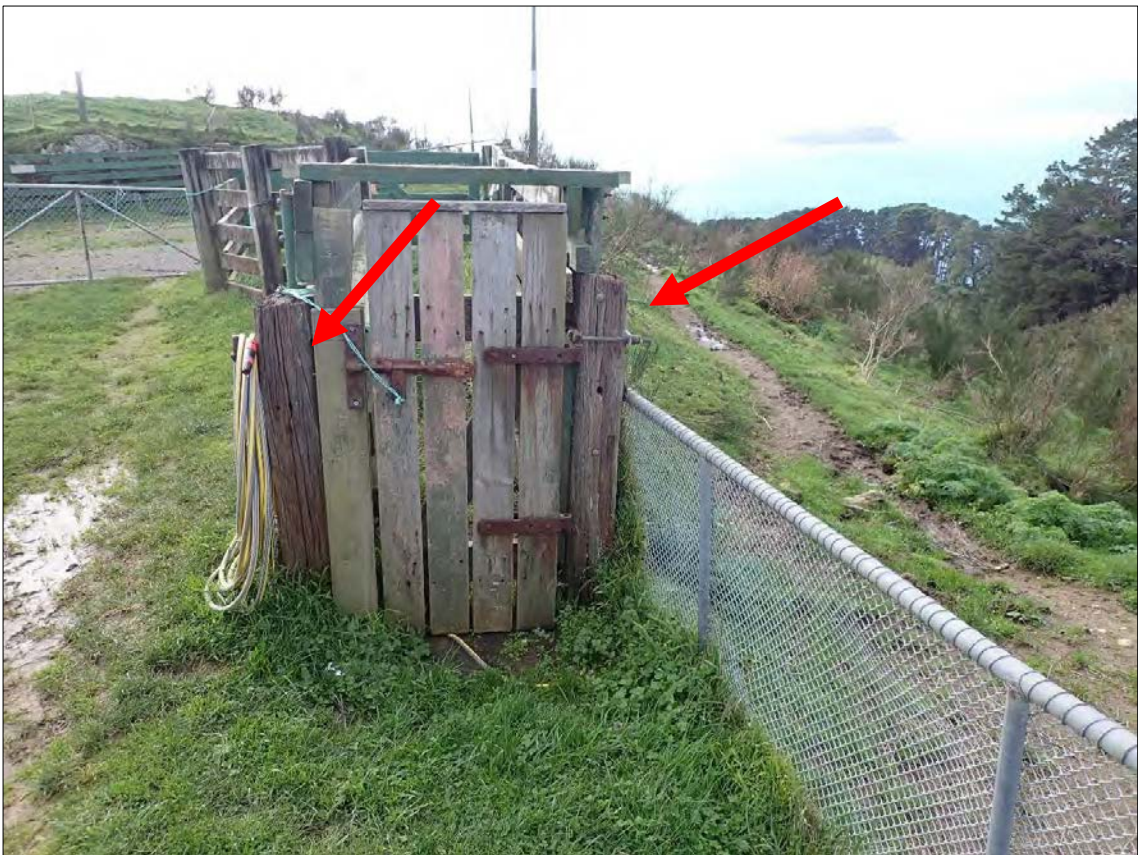
Figure 270. Feature 28: Farmstead. Example of early/original timber posts and reused hardware.

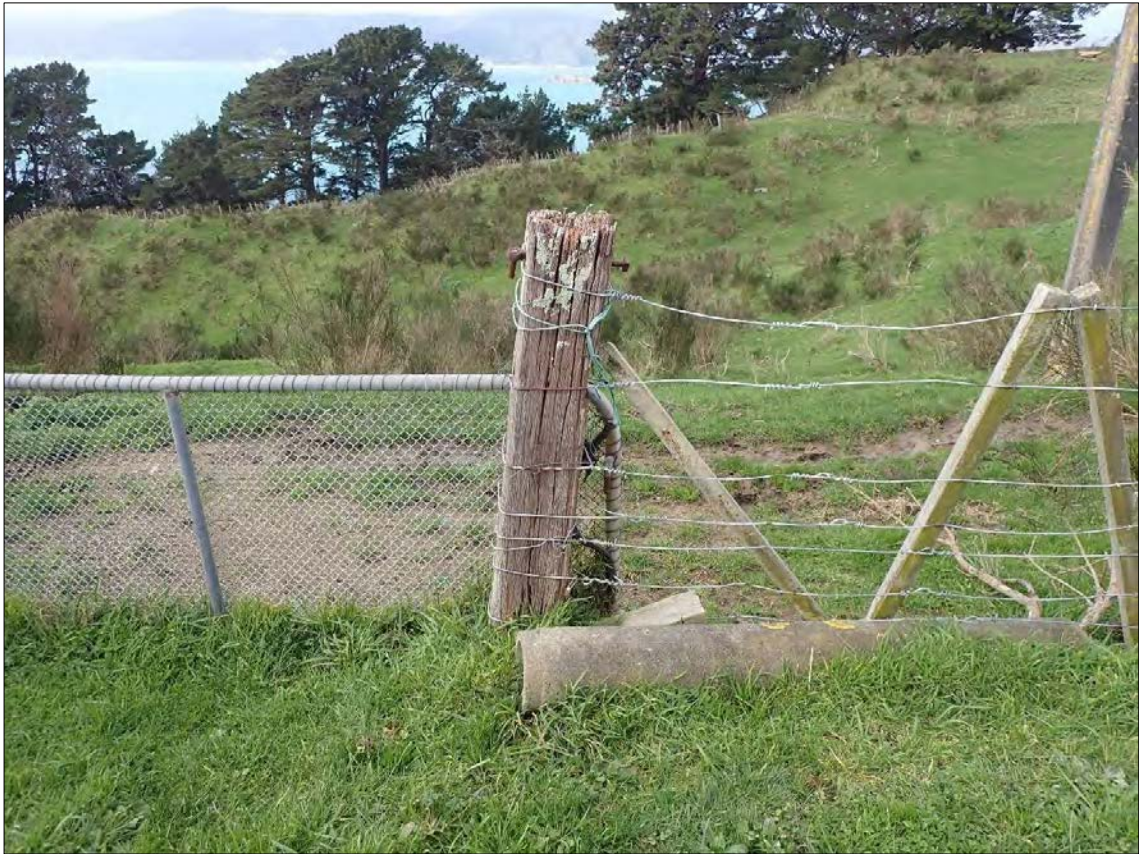
Figure 271. Feature 28: Farmstead. Example of early/original timber posts with gudgeon.
