Subject: Land instability at 58 Akoranga Drive

As we discussed, there are a couple of issues pertaining to the Awataha Marae site at 58 Akoranga Drive, Northcote that need progressing.

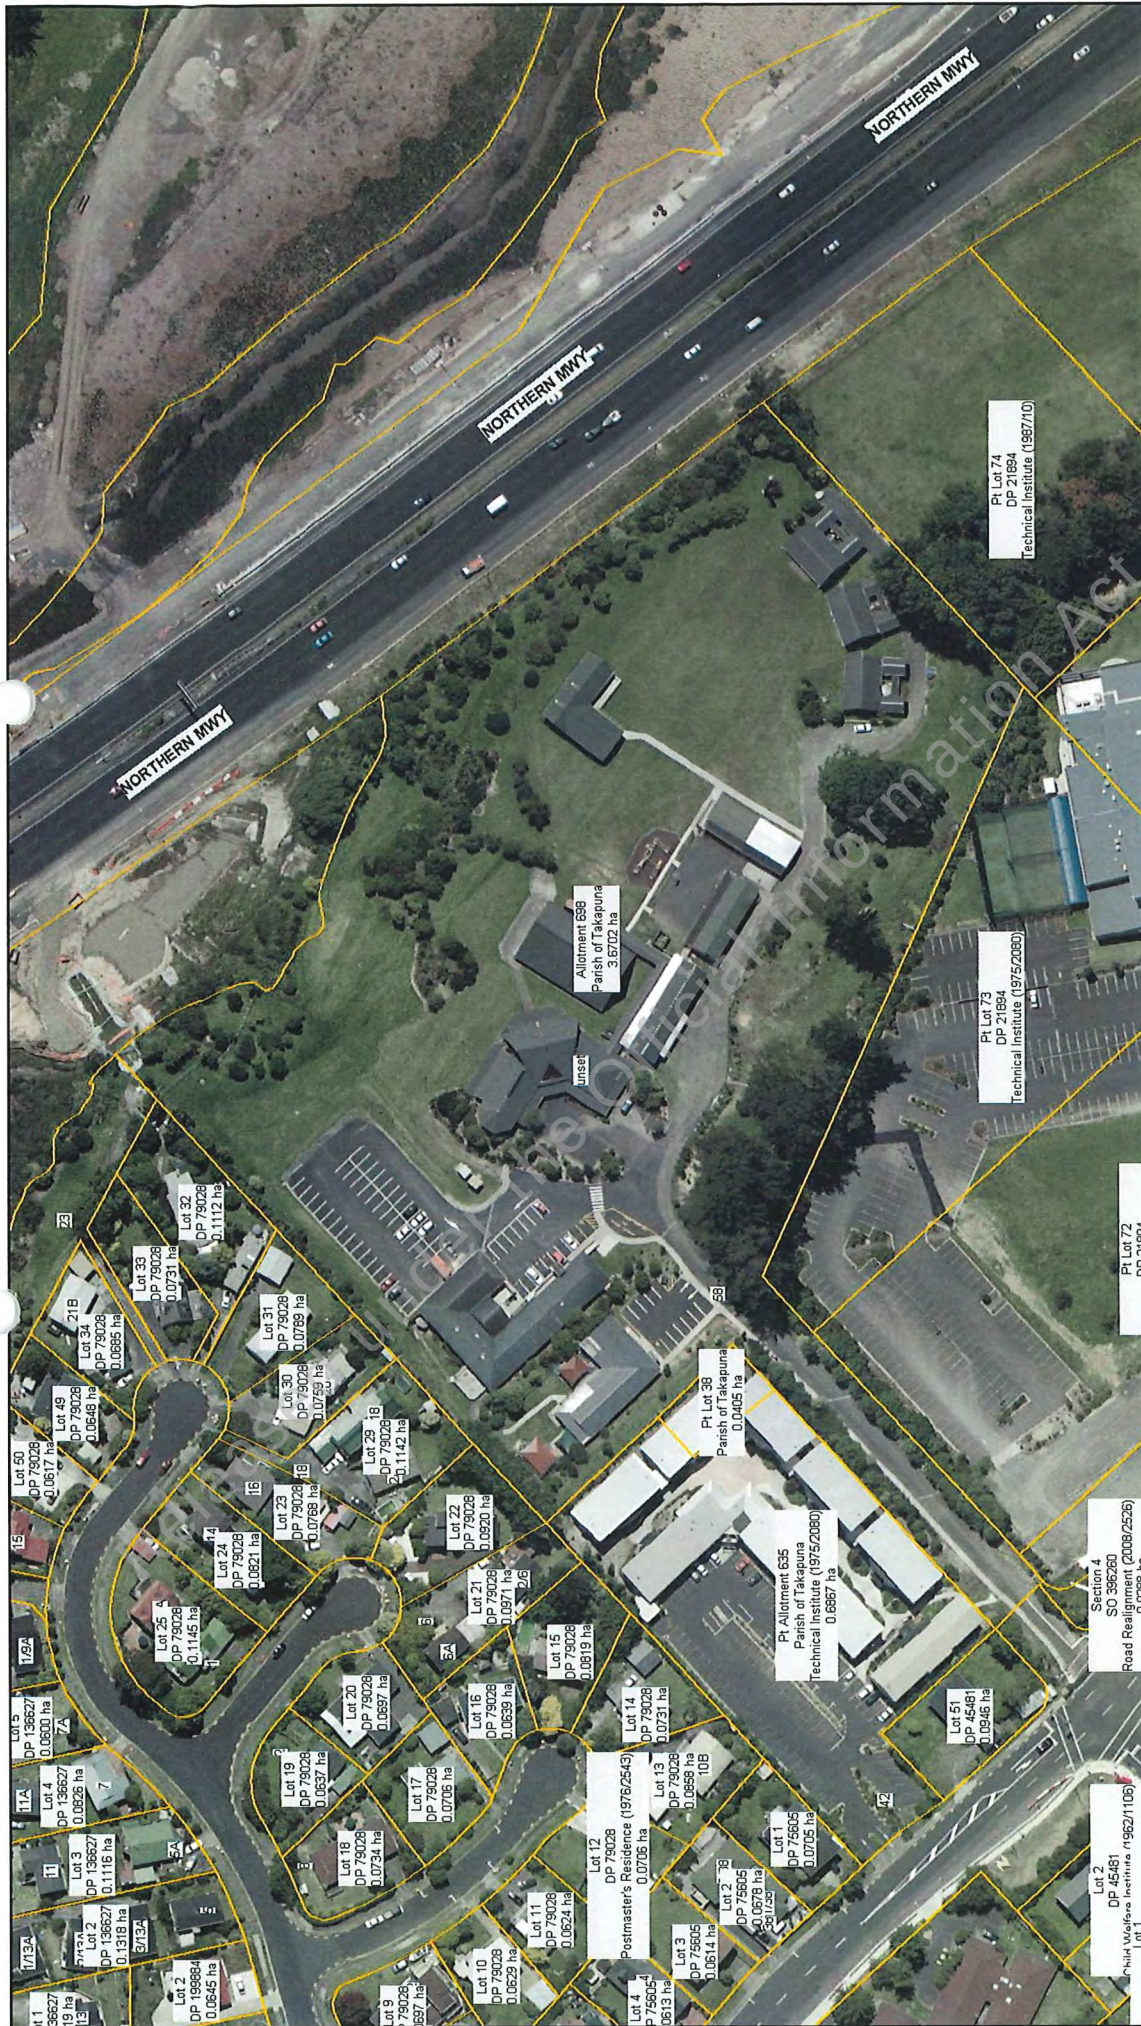
- I will talk to LINZ about the tree stump however if it is not a hazard they might leave it.
- Treescape was supposed to mulch the branches please confirm if they have not done this yet.
- Poplar trees - I've attached a map of the site. Could you identify the trees that are causing concern as i have doubts they are on LINZ's land. (refer attached)
