FORMER TOKANUI HOSPITAL
DEMOLITION AND REMEDIATION
DEMOLITION MANAGEMENT PLAN

Project No. 33205		Approved for Issue		
Version No.	No. 4 Name		Sean Finnigan	
Status	Final		A Lin	
Authors	E Bish / S Finnigan	signature	N and	
Reviewer	S Finnigan	Date	9/05/2024

DEMOLITION, DECONSTRUCTION & REMEDIATION MANAGEMENT PLAN

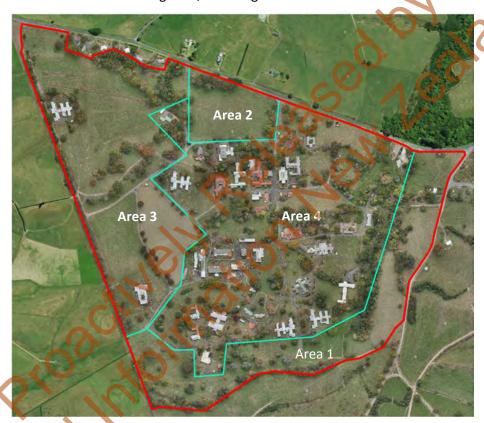
Figure 1: Site location and extent showing 4 deferred selection properties

The former Tokanui Hospital (the Site) was a psychiatric hospital approximately 80 hectares (ha) in area, with 76 buildings, a wastewater pump station, swimming pool, eight substations, a closed landfill (also referred to as the 'existing disposal site') and substantial roading and underground infrastructure and services. The site location and extent is shown in Figure 1, including the 4 areas referred to in the Deed.

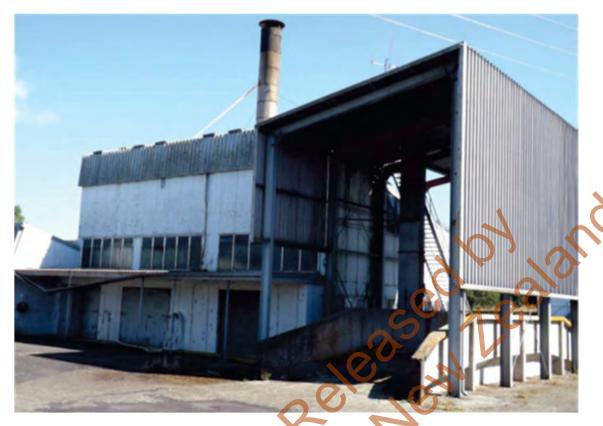
Figure 3: Boiler House

The boiler house (B68) is shown in Figure 3.

- Temporary stability of the concrete hopper structures and suspended cones to be maintained while remainder of building is taken down.
- The hoppers need to be taken down in a controlled manner. No detailed drawings are available but it is possible/likely that the suspended hopper cones are reliant on the concrete walls above. The weight of the cones should be relieved by propping before the hopper walls are taken down.
- Given the location of the Boiler House, it is proposed that this structure be demolished last out of the structures covered in this section.

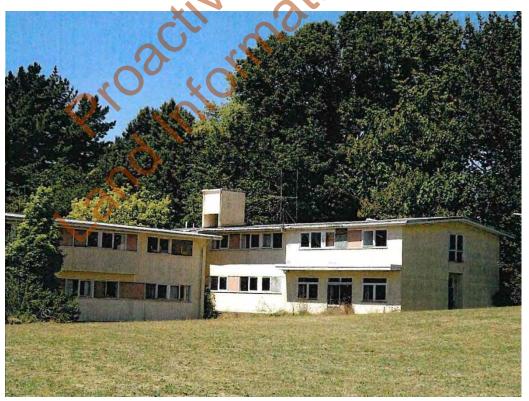
Figure 4: Ward 21 (B26)
May 2024 Project No. 33205
Toitū Te Whenua – Land Information New Zealand
Demolition Management Plan

Ward 21 (B61) is shown in Figure 4.

- Class B ACM present to building exterior, ceiling void and internal building structure.
- No demolition hazards noted.
- Given location and demarcation as a culturally significant area, removal of this structure will require
 observation by a cultural monitor at all times, especially during removal of any below ground
 infrastructure.

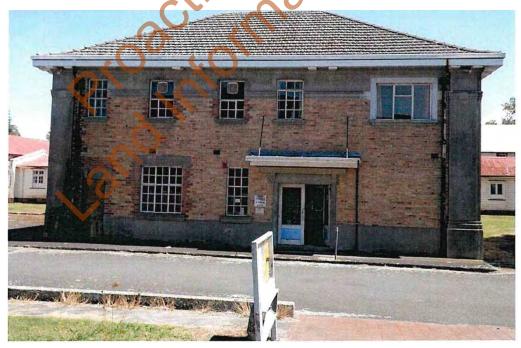
Figure 5: Waipa Community and Training Centre (B10)

The Waipa Community and Training Centre (B10) is shown in Figure 5.

- Class A ACM present in roof void and internal building structure
- No demolition hazards noted.
- Suggested early demolition and removal, to create more space and turning bays on main access road.

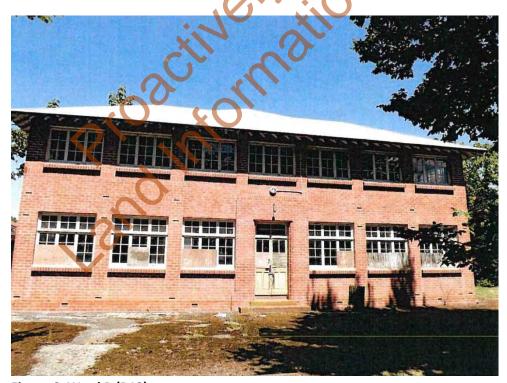
Figure 6: Ward B (B12)

Ward B (B12) is shown in Figure 6.

- Class B ACM identified to internal components of boiler room, sheds and switchboards.
- No demolition hazards noted.
- Suggested early demolition and removal, to create more space and turning bays on main access road.

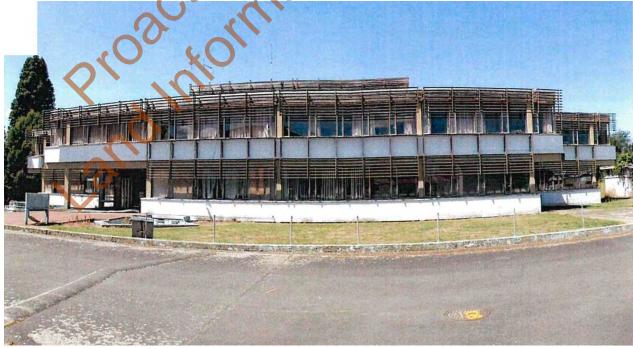
Figure 7: Main Administration Building (B1)

The main administration building (B1) is shown in Figure 7.

- Class A & B ACM identified to external and internal components.
- No demolition hazards identified.
- Suggested early demolition and removal, to create more space and turning bays on main access road.

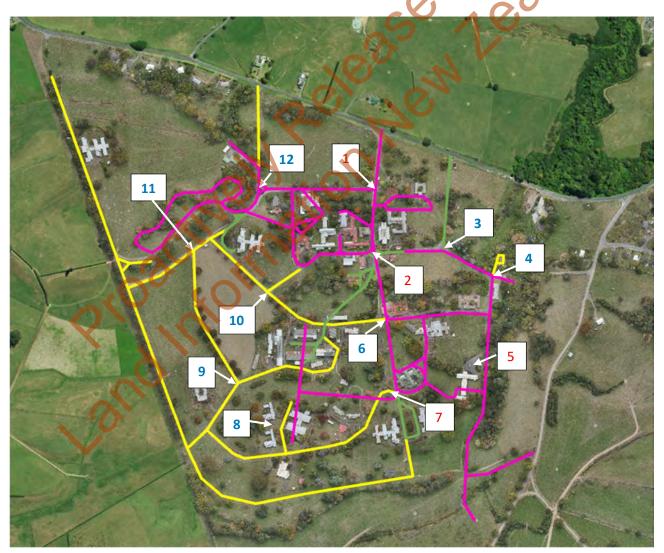
A review of historical aerials came up with three eras for road construction as shown in Figure 9 below. Overlaying the GHD sampling results onto this figure found that all the coal tar "hits" coincide with the "pink" network (1944), but it is not entirely consistent. Adopting a conservative approach, based on the limited sampling undertaken by GHD, all of the "pink" road network has been assumed to contain coal tar.

Figure 9: Road construction eras from aerial photography review (pink = 1944, green = 1961, yellow = 1974); red colour exceeds WasteMINZ Coal Tar Guidelines; blue colour = below WasteMINZ Coal Tar Guidelines:

This investigation found four locations where coal tar use was considered likely, these locations were Asph 01, 02, 05 & 07, which correlate to intersections on Roads 1, 2 and 3. The coal tar samples contain PAHs at elevated concentrations (Benzo-a-pyrene (equivalent) (BaP(eq)) = 62, 38, 34 and 2.9mg/kg in samples 01 (pavement only), 02 and 05 (pavement and basecourse) and 07 (basecourse) respectively). Leaching of PAHs from all samples was very low. BaP(eq) is a measure of the potential overall PAHs carcinogenicity. The results indicate this is low risk, with the guideline for commercial/industrial sites (outdoor workers), unpaved areas being 35mg/kg. In this case, these results derive from paved areas and hence the PAHs are likely to be tightly bound to the pavement as indicated by the TCLP leaching results, meaning the 35mg/kg guideline will be conservative.

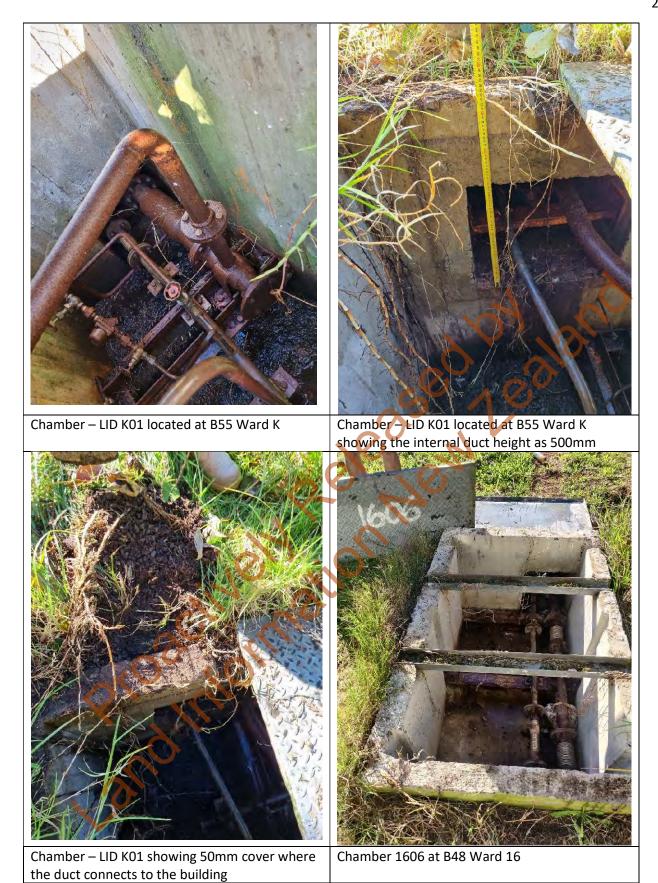
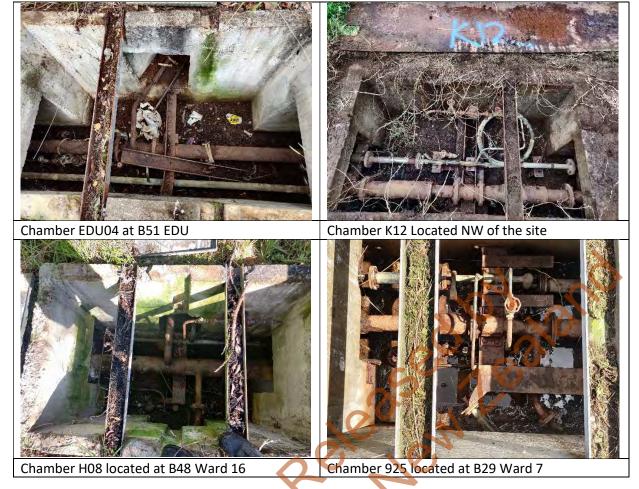
Some photos of the ducting are included below for information. More details and photos are included in the Horizontal Infrastructure Report.

Figure 10: Representative Photos of the Concrete Ducting System

Based on historical plans, composition of the steam lines was generally ungalvanized mild steel of either medium or heavy grade. The return condensate lines were copper. In some areas there was a third pipe, conveying hot water pipes, but some drawings refer to this as "to be removed". Bronze anchors and guides for the condensate pipes are referred to on some drawings. Pipe sizes are shown as varying from 1.5" to 2.5" (38-63mm for condensate) and 2"-6" (50-150mm) for steam. The pipe system includes significant numbers of valves, anchors, brackets and guides. Cover over the concrete ducting varies but is around 400mm on the drawings reviewed, which only cover a small part of the overall system.

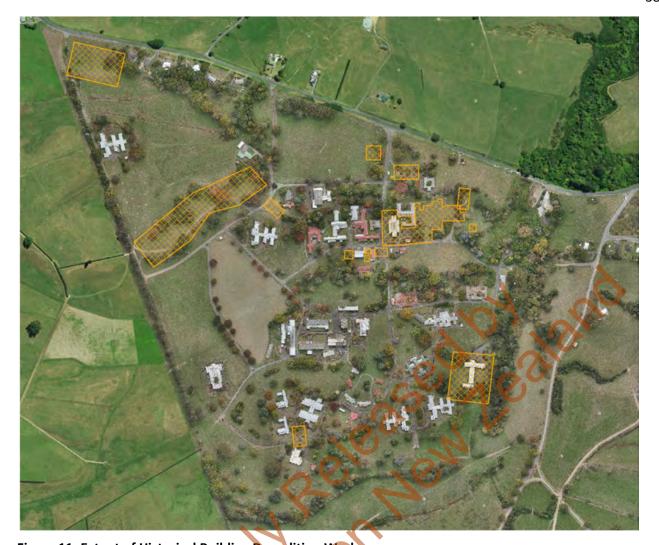
Figure 11: Extent of Historical Building Demolition Works

During February 2024 site investigation work, some historical demolition debris, including some asbestos sheet fragments, filament bulbs, burnt material, terracotta/earthware pipes, etc. was found in rare/minor/small quantities at variable depths ranging from near surface to up to 1.2m on the northern sides of Buildings B02 and B26. A review of historical aerial photographs (dentified that some buildings, or parts of buildings, have been demolished in these areas in the past. All of these areas have been investigated as part of intrusive investigations by Aecom/GHD with no significant demolition debris or contaminated soil found. Nevertheless, some fill and minor demolition debris may be found in these areas during associated demolition works, particularly during the removal of building footings/foundations and any buried services. This may also apply to the industrial area, where some discoloured fill was encountered. The extent of the historical demolition works is shown in Figure 11. The contractor should be aware of this, and advise LINZ or their nominated representative, if such fill/materials are found. Accidental discovery protocols will be triggered, if the find is significant (e.g. asbestos fragments, concentrated pockets of demolition debris.)
