FORMER TOKANUI HOSPITAL
DEMOLITION AND REMEDIATION
DEMOLITION, DECONSTRUCTION & REMEDIATION
MANAGEMENT PLAN - DRAFT

Project No.	33205	Approved	for Issue
Version No. 6 No.		Name Sean Finnigan	
Status	Final	Cian atura	A Jin
Authors	E Bish / S Finnigan	signature	N and
Reviewer	S Finnigan	Date	15/11/2024

## TOITŪ TE WHENUA – LAND INFORMATION NEW ZEALAND FORMER TOKANUI HOSPITAL DEMOLITION AND REMEDIATION

## **DEMOLITION, DECONSTRUCTION & REMEDIATION MANAGEMENT PLAN - DRAFT**

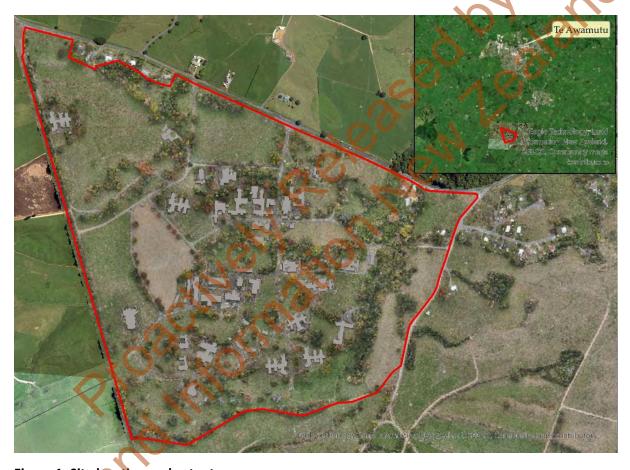
Figure 1: Site location and extent

The former Tokanui Hospital (the Site) was a psychiatric hospital approximately 80 hectares (ha) in area, with 76 buildings, a wastewater pump station, swimming pool, eight substations, a closed landfill (also referred to as the 'existing disposal site') and substantial roading and underground infrastructure and services. The site location and extent is shown in Figure 1

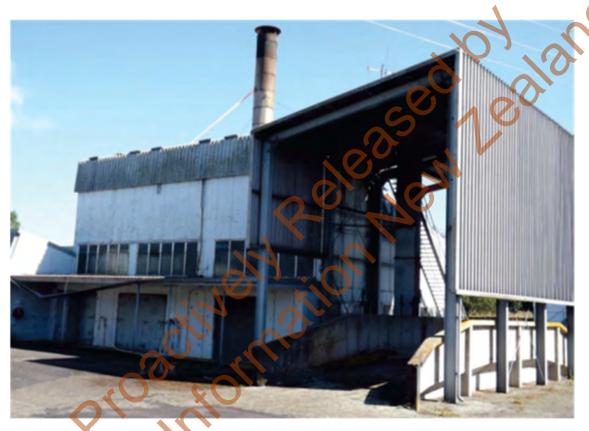
- Large steel frame lean-to addition to the north of the main boiler room and bolted back to the reinforced concrete hopper framing.
- Steel frame portal legs cased in concrete to approximately 3m above ground level. Reinforced concrete perimeter walls to same height with timber framing above.

- Three large diameter metal chimneys to 15-20m above ground level stabilised with tie wires attached to main building.
- Slab-on-grade ground floor. Assumed pad bases to columns and strip footings to masonry walls.

Figure 3: Boiler House

The boiler house (B68) is shown in Figure 3.

- Take down the projecting metal chimneys and remove the boilers.
- Demolish the independent steel portal vehicle bay structure together with the associated concrete ramp structure and coal screw.
- Demolish the lean-to additions to the North and single storey workshops to the West in order to leave the three hoppers standing independently.
- Stabilise the three suspended hopper cones by propping from ground level or installing a steel cradle frame in order to relieve the load from the perimeter ring beams and/or hopper walls.
- Break out the concrete roof slab and take down the hopper walls to the top of ring beam level.
- Detach the hopper cones from the perimeter ring beams (while supported from ground level) and either break out and remove piece by piece or lift out whole using a crane.

- Demolish the remaining concrete ring beams and columns down to ground.
- Break out ground floor slab and grub out foundations.

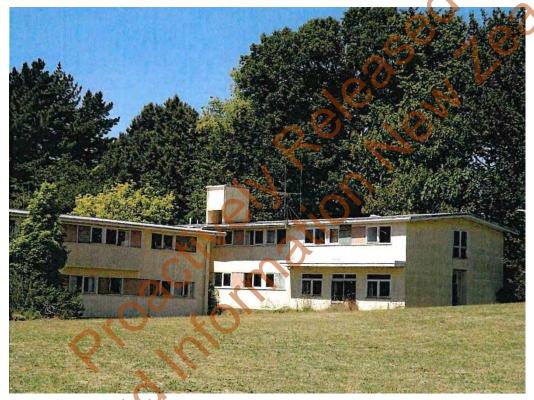
Figure 4: Ward 21 (B26)

- Two Storey timber frame ward accommodation block.
- Two independent blocks in an L-shape configuration with short linking corridors.
- Cross wall configuration with load bearing bedroom walls and central full-length corridors at both levels. Lateral stability provided by plasterboard linings
- Light weight duo-pitch roof with central ridge line. Long run metal sheet finish and plasterboard ceilings.
- Cement board finish to external walls.
- Timber first floor and suspended timber ground floor with concrete perimeter walls.

Ward 21 (B61) is shown in Figure 4.

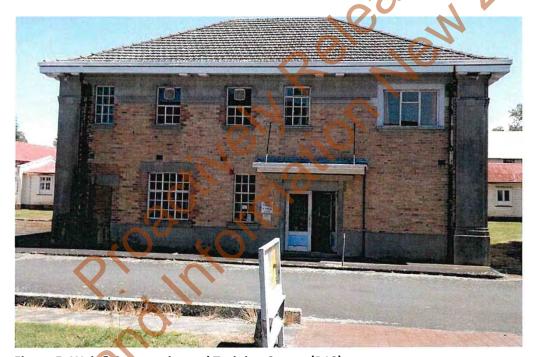
Figure 5: Waipā Community and Training Centre (B10)

- Two Storey unreinforced masonry (URM) building. Approximately 17m wide by 11m deep by 6.5m high
- Traditional hipped timber roof with heavy concrete tile finish.
- Roof and timber first floor supported off central URM spine walls running in both East-West and North-South directions
- Remainder of internal walls at both floor levels constructed using lightweight timber framing.
- Slab-on-grade ground floor construction.

The Waipā Community and Training Centre (B10) is shown in Figure 5

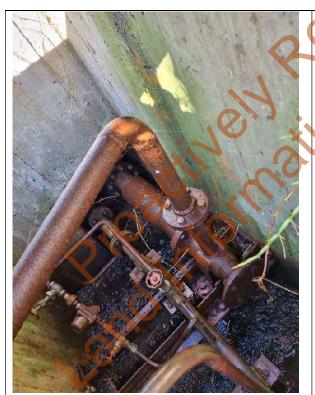
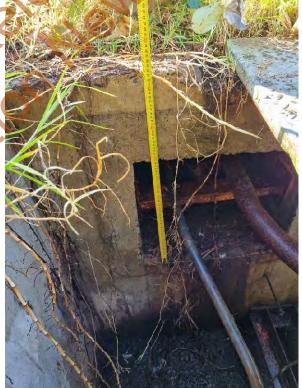
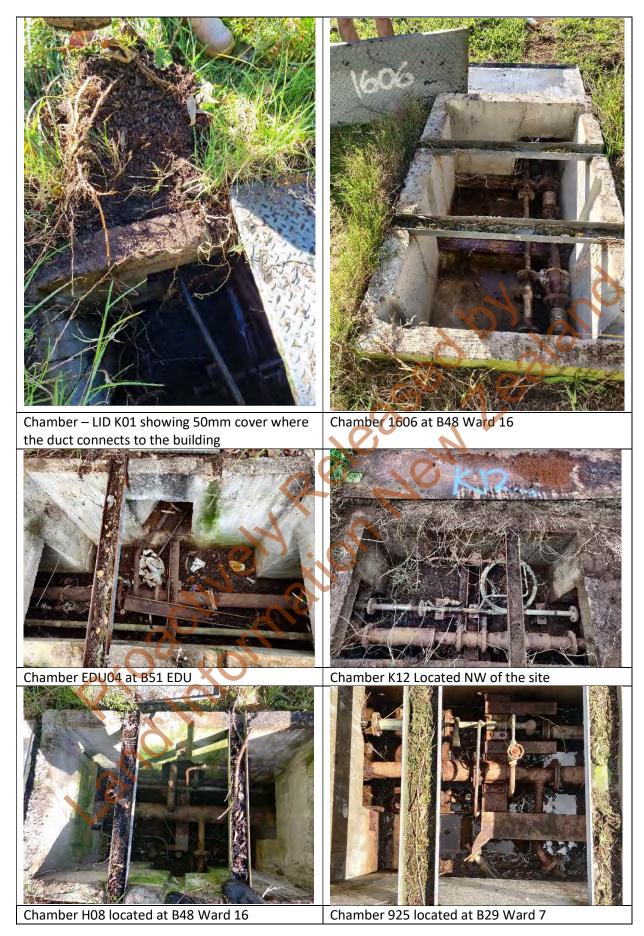
Chamber - LID K01 located at B55 Ward K

Chamber – LID K01 located at B55 Ward K showing the internal duct height as 500mm

Figure 13: Representative Photos of the Concrete Ducting System

Based on historical plans, composition of the steam lines was generally ungalvanized mild steel of either medium or heavy grade. The return condensate lines were copper. In some areas there was a third pipe, conveying hot water pipes, but some drawings refer to this as "to be removed". Bronze anchors and guides for the condensate pipes are referred to on some drawings. Pipe sizes are shown as varying from 1.5" to 2.5" (38-63mm for condensate) and 2"-6" (50-150mm) for steam. The pipe system includes significant numbers of valves, anchors, brackets and guides. Cover over the concrete ducting varies but is around 400mm on the drawings reviewed, which only cover a small part of the overall system.

Some photos of the ducting are included below for information. More details and photos are included in the Horizontal Infrastructure Report.

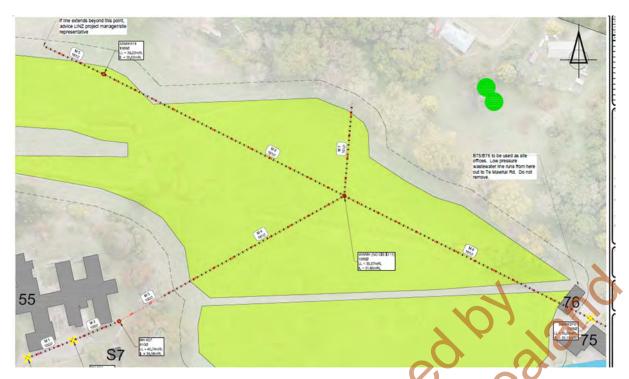
Figure 14: Above ground wastewater lines through NW wetland area

The extent of the wastewater pipeline within the NW wetland is shown in Figures 14 and 15 below.

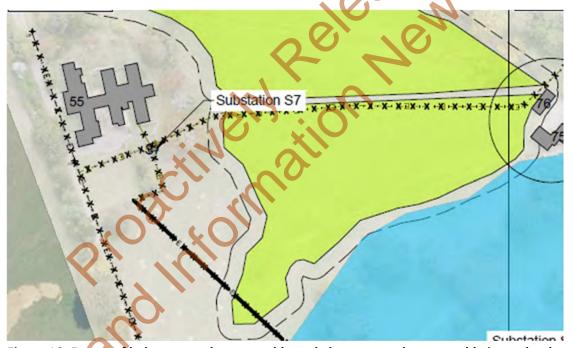
Figure 16: Extent of below ground power cable and above ground power cable in wetland area.

The length of power cabling through the wetland area is approximately 210m long, as shown in Figure 16 below. There is also a small section of overhead power cabling that passes through the southern tip of the wetland.

- These works will be done during an extended summer dry period to minimise the potential for damage to the wetland area.
- A small excavator (8T or 13T) will travel on swamp mats placed along the route of the cabling. The cable
  will be exposed at each end and then pulled out by excavator. The cabling will be cut into suitable lengths
  for transport and transferred by a small truck to the storage area for processing for recycling or disposal.
- This process will create a narrow trench where the cable has come out of the ground. Any displaced soil
  from the trench will be placed back into it and the trench topped up with topsoil and tamped down,
  followed by reseeding/replanting with appropriate grass/plants to match the vegetation in the wetland
  area.
- The swamp mats will be removed on completion of the works and any damaged vegetation areas reinstated.

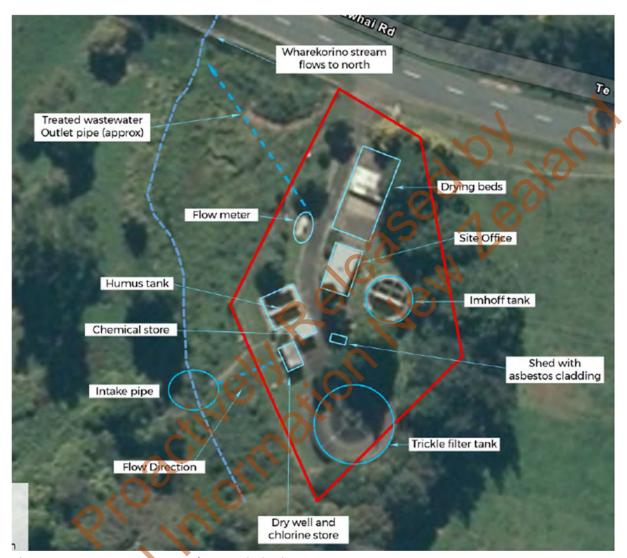
Figure 17: Former WWTP Pre-decommissioning

The WWTP, pre-demolition, is shown below in Figure 17.

- Drying beds
- Site office
- Imhoff Tank
- Humus Tank
- Chemical Store
- Shed
- Dry well and chlorine store

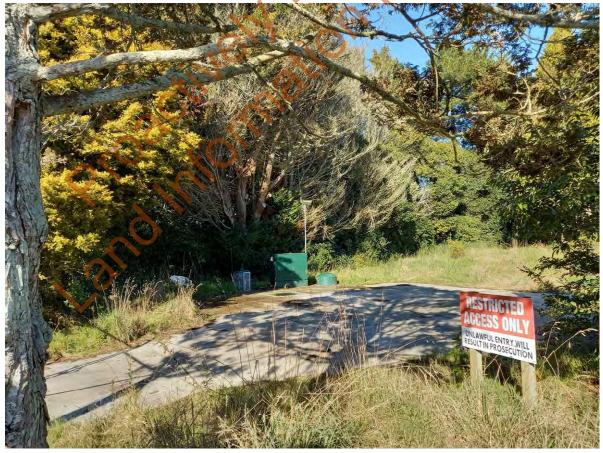
Figure 19: New Wastewater Pump Station (in ground tanks and chambers under concrete pad)

A new wastewater pump station has been installed in the north-east part of the compound. This comprises a number of inground tanks and chambers, including the pump station, set into a concrete pad, and an above ground control panel. This system is shown below in Figures 18 and 19.

The WWPS system, including the concrete pad, needs to be protected from damage during further proposed demolition works in this area (item 1 in attached drawing 33205/2010).

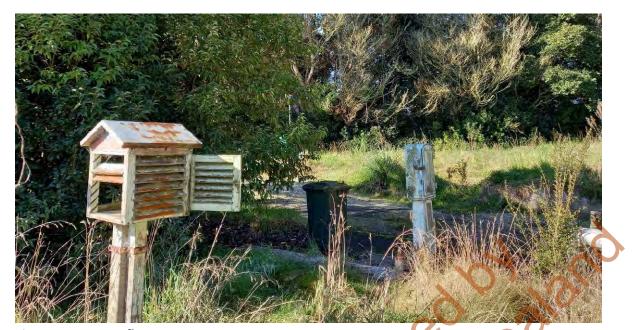
Figure 21: Former flow meter area

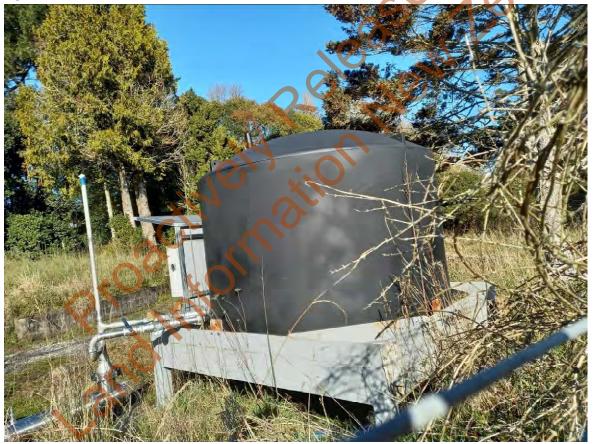
**Figure 22: Redundant UV Treatment Plant**

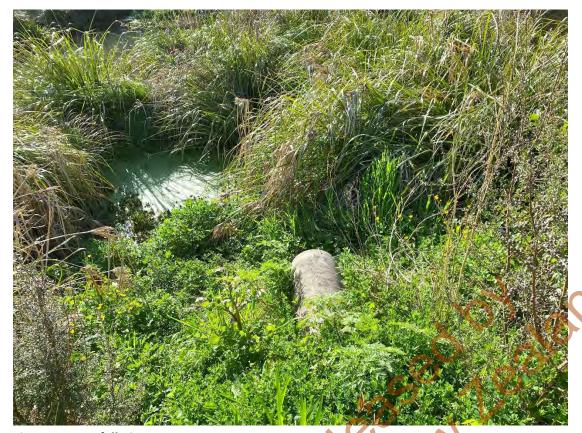
Figure 23: Outfall Pipe

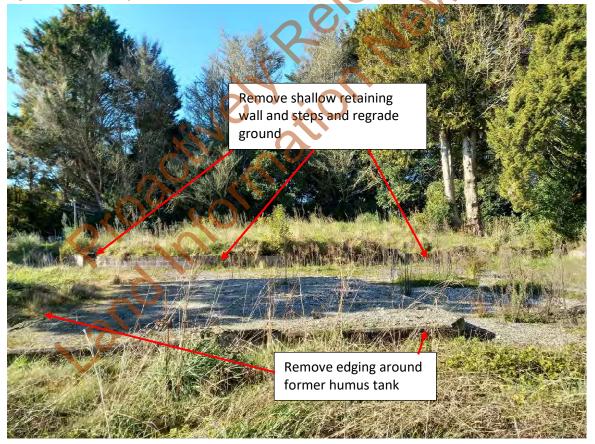
Figure 24: Remove shallow retaining wall and steps and regrade ground (item 5); remove edging around former humus tank and regrade ground (item 6)

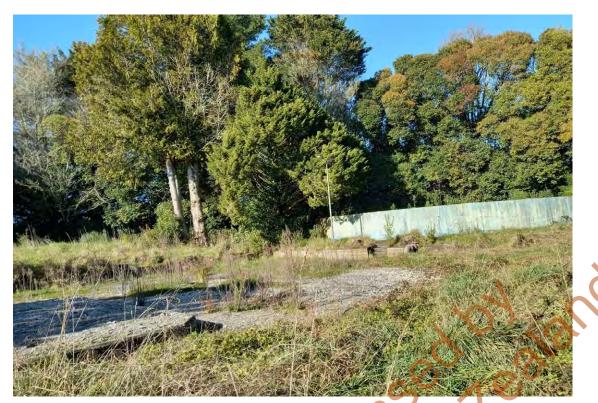
Figure 25: Remove trickling filter (circular tank in background) and stone media (item 7).

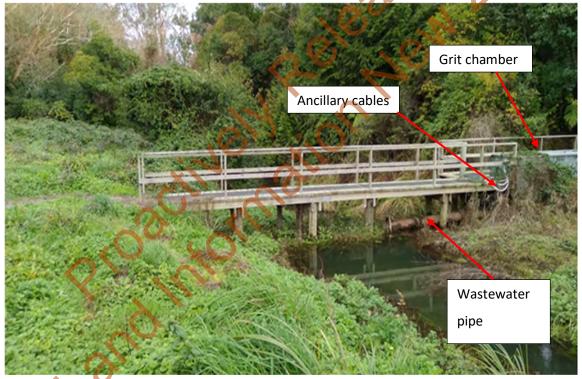
Figure 26: Remove grit chamber on wastewater inlet line, wastewater inlet pipe strapped to footbridge, any ancillary cables/ducting, and footbridge itself (items 8-11)

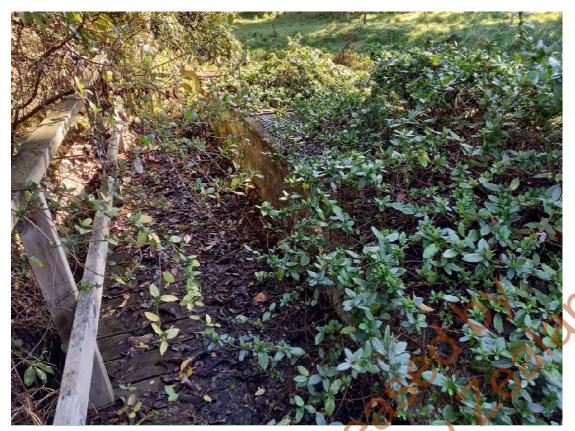
Figure 27: Closeup of grit chamber showing concrete blockwork construction and grated metal lid (largely hidden under vegetation)

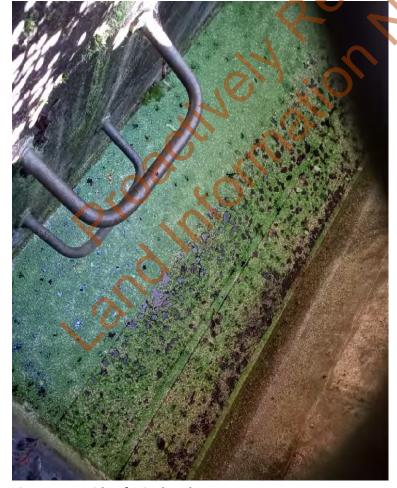
Figure 28: Inside of grit chamber

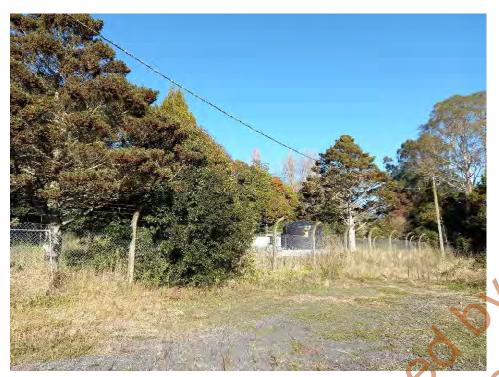
Figure 29: Relocate perimeter fence to reduce compound size. LINZ to confirm extent

- Item 12: Relocate fence to reduce compound size. LINZ to confirm extent.
- Item 13: Remove wastewater pipes down to 800mm depth out to the boundary with the road reserve and remove the stormwater pipe and associated three WWMHs shown in Figure 20. Cap the line at the road reserve boundary and at each end of the wastewater pipe greater than 800mm depth from MH23 to MH22.

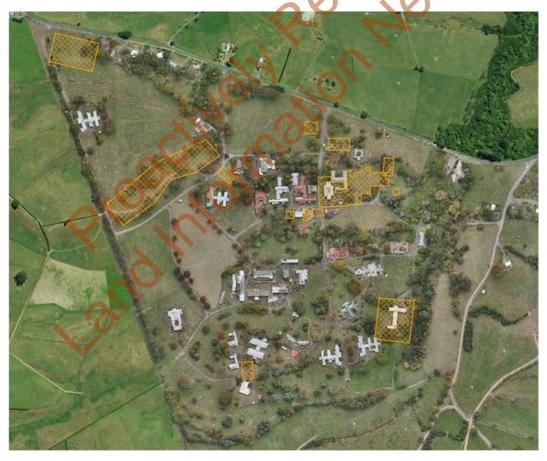
Figure 30: Extent of Historical Building Demolition Works

During February 2024 site investigation work, some historical demolition debris, including some asbestos sheet fragments, filament bulbs, burnt material, terracotta/earthware pipes, etc. was found in rare/minor/small quantities at variable depths ranging from near surface to up to 1.2m on the northern sides of Buildings B02 (northern side of southern arm) and B26 (directly north in carpark area). A review of historical aerial photographs identified that some buildings, or parts of buildings, have been demolished in these areas in the past. All of these areas have been investigated as part of intrusive investigations by AECOM/GHD with no significant demolition debris or contaminated soil found. Nevertheless, some fill and minor demolition debris may be found in these areas during associated demolition works, particularly during the removal of building footings/foundations and any buried services. This may also apply to the industrial area, where some discoloured fill was encountered. The extent of the historical demolition works is shown in Figure 30. The contractor should be aware of this, and advise LINZ or their nominated representative, if such fill/materials are found. Accidental discovery protocols will be triggered, if the find is significant (e.g. asbestos fragments, concentrated pockets of demolition debris.)

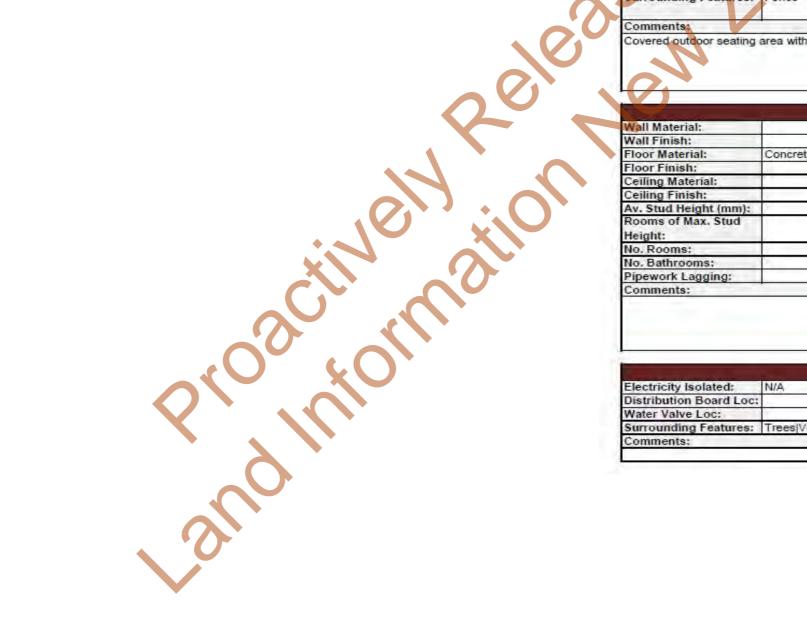
Covered Area by Hall – Small single storey shelter building with concrete floor slab, timber structural poles, corrugated metal pitched roof. A small metal shed is attached as part of the structure

Wall Material:	Galvanised steel Shee	Galvanised steel Sheet cladding Timber pole Ply				
Wall Finish:	Painted	Painted				
Foundation:	Concrete slab with pole brackets					
Roof Material:	Pitched corrugated iro	on				
Roof Finish:	Painted	Gutters Present:	no			
Single Doors:	0	Double Doors:	0			
Ranchsliders:	0	Windows:	0			
Soffit Height (mm):		Soffit Width (mm):				
Surrounding Features	: Fence					
Comments						
Covered outdoor seatin	g area with bridal storage	e shed

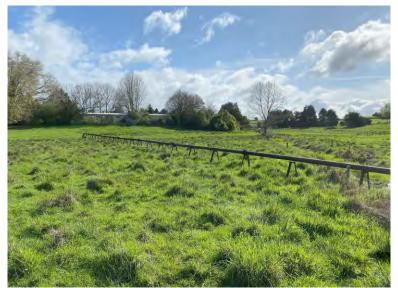
Southern pipeline with footings

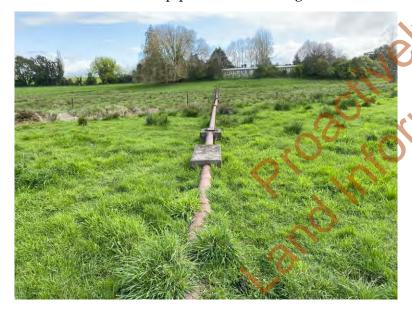
$Southern\ pipeline\ with\ concrete\ casing$

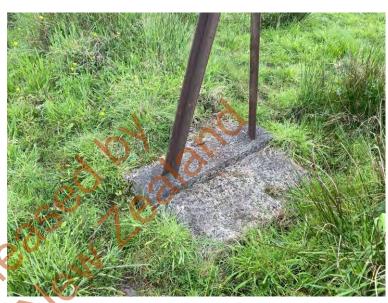
Southern pipeline footings and concrete foundation

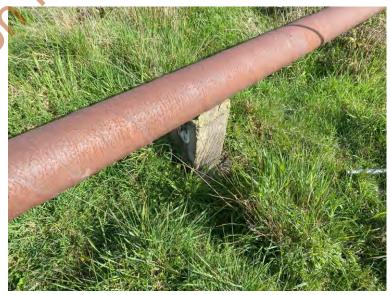
Southern pipeline with concrete pile

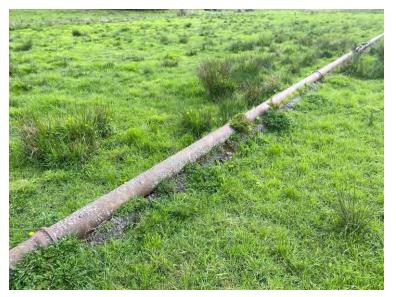
Pipeline situated on concrete foundation

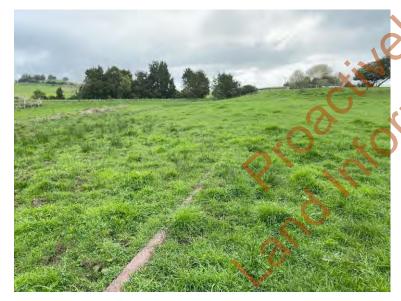
Westernmost pipeline below ground level

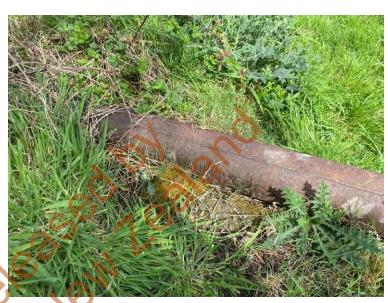
Pipeline situated on concrete foundation

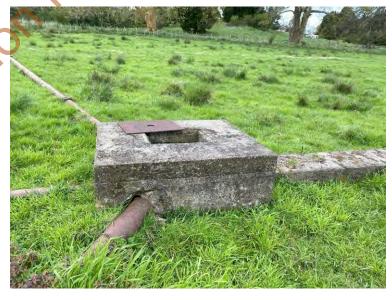
Concrete chamber connecting all four pipelines

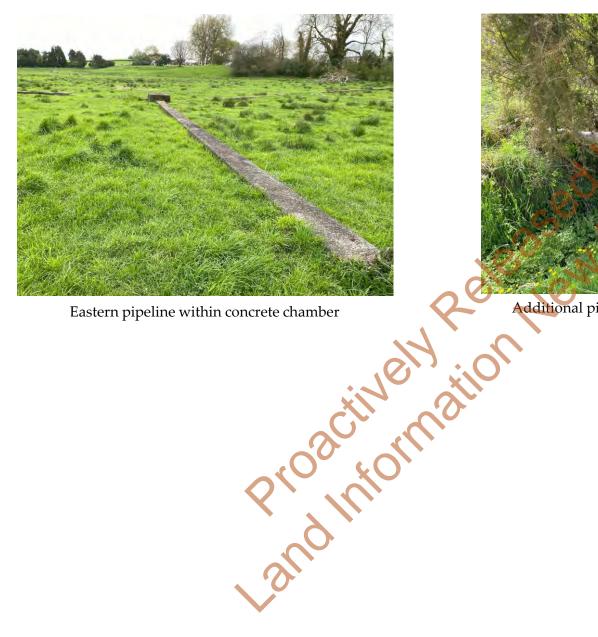
Eastern pipeline within concrete chamber

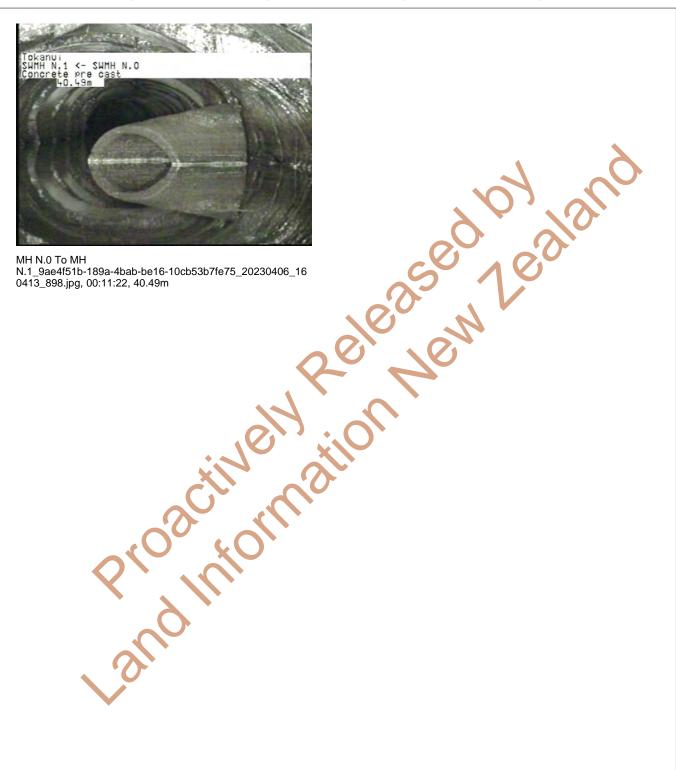
#### Section Pictures - 6/04/2023 - MH N.0 To MH N.1

MH N 0 To MH N.1\_9ae4f51b-189a-4bab-be16-10cb53b7fe75\_20230406\_16 0413\_898.jpg, 00:11:22, 40.49m

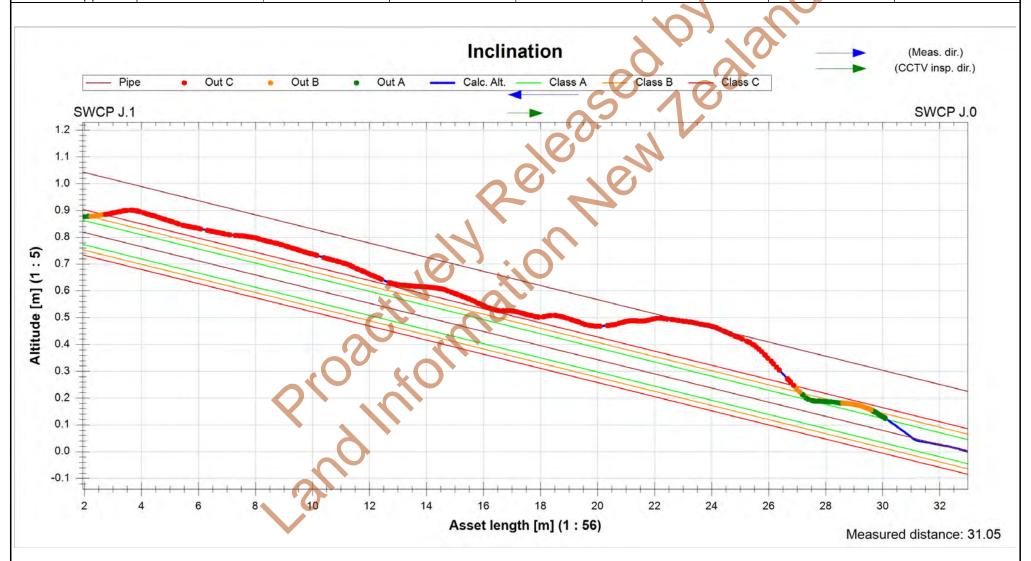
Asset No.	Date	Time	Operator	Town or Suburb	Road	Setup	Surveyed Length
CP J.1 To CP J,0	27/03/2023	12:56 pm	CST Group	Tokanui		Upstream node	31.05 m
Shape	Dia/Height	Width	U/S Node	D/S Node	Start altitude	End altitude	Measured Inc
Circular pipe	225 mm	225 mm	SWCP J.1	SWCP J.0	0.000 m	0.876 m	-2.822 %
