RE: Information Requested - LU/0231/24 & LU/0232/24 Former Tokanui

**Psychiatric Hospital**

FORMER TOKANUI HOSPITAL
DEMOLITION AND REMEDIATION
DEMOLITION, DECONSTRUCTION & REMEDIATION
MANAGEMENT PLAN - DRAFT

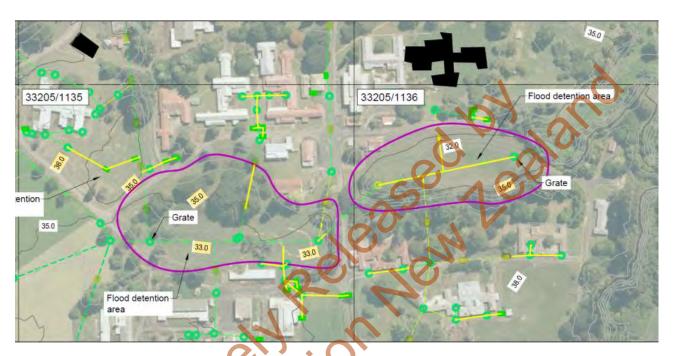
Figure 2: Likely Extent of Pre- and Post-demolition works CCTV of Trunk Stormwater System

LINZ will undertake CCTV of the trunk stormwater line pre- and post-demolition works to check for any damage to this network caused by the contractor. The extent of the CCTV survey will be confirmed by LINZ but is likely to go from grate to grate in Figure 2, as this is the main area where it is considered possible damage to the trunk line may occur.

The contractor shall be responsible for repairing any damage to the trunk system, or removing any debris washed into this line from the MH removal and backfilling, attributed to their activities, based on the CCTV survey results.

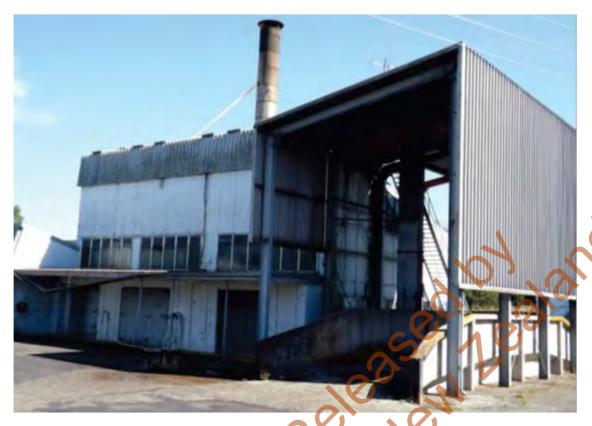
Figure 3: Boiler House

The boiler house (B68) is shown in Figure 3.

- Three large diameter metal chimneys to 15-20m above ground level stabilised with tie wires attached to main building.

• Slab-on-grade ground floor. Assumed pad bases to columns and strip footings to masonry walls.

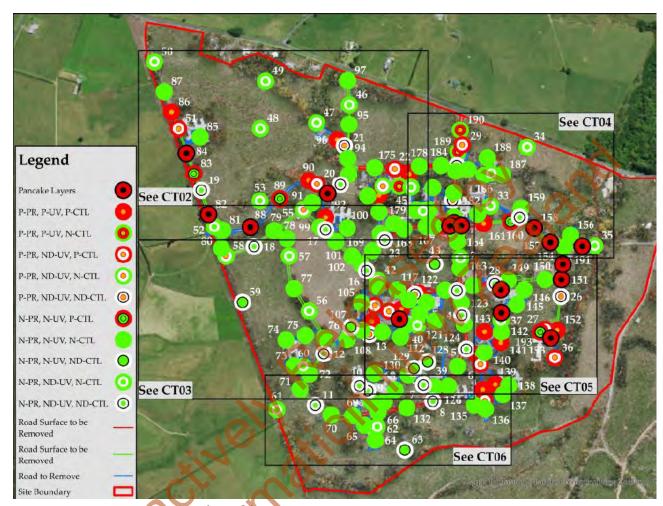
Figure 9: Coal Tar Road Surface (Paving) Overall Sampling Plan

FTL subsequently undertook several more in-depth investigations of both the road construction and for coal tar in the paving, basecourse and subbase roading layers, using a multiple lines of evidence approach

involving a combination of paint tests, UV light fluorescence and laboratory testing to better determine the horizontal and vertical extent of coal tar content in the roading pavement layer and the underlying basecourse and subbase. The results of this investigation are reported on separately in the FTL Coal Tar Intrusive Investigation Report (September 2025). Figure 9 shows the sampling plan for the road surface (pavement) layers, to give an understanding of the sampling density undertaken.

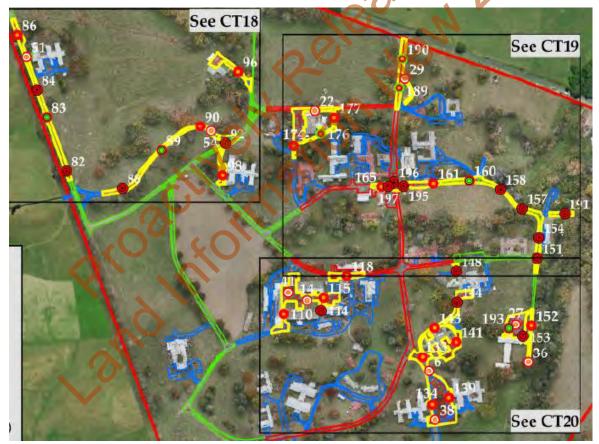
Figure 10: Coal Tar in Roading Surface (Paving) Location Plan – yellow polygons

Coal tar is present across all three road network colours and roading layers. The majority of the coal tar, in terms of areal coverage, is in the surface pavement layers, with the areas with coal tar decreasing in the basecourse and further decreasing in the subbase. A conservative approach has been taken here, in that the entire basecourse and subbase depth profile has been assumed to contain coal tar, based on either a positive paint test and UV reaction or a positive lab result from a single test of these layers at each location. Given these layers are typically significantly thicker than the paving layer, this results in reasonable quantities of coal tar being calculated to be present in both the basecourse and subbase. Furthermore, there are localised areas of the site where multiple 'top ups' of the basecourse and pavement have been done over the years, forming a "pancake" roading structure. Figures 10, 11 and 12 show the areal distribution of coal tar in the paving, basecourse and subbase layers.

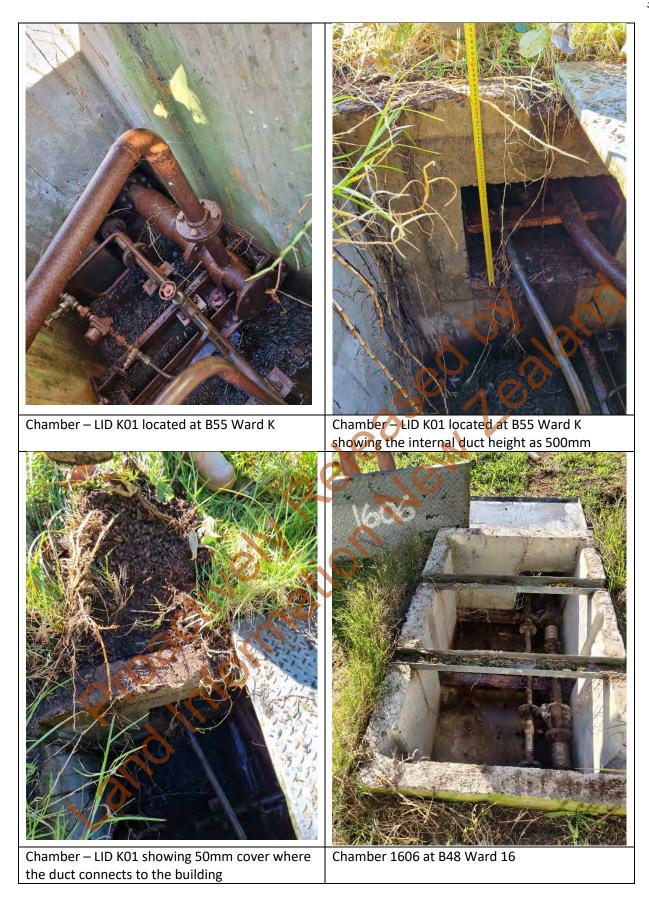
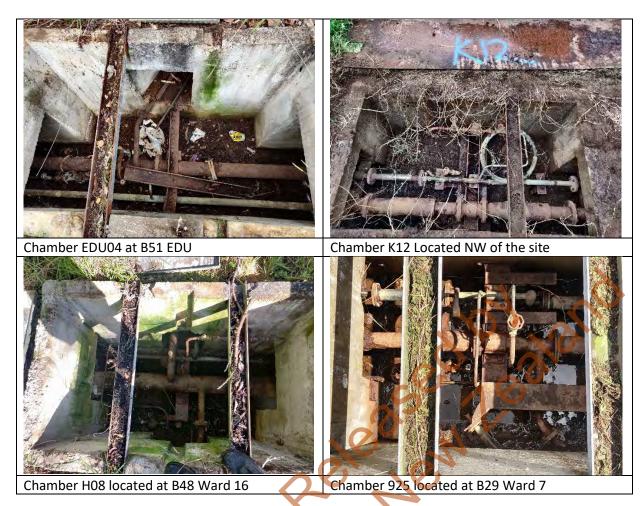
Figure 13: Representative Photos of the Concrete Ducting System

Based on historical plans, composition of the steam lines was generally ungalvanized mild steel of either medium or heavy grade. The return condensate lines were copper. In some areas there was a third pipe, conveying hot water pipes, but some drawings refer to this as "to be removed". Bronze anchors and guides for the condensate pipes are referred to on some drawings. Pipe sizes are shown as varying from 1.5" to 2.5" (38-63mm for condensate) and 2"-6" (50-150mm) for steam. The pipe system includes significant numbers of valves, anchors, brackets and guides. Cover over the concrete ducting varies but is around 400mm on the drawings reviewed, which only cover a small part of the overall system.

Some photos of the ducting are included below for information. More details and photos are included in the Horizontal Infrastructure Report.

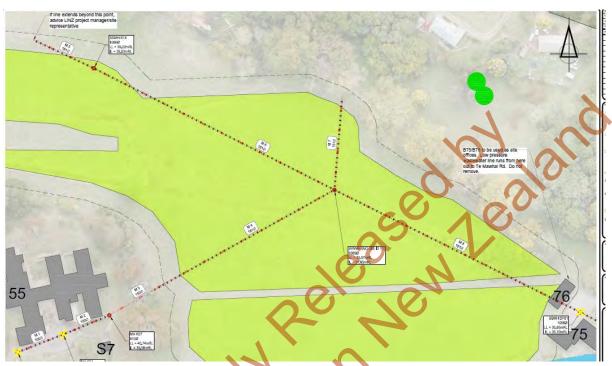
Figure 14: Above ground wastewater lines through NW wetland area

The extent of the wastewater pipeline within the NW wetland is shown in Figures 14 and 15 below.

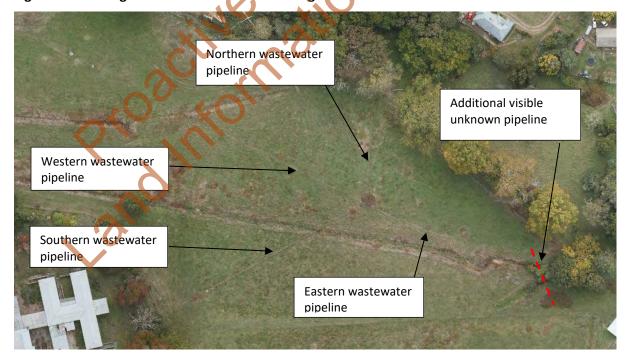
Figure 15: Visible wastewater lines in wetland area

GIS imagery (Figure 15) shows that this pipeline (approx. 150-190mm diameter) is generally above ground, with some areas covered by vegetation.

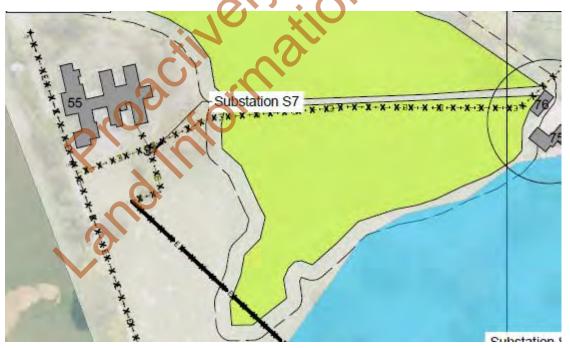
Figure 16: Extent of below ground power cable and above ground power cable in wetland area.

The length of power cabling through the wetland area is approximately 210m long, as shown in Figure 16 below. There is also a small section of overhead power cabling that passes through the southern tip of the wetland.

- These works will be done during an extended summer dry period to minimise the potential for damage to the wetland area.
- A small excavator (8T or 13T) will travel on swamp mats placed along the route of the cabling. The cable
  will be exposed at each end and then pulled out by excavator. The cabling will be cut into suitable lengths
  for transport and transferred by a small truck to the storage area for processing for recycling or disposal.
- This process will create a narrow trench where the cable has come out of the ground. Any displaced soil
  from the trench will be placed back into it and the trench topped up with topsoil and tamped down,
  followed by reseeding/replanting with appropriate grass/plants to match the vegetation in the wetland
  area.
- The swamp mats will be removed on completion of the works and any damaged vegetation areas reinstated.

The overhead power cable can be removed without touching the wetland area.

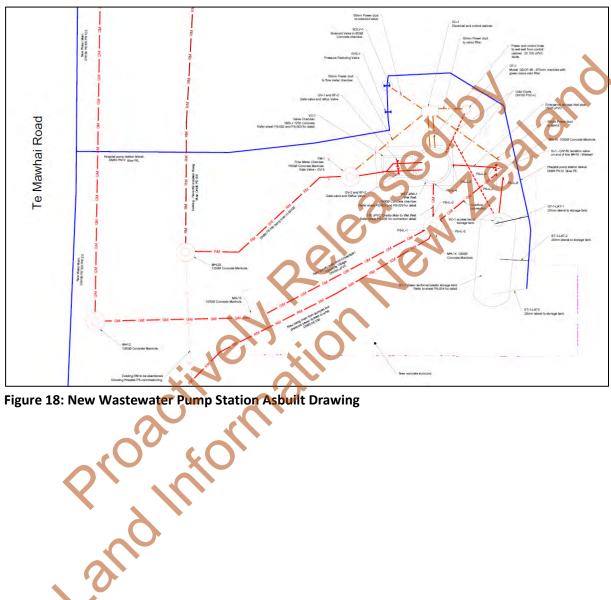
Figure 18: New Wastewater Pump Station Asbuilt Drawing

A new wastewater pump station has been installed in the north-east part of the compound. This comprises a number of inground tanks and chambers, including the pump station, set into a concrete pad, and an above ground control panel. This system is shown below in Figures 18 and 19.

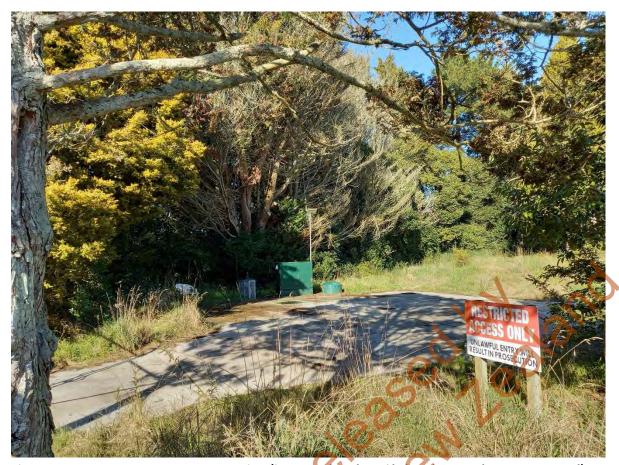
Figure 19: New Wastewater Pump Station (in ground tanks and chambers under concrete pad)

The WWPS system, including the concrete pad, needs to be protected from damage during further proposed demolition works in this area (item 1 in attached drawing 33205/2010).

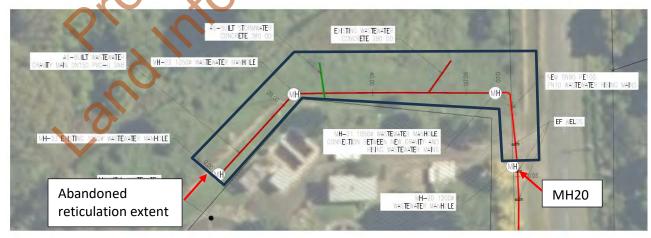
Figure 20: Abandoned wastewater line and MHs (item 13)

When the WWPS became operational, an existing section of wastewater rising and gravity mains from MH20 to the end of the wastewater line (MH23) was abandoned, as shown in Figure 20. This work comprises three DN150 PVC gravity pipes of total length around 67m, with three associated wastewater manholes, and a short section of 3800D stormwater pipe as shown in Figure 20. All of this pipework is less than 800mm deep, except the first 18m of wastewater pipe from MH23 towards MH22.

- Item 12: Relocate fence to reduce compound size. LINZ to confirm extent.
- Item 13: Remove wastewater pipes down to 800mm depth out to the boundary with the road reserve and remove the stormwater pipe and associated three WWMHs shown in Figure 20. Cap the line at the road reserve boundary and at each end of the wastewater pipe greater than 800mm depth from MH23 to MH22.

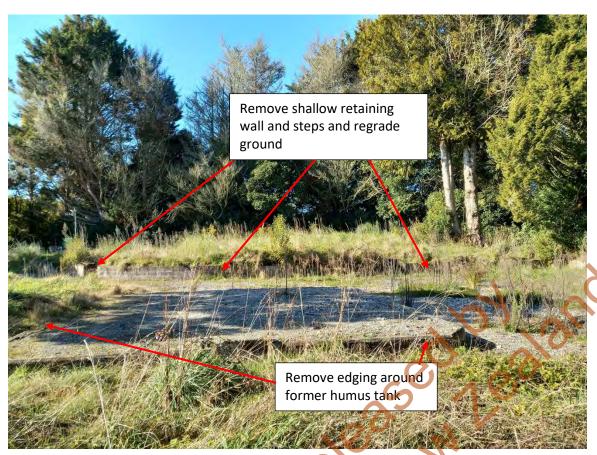
Figure 24: Remove shallow retaining wall and steps and regrade ground (item 5); remove edging around former humus tank and regrade ground (item 6)

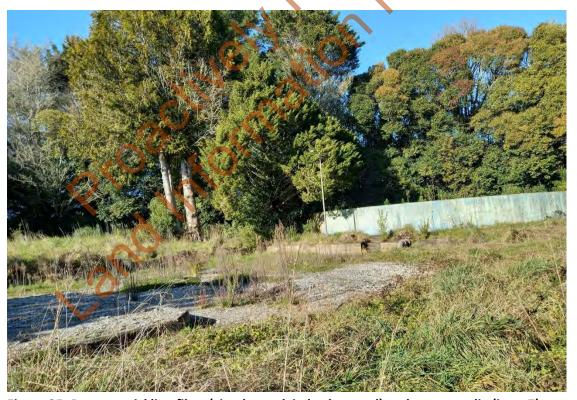
Figure 25: Remove trickling filter (circular tank in background) and stone media (item 7).

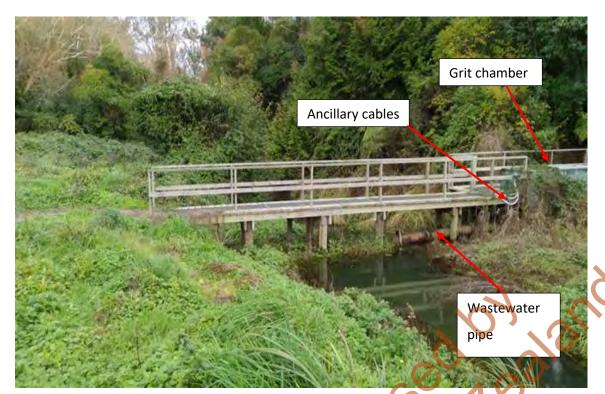
Figure 26: Remove grit chamber on wastewater inlet line, wastewater inlet pipe strapped to footbridge, any ancillary cables/ducting, and footbridge itself (items 8-11)

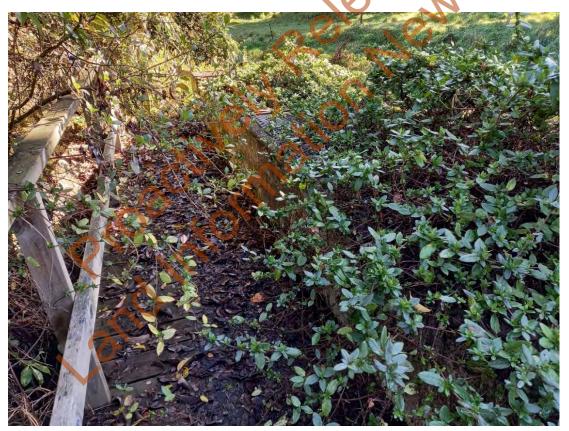
Figure 27: Closeup of grit chamber showing concrete blockwork construction and grated metal lid (largely hidden under vegetation)

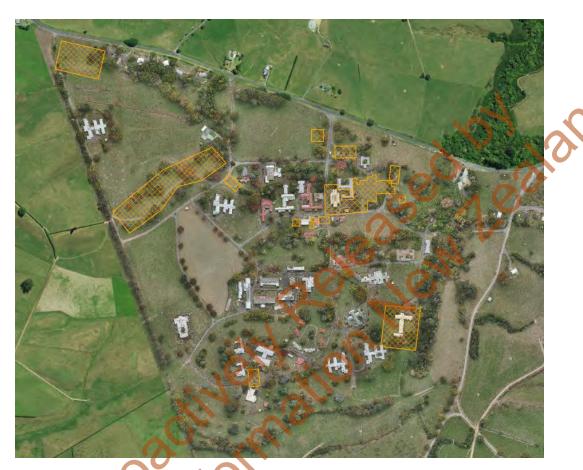
Figure 30: Extent of Historical Building Demolition Works

During February 2024 site investigation work, some historical demolition debris, including some asbestos sheet fragments, filament bulbs, burnt material, terracotta/earthware pipes, etc. was found in rare/minor/small quantities at variable depths ranging from near surface to up to 1.2m on the northern sides of Buildings B02 (northern side of southern arm) and B26 (directly north in carpark area). A review of historical aerial photographs identified that some buildings, or parts of buildings, have been demolished in

these areas in the past. All of these areas have been investigated as part of intrusive investigations by AECOM/GHD with no significant demolition debris or contaminated soil found. Nevertheless, some fill and minor demolition debris may be found in these areas during associated demolition works, particularly during the removal of building footings/foundations and any buried services. This may also apply to the industrial area, where some discoloured fill was encountered. The extent of the historical demolition works is shown in Figure 30. The contractor should be aware of this, and advise LINZ or their nominated representative, if such fill/materials are found. Accidental discovery protocols will be triggered, if the find is significant (e.g. asbestos fragments, concentrated pockets of demolition debris.)

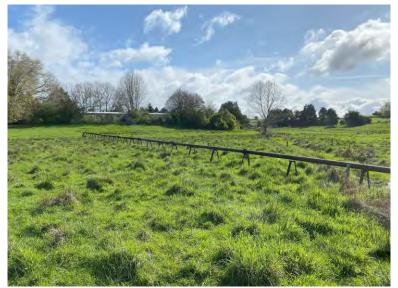
Southern pipeline with footings

Southern	8	Pipe support varies:										
		> concrete block 1	1.04	. (/)	0,1		0.10	0.5	0.2			
		> concrete block 2	0.64		0.108		0.07	0.54	0.2			
		> individual concrete piles	1.8		0.09		0.16	0.45	0.2		No = 4 L (ea) =	0.45 m
	9	> concrete blocks with metal brackets	26.4		0.2		5.28	1	0.2		No = 22 L (ea) =	1.2 m
		Total	392.2		O		53.0				,	
		Total		KOK				Avg	0.28

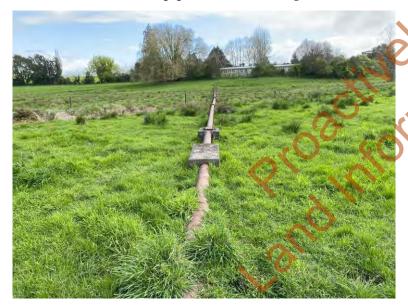
$Southern\ pipeline\ with\ concrete\ casing$

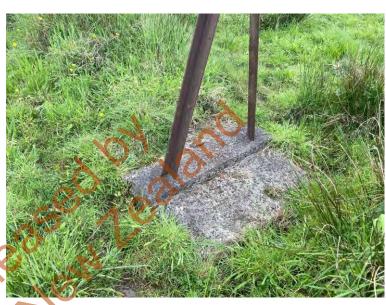
Southern pipeline footings and concrete foundation

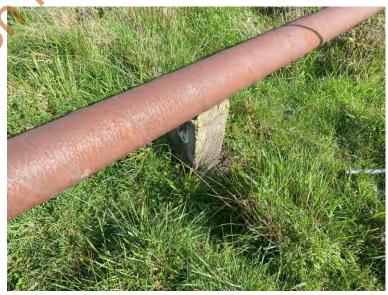
Southern pipeline with concrete pile

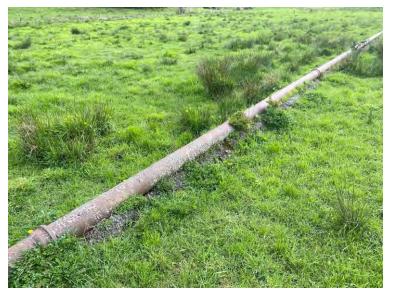
Pipeline situated on concrete foundation

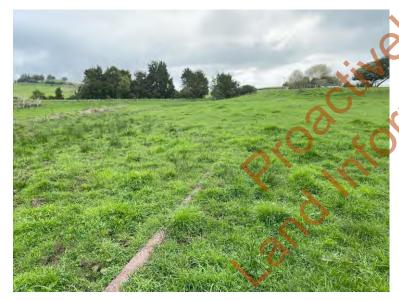
Westernmost pipeline below ground level

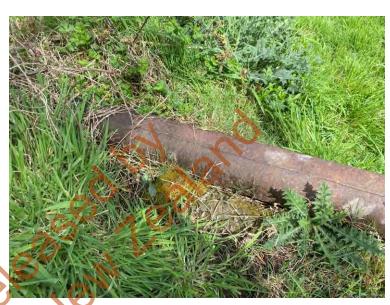
Pipeline situated on concrete foundation

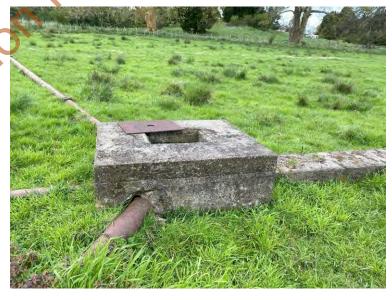
Concrete chamber connecting all four pipelines

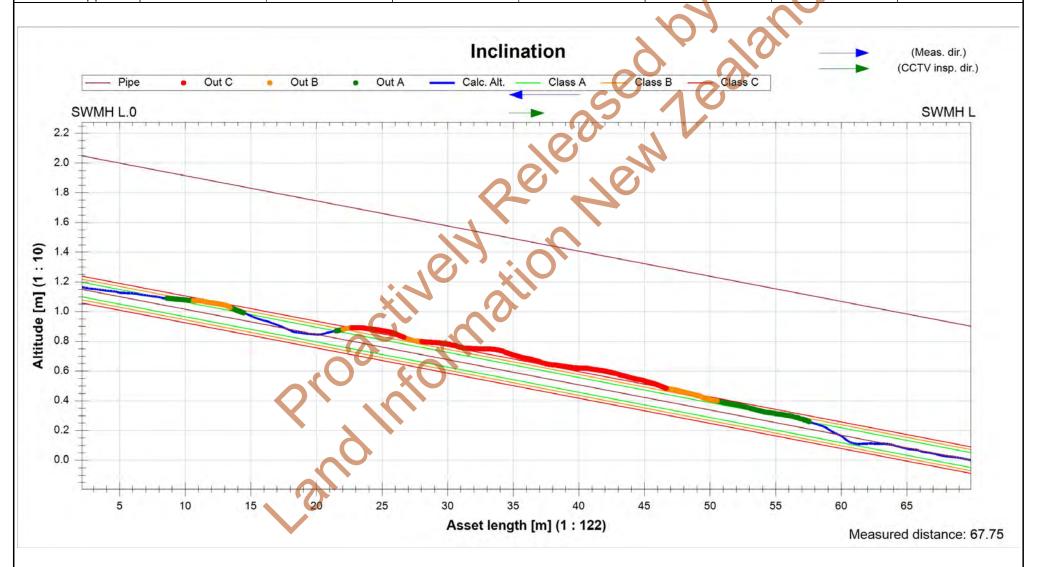
Asset No.	Date	Time	Operator	Town or Suburb	Road	Setup	Surveyed Length
MH L.0 To MH L	28/03/2023	12:26 pm	CST Group	Tokanui		Upstream node	67.75 m
Shape	Dia/Height	Width	U/S Node	D/S Node	Start altitude	End altitude	Measured Inc
Circular pipe	900 mm	900 mm	SWMH L.0	SWMH L	0.000 m	1.163 m	-1.716 %

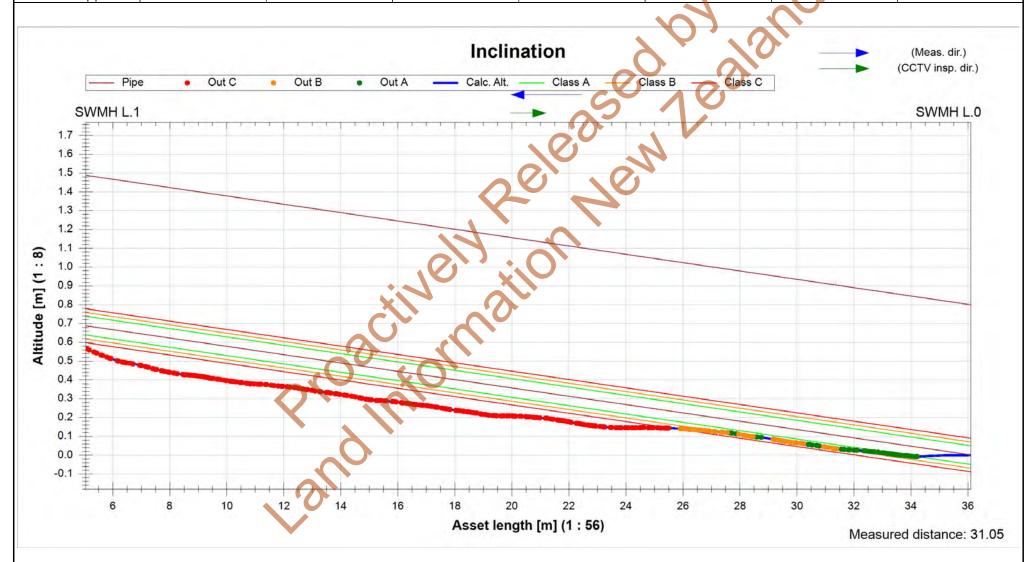
<u> </u>
Asset No.	Date	Time	Operator	Town or Suburb	Road	Setup	Surveyed Length
MH L.1 To MH L.0	28/03/2023	12:17 pm	CST Group	Tokanui		Upstream node	31.05 m
Shape	Dia/Height	Width	U/S Node	D/S Node	Start altitude	End altitude	Measured Inc
Circular pipe	800 mm	800 mm	SWMH L.1	SWMH L.0	0.000 m	0.567 m	-1.827 %

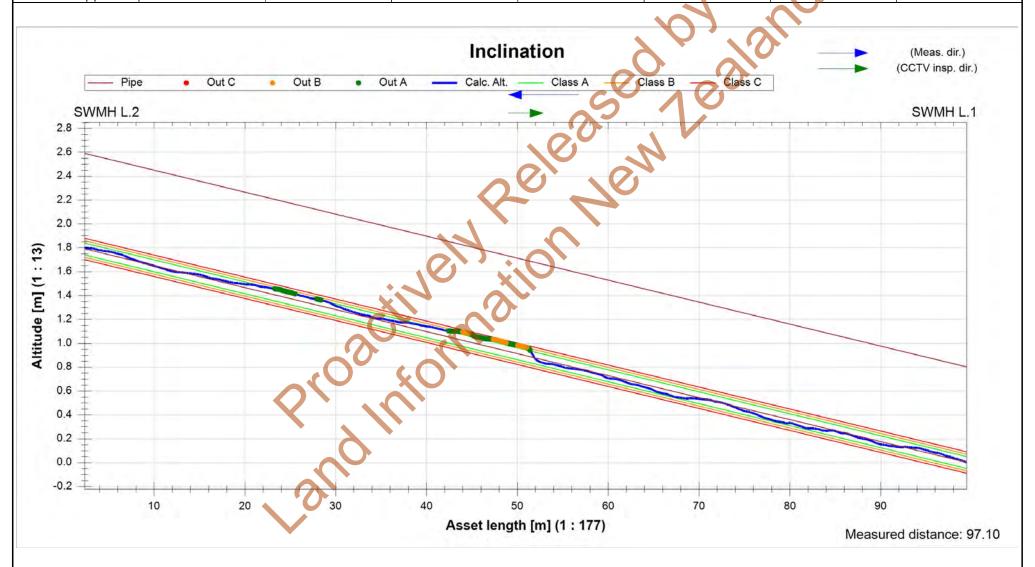
Asset No.	Date	Time	Operator	Town or Suburb	Road	Setup	Surveyed Length
MH L.2 To MH L.1	28/03/2023	11:37 am	CST Group	Tokanui		Upstream node	97.10 m
Shape	Dia/Height	Width	U/S Node	D/S Node	Start altitude	End altitude	Measured Inc
Circular pipe	800 mm	800 mm	SWMH L.2	SWMH L.1	0.000 m	1.800 m	-1.854 %

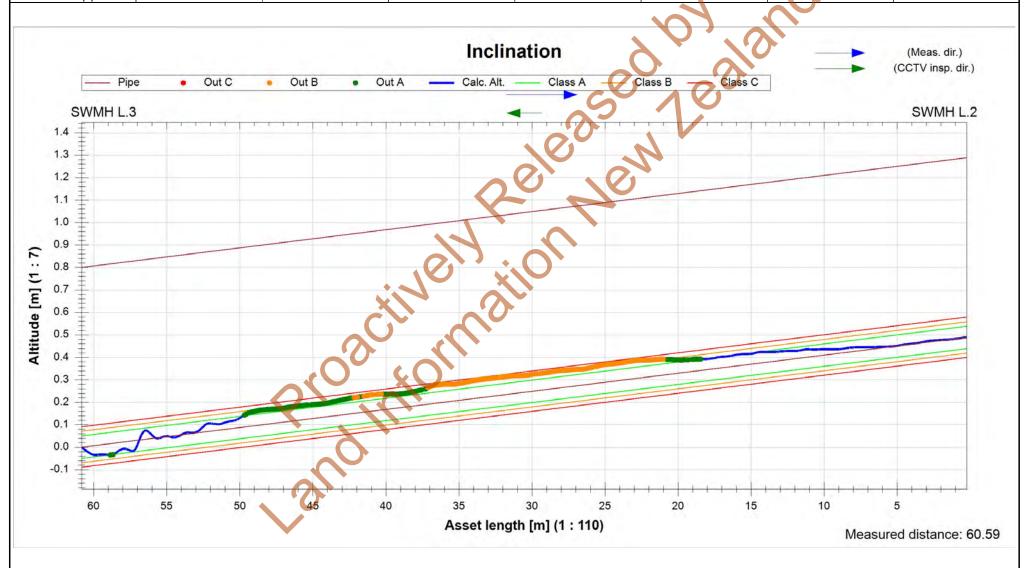
<b>0</b> ,
Asset No.	Date	Time	Operator	Town or Suburb	Road	Setup	Surveyed Length
MH L.2 To MH L.3	28/03/2023	1:46 pm	CST Group	Tokanui		Downstream node	60.59 m
Shape	Dia/Height	Width	U/S Node	D/S Node	Start altitude	End altitude	Measured Inc
Circular pipe	800 mm	800 mm	SWMH L.3	SWMH L.2	0.000 m	0.489 m	0.807 %

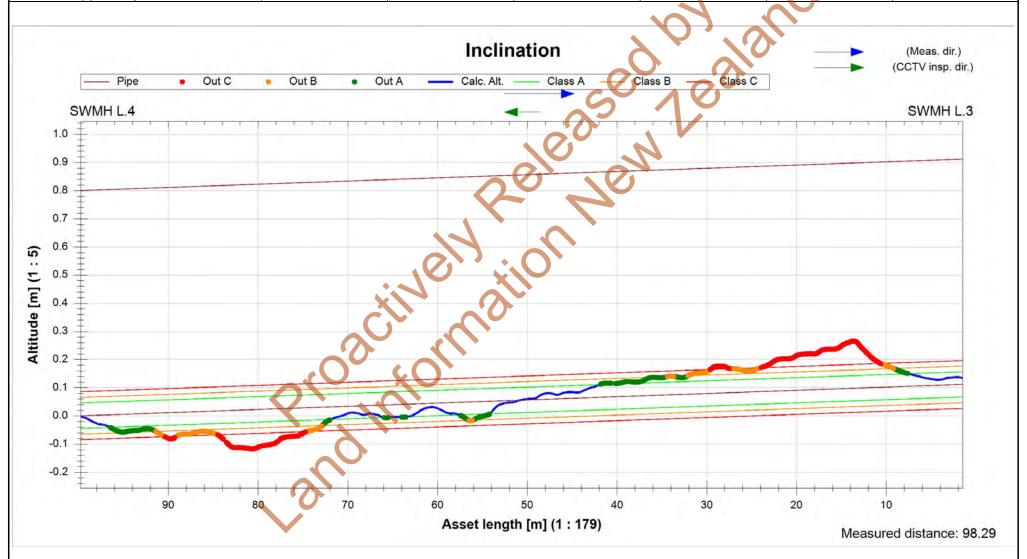
0 ,
Asset No.	Date	Time	Operator	Town or Suburb	Road	Setup	Surveyed Length
MH L.3 To MH L.4	4/04/2023	9:27 am	CST Group	Tokanui		Downstream node	98.29 m
Shape	Dia/Height	Width	U/S Node	D/S Node	Start altitude	End altitude	Measured Inc
Circular pipe	800 mm	800 mm	SWMH L.4	SWMH L.3	0.000 m	0.134 m	0.136 %

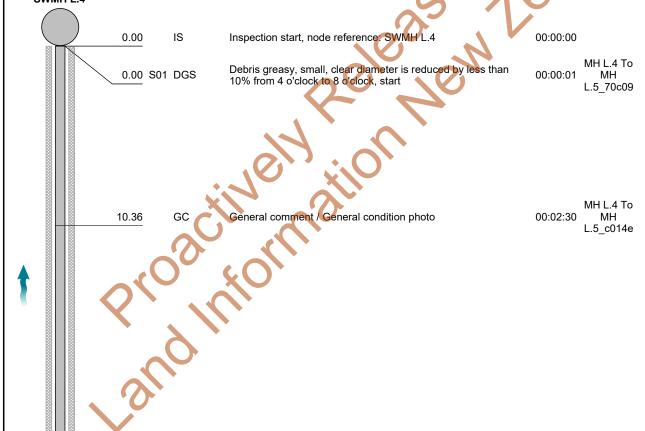
MH L.4 To МН 00:05:34 L.5\_92d46

Debris greasy, small, clear diameter is reduced by less than 10% from 4 o'clock to 8 o'clock, end

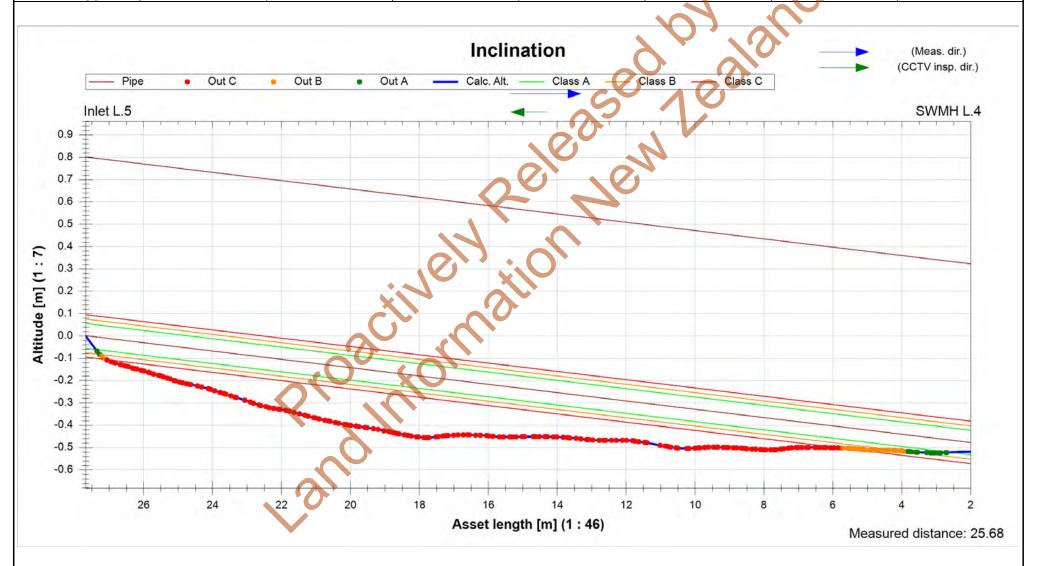
Asset No.	Date	Time	Operator	Town or Suburb	Road	Setup	Surveyed Length
MH L.4 To Inlet	4/04/2023	9:57 am	CST Group	Tokanui		Downstream node	25.68 m
Shape	Dia/Height	Width	U/S Node	D/S Node	Start altitude	End altitude	Measured Inc
Circular pipe	800 mm	800 mm	Inlet L.5	SWMH L.4	0.000 m	-0.519 m	-2.020 %

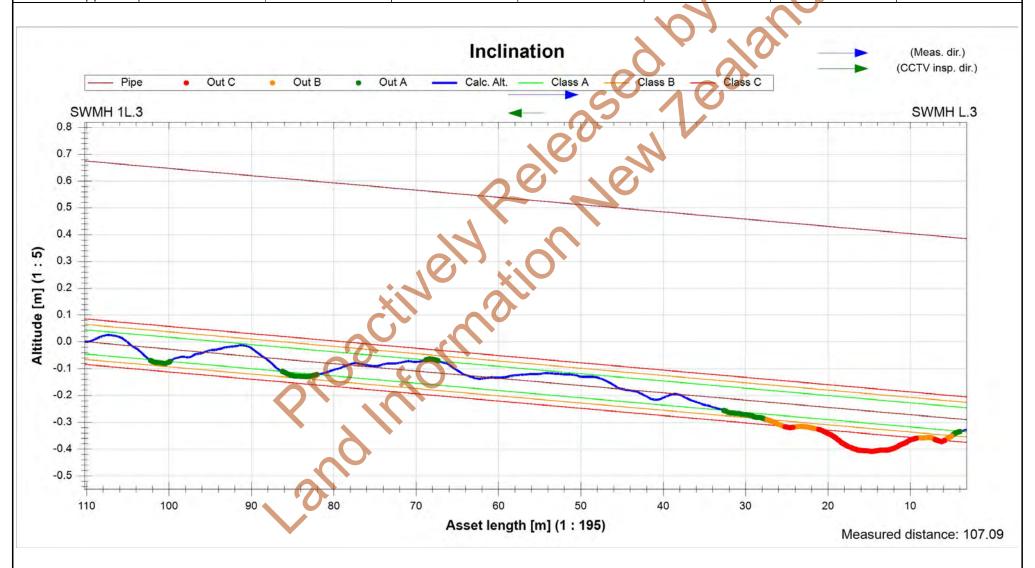
0 ,
Asset No.	Date	Time	Operator	Town or Suburb	Road	Setup	Surveyed Length
MH L.3 To MH 1L.3	4/04/2023	10:27 am	CST Group	Tokanui		Downstream node	107.09 m
Shape	Dia/Height	Width	U/S Node	D/S Node	Start altitude	End altitude	Measured Inc
Circular pipe	675 mm	675 mm	SWMH 1L.3	SWMH L.3	0.000 m	-0.328 m	-0.306 %

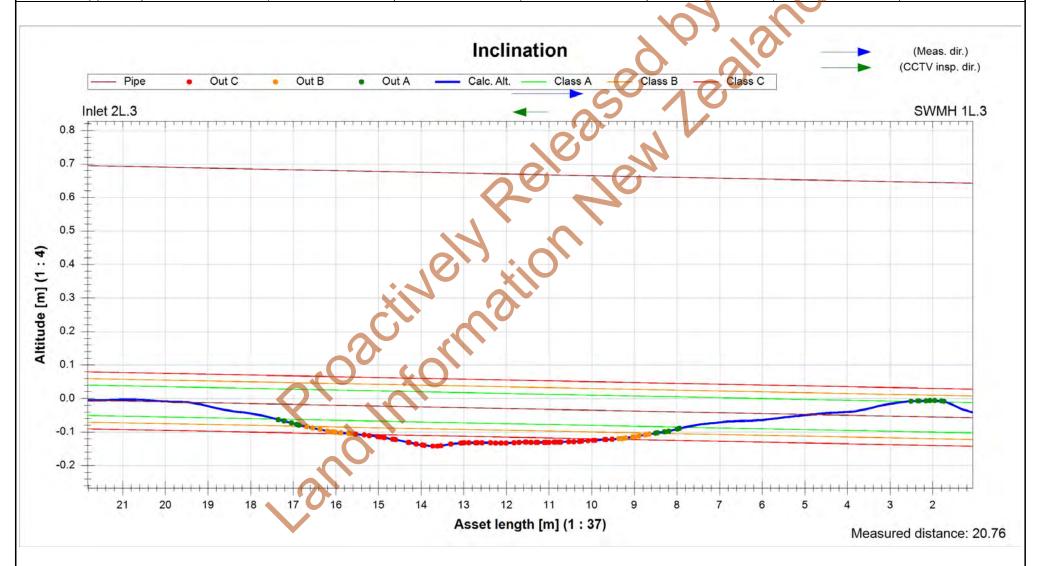
Asset No.	Date	Time	Operator	Town or Suburb	Road	Setup	Surveyed Length
MH 1L.3 To Inlet 2L.3	4/04/2023	11:05 am	CST Group	Tokanui		Downstream node	20.76 m
Shape	Dia/Height	Width	U/S Node	D/S Node	Start altitude	End altitude	Measured Inc
Circular pipe	700 mm	700 mm	Inlet 2L.3	SWMH 1L.3	-0.006 m	-0.042 m	-0.174 %

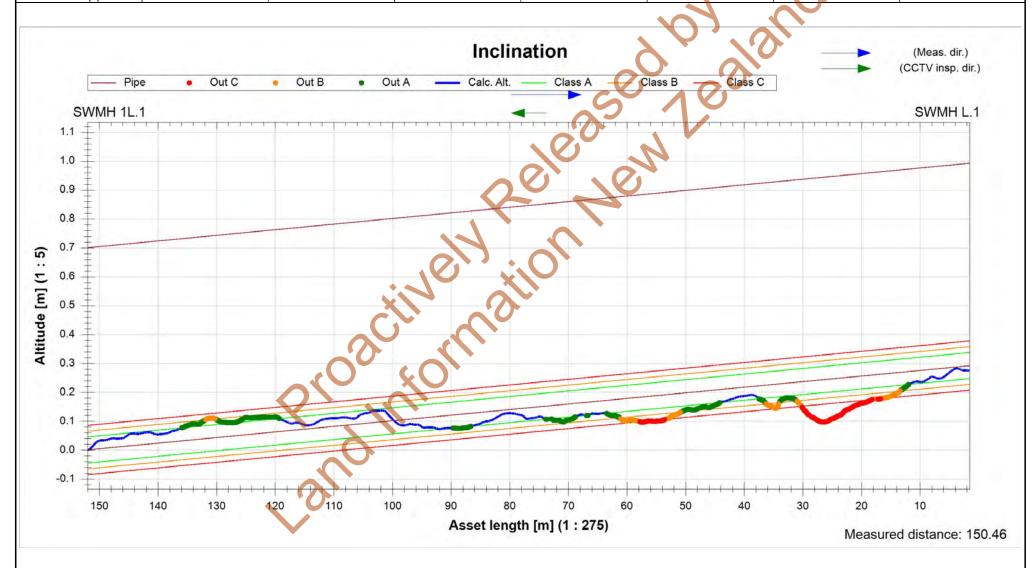
υ,
Asset No. Date Time Operator Town or Suburb Road						Setup	Surveyed Length
MH L.1 To MH 1L.1	4/04/2023	11:59 am	CST Group	Tokanui		Downstream node	150.46 m
Shape	Dia/Height	Width	U/S Node	D/S Node	Start altitude	End altitude	Measured Inc
Circular pipe	700 mm	700 mm	SWMH 1L.1	SWMH L.1	0.000 m	0.276 m	0.183 %

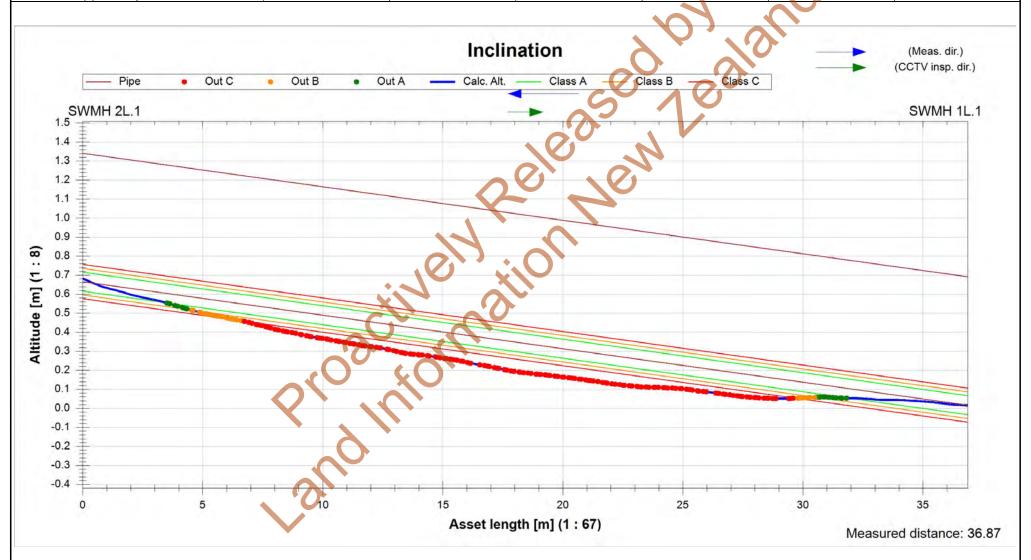
Asset No.	Date	Time	Operator	Town or Suburb	Road	Setup	Surveyed Length
MH 1L.1 To MH 2L.1	6/04/2023	1:18 pm	CST Group	Tokanui		Upstream node	36.87 m
Shape	Dia/Height	Width	U/S Node	D/S Node	Start altitude	End altitude	Measured Inc
Circular pipe	675 mm	675 mm	SWMH 2L.1	SWMH 1L.1	0.016 m	0.682 m	-1.806 %

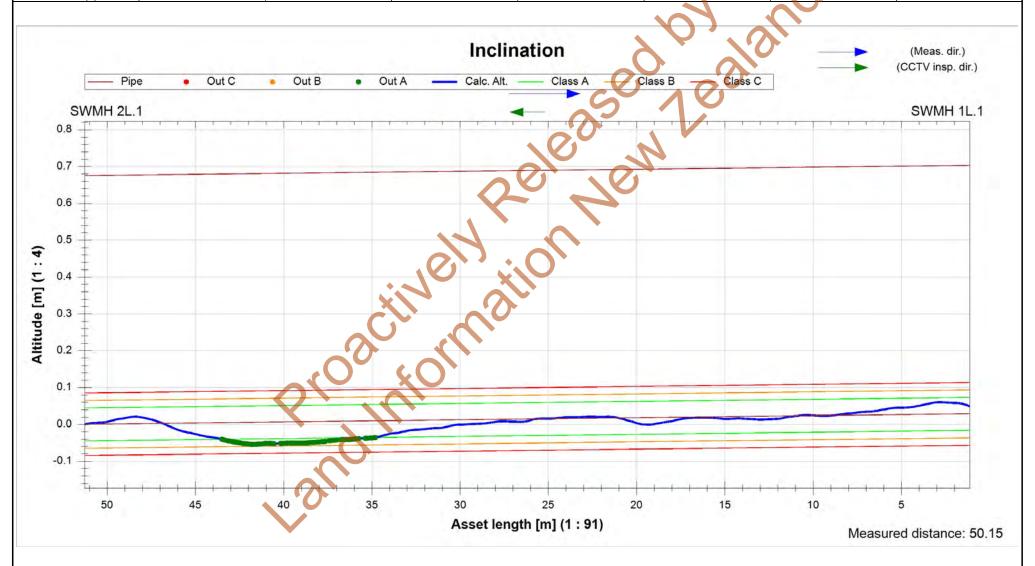
<u> </u>
Asset No.	Date	Time	Operator	Town or Suburb	Road	Setup	Surveyed Length
MH 1L.1 To MH 2L.1	4/04/2023	12:52 pm	CST Group	Tokanui		Downstream node	50.15 m
Shape	Dia/Height	Width	U/S Node	D/S Node	Start altitude	End altitude	Measured Inc
Circular pipe	675 mm	675 mm	SWMH 2L.1	SWMH 1L.1	0.000 m	0.049 m	0.098 %

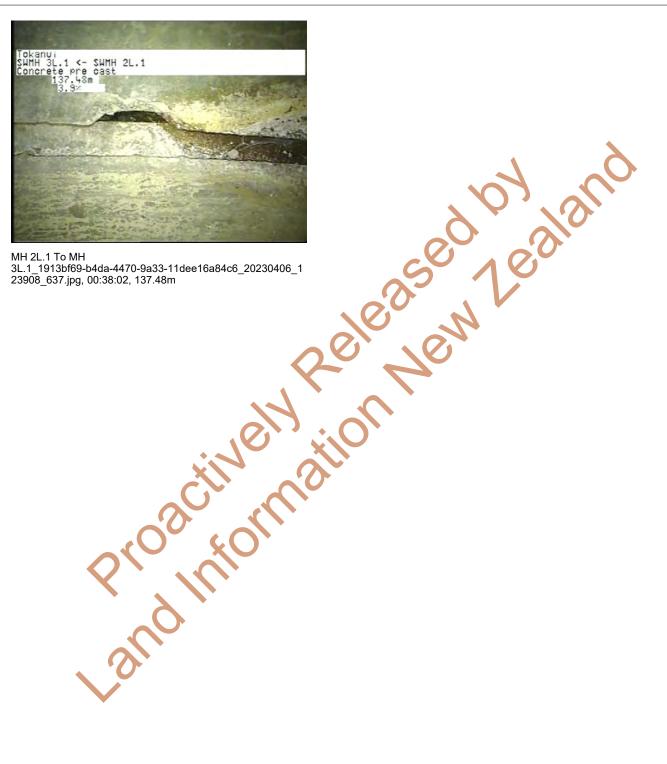
#### Section Pictures - 6/04/2023 - MH 2L.1 To MH 3L.1

MH 2L.1 To MH 3L.1 1913bf69-b4da-4470-9a33-11dee16a84c6 20230406 1 23908\_637.jpg, 00:38:02, 137.48m

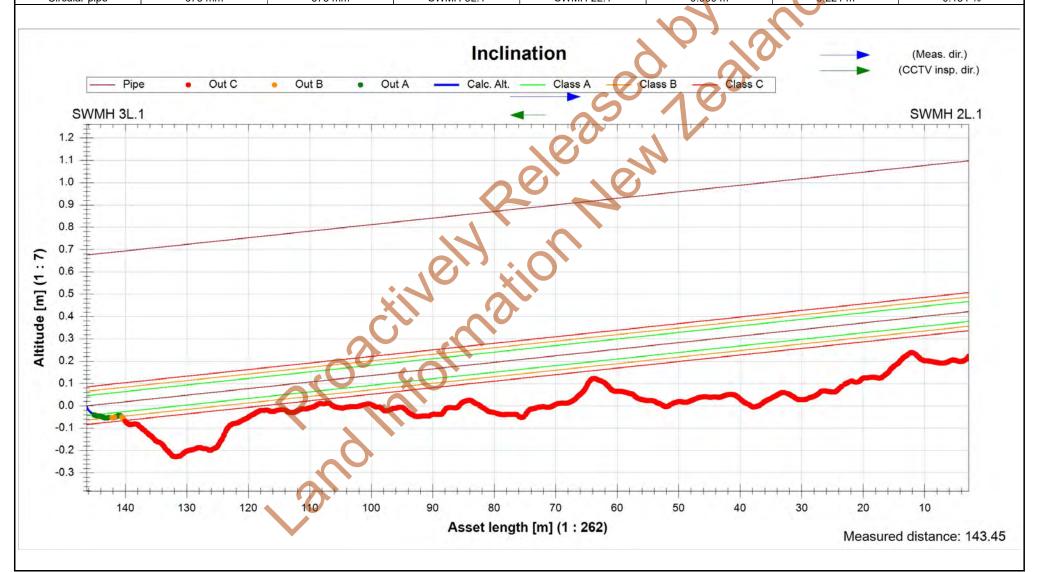
Asset No.	Date	Time	Operator	Town or Suburb	Road	Setup	Surveyed Length
MH 2L.1 To MH 3L.1	6/04/2023	11:56 am	CST Group	Tokanui		Downstream node	143.45 m
Shape	Dia/Height	Width	U/S Node	D/S Node	Start altitude	End altitude	Measured Inc
Circular pine	675 mm	675 mm	SWMH 3L1	SWMH 2L 1	0 000 m	0.221 m	0 154 %

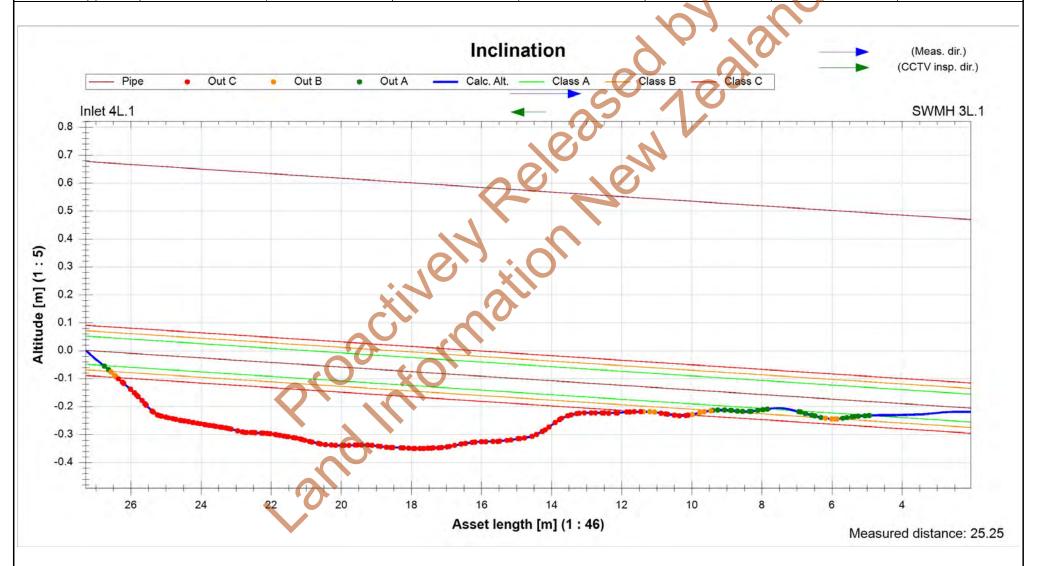
ŭ ,
Asset No.	Date	Time	Operator	Town or Suburb	Road	Setup	Surveyed Length
MH 3L.1 To Inlet 4L.1	6/04/2023	12:44 pm	CST Group	Tokanui		Downstream node	25.25 m
Shape	Dia/Height	Width	U/S Node	D/S Node	Start altitude	End altitude	Measured Inc
Circular pipe	675 mm	675 mm	Inlet 4L.1	SWMH 3L.1	0.002 m	-0.219 m	-0.871 %

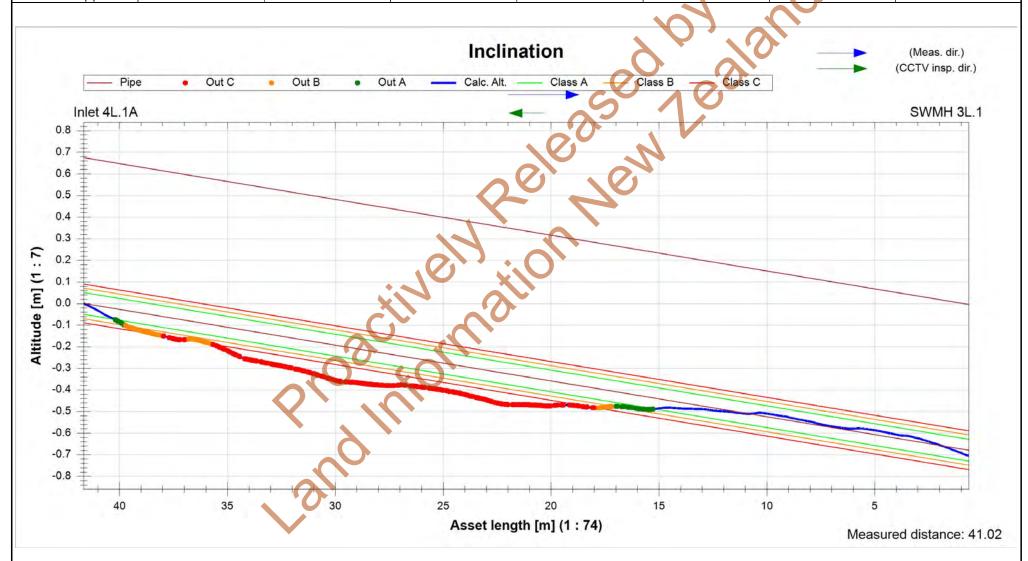
Asset No.	Date	Time	Operator	Town or Suburb	Road	Setup	Surveyed Length
MH 3L.1 To 4L.1A Inlet	6/04/2023	2:23 pm	CST Group	Tokanui		Downstream node	41.02 m
Shape	Dia/Height	Width	U/S Node	D/S Node	Start altitude	End altitude	Measured Inc
Circular pipe	675 mm	675 mm	Inlet 4L.1A	SWMH 3L.1	0.000 m	-0.704 m	-1.717 %

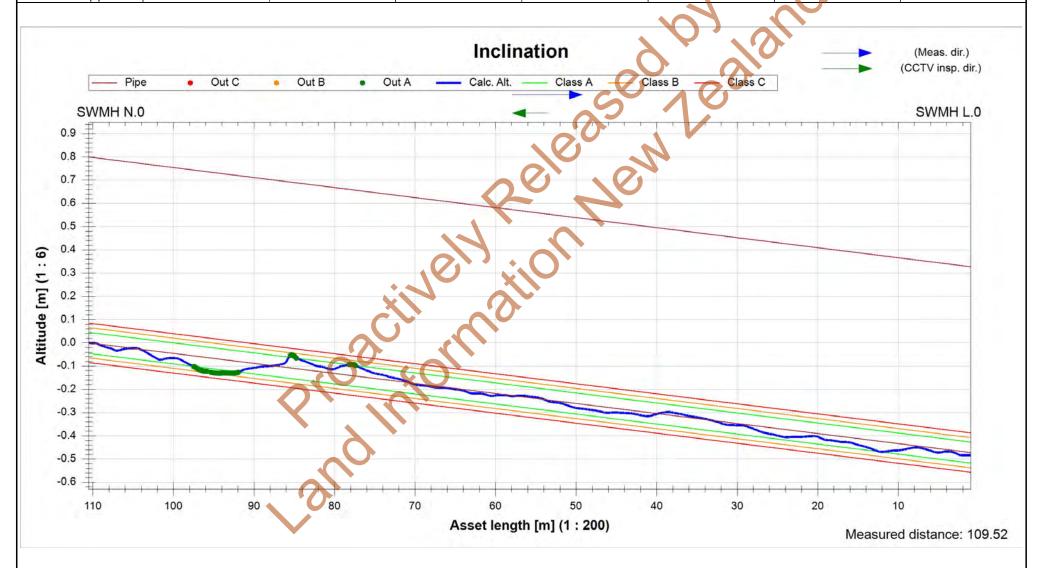
Asset No.	Date	Time	Operator	Town or Suburb	Road	Setup	Surveyed Length
MH L.0 To MH N.0	6/04/2023	3:24 pm	CST Group	Tokanui		Downstream node	109.52 m
Shape	Dia/Height	Width	U/S Node	D/S Node	Start altitude	End altitude	Measured Inc
Circular pipe	800 mm	800 mm	SWMH N.0	SWMH L.0	0.000 m	-0.484 m	-0.442 %

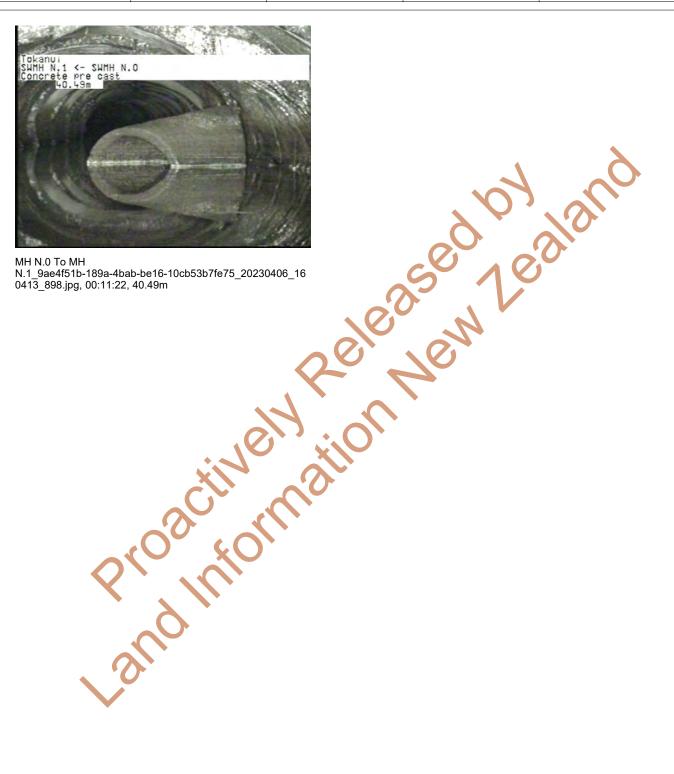
### Section Pictures - 6/04/2023 - MH N.0 To MH N.1

MH N 0 To MH N.1 9ae4f51b-189a-4bab-be16-10cb53b7fe75 20230406 16 0413\_898.jpg, 00:11:22, 40.49m

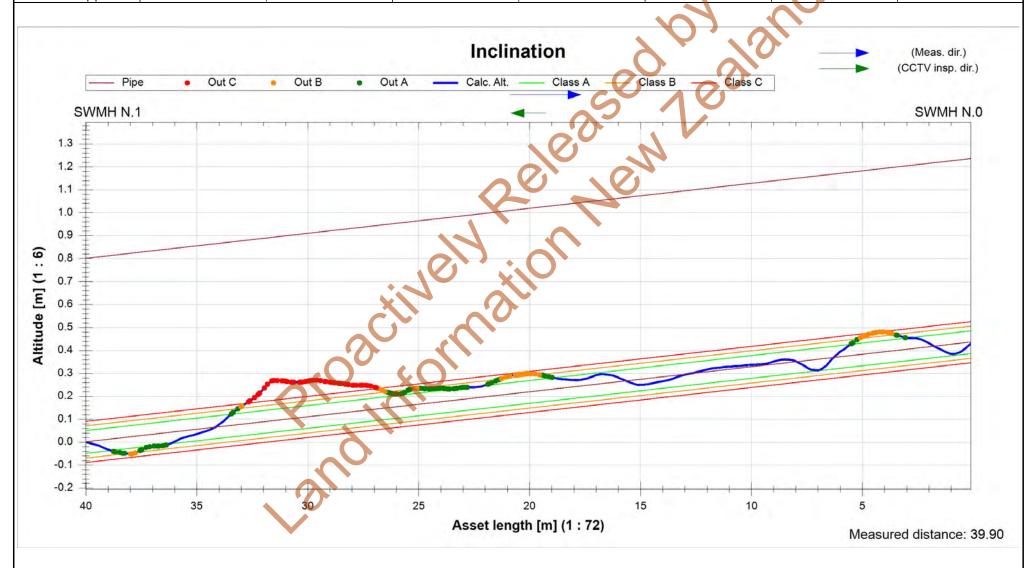
# Section Inclination - 6/04/2023 - MH N.0 To MH N.1

Asset No.	Date	Time	Operator	Town or Suburb	Road	Setup	Surveyed Length
MH N.0 To MH N.1	6/04/2023	3:50 pm	CST Group	Tokanui		Downstream node	39.90 m
Shape	Dia/Height	Width	U/S Node	D/S Node	Start altitude	End altitude	Measured Inc
Circular pipe	800 mm	800 mm	SWMH N.1	SWMH N.0	0.000 m	0.429 m	1.074 %

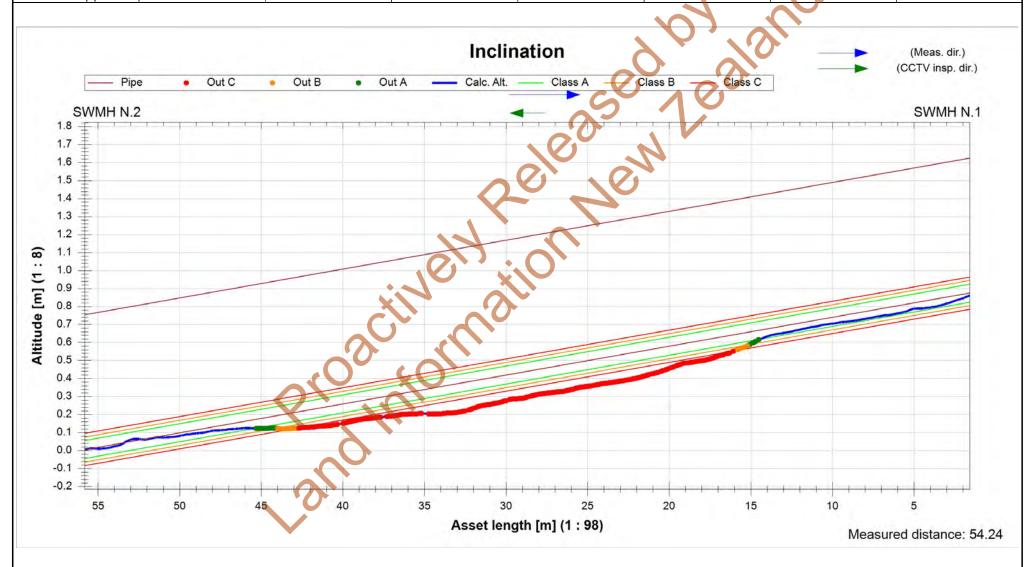
Asset No.	Date	Time	Operator	Town or Suburb	Road	Setup	Surveyed Length
MH N.1 To MH N.2	24/04/2023	9:46 am	CST Group	Tokanui		Downstream node	54.24 m
Shape	Dia/Height	Width	U/S Node	D/S Node	Start altitude	End altitude	Measured Inc
Circular pipe	750 mm	750 mm	SWMH N.2	SWMH N.1	0.004 m	0.860 m	1.578 %

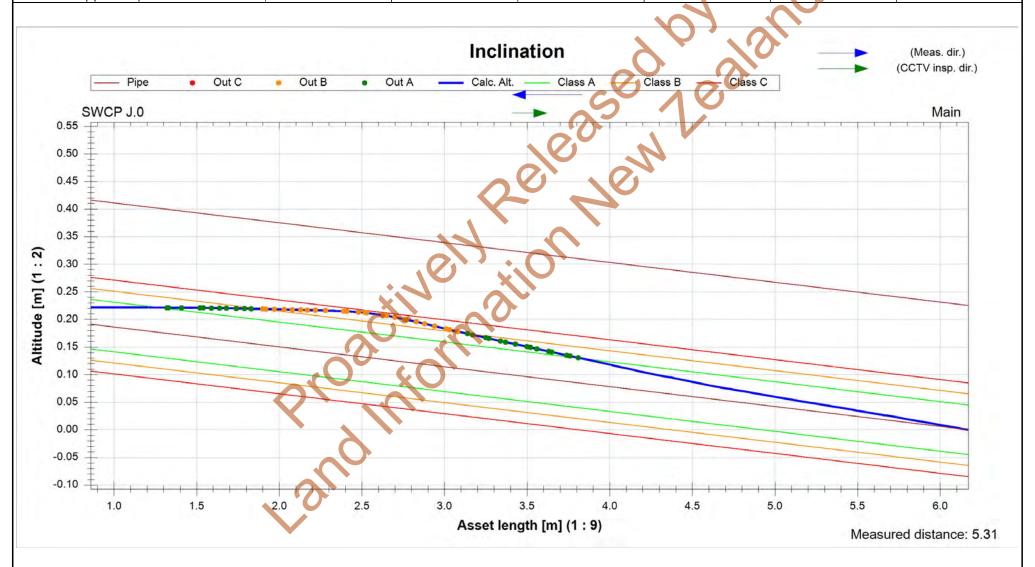
# Section Inclination - 27/03/2023 - CP J.0 To Main

Asset No.	Date	Time	Operator	Town or Suburb	Road	Setup	Surveyed Length
CP J.0 To Main	27/03/2023	1:35 pm	CST Group	Tokanui		Upstream node	5.31 m
Shape	Dia/Height	Width	U/S Node	D/S Node	Start altitude	End altitude	Measured Inc
Circular pipe	225 mm	225 mm	SWCP J.0	Main	0.000 m	0.222 m	-4.174 %

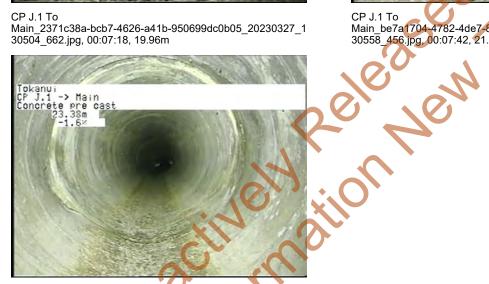
Main\_d7b5f459-51b5-438e-8b58-3e1d4f671a4d\_20230327\_1 30837\_353.jpg, 00:08:32, 23.38m

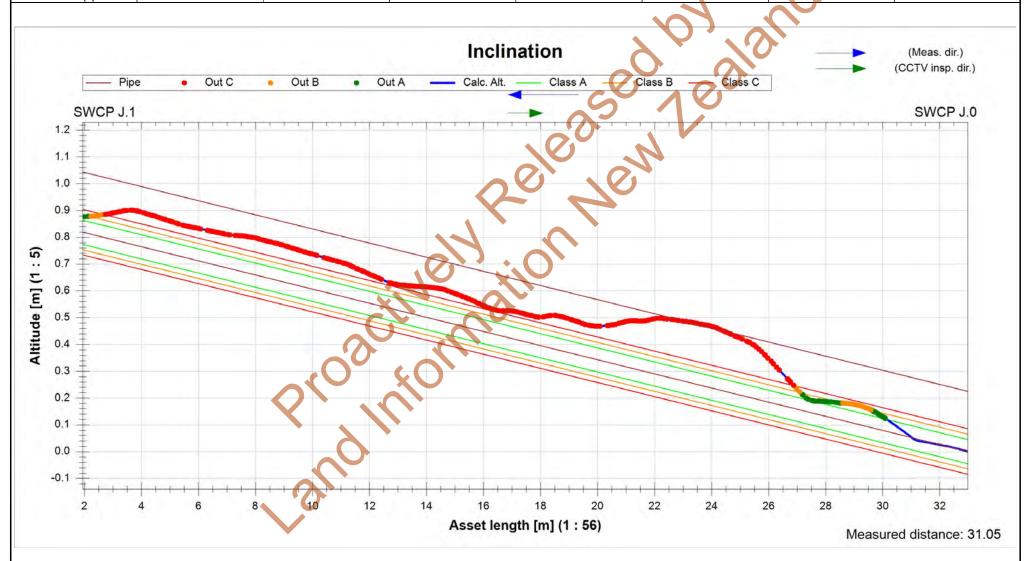
Asset No.	Date	Time	Operator	Town or Suburb	Road	Setup	Surveyed Length
CP J.1 To CP J,0	27/03/2023	12:56 pm	CST Group	Tokanui		Upstream node	31.05 m
Shape	Dia/Height	Width	U/S Node	D/S Node	Start altitude	End altitude	Measured Inc
Circular pipe	225 mm	225 mm	SWCP J.1	SWCP J.0	0.000 m	0.876 m	-2.822 %
