FORMER TOKANUI HOSPITAL
EXISTING DISPOSAL SITE – FLOOD RISK & MITIGATION
ASSESSMENT REPORT

TOITŪ TE WHENUA – LAND INFORMATION NEW ZEALAND
FORMER TOKANUI PSYCHIATRIC HOSPITAL DEMOLITION AND REMEDIATION
EXISTING DISPOSAL SITE – FLOOD RISK & MITIGATION ASSESSMENT REPORT

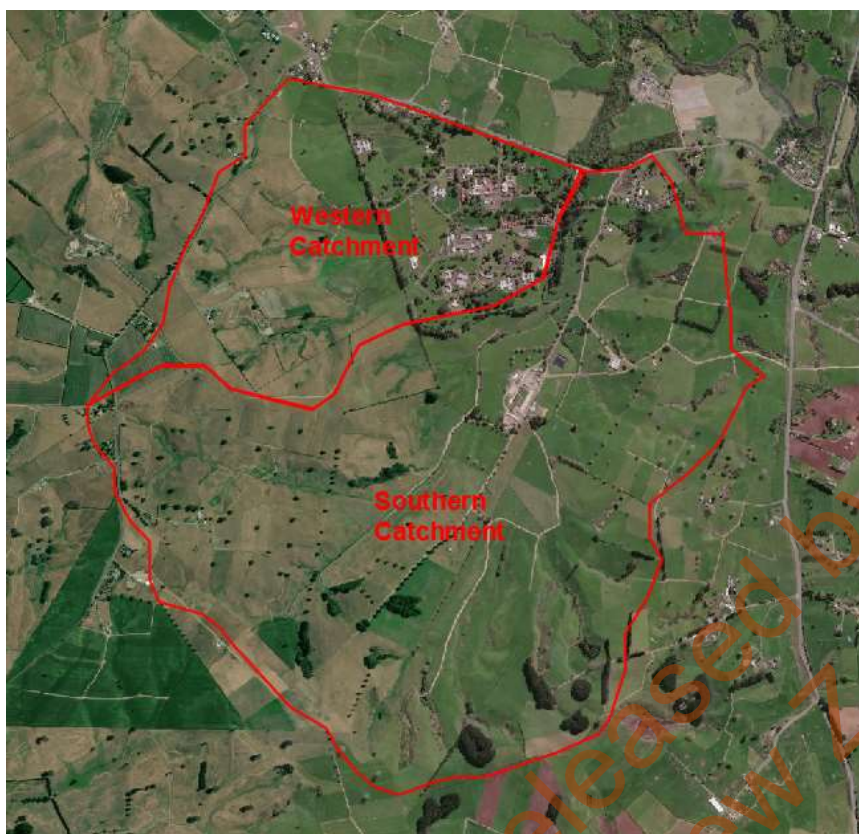
Figure 1: Catchment Locations

Stormwater flows were calculated using the Waikato Stormwater Runoff Modelling Guideline TR20/06 methodology. The catchment is primarily composed of alluvium and colluvium gravel sand and mud. A curve number of 74 was assumed for the entire area corresponding to good condition, open space with group C soils. The catchment flow hydrograph was modelled in HEC-HMS for the 1% Annual Exceedance Probability (AEP) rainfall event, as well as the 1% AEP (annual exceedance probability) event including an allowance for climate change. Climate change was accounted for by using the HIRDS RCP8.5 “business as usual” rainfall scenario for the years 2081-2100 (refer Figure 2), equivalent to a rainfall increase of approximately 22.5% over existing rainfall. This is considered more conservative than allowing for a 2.1 degree increase in temperature as specified by the Waikato Stormwater Runoff Modelling Guideline. Refer Appendix A for associated calculations.

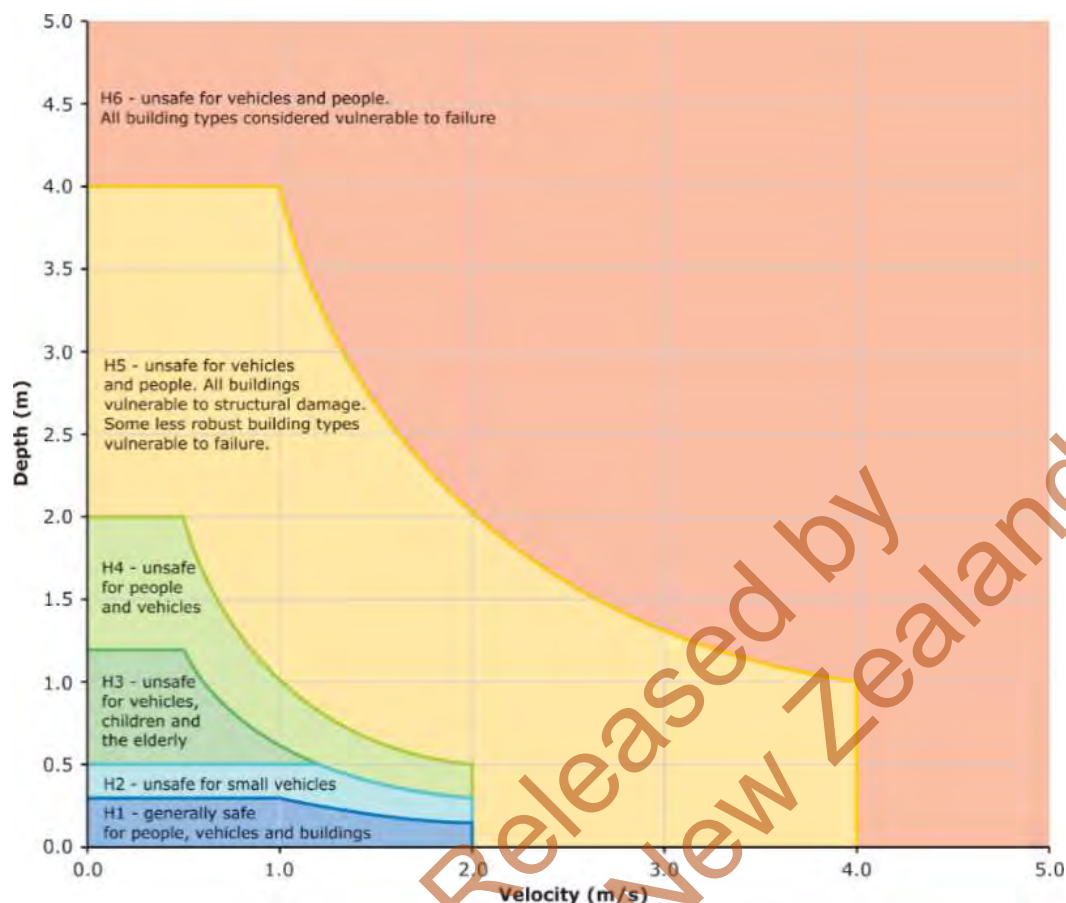
Figure 4: Depth/Velocity Envelopes (from Smith et al., 2014 – from Australian Rainfall and Runoff – Book 6: Flood Hydraulics, Chapter 7 Safety Design Criteria).

- (e) Effect on overtopping of flood waters on Te Mawhai Road. This is considered to be the most critical potential effect. This was evaluated in terms of the modelled flow depth and velocity across the road and corresponding flood hazard, which is a function of both the depth and velocity and expressed as a hazard rating increasing in severity from category H1 to H6, as shown in the following diagram.

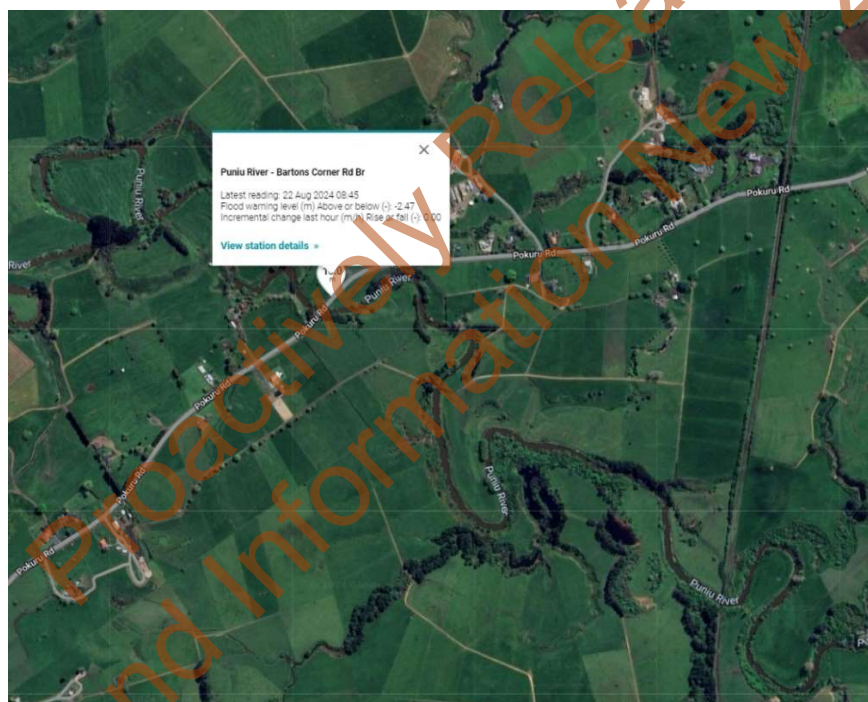
Figure 9: Location of Pūniu at Bartons Corner Rd Br station.

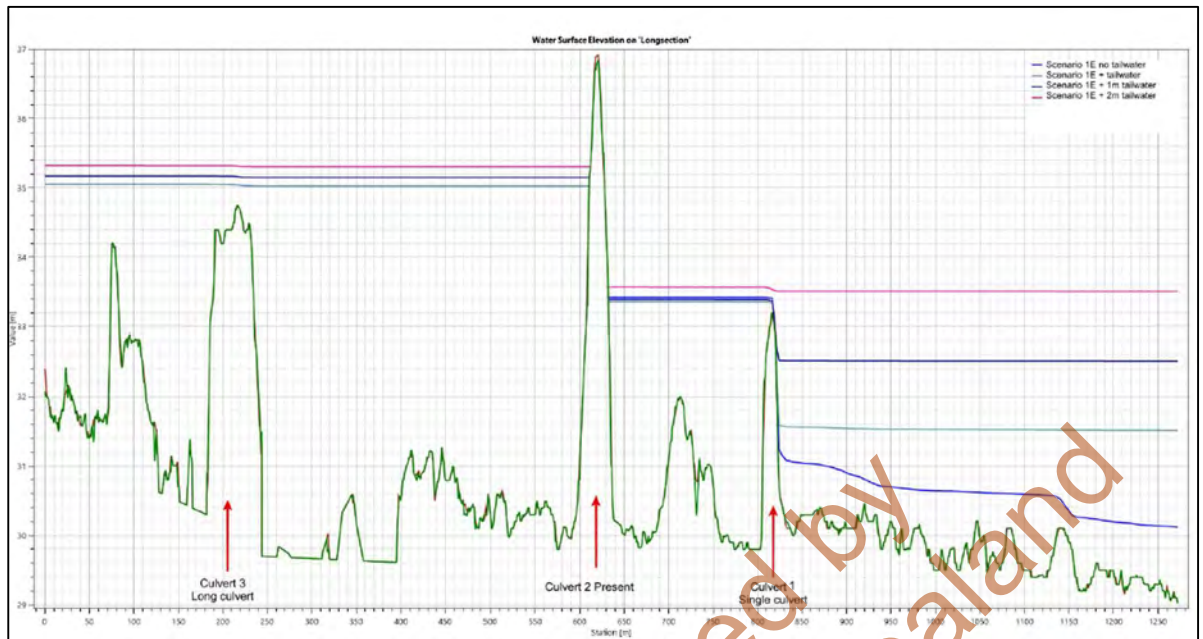
Figure 11: Model Results – Scenario 1E

When another 2m is added to the tailwater level (to 33.51mRL), water levels at Te Mawhai Road in the existing scenario begin to increase higher than the no tailwater existing scenario (1E) water levels, hence showing that the tailwater is starting to have an effect on the water level at Te Mawhai Rd (refer Figure 11 and drawing M05).

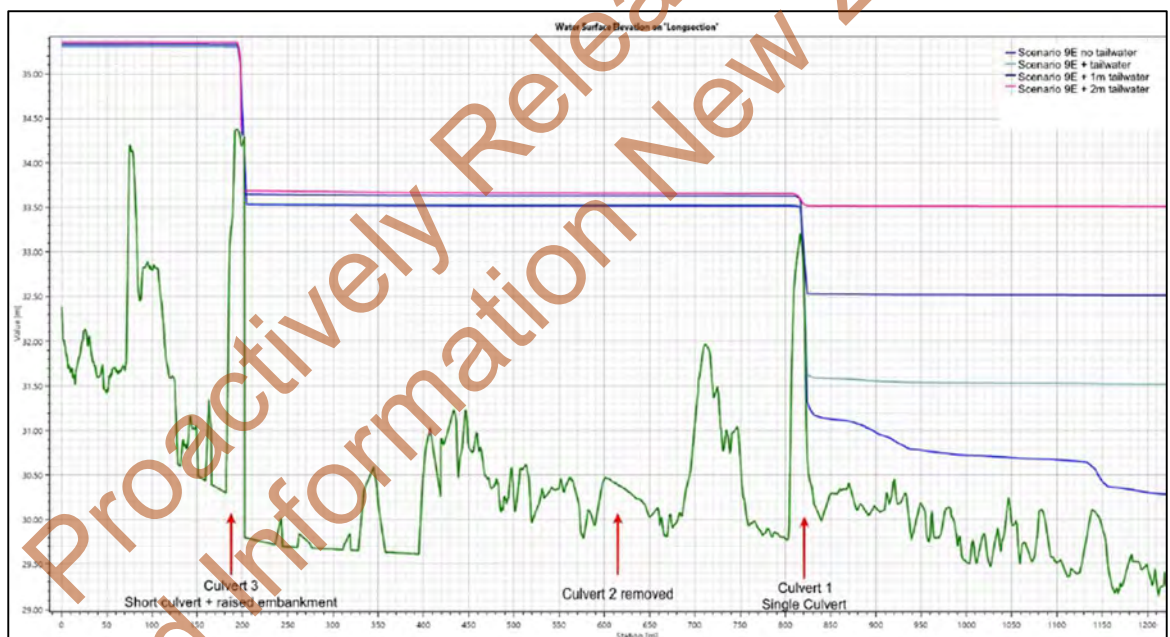
Figure 12: Model Results – Scenario 9E

In scenario 9 with a single culvert at Te Mawhai Road (9E), the water level remains consistently higher than in scenario 1E, both before and after the tailwater is applied (Figure 12). Therefore, this single culvert option is not as effective as scenario 14E in managing downstream water and tailwater effects.

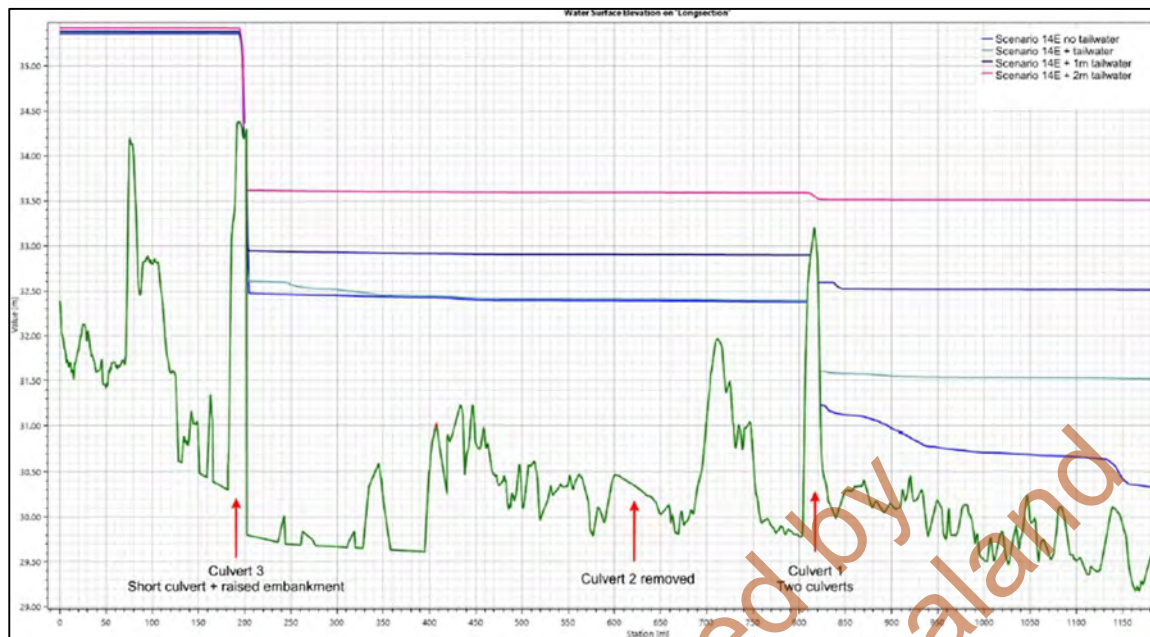
Figure 13: Model Results – Scenario 14E

In scenario 14 with 2 culverts at Te Mawhai Rd (14E), there is no overtopping over Te Mawhai Road until when another 2m is added to the tailwater (refer Figure 13 and drawing M07). Water level at Te Mawhai Rd in 14E is similar to that of 1E, where both levels are close to the increased tailwater level. It is observed that when overtopping occurs at Te Mawhai Road, the WWPS would also be inundated. This highlights that this scenario does not worsen tailwater effects but actually prevents inundation of WWPS and overtopping at Te Mawhai Road until tailwater increases by over 1m.

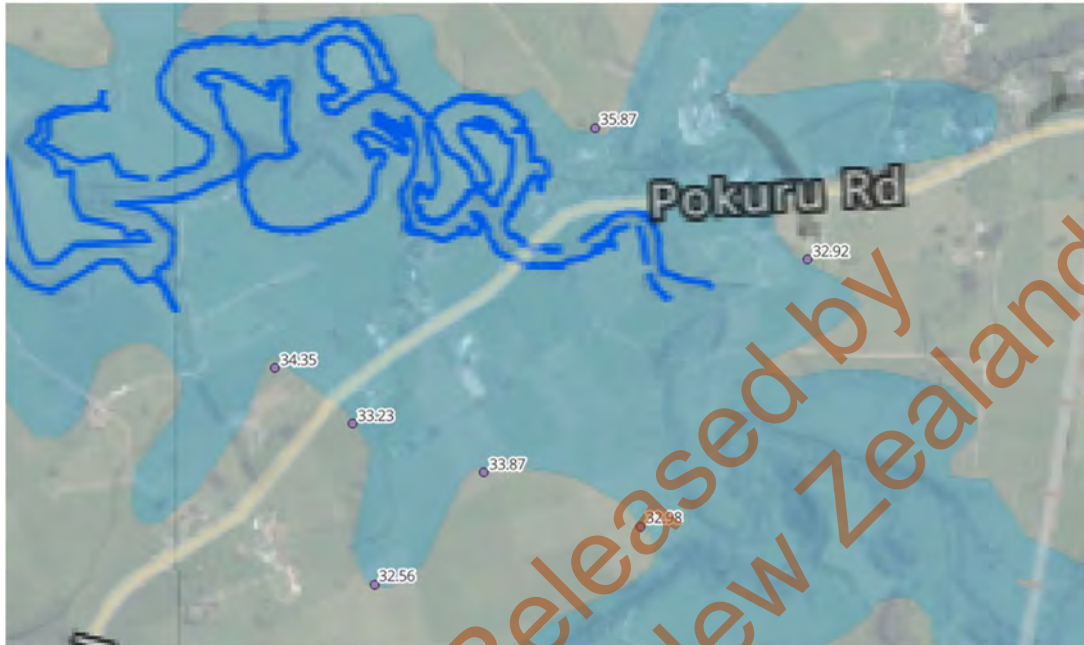
Figure 14: Flood levels at Pokuru Rd bridge based on WRC Flood Hazard Extent.

Checking contour data against the WRC flood extent gives higher flood levels of 32.2mRL to 36mRL in this area, as shown in Figure 14, again noting that these levels are not consistent (i.e. flood levels upstream are lower than downstream and flood levels vary on opposite sides).

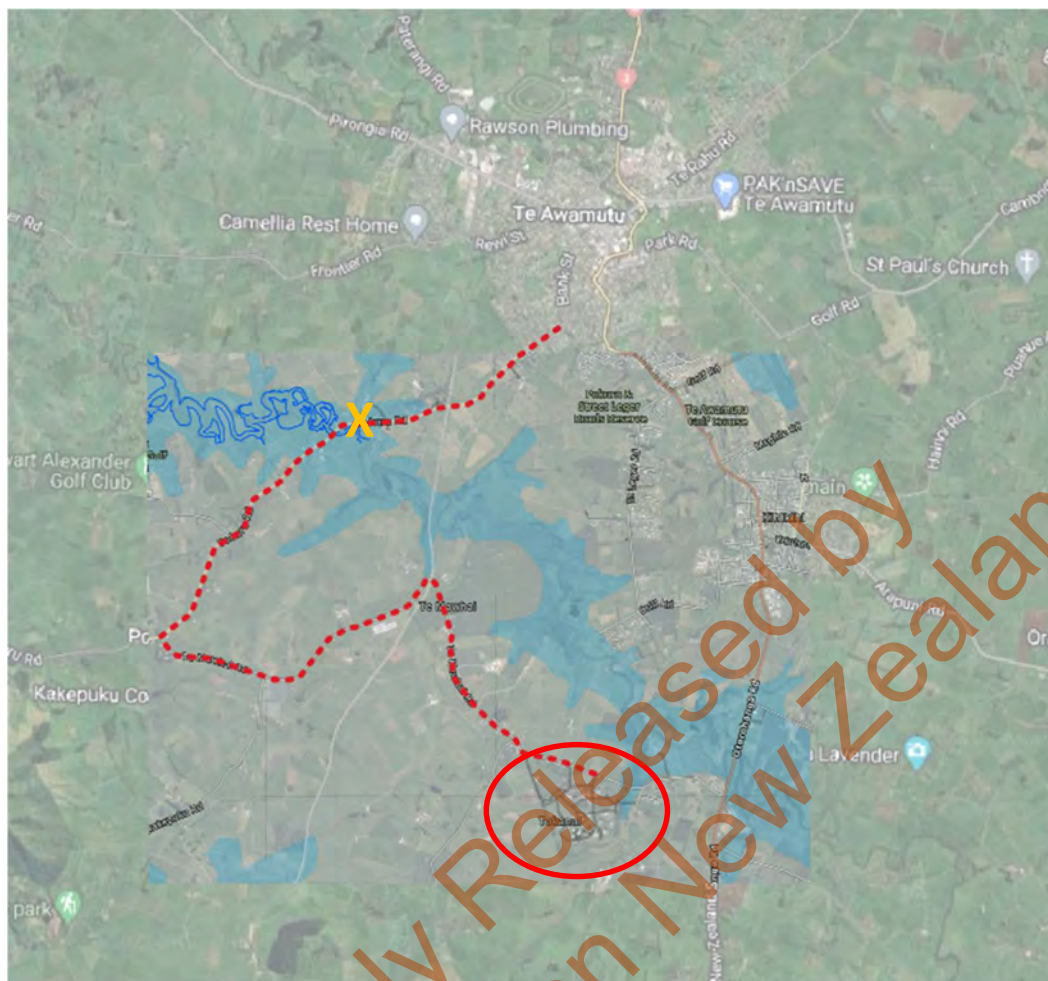
Figure 17: Access/egress route from subject site to nearest town, Te Awamutu. Location of subject site (red circle) and Pūniu at Barton's Corner Rd Br station (orange X).

In the event of flooding on Te Mawhai Road northeast of the subject site, the emergency access and egress route to the nearest town, Te Awamutu, would be via the northwest side of the subject site. From there, the route follows Te Mawhai Road westward, then turns northeast towards Pokuru Road, and finally continues to Te Awamutu, as indicated by the red dashed lines in Figure 15.

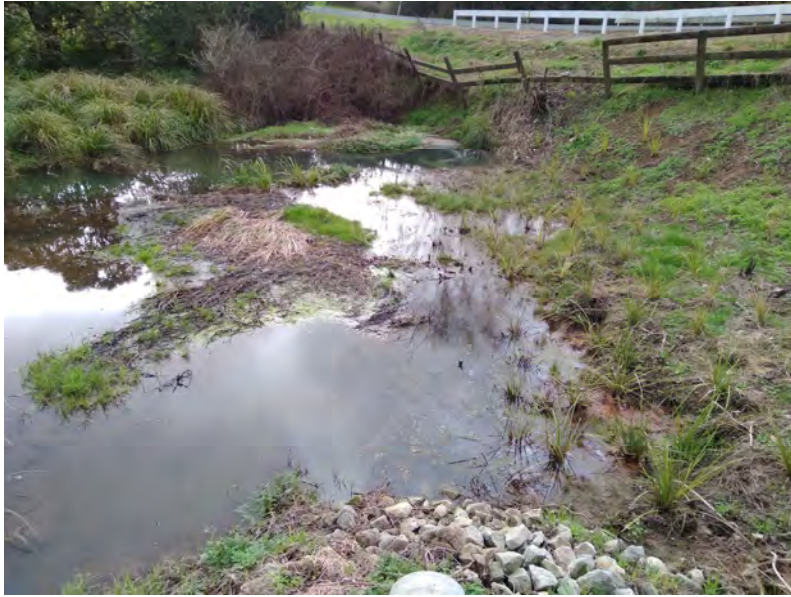
Culvert 1 Inlet – showing signs of bank slumping/
subsidence

- (b) It was explained that several attempts had already been made to locate Culvert 1 but without success, due to it being submerged. Photos were shared showing some signs of subsidence in the road embankment on the inlet side of this culvert. Mr Hudson also advised that fallen trees and willows is relatively common in the district on small streams similar to this one and these can cause culverts upgradient of them to be submerged. He advised that if the culvert was found to be blocked or collapsed, or downstream trees need removing, then their road maintenance crew can assist with this.

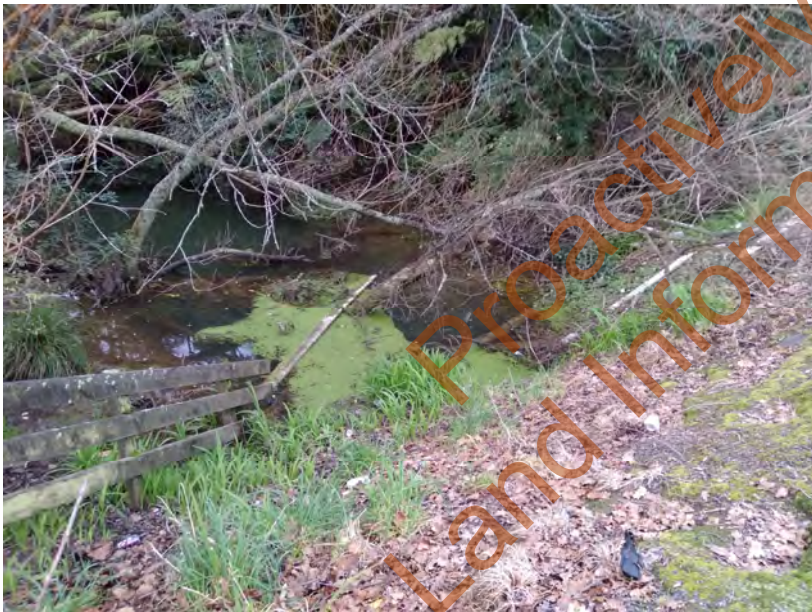
Culvert 1 Outlet – note extensive debris/windfall

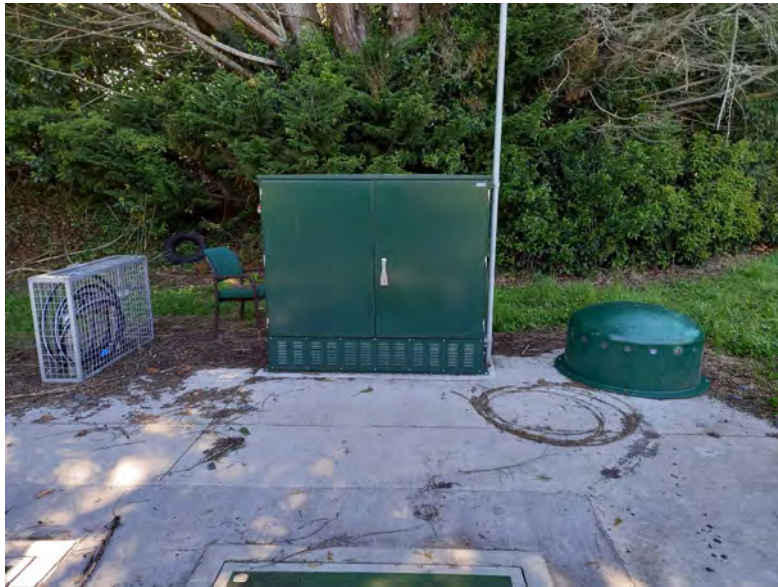
Wastewater Pump Station (WWPS)

- (e) LINZ own the WWPS but have a maintenance agreement for it with WDC. To minimise flood damage to the WWPS, consideration may be given to raising the electrical control cabinet, noting that the WWPS access lids are all sealed. However, Mr Hodson advised that WDC likes the control cabinets to be close to the WWPS for ease of maintenance.

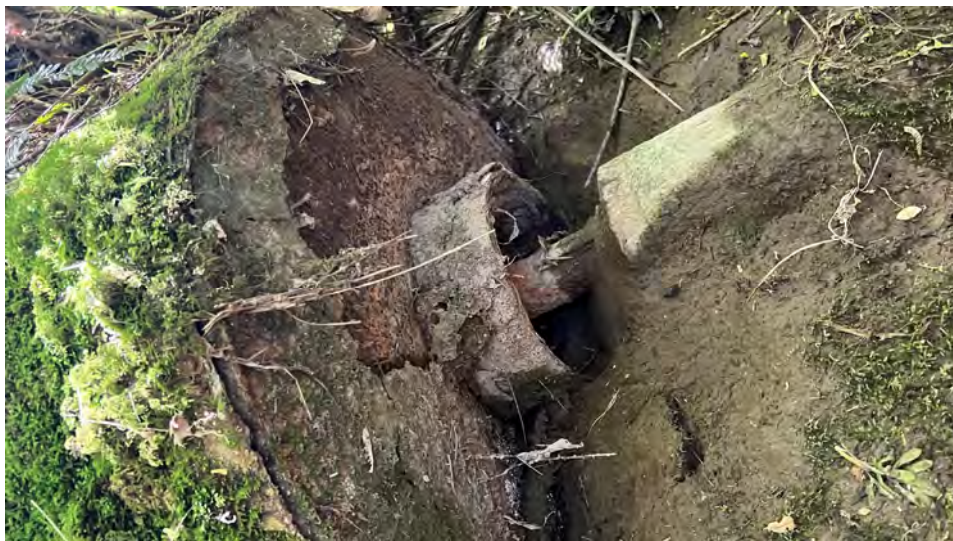
Unidentified feature at western bank - Culvert 3 Outlet
